Semi-annual environmental monitoring report

Project number: 45169-001
Loan number: ADB Loan 3056-KGZ (SF)
Grant number: 0366-KGZ (SF)

January – June 2021

KGZ: Central Asia Regional Economic Cooperation
Corridor 3 (Bishkek -Osh Road) Improvement
Project, Phase 4

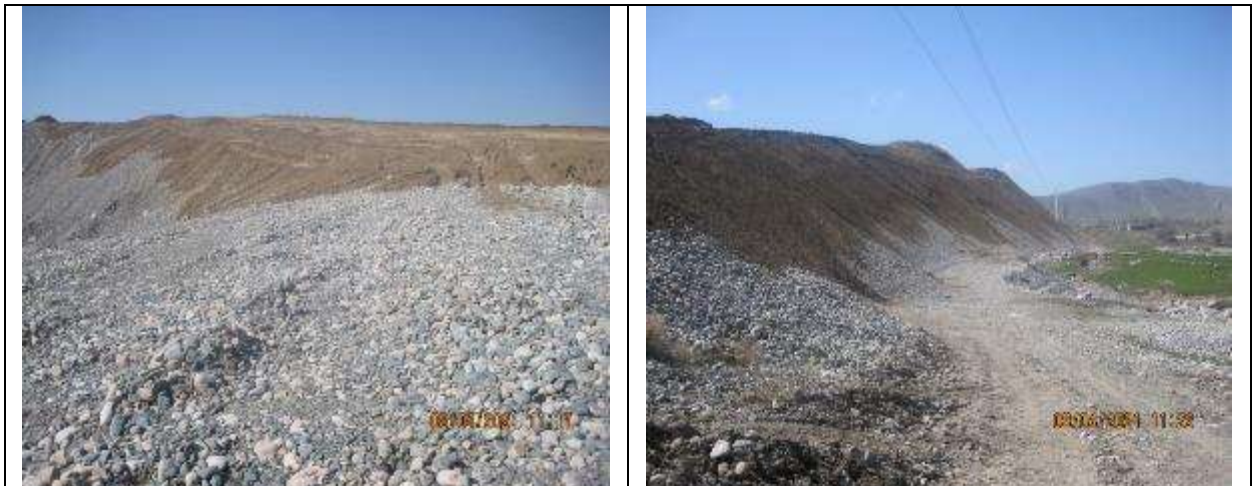
Figure 20 Jelamysh borrow pit after reclamation

53. Reclamation works at the Jelamysh borrow pit were completed in early April. However, the contractor has not completed the formal handover of this site, and the reclamation completion certificate has not yet been signed. The district Commission conducted a visit to the Jelamysh borrow pit on June 14, 2021. Based on the results of the site inspection, the district commission found some problems with leveling the ground, which must be eliminated by the Contractor. The contractor expects to complete the levelling work by the end of July 2021. The commission's repeated visit for the acceptance of the reclaimed borrow pit is scheduled for July 23, 2021.

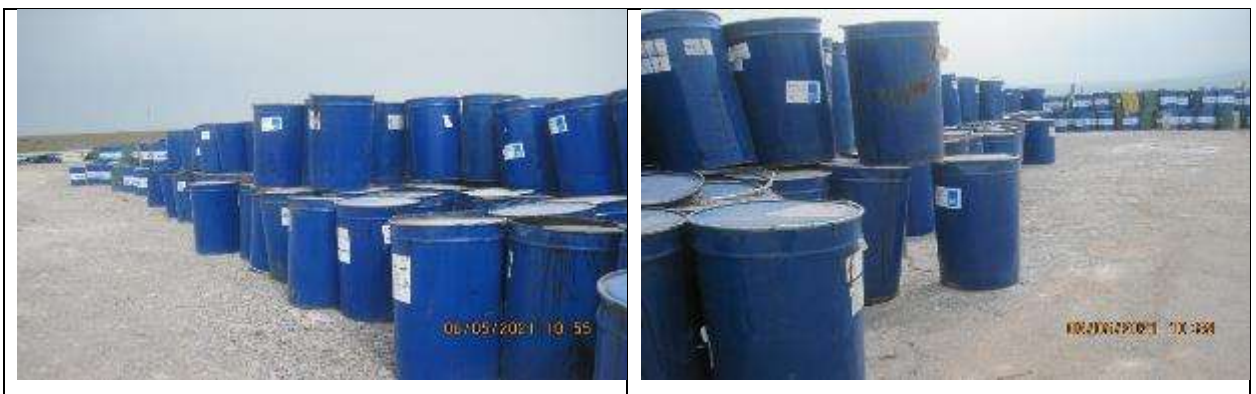
67. To prepare the asphalt mixture, a large number of barrels with bitumen were delivered to the production site, which were partially placed on a specially prepared area. A large number of barrels were installed on the ground, without the use of an anti-filtration coating.

Figure 25 Barrels of bitumen on a special prepared site

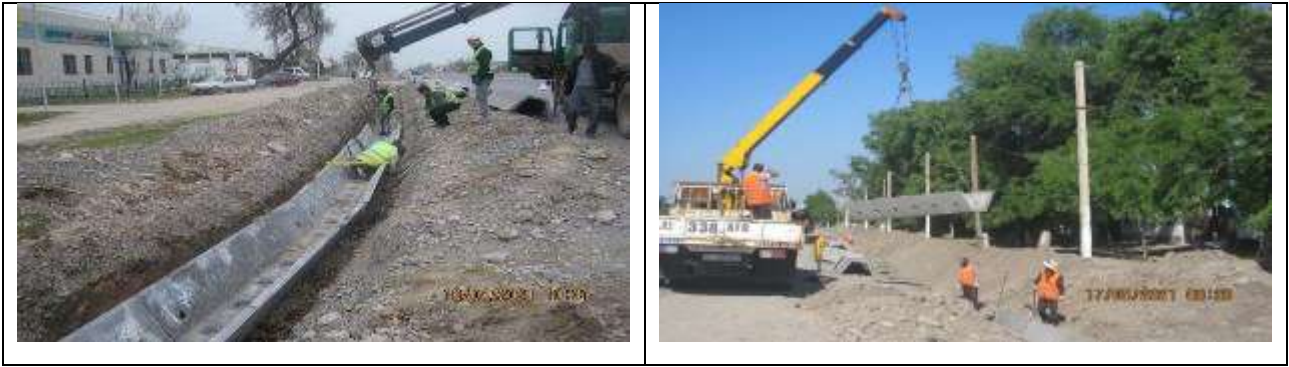
Figure 33 Violation of safety precautions during installation of culvert chutes.

113. During the work on the installation of culvert chutes, the facts of safety violations were noted (absence of helmets) when moving load by cranes. The contractor was notified on the need for constant monitoring of safety measures and explanatory work among workers.

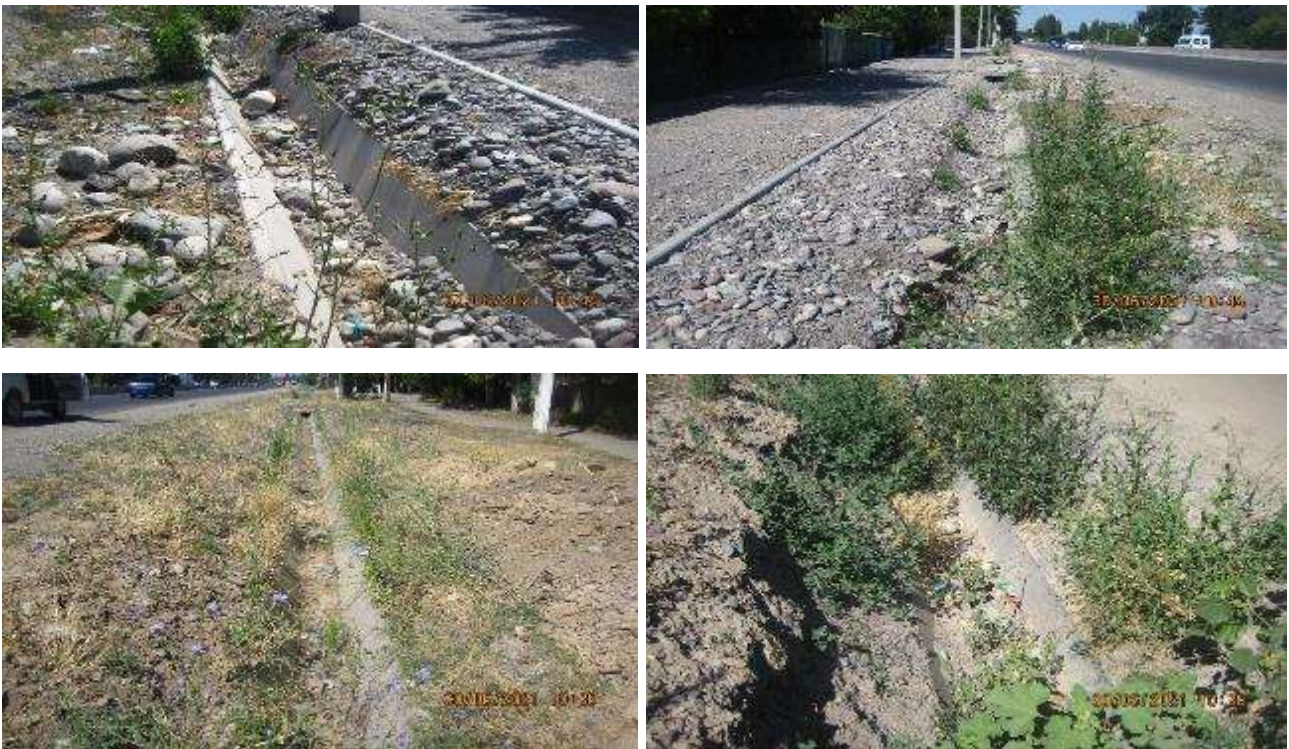
114. Previously installed culvert chutes in many places are overgrown with grass, filled with construction waste. The contractor was warned about the elimination of the detected violations, but the situation remained unchanged.

Figure 34 Condition of previously installed chutes

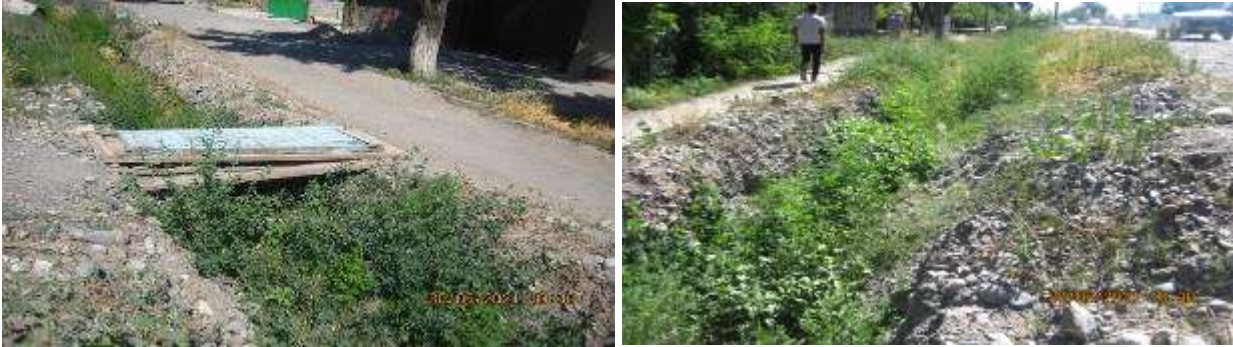
Figure 35 Previously excavated and abandoned trench for culvert chutes

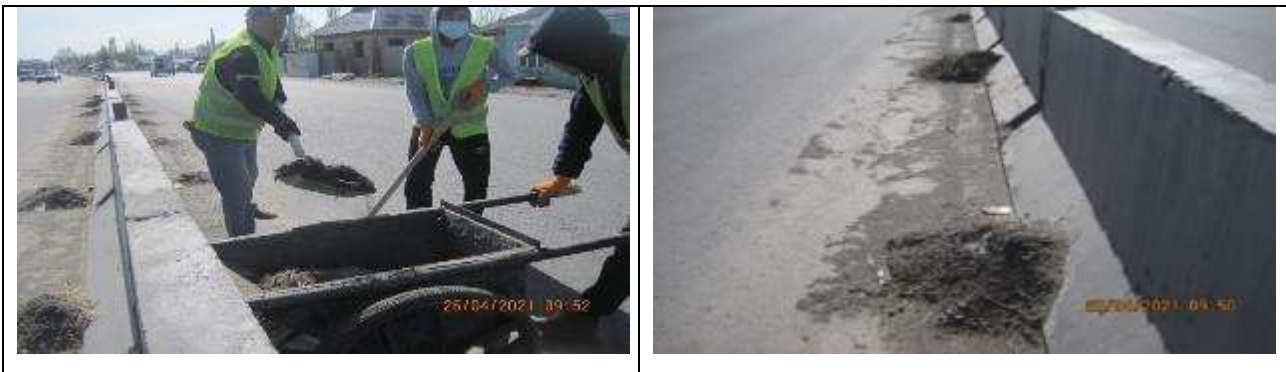
117. During the monitoring, it was found that the soil accumulated near the parapets in the winter period was cleaned out and taken to the road shoulder, which is unacceptable, since in case of rains, in wet condition, it will turn into mud, which will contribute to public dissatisfaction. A letter was sent to the contractor about the need to immediately remove soil waste from the road to places specially designated by the local administration. This violation was eliminated by the Contractor in due time.

Figure 36 Cleaning parapets from accumulated soil

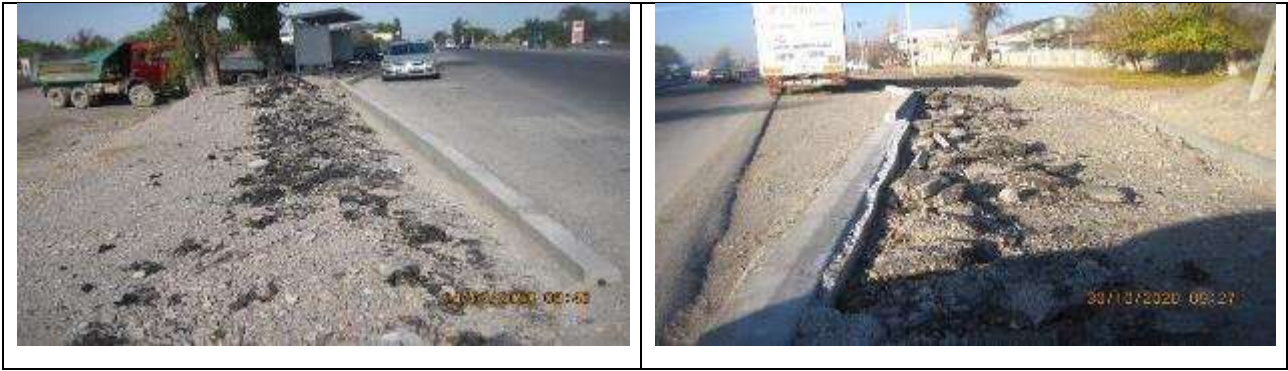
119. Also, during the reporting period work was carried out on the construction of bus stops. This produced a large amount of asphalt scraps. The contractor was repeatedly warned about the need for timely removal of waste from the road.

Figure 37 Cleaning of bus stops from asphalt scraps

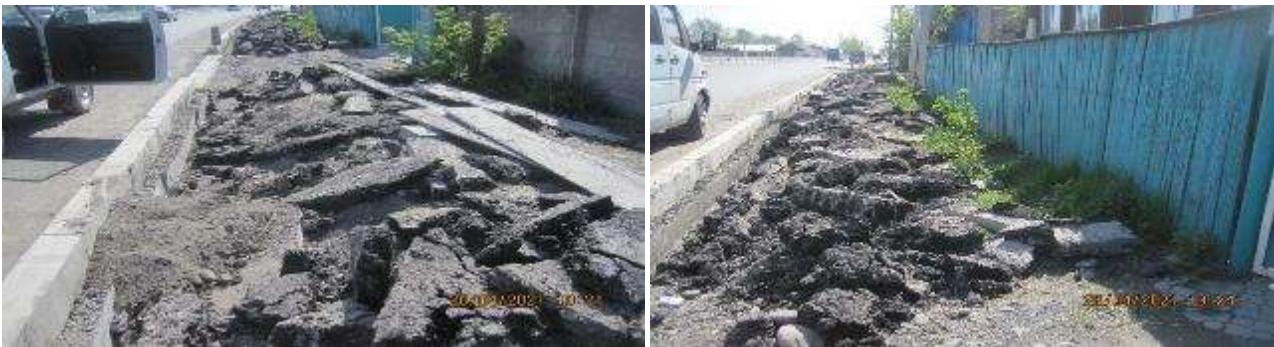
120. On the road section (south side) km 41 + 90, sidewalk was covered with the removed asphalt. The locals were forced to walk on the carriageway, which posed a threat to life. A letter was sent to the contractor with the established deadlines for the elimination of this violation. In due time, the removed asphalt was taken out, the sidewalk was cleared.

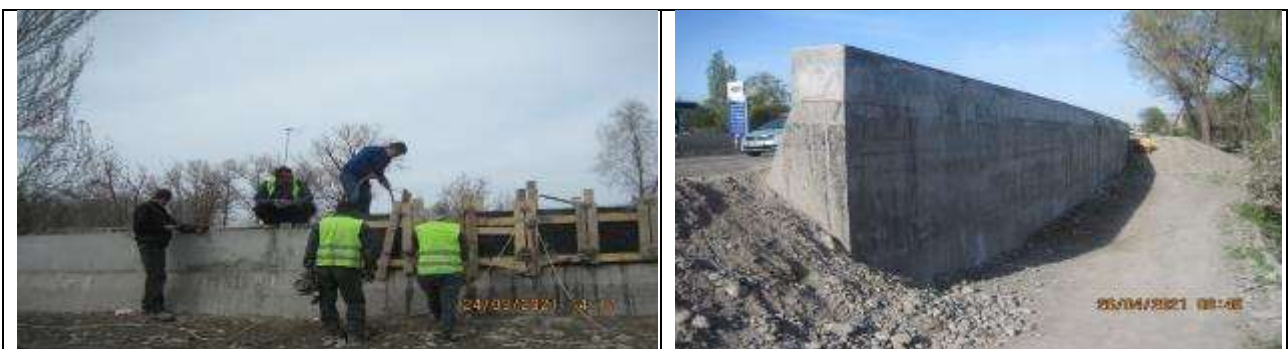
121. At km 26 + 500 (north side), a retaining wall was built up. During the work, violations by the workers of Safety and Health precautions were noted (work at height without personal protective equipment, lack of protective helmets). There were no special devices for work at height - ladders. The contractor was recommended to check the knowledge of occupational health and safety requirements of workers and, if necessary, to re-instruct on occupational health and safety.

Figure 38 Violation of safety precautions when working at height

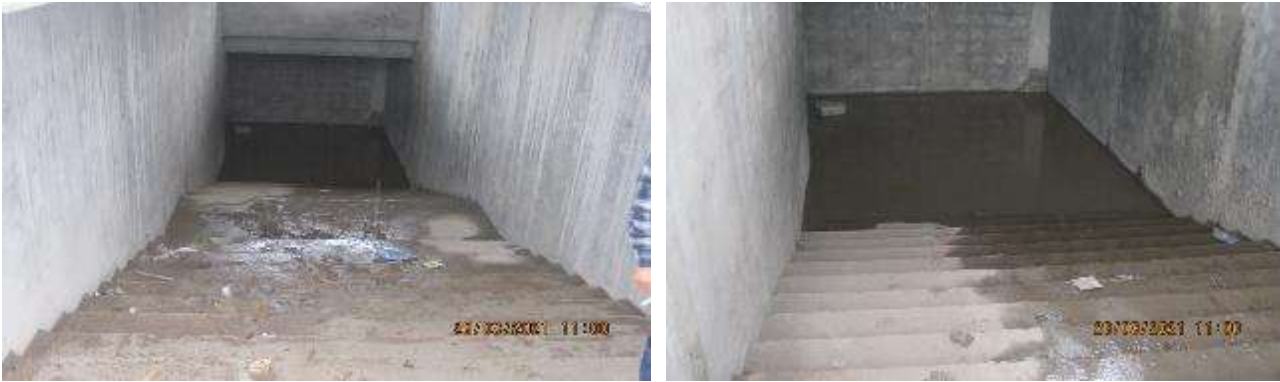
122. Currently, the construction of five underground passages is almost completed. Considering that during the construction of underground passages, the presence of a close occurrence of the groundwater level was noted, the Consultant constantly monitors these objects to identify flooding and the possibility of timely elimination.

Figure 39 Underground passage flooding at km 57 + 420 during the rainy season in March 2021

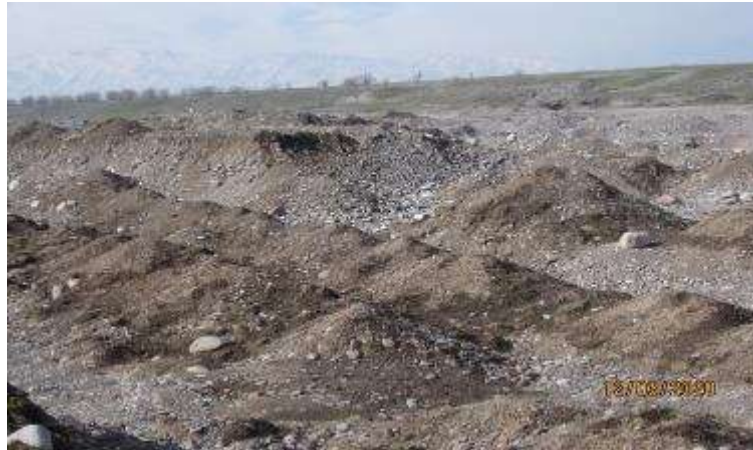
129. **Ak-Suu 2 borrow pit.** To date, there are large areas of lands disturbed in the process of subsoil use. The levelling of these areas has started.

Figure 41 Areas disturbed in the process of subsoil use in Ak-Suu 2 borrow pit

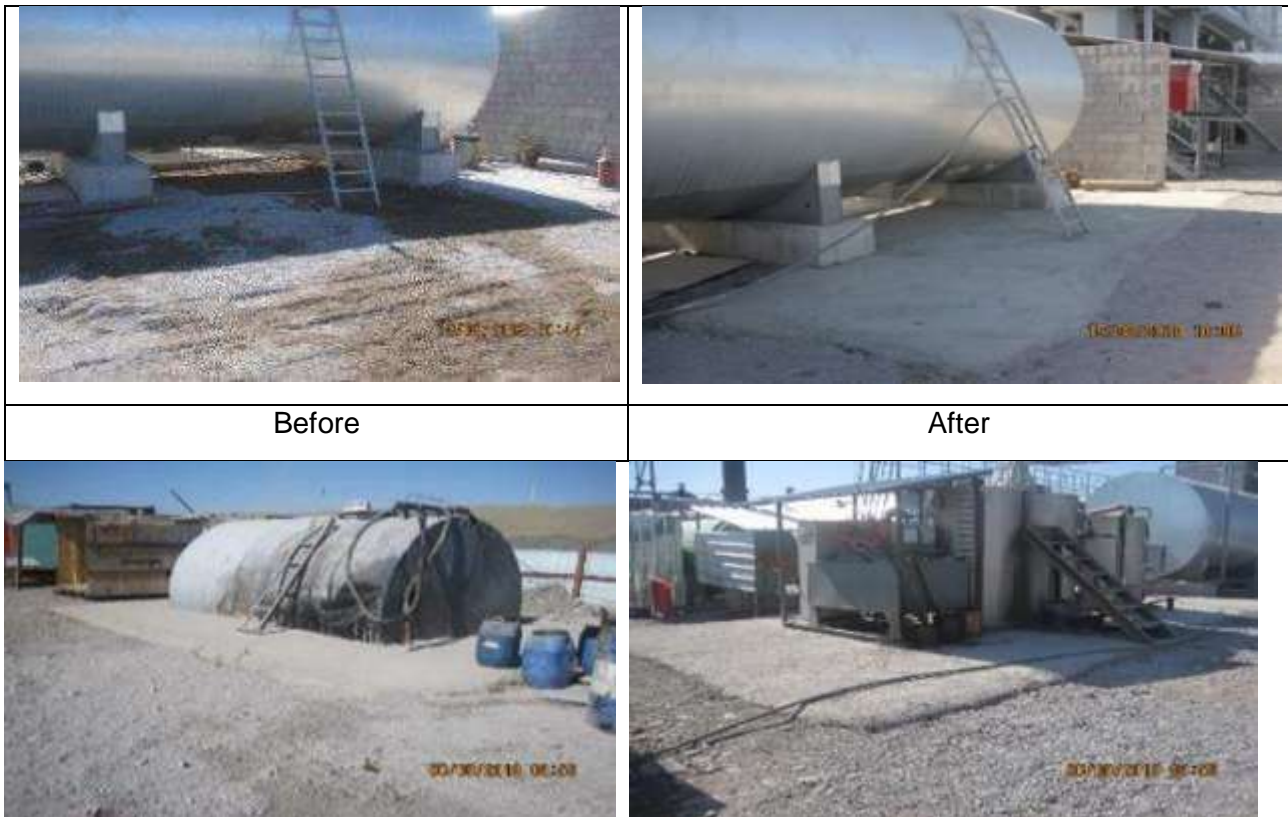
Figure 43 Impermeable protective coating around chemical containers

132. The contractor was recommended to protect the soil around the tanks with chemical reagents from spills and leaks of hazardous materials with an impenetrable protective coating. These recommendations were taken into account and implemented by the Contractor.

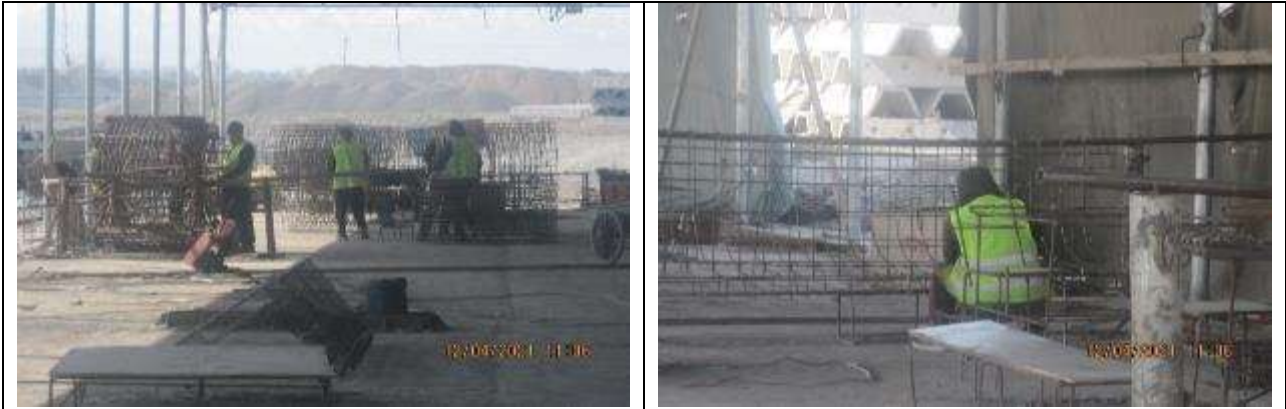
(concrete rings, trays, curbs, New Jersey-type fences, etc.) was also carried out. Workers are not provided with sufficient personal protective equipment.

Figure 45 Work of the reinforcement-welding section

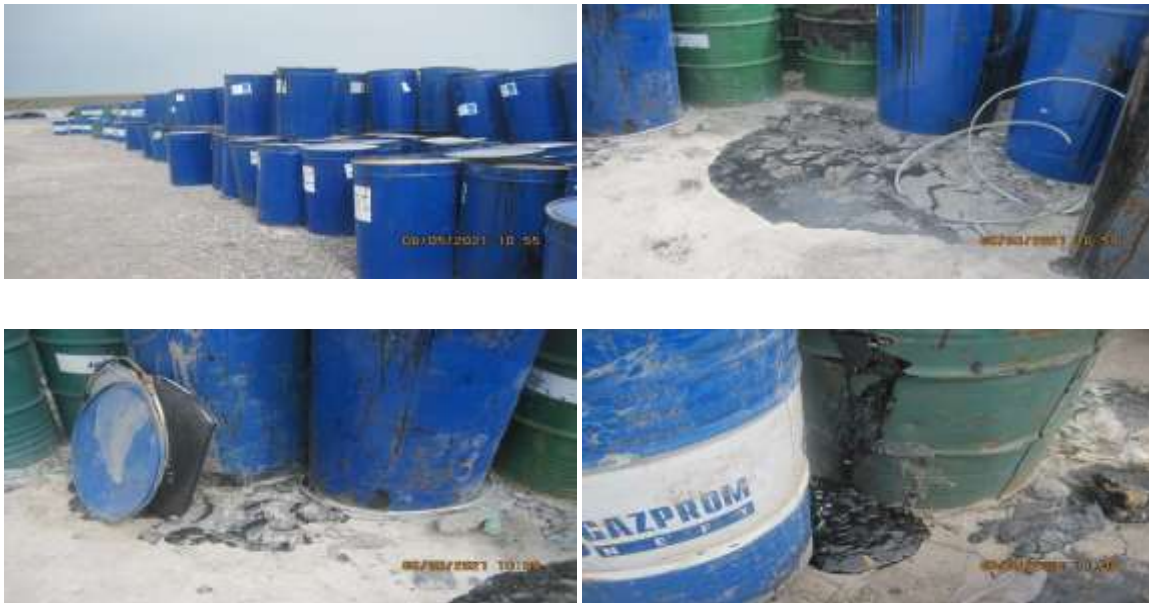
140. For the preparation of the asphalt mixture, a large number of barrels with bitumen were delivered to the production site, which were partially placed on a specially prepared site. A large number of barrels were installed on the ground, without the use of an anti-filtration coating. Bitumen leaks have been detected. A letter was sent to the contractor to eliminate this environmental violation.

Figure 50 Bitumen leaks

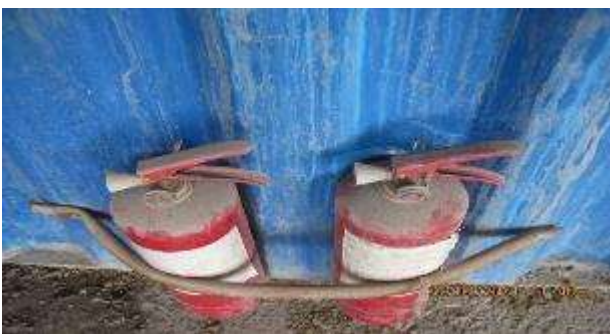
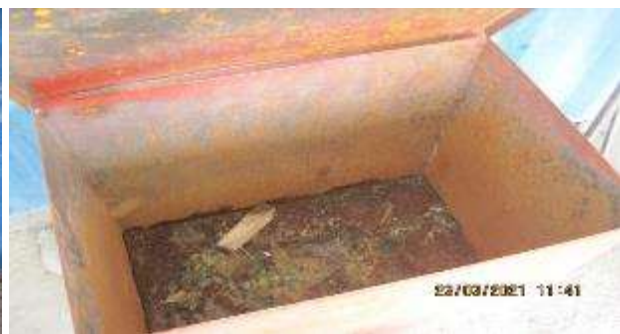
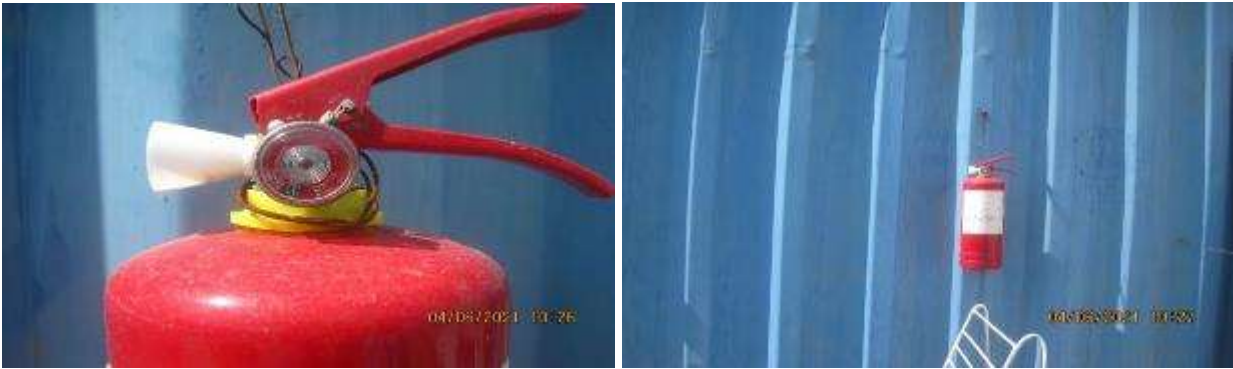
148. Also, fire extinguishers are fixed on the sunny side of the living room, which is also unacceptable. Contractor was instructed that the fire extinguishers should be placed in an area protected from the sun in such a way that they are protected from direct sunlight. They can be installed on the floor, with mandatory fixation from a possible fall in case of accidental exposure. A letter was sent to the contractor with the specified deadlines for eliminating the detected violation. The contractor replaced unusable fire extinguishers, the box on the fire shield is filled with sand.

Figure 54 Fire extinguishers installed with violations on the territory of the production site

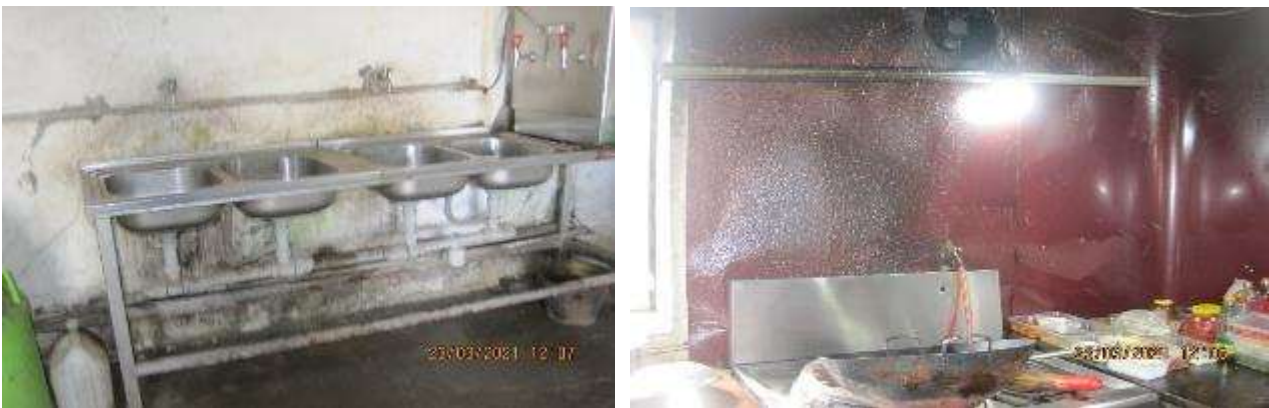
Figure 55 The unsatisfactory state of the kitchen block on the territory of Belovodsk

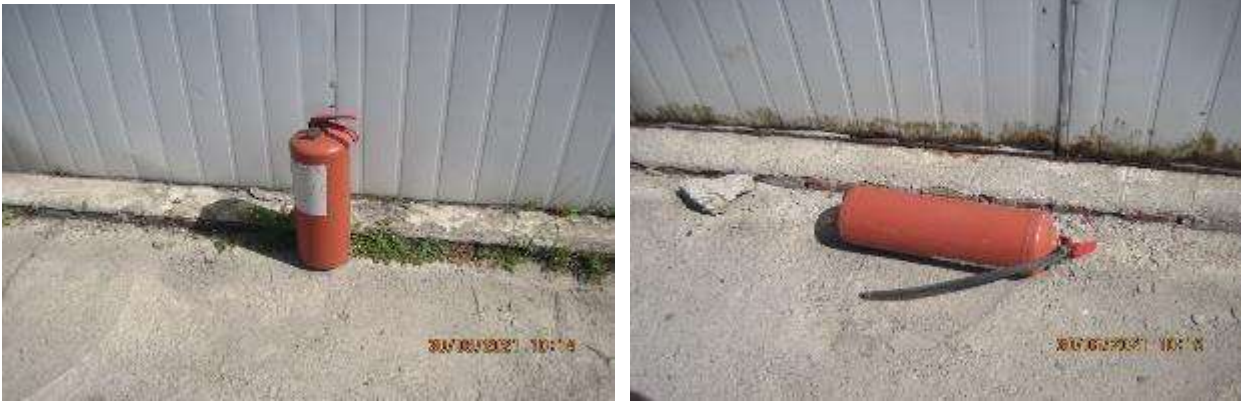
Figure 56 Fire extinguishers installed with violations on the territory of the base in Sokuluk

152. The contractor was warned about this violation, the fire extinguishers were removed to the premises.

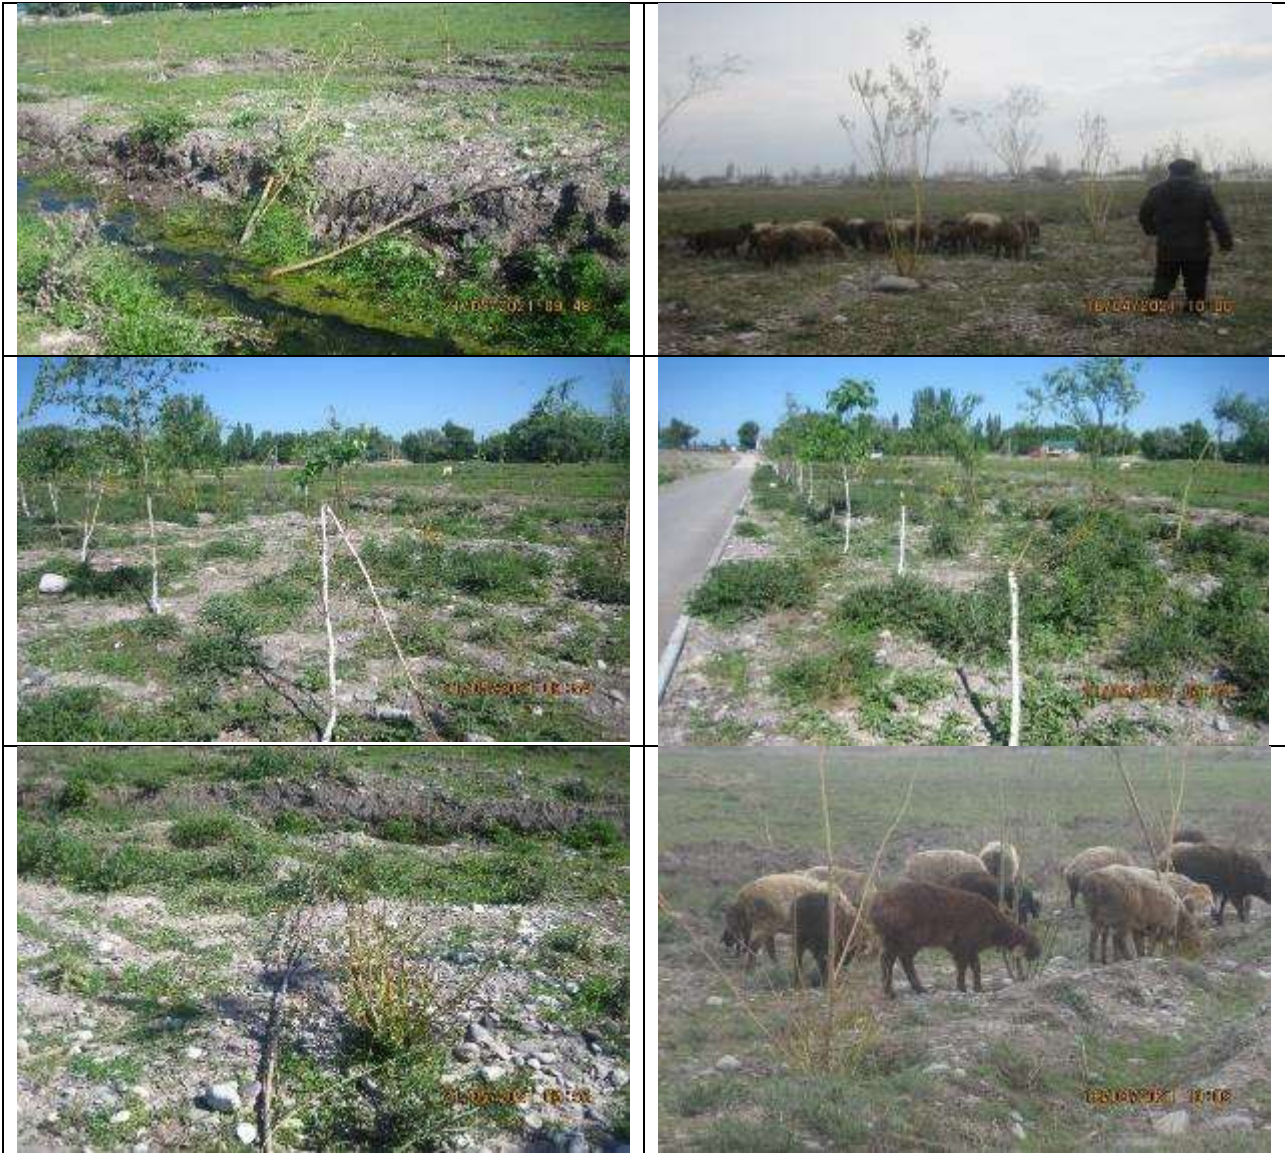
Figure 59 Seedlings eaten by domestic animals and broken seedlings
