# Semi-annual environmental monitoring report

July - December 2021

Central Asian Regional Economic Cooperation Corridor 3 Improvement Project (Bishkek-Osh road), Phase 4, Bishkek-Kara-Balta section (km 8.5 - km 61).

**Prepared by:** Joint Venture Temelsu International Engineering Services Inc., E.Gen Consultants Ltd., and Desh Upodesh Ltd. in association with Kyrgyz TREC International, Ltd. for the Ministry of Transport and Communications of the Kyrgyz Republic and the Asian Development Bank

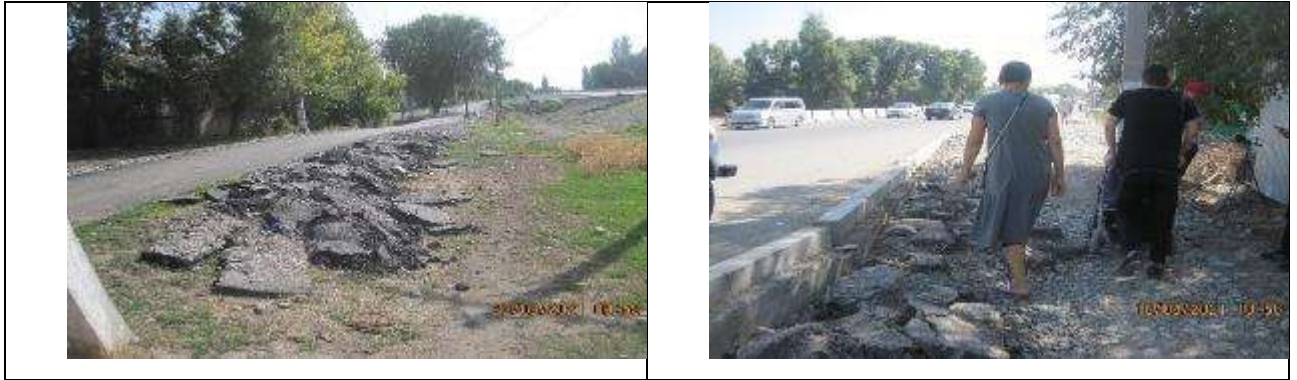
112. During the construction of bus stops and sidewalks, a large number of asphalt scraps was accumulated. The contractor did not always remove waste from the road in a timely manner. In the village of Sokuluk, at km 26+820 section, the sidewalk was littered with large pieces of asphalt scraps, which made it difficult for pedestrians to walk on it. A letter was sent to the contractor about the elimination of this violation. In due time, the waste of the old asphalt was removed.

Figure 43. Asphalt scraps on the road.

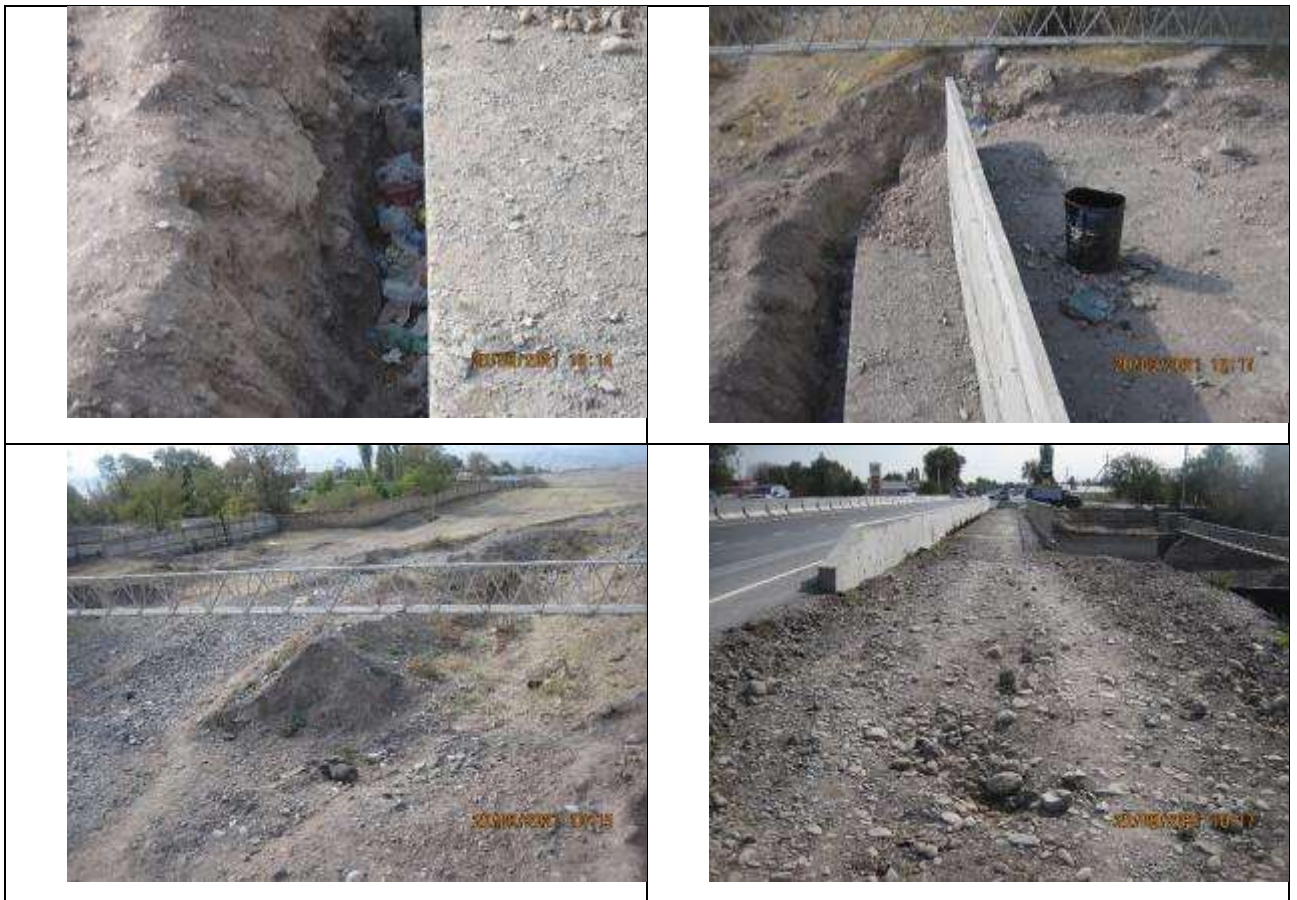
115. During the environmental monitoring of construction sites, it was also found that during the construction of retaining walls on the Ak-Suu River, a trench was not backfilled, and is littered with plastic bags and bottles. The construction of retaining walls remains unfinished to date, which may cause flooding of the adjacent territory when water to flow into riverbed. Also, to date, the soil which used to regulate the flow of water in the river during construction has not been removed from the riverbed. A letter was sent to the contractor about the elimination of these violations.

Figure 46. Ak-Suu River after unfinished construction.

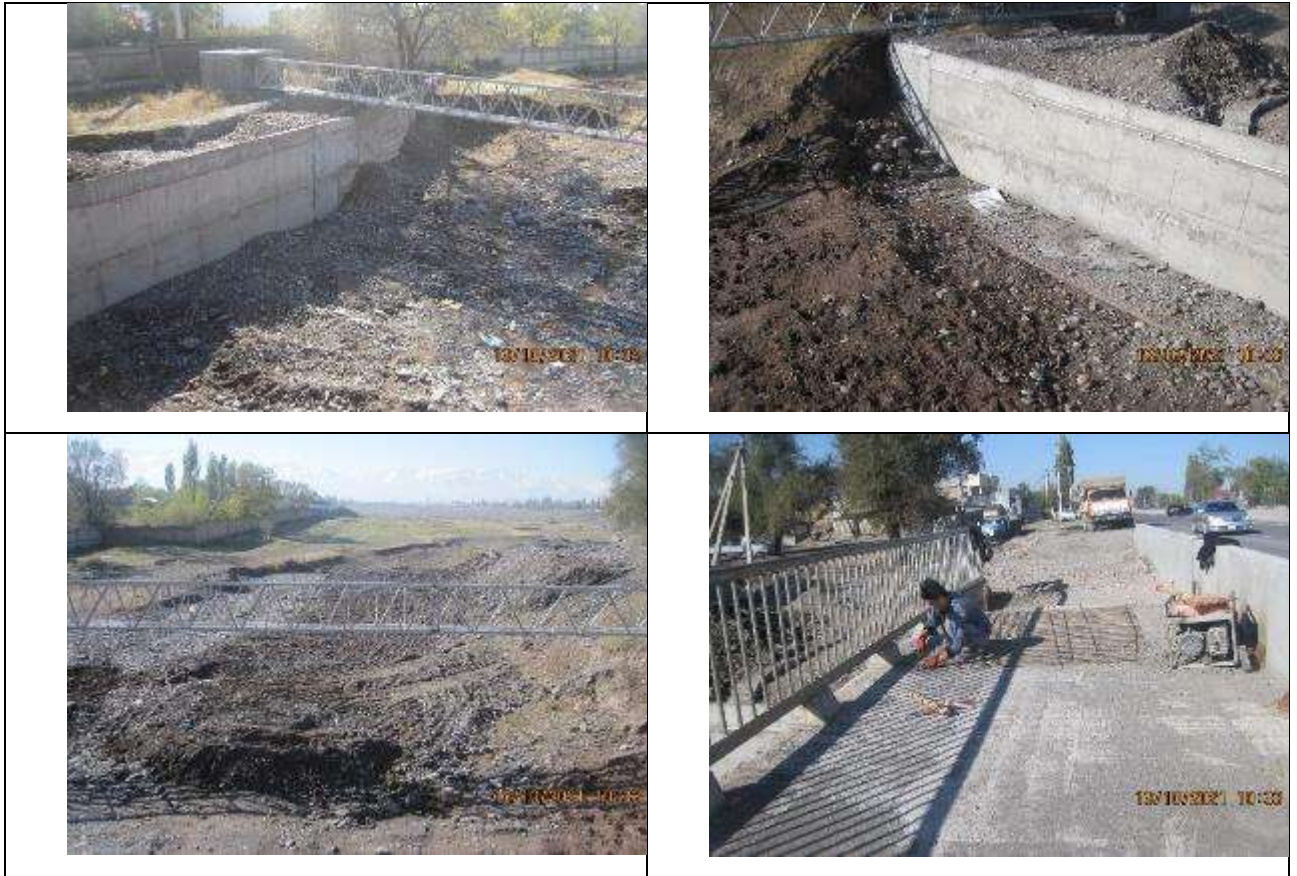
Figure 47 Ak-Suu River after completion of construction.

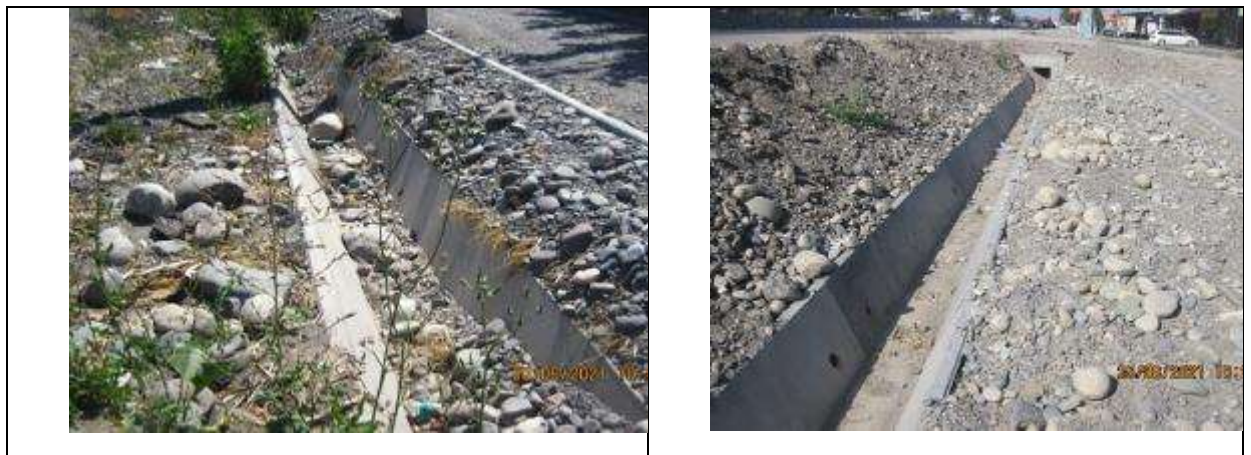
116. Previously installed culvert ditches in many places are overgrown with grass, filled with construction waste. The contractor was warned about the elimination of the detected violations. In November, after the completion of the main works on the road, the Contractor started cleaning the ditches.

Figure 48 Condition of previously installed ditches before and after cleaning.

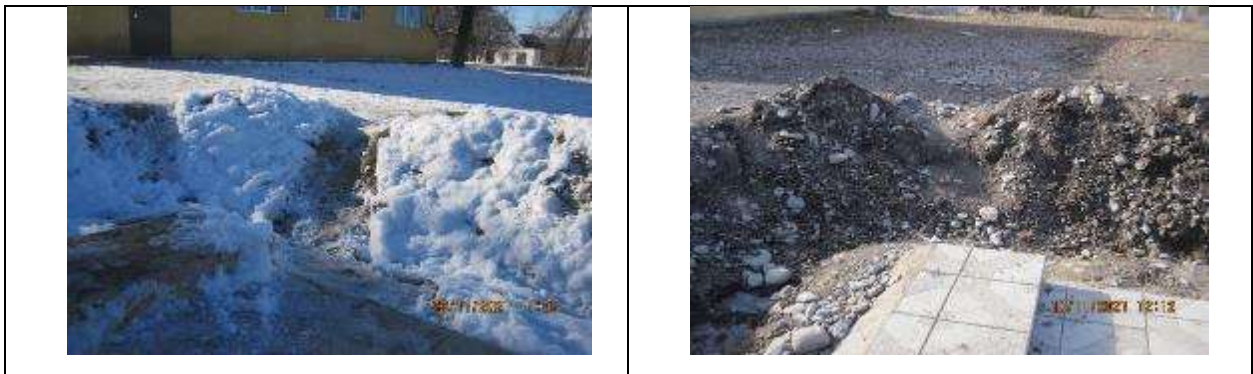
119. Also, construction waste was not removed, and the territory was not leveled near the underpass located opposite the school in the village of Novonikolaevka.

Figure 50 Construction waste near the underpass located opposite the school in the village of Novonikolaevka.

120. It was difficult for schoolchildren to descend to this underpass, especially in conditions of ice, which could cause a fall and injury. A letter was sent to the contractor about the elimination of these violations. The violations were eliminated within the established time frame.

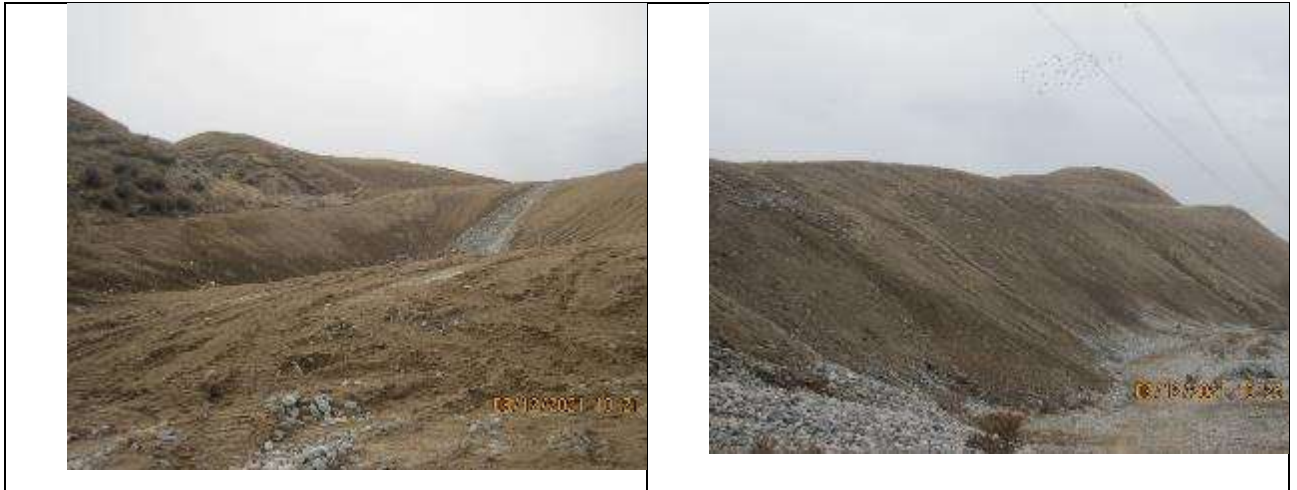
124. **Jelamysh borrow pit.** Currently, work on the reclamation of the borrow pit has been completed.

Figure 51 Jelamysh borrow pit after reclamation.

126. The Commission for the handover of the reclaimed borrow pit worked in June 2021. As a result of the work, some shortcomings were identified, which were eliminated by the Contractor. It was needed to additionally level the road to the borrow pit. The main reason for the delay in the Commission's work was some replacements in the commission membership. Currently, the new membership of the Commission has been approved and it is planned that the commission will continue its work in January 2022. The contractor plans to complete the handover of Jelamysh borrow pit by mid-February 2022.

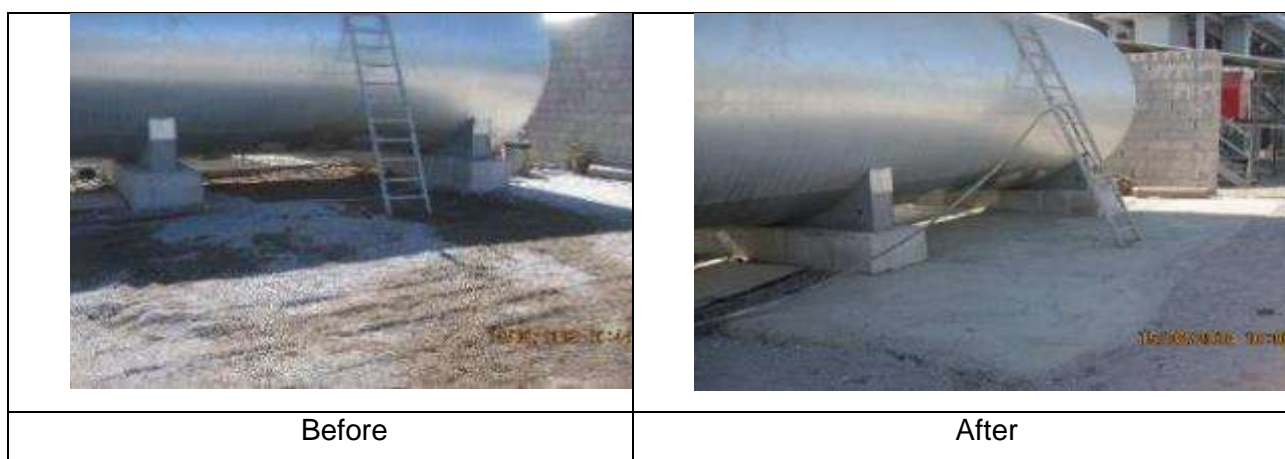
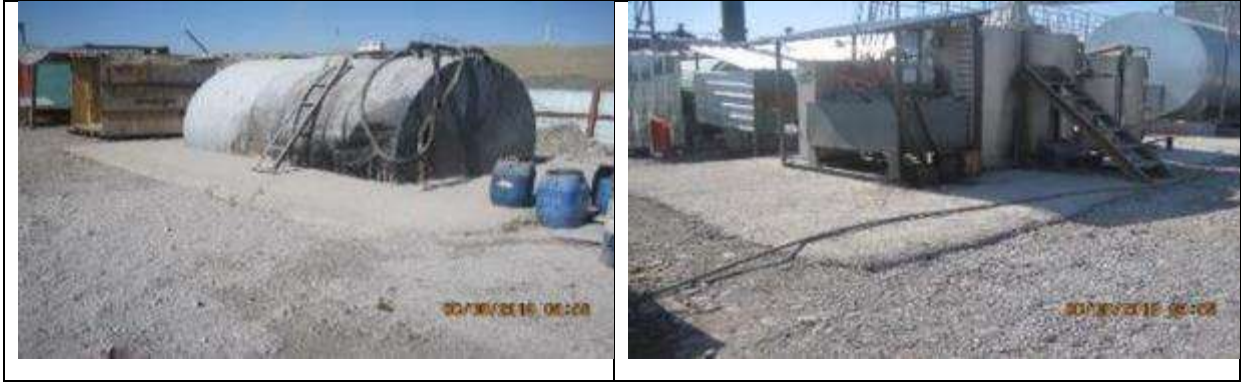
132. The territory of the plant is located in the bed of the Ak-Suu river on a pebble foundation, which is characterized by a high value of the filtration coefficient. To exclude soil contamination on the production site with bitumen and other chemical reagents that can get into the underground aquifer, the contractor was given clear instructions on the need to immediately clear the areas of bitumen and other chemical reagents leaks. This issue is under constant control by the Consultant.

133. During the operation of the plant, all soil around the containers with chemicals should be protected from leaks and spills of hazardous materials with an impervious protective coating.

Figure 53 Impermeable protective coating around chemical containers.

134. The contractor was recommended to protect the soil around the tanks with chemical reagents from spills and leaks of hazardous materials with an impenetrable protective coating. These recommendations were taken into account and implemented by the Contractor.

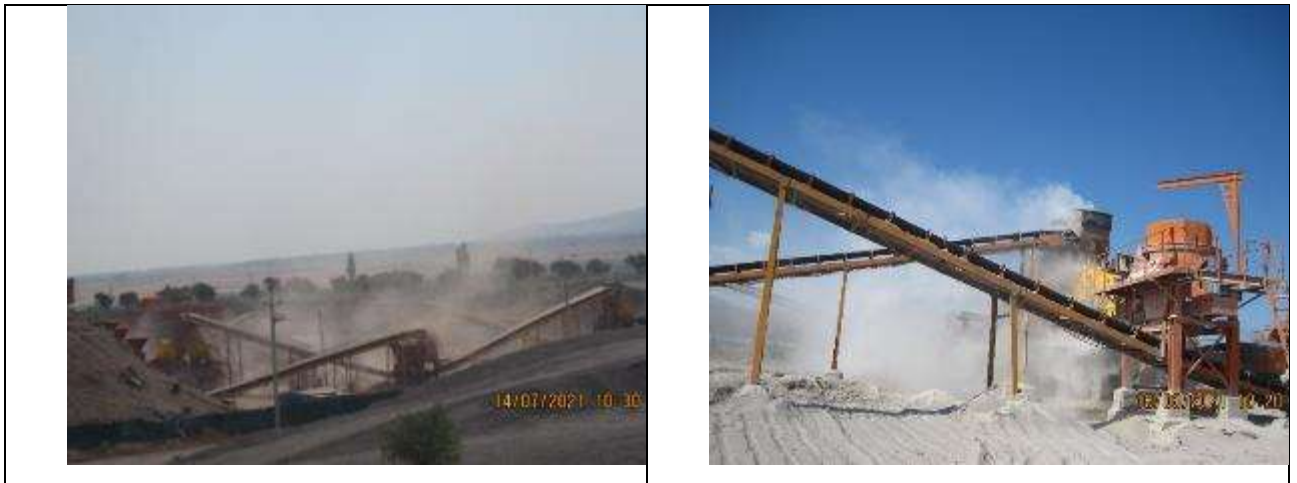
135. At the production site for the plant's placement, work was carried out on crushing sand and gravel raw materials and preparing stocks of materials. With the onset of the hot season, there were facts of dusting during the operation of the stone crushing plant. A letter was sent to the contractor to eliminate this violation. The contractor explains that dusting occurs when the plant is started up and that this is inevitable. The contractor has arranged water sprinkling around the stone crushing plant. Workers were provided with respirators.

Figure 54 Operation of the stone crushing plant without watering the raw materials.

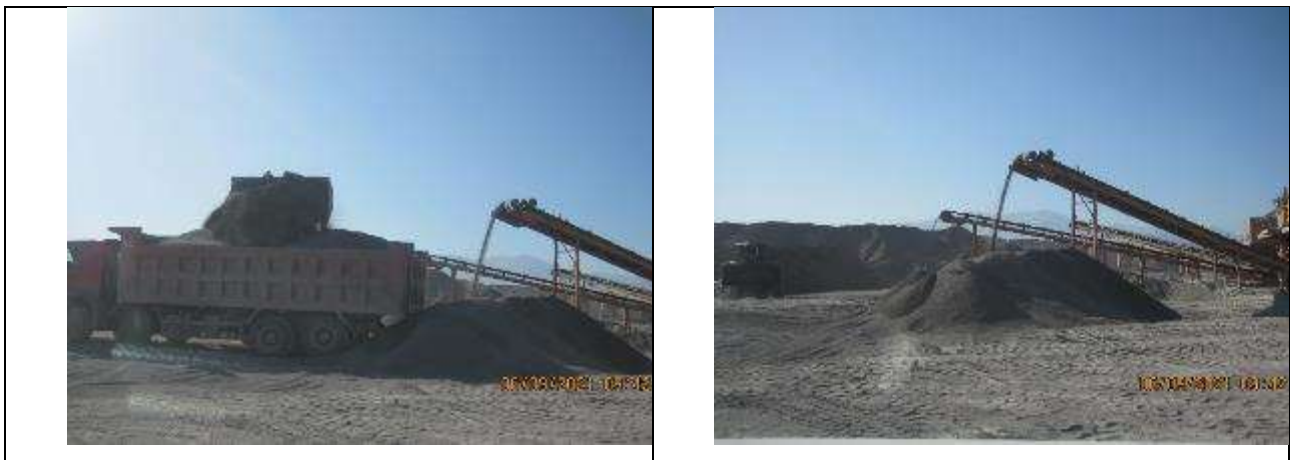
Figure 55 Operation of the stone crushing plant with moistened raw materials.

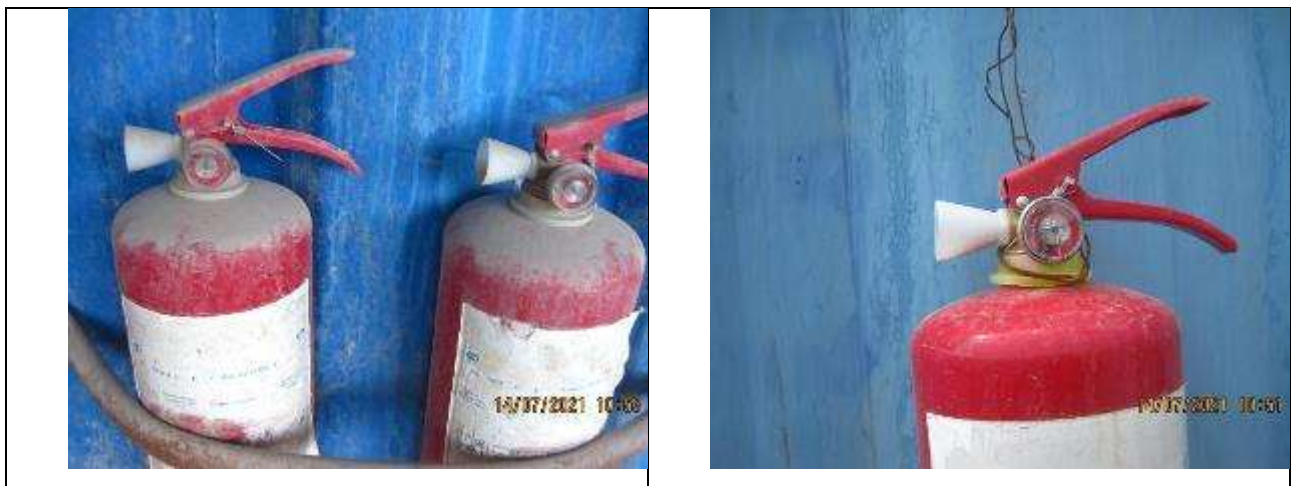
146. During monitoring in the workers' camp, it was found that the fire extinguishers had become unusable, it was necessary to recharge or purchase new ones.

Figure 66 Fire extinguishers installed with violations on the territory of the production site.

147. Also, fire extinguishers are fixed on the sunny side of the living room, which is also unacceptable. Contractor was instructed that the fire extinguishers should be placed in an area protected from the sun in such a way that they are protected from direct sunlight. They can be installed on the floor, with mandatory fixation from a possible fall in case of accidental exposure. A letter was sent to the contractor with the specified deadlines for eliminating the detected violation. The violations were not eliminated by the Contractor within the established time frame. A repeated letter was sent. Only after that, the Contractor replaced the unsuitable fire extinguishers. The fire extinguishers were removed from the sunny side of the living permits.

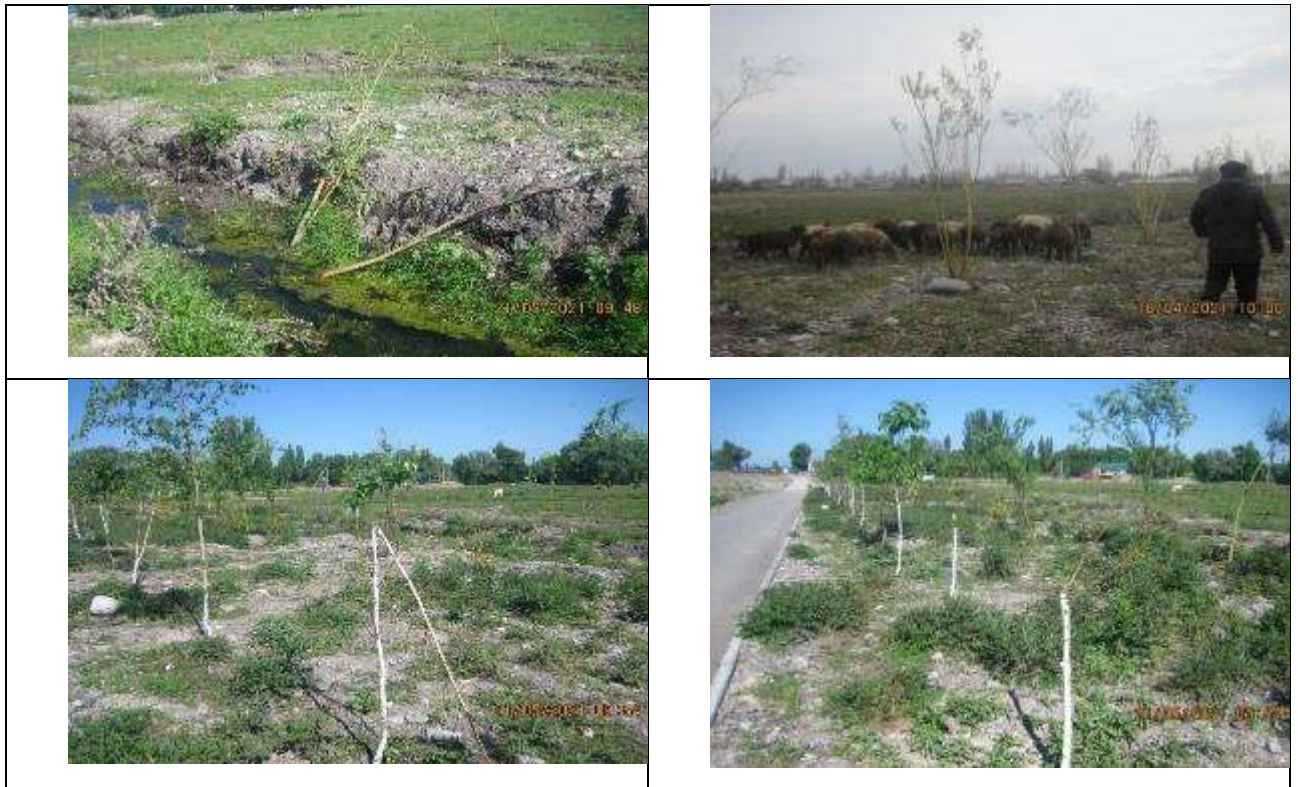
161. Visual monitoring allows us to conclude that the planted seedlings have taken root and are in a satisfactory condition. We would like to note that there are facts of "damage" of the planted seedlings, this is the scrapping of the planted seedlings, some facts of theft by unidentified persons, uncontrolled grazing of domestic animals that eat young shoots. On this issue, MoTC applied to the Local Self-Government Bodies in order to carry out explanatory work among the local residents,

Figure 69 Seedlings eaten by domestic animals and broken seedlings.

since it will be impossible to restore the number of green spaces without the support of local self-government bodies.

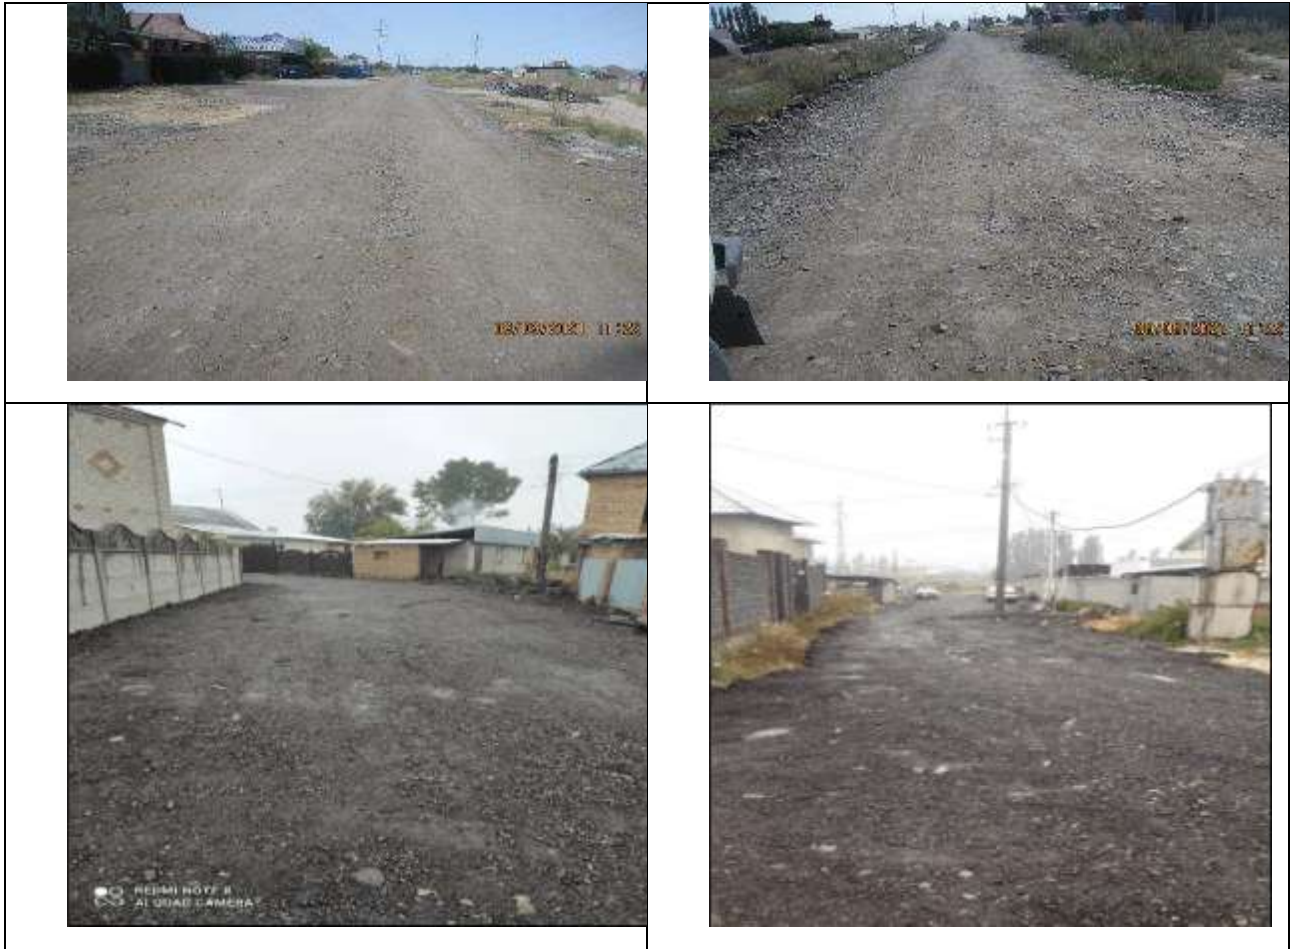
Figure 90 Dumping of old asphalt on internal roads of Novopavlovka village.

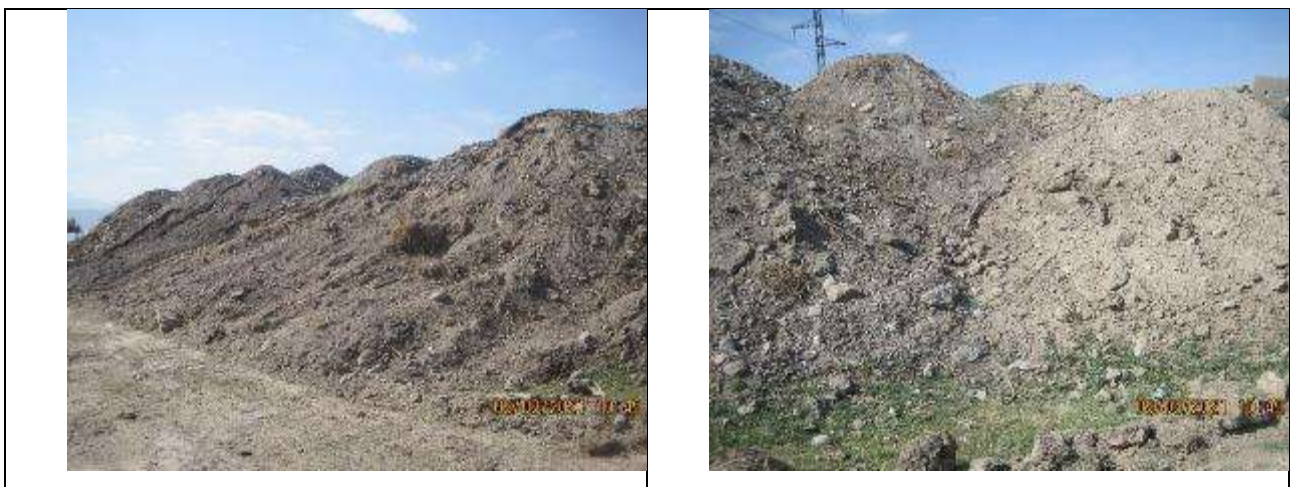
Figure 91 Dumping of soil unsuitable for road construction in the Voенно-Antonovka village.

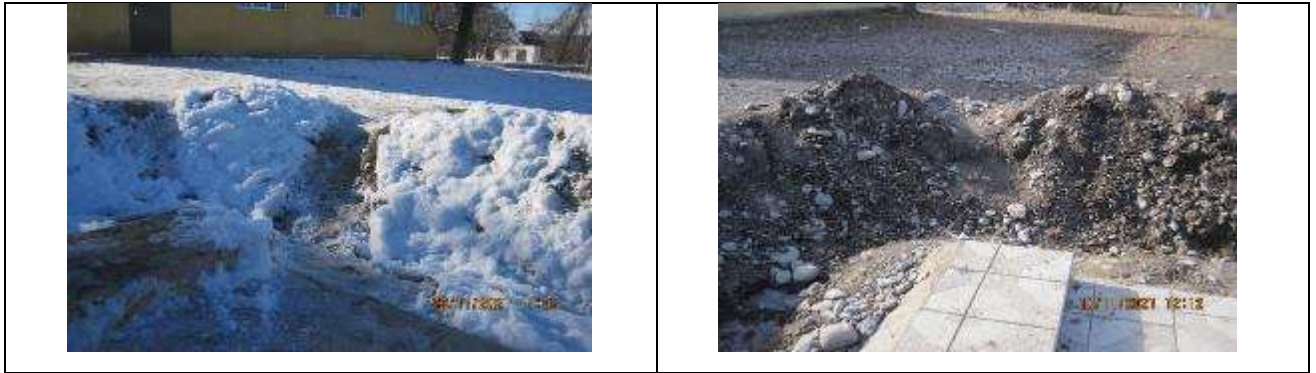
Figure 97 Construction waste near the underpass located opposite the school in the Novonikolaevka village.

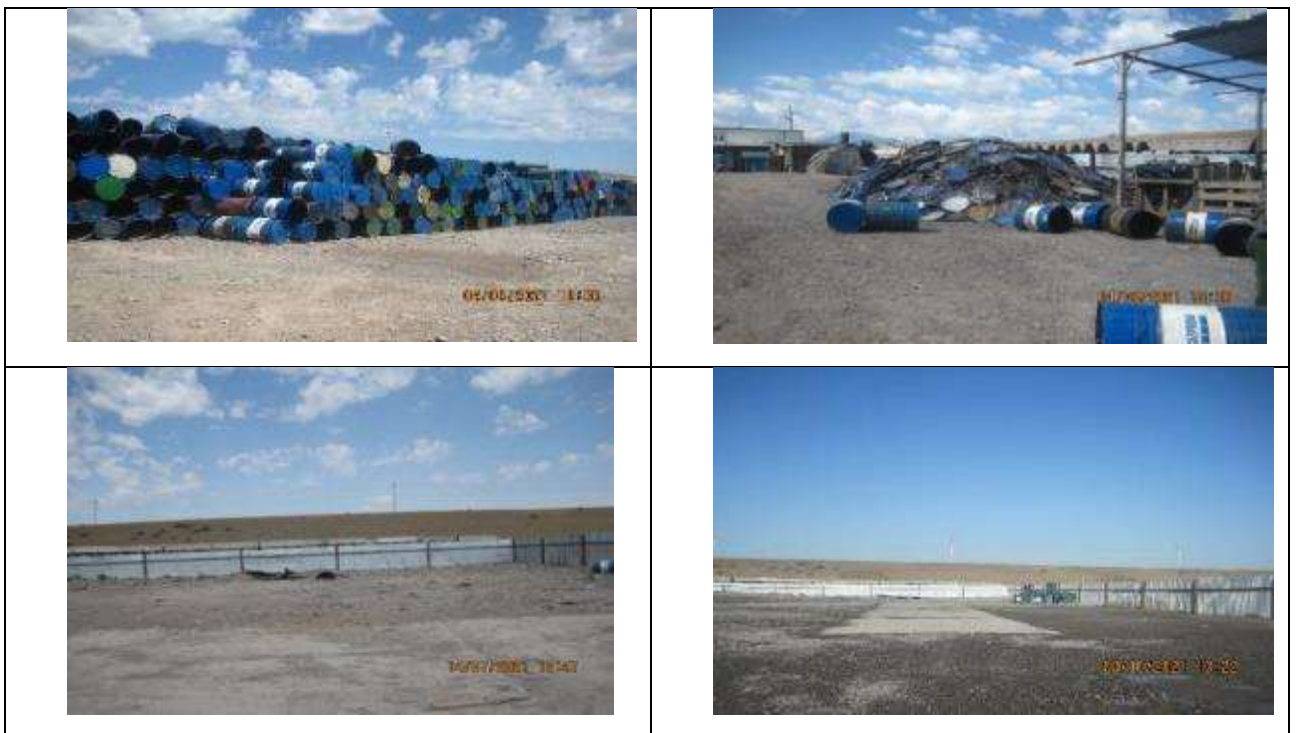
Figure 98 The area occupied by empty barrels before and after the removal of barrels.
