Semi-Annual Environmental Monitoring Report

July - December 2021

CAREC Corridors 1 and 3 Connecting Road Project (Phase 2). Additional Financing. Lot 1 "Balykchy km 0 -km. 43", Lot 2 "Kochkor - Epkin (km. 62+400 - km. 89+500)".

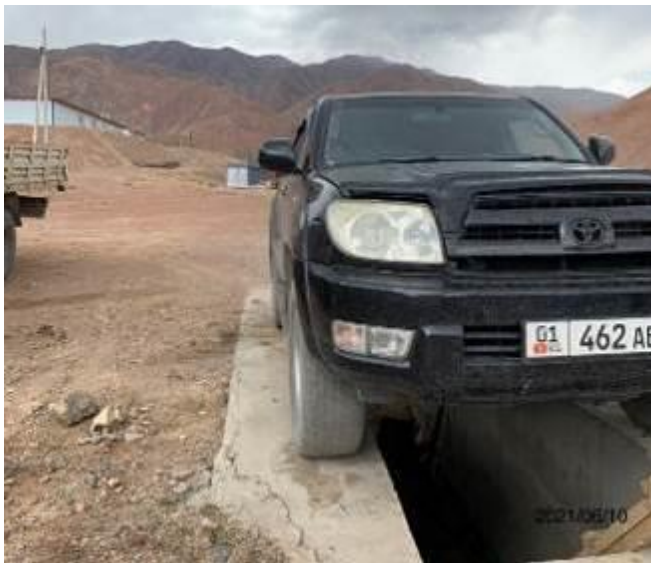
No п/п	Comments, non-compliances, recommendations	Corrective measures	Responsible Executor. Deadlines	Status of the previous Corrective measures execution Deadlines for non-compliance elimination
Lot 1				
1	The place of inspection, repair and oil replacement of transport and construction equipment is in open air, the area around inspection pit has no hard surface and is exposed to contamination by oil products during oil replacement work (photo 51).	Provide the construction of a specialized box for the inspection, repair, and oil replacement equipment. Arrange a warehouse for storage of fuels and lubricants (motor oil, waste oil).	Deadline is August 25, 2021.	Eliminated. (Photo 53, 54).
2	Wastewater collection	Provide a waterproof	Deadline is	Performed. Reinforced

Photo 52. An open-air observation pit.

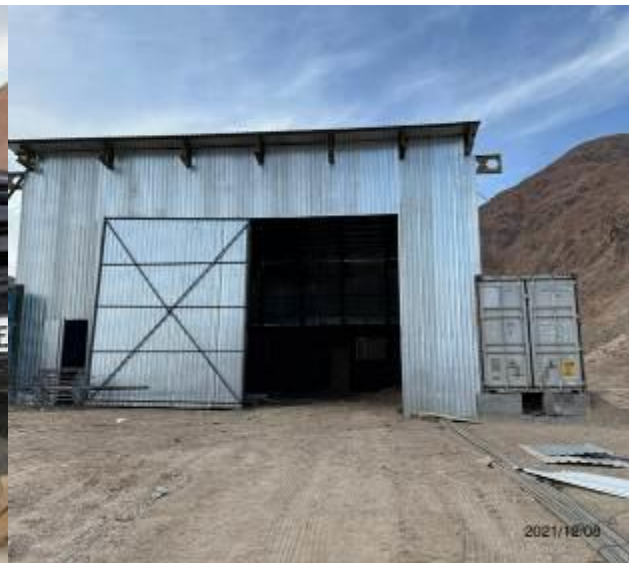
Photo 53. Machine repair box and nearby container for storing used oil.

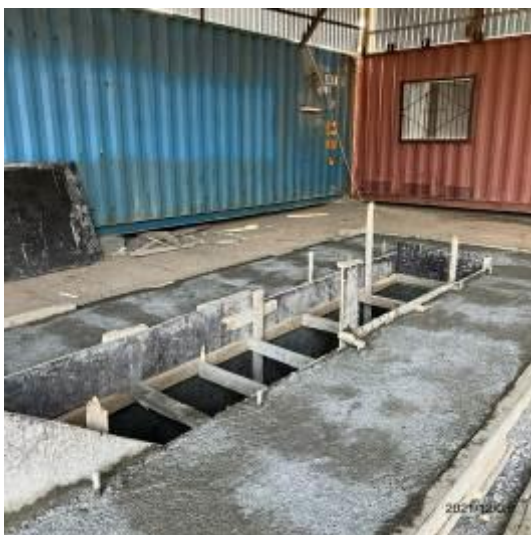
Photo 54. Concreted inspection pit inside the box.

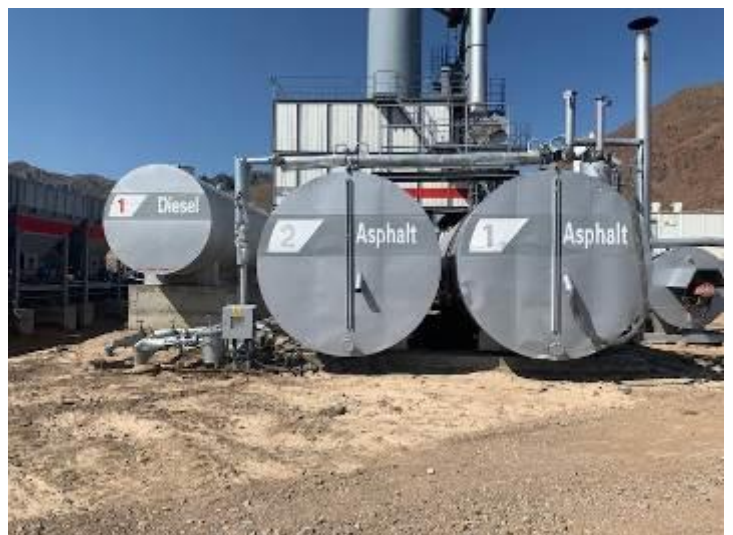
7	To prevent soil contamination with petroleum products, ensure storage of tanks with fuel and lubricants on a waterproof and oil-proof surface and under a shelter to protect from precipitation	Accelerate construction of warehouse	Contractor "Synohydro. Deadline to May 25, 2021. Deadline extended to August 25, 2021.	Eliminated (Photo 61, 62)
8	Emissions of pollutants from technological equipment of asphalt concrete plant where sealing damaged on connecting hoses (photo 63, 64).	Inspect connection hoses, shutters, joints on technological equipment of concrete mixing plant and ensure their sealing	Deadline is urgent.	Partially completed. Works in progress. Asphalt concrete plant is stopped for winter period, during which all repair works on technological equipment will be carried out.
9	Pollution of territory by oil products (photo 65)	Ensure that area is cleaned up	As a matter of urgency	Eliminated (Photo 66)

Photo 55. Storage area for tanks with bitumen and diesel fuel.

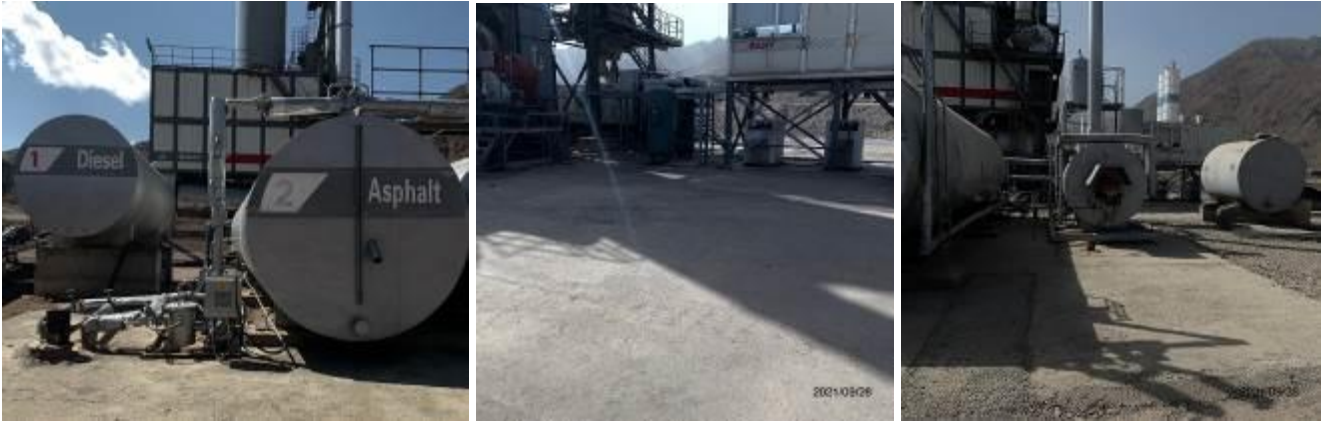
Photo 56, 57, 58 Provided asphaltting and concreting of production site and warehouses of fuel and bitumen at asphalt plant.

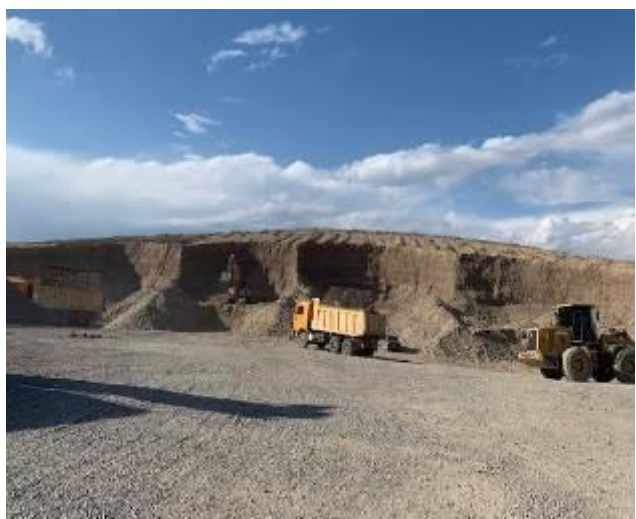
No n/n	Comments, non-compliances, recommendations	Corrective measures	Responsible Executor. Deadlines	Status of the previous Corrective measures execution Deadlines for non-compliance elimination
6	Lot 2, during development of open pit km.71+500 and 81+200, the industrial safety requirements are not observed in terms of ensuring stability of pit's slopes: there is a risk of collapse, i.e. the slope angle of pit's slope is 90°, according to "Methodological instructions for determining slope angle of slopes, benches and dumps, pits under construction and in operation, is 70° - which provides stability of slopes (photo 60).	Contractor was issued Instructions on need to ensure stability of pit walls during quarrying (letter KGZ4267/02/01/JPL/109 dated 23.11.2021).	Continuously throughout development period	Eliminated. Quarry at km 81+200. Quarry km 71+500 stability of quarry sides is not ensured. Stability works have been started and will be completed by spring.

Photo 60. Lot 2. Quarry km 71+500.

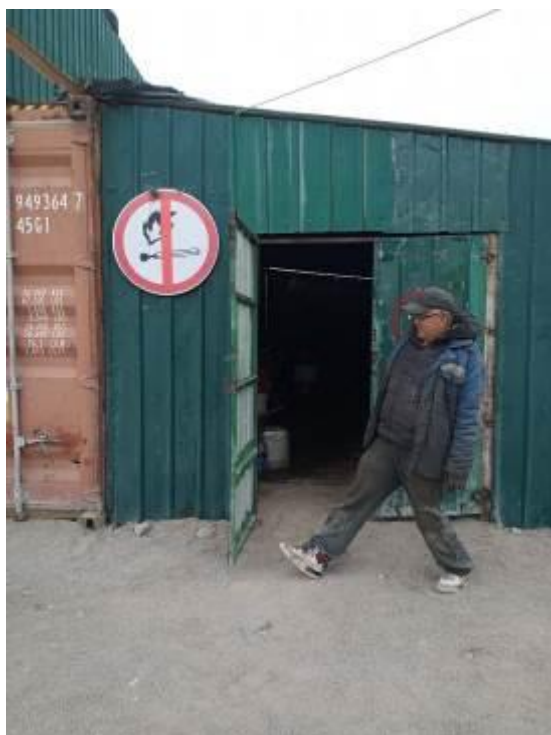
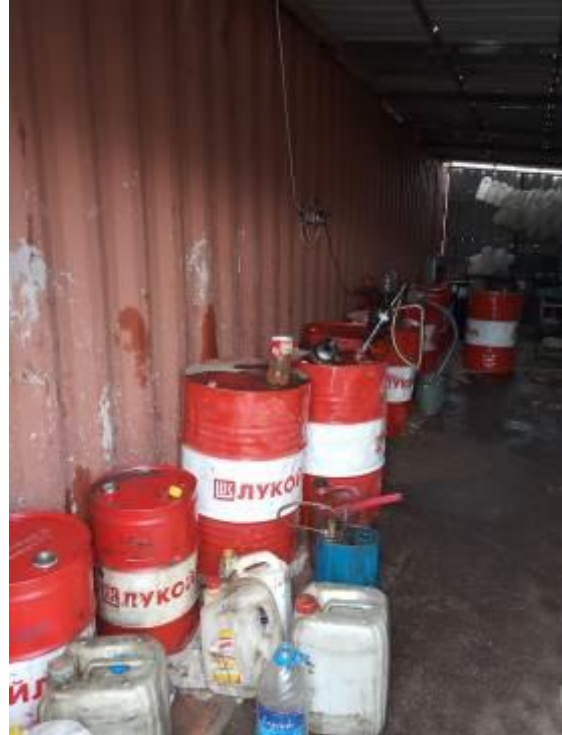
Photo 61, 62. Warehouse storage of fuel and lubricants and waste oil on Lot 2.

51. In reporting period there were 11 non-compliances, of which 9 were resolved during reporting period, 1 was not resolved and 1 was partially resolved. One non-conformance is related to fact that fuel storage warehouse (Lot 2) does not provide protective measures in case of possible emergency leaks, spills. Corrective actions for safety in case of emergency diesel fuel spills were prescribed to Contractor to eliminate. Concrete pit devices to collect emergency spills should be constructed. Due to lower winter temperatures, the concreting work was postponed until March 2022. The second non-conformance is related to sealing of technological equipment and damage to connection hoses of ACP used for emission of pollutants into atmosphere. Contractor partially completed prescribed work. The operation of asphalt plant is suspended for winter period, during which it will be repaired.

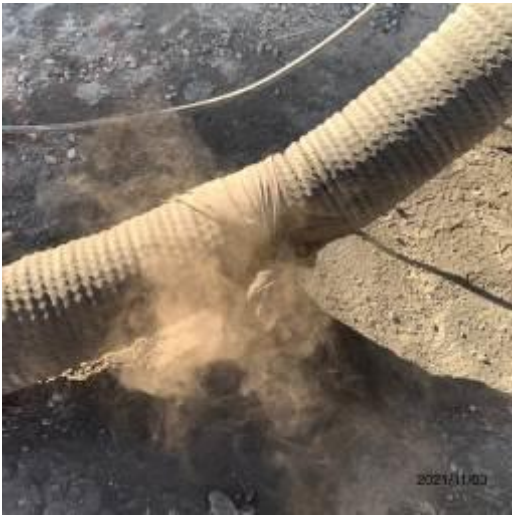
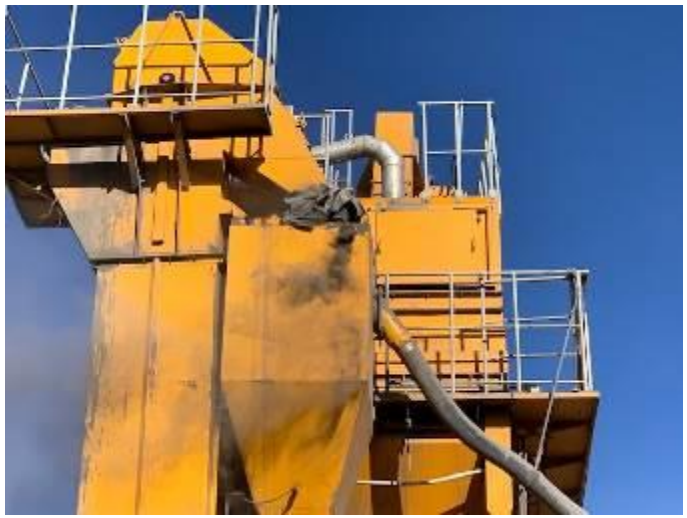
Photo 63 and 64. Lot 2. Emissions from the damaged sections on the connection hoses.

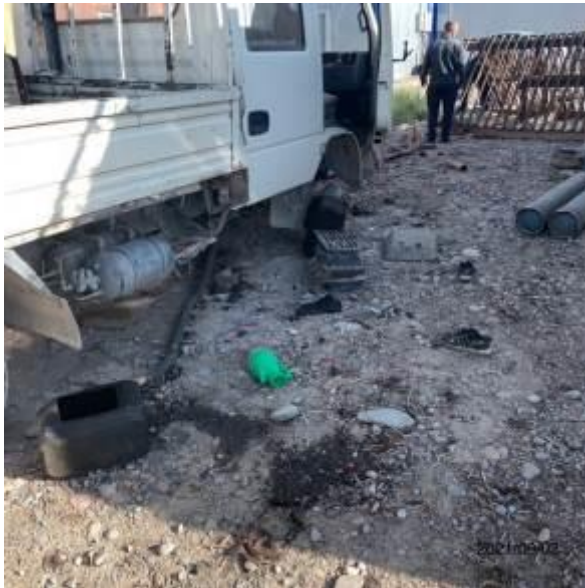
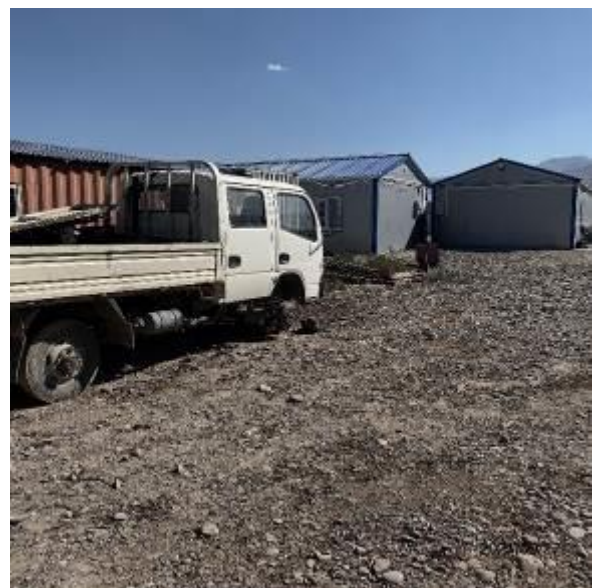
Photo 65 before cleaning and photo 66 after.

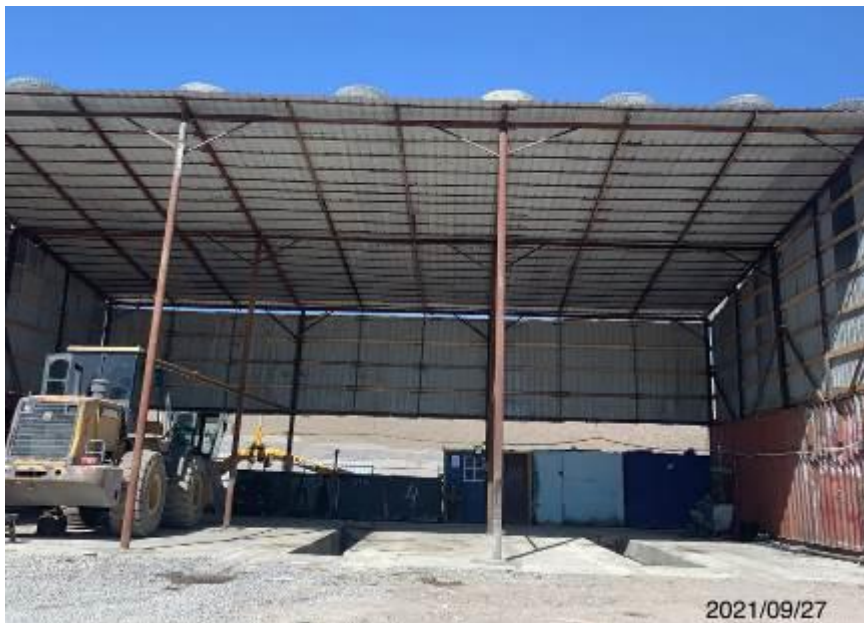
10	There is no specialized place for inspection, repair and oil changes.	Ensure construction of a specialized box for inspection, repair and oil	Until August 25, 2021.	Eliminated. (Photo 67).

Photo 67. Specialized area for the inspection and repair of transport and construction equipment.
