Environmental Monitoring Report

Semestral Report (January–June 2021)
July 2021

Kyrgyz Republic: Central Asia Regional Economic Cooperation Corridors 1 and 3 Connector Road Project (Phase 2)-Additional Financing

Section 1: Balykchy–Kochkor Road (km 0–km 43) and
Section 2A: Kochkor–Epkin Road (km 64–km 89)

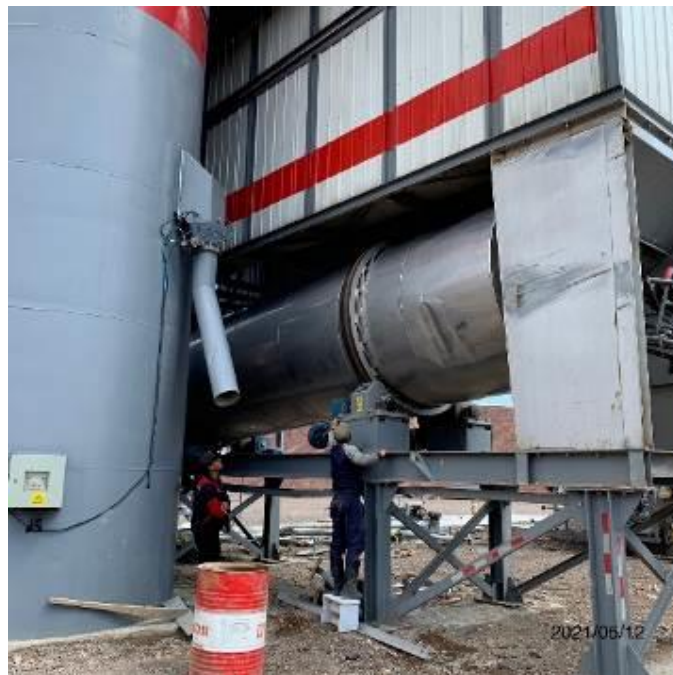
5	Finding workers at construction sites without personal protective equipment (photos 55-56).	Provide all employees with personal protective equipment (special protective clothing, footwear, helmets, noise protection equipment, respiratory protection, etc.) according to work specifics	Contractor "Sinohydro" Urgently	<u>Done</u> Additional monitoring will be conducted on this issue.
Lot 1				
6	On April 26, the storage of old asphalt was found on the area for a dump of unusable soil at km 12 + 000 LHS of the road at 100m distance (Photo 57)	According to verbal instructions, the Contractor, within three days, ensured the removal of the waste of old asphalt to an authorized site for the disposal of waste of old asphalt concrete. Issued April 26, 2021r.	Deadlines Until April 29, 2021	<u>Done</u> (photos 58, 59)
		Submit to Engineer all permits from the relevant local self-government bodies, the territorial administration of the State Committee for Economics and Control. Develop a plan for the	Deadline until May 20, 2021	<u>Done</u>

Photo 56. Concrete plant worker with no personal protective equipment.

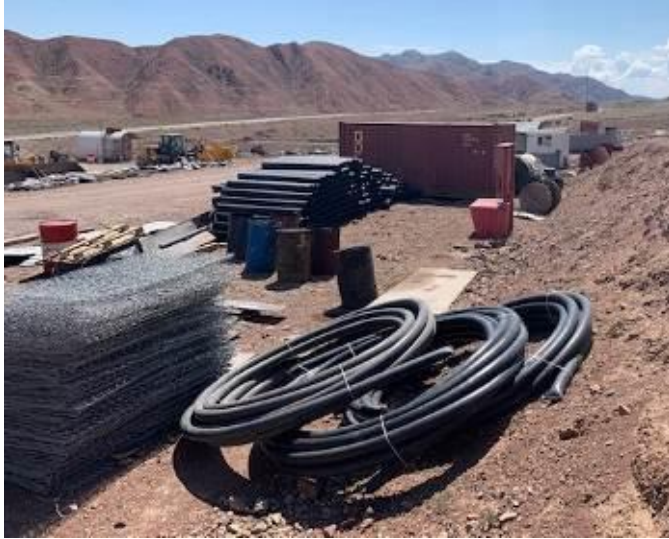
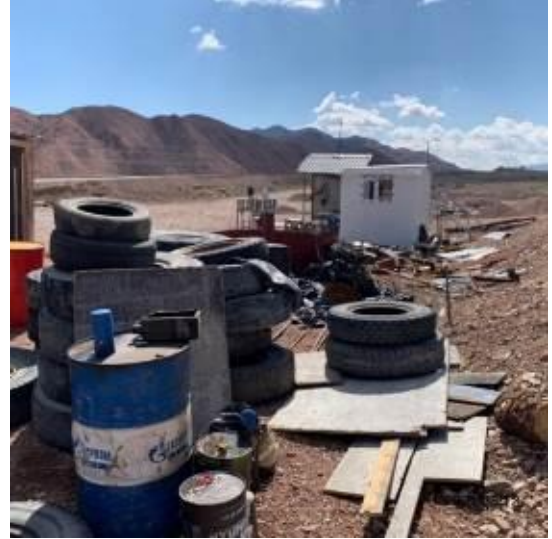
8	The conditions of storage and keeping materials and production wastes do not comply with environmental requirements (photos 62, 63).	Provide separate storage of materials from waste tires, waste oils.	Contractor "Sinohydro". Deadline until May 25, 2021	<u>Done</u> (photos 64, 65).
9	On Lot 1, watering of the roadway is carried out by sprinklers with gravity water supply (photo 66). The use of a gravity irrigation system is not effective enough, since it requires more water consumption and more time to watering the same distance of the road than when using a pressure irrigation	Recommended for the effectiveness of roadside watering: on water-washing machines with gravity irrigation, install pumps for spraying water. The use of a pressurized irrigation system significantly increases the efficiency of watering and the operation of a watering machine, which makes it possible to reduce water consumption by 2 times, and to increase	Contractor «Sinohydro». Deadline July 15 2021	<u>Done</u> One of the three sprinklers has a pump for spraying water (Photo 67). The rest of the machines will be pumped as soon as they arrive, which is expected by July 15th.

Photos 62. and Photo 63. The conditions of storage and keeping of materials and production waste do not comply with environmental requirements.

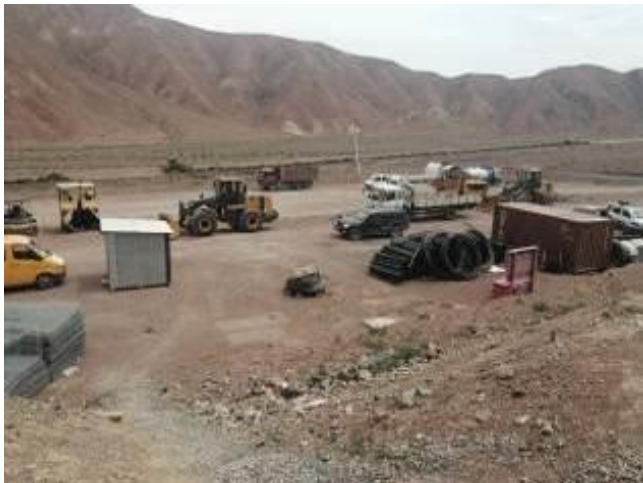
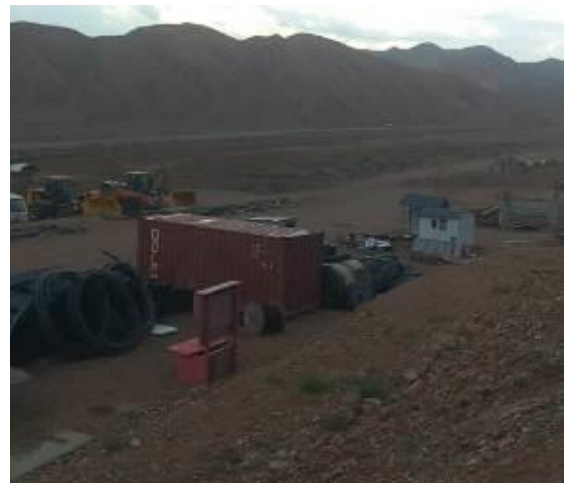
Photo 64 and Photo 65. Lot 1 after cleaning and orderly storage of materials and waste oils and tires.

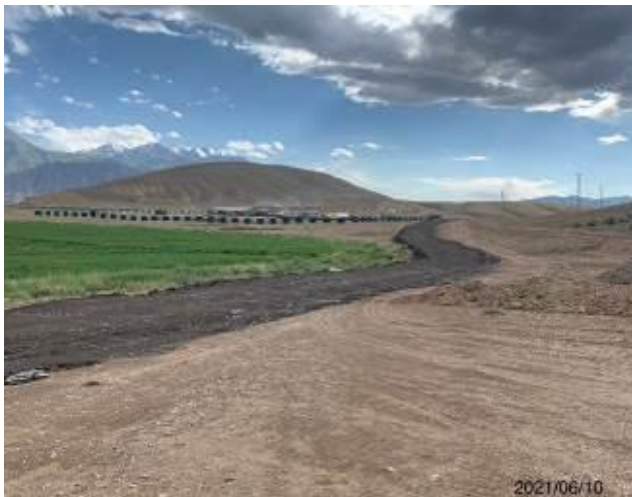
Photo 70, 71. Lot 2. Backfilled technological earthen road to the crusher plant.

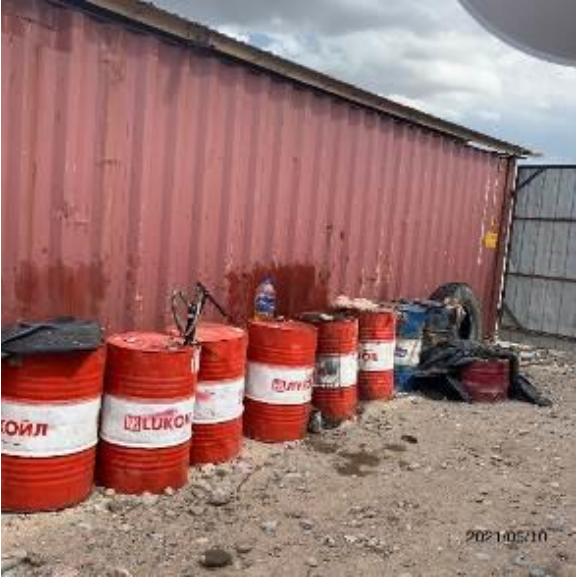
12	Storage conditions of containers with fuels and lubricants do not meet environmental requirements (photo 74)	In order to prevent soil contamination with oil products, ensure storage of containers with fuels and lubricants on a waterproof and oil-tight surface and under a canopy to protect against atmospheric precipitation	Contractor "Sinohydro". Deadline until May 25, 2021	<u>Not executed</u> (photo 75). Cleaning of the territory and temporary storage of containers with fuels and lubricants under a protective film until the completion of the construction of a covered warehouse for fuels and lubricants was ensured. Concreting of site will be done as soon as concrete-mixing unit completed. Scheduled

Photo 74. Lot 2. Storage conditions for fuels do not meet environmental requirements.

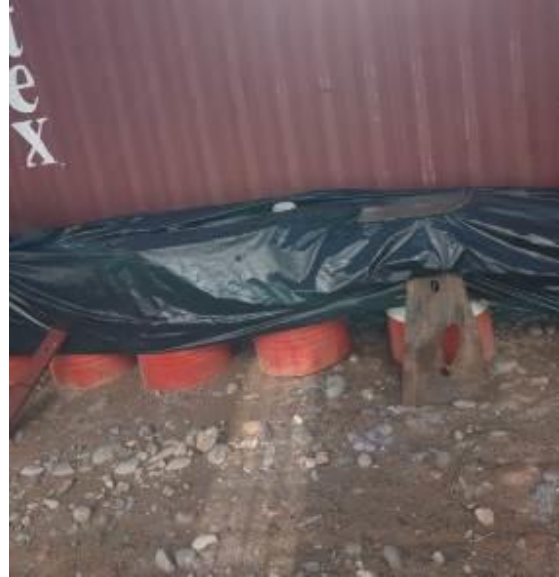
Photo 75. Lot 2. Cleaning of the territory and storage of containers with fuels under a protective film.

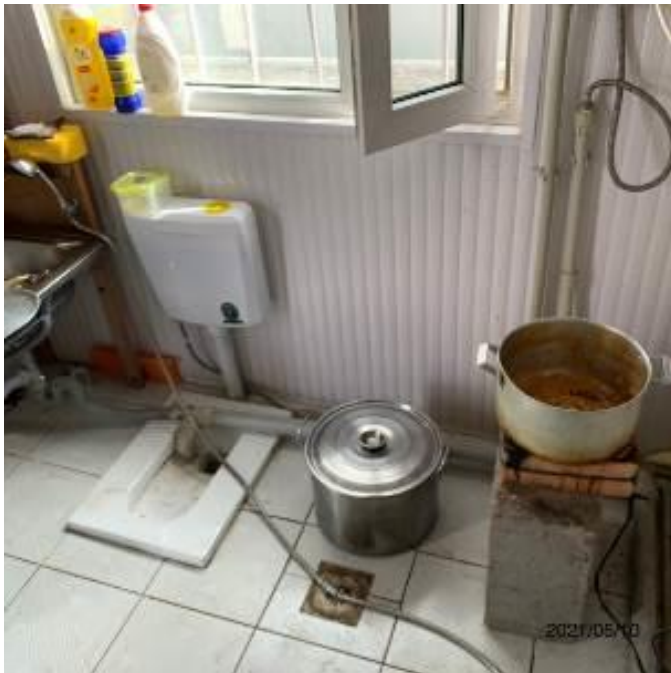
Photo 76. Lot 2. The bathroom transformed into kitchen.

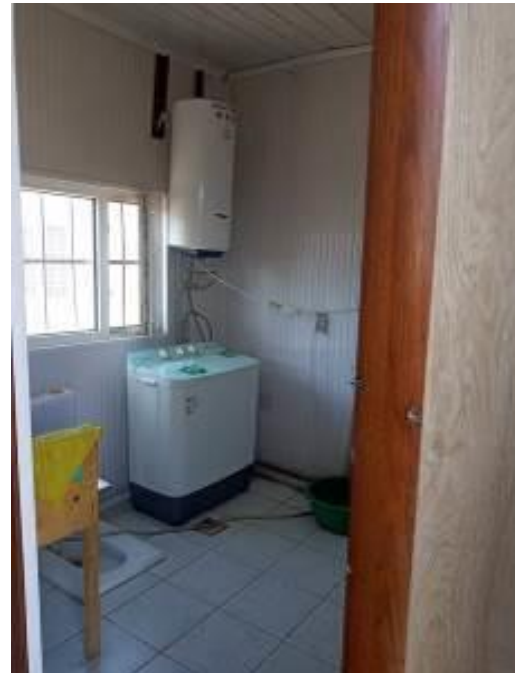
Photo 77. The bathroom is brought into conformity with its purpose.

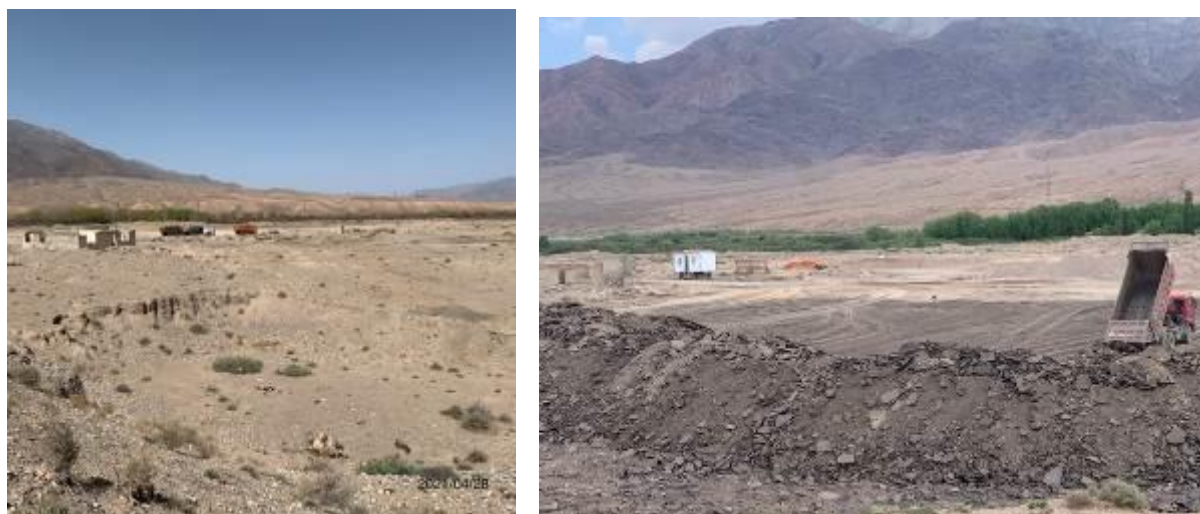
74. The old asphalt removed on Lot 1 was taken out for burial at the old quarry at km 7 + 100 (photo 84). The contractor has developed a Plan for the disposal of old asphalt, agreed with the territorial department of environmental protection of the State Committee for Environmental Protection of the Kyrgyz Republic.

Photo 82. Spoil bank of old asphalt concrete at km. 7 + 100LHS before disposal, on the right during disposal.

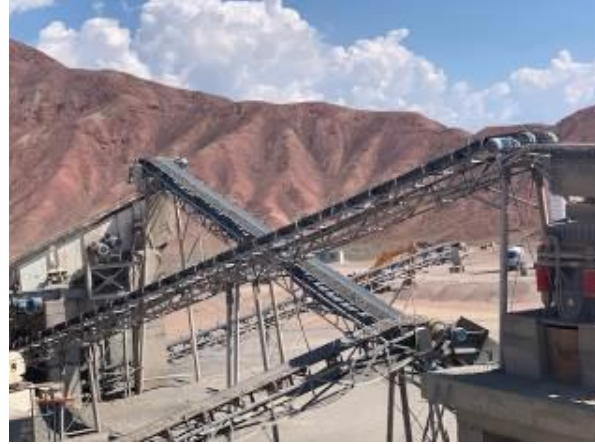
Photo 100. Lot 1. During the operation of crusher plant, dust emission is observed. Hydraulic irrigation system provided at crusher plant.
