Project Number: 45169-001
Loan Number: ADB Loan 3056-KGZ (SF)
Grant Number: 0366-KGZ (SF)

Semi-Annual Environmental Monitoring Report
July 1 – December 31, 2019

CAREC Corridor 3 Improvement Project (Bishkek – Osh road), Phase 4 (km
15.9-61)

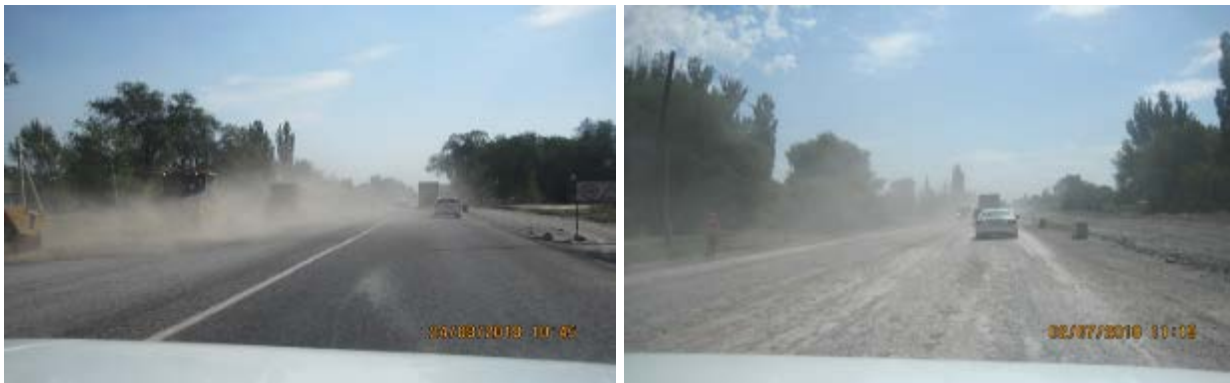
74. Dust generation has the main impact on the environment during the earthworks. In the road construction sites, water sprinkling of the road, including shoulders was carried out from 7 am to 20 pm without a break for lunch. The contractor has drawn up a schedule for water sprinkling with an interval between watering 30 minutes. Despite the fact that several watering machines were operating on construction sites, the increased air temperature led to increased dust generation on the road.

Figure 26 Increased dust generation at construction sites

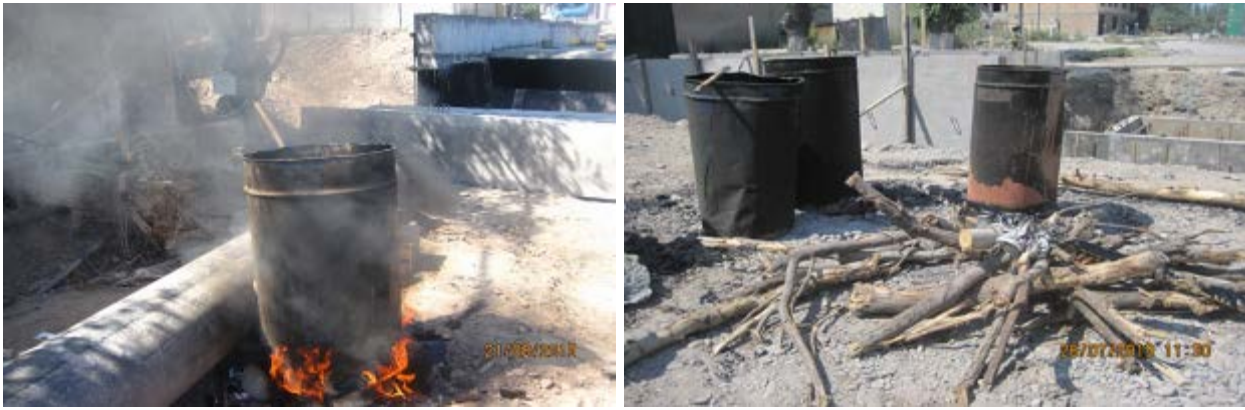
77. Bitumen for waterproofing pipes, bridges and underground passages is melted at the construction site. Given that the Contractor did not provide dry firewood for these purposes, the workers were forced to burn bitumen. As a result, emitted poisonous black smoke has a negative impact on the health of workers and residents of the village. Another warning was issued to the contractor indicating the violation. After conducting explanatory conversations with the Contractor and delivering firewood to the construction sites, the situation improved. Firewood was distributed, and there was less smoke. The contractor was recommended to conduct explanatory work about the rules with specialists responsible for waterproofing works.

Figure 27 Melting of bitumen during waterproofing works

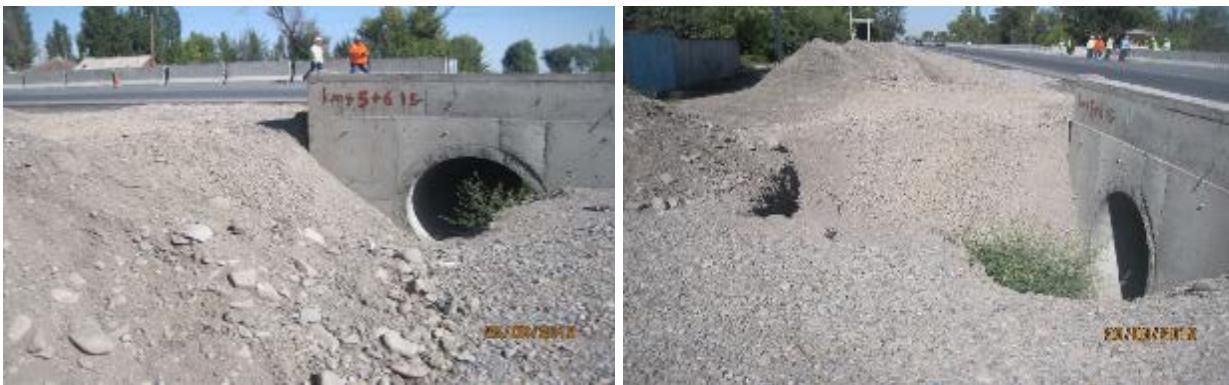
78. Some culverts were left with open trenches, and in the rainy season they filled with water and pose a danger to the residents and pets. The contractor was given instructions and work was carried out on temporary backfill or arranging of temporary fencing of the identified areas.

Figure 28 Violations on the constructed structures

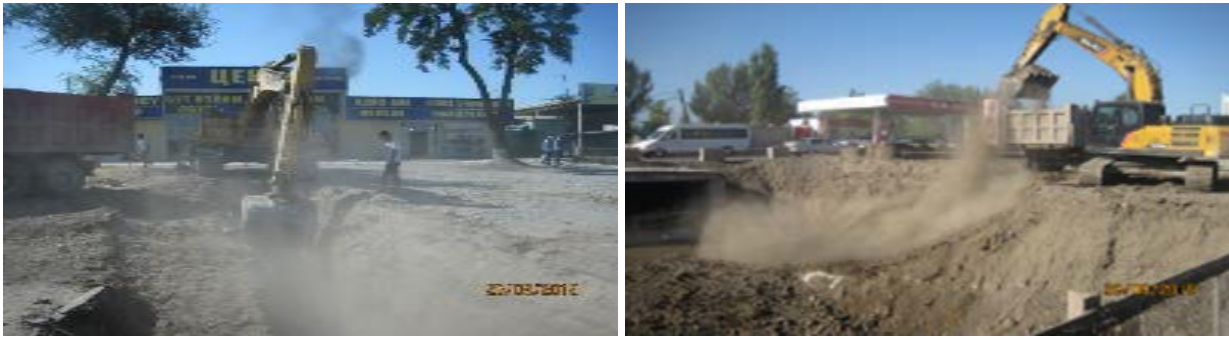
80. Despite the regular water sprinkling, some road sections were subject to dusting where the construction of culverts and bridges was carried out.

Figure 29 Dusting in construction sites

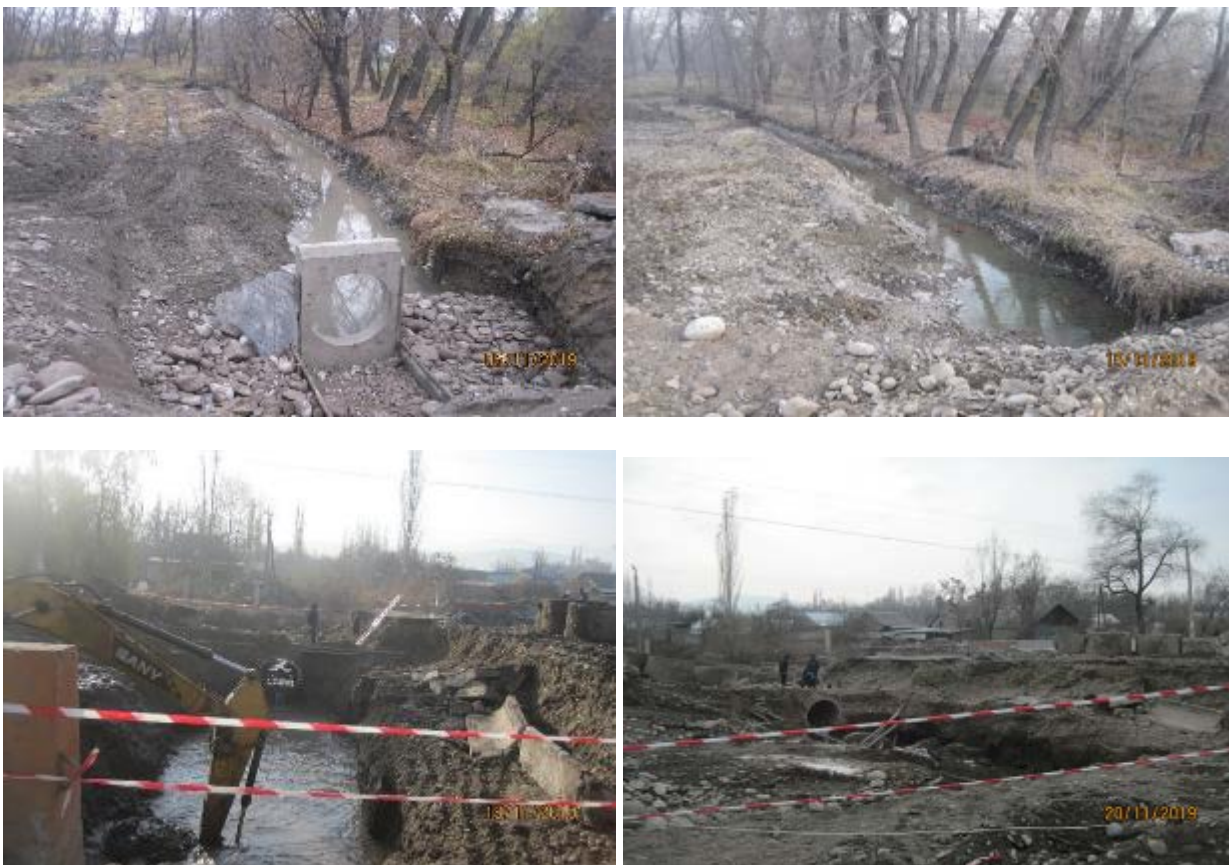
81. At km 26+850, during the construction of the culvert, ground water was outcropped. A letter was sent to the contractor that in order to drain ground water from this site, it is necessary to extend the drain ditch, and after completion of construction work, to level the ground. The recommendations were implemented.

Figure 30 Ground water outcropping during the construction of culverts

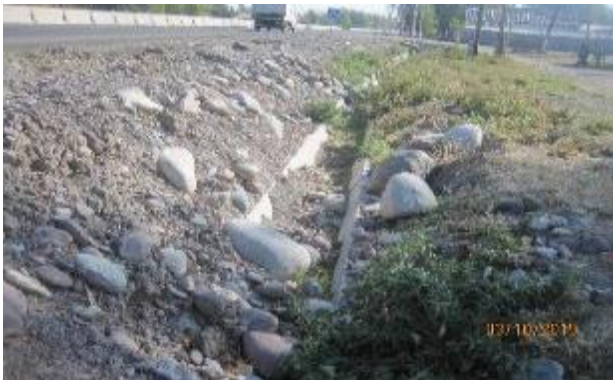
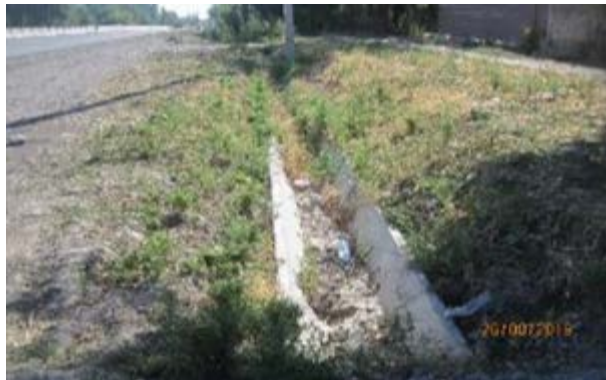
84. Previously installed chutes were overgrown with grass, and filled with construction waste. A letter was sent to the contractor to eliminate the identified violations.

Figure 32 The state of constructed chutes

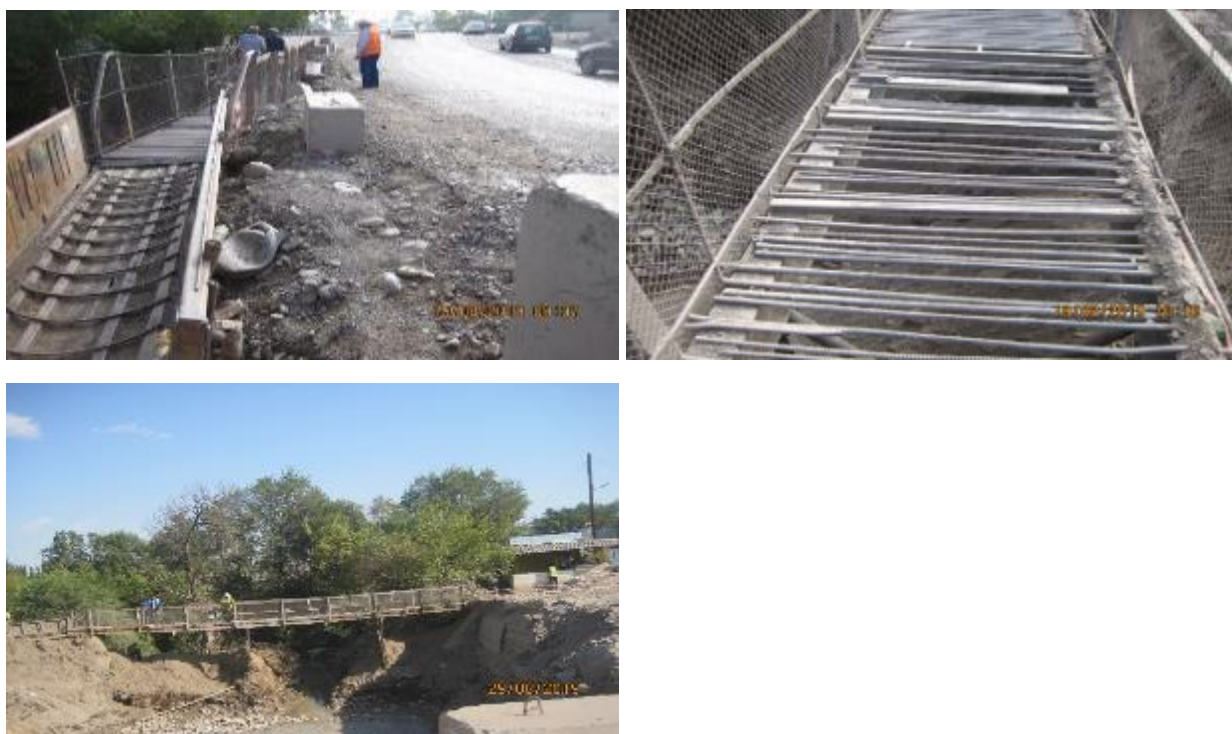
86. In the construction of the bridge at Krepostnoy canal (km 40.7), the pedestrian bridge was on insufficient condition and posed a danger to pedestrians.

Figure 34 Violations during the construction of a pedestrian bridge at the Krepostnoy canal

88. A letter was sent to the contractor with instructions to take measures for elimination of the detected violations. Within the specified time frame, the violations were eliminated. The bridge was covered with a concrete layer. Garbage is removed, a ladder is made to work at height.

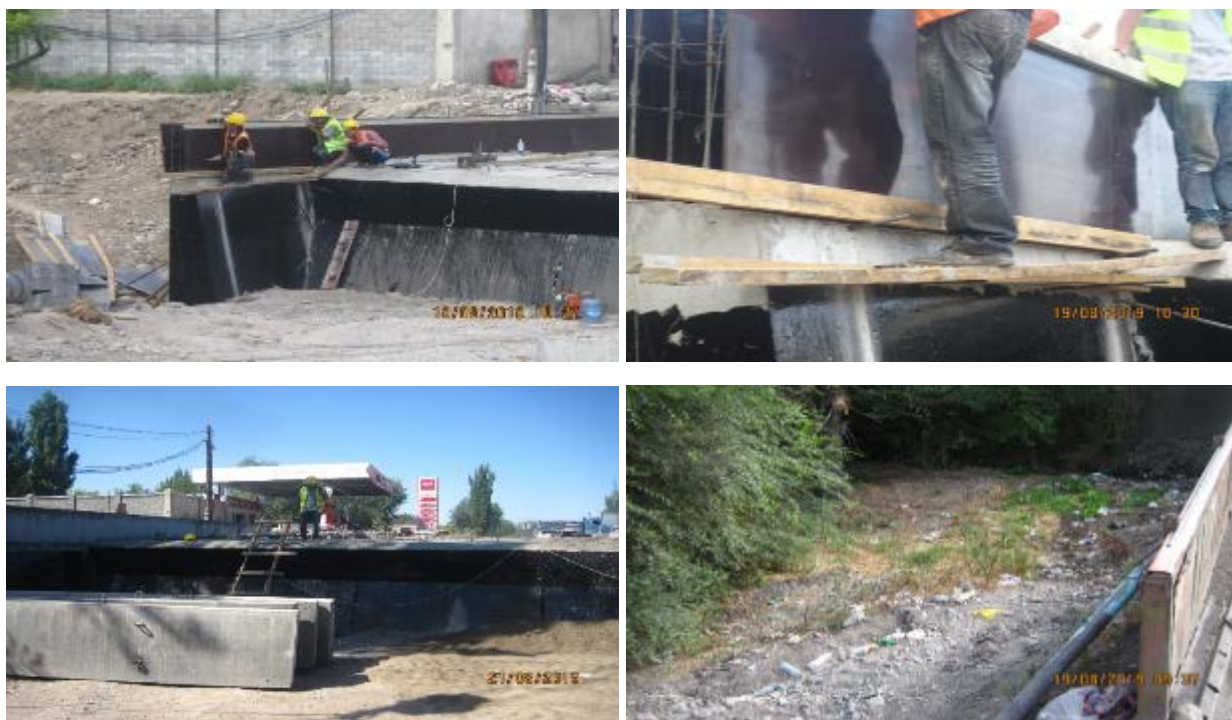
87. The construction of the bridge was carried out with gross violations of safety precautions. There were no special means for working at height, ladders, or equipped platforms. The area around the bridge was littered.

Figure 35 Safety violations during the construction of the bridge at the Krepostnoy canal

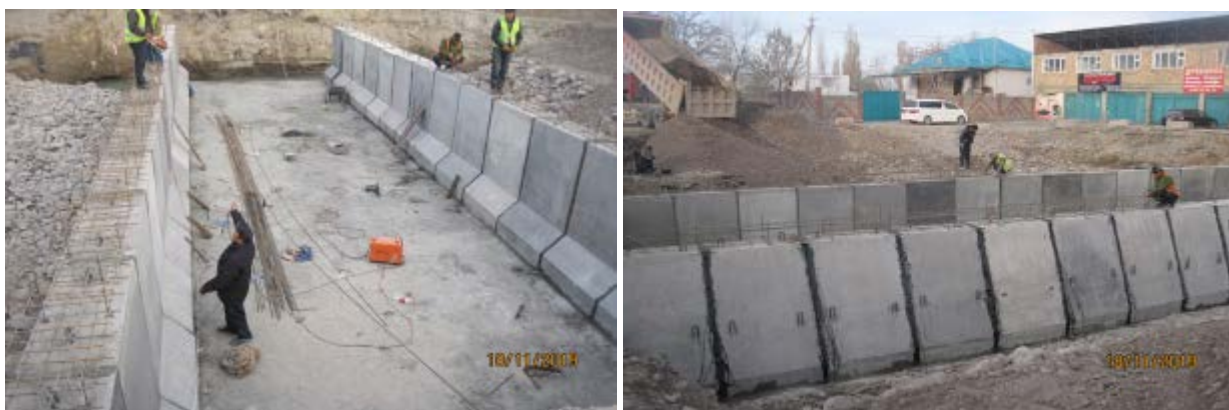
90. Construction of the bridge at the Jantai canal (km 24+110) was also carried out with gross violations of safety precautions. There were no special means for working at height. During the specified period, ladders and platforms were installed.

Figure 37 Safety violations during the construction of the bridge at the Jantai canal

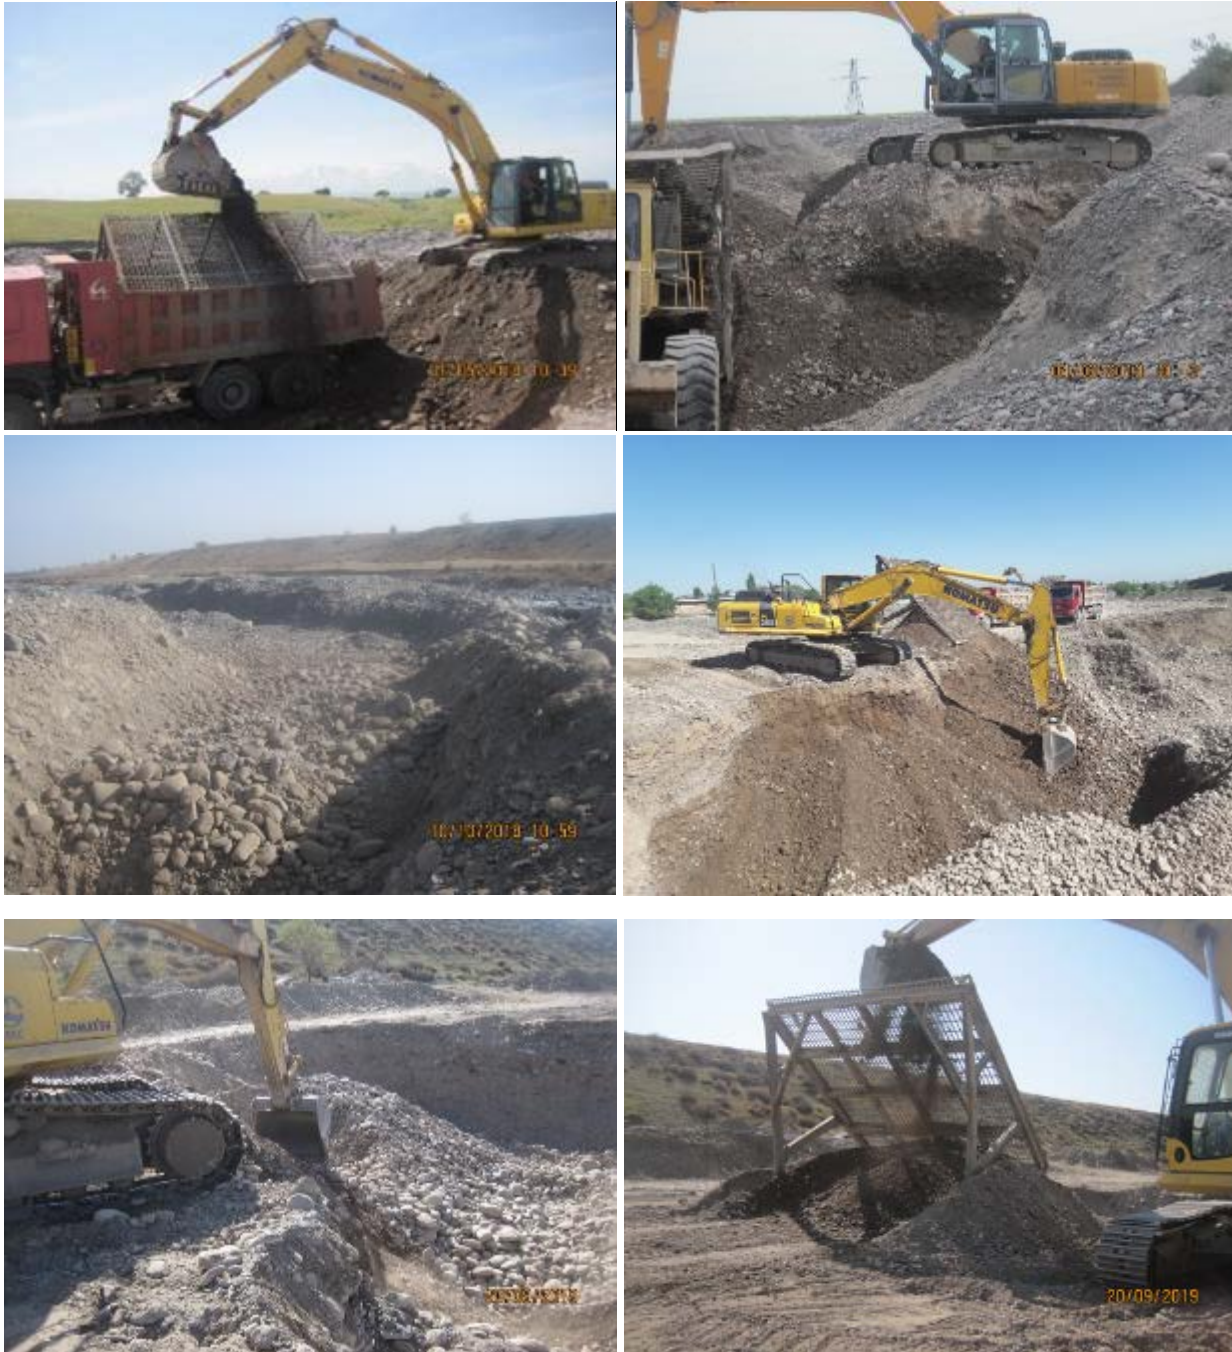
94. In many places, the development depth was exceeded by 2-3 m from the design depth. Letter was sent to the contractor with indication of violations, and on the need to bring the parameters of the development into line with the design, compliance with safety precautions and terms of elimination of the identified violations. The contractor carried out leveling works in order to bring the depth of the borrow-pit development in line with the requirements of the design.

Figure 41. Mining of Ak-Suu 2 borrow-pit

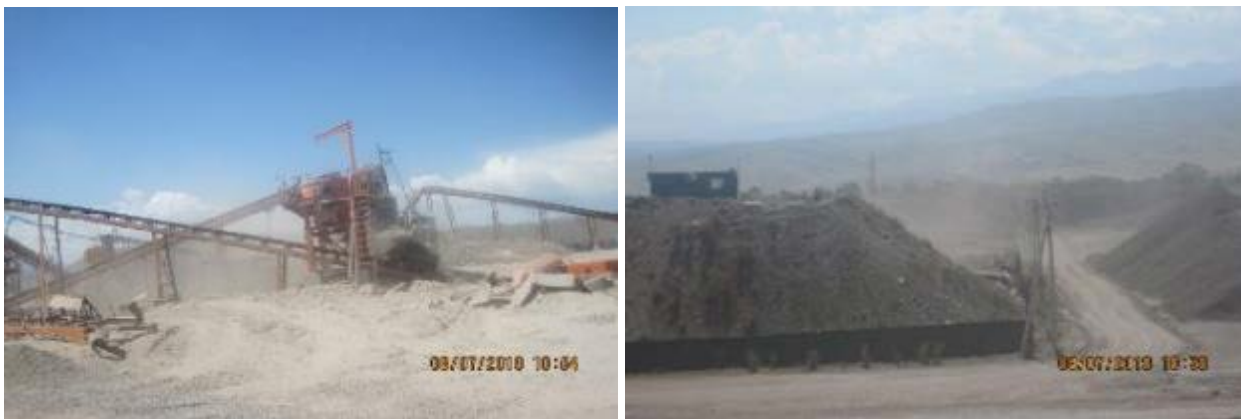
98. During the monitoring of work on the territory of the production site, it was found that dusting occurs during the operation of the stone crushing plant due to a breakdown of the watering system. In this period the stone-crushing plant operates without water sprinkling, polluting the plant's territory and the area adjacent to the plant. Several non-compliance letters were sent to the Contractor, but the violation continued. The contractor explained the situation by frequent breakdown of the watering system (clogging of spray nozzles) and breakdowns on pipelines. The contractor promised to prevent the recurrence of such violations and, if necessary, to repair the water sprinkling system immediately. This issue will be monitored by the Consultant during the next construction season in 2020

99. Whereby the requirements of the general conditions of the Contract - Technical Specifications clause 1.2.10 (j) were violated: "Crushing plants should only work with dust control devices".

Figure 43 Dusting in the stone crushing plant

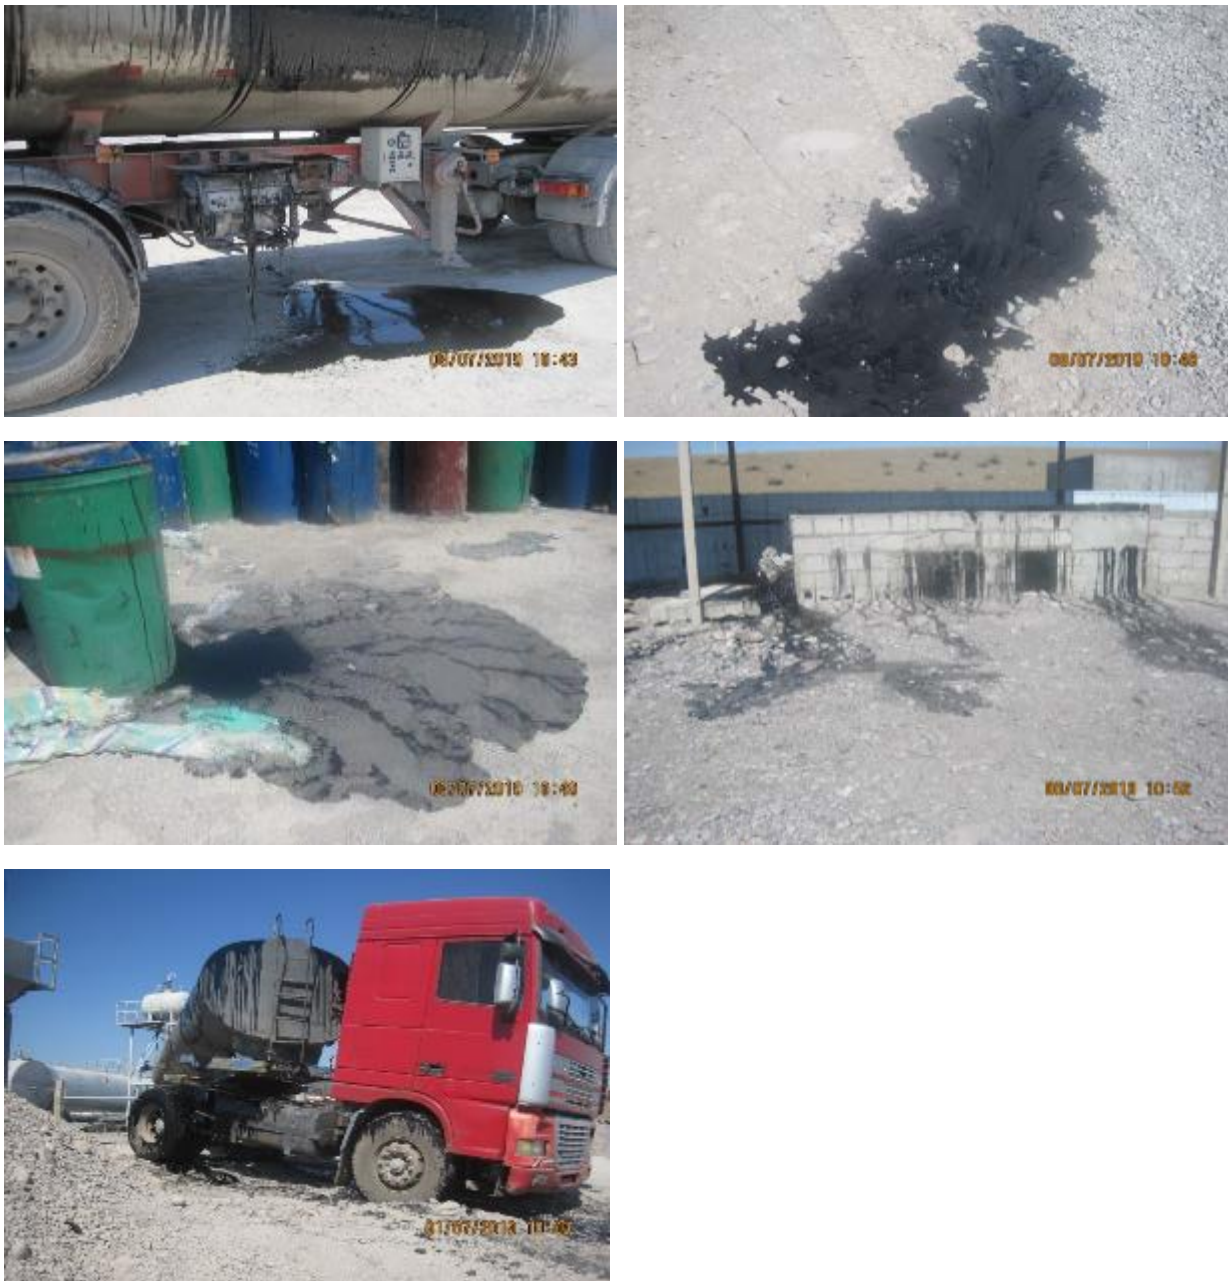
100. Bitumen leakages were also found at the area of asphalt plant. Comments are made to the contractor about identified leakages which are not eliminated in a timely manner. The consultant constantly monitors the condition of storage sites for drums with bitumen.

101. Despite the fact that bitumen pollution is local issue, however, it does not become less dangerous, given that the plant is located in the riverbed of the AK-Suu river, on a pebble bed, which is characterized by a high filtration coefficient. Soil contamination with bitumen is inevitably accompanied by the entry of large amounts of different chemical substances into the underground aquifer, causing damage to the environment. In this regard, the contractor has been given clear instructions on the need for immediate clearance of areas of bitumen leakages. This issue is under constant control of the Consultant.

Figure 44 Bitumen leakages at the asphalt plant

102. Initially, identified bitumen leakages were not collected and removed, but only backfilled with soil, which is unacceptable. After the following warnings, the bitumen was collected. No further bitumen leakages were observed.

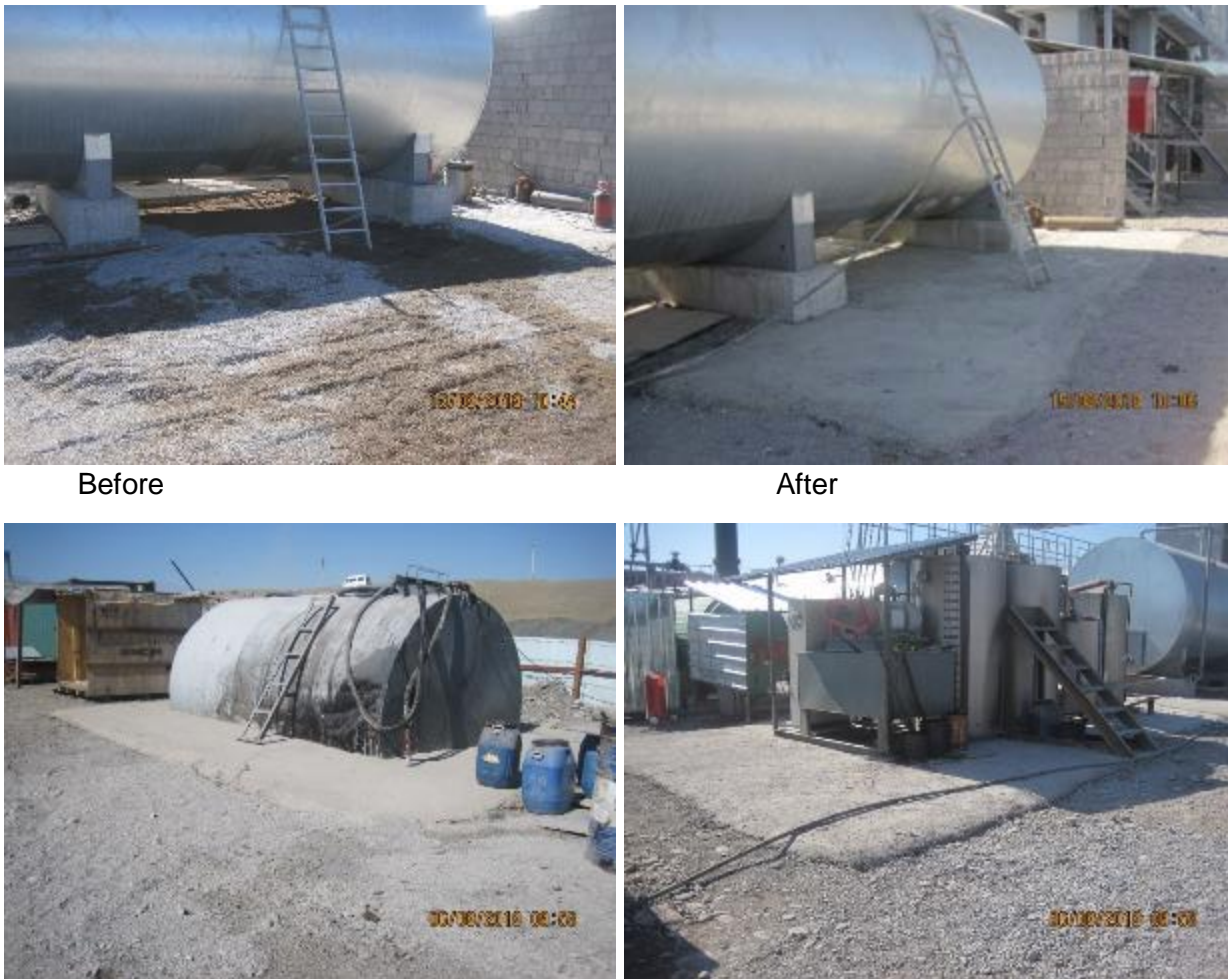
Before

103. During the operation of the plant, all the soil around the containers with chemicals must be protected with an impermeable protective coating from leakage and spills of hazardous materials.

104. The contractor was recommended to protect the soil around the containers with chemicals from leakage and spills of hazardous materials with an impermeable protective platform. These recommendations were taken into account and implemented by the Contractor.

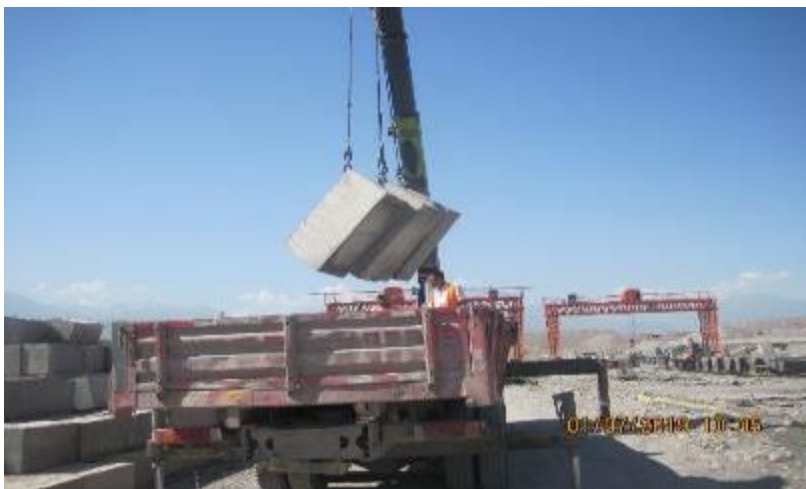
105. Despite the regular trainings conducted by the Contractor's safety specialist, safety violations/non-compliances are observed at the site where reinforced concrete products are manufactured. Warnings about preventing such violations are ignored.

Figure 46 Violations of safety precautions at the site of production of reinforced concrete structures

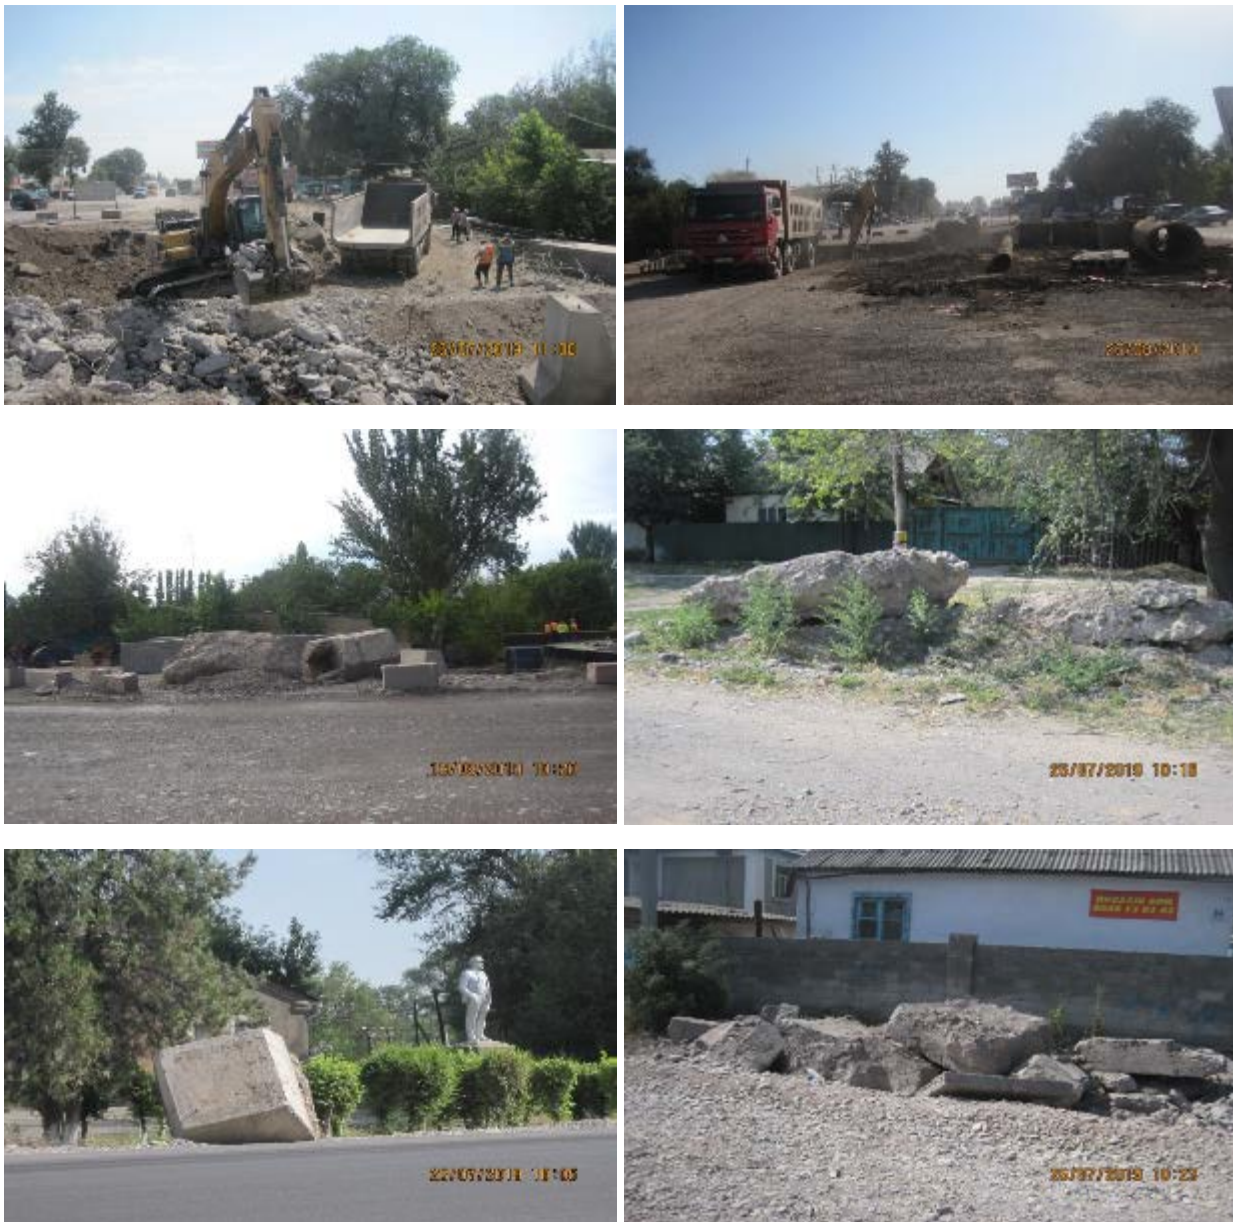
111. Verbal and written warnings were constantly given to the Contractor about the need to remove all construction waste from the road shoulder. The contractor gave an explanation, after which it was agreed that the removal of construction waste from the project site will be carried out as it accumulates.

Figure 48 Construction waste on the road

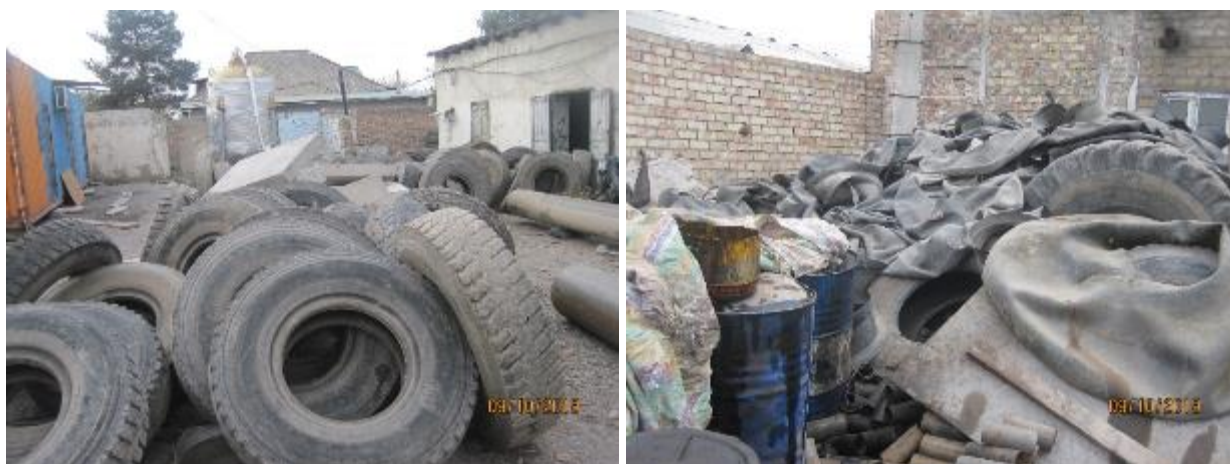
120. In the camp of Belovodskoe village, a large number of old car tires are stored on the camp site. It is necessary to take measures for their removal and disposal. If there is no possibility of recycling, Contractor should involve a specialized company. The contractor explains that the issue of old tires will be resolved by April 2020. The contractor is looking for a specialized company that can take out the accumulated tires for the further disposal.

Figure 53 Storage of old tires in the Belovodskoye

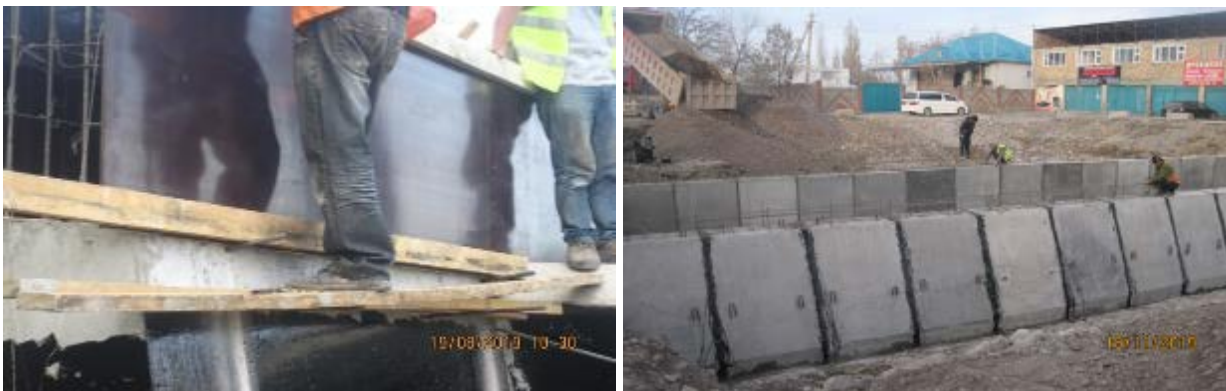
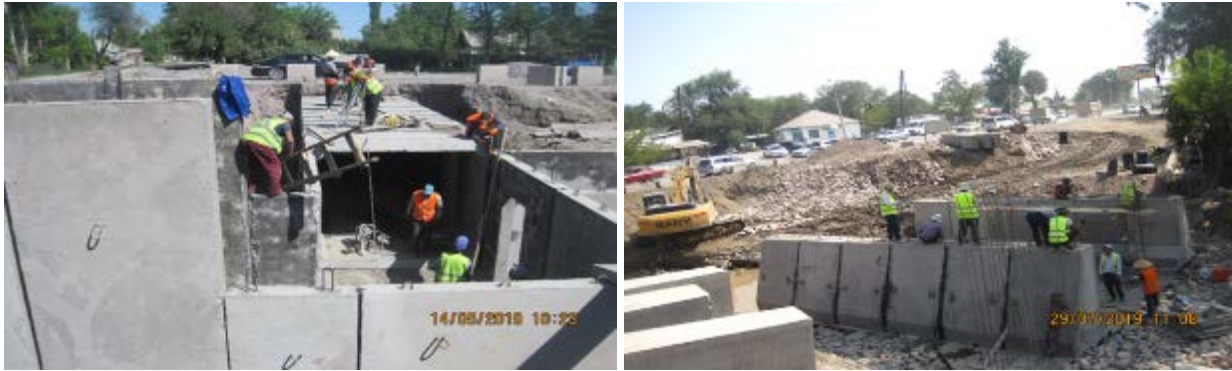
Figure 68 Working at height without personal protective equipment

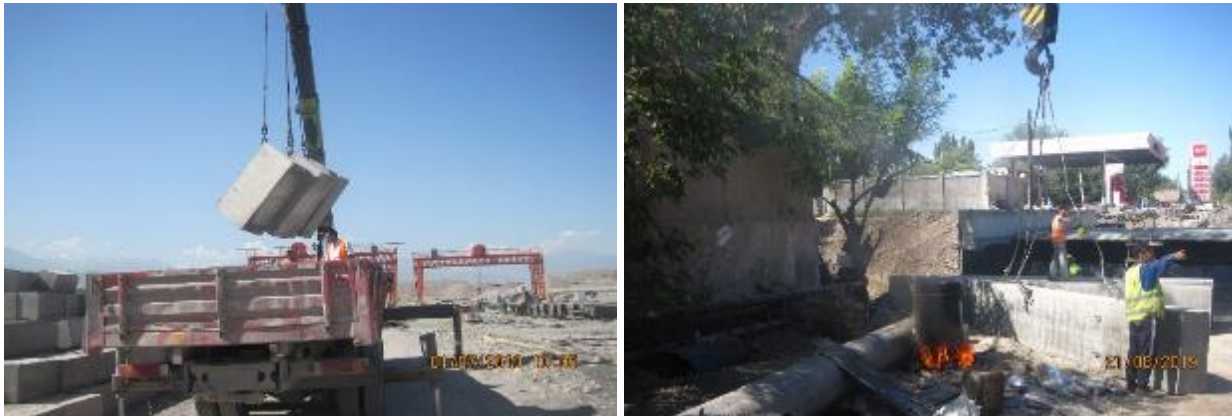
Figure 69 Safety violations when crane operates

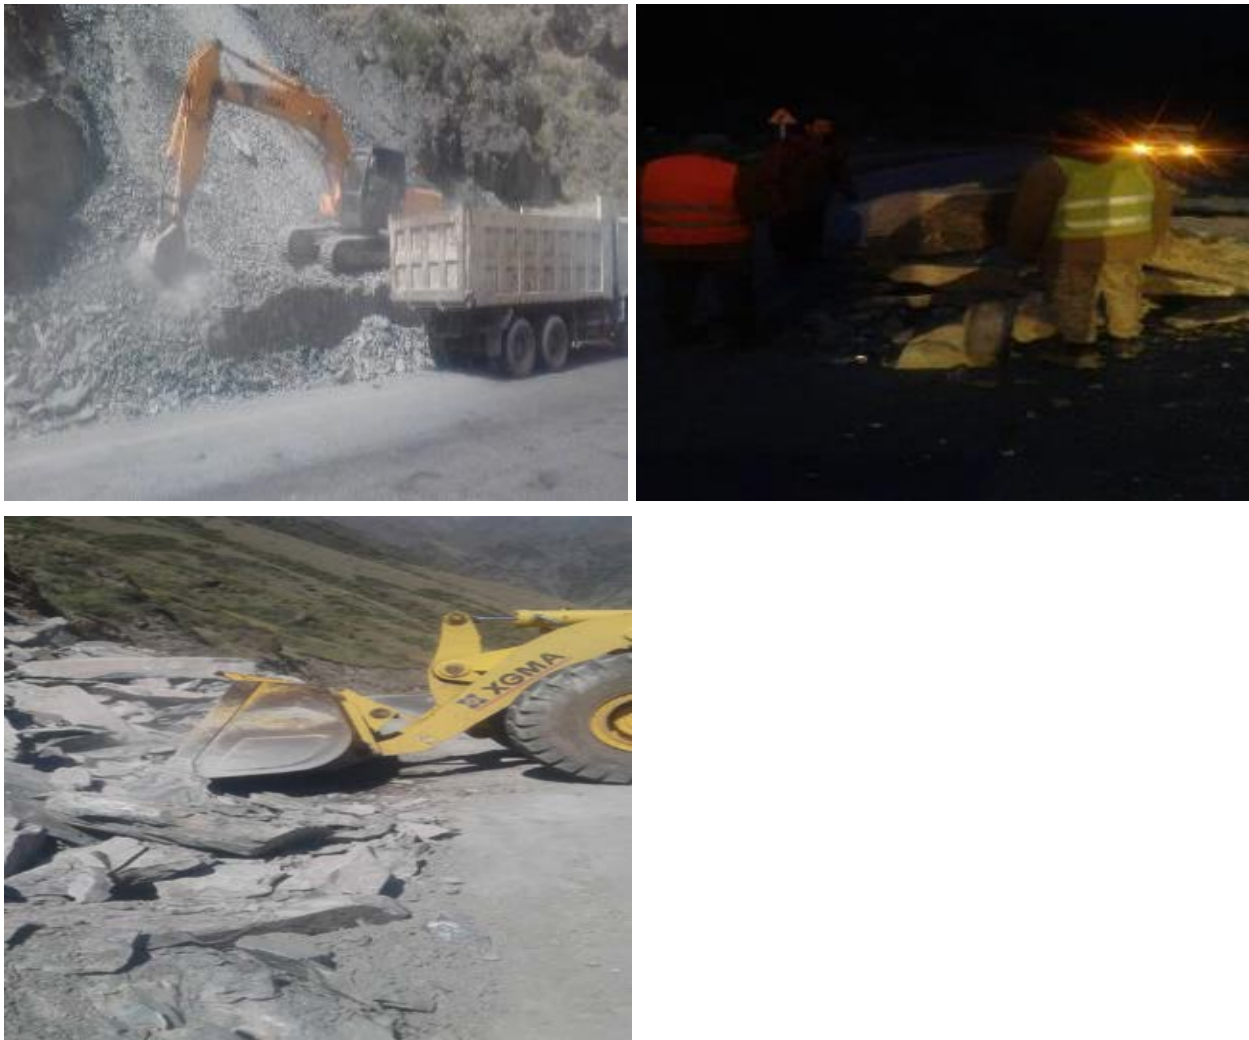
Figure -8. Rockfall hazard
