Project Number: 45169-001  
Reporting Period: January 10 June 30, 2019

Semi-Annual Environmental Monitoring Report: January 1-June 30, 2019

Kyrgyz Republic:  
CAREC Corridor 3 Improvement Project (Bishkek-Osh  
Road), Phase 4 (Km 15.9-60)

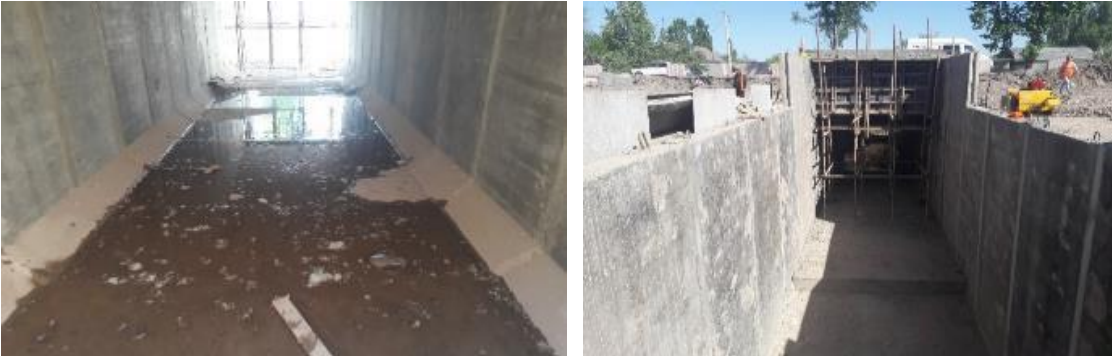
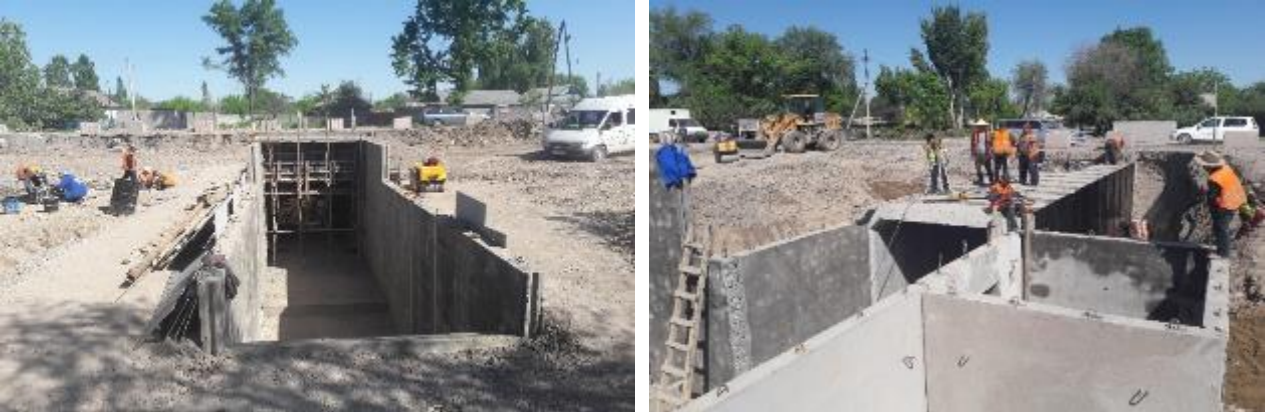
41. At sections 2.3 and 2.4, construction of three underground crossings near vulnerable areas (schools) is underway. The close location of groundwater complicates the construction of crossings (Figure 5). It is necessary constantly pump out a large amount of groundwater and block the foundation with large stones, as well as do waterproofing. Construction of underground crossings is at the final stage. Upon completion, all construction waste will be removed.

**Figure 5. Underground pedestrian crossing and flooding issue**

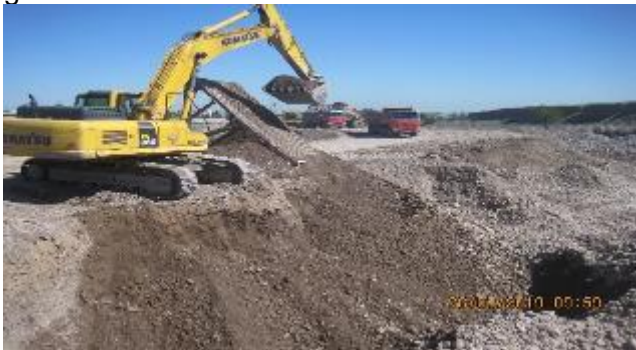
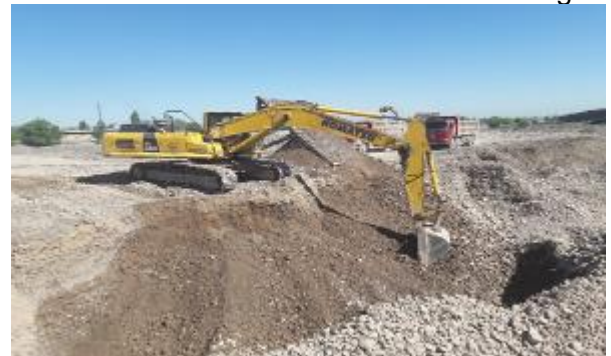
On the part of the contractor, in the development of the Kara-Balta borrow pit, inconsistencies have been made, in part the excess of the depth of the borrow pit development. This inconsistency was noted by the Engineer, which was instructed by the Contractor to immediately fix the inconsistencies. After that, the contractor carried out the appropriate work and brought the development depth of the borrow pit to the appropriate depth. Also, the Engineer noted the non-observance of safety precautions when working an excavator at the Kara-Balt borrow pit. Excavator work at the edge of a cut regularly removing material from below the machines (Figure 9), potentially destabilizing the machine and putting the operator in danger.

Figure 9. Kara-Balta borrow site and excavation depth exceeds permit

45. Letter No. EP-CR5-HN-1065 was sent to the contractor with indication of violations, and on the need to bring development parameters into line with the design, cleaning and restoring the riverbed, observing safety regulations and deadlines for eliminating the violations revealed. The June 2019 inspection indicated that little had changed.

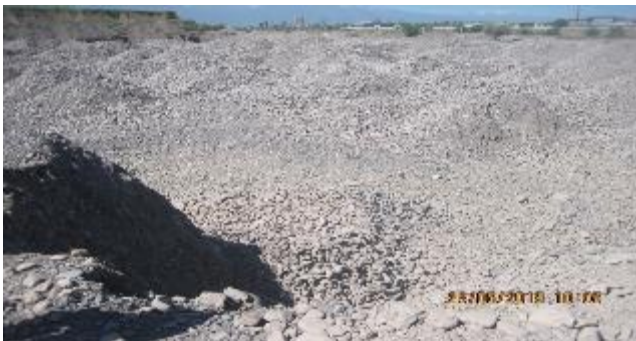
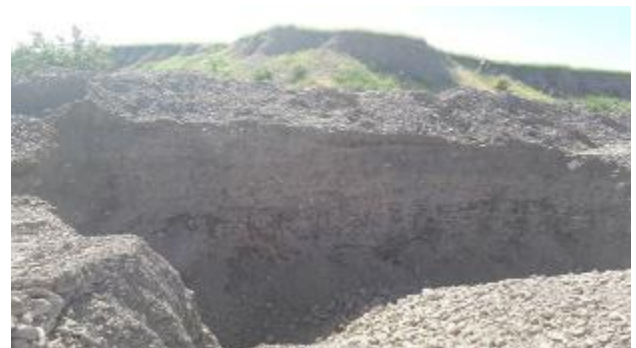
Figure 10. Violating excavation depth during the reopening of the Kara-Balta borrow-pit

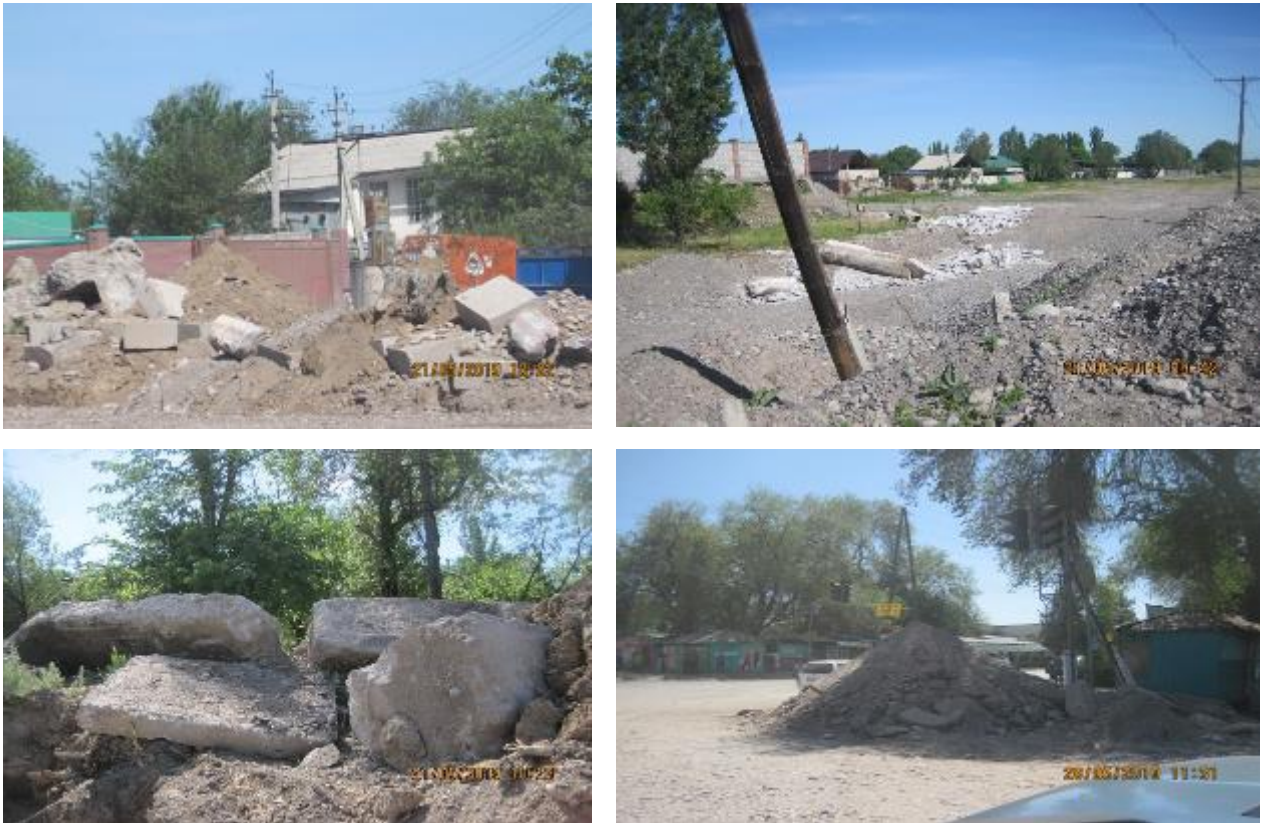
47. During the reconstruction of culverts, old concrete products are stored on the road shoulders and are not removed in a timely manner. Recently, areas for the placement of old reinforced concrete products have been determined together with the local authorities. These materials (Figure 11), together with roadside soils will now be removed to these areas.
48. Oral instructions were constantly given to the Contractor about the need to remove all construction waste from the roadside, and a letter was sent to the Contractor No. EP-CR5-HN-1051, to which reply was received that waste removal has begun. From the contractor's side, an explanation is given that the remnants of unfit reinforced concrete products will be moved away from the site as they accumulate at the project site.

Figure 11. Examples of construction debris along roadside

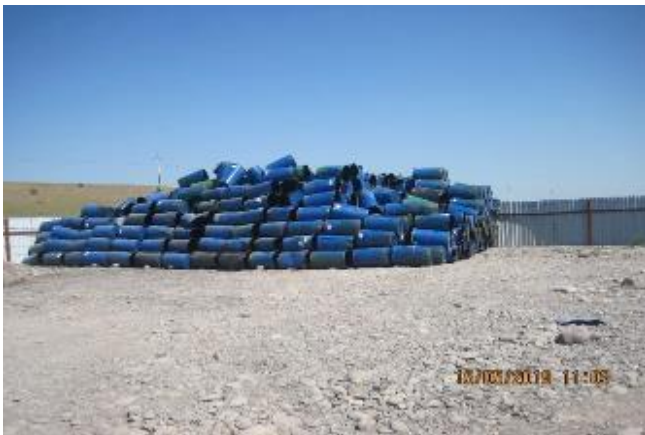
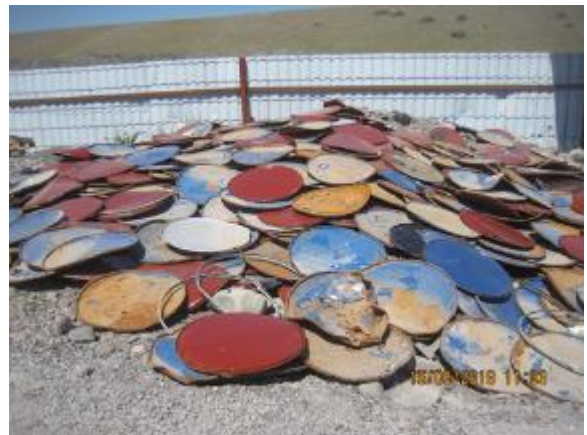
51. Empty and full drums of bitumen are placed on a specially prepared site. A large number of empty bitumen barrels and metal lids from the barrels are accumulating (**Figure 14**) on the site (although not contaminating the ground). The contractor plans to use part of the empty barrels as a temporary arrangement in the areas where the work is being done, having previously painted them and installed reflective tape on the barrels. The engineer has given the Contractor instructions on the need to dispose of unused empty barrels. This issue is at the decision stage.

**Figure 14. Empty bitumen barrels and lids storage**

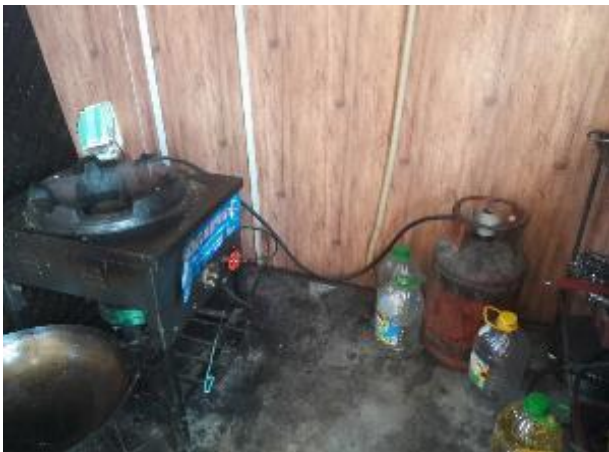
55. A warning was also given to the removal of gas cylinders (Figure 17) from the room and placing them in metal cabinets, but this violation has not yet been eliminated. There is an urgent need to remove gas cylinders from the kitchen.

**Figure 17. Placement of propane tanks near open flame**

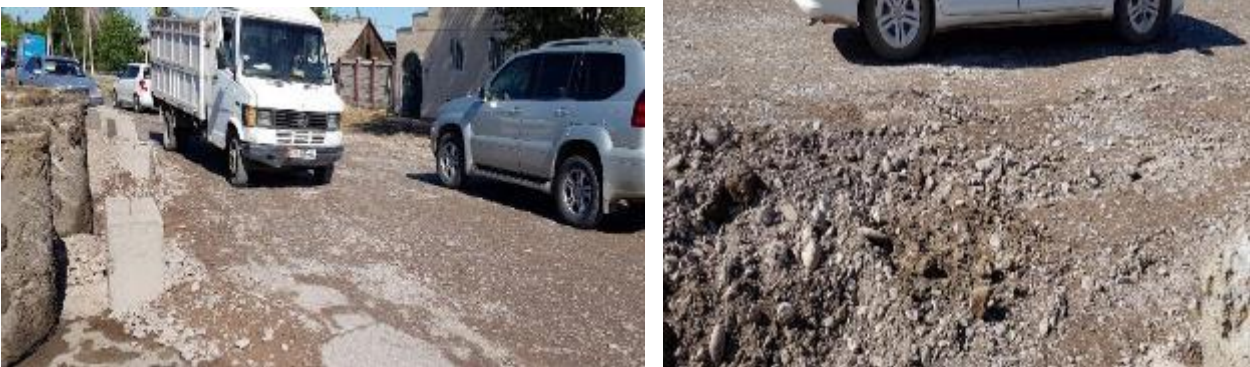
- 61. During the survey it was revealed that from PK-422+27 (Km 50.73) to PK-430 (Km 51.5), approximately 900 m, a continuous parapet barriers were installed in the middle of the carriageway (without breaks). In the case of local residents on this issue, the Consultant will consider the issue of organizing gaps based on road safety and local road safety standards, as well as taking into account the consent of the road police.
- 62. In the village of Alexandrovka on the bypass roads in the repair zones, there were dangerous blockages note which affected the traffic movement and lead to significant traffic jams – The contractor was told to rectify this condition immediately. Inspection by the CSC's international environmental consultant indicated that repair was only partially completed.

**Figure 19. Alexandrovka construction waste blocking road**

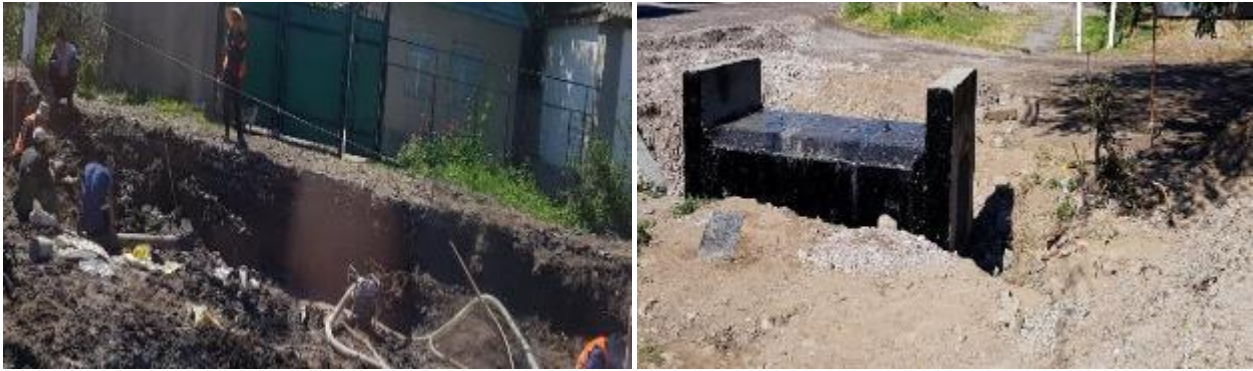
- 63. In Alexandrovka, operations were carried out at night-time, while the safety rules and regulations were not observed, workers were on the work sites at night without safety helmets, some without high-visibility jackets, without a traffic controller present, without fencing and without lighting. The contractor has issued this equipment to the workers, but does not enforce its use, most likely since a subcontractor who does not follow instructions was actually doing the work. At the time of preparing the report, the contractor accepted all the comments and proceeded to eliminate them.

**Figure 20. Unsafe Construction Practices, Alexandrovka Village**

- 64. Also on the part of the Engineer, the contractor was instructed to: When working at night, it is necessary to have a safety engineer and site manager present; supervise workers using the high-visibility jackets; provide rehabilitation or arrangement of temporary pedestrian crossings.

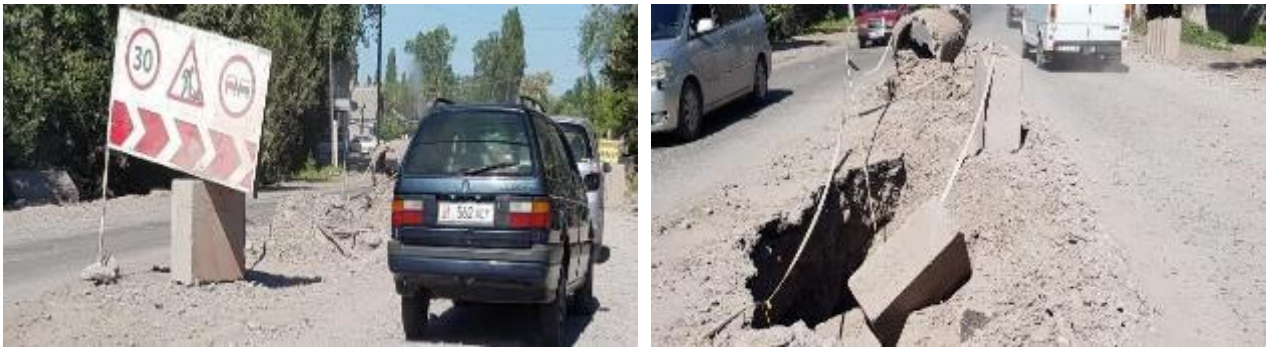
65. Village of Poltavka - there is no sign warning of children crossing to the nearby school. It is necessary to promptly install traffic signs, especially near schools. This work must be completed before the start of the school season. This issue will be monitored in August, to make sure that by the start of school the passage / transition will ensure security properly.
66. In Belavodsk, in areas where new drainage pipes were built, there is a roughness of the road and the presence of holes. The contractor was instructed to restore damaged asphalt, the presence of the necessary warning signs and their timely removal of dirt to improve their visibility at night. (Figure 21).

**Figure 21. Dangerous construction practices, Belavodsk**

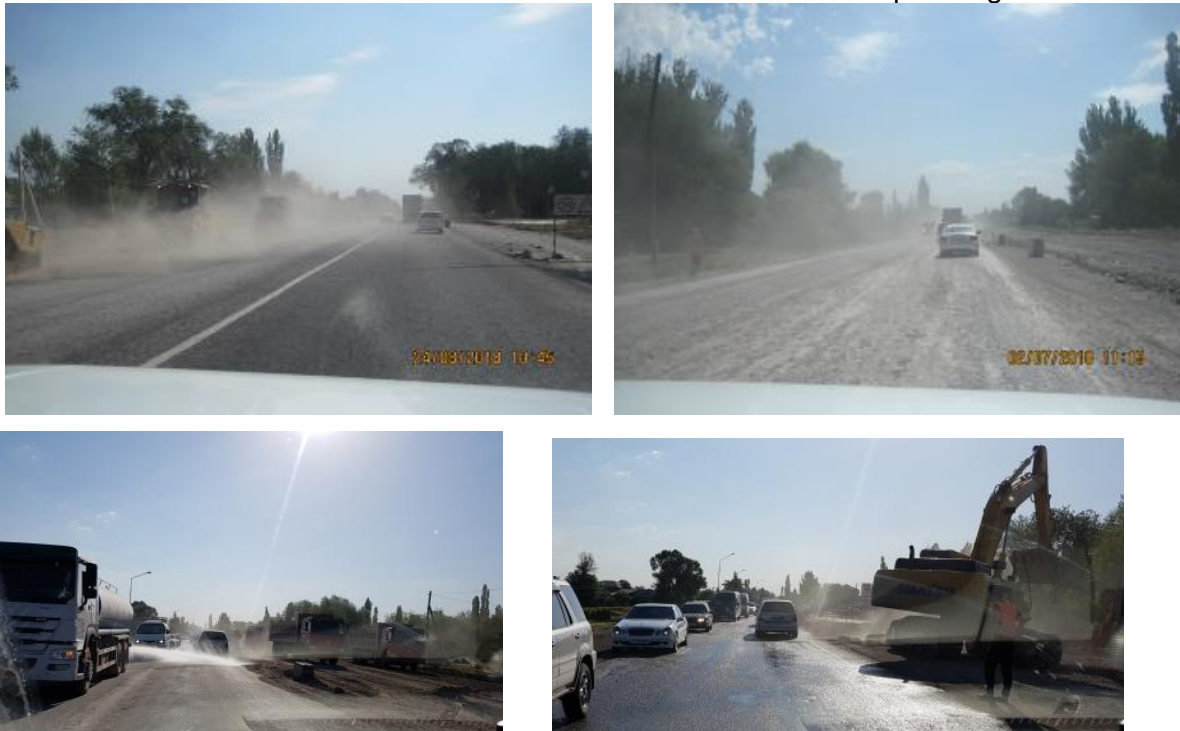
99. Dust formation has the main impact on the environment during the execution of earthworks. The engineer constantly monitors dust suppression activities and sends appropriate instructions to the contractor. The increased air temperature led to increase of dust formation in the road, Engineer given to the Contractor warnings on the need to increase the water sprinkling. In this regard, the Contractor was instructed to increase the intensity of road watering sprinkling, including shoulders, at construction sites from 6 a.m. to 20 p.m. without a break for lunch. The contractor has drawn up a schedule of water sprinkling of the road with an indication of the interval between water sprinkling 30 minutes.

Figure 26. Dust generation example. Dust suppression event example.

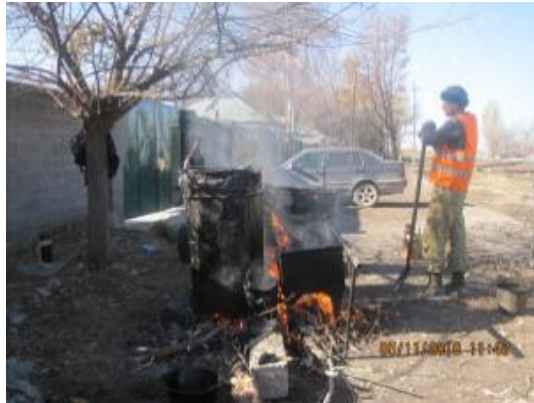
100. During the construction of culverts, the works on waterproofing culverts with bitumen (Figure 27). These violations include the burning of bitumen due to lack of firewood. After the CSC provided an explanation and instructed the contractor, firewood was transported to the work sites.

**Figure 27. Burning bitumen to heat bitumen during the waterproofing of culverts**

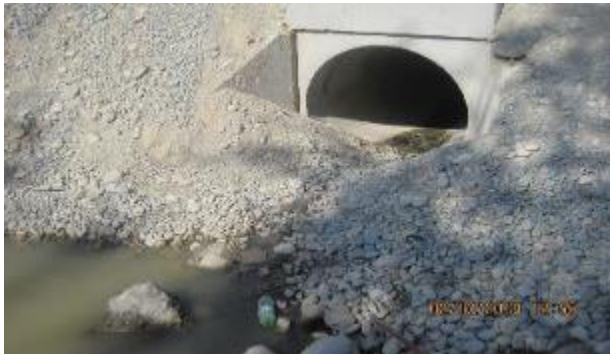
**Figure 28. Debris almost totally blocking new culvert entrance**

102. The construction inspectors noted that this is quite common when culverts are extended (Figure 28). Therefore, inspections will be much more vigilant, and all new installed culverts must be checked against design specifications and certified to be clear of all obstructions both upstream and downstream of structure.

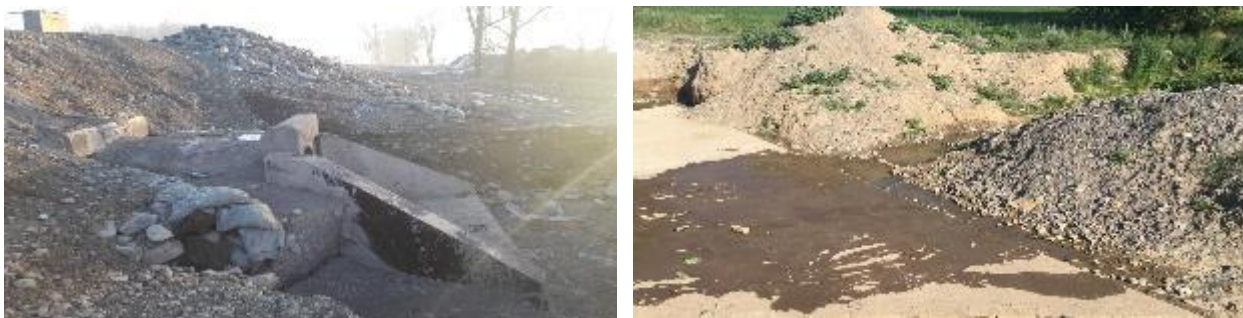
**Figure 29. The culvert with an extra section added and Jelamysh R. bridge blockage**

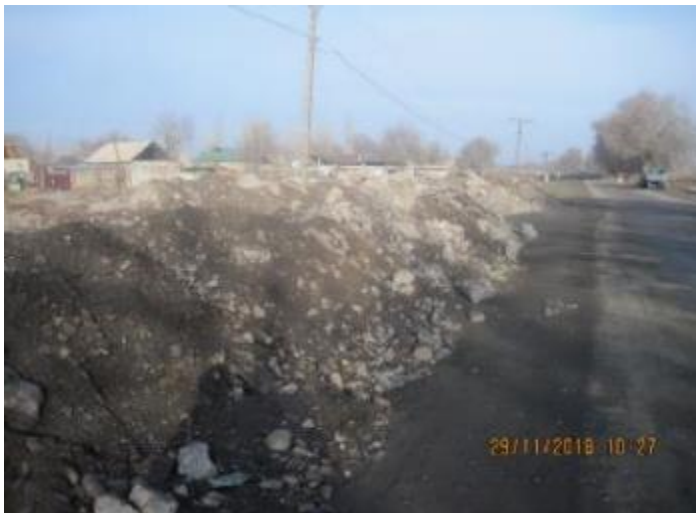
106. A large amount of construction waste is stockpiled at the northern side of the bridge under construction. A letter was sent to the Contractor on the need to take out the formed concrete waste to the designated places.

**Figure 300 Construction waste at the northern side of the bridge under construction**

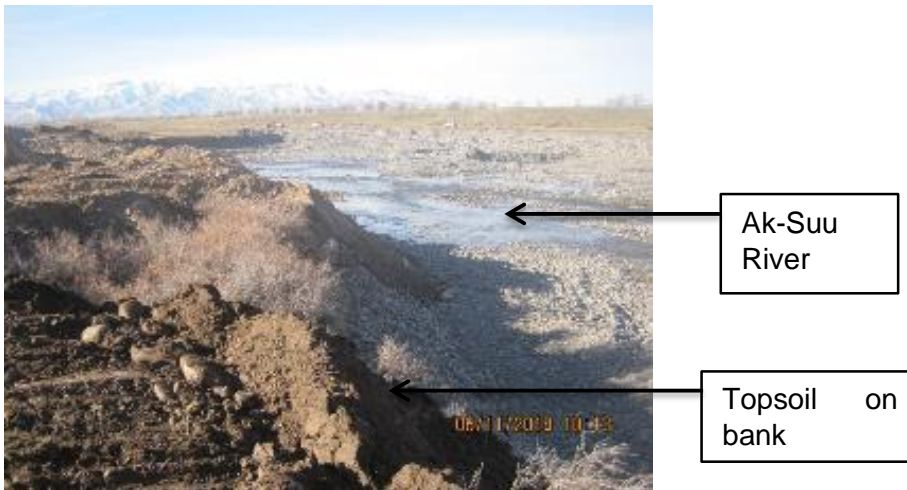
riverbed, which is a violation of environmental legislation. Another letter was sent to the Contractor on the need to remove all dumped soil from the riverbed. Later the soil was removed to the boundary of the borrow-pit. Further, the soil will be used for reclamation of the borrow-pit (Figure 311)

**Figure 311. Topsoil incorrectly stored at the river shore**

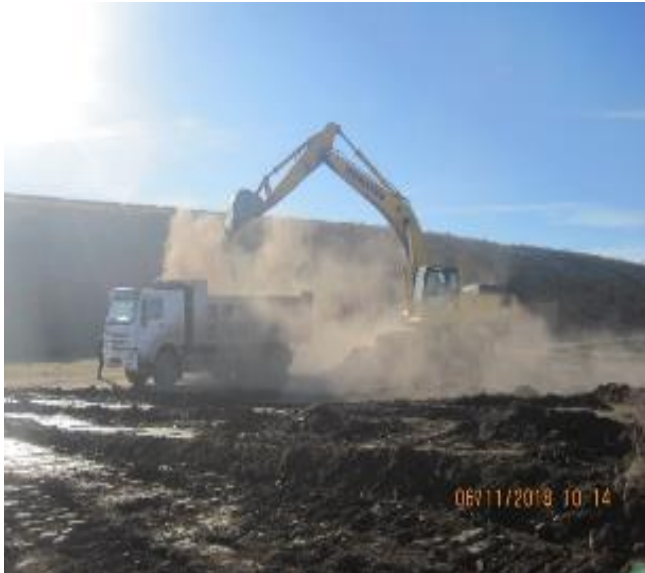
110. Dust suppression at the Ak-Suu pit is conducted quite intermittently which has led considerable dust in the area (Figure 322). In March and April 2019, the Consultant held additional discussions on the issue of dust suppression measures, in order to improve the situation, and also raise the issue of increasing the number of water transport vehicles. These discussions resulted in a commitment by the contractor to increase the frequency of water sprinkling. To confirm this commitment, inspection during July and August will be important.

**Figure 322 Dust formation during Ak-Suu borrow-pit mining**

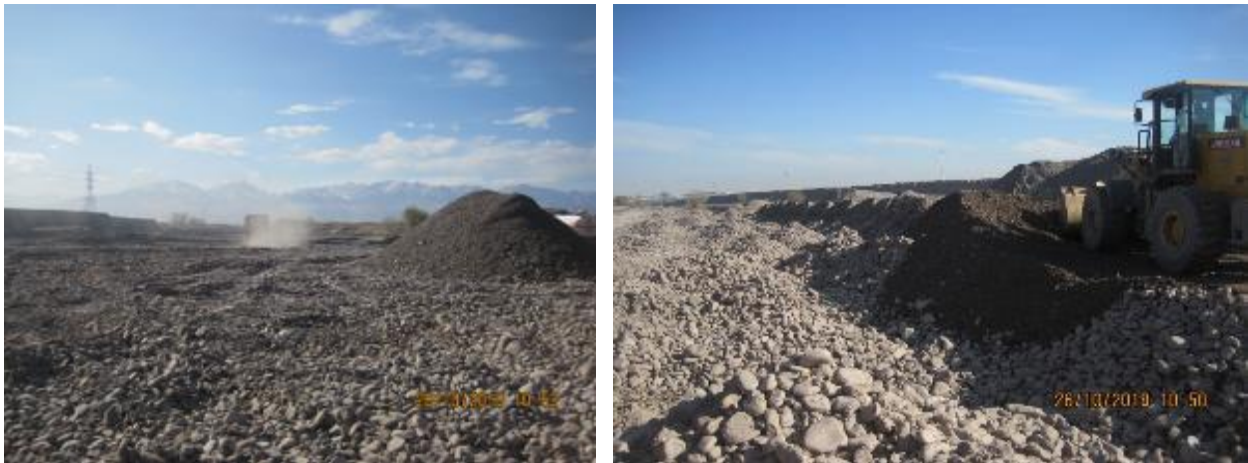
112. Development of Kara-Balta borrow-pit started in September 2018. Works on excavating, sifting and stockpiling of material in the spoil areas were carried out until the end of Nov. when it was suspended when the project closed for the winter season. During the reporting period, non-compliance with the requirements of the depth of borrow pit development, which were resolved by the Contractor after the Engineer relevant comments. (Figure 344. Kara-Balta borrow pit)

**Figure 354. Kara-Balta borrow-pit operations**

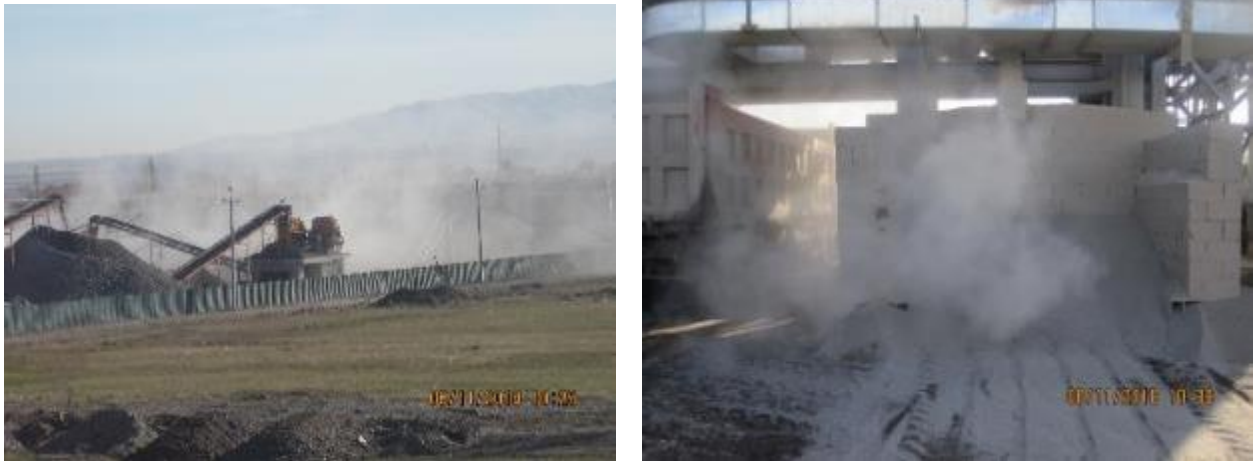
118. Several non-compliance letters were sent to the Contractor. The Contractor explained the situation by claiming a breakdown of the water pipeline to the facilities. EPTISA has reminded the contractor that the general conditions of the Contract - Technical Specifications clause 1.2.10 (j) states, "Crushing plants should only operate with dust control devices working".

**Figure 398. Dust in the aggregate processing plant and the asphalt plant**

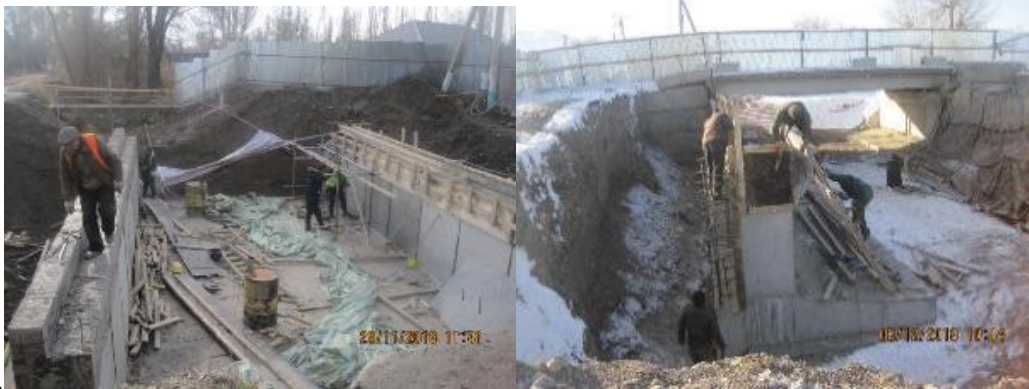
**Figure 422. Carrying out of works at height without PPE**

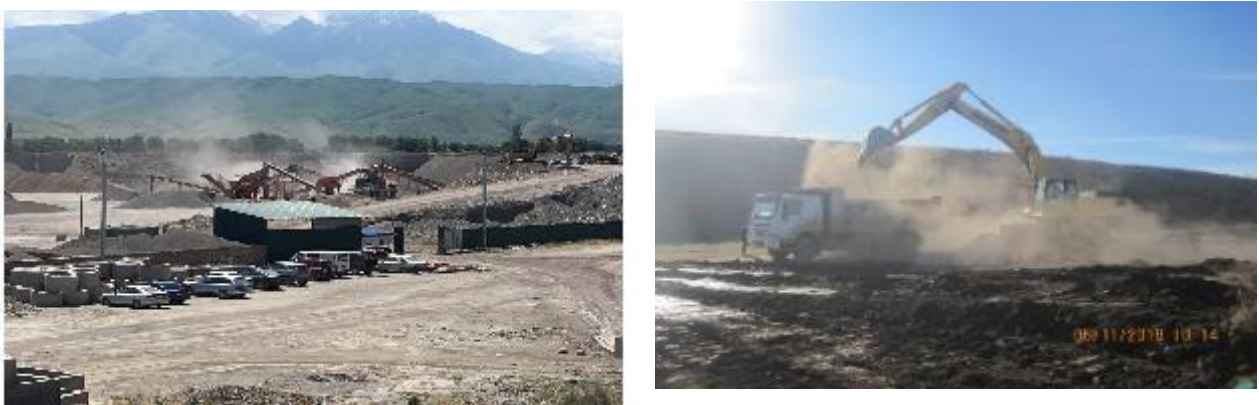
**Figure 433 Operation of equipment without water sprinkling.**

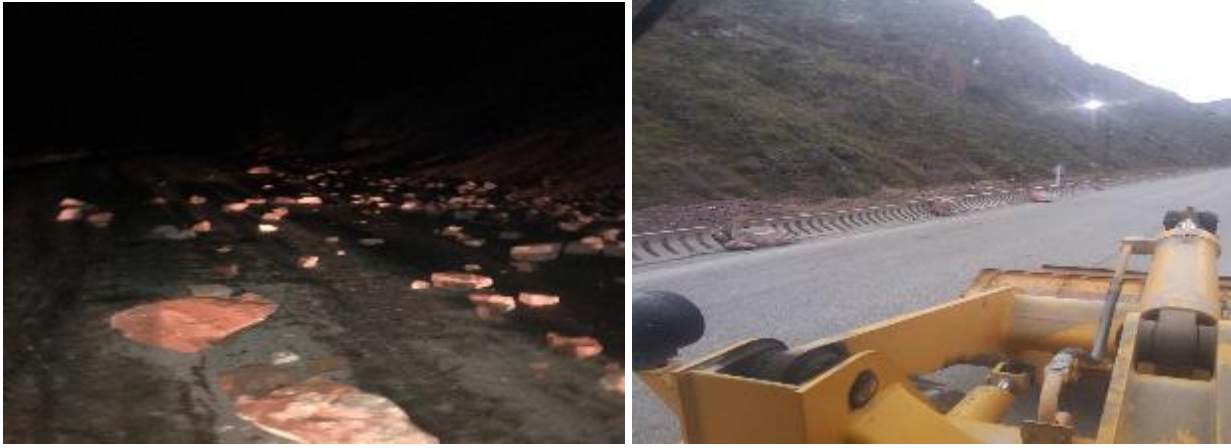
Figure 11. Danger of rockfalls
