Project Number: 45169-001
Loan Number: ADB Loan 3056-KGZ (SF)
Grant Number: 0366-KGZ (SF)

Semi-Annual Environmental Monitoring Report
January 1 – June 30, 2020

CAREC Corridor 3 Improvement Project (Bishkek – Osh road), Phase 4 (km 15.9 – km 61)

Submission date: July 2020

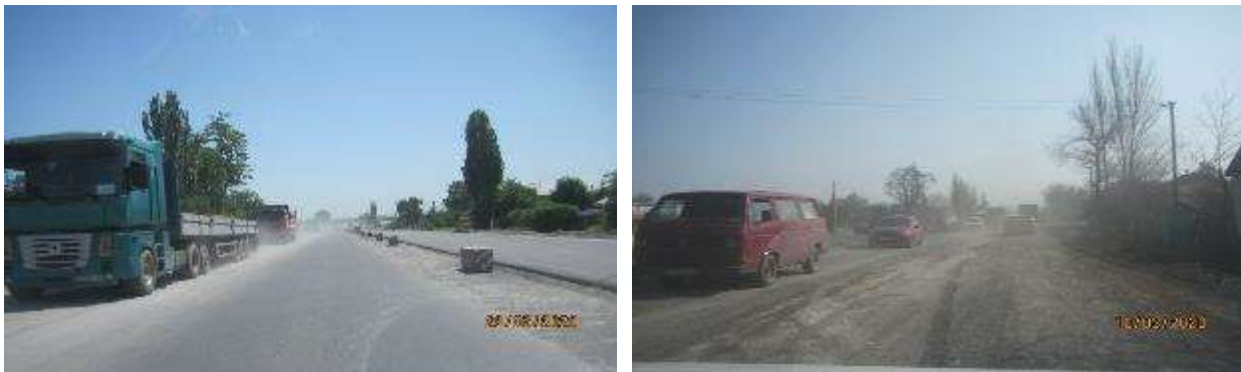
Figure 27 Increased dust generation at construction sites

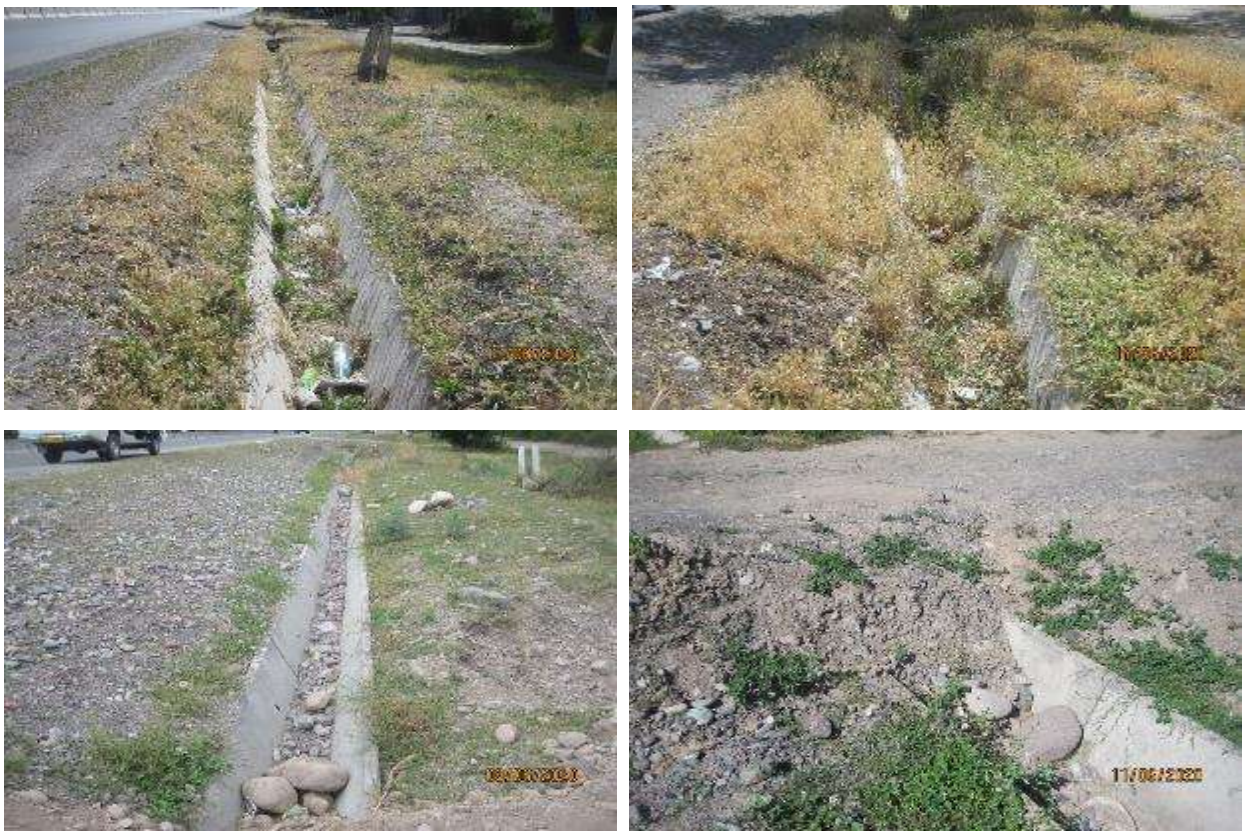
85. Previously installed chutes are overgrown with grass and covered with construction waste. A letter was sent to the contractor to eliminate the identified violations.

Figure 30 State of the previously installed chutes

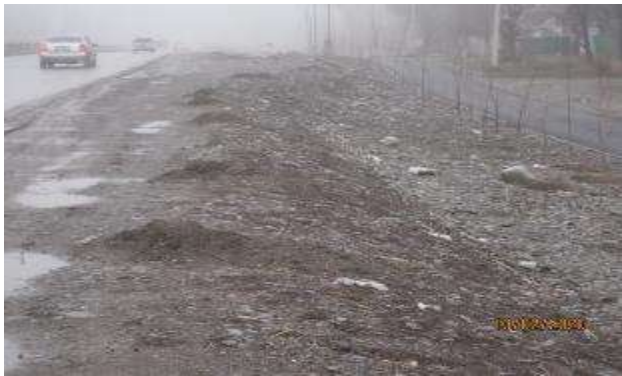
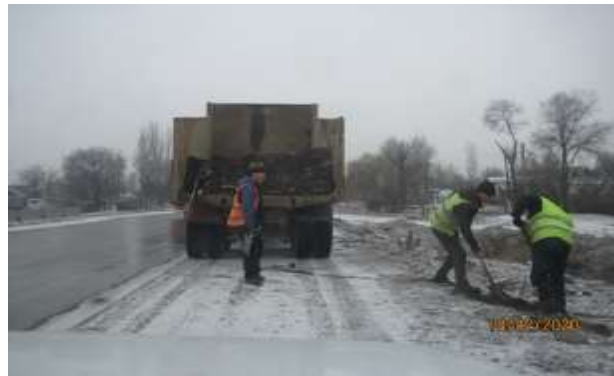
87. During the monitoring it was found that on the road shoulders in the village of Petrovka, starting from km 47, where work was carried out to strengthen the parapets, there were not removed earth waste, stored in small heaps. And due to atmospheric precipitation, the waste was washed away and polluted the surrounding area. A letter was sent to the contractor indicating the time frame for fixing this violation.

Figure 31 Collection and removal of earth waste from the road shoulder

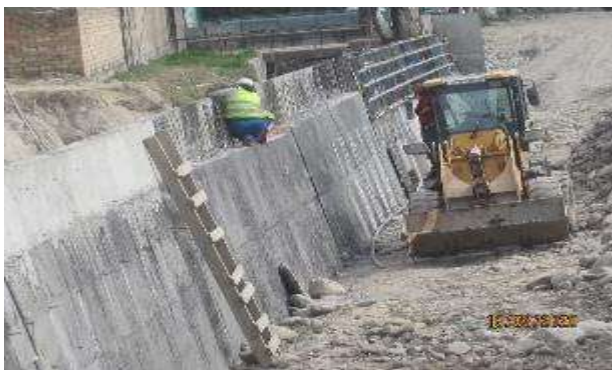
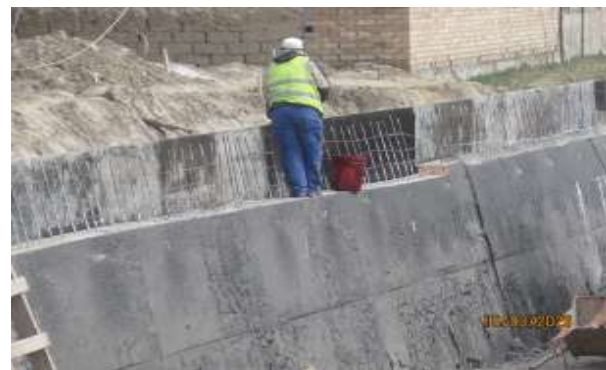
Figure 33 Violation of safety precautions during the construction of the bridge at the Jantai canal

91. During bridge construction works at the Jantai canal (KM 24+110), safety violations were noted. In the presence of special means for working at height - ladders, workers worked without using them. The contractor was notified of the need for constant monitoring of safety precautions and awareness-raising among the workers.

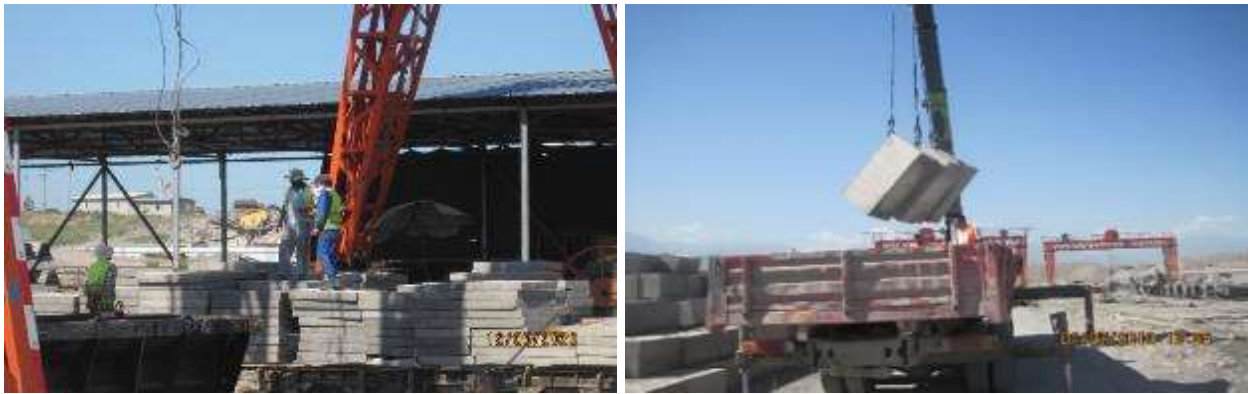
107. Despite regular training conducted by the Contractor's safety specialist, violations/non-compliance with safety precautions were observed at the site for manufacturing of concrete products when lifting and moving weight suspended with a travelling crane hook. The issue of compliance and observance of safety precautions will be monitored by the Consultant on an ongoing basis. During the July the Contractor's safety specialist will conduct additional lectures for the staff.

Figure 42 Safety violations

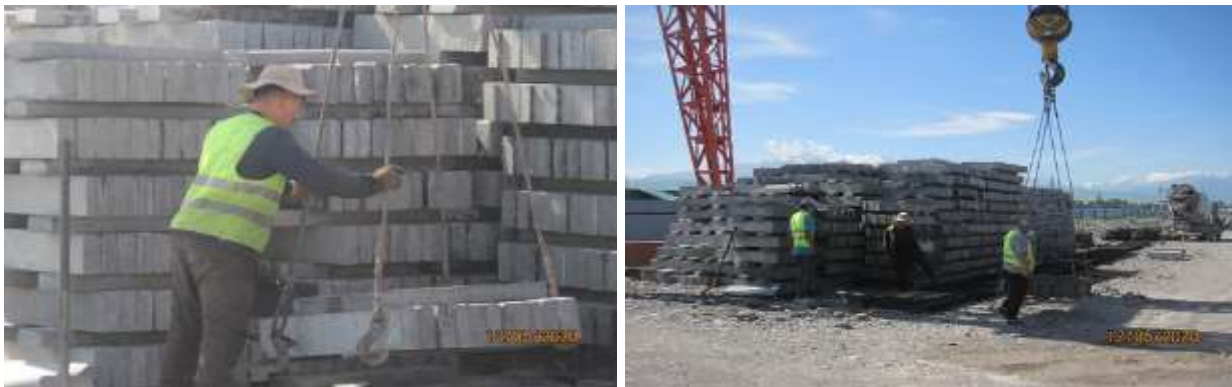
Figure 43 Lack of personal protective equipment of workers at the site of production of reinforced concrete products when lifting and moving loads

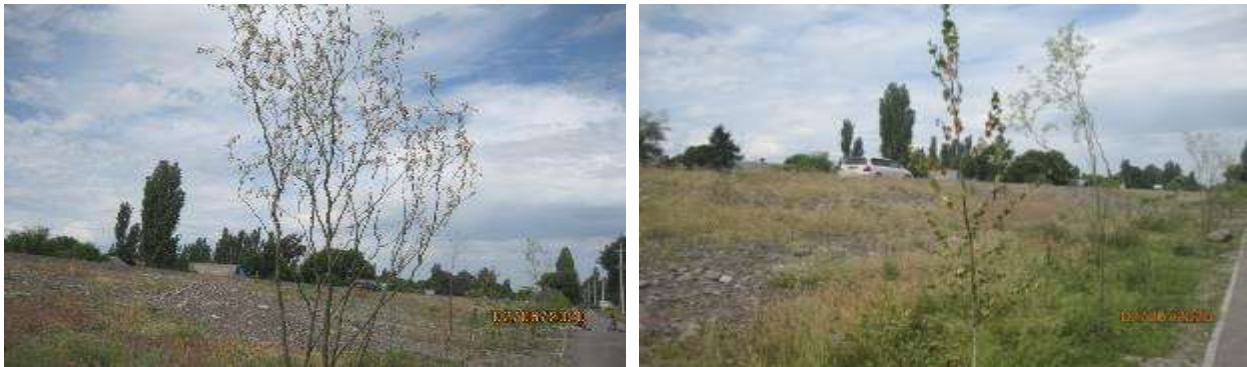
113. To provide the seedlings with the right amount of moisture, watering should be done regularly every 3 days. Before the first watering, it was necessary to make holes near each seedling. A letter was sent to the contractor about the need to make regular watering every 3 days. Despite constant reminders to the Contractor, the seedlings were not watered regularly. Given the hot weather, some of the seedlings began to dry out. The consultant carried out a preliminary calculation of the survival rate of seedlings, which was 95%. Given that the planting of seedlings is not completed, the numbers on the survival rate of seedlings will change and the final percentage of survival will be summed up in 2021. The contractor was given an additional explanation that, in accordance with the terms of the current contract, all dried seedlings will be restored at the expense of the contractor

Figure 46 Seedlings before regular watering

114. Additional letter was sent to the contractor with instructions for regular watering of the seedlings.

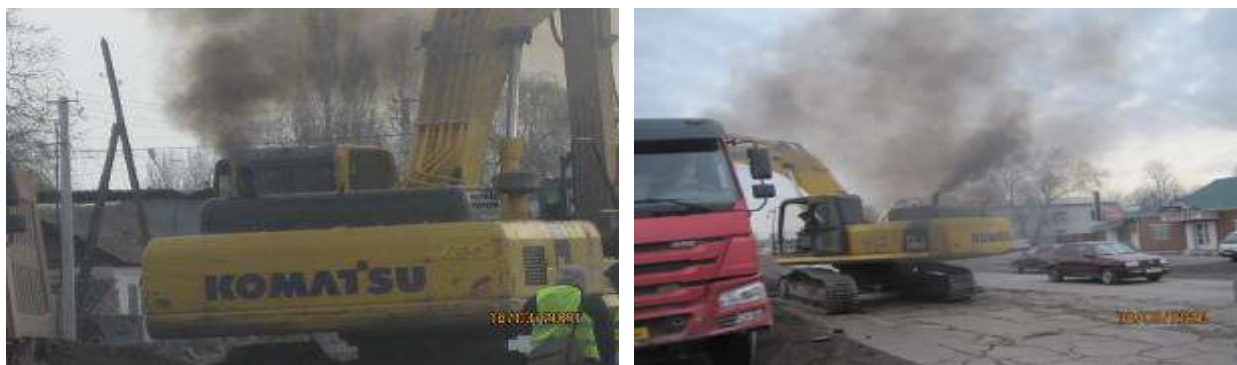
122. During the monitoring, it was found that the excavator operating in the village of Belovodskoe (section 6) on the removal of old asphalt was in poor technical condition, emitting black smoke, causing harm to health, the driver of the excavator, the population, and the environment.

Figure 52 Unsatisfactory technical condition of the excavator

123. In this regard, the work of the excavator was suspended until it was restored to regular technical condition.

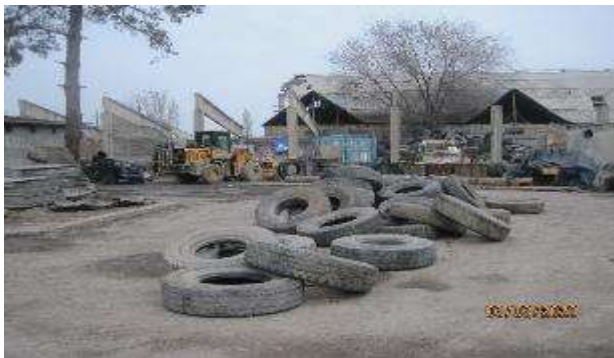
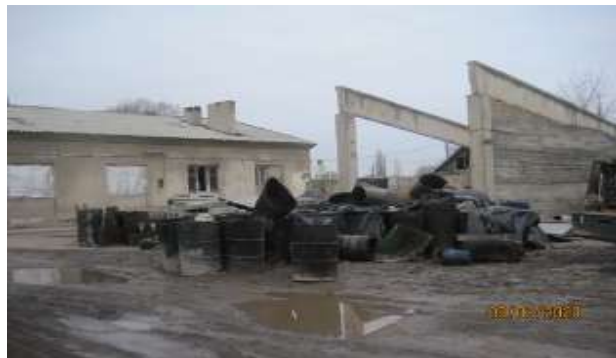
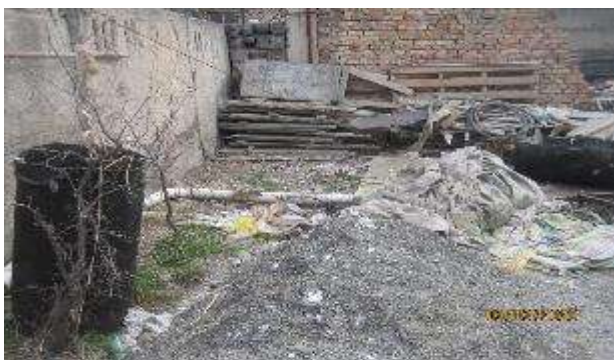
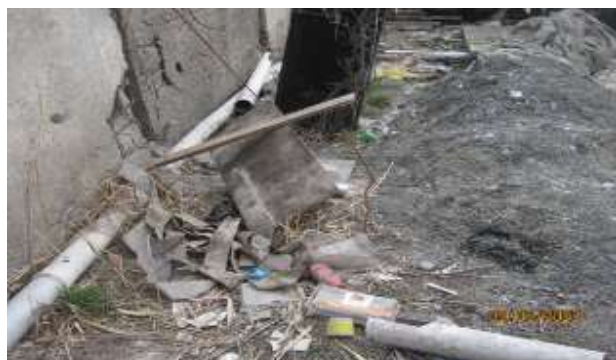
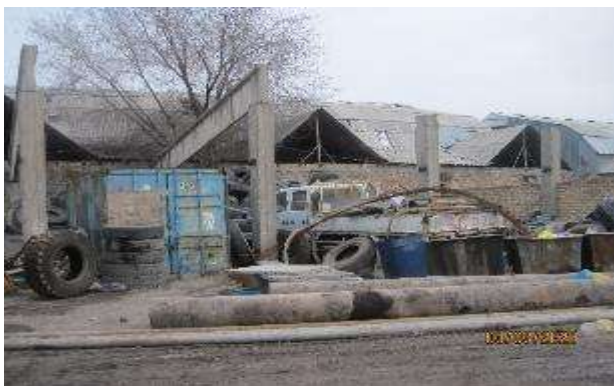
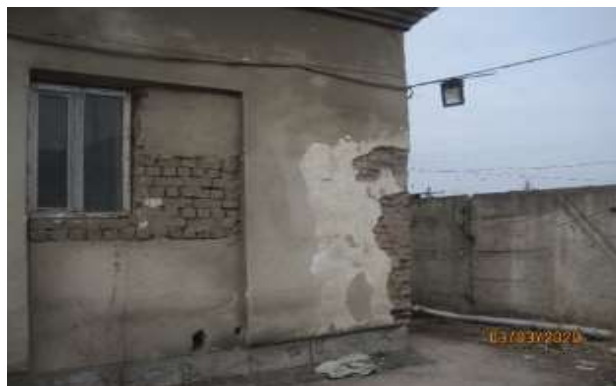
125. In March, during the monitoring the state of the camps where workers lived, it was found that the camp in the village of Belovodskoye was in an unsatisfactory condition. A large amount

of production and household waste has accumulated on the territory. The house where the workers will live is also in an unsatisfactory condition. A letter was sent to the contractor demanding to bring the territory to the proper condition. The territory was partially cleaned, but it is necessary to fill the surface of the territory with crushed stone in order to eliminate dirt and puddles.

Figure 55 The territory of the camp in the village of Belovodskoye after the winter period

128. It was recommended to remove all waste from the camp as soon as possible. Bring the house of workers in proper condition. The fill the area of the camp with crushed stone, hold conversations with the workers living on the territory of the camp about compliance with the rules of hygienic maintenance of the territory of residence, taking into account the fact that despite the garbage cans located next to the house of residence, household garbage is thrown out on the territory.

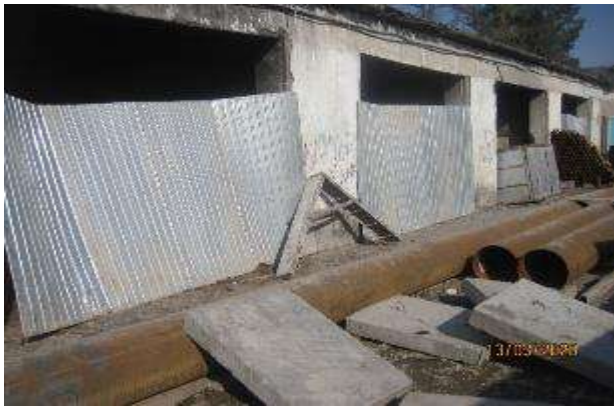
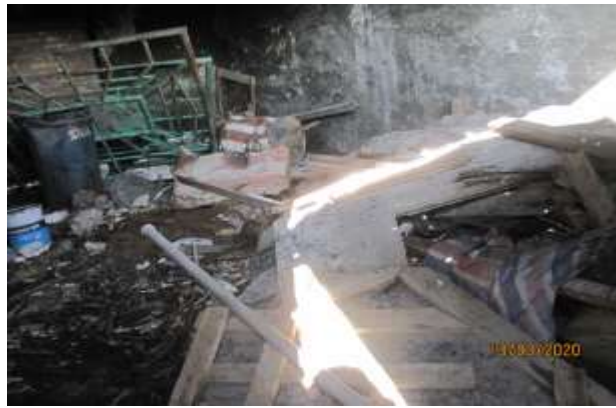
126. Repair workshops are covered with metal sheets to hide the disorder inside.

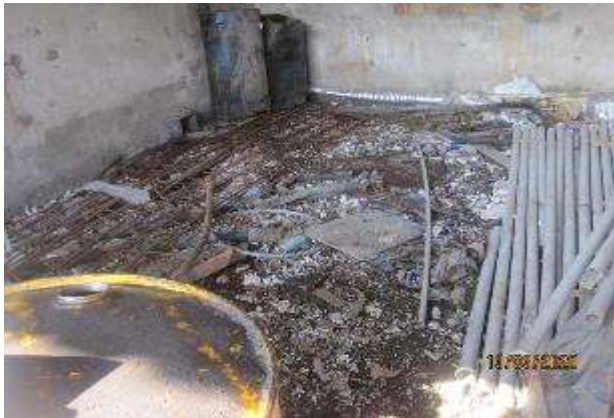
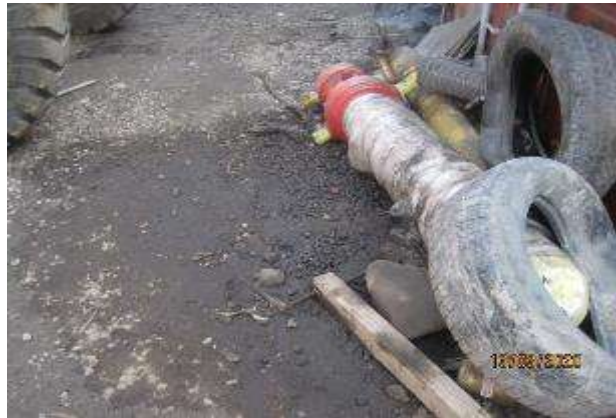
127. There are also oil spills on the ground.

Figure 56 The territory of the camp in the village of Belovodskoye after the winter period

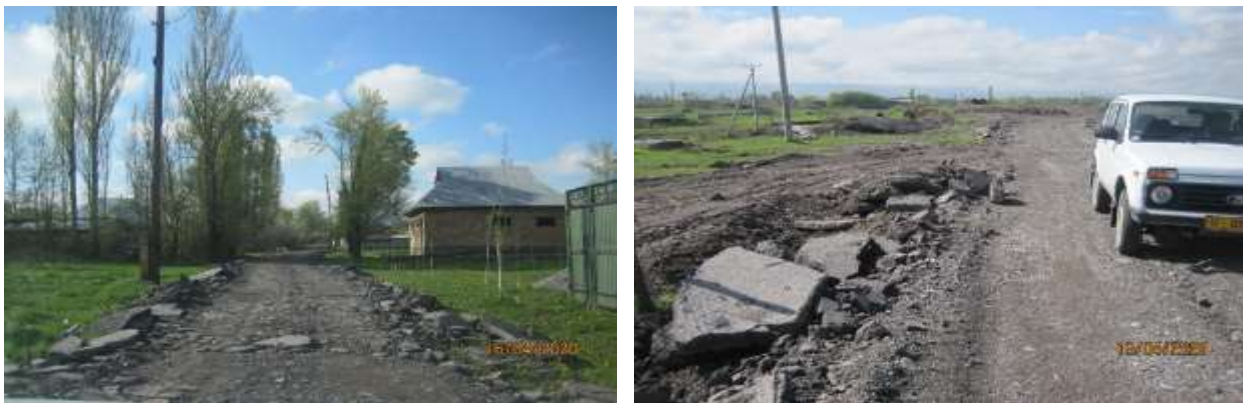
164. The old asphalt was taken out to the Kalinina street. In many places on the road shoulders, the asphalt was not originally levelled, there were large pieces of asphalt.

Figure 62 Kalinina street before levelling

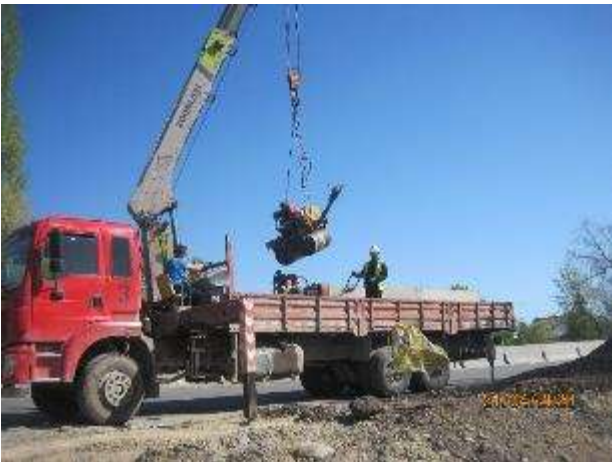
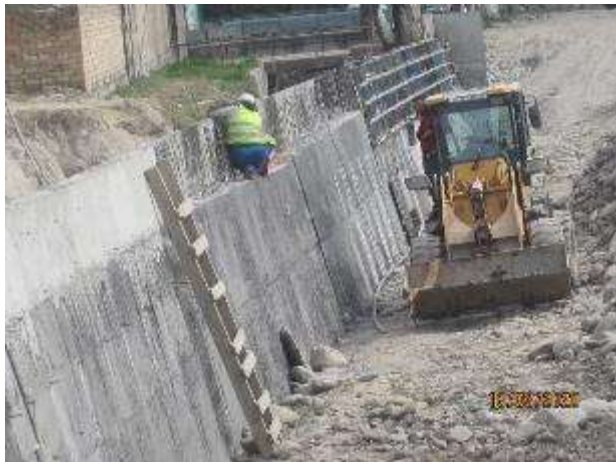
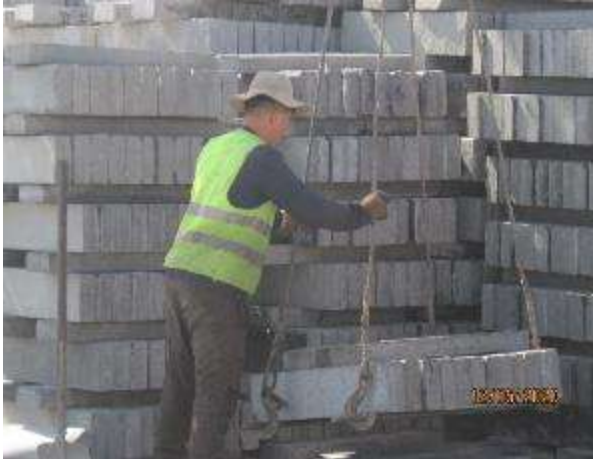
Figure 68 Safety violations when moving loads with a crane and working at height

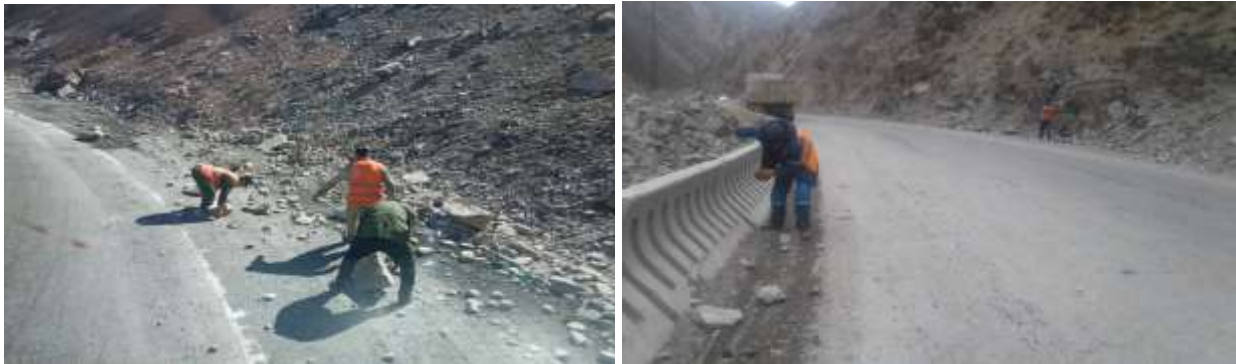
33. On the areas of km 86.9 - 88.7 and km 98, rockfalls occur due to heavy rains. Also in this area there are large rock pieces hanging over the road, representing the threat of spalling and falling onto the road, representing a danger to passing vehicles.

Figure-8. Rockfall hazard
