Environmental Monitoring Report

7th Semi-annual Report
January 2021

KGZ: Central Asia Regional Economic Cooperation Corridor 3 (Bishkek -Osh Road) Improvement Project, Phase 4

Prepared by Joint Venture Temelsu International Engineering Services Inc., E.Gen Consultants Ltd., and Dosh Upodosh Ltd. in association with Kyrgyz TREC International, Ltd. for the Ministry of Transport and Roads of the Kyrgyz Republic and the Asian Development Bank.

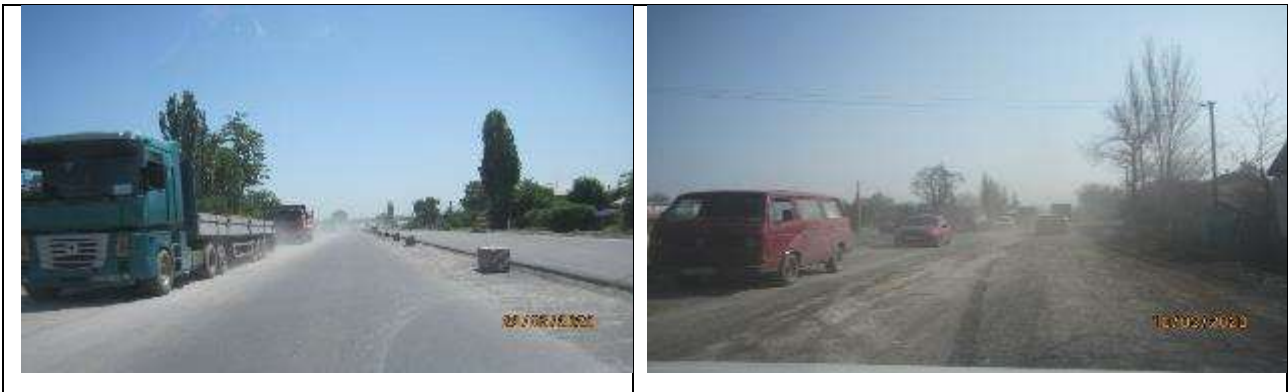
96. In previous periods dust generation has the main impact on the environment during the earthworks. In the reporting period, single cases of dust generation were noted, about which the Contractor was immediately warned. At the construction sites water-sprinkling of the road including the shoulders was carried out from 7 am to 8 pm without a lunch break. The contractor has drawn up a schedule for water sprinkling with an interval between watering 30 minutes. Considering the small scope of work on the road and the fact that several watering machines worked on the construction sites, which water the road in time, dust generation was rarely observed at the construction sites. No complaints for dust formation were received from the local residents or local government authorities during the reporting period.

Figure 30 Increased dust formation at construction sites

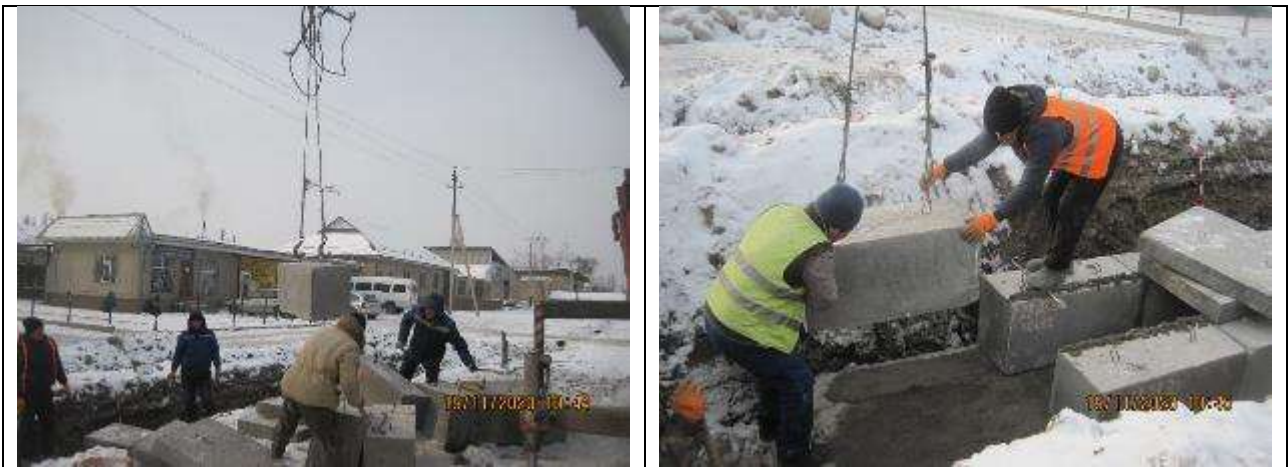
Figure 33 Violation of safety precautions during installation of culvert chutes

100. During the work on the installation of culvert chutes, the facts of safety violations were noted (the absence of helmets) when moving load by cranes. The contractor was notified on the need for constant monitoring of safety measures and explanatory work among workers.

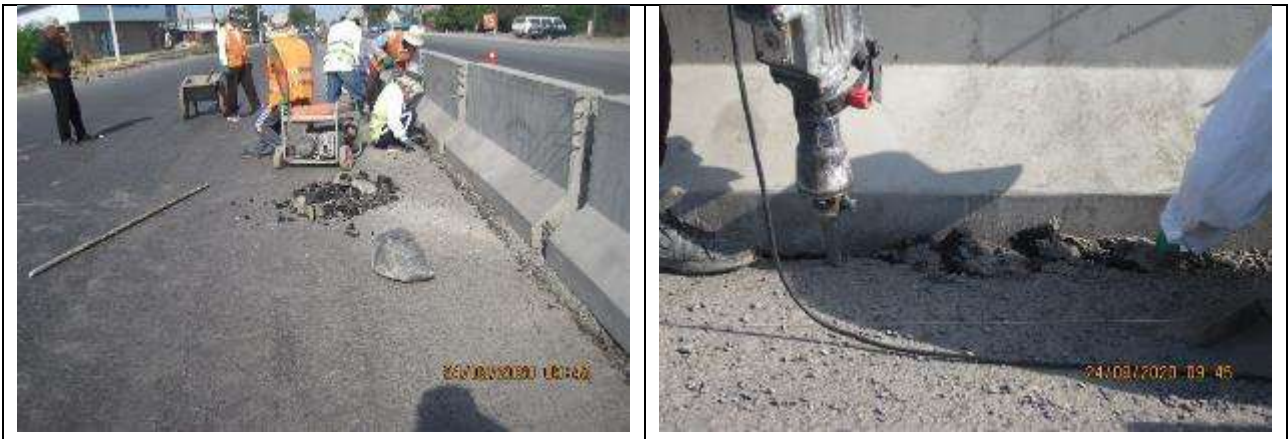
102. In course of monitoring, it was found that on the road shoulders, where work was carried out to strengthen the parapets, there were not removed soil waste, laid in the form of small piles. Under the impact of atmospheric precipitation, the waste was washed away and polluted the surrounding

area. A letter was sent to the contractor with an indication of the time frame for eliminating this violation.

Figure 34 Cleaning of parapets from accumulated soil

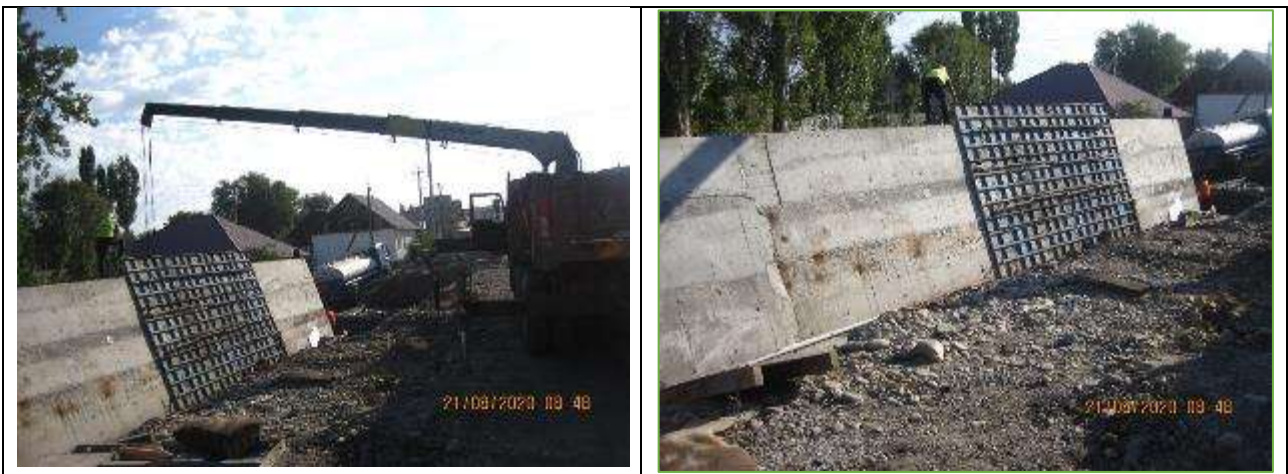
Figure 38 Violation of safety precautions during work at height

107. During the construction of retaining wall at km 26+500, there were cases of safety violations. There were no special means for working at height - ladders. The workers worked without helmets. The contractor was notified on the need for constant monitoring of safety measures and explanatory work among workers.

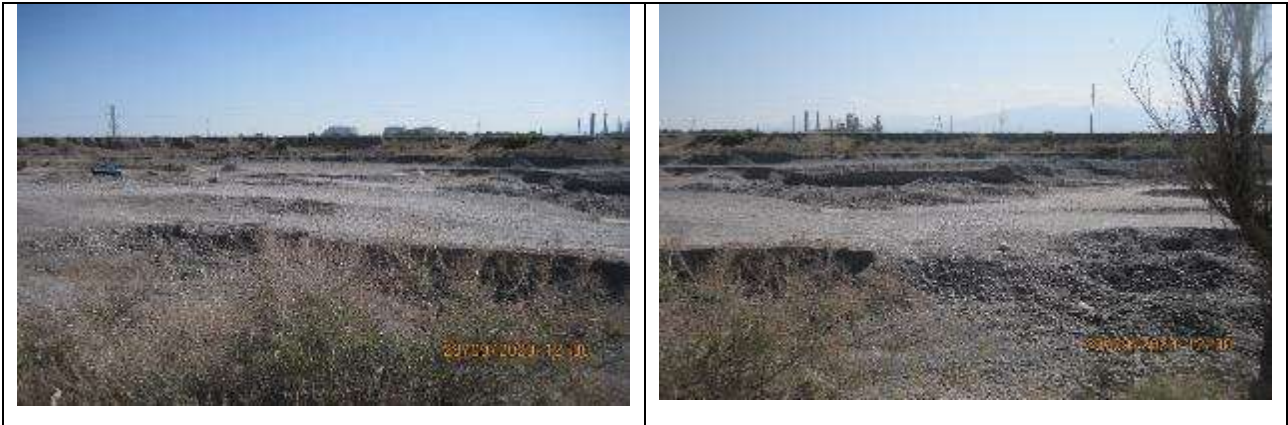
Figure 41 Kara Balta borrow pit at present time

120. In the course of the monitoring it was found that unauthorized persons are working on the borrow pit area allotted to the Contractor, which leads to disruption of the borrow pit surface, forming deep cuts.

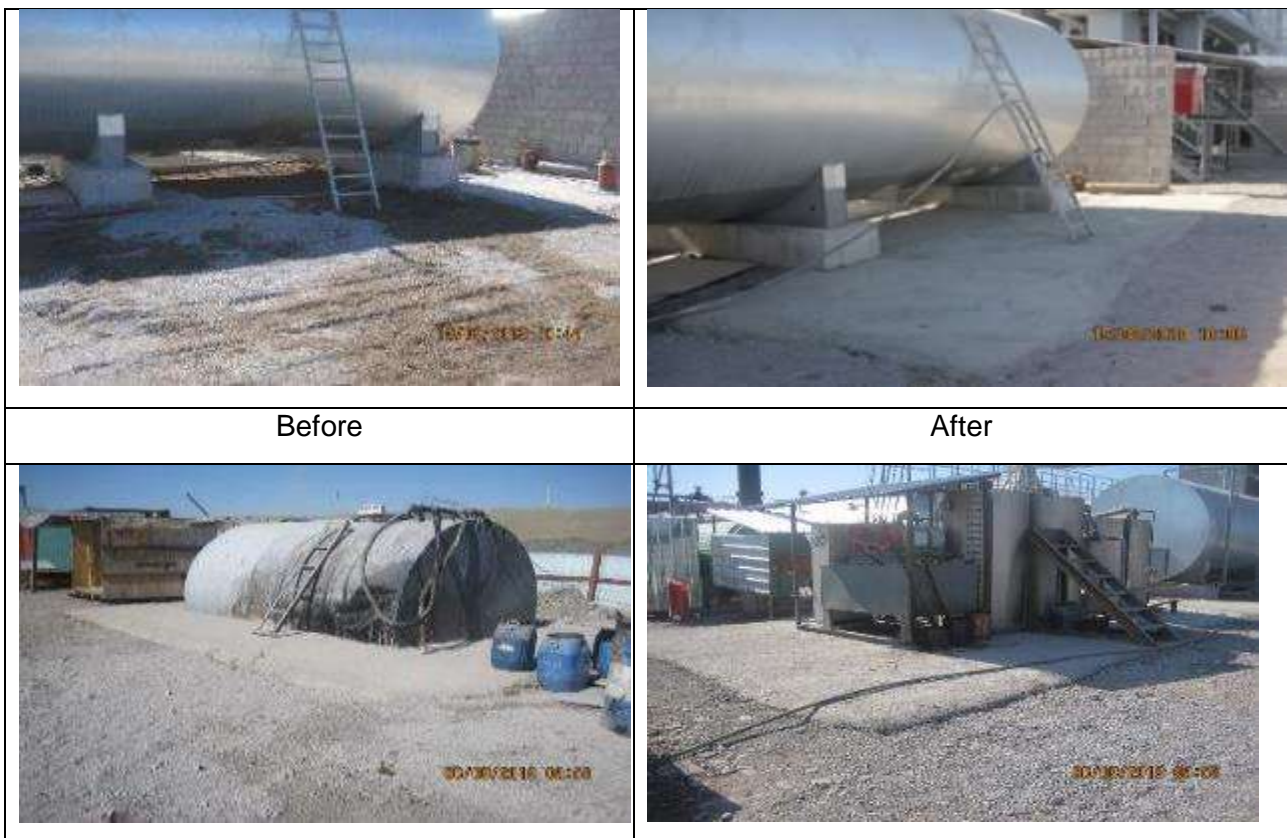
127. During the plant operation, all the soil around the tanks with chemical substances should be protected from leaks and spills of hazardous materials by an impermeable protective coating.

Figure 43 Impermeable protective coating around chemical containers

128. The contractor was recommended to protect the soil around the tanks with chemical substances from leaks and spills of hazardous materials with an impermeable protective coating. These recommendations were taken into account and implemented by the Contractor.

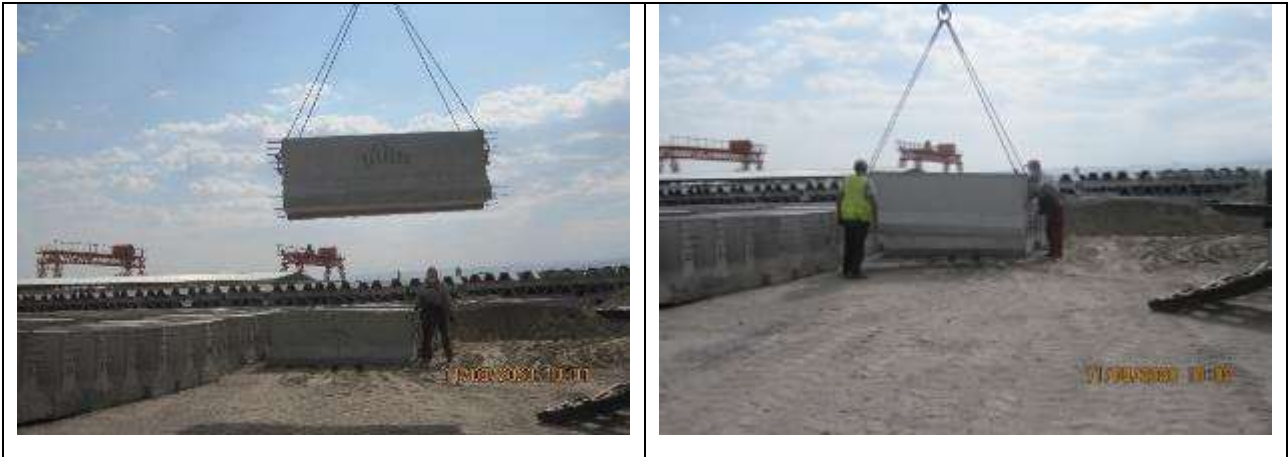
132. Despite regular training conducted by the Contractor's safety specialist, violations/non-compliance with safety precautions were observed at the site for manufacturing of concrete products when lifting and moving weight suspended with a travelling crane hook. The issue of compliance and observance of safety precautions will be monitored by the Consultant on an ongoing basis. During the July the Contractor's safety specialist conducted additional lectures for the staff.

Figure 46 Violations of safety precautions when working with the crane. Lack of personal protective equipment

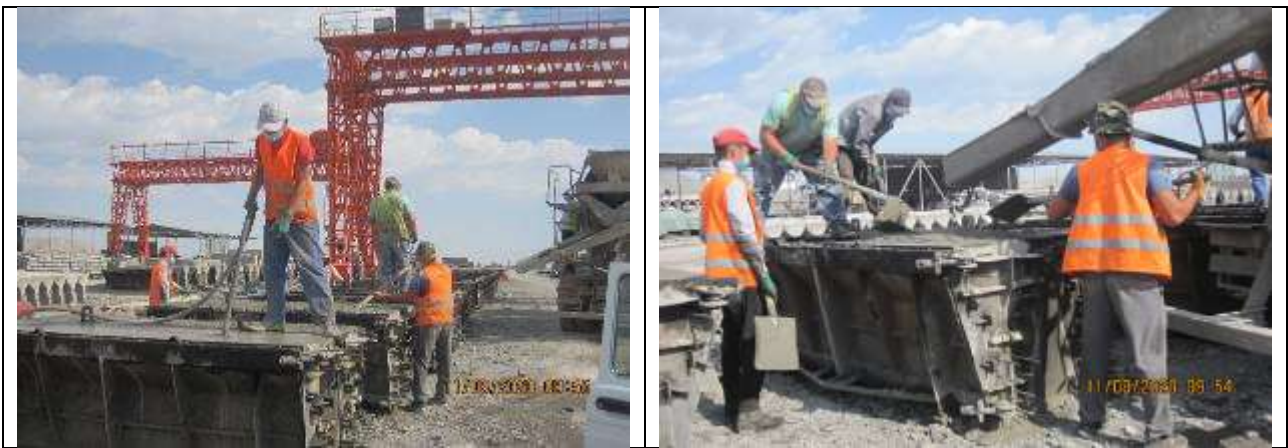
Figure 47 Lack of personal protective equipment for workers at the site for the production of reinforced concrete products when lifting and moving cargo

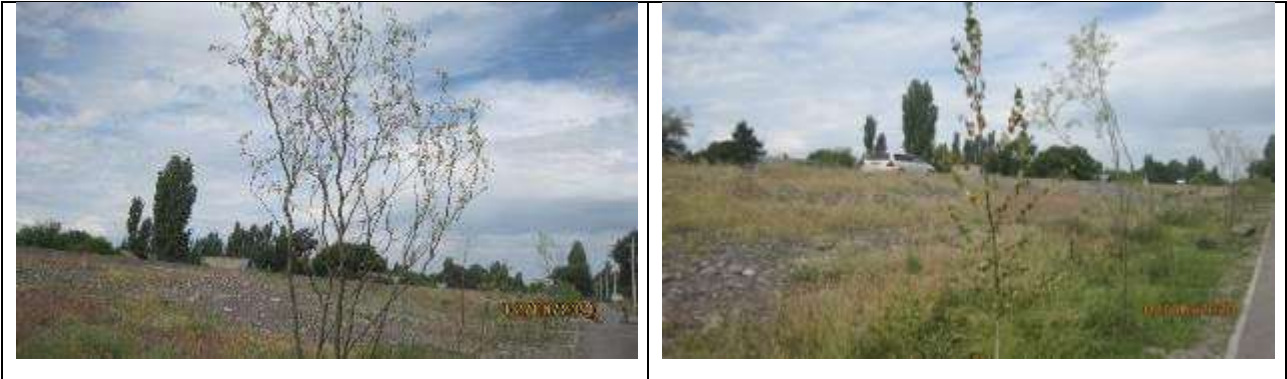
Figure 48 Seedlings before the start of regular watering

136. To provide the seedlings with the sufficient moisture, a letter was sent to the contractor about the need to make regular watering every 3 days. Despite constant reminders, the seedlings were not watered regularly. Given the hot weather, some of the seedlings began to dry out. The consultant carried out a preliminary calculation of the survival rate of seedlings, which was 95%. Given that the planting of seedlings is not completed, the numbers on the survival rate of seedlings will change and the final percentage of survival will be summed up in spring 2021. The contractor was given an additional explanation that, in accordance with the terms of the current contract, all dried seedlings will be restored at the expense of the contractor.

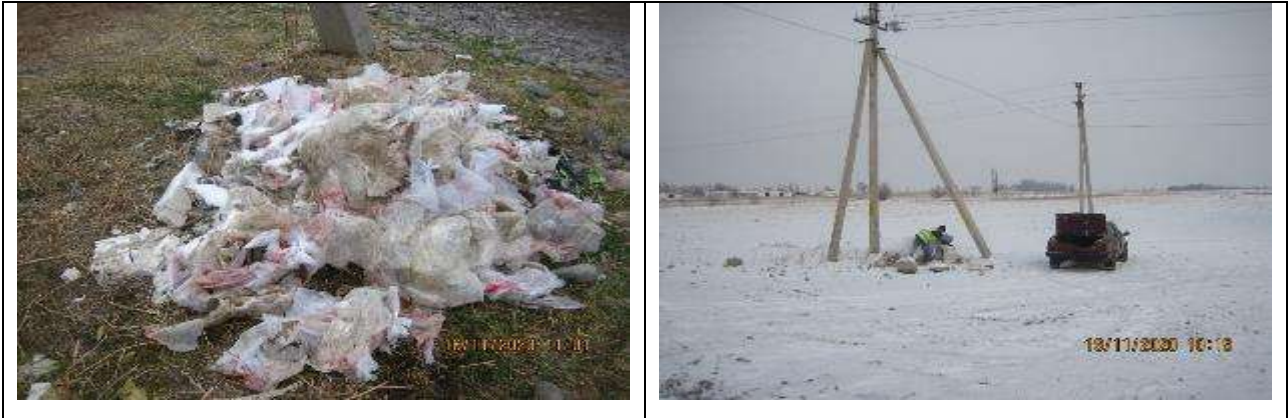
Figure 51 Plastic bags left after planting and piled up in a heap and cleaning of these bags

139. A letter was sent to the contractor with the requirements to level the excess soil around the planted seedlings as soon as possible and remove the plastic bags in which the seedlings were packed.

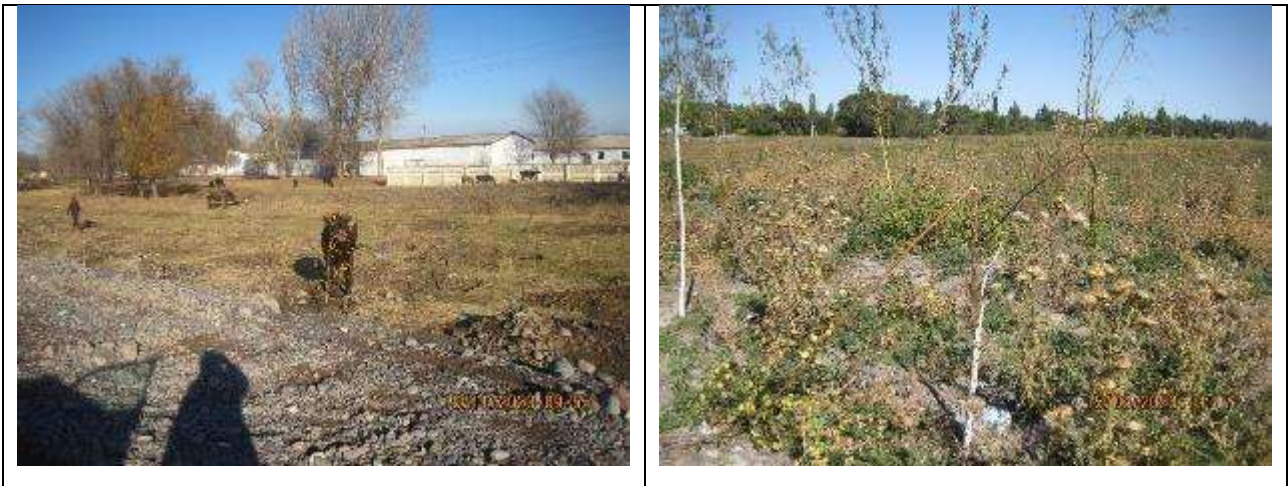
140. The planted seedlings are threatened by domestic animals during grazing, as well as by unscrupulous local residents who break the seedlings for incomprehensible intentions. More than 10 birches were broken.

Figure 52 Seedlings eaten by pets and broken seedlings

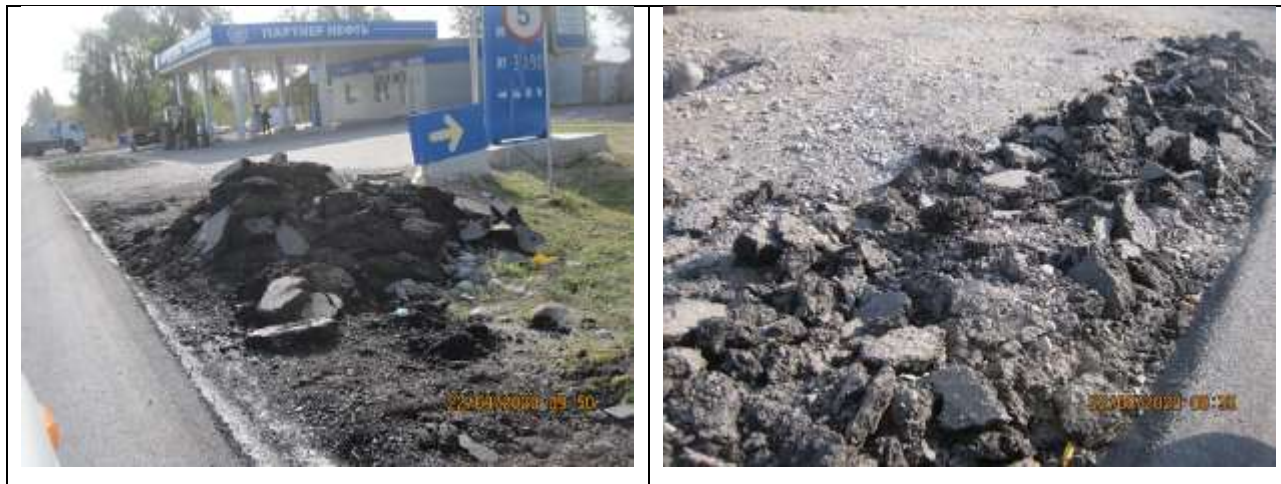
145. During the construction of bus stops and installation of parapets, asphalt waste is formed, which was not always taken out during the time. The contractor was warned about the need for its timely removal.

Figure 55 Asphalt waste on the road

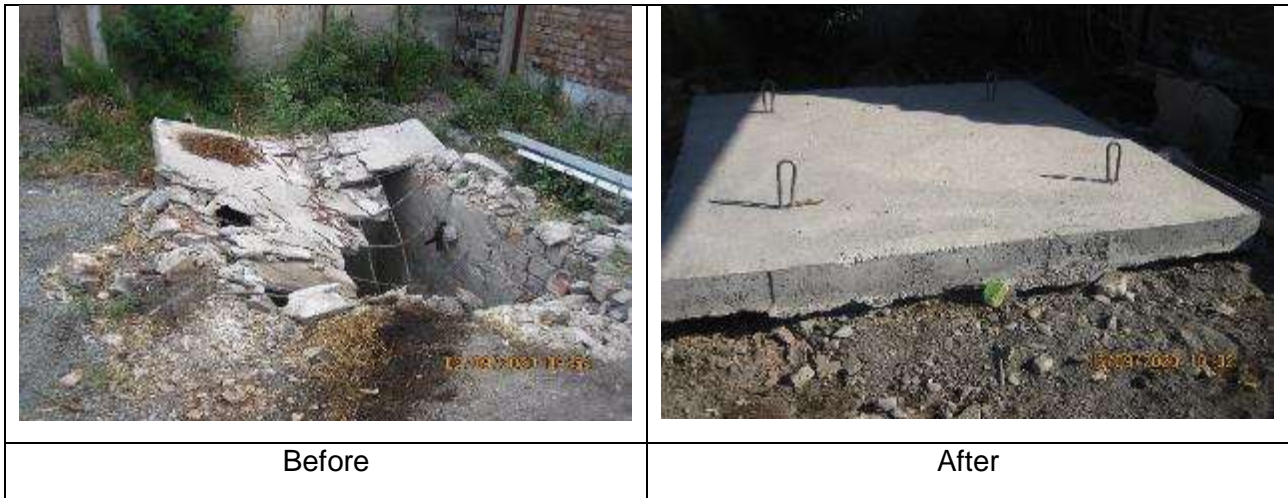
148. During monitoring on the camp area in the village of Belovodskoye, it was found that the top slab on the drain pit was destroyed. Considering that the pit was filled with sewage, this situation posed a threat to the life and health of the specialists living at the base. A letter was sent to the contractor indicating the timeframe for the elimination of this violation. The slab was replaced within the specified time frame.

Figure 57 Top slab on the drain pit

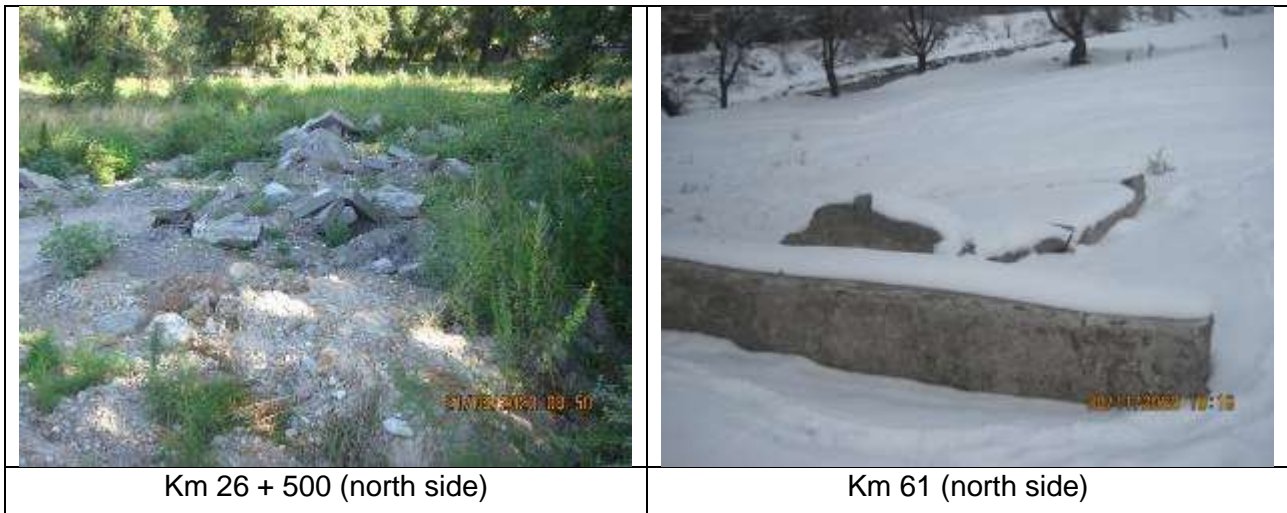
Figure 71 Reinforced concrete waste on the road

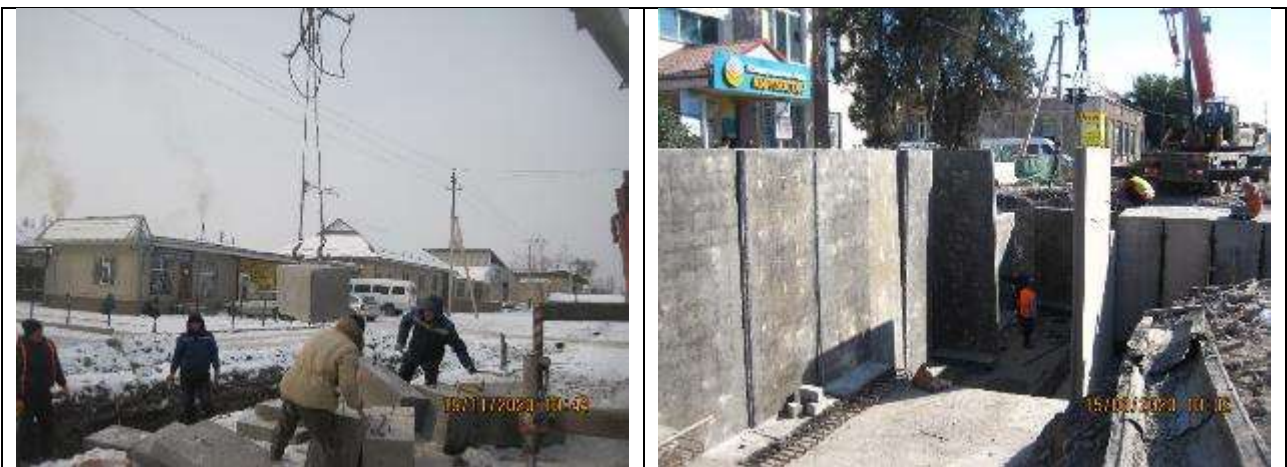
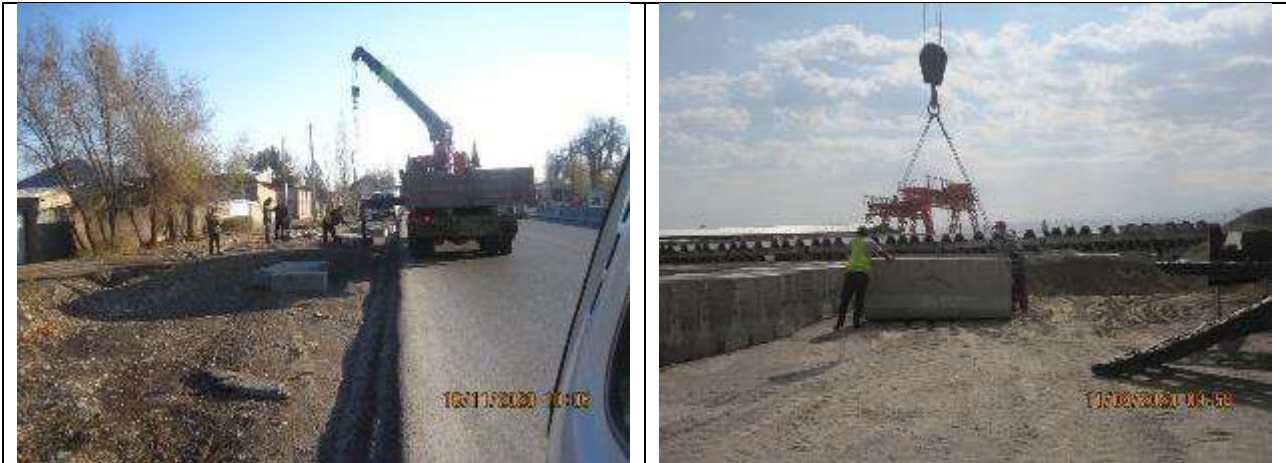
Figure 77 Violations of safety precautions when moving loads with a crane and working at height

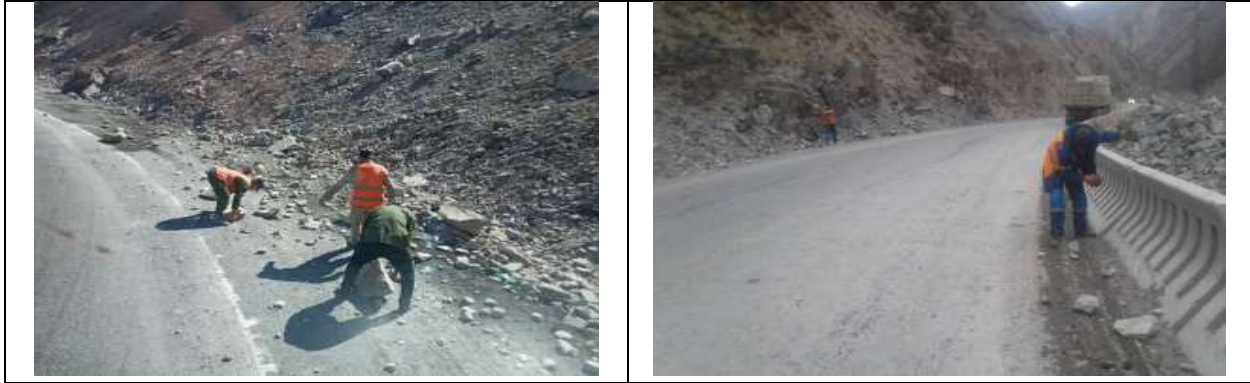
Figure-8. Rockfall hazard
