Semi-annual Environmental Monitoring Report

Project Number: 48401-007
Reporting period: August 2020

CAREC Corridors 1 and 3 Connector Road, Section 2B Epkin-Dyikan [Bashkuugandy], Km : 89+500 – 159+200 Project

Zhumaliev T.N., National Environmental Specialist,
Gentek Consulting Ltd.
Bishkek, Kyrgyzstan

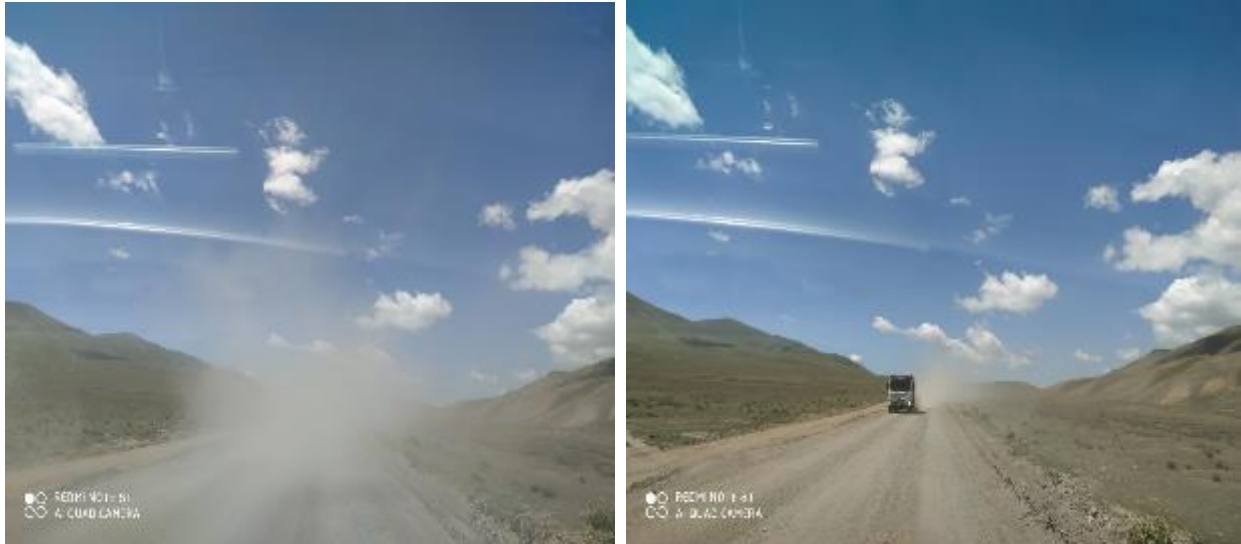
Figure 16. Increased dust formation on project sections

54. Dust formation has a major impact on the environment during earthworks. The increased air temperature has resulted in increased dust formation on the existing road, which is currently on the Contractor's balance. Dust control measures are carried out in the areas with ongoing road construction works. In this regard, the Contractor was instructed to increase the intensity of spraying of the road, including roadsides, at construction sites from 7 am to 7 pm. At present time nine watering machines are allocated for this task, and each of them watering 4-5 times per day. However, dust control measures are still inadequate, increased dust leads to road safety problems, and elevated temperatures lead to water lack in the region and competition with local farmers for access to water. The Contractor was instructed to draw up a road irrigation schedule with a 30 minute interval between irrigations and to open a log to track dust control work. The Safety Engineer of the Consultant recommended to the Contractor to install the Hydrant pump in the places where the watering machines take in water.

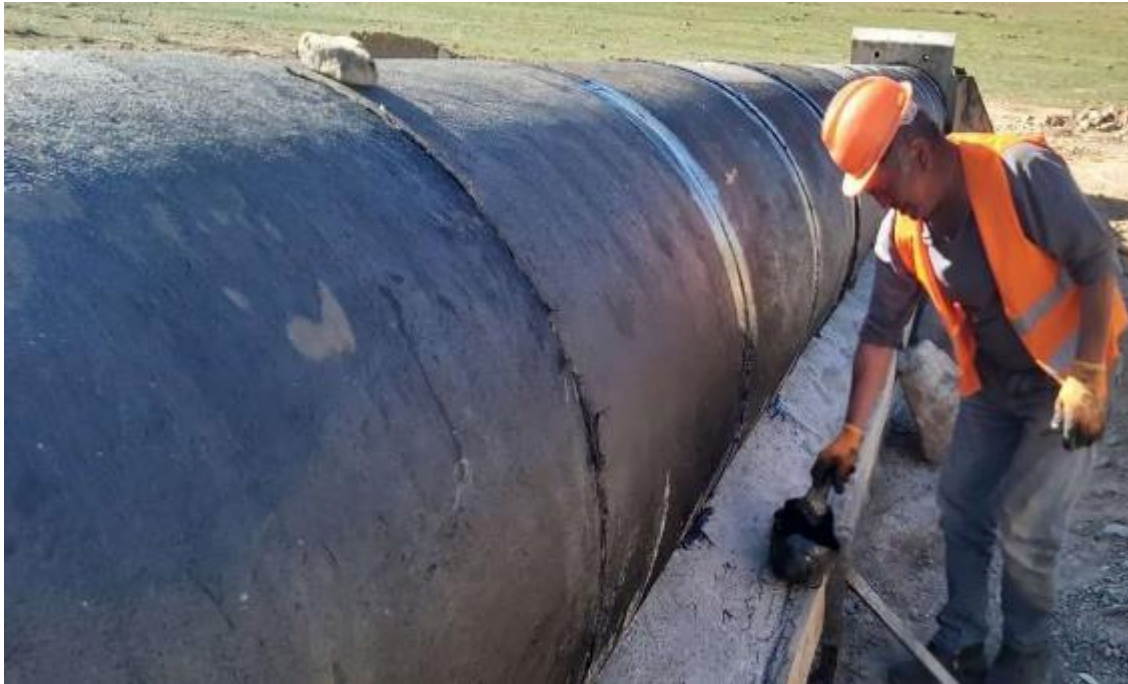
Figure 17. Waterproofing culverts with bitumen

55. A partial impact on the environment during the construction of culverts may be waterproofing with bitumen.
56. Bitumen for waterproofing culverts and bridges is usually melted at the construction site. If the Contractor does not provide dry firewood for these purposes, the workers will have to maintain the fire by burning bitumen or worn out old tires from trucks. As a result, the black smoke generated by this will negatively affect the health of workers and residents of nearby villages.

57. The Contractor was given a verbal warning indicating this issue and it was recommended to conduct an explanatory work with the specialists responsible for waterproofing works.

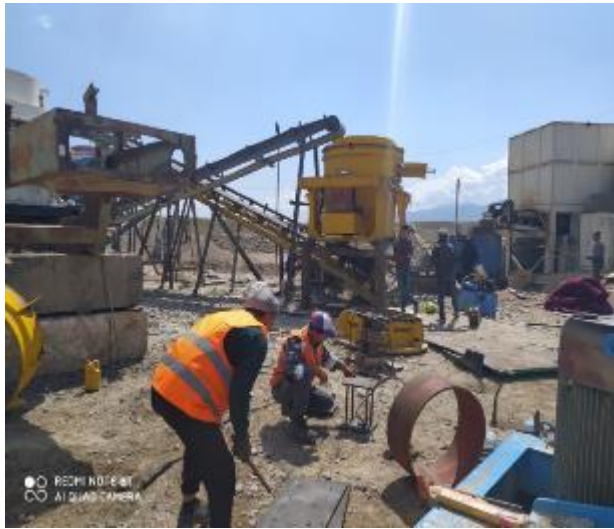
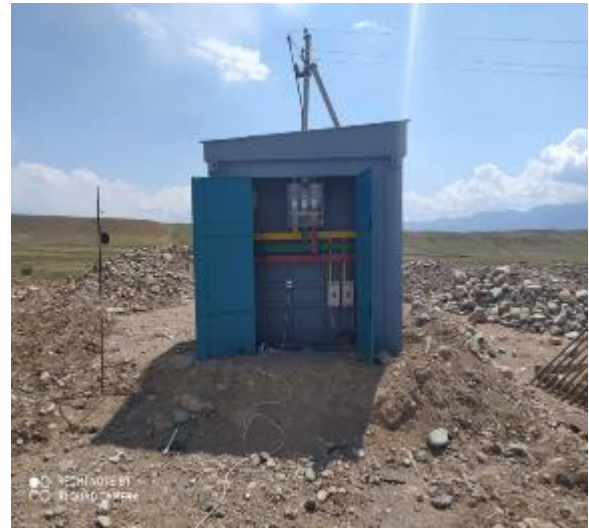
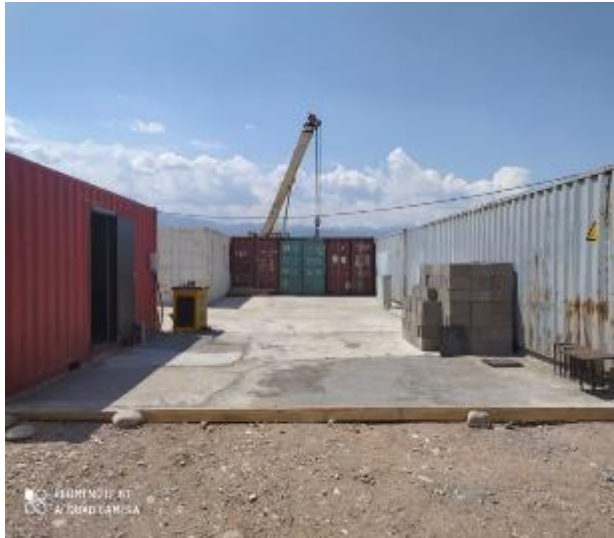
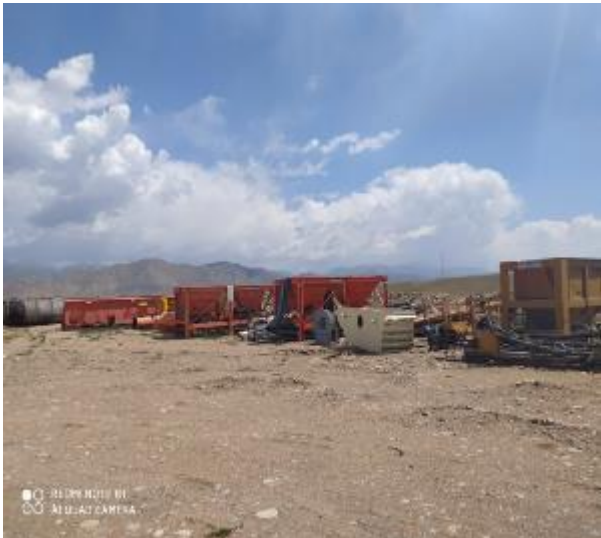
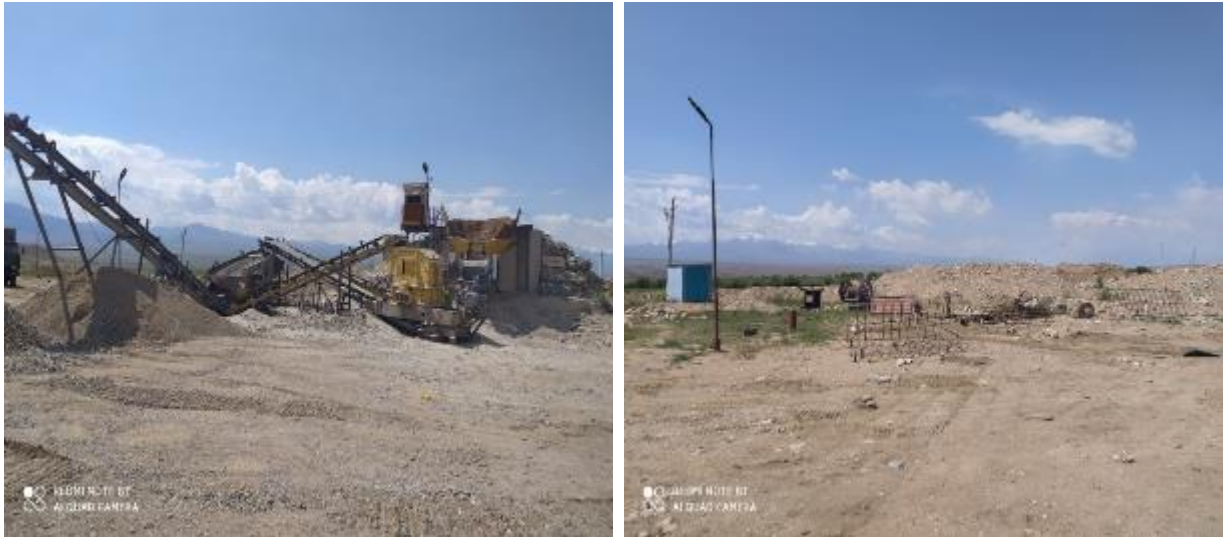
Figure 23. Production site territory

66. It was found that the Crusher was working without proper maintenance of cleanliness and order of the workplace with separate processing of construction and household waste and the absence of a fire shield in place.
67. On the production site territory, tanks for fuels and lubricants were not installed on a concrete base. Fuel and oil spill on the ground was detected during the walk-around. The fire shield was not completed. A non-compliance letter was sent to the Contractor and the problematic issues were resolved.

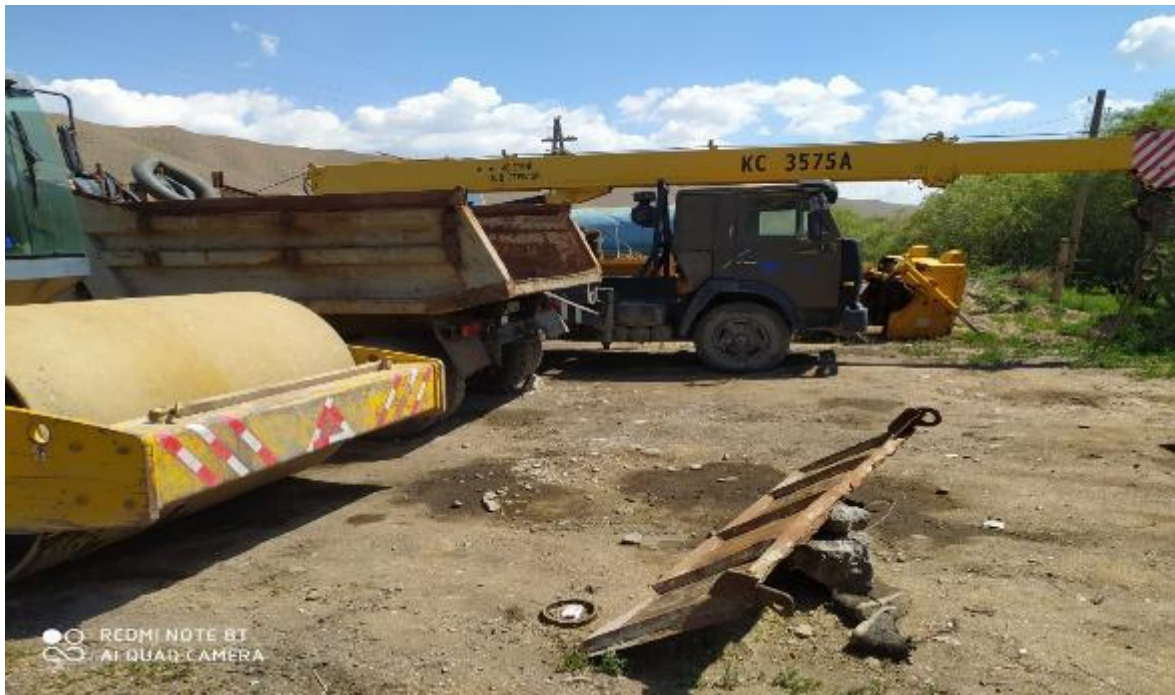
Figure 25. Oil leaks at subcontractor's equipment parking lot

68. Oil leaks from the equipment were found at the parking lot of the subcontractor's heavy vehicles. The Contractor received comments on the detected leaks, which were promptly eliminated (the contaminated soil was removed and taken to a specially designated place).

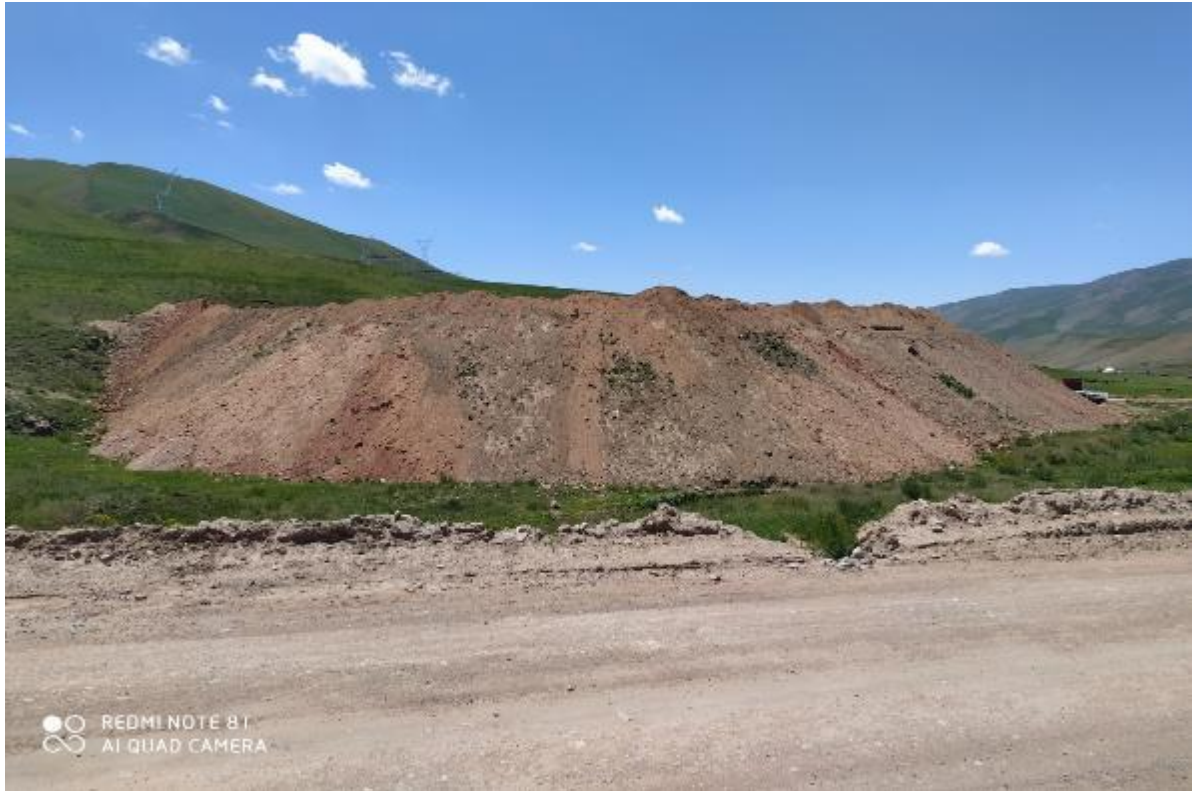
Figure 31. Dump at km 112+600

93. A letter was sent to the Bash-Kuugandy aiyl okmotu for storing inert material on a new dump at km 155 + 760, RHS 39 m.
94. At km 112 + 600, the dump was stacked close to the bank of the stream, thereby creating a risk of blocking the river and flooding the bank. In this regard, the contractor was given a written notice not to carry out storage of dumps near the banks of rivers, streams or mudflows in the future.

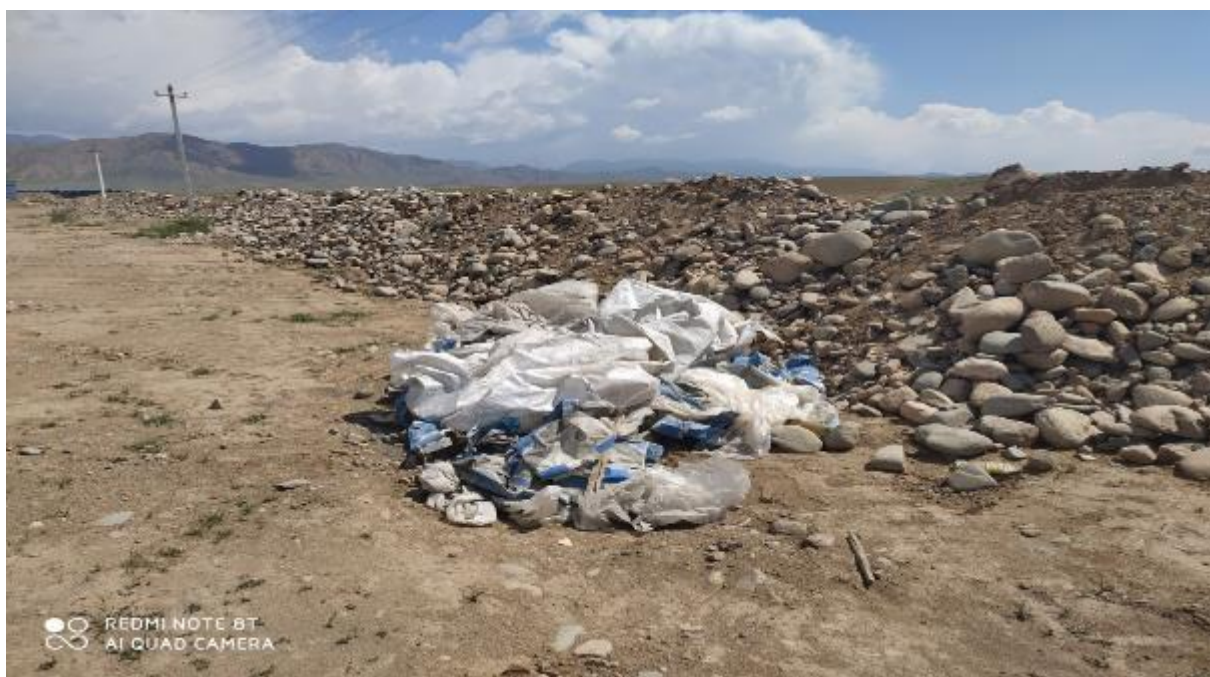
Figure 33. Waste on the production base territory

and hazardous waste in accordance with the Waste Management Plan of the SSEMP and draw up an agreement with local waste collection organizations.

97. Based on the notification, the territory of the production site was cleared of construction waste. All noted violations were eliminated. Separate waste containers were installed. Fire safety measures were taken, fire shields were completed.

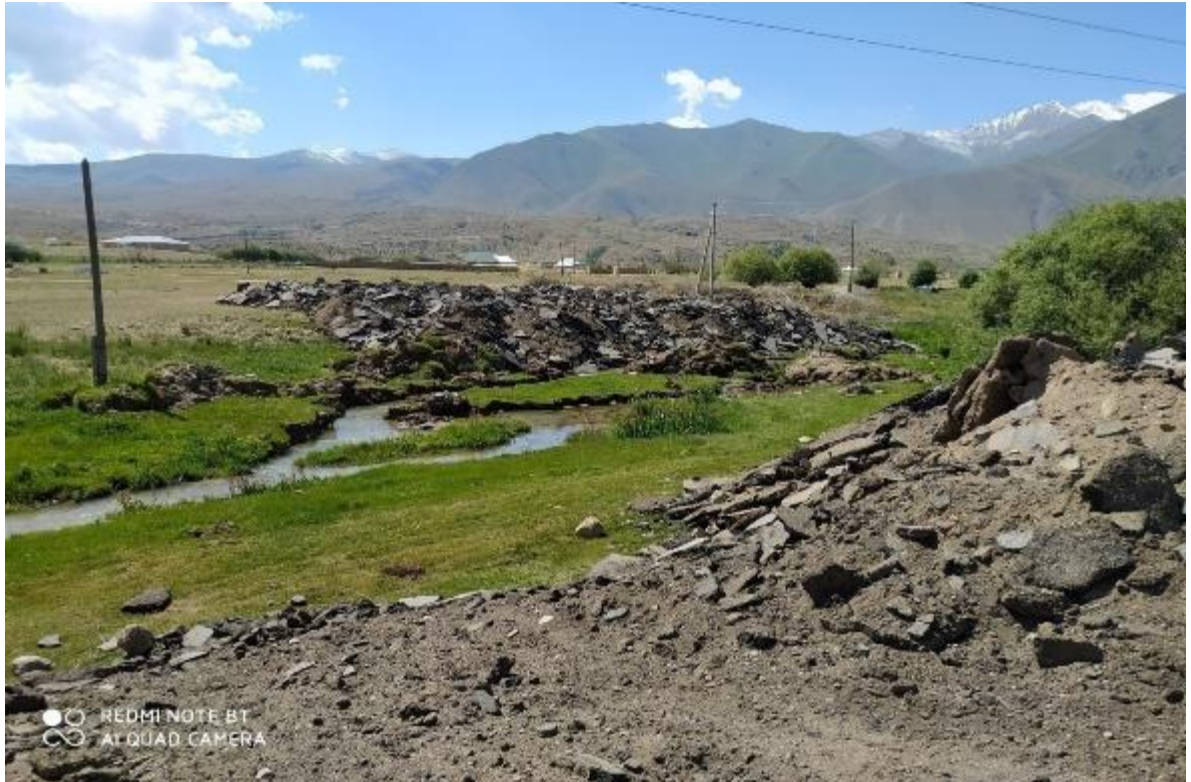
Figure 40. Stripped old asphalt transported to swampy area

122. The total volume of stripped and removed old asphalt by the reporting period is 6806 m³. According to BoQ the estimated volume of asphalt to be removed is approximately 11,946.71 m³;
123. The stripped asphalt is mainly transported at the request of the heads of aiyl okmotu and local residents for the arrangement of country roads and embankments at private sites. The owners themselves make the leveling of private plots.
124. The recycling of old asphalt is handled by the Contractor's environmental specialist, Nurdinov Nurlan.
125. At km 90 + 100, the stripped old asphalt was transported to a swampy area on the bank of the stream.

126. Upon written notification from the Consultant, the Contractor removed the old asphalt and cleared the site.

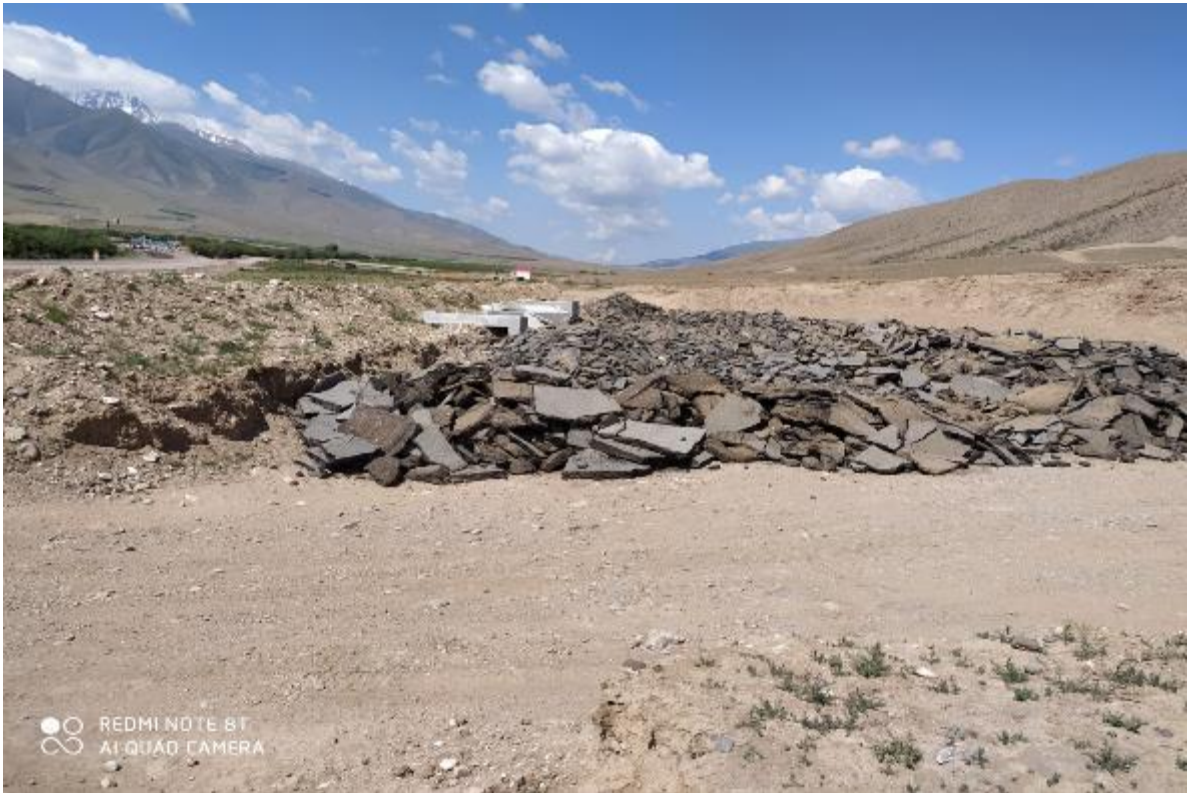
Figure 42. Old asphalt at km 91+360

128. At km 91 + 360, the stripped old asphalt was stored on the territory of the quarry

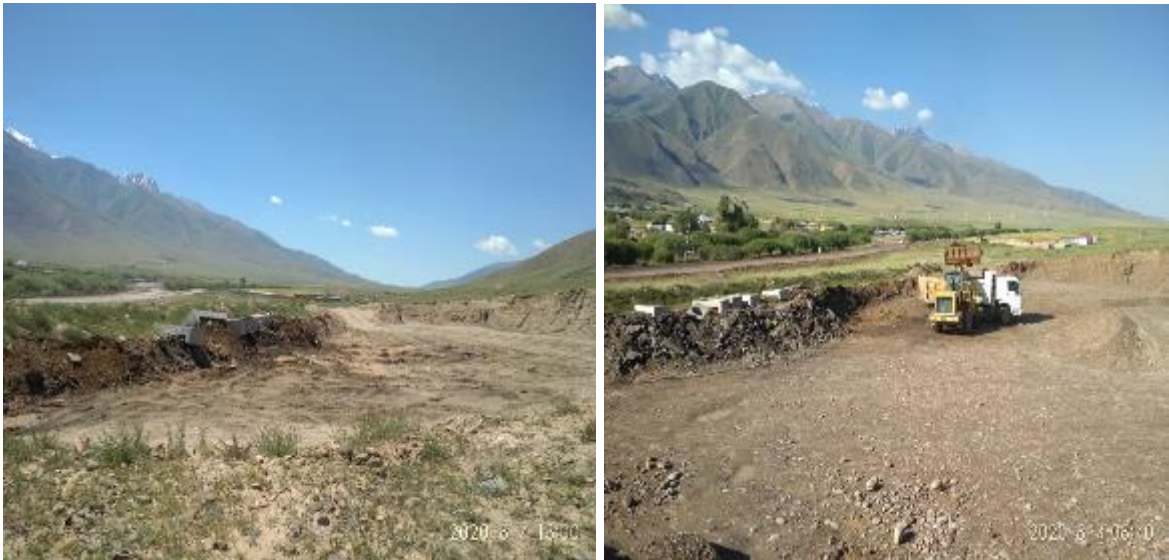
Figure 43. Old asphalt removed and cleared at km 91+360

129. Later, the old asphalt in this area was taken out to fill the roads of Ak-Chiy v.

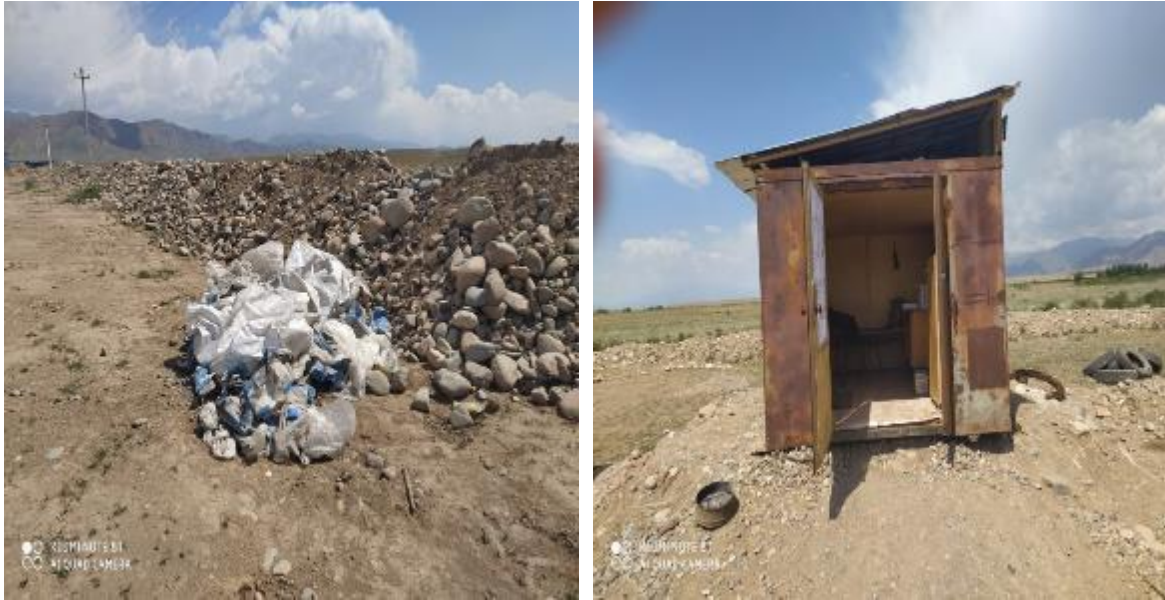
Figure 44: Waste at the contractor's site, cement bags and scattered old truck tires near the checkpoint
