Environmental Monitoring Report

Project Number: 42399-02

Kyrgyz Republic
CAREC Transport Corridor -1
(Bishkek – Torugart road) Project 3
SECTION KM479 to 539

20 DECEMBER 2015

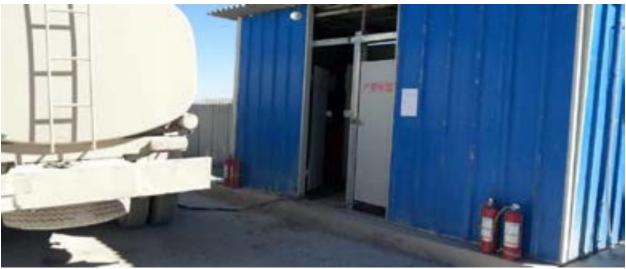
Figure 48: Truck refuelling at dedicated camp facility

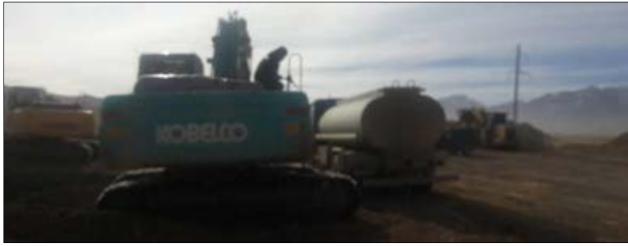
Figure 49: Onsite refuelling of plant by dedicated refuelling truck

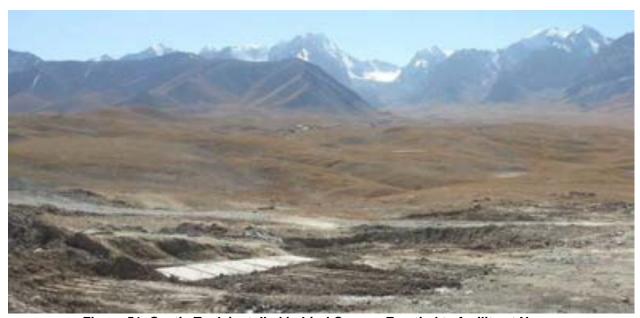
Figure 51: Septic Tank installed behind Camp – Emptied to facility at Naryn

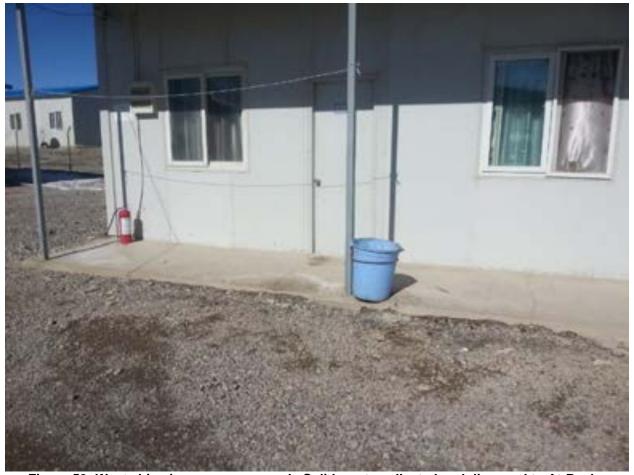
Figure 53: Waste bins in camp compound- Solid waste collected and disposed to At-Bashy

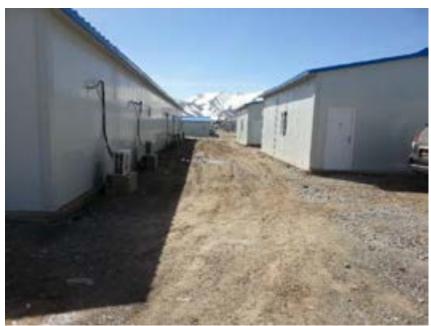
Figure 55: Camp accommodation. Note heat pumps and absence of litter

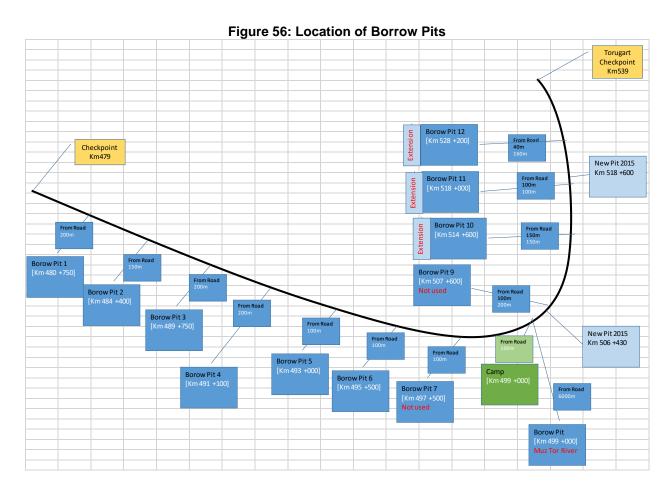
Borrow Pit #/Location	Date	Status	Photo – Status
Section – 1			
#1 480+750 RHS Volume 150,000m³ 100 x 600 m 200m from road	June 15	Not started In progress Extraction complete Restoration phase	Figure 57: Borrow Pit #1 – Extraction now completed (June 14)
	Sept 15		Figure 58: Borrow Pit #1 (Sept 15) – Restoration complete
