Biannual Environmental Monitoring Report

Project Number: 42399
Grant Number: ADB Loan No. 2533-KGZ (SF) and Grant No. 0153-KGZ (SF)
Reporting Period: July-December 2013

Kyrgyz Republic
CAREC Transport Corridor -1
(Bishkek – Torugart road) Project 2
Section 1, km 365+500 – 400+600
Section 2, km 439+000 – 479+000

Prepared By the Ministry of Transport and Communications of the Kyrgyz Republic

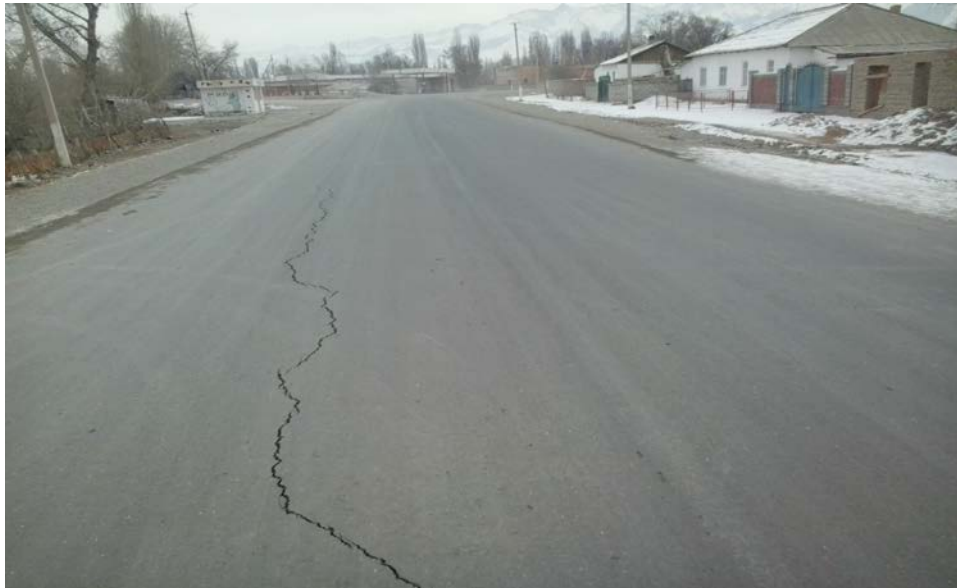
2. An important issue arose over the winter: cracks in the road appeared in December-January 2013 as a result of frost-heave. Similar cracks appeared on BNT 1 the previous winter. While this is a design issue (all future projects will include anti-frost layers), it also affects road sustainability. Retroactive measures (e.g., additional drainage) are being undertaken but the key to the road reaching its planned life is that proper maintenance including filling the cracks with bitumen each winter is essential. Although filled with bitumen in March-April 2013, the cracks have since re-opened as shown in Figure 1.

Figure 1: Frost-heave Cracks at km7+400-7+420, 22 January 2014

36. The frost-heave cracks will be treated with bitumen during the late February-April period.

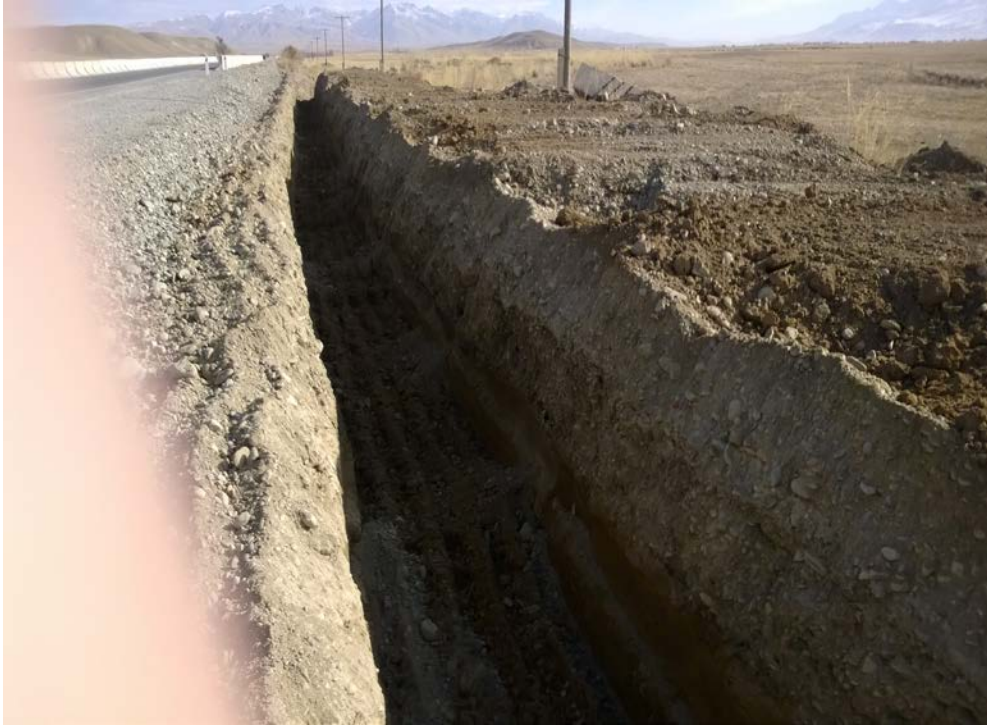
Additional drainage at km387+200

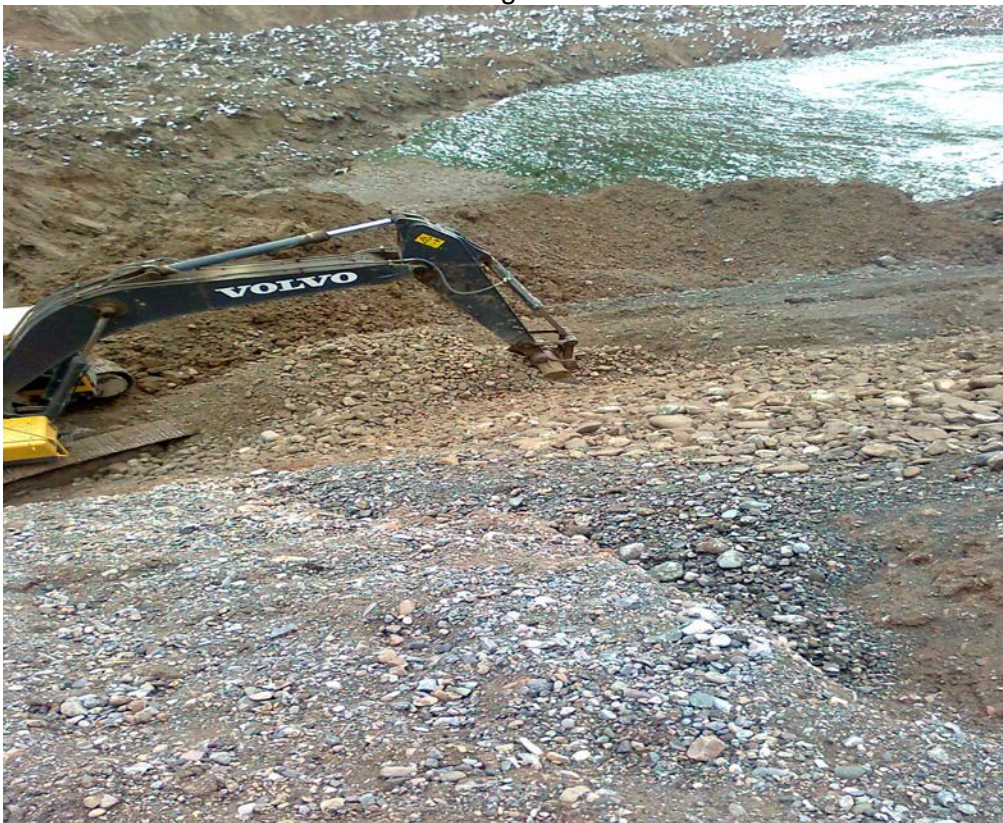
Slope stabilization against erosion at km368
