Environmental Monitoring Report

Project Number: 42399-02
Grant Number: ADB Loan No. 2755-KGZ (SF)
Reporting Period: June to December 2013

Kyrgyz Republic
CAREC Transport Corridor -1
(Bishkek – Torugart road) Project 3
SECTION KM479 to 539

Prepared By the Ministry of Transport and
Communications of the Kyrgyz Republic

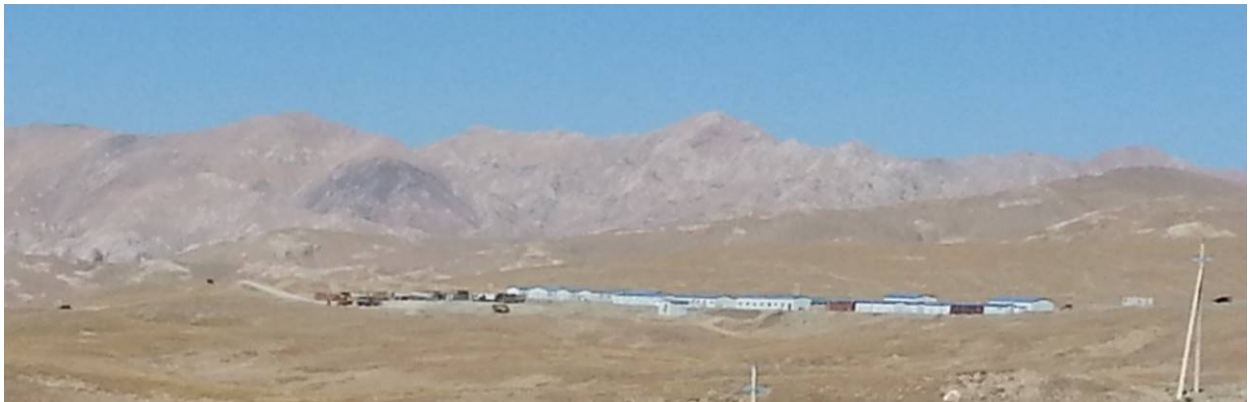
Figure 1: Construction Camp at Km500 – Looking East from Asphalt Plant access road

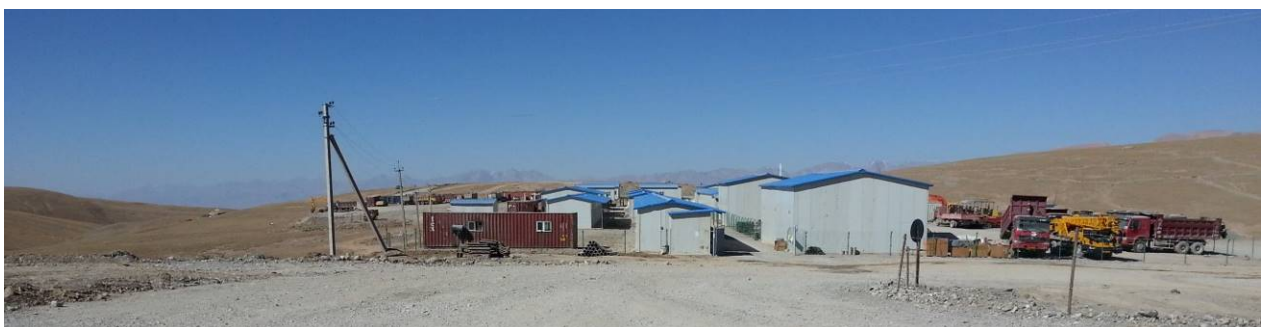
Figure 2: Construction Camp at Km500 looking North across Maintenance Area

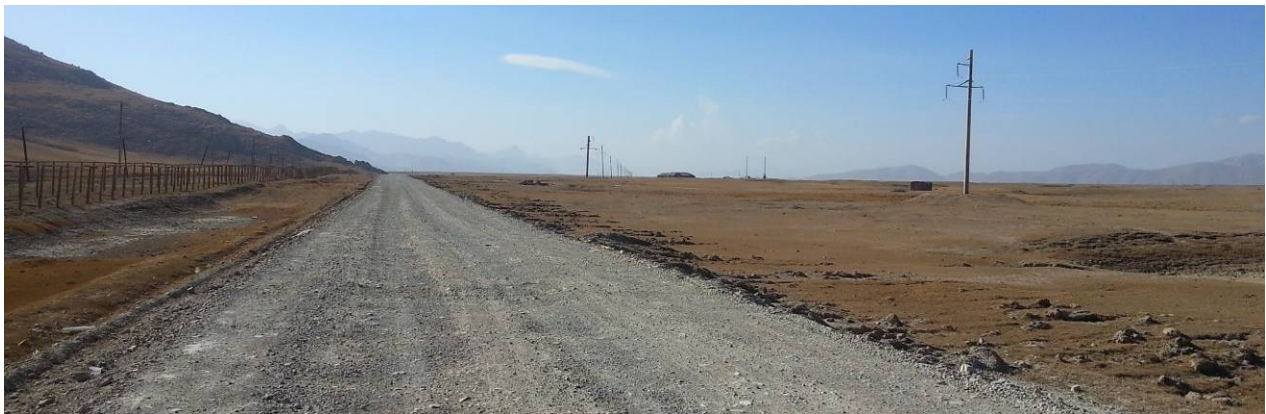
Figure 3: Typical Road Alignment prior to works (around Km520)

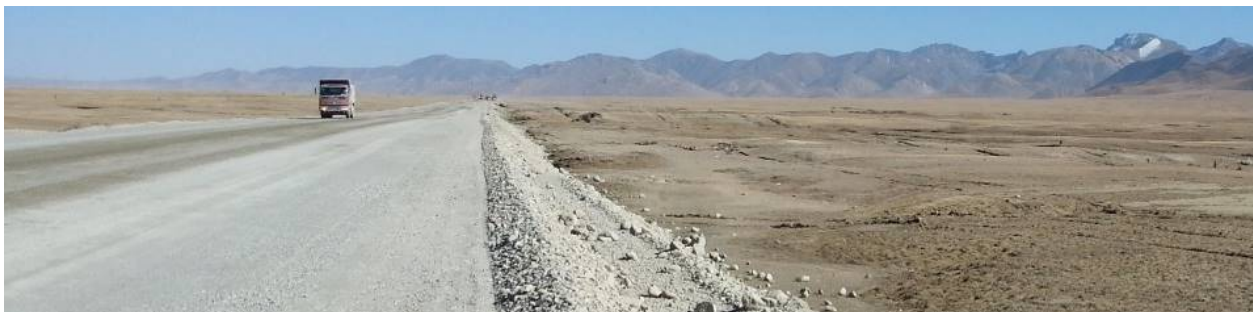
Figure 4: Typical Road Alignment after 2013 works on road foundation (around Km 502)

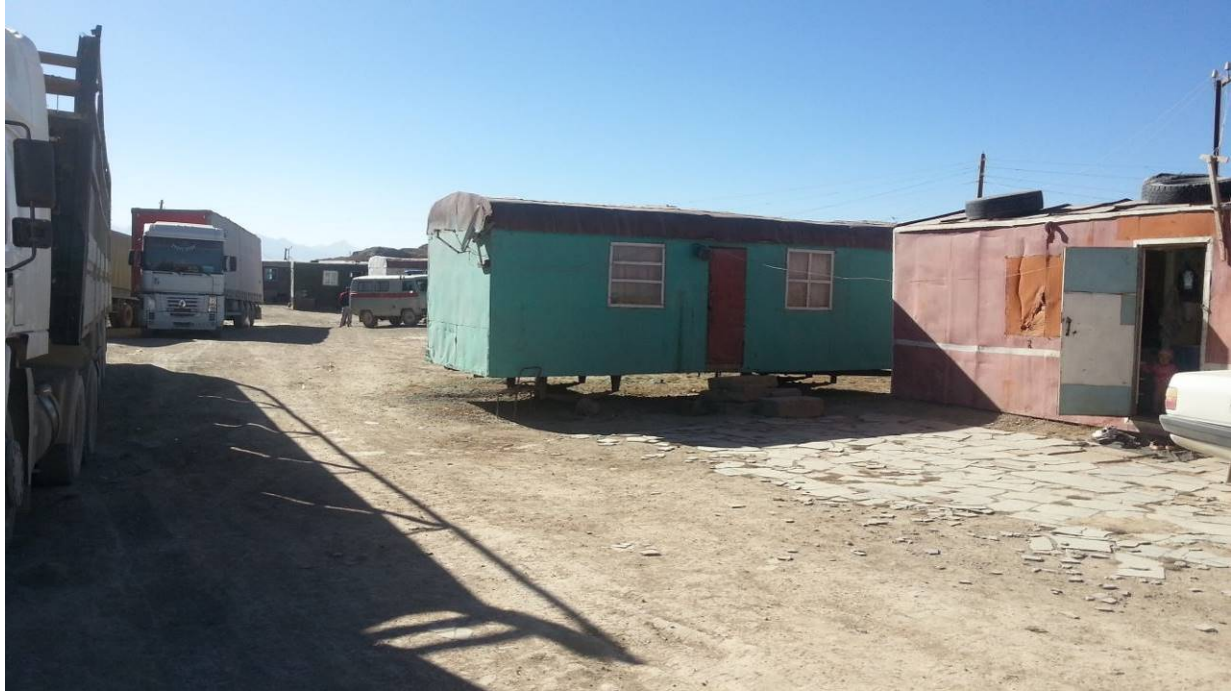
Figure 15: Trailers at Border Holding Area (Km 530)

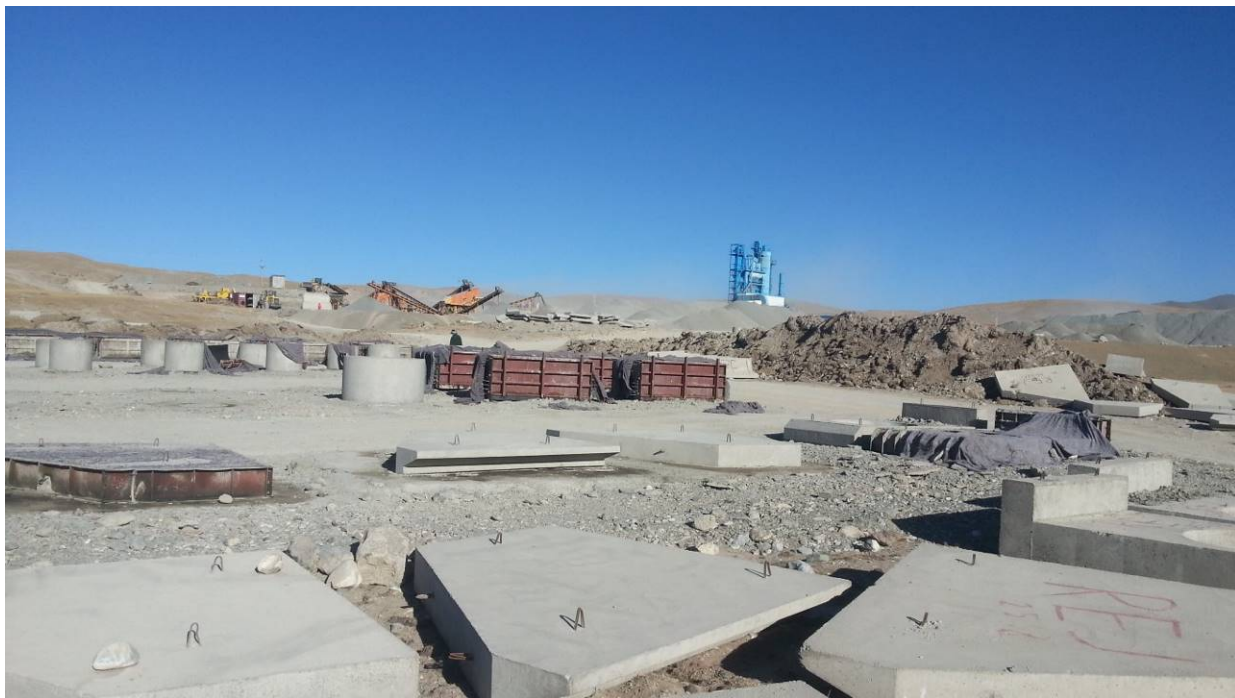
Figure 16: Precast Concrete production, asphalt plant, crushing and grading areas

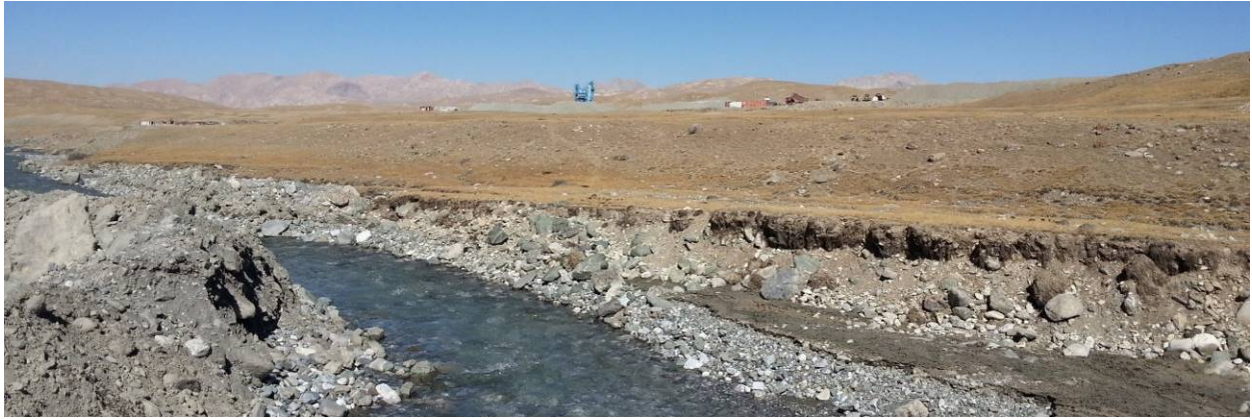
Figure 17: Borrow Pit #8 on Muz Tor River – Note Asphalt and Crushing Plant in distance

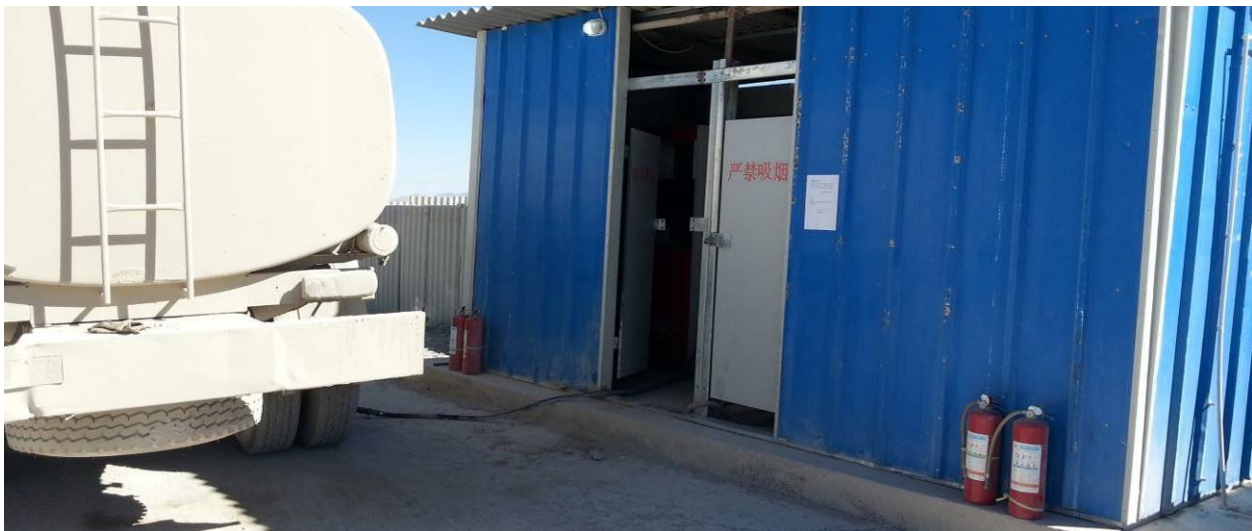
Figure 18: Truck refuelling at dedicated camp facility

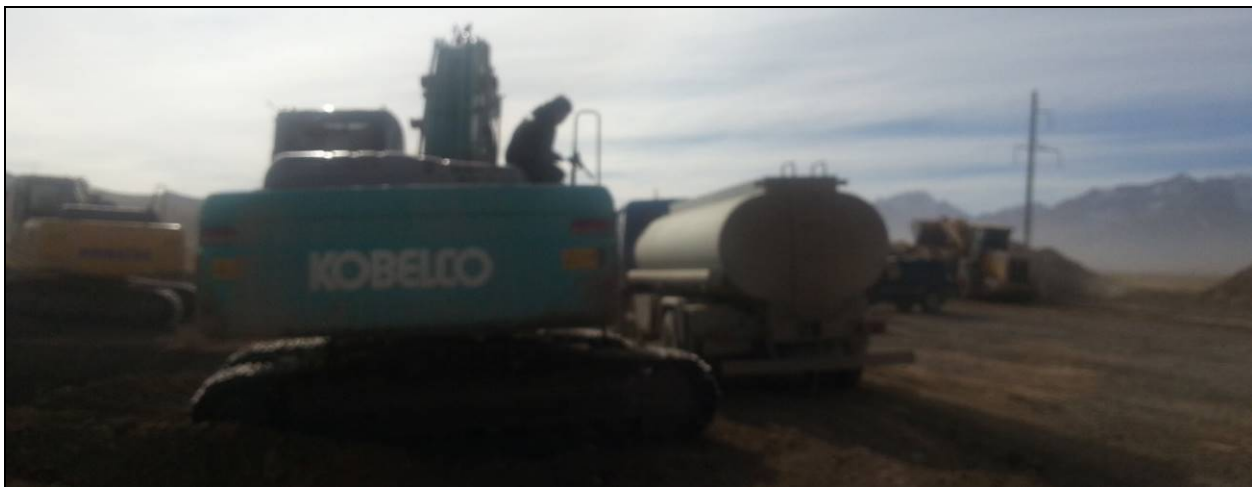
Figure 19: Onsite refuelling of plant by dedicated refuelling truck

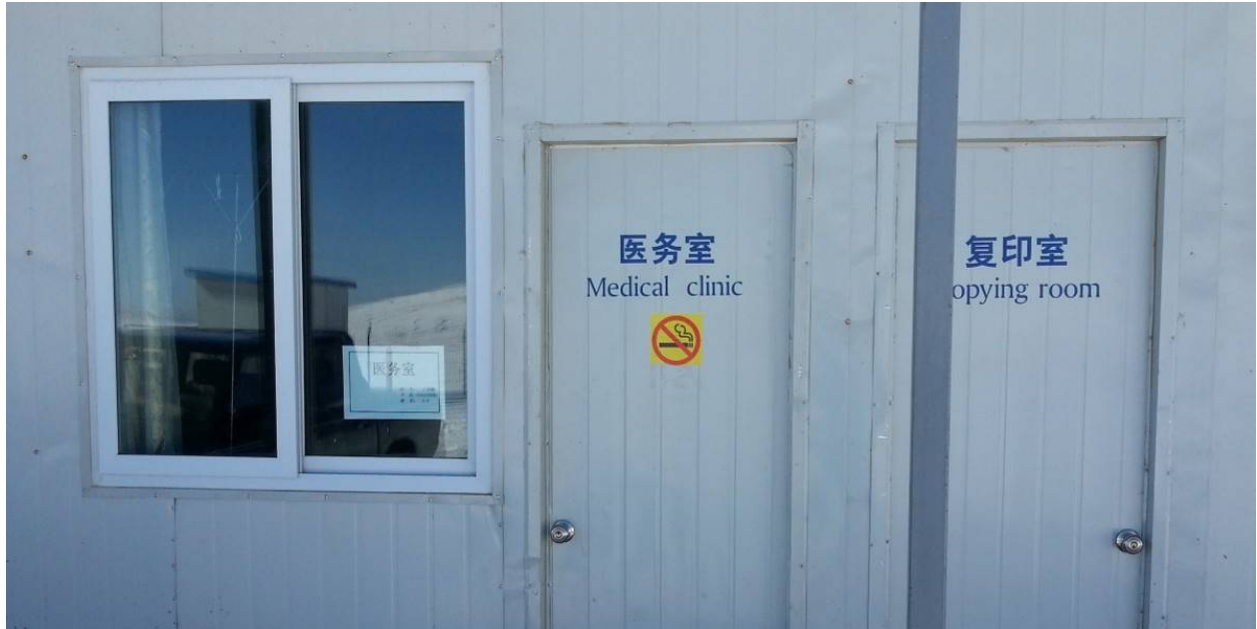
Figure 20: Dedicated On-site Medical Clinic at the Camp

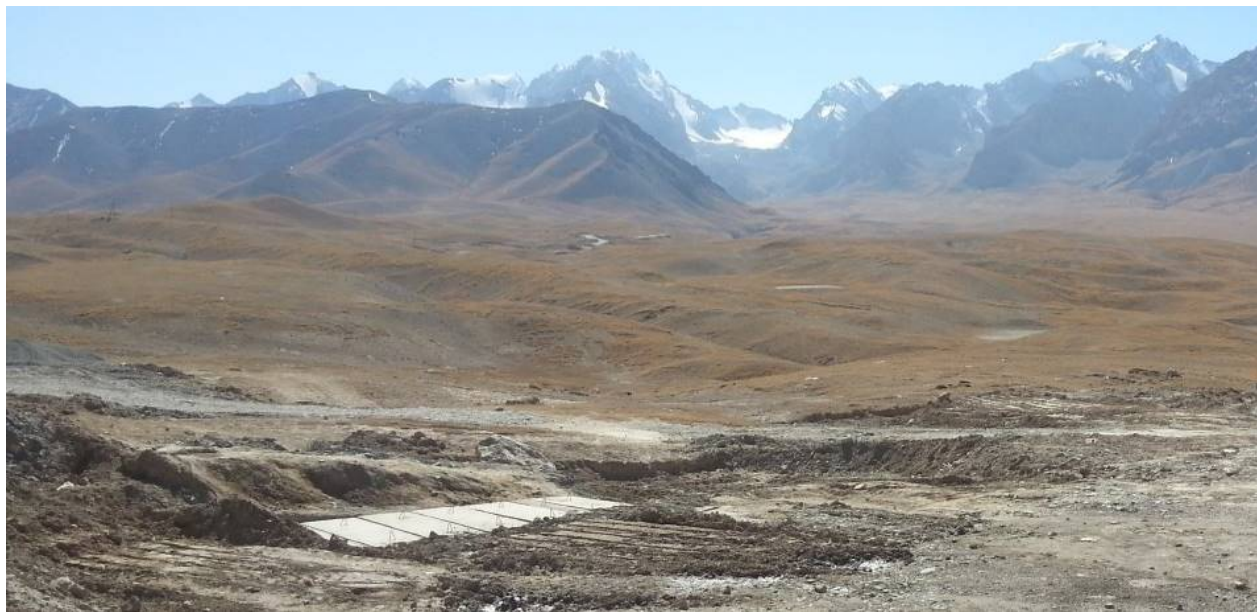
Figure 21: Septic Tank installed behind Camp – Emptied to facility at Naryn

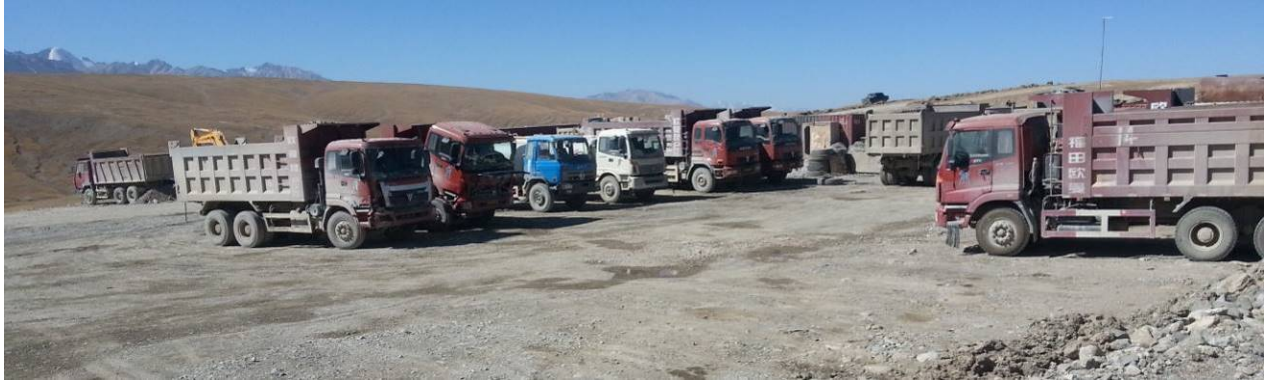
Figure 22: Overnight vehicle parking on rolled hardstanding

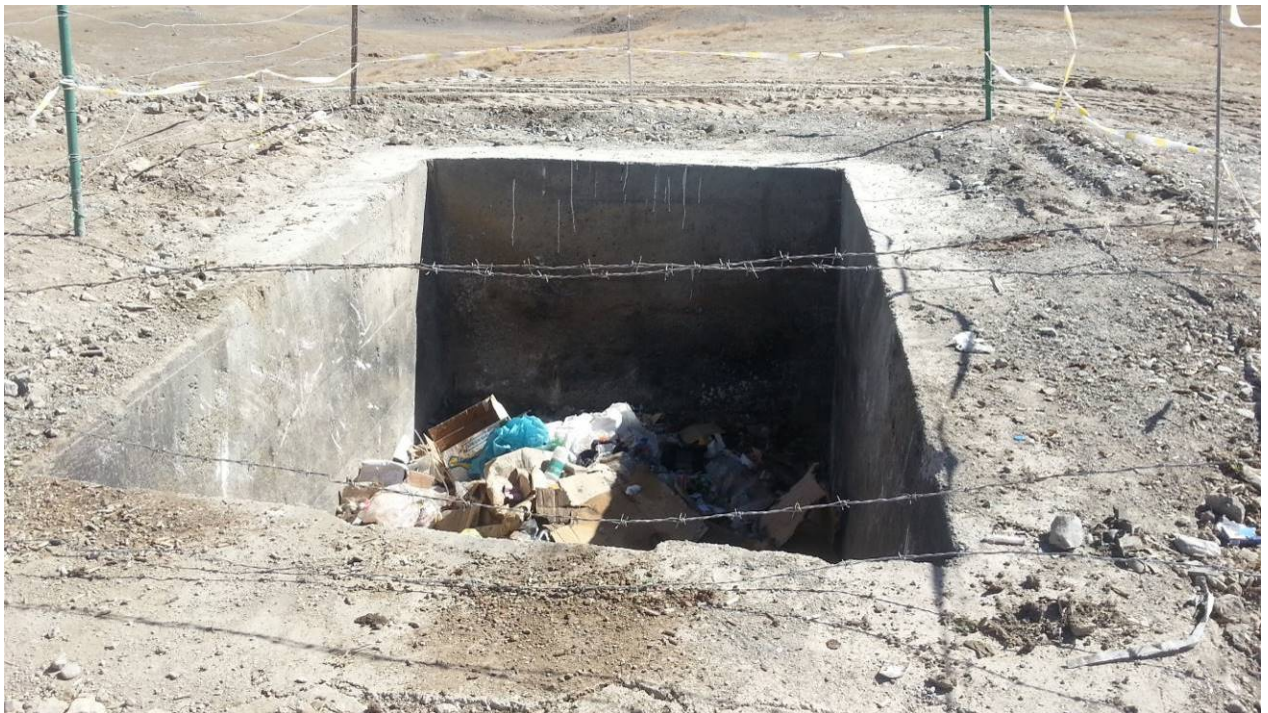
Figure 23: Fenced solid waste transfer point – Waste is collected and disposed to At-Bashy

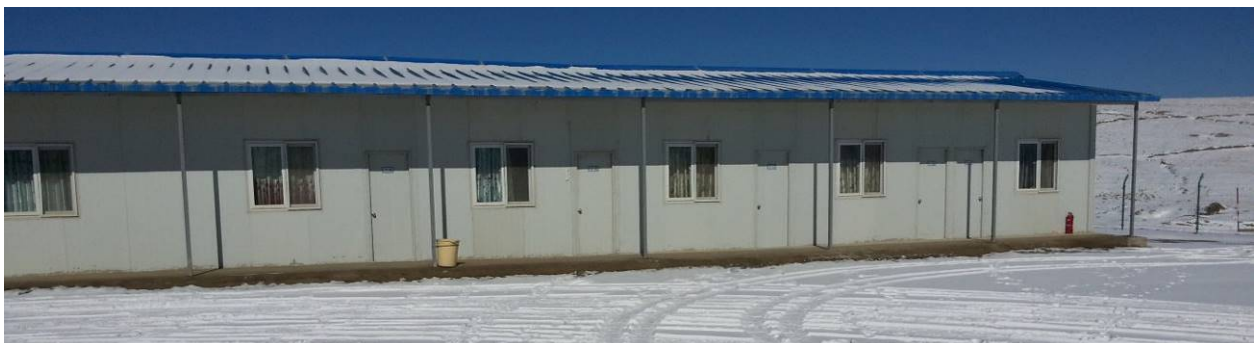
Figure 24: Waste bins and fire extinguishers provided at Camp

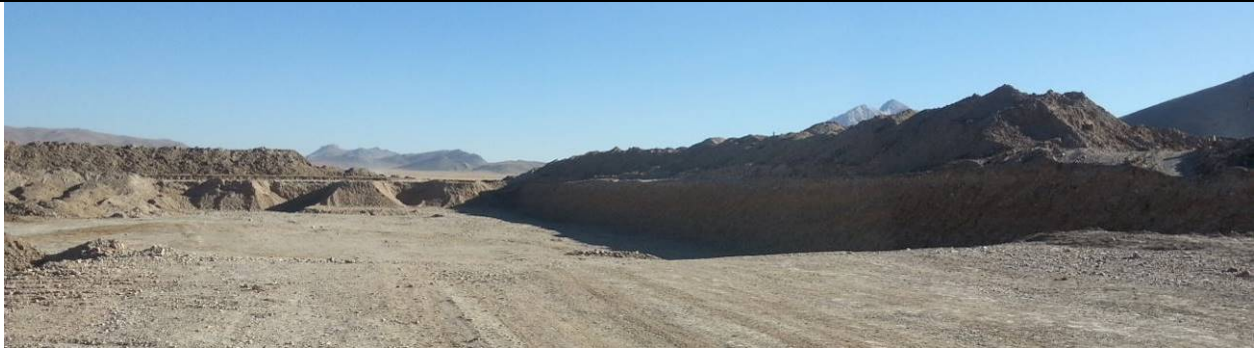
<p>Figure 26: Borrow Pit #2 – Topsoil stored on edge of pit and imported spoil material placed</p>

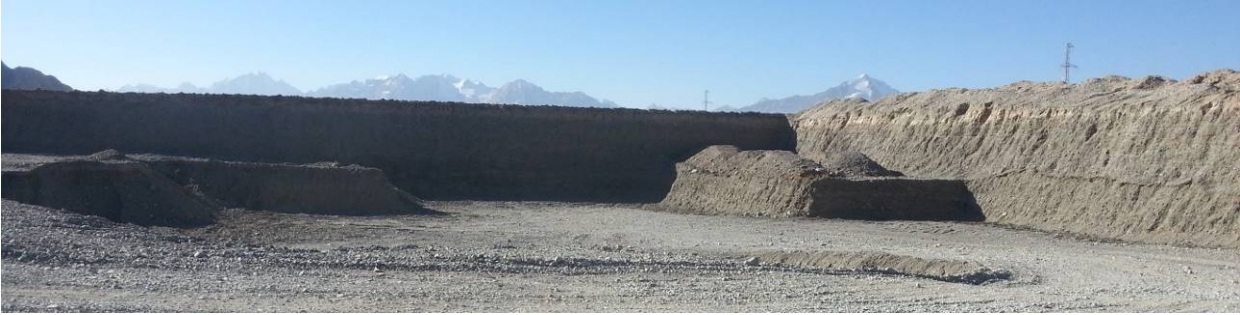
<p style="text-align: center;">Figure 27: Borrow Pit #3 – Extraction for season complete</p>
#4 <hr/> 491+100 RHS <hr/> Volume 480,000m ³ <hr/> 800 x 300 m <hr/> 200m from road	Oct 2013	Not started <input type="checkbox"/> In progress <input type="checkbox"/> Extraction complete <input checked="" type="checkbox"/> Restoration phase <input type="checkbox"/>

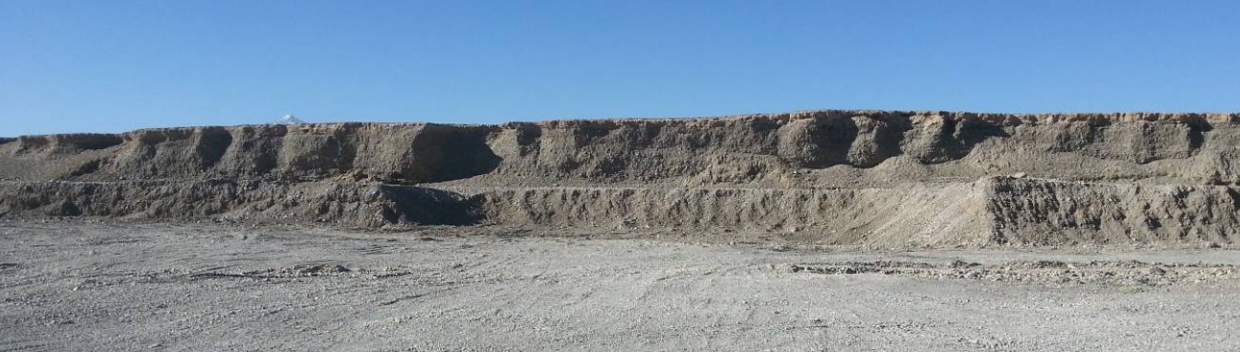
<p style="text-align: center;">Figure 28: Borrow Pit #4 – Extraction for season complete</p>

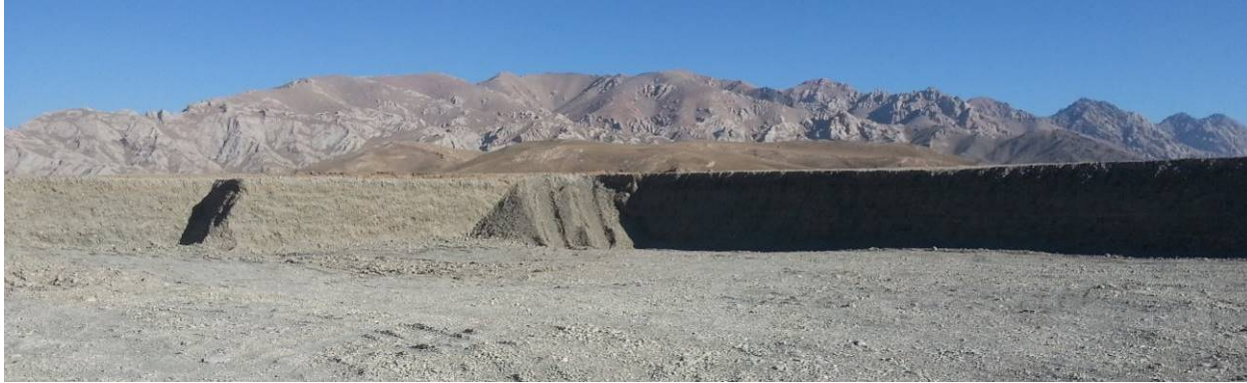
<p data-bbox="919 646 1654 678">Figure 29: Borrow Pit #5 – Extraction for season complete</p>
<p>#6</p> <hr/> <p>495+500 RHS</p> <hr/> <p>Volume 120,000m³</p> <hr/> <p>300 x 200 m</p> <hr/> <p>100m from road</p>	<p>Oct 2013</p>	<p>Not started <input type="checkbox"/></p> <p>In progress <input checked="" type="checkbox"/></p> <p>Extraction complete <input type="checkbox"/></p> <p>Restoration phase <input type="checkbox"/></p>

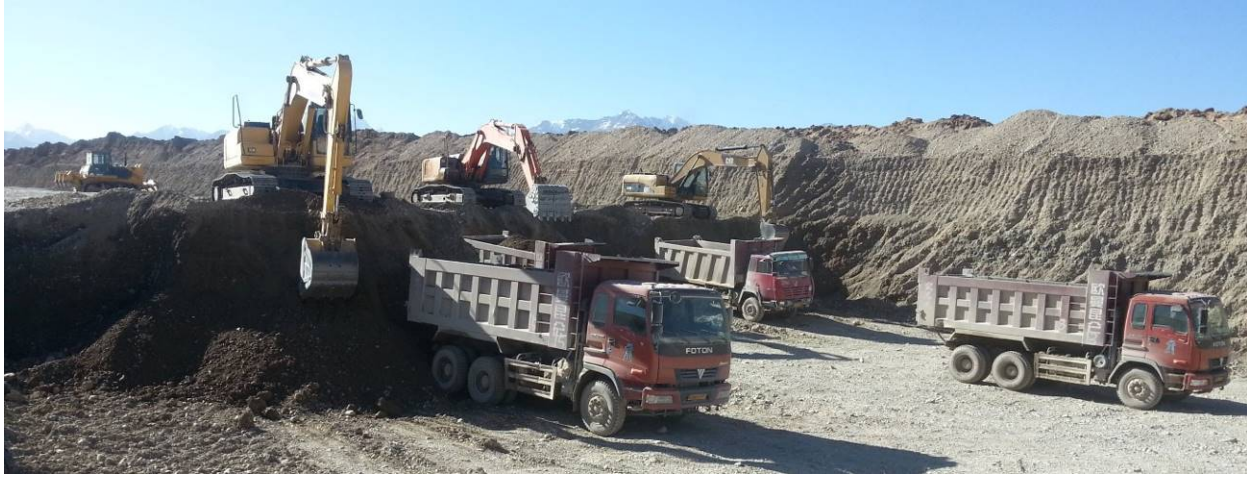
<p data-bbox="772 1182 1801 1214">Figure 30: Borrow Pit #6 – Note that dampness of extracted material reduces dust</p>

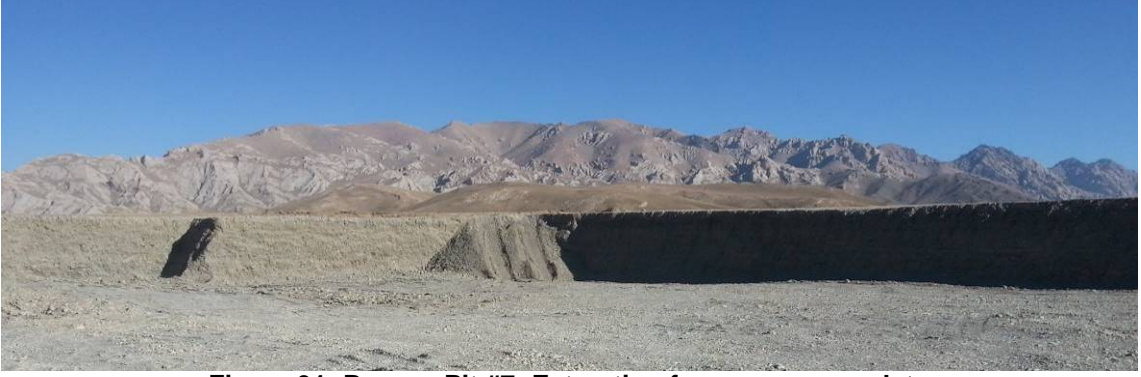
<p style="text-align: center;">Figure 31: Borrow Pit #7- Extraction for season complete</p>
#8 <hr/> Muz Tor River <hr/> 499+000 RHS <hr/> Volume 3,000,000m ³ <hr/> 750 x 2000 m <hr/> 6000m from road	Oct 2013	Not started <input type="checkbox"/> In progress <input checked="" type="checkbox"/> Extraction complete <input type="checkbox"/> Restoration phase <input type="checkbox"/>

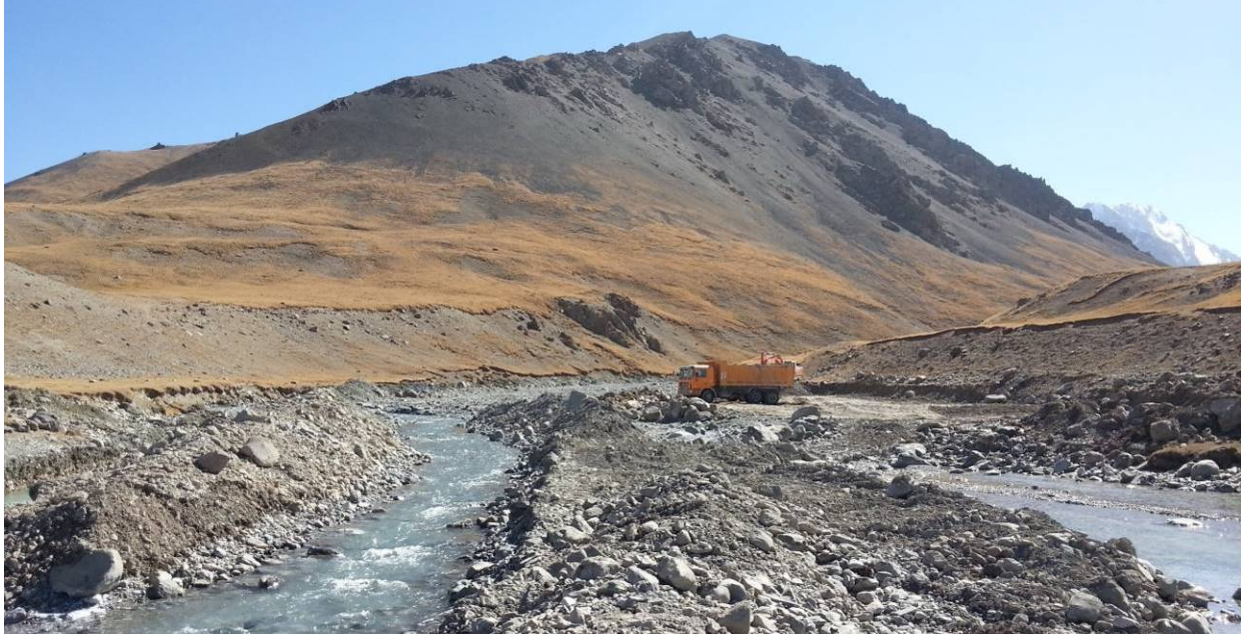
<p style="text-align: center;">Figure 32: Borrow Area #8: Muz Tor River – Note maintained channel on LHS of photo</p>

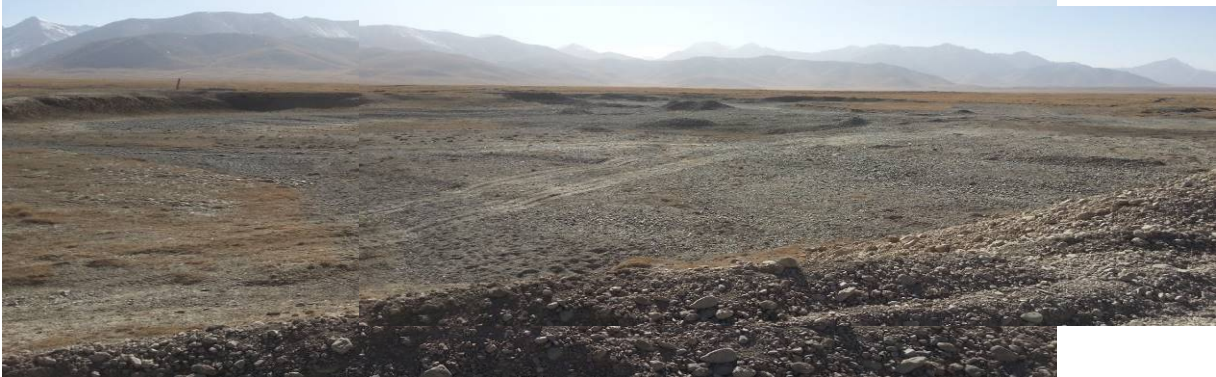
<p data-bbox="667 662 1696 685">Figure 37: Borrow Pit at Km508 – Not used due to presence of rare insect species</p>
