Semi-Annual Environmental Monitoring
Report

January 1 - June 30, 2018, Including 2017 Reporting.

Kyrgyz Republic:
CAREC Transport Corridor 3 (Bishkek-Osh Road)
Improvement Project, Phase 4

Prepared by
EPTISA Servicios De Ingeniería S.L.
Eptisa Muhendislik and RAM Engineering

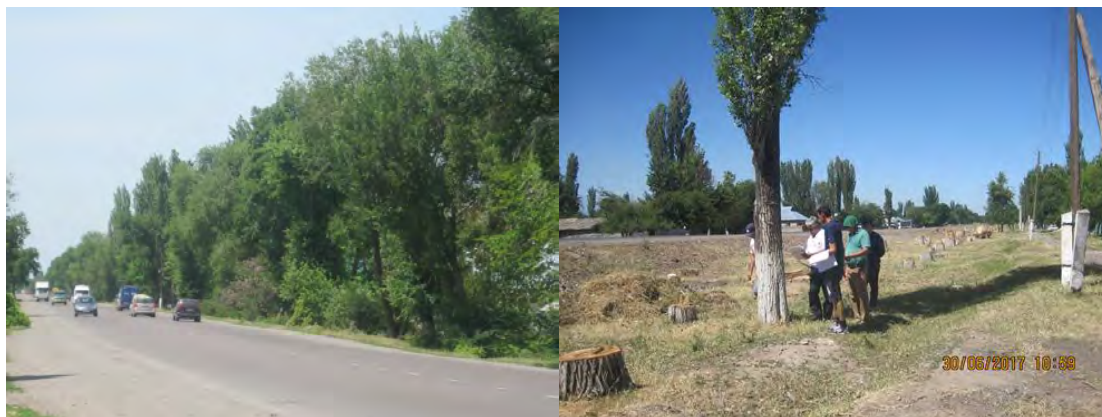
Figure 3 Section1. 3: Scene Before (left panel) and after (right panel) tree cutting

² During the mission in June 2017, ADB voiced surprise about the tree cutting, yet this information was recorded in 2015 and mentioned in several; short reports prepared by EPTISA, which urged tree conservation.

98. The failure by the contractor to prepare the plan as specified in the IEE led to ADB requiring the contractor to prepare site specific tree management /replanting plans for Sections 1.1 through 1.4. However, this work was assigned to EPTISA. A specialist subcontractor was retained to prepare these plans and they are complete and have been approved by ADB, allowing with cutting in these sections to proceed.

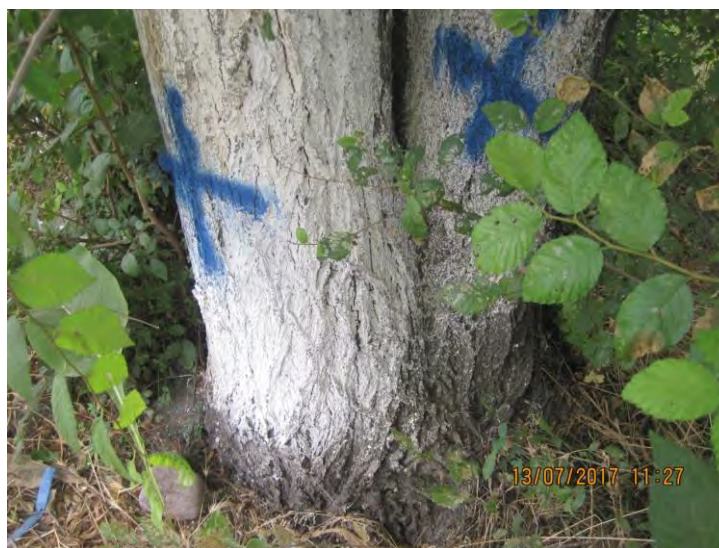
Figure 4. Example of tree marking

99. To ensure that only trees needing to be cut were felled, all trees to be cut were marked with a blue X (Figure 4), and within Right-Of-Way boundaries defined by survey stakes in all four sections.

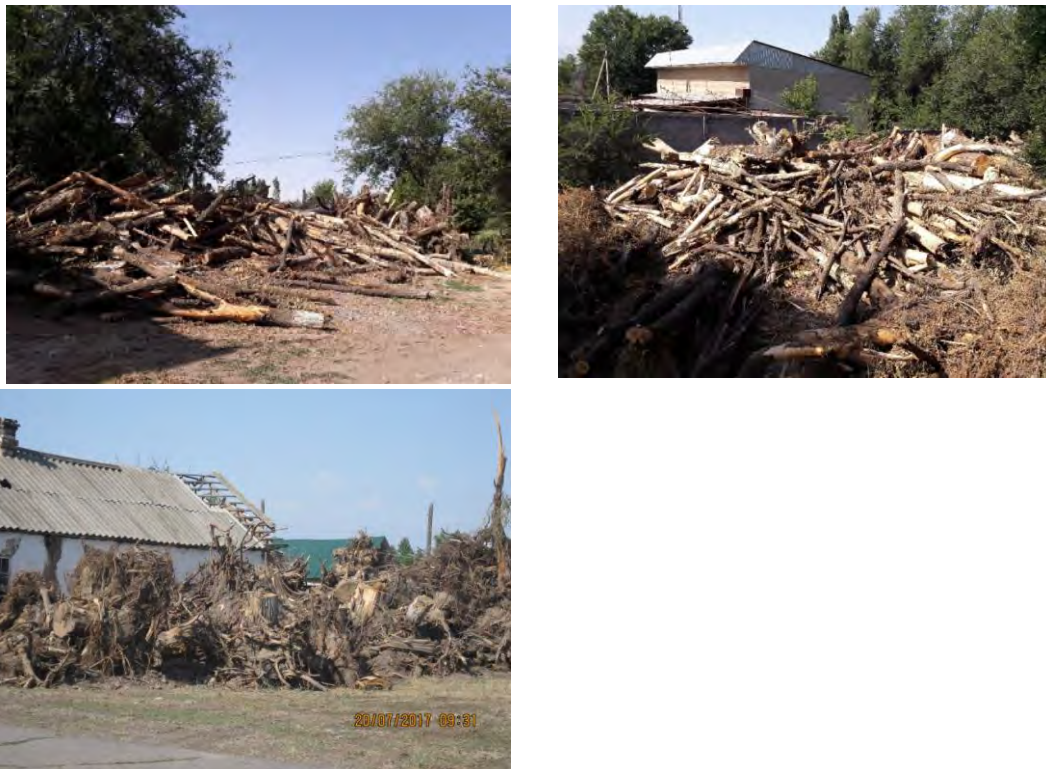
Figure 5. Logs and tree root storage sites along Section 1.3.

101. As shown in the 2017 photos (Figure 5) the tree logs were taken to a municipally approved storage area to be distributed at a later time. Logs were not stacked, as is the standard practice, but rather dumped, resulting in dangerous conditions with logs, sometimes weighing many tons, potentially rolling onto workers or people playing in the area. This problem was corrected in 2017 and logs are stored in fenced areas. Tree cutting is restarting in August 2018.

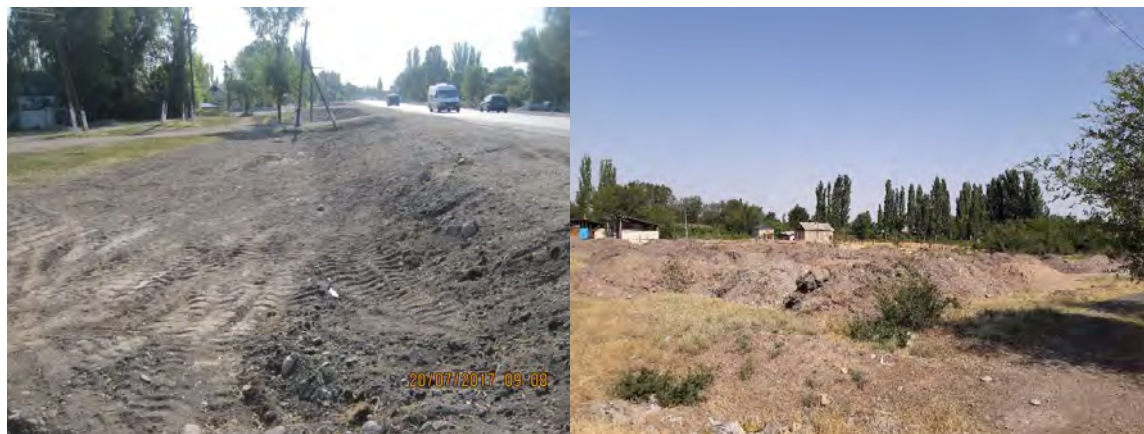
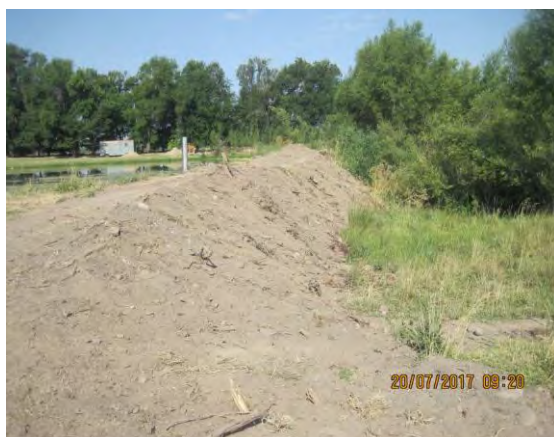
Figure 6 Topsoil Storage Areas Section 1.1

111. Figure 6). The contractor's and EPTISA's national environmental specialists have been carefully documenting this activity

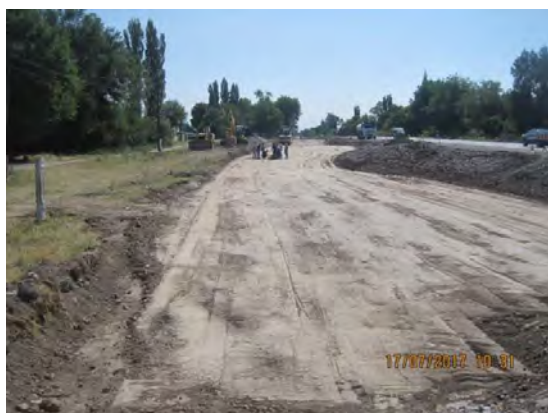
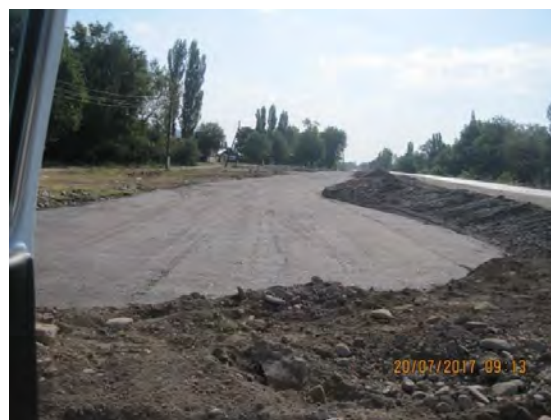
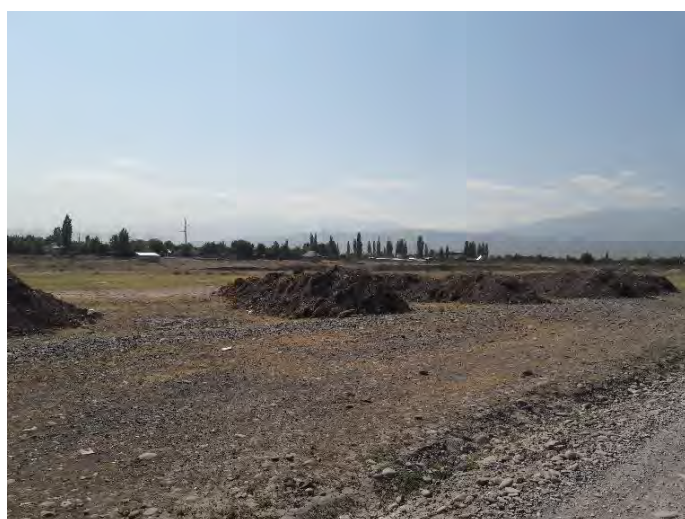
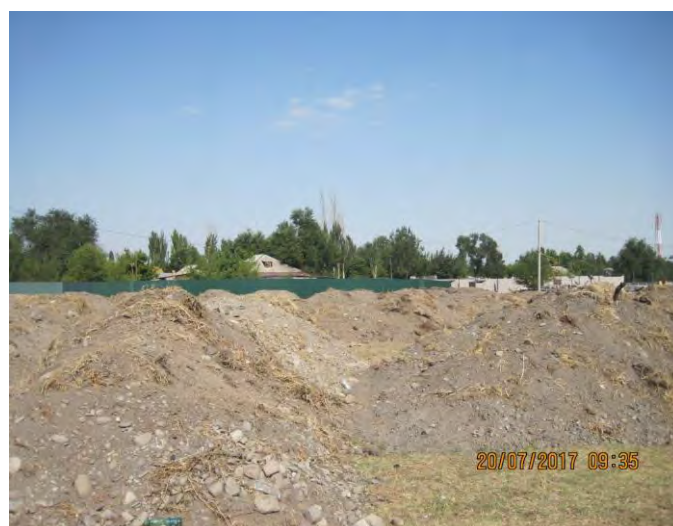
Figure 7. Subgrade preparation and topsoil storage Section 1.3.

113. The contractor's environmental monitor as well as EPTISA's environmental specialists are monitoring topsoil management and are reporting on this monthly.

115. These findings were given to MOTR for actions with a recommendation that topsoil use not be allowed for garden soil enhancement etc.

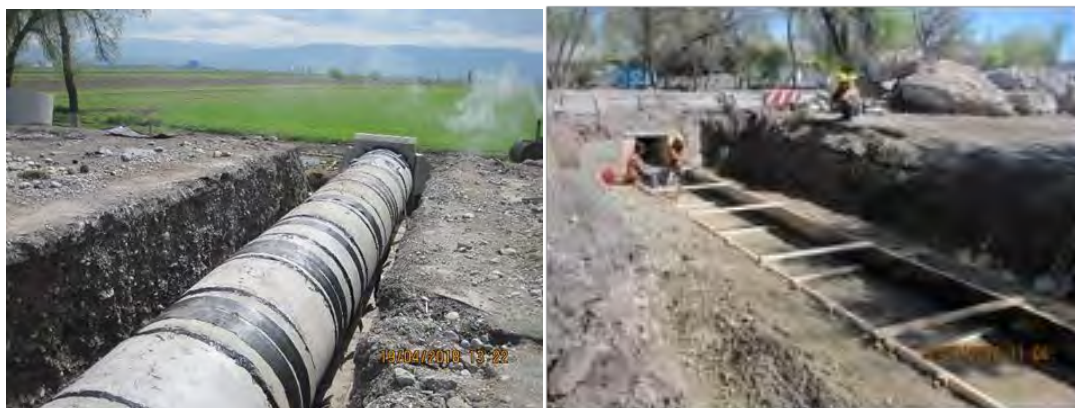
Figure 8. Site 1.3 Culvert Replacement

121. On the site 1.3, on the south side of the road, work on dismantling of old and installation of new culverts has been started.

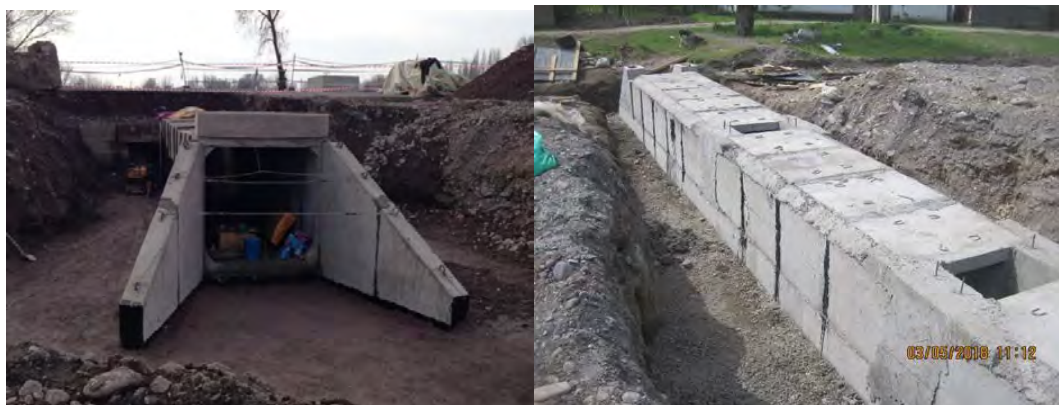
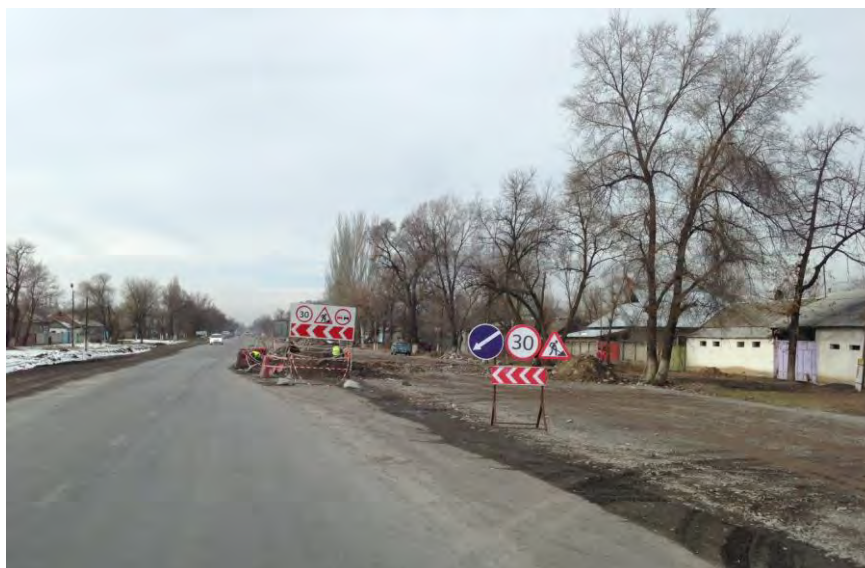
Figure 9. Culvert construction site in Section 1.3 showing standard diversion signage

122. On the Site 1-3 RK 371+00 – 431+00 (Petrovka village 45,6-51,6 km) works on dismantling of old and installation of new culverts, on the south side of the road were continued. On the North side of the road on the section 1.3 (Petrovka village 45,6-51,6 km) the construction of pipes was completed. In this site, the problem, during installation of new pipes, is created by wedged ground water.

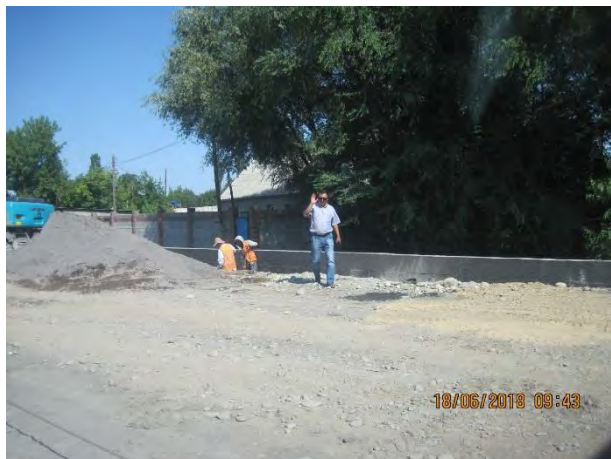
Figure 10. Retaining wall construction site

124. Also, in places where there are steep slopes, work was carried out to install 165m of retaining walls. In order to ensure the safety of traffic, the site of work is fenced; barriers and signs of traffic safety are installed. New night lighting devices have been installed.

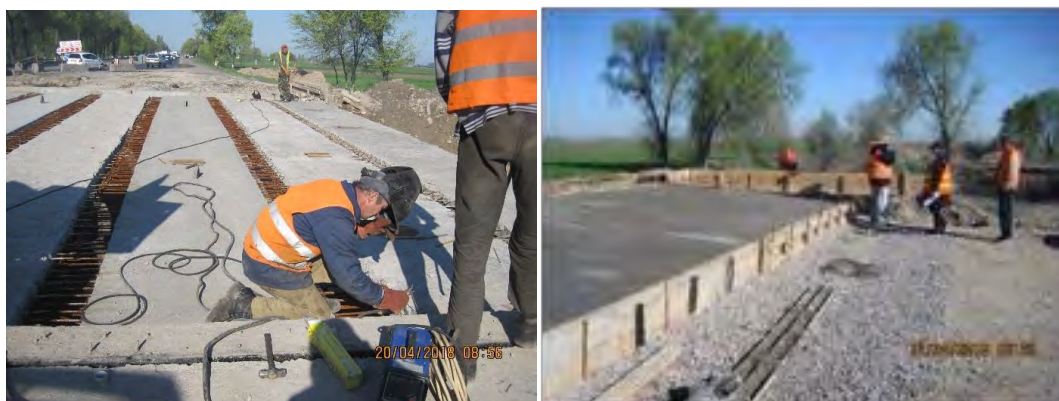
125. **The Bridge over Jelamysh River.**-In April 2018, construction work continued on the construction of the bridge over the Jelamysh River on the north side of the road, which began in the autumn of 2017 and was completed in May, and the north side of the bridge was opened for traffic.

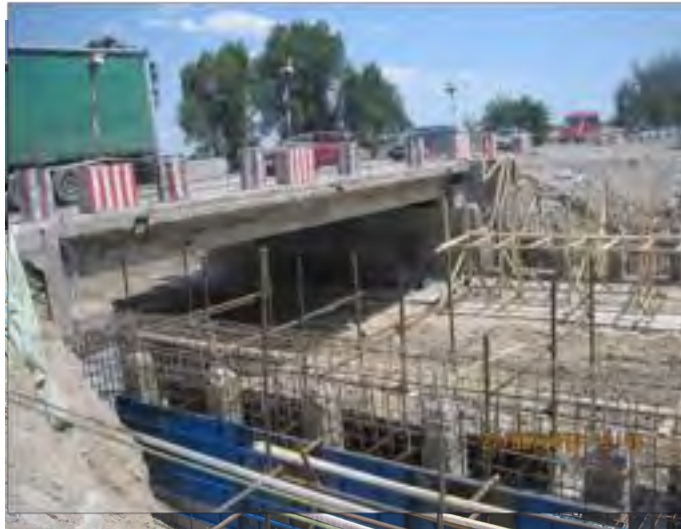
126. In May, work on the construction of the south side of the bridge has been started. There is no water in the Jelamysh River.

The road in the area of bridge construction is constantly irrigated with water.

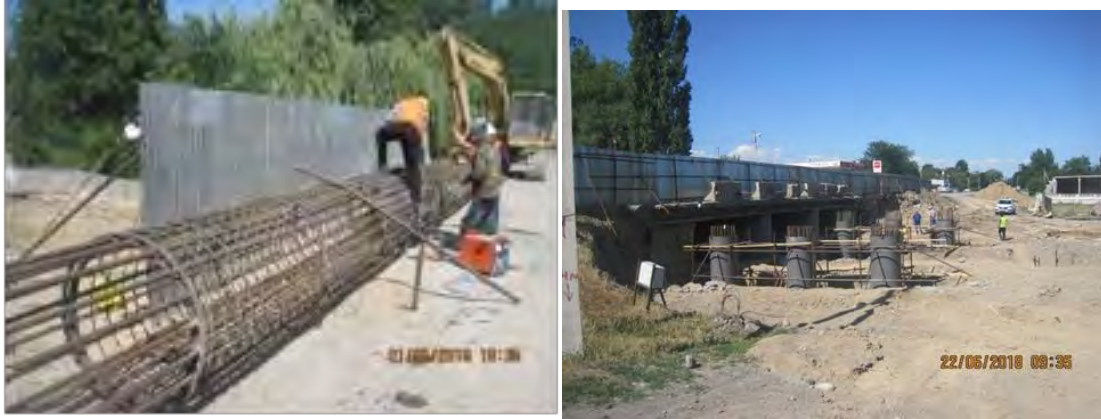
Fabrication of rebar framework for bridge piers and piers being poured-in-place in dry riverbed.

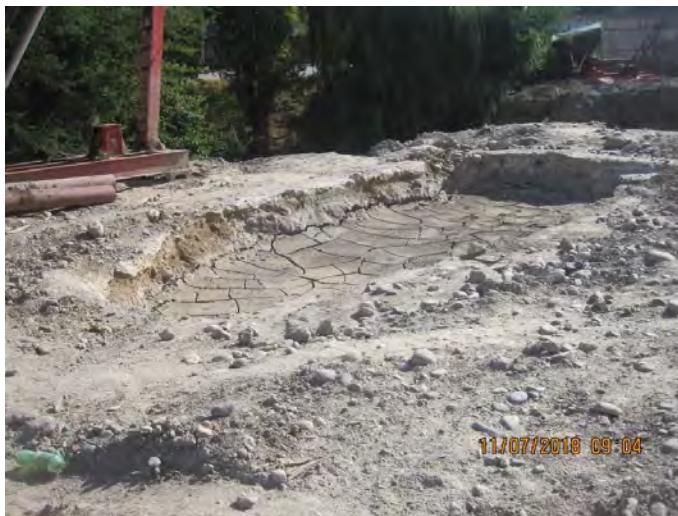
Pit for dehydration of bentonite clay to be removed to secure landfill site for burial.

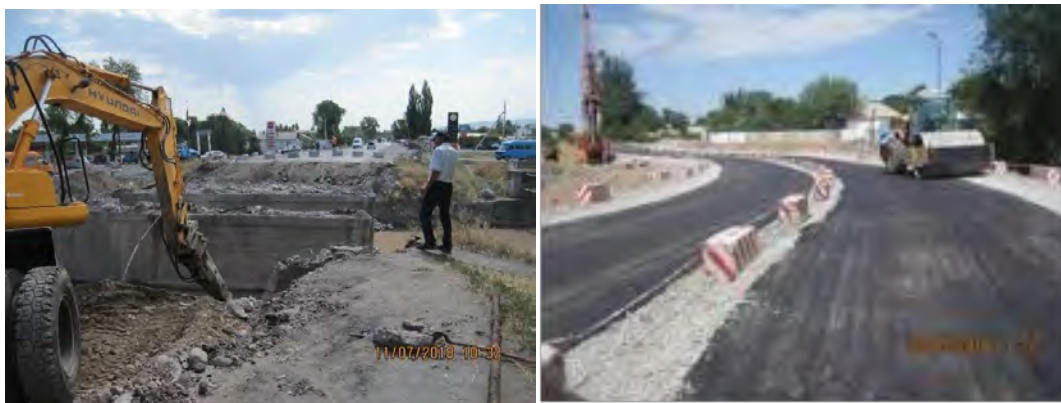
131. Currently, the bridge width has been extended from 7 to 15 meter, based on EPTISA's instruction. But during the construction provision for pedestrians was not provided. The contractor is undertaking this work now.

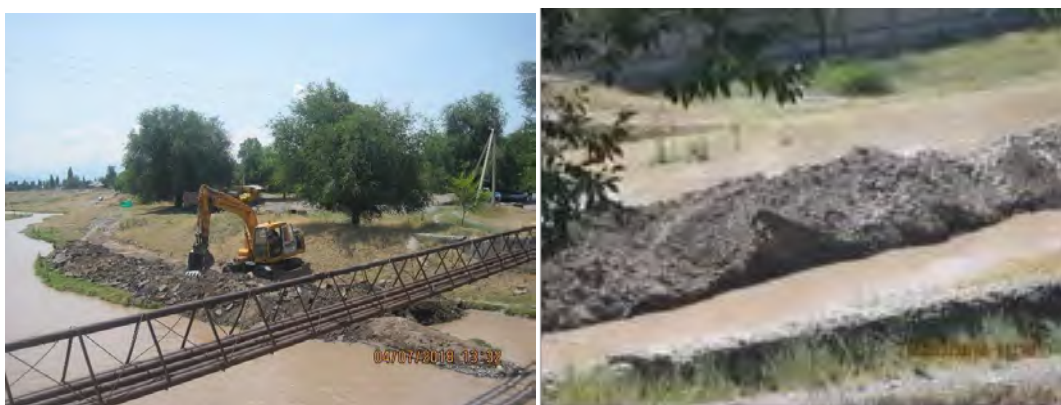
132. The construction company building the bridge has stored old asphalt in the riverbed, which is a flagrant violation of environmental legislation, about what the letter of non-compliance was sent to the Contractor No.EP-CR5-HN-576 of 06.07. 2018.

133. The riverbed is also filled with excess construction soil, which is currently not possible to remove due to the large volume of floodwaters (lower right photo).

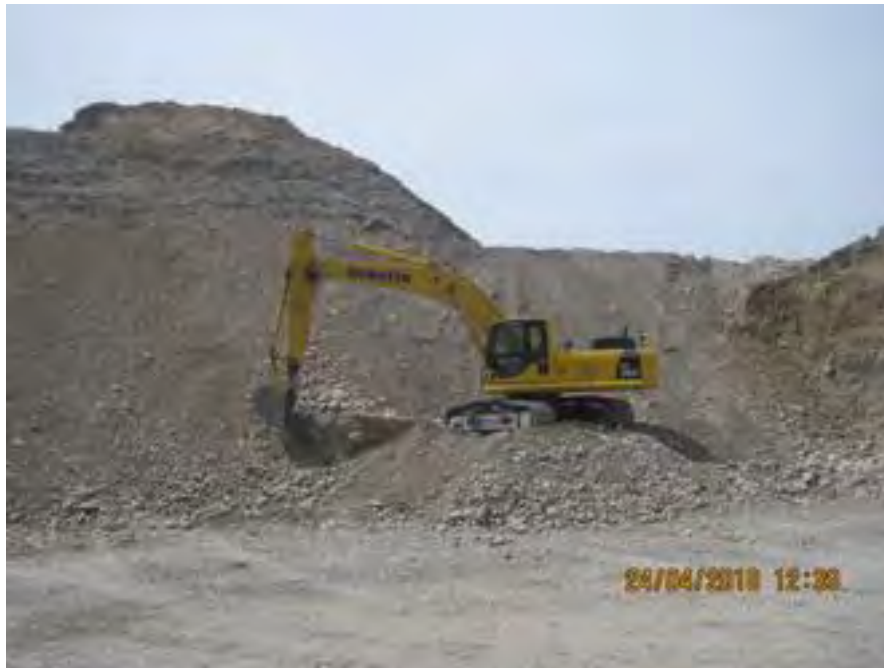
The Jelamysh Borrow site

143. **At the Jelamysh Borrow Site** the height of bench is approximately 10 m, while the project provided that the development will be done in layers with the height of bench of 5 m, starting from the top platform. It is also established that the base of the borrow-pit side goes beyond the established boundaries and went to the country road, threatening with a rockfall. The border of the dumps of sifted inert materials, also beyond the contour of the borrow-pit site. After the violations were reported on May 3, the work at the borrow-pit was stopped №ER-CR5-HN-397 to remedy the situation.

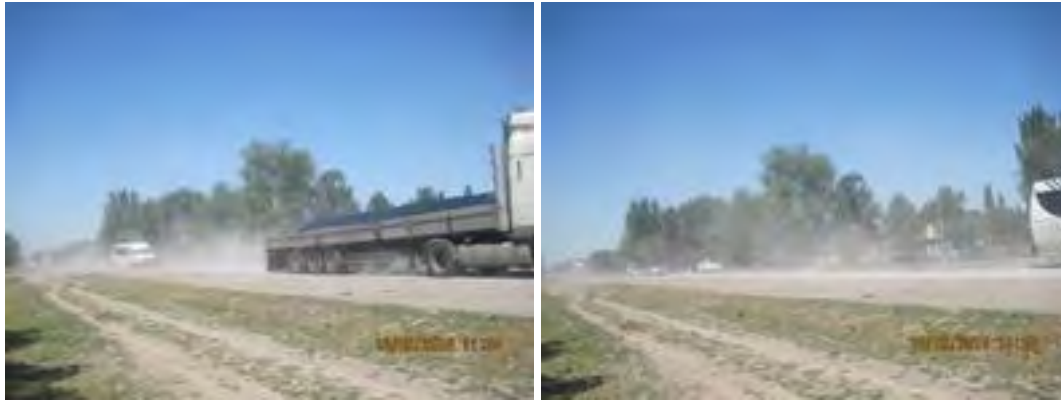
147. **2018** The implementation of dust control measures at construction sites continues to be an issue since while being undertaken, it has not been adjusted in relation to higher air temperatures and reduced precipitation. Complaints are being received orally by EPTISA's monitor. Despite preparing watering schedule water tanker drivers are not adhering to this and therefore very dusty conditions persist.

148. In view of the situation, the Contractor was instructed to increase the intensity of watering the road, including the roadside, in the construction site from 6 am to 20 pm, without a break for lunch. This new schedule is now being implemented

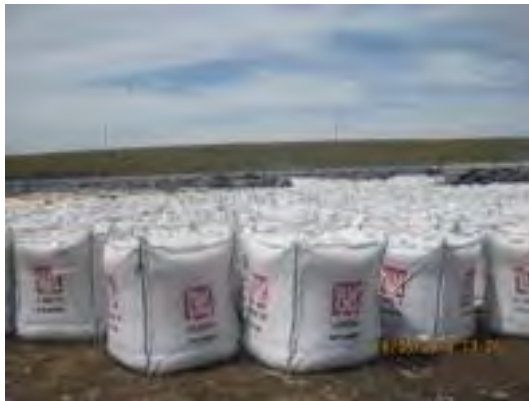
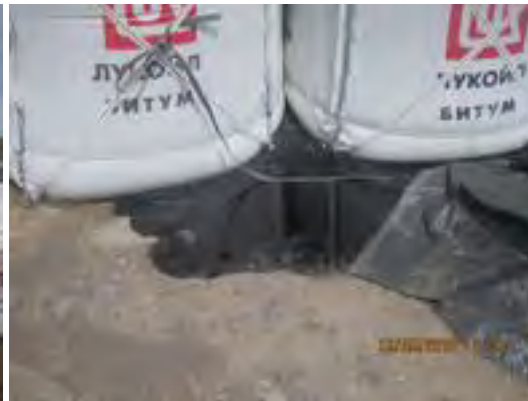
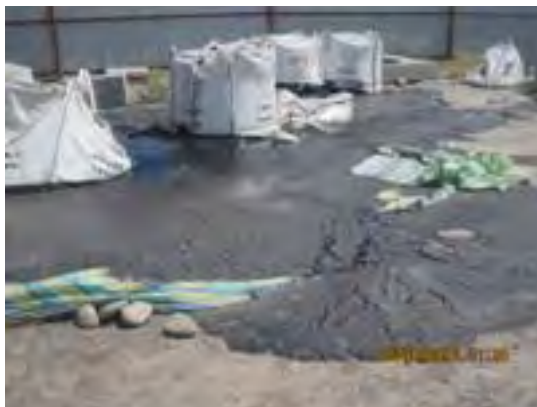
153. **Bitumen-** Large amounts of bitumen are being delivered to the ATP site and bags are breaking and the bitumen spills are increasing.

154. Bags of bitumen are breaking open and material is spilled on the ground without the observance of environmental measures and immediate clean up. Visual inspection

established that some of the packages when unloading were torn open, but never repaired. As a result, the contamination continues and compliance letter No. EP-CR5-HN-439 of 17.05 2018 was sent on May 17th.

156. The Contractor has started construction of a canopy for storage of unused bitumen and bitumen packaging. But despite that the leakage has increased as air temperatures rise. All this continues to contribute to the pollution of soil and groundwater. In addition to several direct warnings a second non-compliance letter (no. EP-CR5-HN-540 of 22.06.2018) was sent on late June.

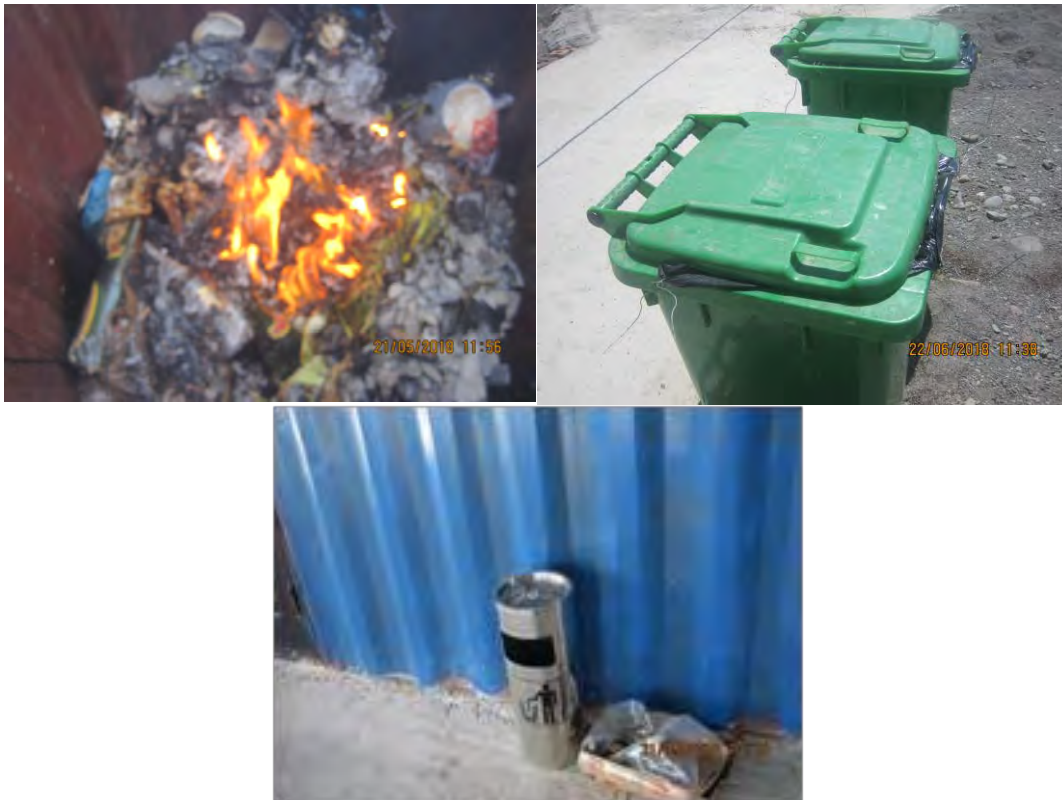
160. In the workers' camps, food waste is thrown into the open metal trash containers as is and becomes an ideal environment for parasites growth and in the heat creates a serious odor and threatens the health of the workers. Food remains must be disposed of daily in the summer but it not done, as waste contractors have not been asked to do this. But given that the daily export of food waste is not it was recommended to food waste be stored in a special plastic bins with lids allowing for the material to be disposed of after a few days.

Illegal waste burning and food waste bins and cigarette butt receptacles at contractor offices

162. A special meeting was held with the contractor on May 30, 2018 to explain these requirements. This was initiated with a non-compliance letter No. ER-CR5-HN-397 dated 4.05.2018), but not acted on by the contractor until May 30th, 2018.

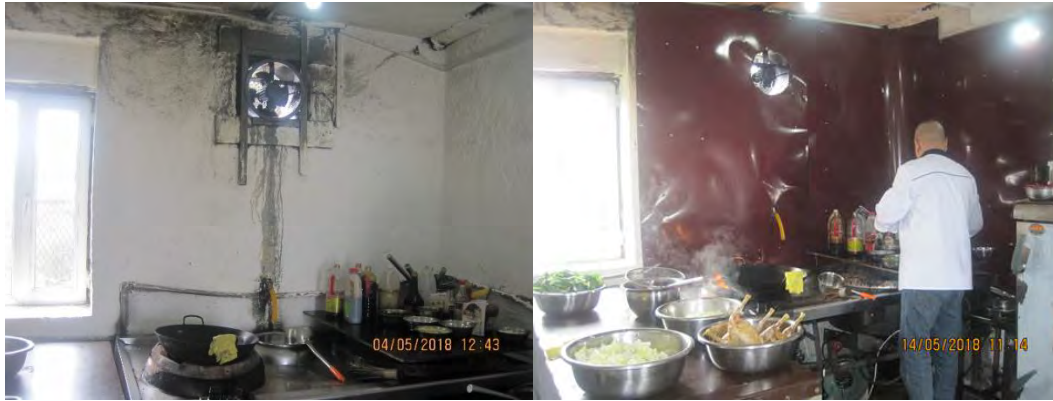
A washable plastic non-combustible coating on kitchen wall at Sokuluk Construction Camp

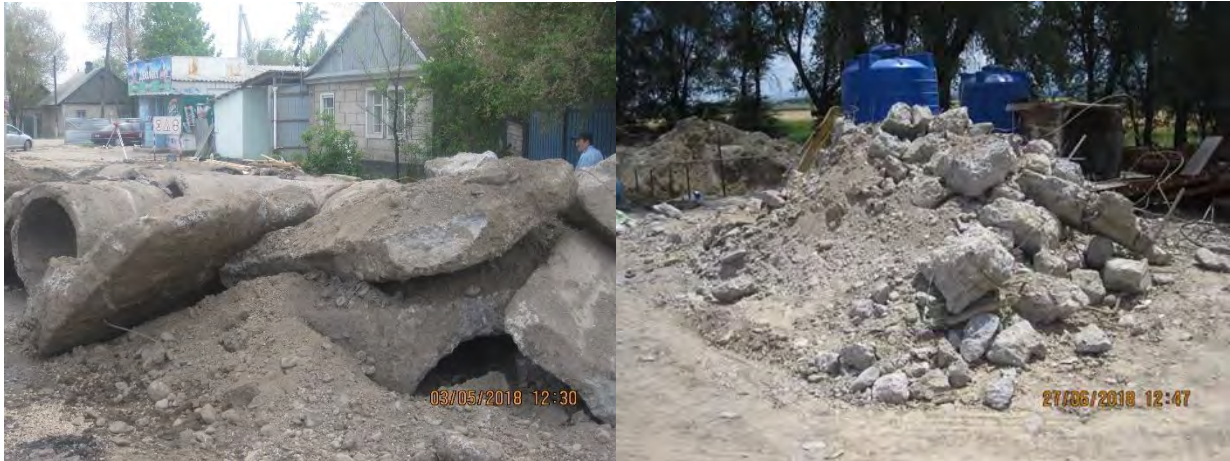
An old asphalt

The construction waste generated during the construction of bridges and culverts should be transported in time to the dedicated ROE sites for the storage of old concrete products. About what, the letter to the Contractor No. ER-CR5-HN-467 of 25.05. 2018, was sent.

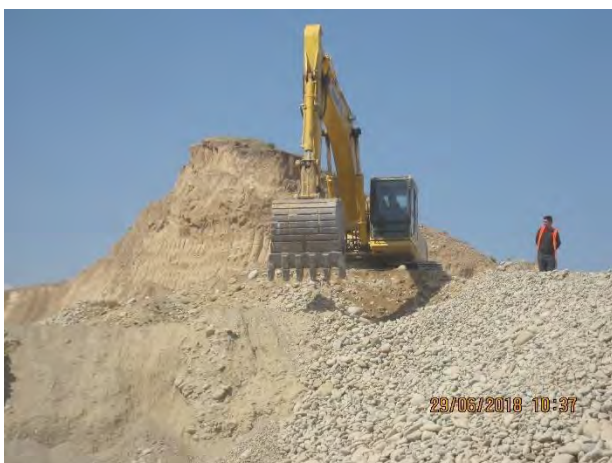
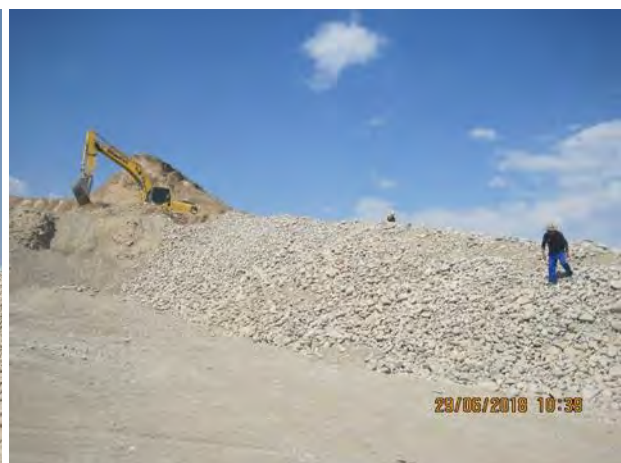
The photographs show the thickness of the strip

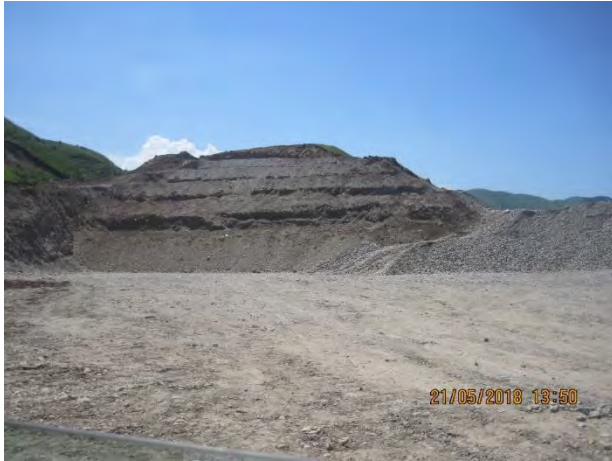
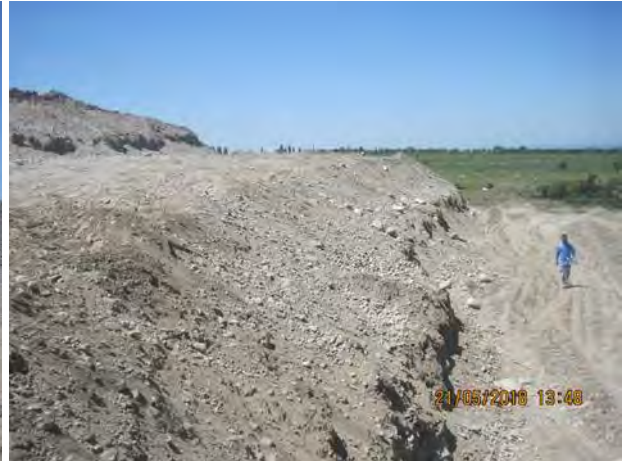
General view of the borrow-pit. Width of benches

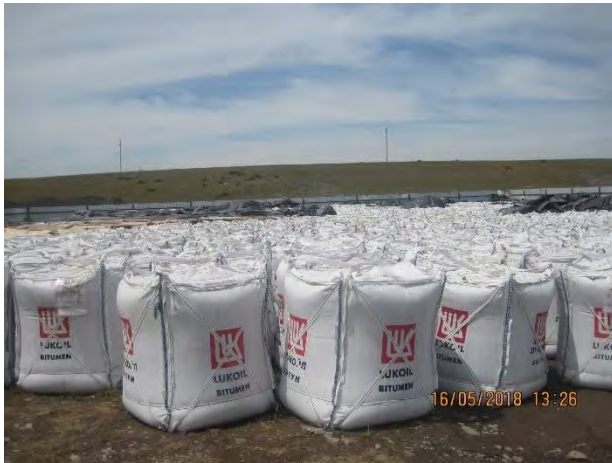
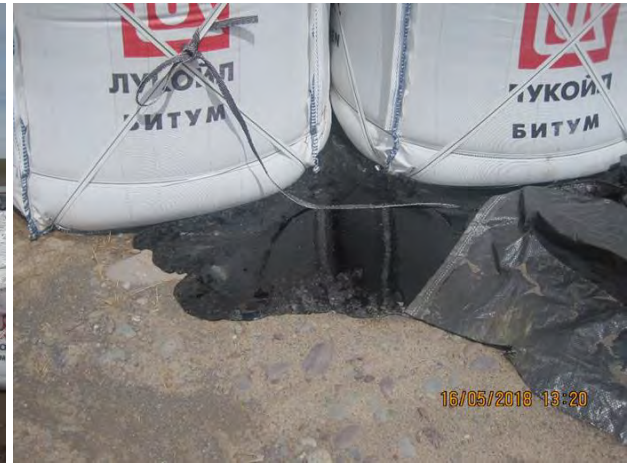
A large amount of bitumen has been Delivered to the ACP territory. Bitumen is delivered in polyethylene packages.

The bitumen was discharged on the ground without the observance of environmental measures. Visual inspection established that some of the package when unloading suffered, in consequence, has been the leakage of bitumen on the ground. This was reported in a letter № EP-CR5-HN-439 of 17.05 2018.
