# **Semi-annual Environmental Monitoring Report**

Kyrgyz Republic:  
CAREC Transport Corridor 3 (Bishkek-Osh Road)  
Improvement Project, Phase 4

Prepared by Ministry of Transport and Road KR  
in consort with EPTISA Servicios De Ingeniería S.L.  
Eptisa Muhendislik and RAM Engineering

January 2018

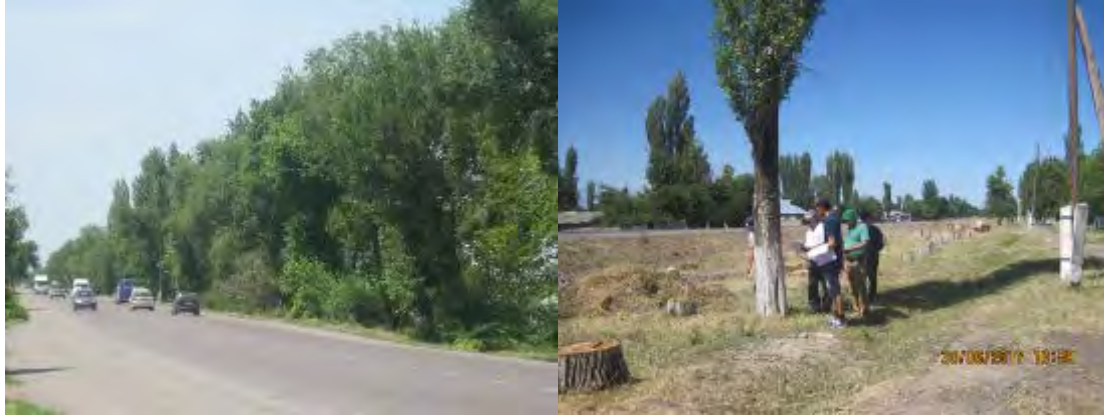
Figure 6 Section 3: Scene Before (left panel) and after (right panel) tree cutting

92. A number of instructions by the IES in the IEE and repeated in the CEMWP items No. 1.8 and 2.5.3, specifying a re-inventory of trees to be cut and mapping of their locations was not carried out in advance but in parallel with the start of tree cutting in Section 4 around June 20th. The IEE contained considerable details on the tree cutting actions and provided photos showing fully mature trees scheduled for cutting. The action should not have been a surprise to anyone, and yet ADB noted this during their mission in June 2017.

93. The failure by the contractor to prepare the plan as specified in the IEE led to ADB requiring the contractor to prepare site specific tree management /replanting plans for Sections 1 through 4. However, this work was assigned to EPTISA. A specialist subcontractor was retained to prepare these plans and they are complete and have been approved by ADB, allowing with cutting in these sections to proceed.

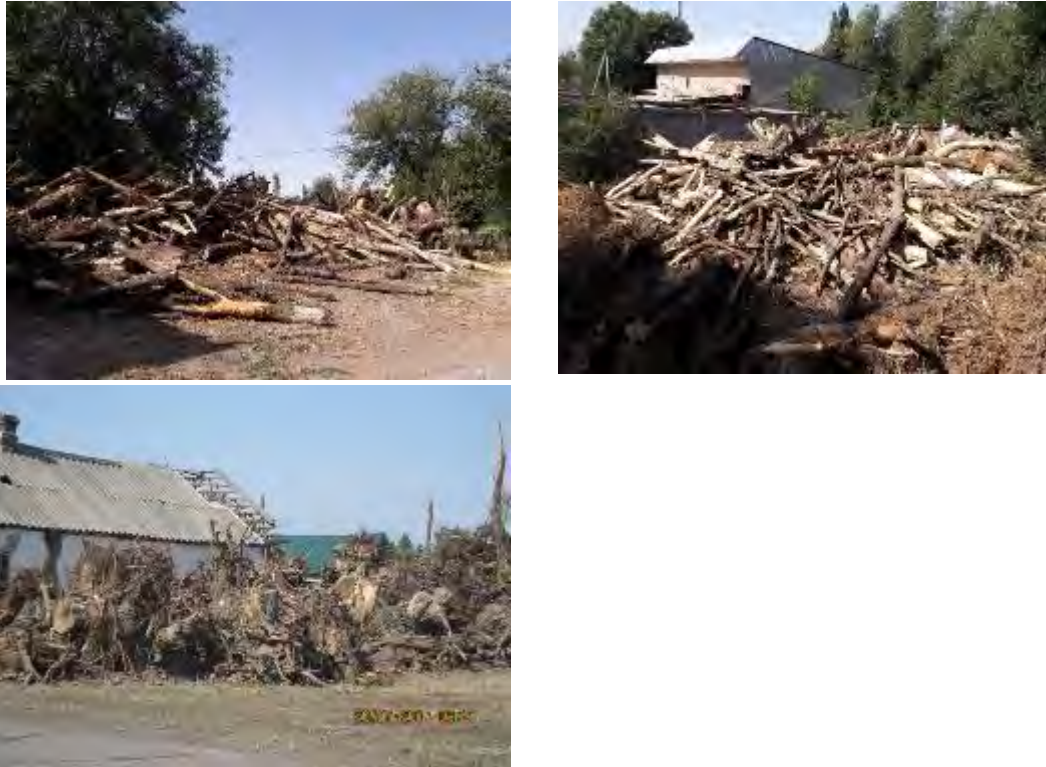
Figure 8. Logs and tree root storage sites along Section 3.

96. As shown in the photos (Figure 8) the tree logs were taken to a municipally approved storage area to be distributed at a later time. **Logs were not stacked, as is the standard practice, but rather dumped, resulting in dangerous conditions with logs, sometimes weighing many tons, potentially rolling onto workers or people playing in the area.**

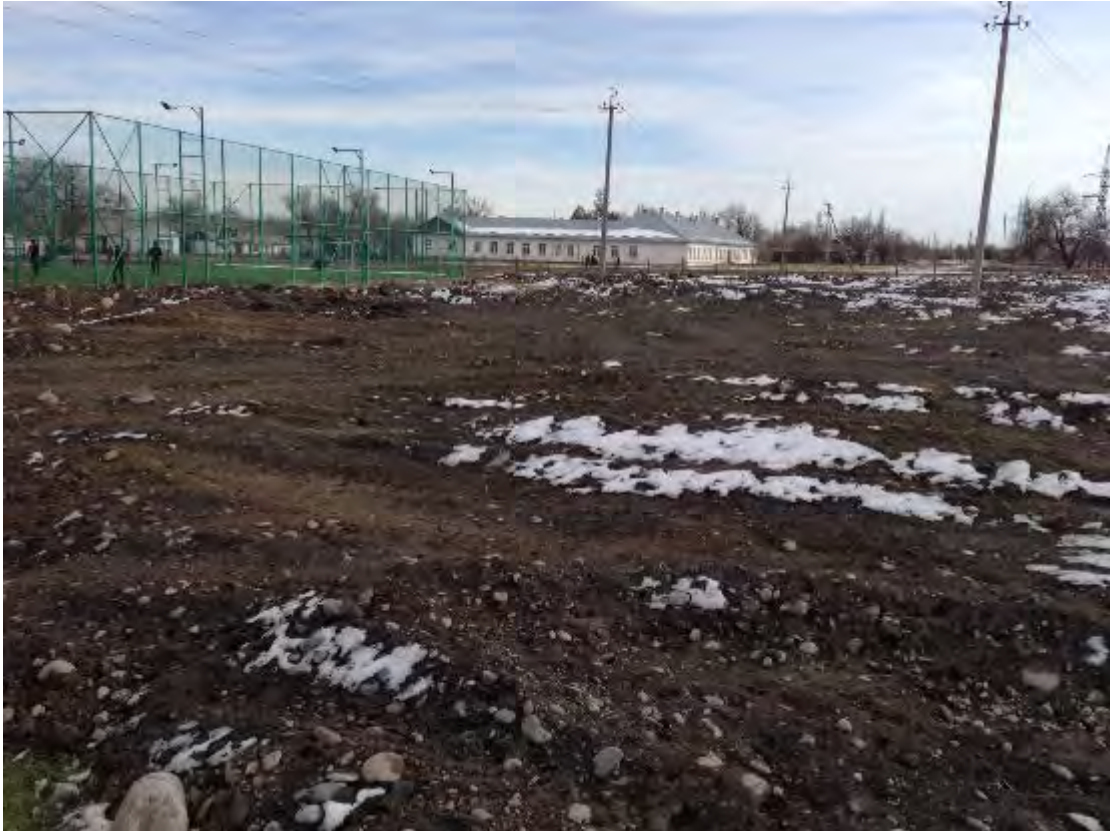
Figure 11 Ak-Suu topsoil storage area, graded for use by local community

107. For a time topsoil use by local residents as garden soil was considered, but after soil testing by EPTISA found significant levels of lead in these materials, residents were informed that such use was prohibited.

108. ***In effect the contractor has disposed of the topsoil without permission of the CSC or MOTR and now will be required to provide thousands of m<sup>3</sup> when rehabilitation of the shoulders takes place.***

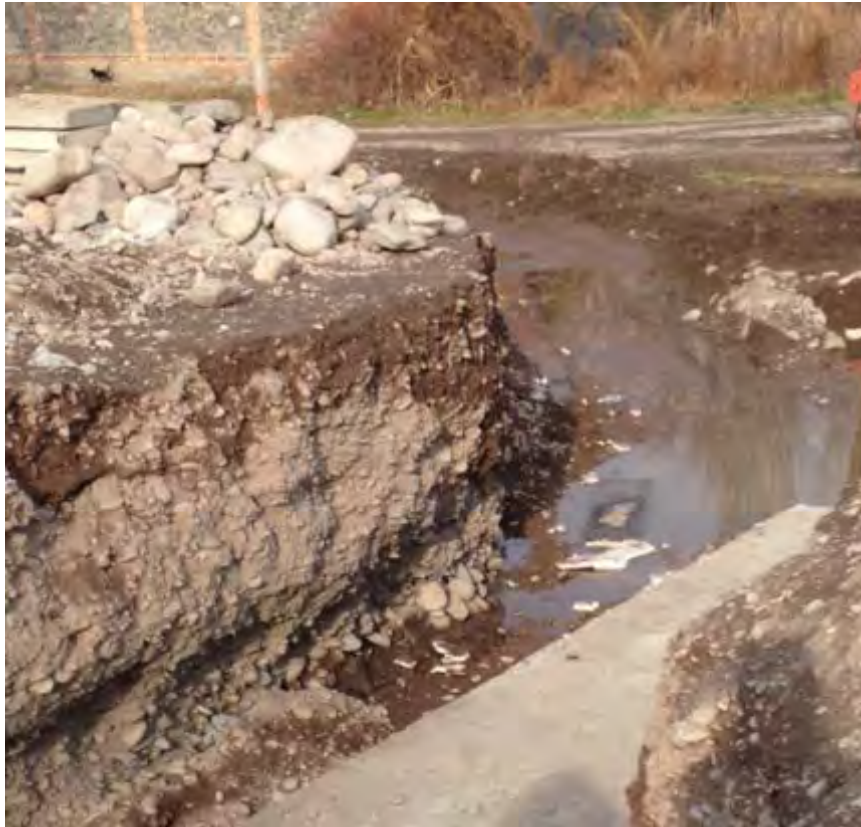
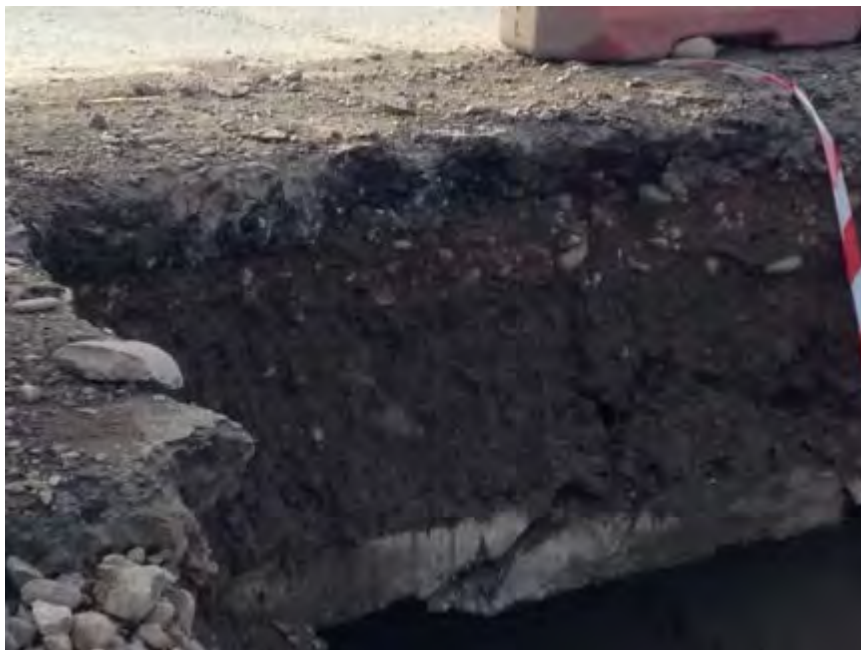
Figure 15. Work area left with undercut banks, >1m high a danger of cave in, and lower panel showing where culvert removed and road surface in imminent danger of collapse

113. After the inspection of 5 of these culvert three serious non-compliance issues were identified, namely a) Safety at the work site, especially after construction has stopped for any reason b) Confirmation that culvert sections left in the ground are unobstructed and that placement allows for ample slope for quick drainage c) adequate design of drainage channels downstream of the culvert discharge

114. **CEMWP No. 2.9.4 and Annex 4- Safety-** While the perennial problem with the use of PPE was evident at all sites, particularly related to footwear and hardhats and secondly the proper securing of the work site to make sure that cave ins are not possible and people accidentally falling into the work site does not occur. At one of the larger sites the roads pavement where the culvert has been excavated was in imminent danger of collapse resulting in a serious vehicle accident. Secondly the failure to secure work areas such that when people come close to the sited, sidewalls cannot collapse easily. ***The safety engineer was informed and action is being taken and further training will be provided the safety engineer.***

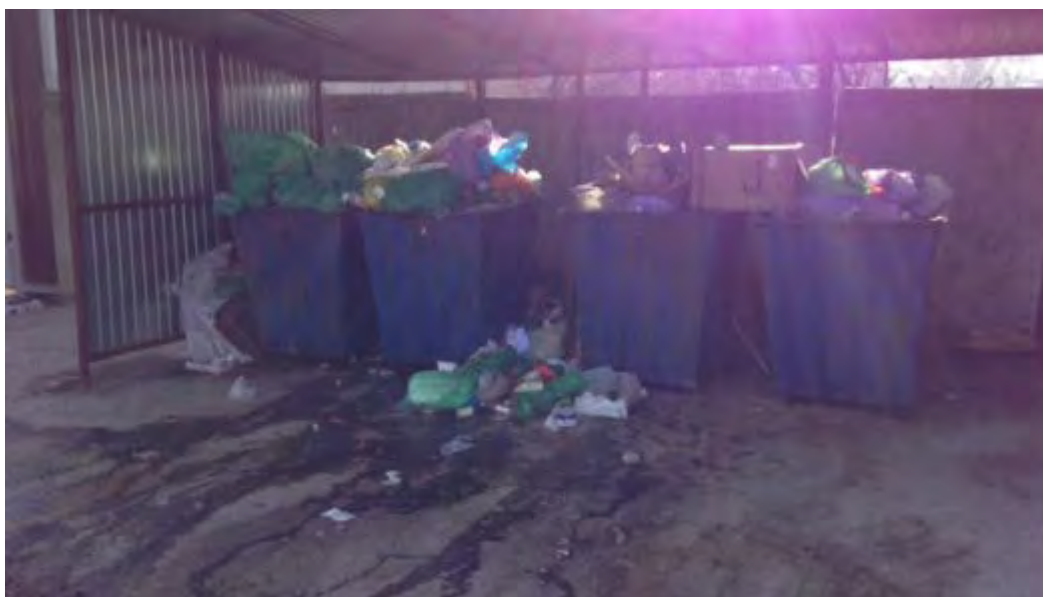
Figure 17. Garbage at contractor's yard 29,11,'17,not cleared for past weeks

121. **CEMWP 2.3, 2.6.2; Annexes 4,5 & CEMWP No. 2.6.2 and Annexes 5 & 7** Waste on this project consists of used or broken construction equipment building materials and paper and cardboard products scattered around the contractor's yard, as well as unsorted garbage namely dry waste, plastic and glass as well as wet food scraps dumped in overflowing bins at the entrance to the contractor's site, attracting flies vermin and dogs.

122. Fortunately it is winter and cold temperatures prevent the very strong odour and health hazard that would be present with warmer temperatures.

123. ***Contractor's camp waste needs to be sorted with plastic, glass in one bin, paper in another, hazardous materials in the 3rd and organic waste in another.***

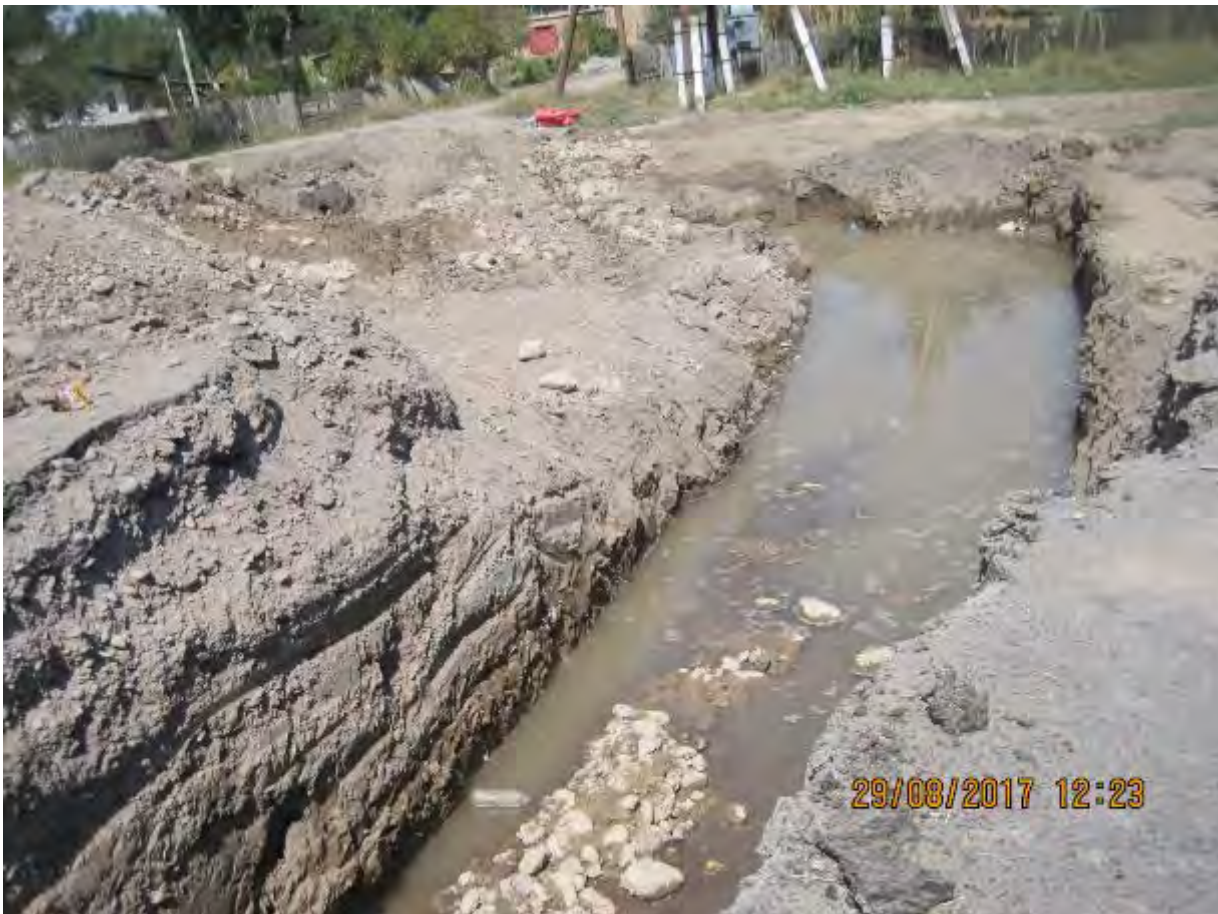
Driven out a wedge groundwater causes problem.

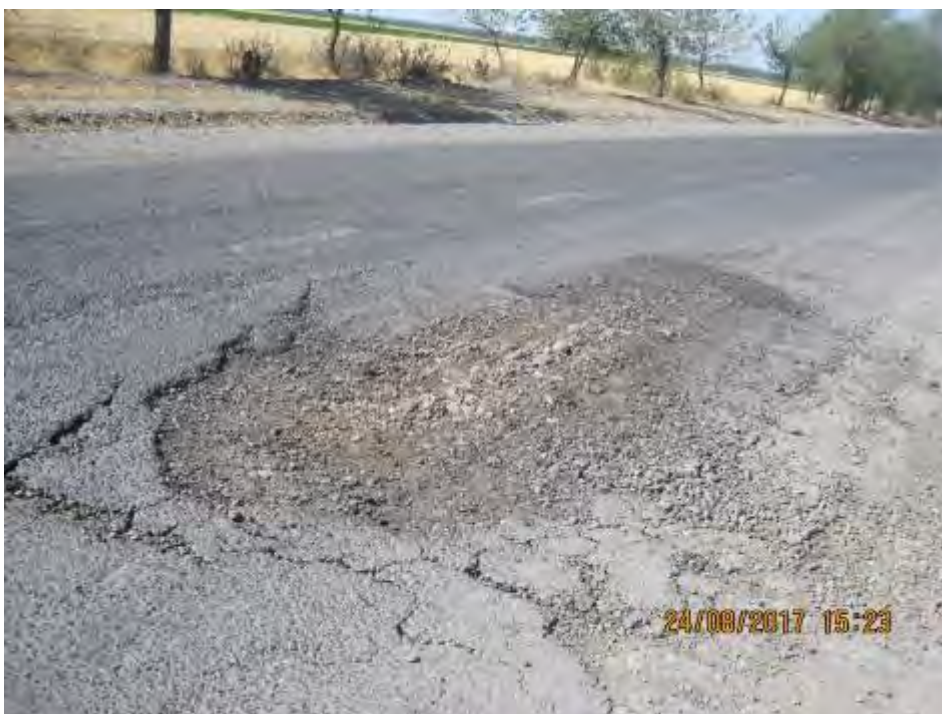
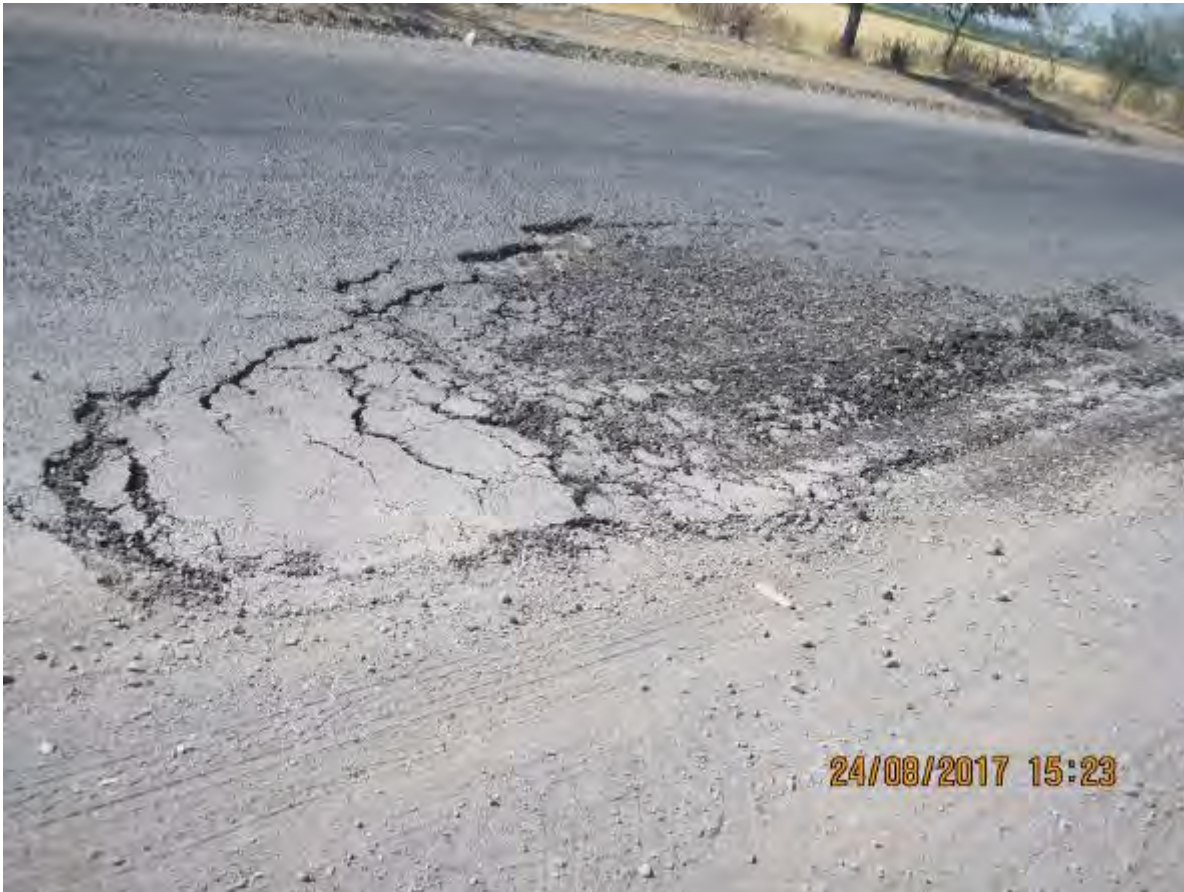
On the road section, between 3 and 4 km, leading to a borrow pit, there is a problematic area on which permanent damage to asphalt is noted. At the present, the Contractor is trying to improve situation on this road site.

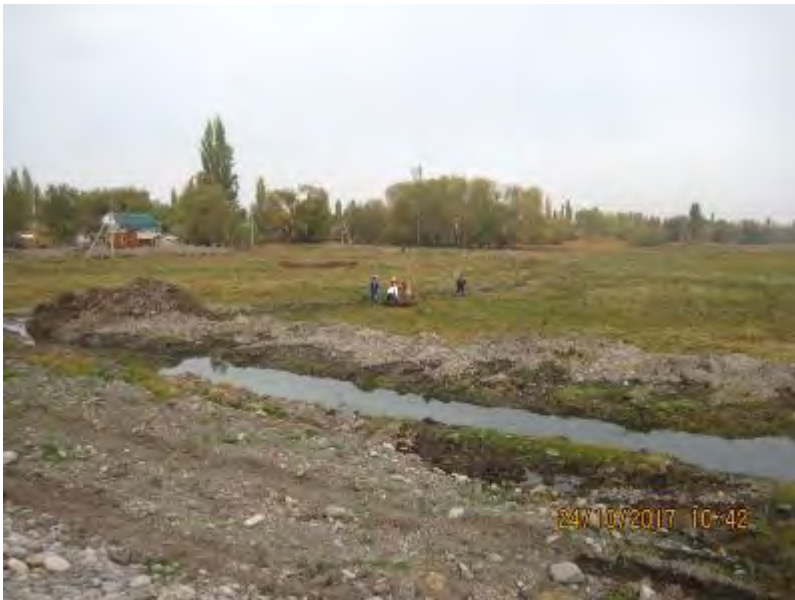
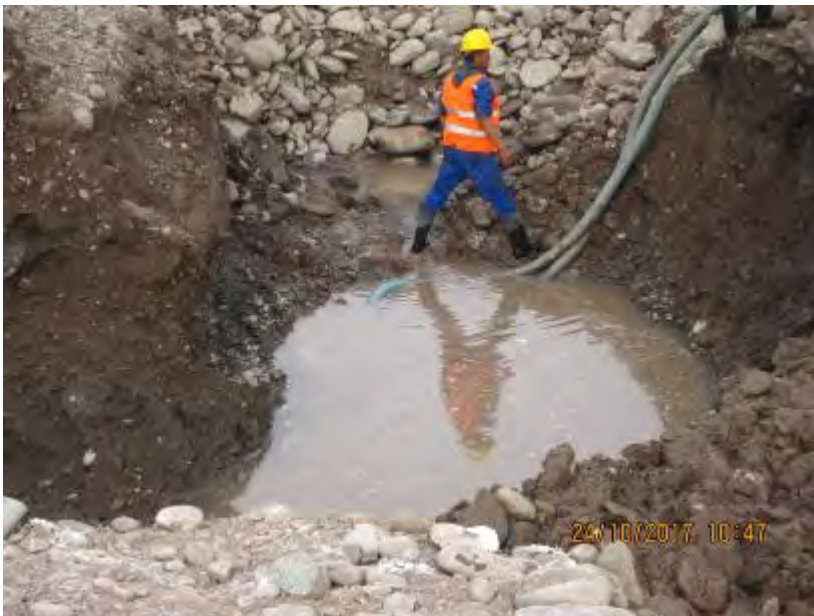
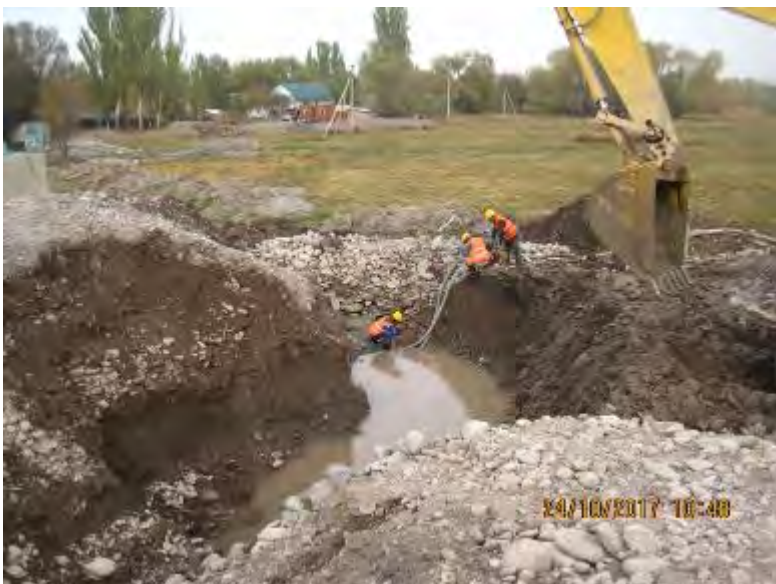
Driven out a wedge groundwater causes problem.

Existing old pipes are almost completely locked by soil.

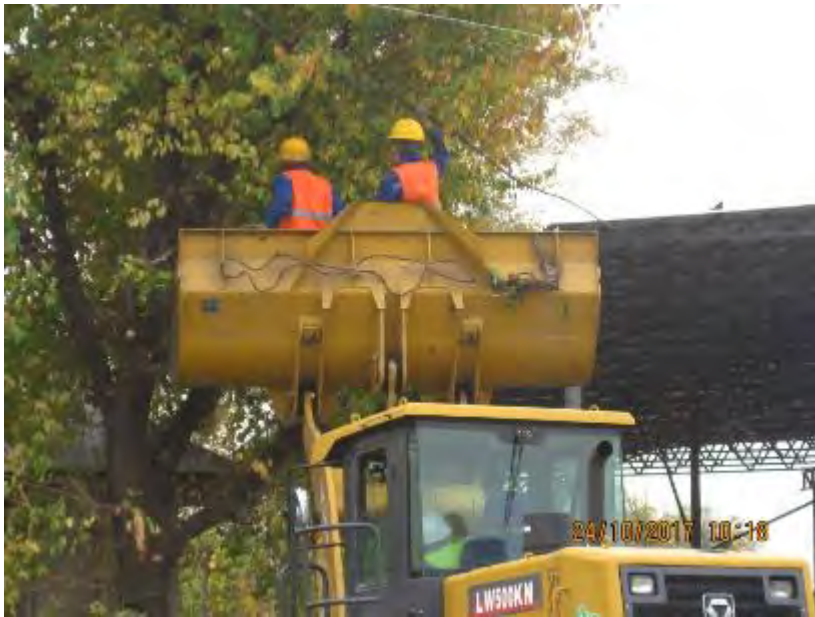
*In violation of safety regulations, due to the lack of a lift, workers are working at a height in the loader bucket*

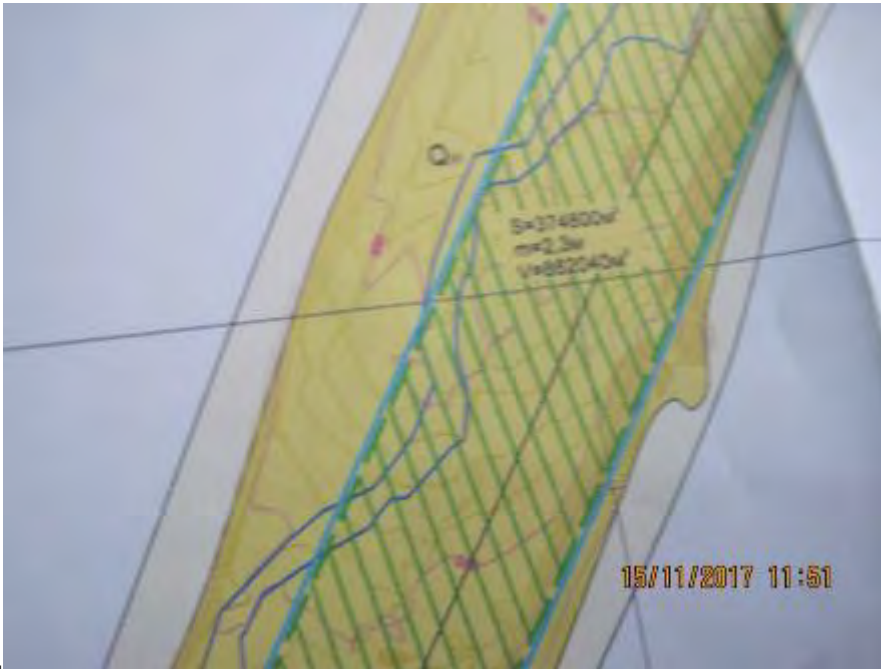
During the monitoring of the construction work, violations in the development of the Aksu 2 borrow pit were revealed, so with the allowed depth of development of 2.3 meters, the development is conducted to a depth of 4 or more meters. And the development is conducted in one small area, while the allocated and approved under the borrow pit area is very large.

At the meeting, the chief engineer of the Contractor explained this by the fact that the material necessary for the construction works on the road is at a depth of more than 2 meters and that they did not know that it is impossible to dig deeper than 2,3 m, since they planned to fill up all unused material .

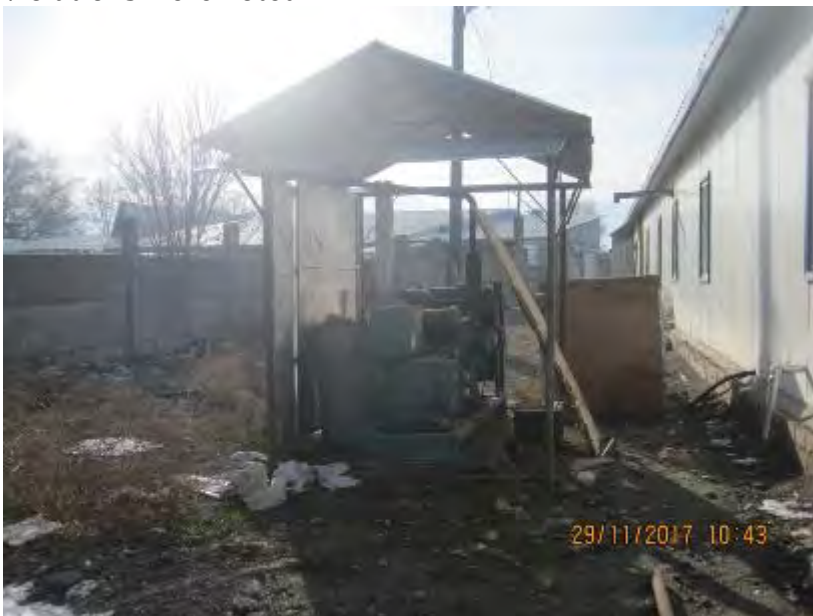
**CEMWP № 2.9.4 Contractor's construction camp. Lack of proper waste management**

On the territory of the Contractor's construction camp on the day of monitoring the following violations were noted

The generator is installed directly on the ground, without a concrete base. The area surrounding the transformer is littered.
