Project Number: 45169-001  
Loan Number: ADB Loan 3056-KGZ (SF)  
Grant Number: 0366-KGZ (SF)

Semi-annual Environmental Report  
From July 1 to December 31 2018

CAREC Corridor 3 Improvement Project (Bishkek- Osh  
Road), Phase 4

**EPTISA Servicios De Ingeniería S.L. Eptisa Muhendislik and RAM Engineering**

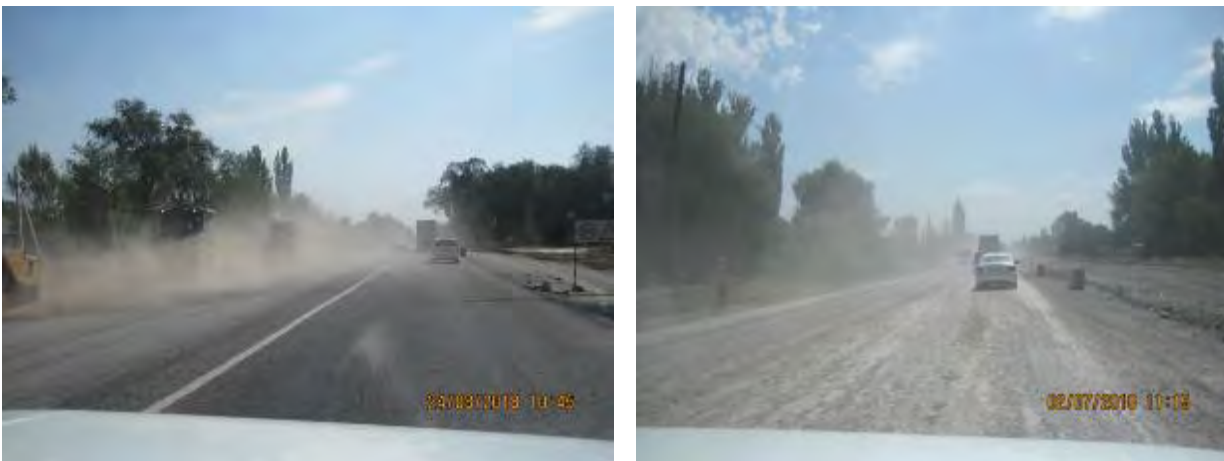
80. Dust formation has the main impact on the environment during the execution of earthworks. The increased air temperature led to increase of dust formation in the road, but despite repeated warnings given to the Contractor on the need to increase the water sprinkling, the situation did not change. In this regard, the Contractor was instructed to increase the intensity of road watering sprinkling, including shoulders, at construction sites from 6 a.m. to 20 p.m. without a break for lunch. The contractor has drawn up a schedule of water sprinkling of the road with an indication of the interval between water sprinkling 30 minutes. But the constant monitoring of compliance with the interval for water sprinkling by watering machines was not made.

Figure 30 Increased dust formation at construction sites

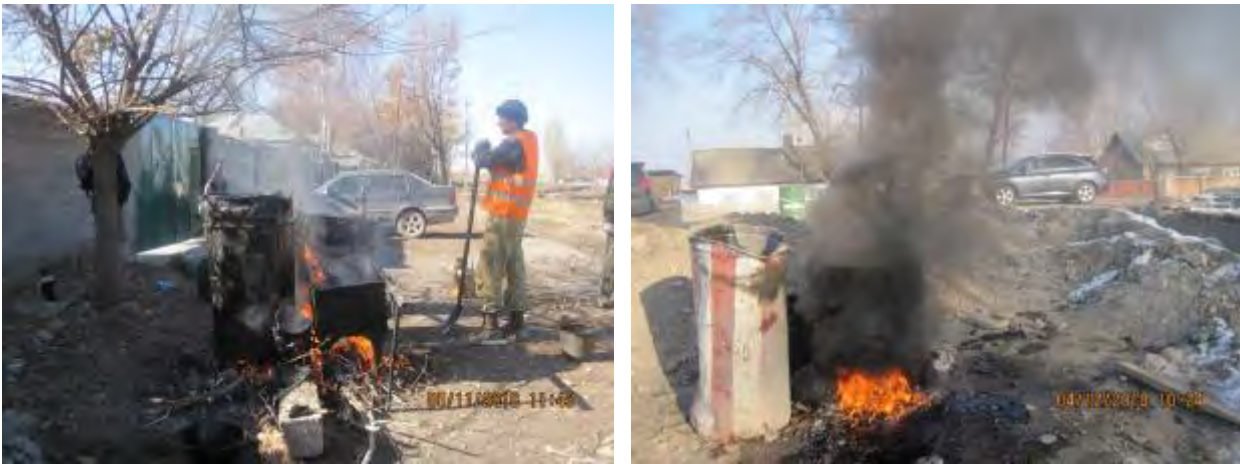
81. With decreasing air temperature and increasing precipitation, dust formation in the roads decreased, but water sprinkling was carried out before the onset of frost.
82. During the construction of culverts, the works on waterproofing with bitumen had significant impact on the environment.
83. These violations include the installation of barrels for bitumen melting directly under the trees, next to the residential houses, the melting of bitumen was carried out by burning of bitumen due to lack of firewood. The resulting black poisonous smoke spread throughout the village, causing harm to health of local community and workers. The Contractor was recommended to promptly conduct explanatory work in sites with the experts responsible for production of waterproofing works about the rules of these works.

Figure 31 Violations in the melting of the bitumen during the waterproofing of culvert pipes

- 84. After the Contractor's explanatory conversations and delivery of firewood to the construction sites, the situation has improved.
- 85. During the construction of the culverts at KM 16 of the road, slope steepness was done without taking into account the angle of gravel material's natural slope. Therefore, there is a shedding of gravel, which led to the overlapping of inlet and outlet holes of pipe and stagnation of the incoming water. It is necessary to clean up the pipe from blockages, as well as to inspect and clean all constructed culvert pipes.

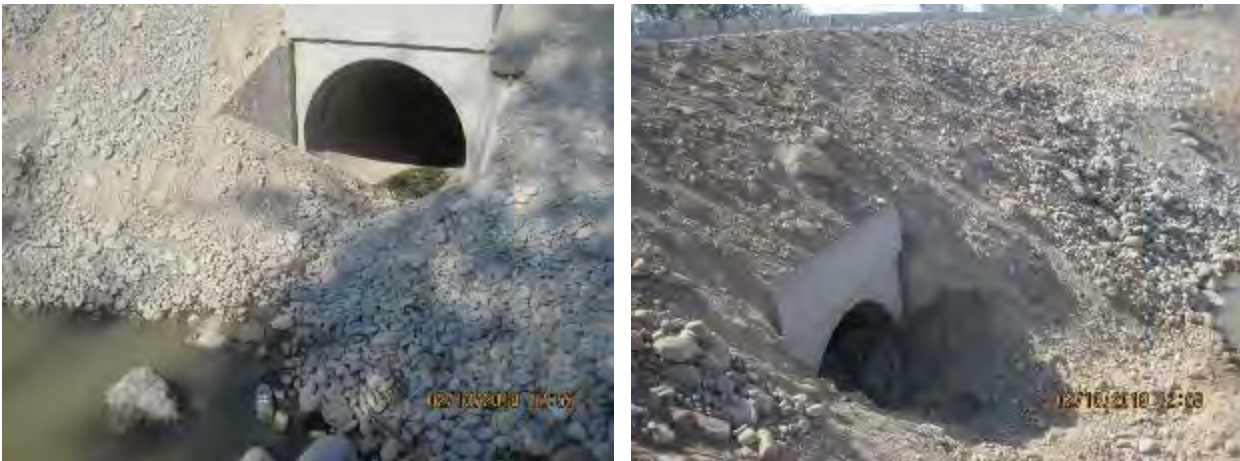
Figure 32 Overlapping of inlet and outlet holes of the pipe caused by gravel shedding

- 86. To take measures to prevent gravel shedding around the culvert pipes.

- 87. The Contractor cleaned the inlet and outlet holes of the pipe. Pipe length has been extended. An extra section has been added to the pipe. Eptisa inspectors inspected constructed pipes; when such violations were detected, clearing measures were taken.

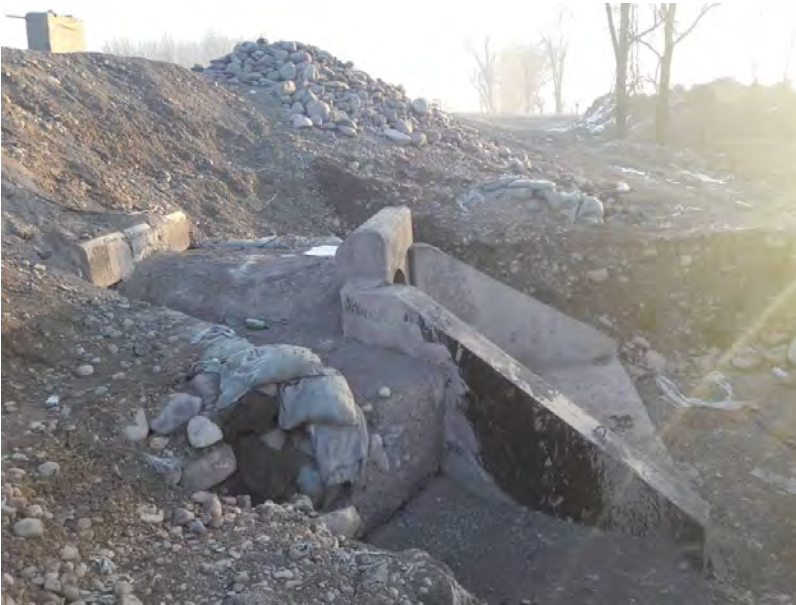
Figure 33 The pipe with an extra section

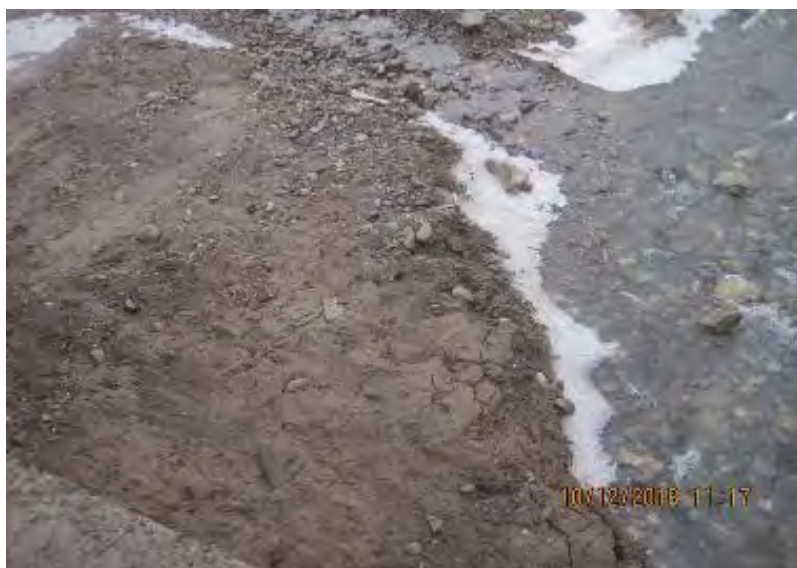
91. Currently, the river bed is blocked by an earthen dam. The water flow goes along the right bank and wash out the clay from the pit located in the riverbed with used clay, which causes river pollution. The Contractor was warned on need of urgent cleaning of the riverbed, but until now, the situation remains unchanged.

Figure 34 Residual clay at the riverbed of Ak-Suu River

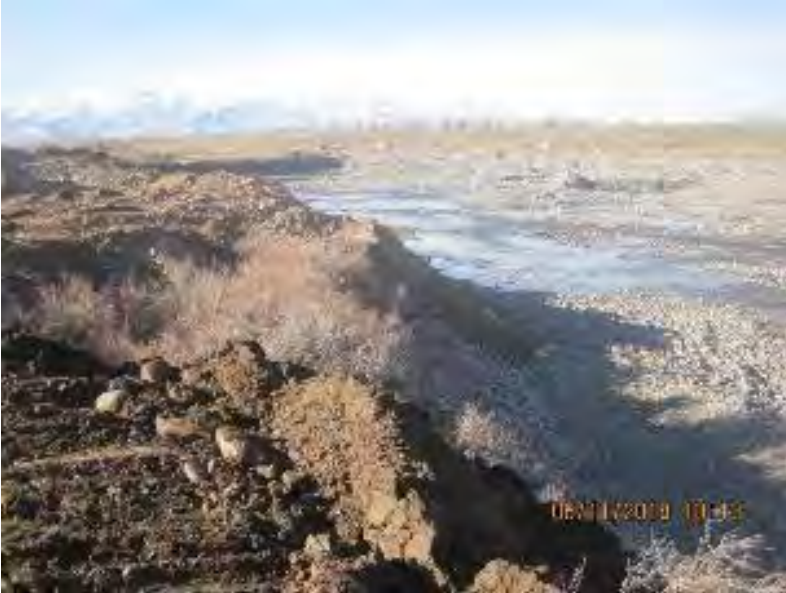
95. In November, the development of borrow-pit located at the right side of Ak-Suu River has been started. It was revealed that the top soil and unsuitable soil dumped by bulldozer into the riverbed, which is a violation of environmental legislation.
96. Another letter was sent to the Contractor on the need to remove all dumped soil from the riverbed. Later the soil was removed to the boundary of the borrow-pit. Further, the soil will be used for reclamation of the borrow-pit.

Figure 36 Top soil shifted to the riverbed side

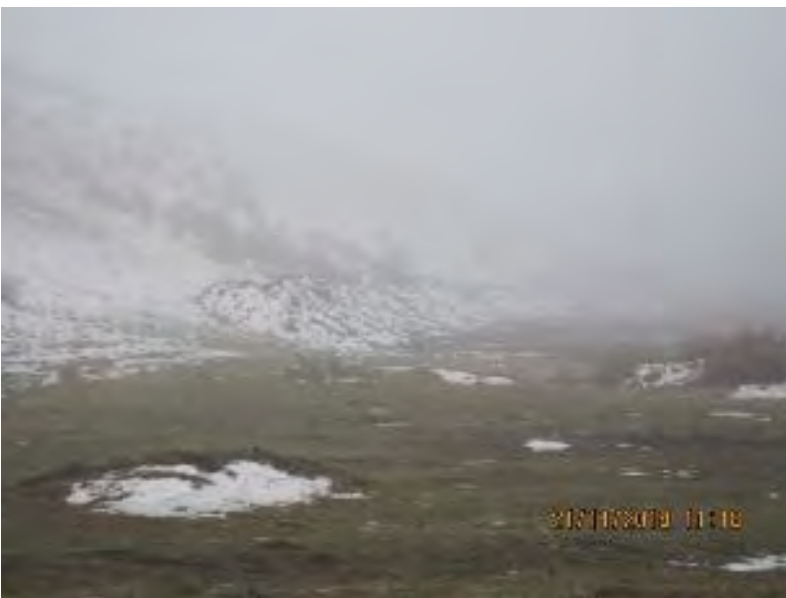
Figure 37 Top soil shifted to the boundary of the borrow-pit

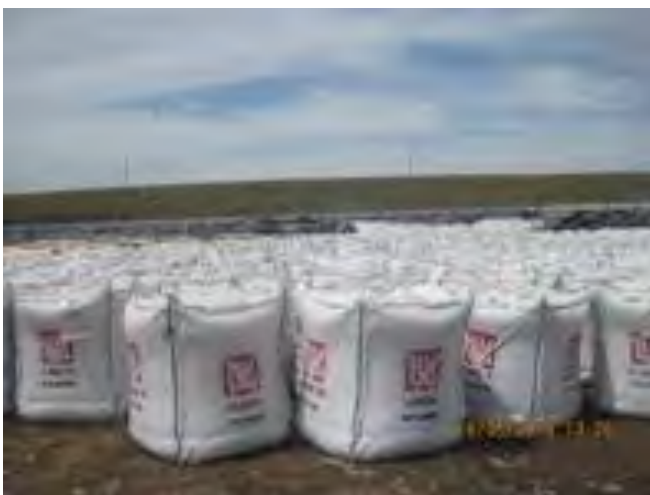
101. *Bitumen issues* – As it was already noted in the previous report, a large amount of bitumen in plastic packages was brought to the plant, which were placed directly on the soil. With increasing temperature, the leakage of bitumen in the soil has steadily increased. There was an uncontrollable situation that could be corrected only after using all the bitumen. Several letters were sent to the Contractor with recommendations to appoint a responsible officer to control the bitumen leaks and timely clean it from the soil.

Figure 41 Bitumen in plastic packages

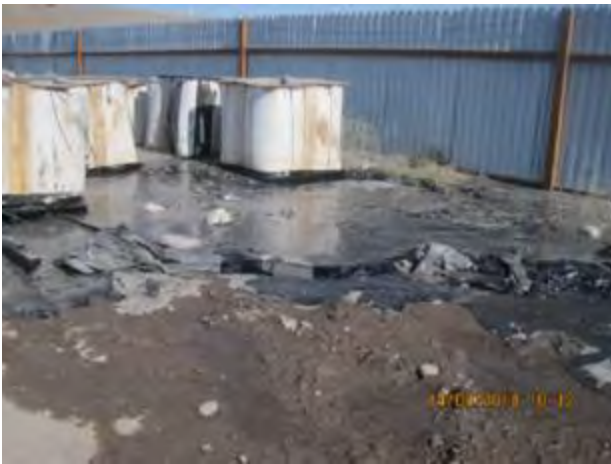
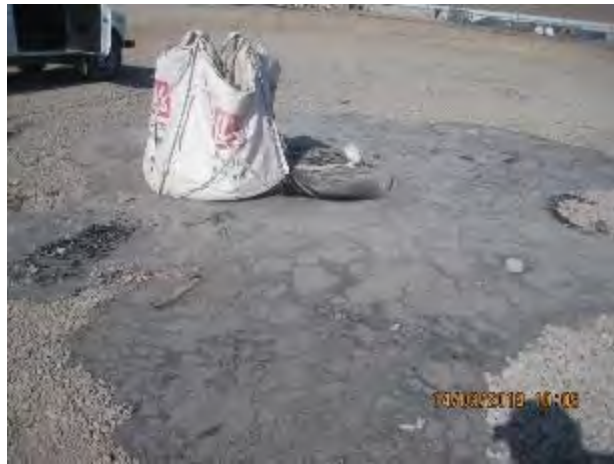
Figure 42 Leakage of bitumen to the soil

102. At the end of September all bitumen located at the asphalt plant was used up. All leakages were collected and stacked in barrels. A concrete platform for bitumen storage has been prepared. Empty barrels of bitumen are stored in the asphalt plant and are used as road barriers

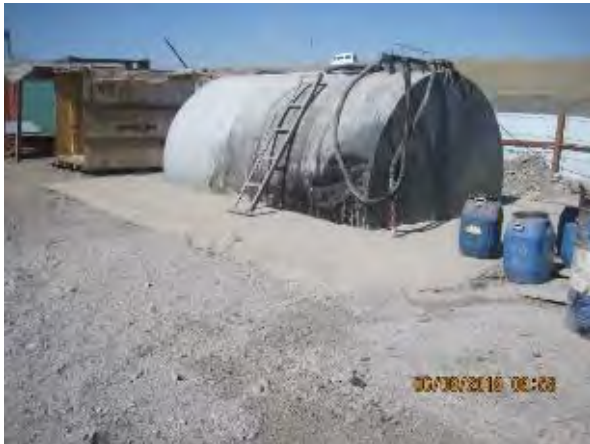
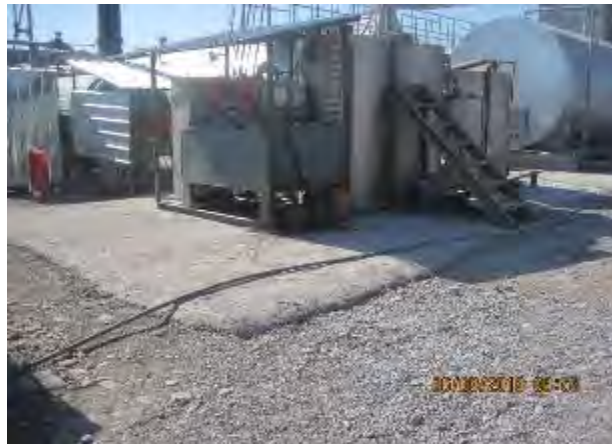
Before

104. During the operation of the plant, all soil around the tanks with chemicals must be protected from leaks and spills of hazardous materials with an impermeable protective coating.

105. The Contractor was recommended to protect the soil around the tanks with chemicals from leaks and spills of hazardous materials with an impermeable protective coating. These recommendations were considered and performed by the Contractor.

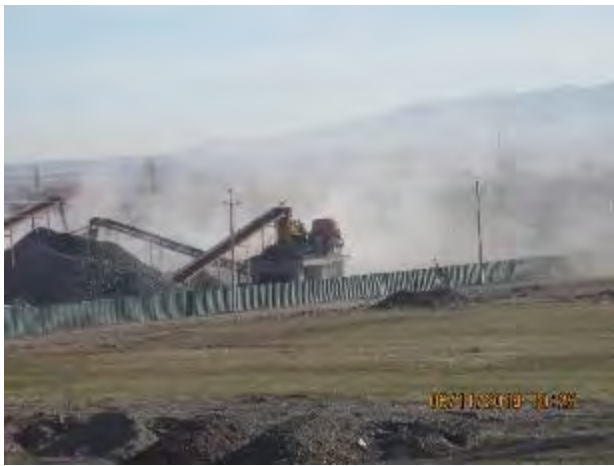
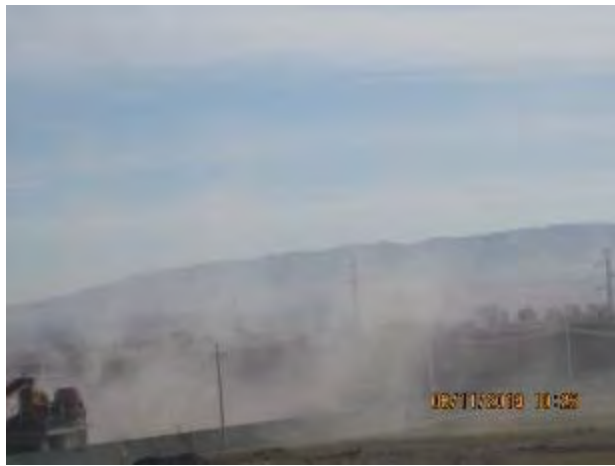
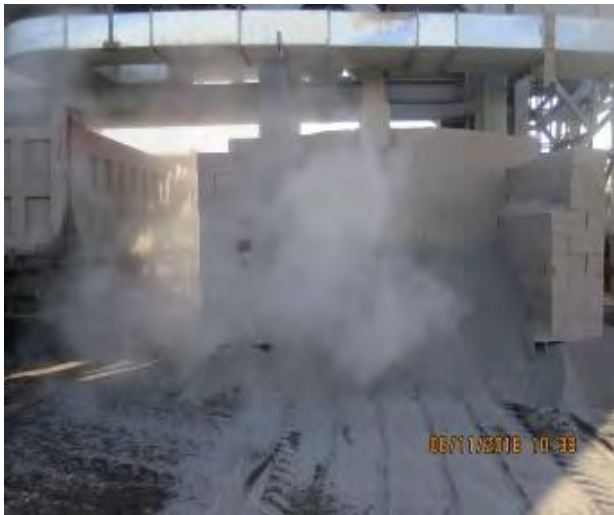
106. It has repeatedly been found that the stone-crushing plant operates without water sprinkling, polluting the plant's territory and the area adjacent to the plant, causing harm to health and the environment. Several non-compliance letters were sent to the Contractor, but the violation continued. All warnings from Eptisa were ignored. The Contractor explained the situation by breakdowns on pipelines.

107. Whereby the requirements of the general conditions of the Contract - Technical Specifications clause 1.2.10 (j) were violated: "Crushing plants should only work with dust control devices". Also abundant dust formation is noted at the asphalt plant.

Figure 46 Dust in the stone crushing plant and the asphalt plant

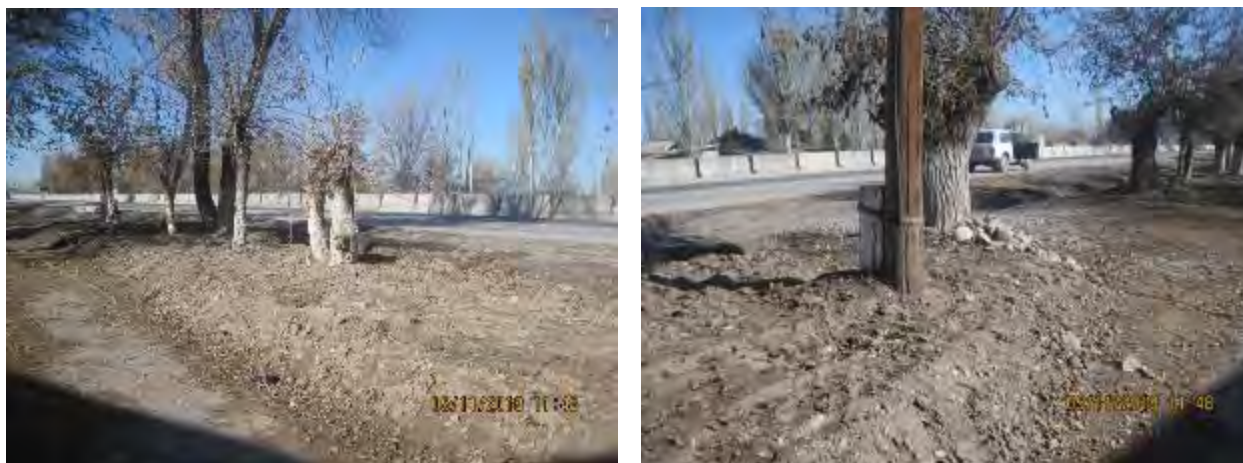
Figure 47 Stems of trees during installation of concrete culvert chutes before and after clearing of stems from the soil

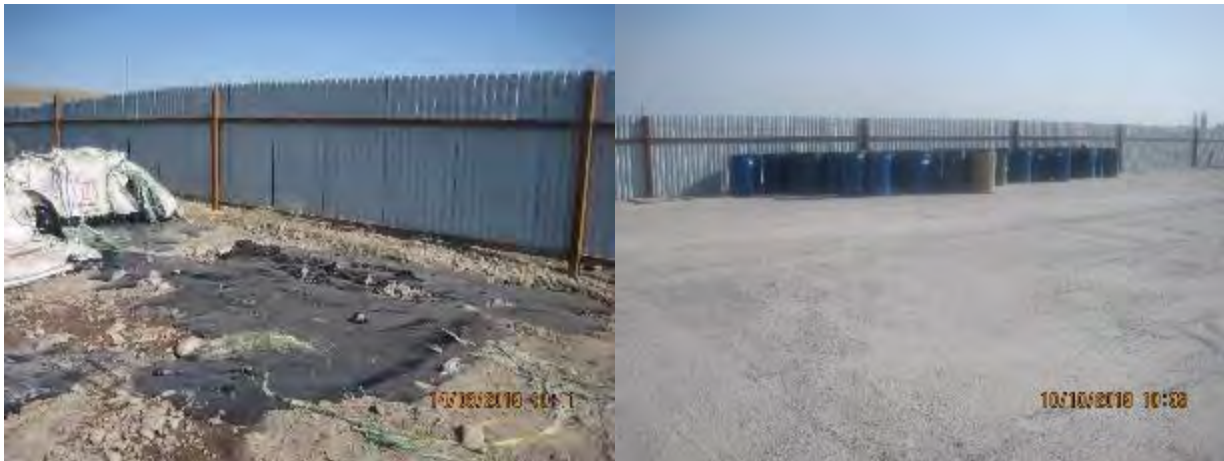
Before

112. Uncontrolled spills of bitumen to the soil became an unanticipated environmental impact during the construction works. A large amount of bitumen was delivered to the plant in plastic packaging. Packages with bitumen were placed directly in the soil without placement of waterproofing membrane. Affected by high air temperatures and mechanical damage of the packaging, bitumen spread over the territory, posing a threat of groundwater pollution. A team of workers was organized, that was engaged in the collection of bitumen from the soil. Bitumen leaks were collected from the soil and stored in barrels. After melting in a special equipment, bitumen was used for waterproofing in the construction of culverts. After using of all bitumen reserves in plastic packaging and cleaning the area from leaks, a special concreted platform was prepared for bitumen storing in the future. Currently, bitumen is delivered to the plant in metal barrels that are installed in the constructed platform. In addition, two bitumen pits are rented, from where bitumen is delivered to the plant by bitumen carriers.

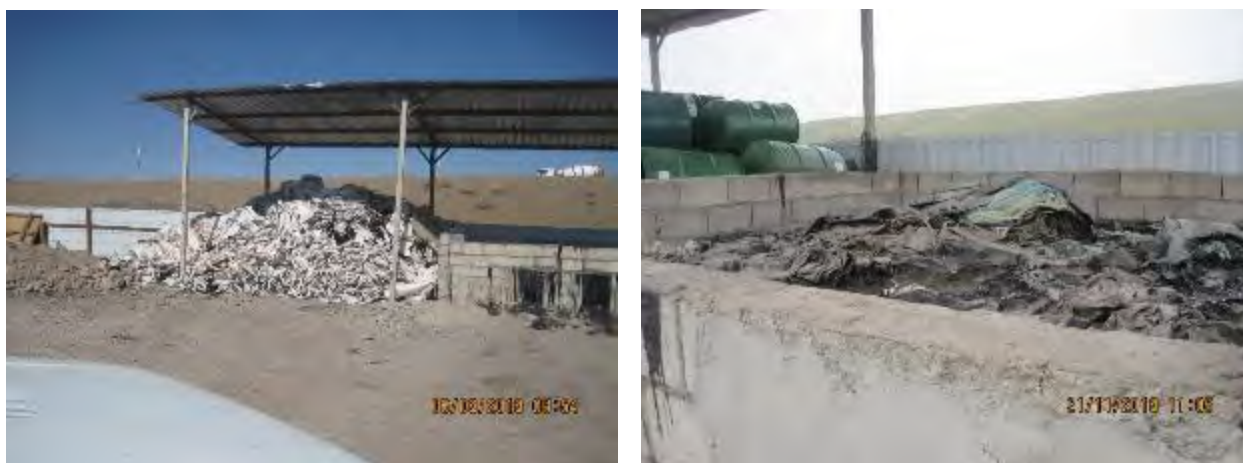
Figure 63 Waste from plastic packages of bitumen

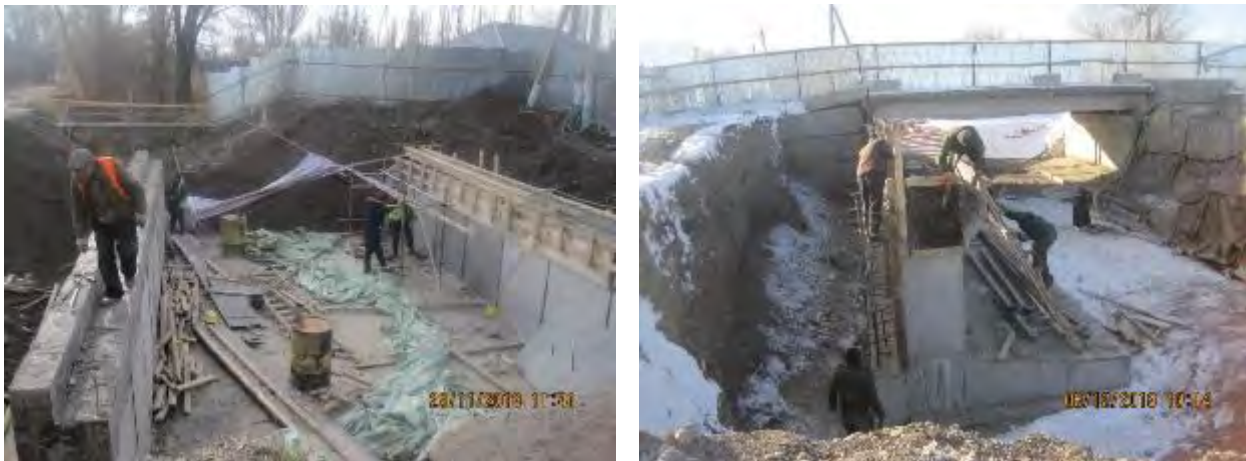
Figure 65 Carrying out of works at height without personal protective means

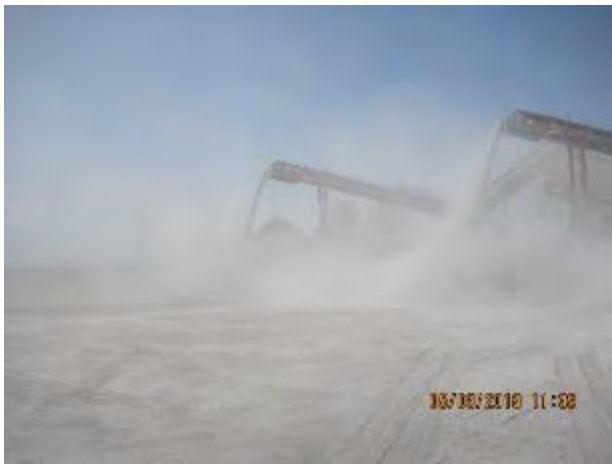
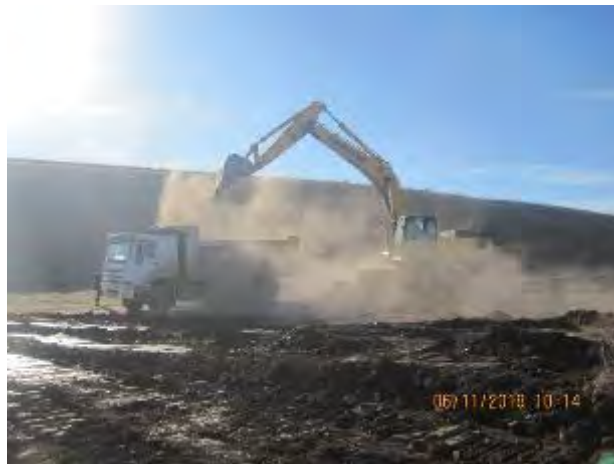
Figure 66 Operation of equipment without water sprinkling, with causing harm to the health of workers

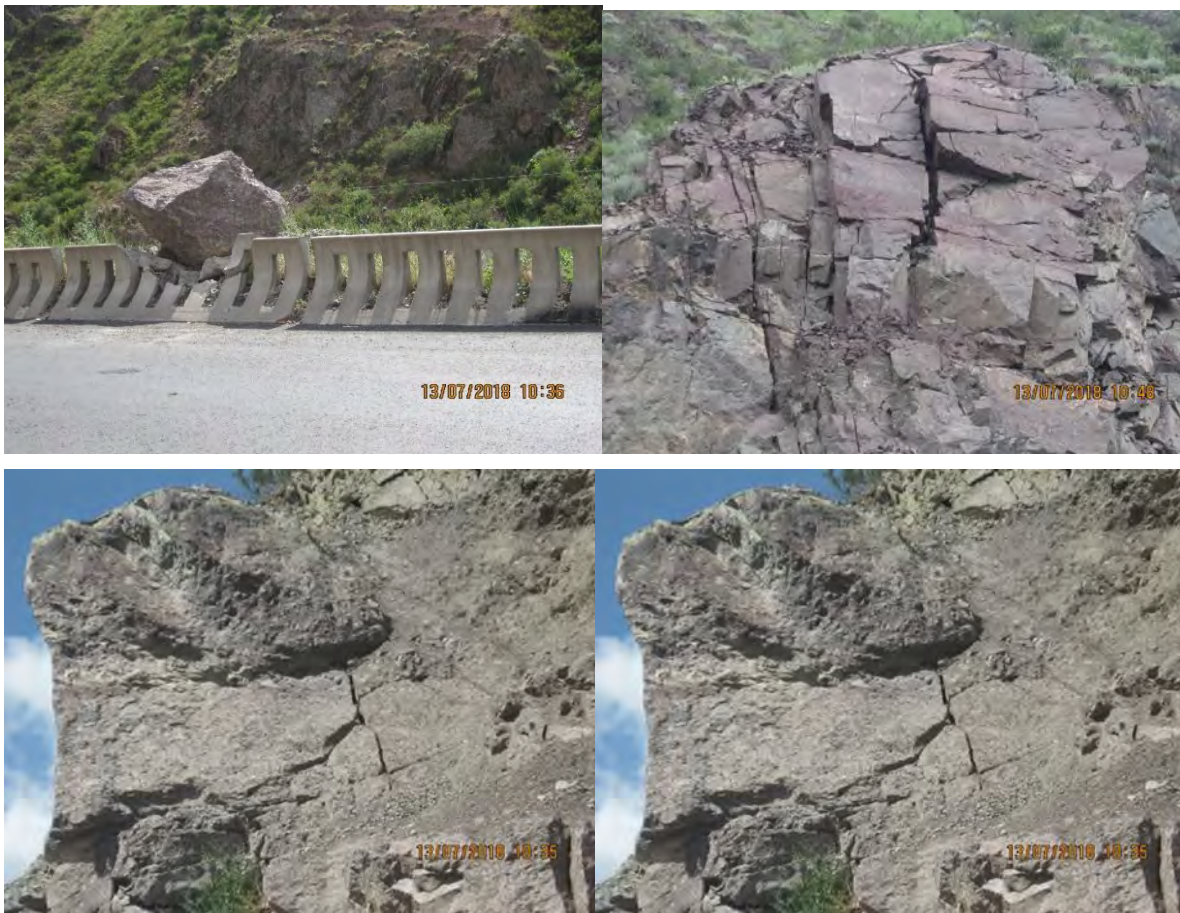
Figure 8 Danger of rockfall
