Semi-annual environmental monitoring report

January - June 2023

Central Asian Regional Economic Cooperation Corridor 3 Improvement Project (Bishkek-Osh Road), Phase 4, Bishkek-Kara-Balta section (km 8.5 - km 61).

Prepared by: Joint Venture Temelsu International Engineering Services Inc., E. Gen Consultants Ltd., and Desh Upodesh Ltd. in association with Kyrgyz TREC International, Ltd. for the Ministry of Transport and Communications of the Kyrgyz Republic and the Asian Development Bank.

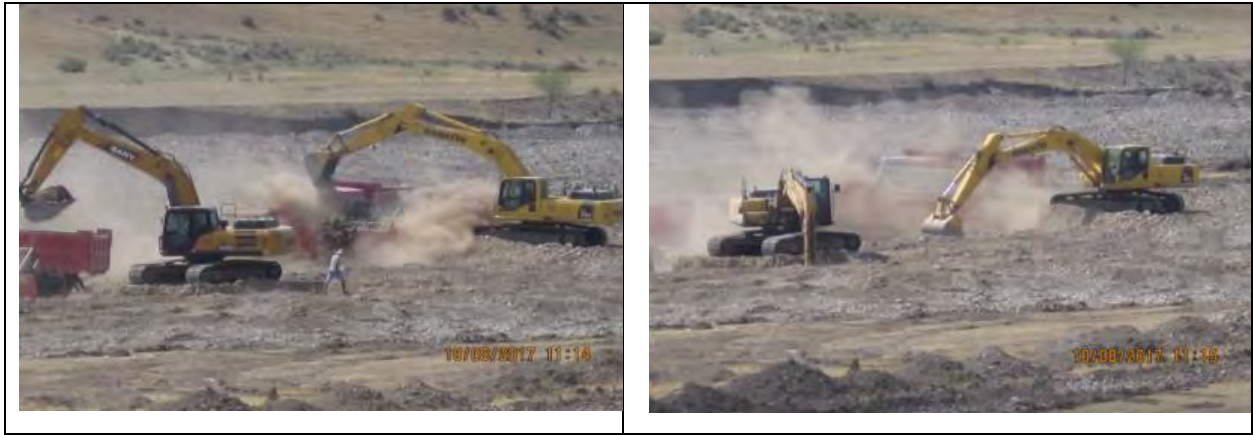
57. At the beginning of borrow pit development, dusting was observed both on the territory of the borrow pit area and on the road leading to the it. After written warnings, the Contractor allocated 2 watering machines for regular water sprinkling at the borrow pit area, and on the road leading to it. In the reporting period, dusting was not observed during work at the borrow pit.

Figure 19 Dusting during work at the Aksuu 2 borrow pit. In the foreground, the removed soil layer.

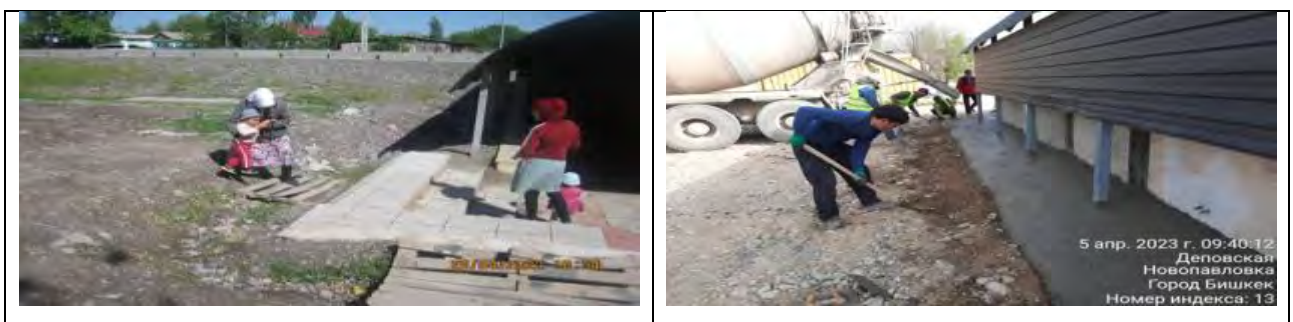
134. During the reporting period, completion works were carried out on the underpasses. Walls and steps were covered with finishing tiles. Ceilings were built up, walls were finished, and a concrete pavement perimeter was constructed. The area around the underpass near the school in the village of Novonikolaevka (km 59+640) was in an unsatisfactory condition. It was difficult for schoolchildren to go down to this underpass, especially in icy conditions, which could cause falls and injuries. A letter was sent to the contractor to eliminate these violations.

Figure 41 Violations near the underpass opposite the school in the village of Novonikolaevka

135. The violations were eliminated. A reinforced concrete pavement perimeter was constructed around the crossing, and the roof of the ceiling was built up. Metal gratings were installed on the road near the crossing.

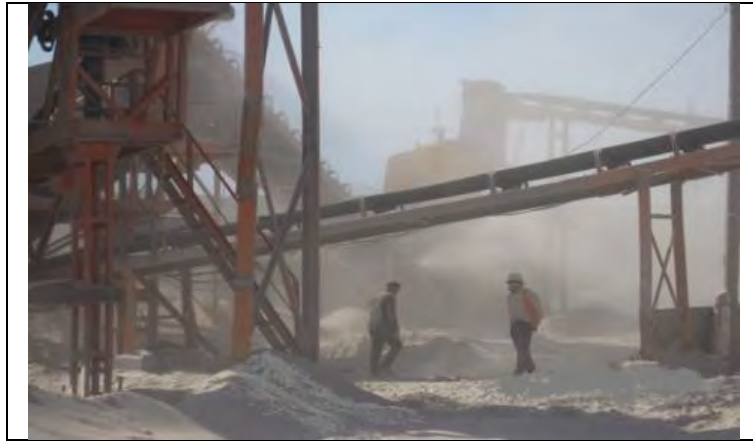
150. Water supply has been restored. But this problem recurred periodically throughout the entire construction period.

Figure 45 Stone crushing plant without water sprinkling

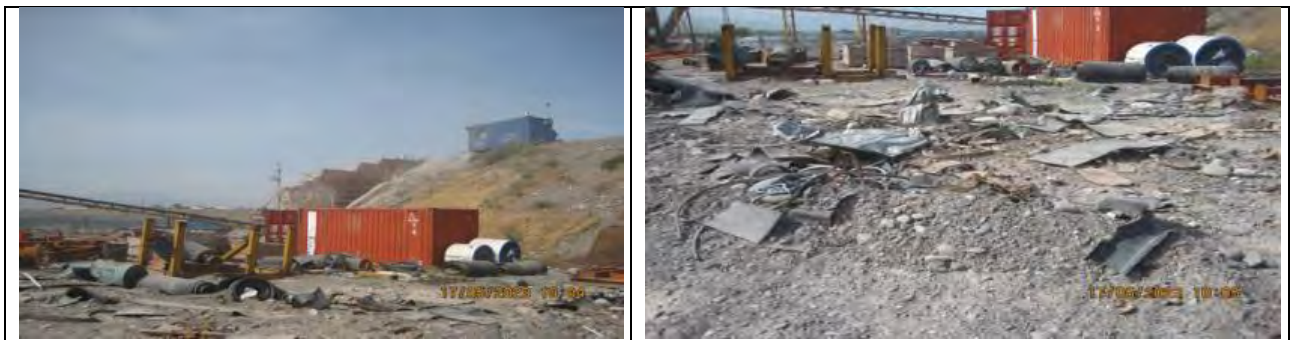
151. It was also found that a large amount of waste accumulated on the territory of the stone crushing plant.

Figure 46 Large amount of waste in the territory of the stone crushing plant

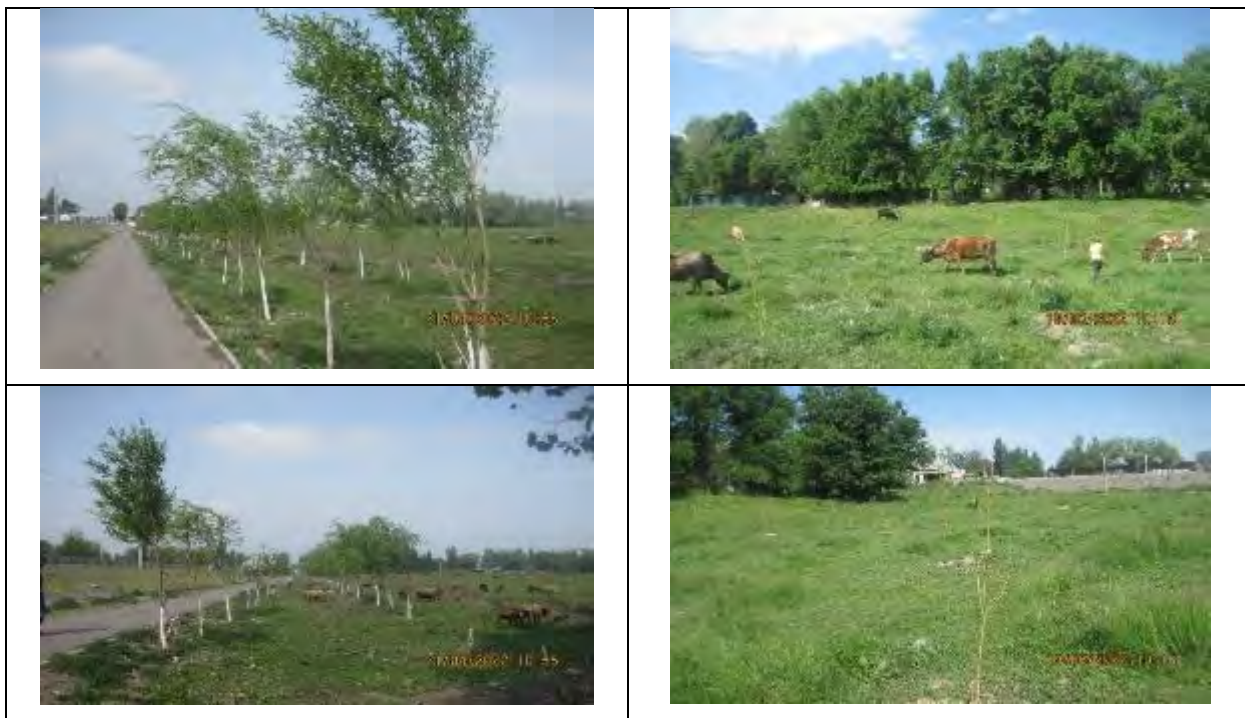
179. During the period of high temperatures in 2022, for unknown reasons, the Contractor did not water the seedlings for a long time despite repeated verbal and written warnings. As a result, there are dead seedlings.

Figure 57 Livestock grazing on the plots of planted seedlings in the villages of Poltavka and Petrovka

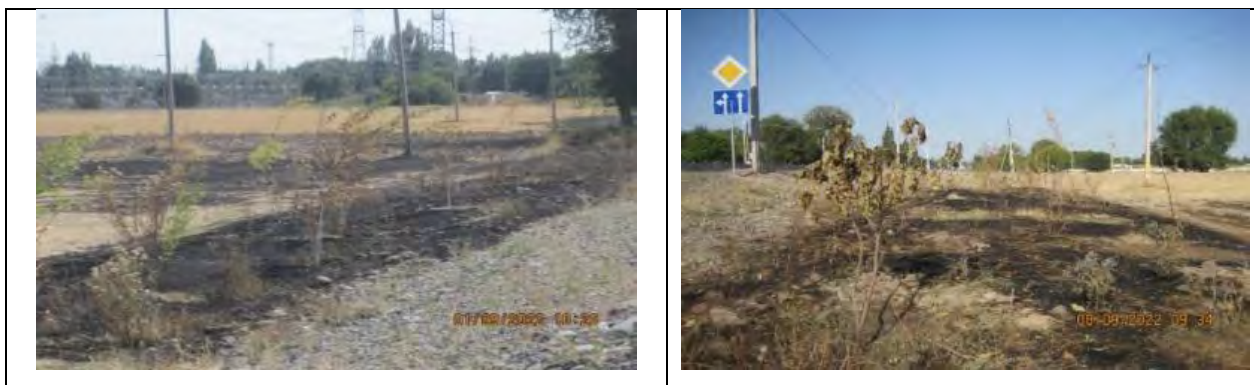
180. When burning dead wood in the villages of Poltavka and Voенно-Antonovka, the fire spread to seedlings. More than 195 seedlings died.

Figure 58 Burnt seedlings in the village of Poltavka

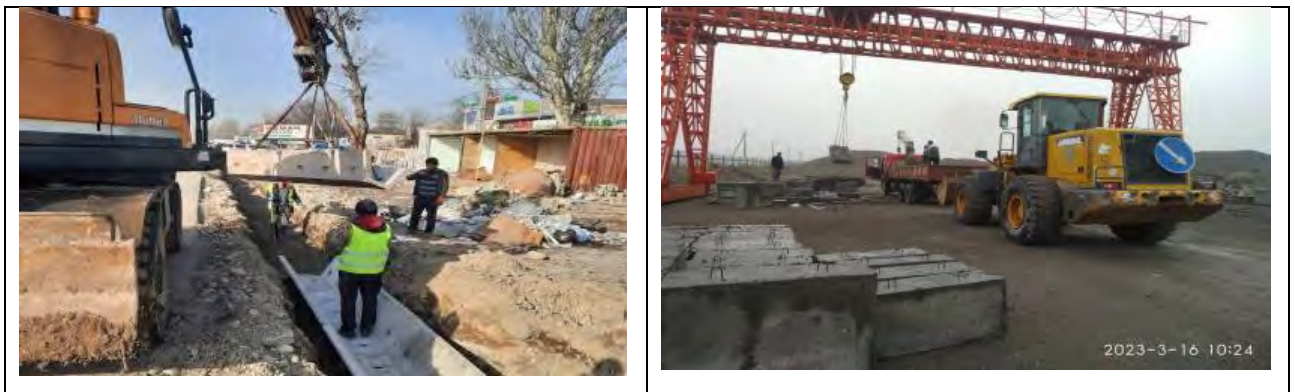
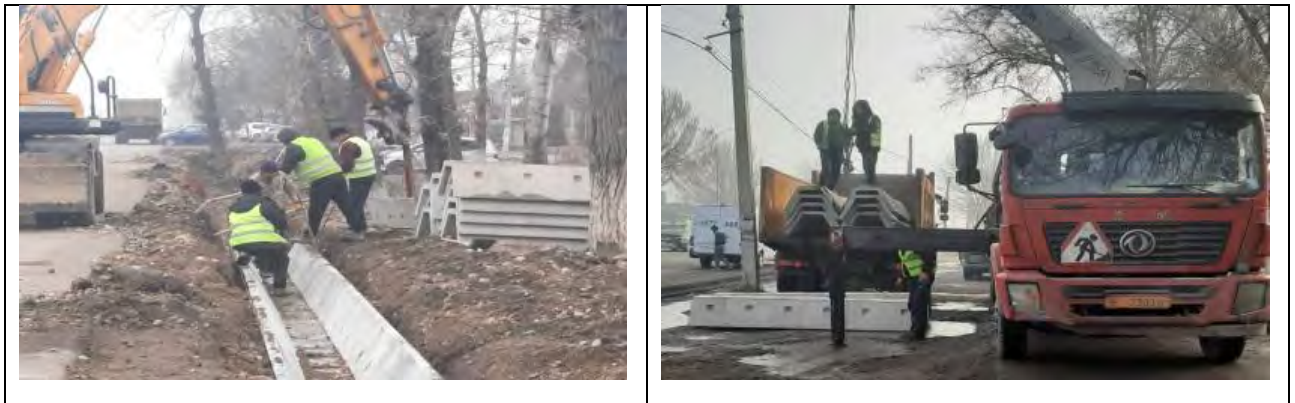
248. But, despite the regular training of workers, the construction supervision consultant noted non-compliance with safety precautions, especially during work at height and installation of drainage ditches. Also, there were noted non-compliances when moving load by crane. The workers were in the crane operation area without personal protective means. Cases of non-compliance with safety precautions were noted both at the site for the manufacture of reinforced concrete structures and during installation of ditches. Verbal and written warnings were repeatedly given to the Contractor, but violations continue.

Figure 67 Failure to comply with safety precautions when moving load with a crane

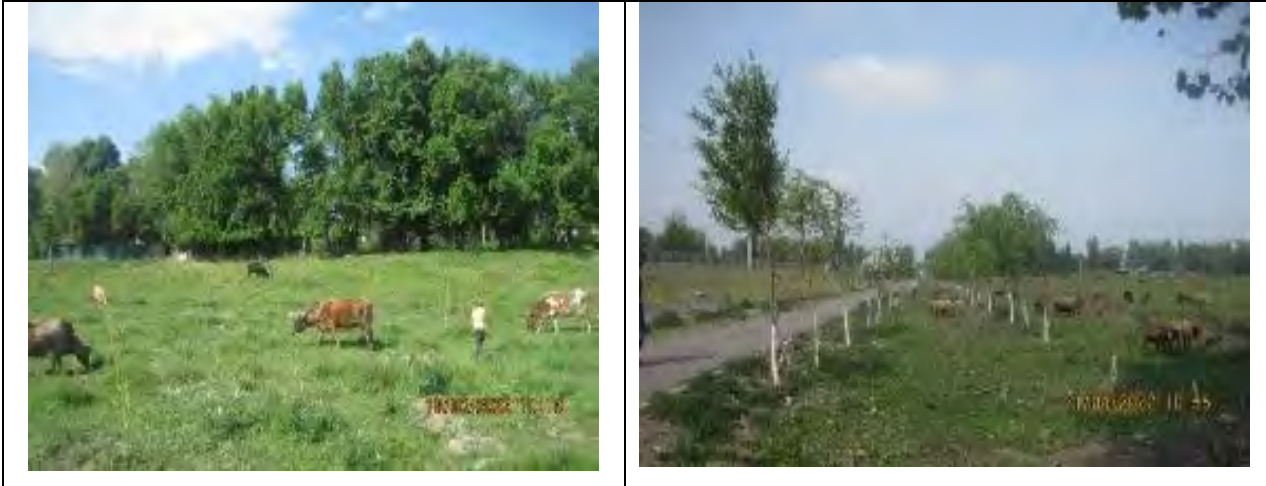
63. When monitoring the survival rate of seedlings in the village of Poltavka, it was found that the seedlings are in critical condition. A large number of cows, goats and sheep are grazed in the places where seedlings are planted. As a result, young shoots on seedlings were eaten by animals. A large number of seedlings were broken by children. According to representatives of the local authorities, despite holding constant explanatory conversations with the population, grazing continues.

Figure 10 Livestock grazing on the plots of planted seedlings in the villages of Poltavka and Petrovka

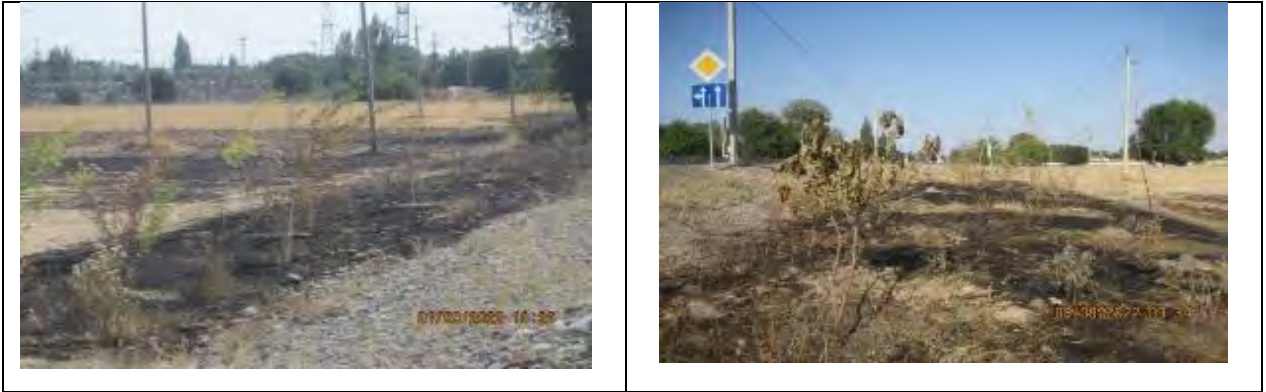
64. When burning dead wood in the fields of Poltavka village, the fire spread to seedlings. 45 seedlings died. In the Voyenno-Antonovka village 150 seedlings burned.

Figure 11 Burnt seedlings in the Poltavka village

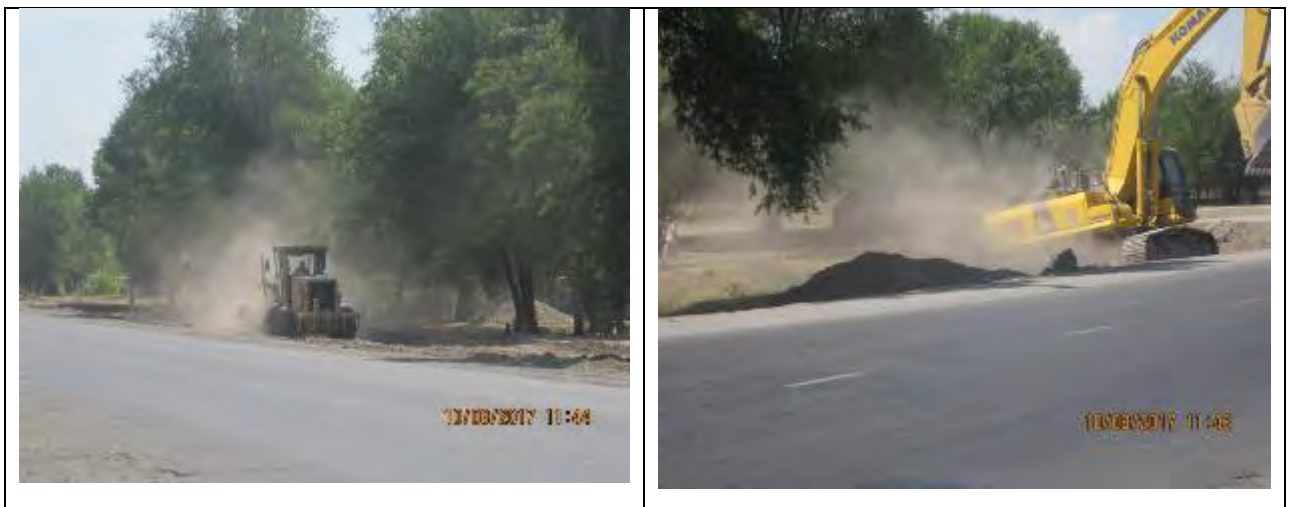
Figure 12 Dusting observed during the removal of topsoil

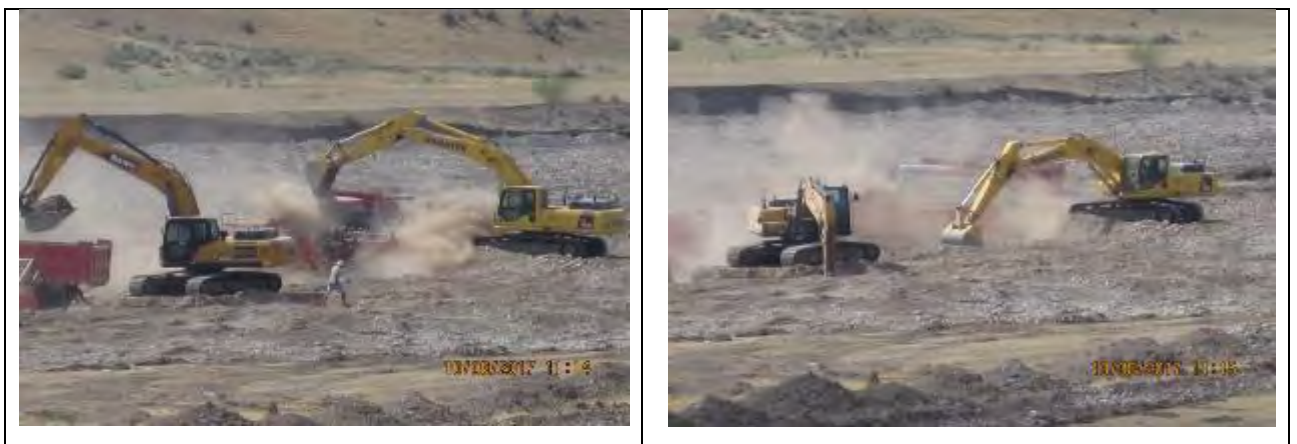
87. At the beginning of the borrow pit development, dusting was observed both on the territory of the production site and on the road leading to the borrow pit. After written warnings, the Contractor allocated 2 watering machines for permanent water sprinkling on the territory of the borrow pit, and on the road leading to it. Dust during the performance of works has become minimal.

Figure 17 Dusting during work at the Ak-Suu 2 borrow pit. In the foreground, the removed soil layer

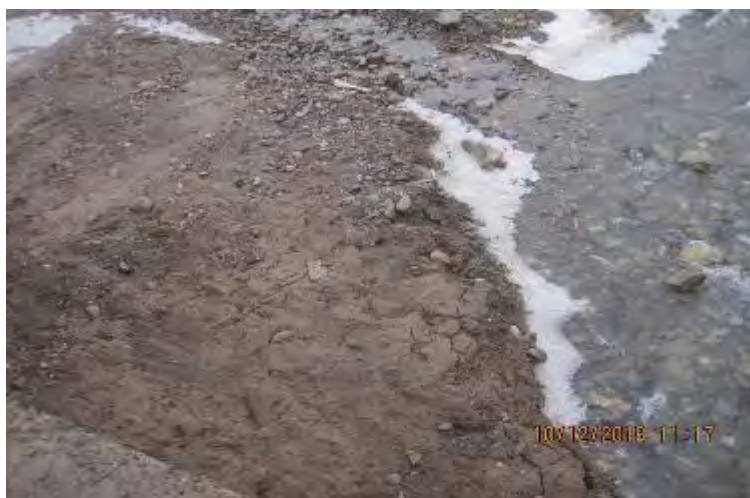
Figure 43 Residue of clay in the Ak-Suu riverbed

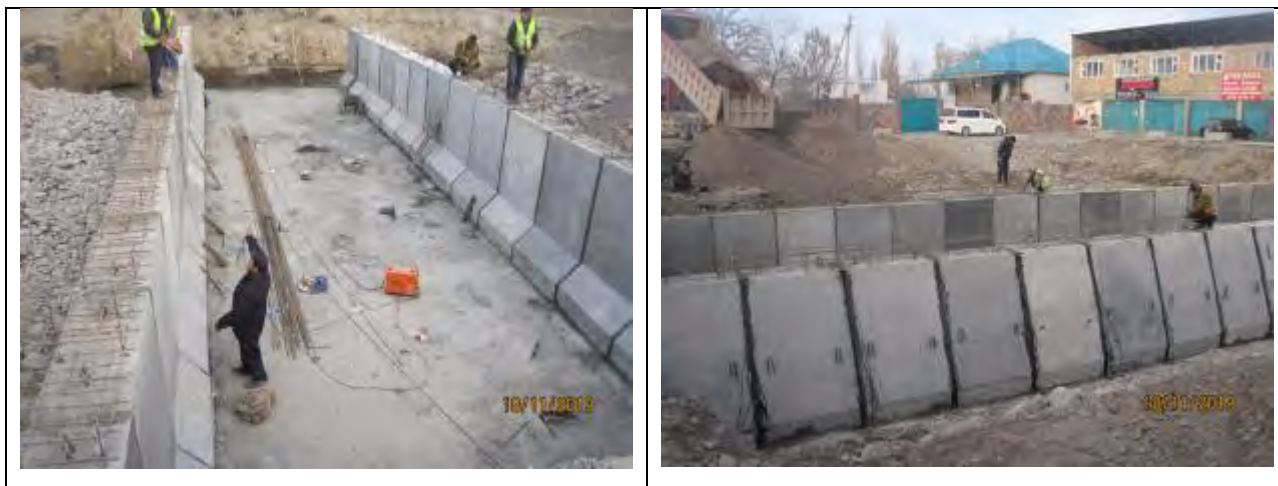
Figure 45 Safety violations during the construction of the bridge on the Jantai Canal

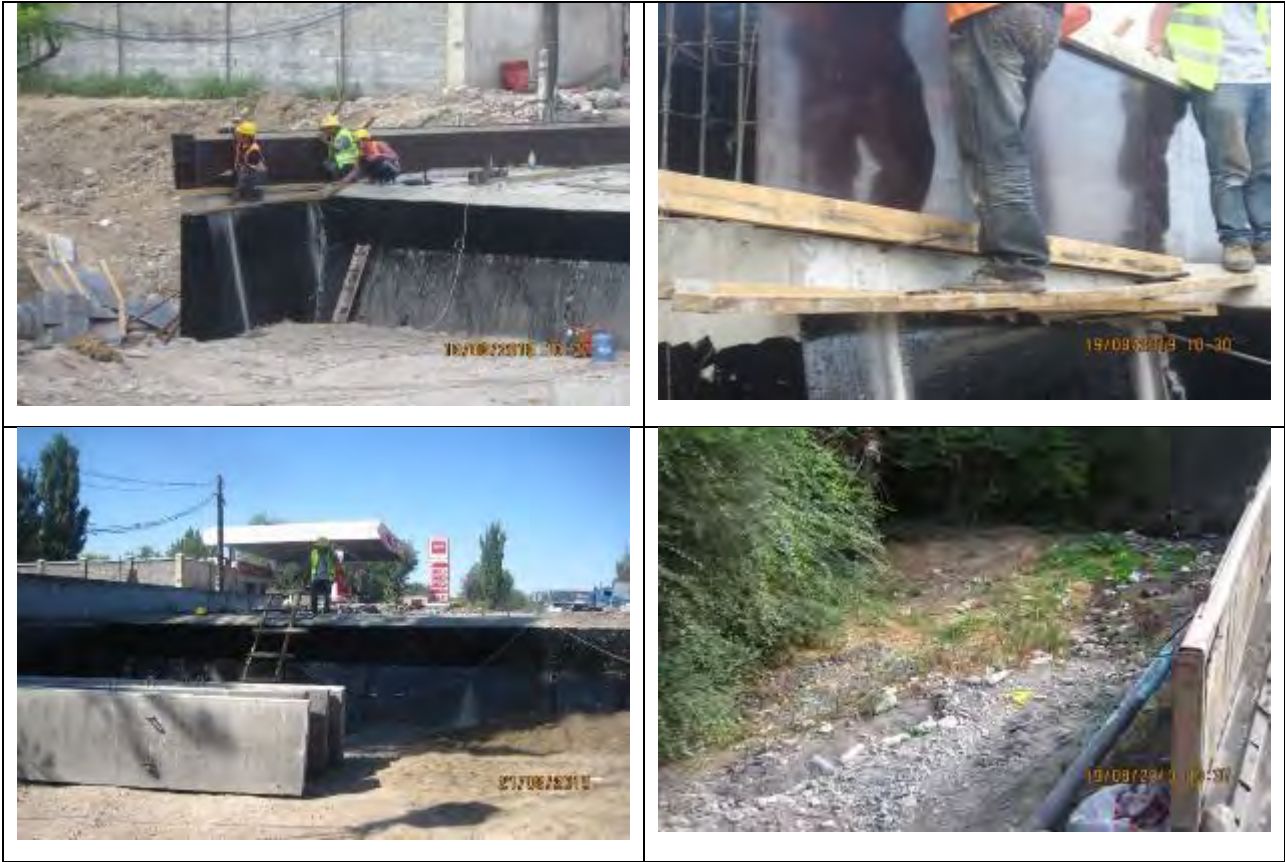
Figure 47 Safety violations during the construction of bridge on the Krepostnoy Canal

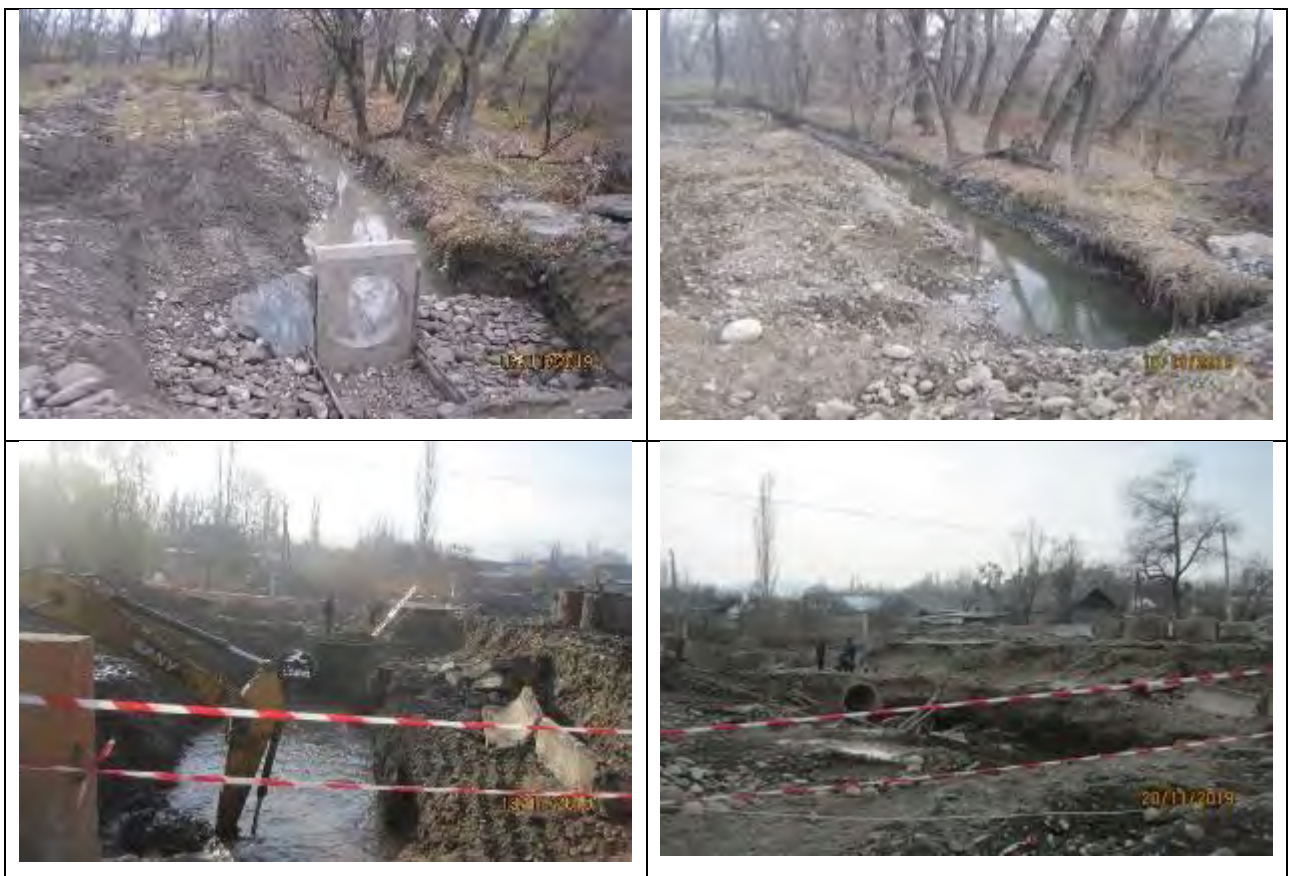
Figure 52 Wedging out of groundwater during the construction of culvert pipes

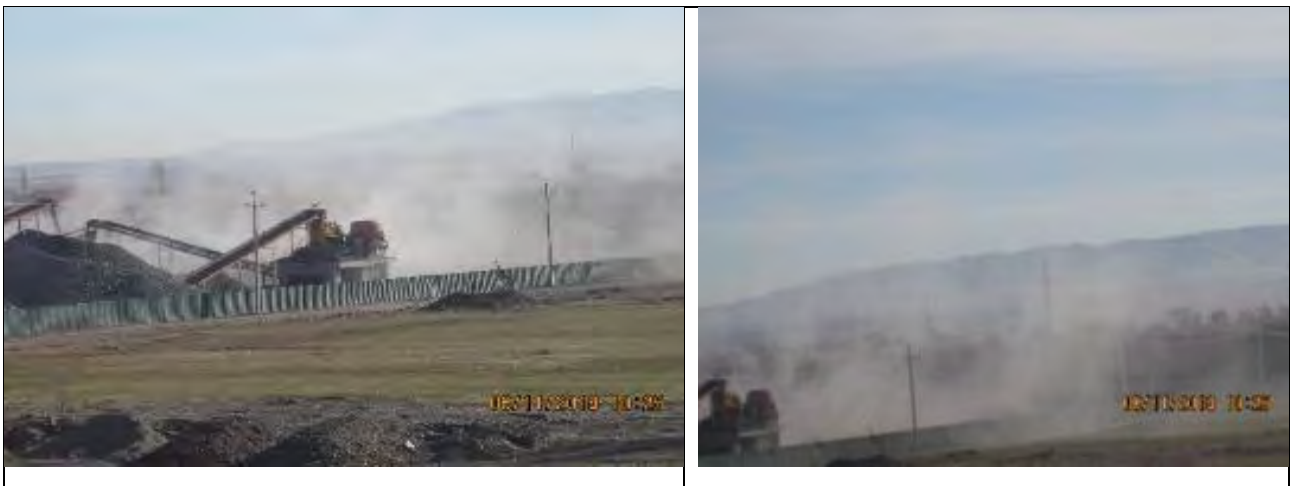
Figure 65 Dust in stone crushing plant

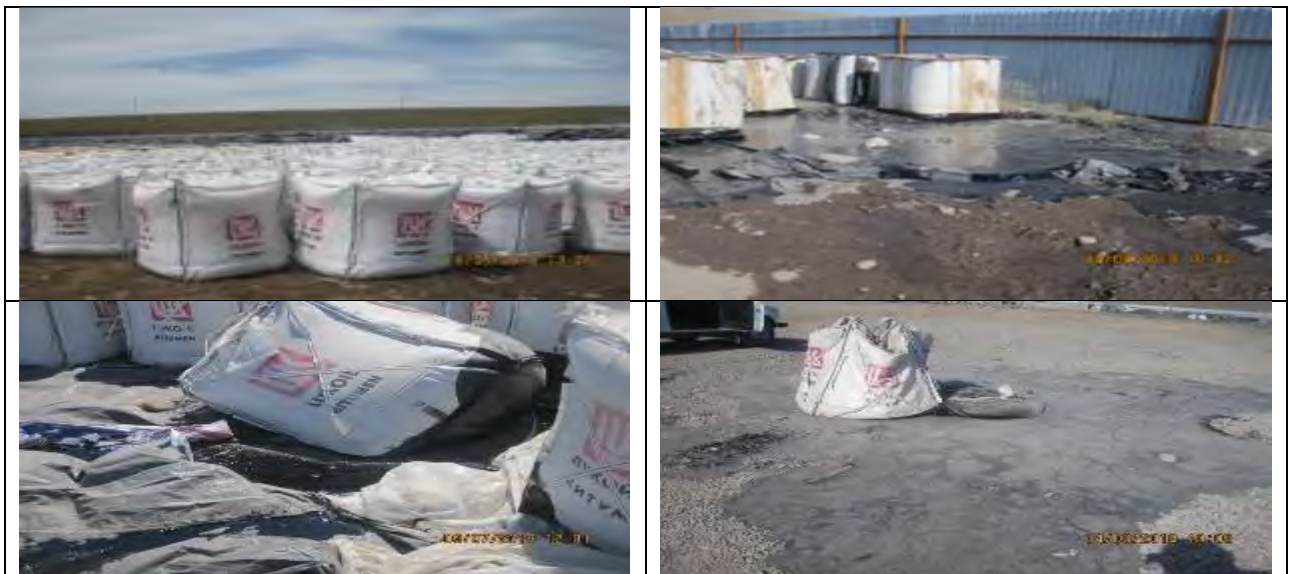
Figure 69 Bitumen in plastic packages. Bitumen leaks to the ground
