Semi-annual environmental monitoring report

July - December 2023

Central Asian Regional Economic Cooperation Corridor 3 Improvement Project (Bishkek-Osh Road), Phase 4, Bishkek-Kara-Balta section (km 8.5 - km 61).

Prepared by: Joint Venture Temelsu International Engineering Services Inc., E. Gen Consultants Ltd., and Desh Upodesh Ltd. in association with Kyrgyz TREC International, Ltd. for the Ministry of Transport and Communications of the Kyrgyz Republic and the Asian Development Bank.

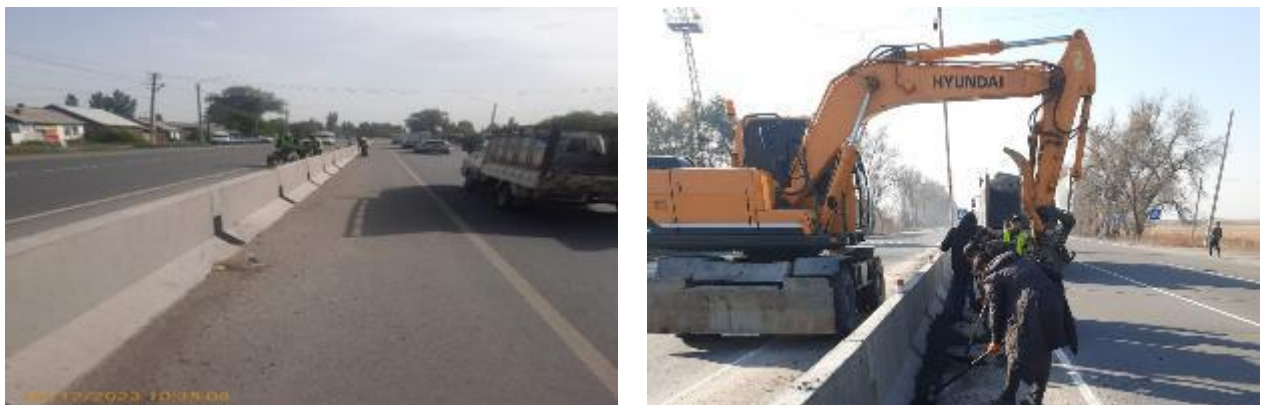
Figure 29 Cleaning and removal soil waste near parapets

99. During the monitoring in July, it was found that on the road shoulders, where work was carried out on strengthening the parapets, there were not removed soil waste which was stored in small

piles. The contractor was warned with an indication of timing to fix this violation. In due time, soil waste was collected on the shoulders and removed. Further, the soil accumulated near the parapets was cleaned and removed in a timely manner.

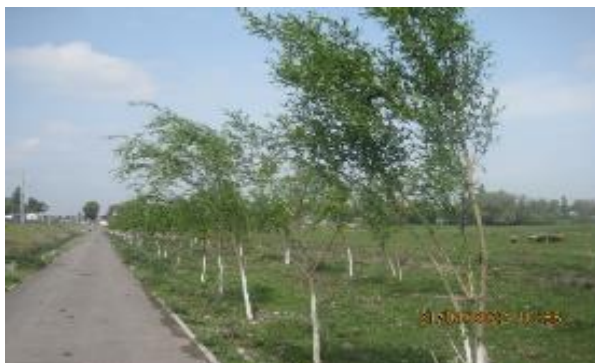
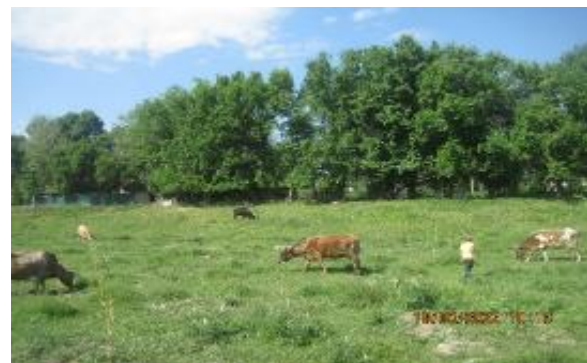
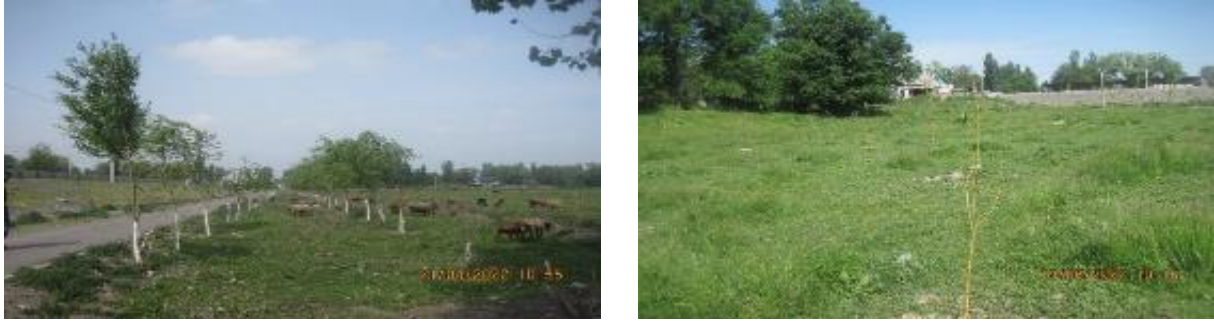
131. When monitoring the survival rate of seedlings in the village of Poltavka, it was found that the seedlings are in critical condition. A large number of cows, goats and sheep are grazed in the places where seedlings are planted. As a result, young shoots on seedlings are eaten by animals. A large number of seedlings are broken by children. According to representatives of the local aiyl okmotu, despite holding constant explanatory conversations with the population, grazing continues.

132. During the period of high temperatures in 2022 - 2023, for unknown reasons, the Contractor did not water the seedlings for a long time despite repeated verbal and written warnings. As a result, there are dead seedlings.

Figure 43 Livestock grazing on the plots of planted seedlings in the villages of Poltavka and Petrovka

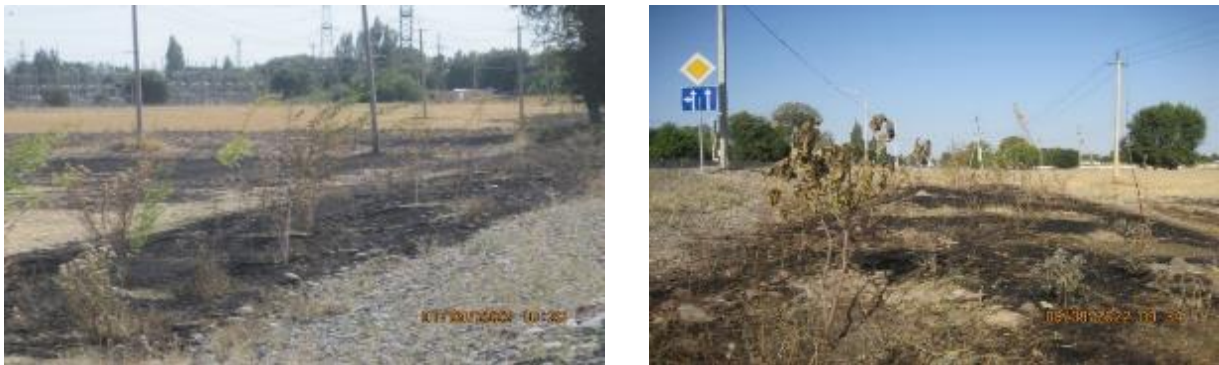
133. When burning dead wood in the villages of Poltavka and Voенno-Antonovka, the fire spread to seedlings. More than 195 seedlings died.

Figure 44 Burnt seedlings in the village of Poltavka

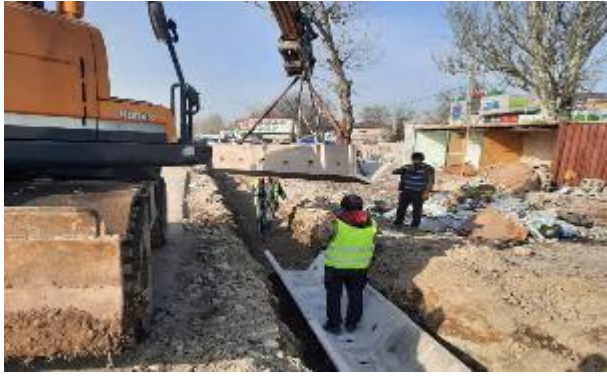
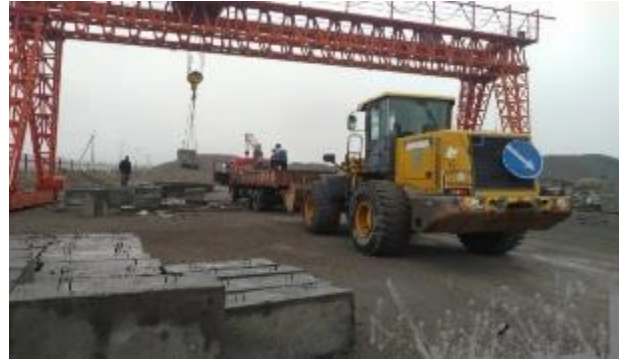
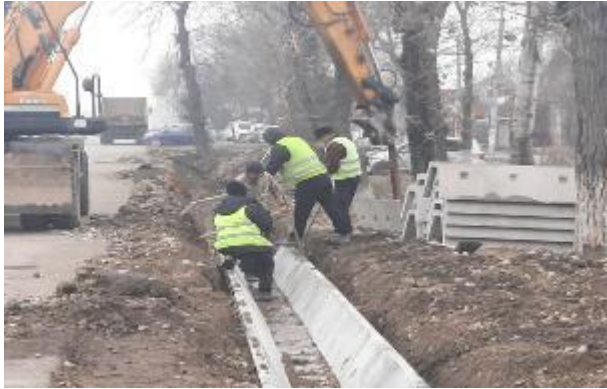
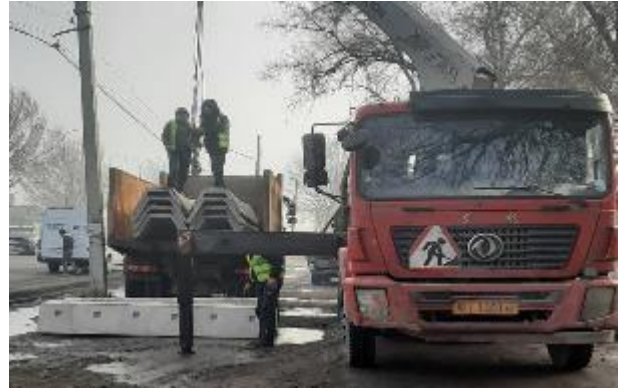
187. But, despite the regular training of workers, the construction supervision consultant noted non-compliance with safety precautions, especially during work at height and installation of drainage ditches. Also, there were noted non-compliances when moving load by crane. The workers were in the crane operation area without personal protective means. Cases of non-compliance with safety precautions were noted both at the site for the manufacture of reinforced concrete structures and during installation of ditches. Verbal and written warnings were repeatedly given to the Contractor. Despite repeated verbal and written warnings to the Contractor, violations recurred.

Figure 51 Failure to comply with safety precautions when moving load with a crane

188. The contractor was recommended to regularly check the workers knowledge of the requirements of occupational safety and health and, if necessary, to conduct repeat training on OHS.

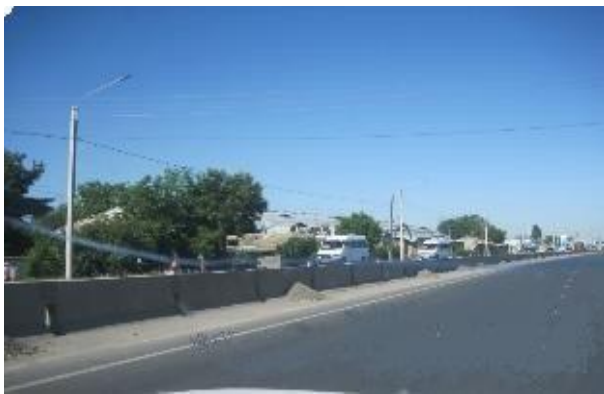
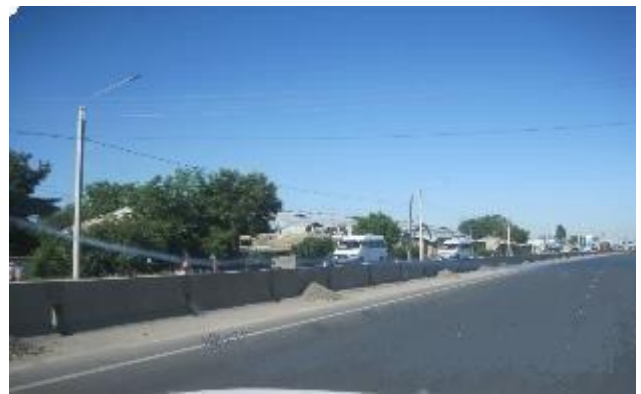
96. During the monitoring, it was found that on the road shoulders, near parapets, a soil waste is accumulated. The contractor was warned about the timely removal of waste. Further, the soil waste was collected from the shoulders in a timely manner and taken out.

Figure 30 Cleaning of parapets from soil waste and removal of waste from the road

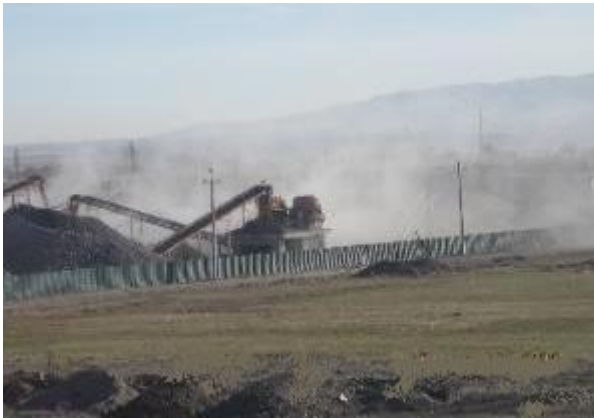
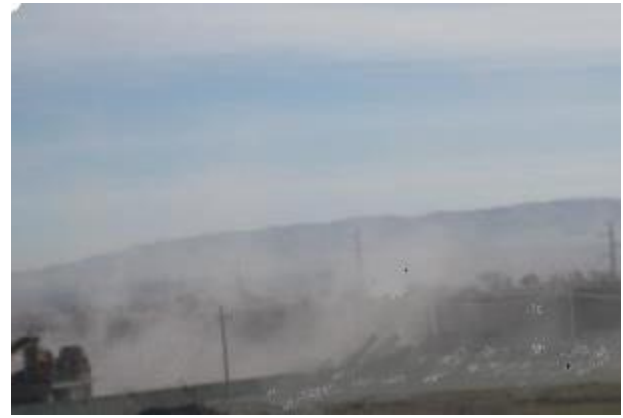
116. *Problems with the stone crusher.* It has been repeatedly found that the stone crushing plant operates without water sprinkling, thus polluting the territory of the plant and the territory adjacent to the plant, causing harm to health and the environment. Several letters of non-compliance were sent to the contractor, but the violation continued. The contractor explained the current situation by breakdowns in pipelines.

Figure 41 Dust in stone crushing plant and the surrounding area

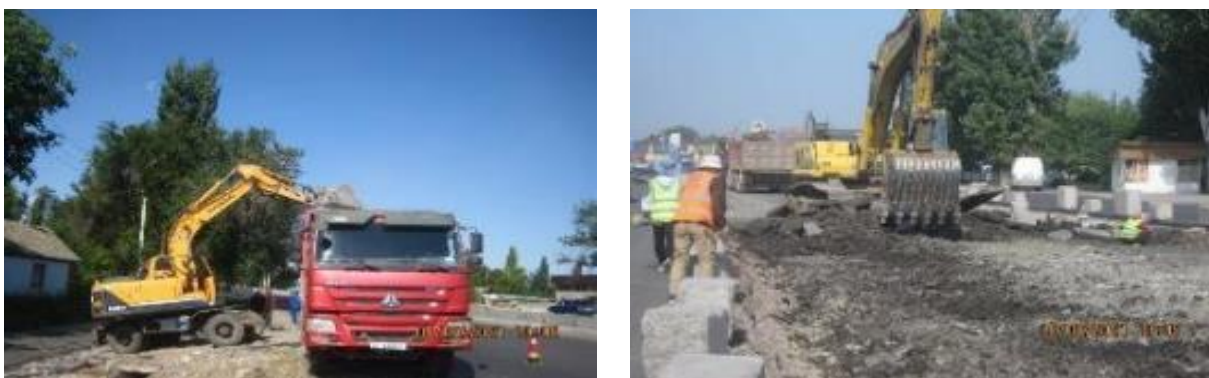
142. In the process of excavating the old asphalt concrete pavement, the problem of crushing the old asphalt to a size of 20x20 remained unresolved. Given that the villages do not have equipment for leveling large pieces of old asphalt, the problem arose to take out uncrushed old asphalt for backfilling rural streets proposed by local authorities.

Figure 52 Taking out of removed asphalt in the Voенно-Antonovka village
