# Semi-annual Environmental Monitoring Report

Semi-annual Environmental Monitoring Report  
January to June 2024

## **CAREC Corridors 1 and 3 Connector Road, Section 2B Epkin-Dyikan [Bashkugandy], Km: 89+500 – 159+200 Project**

Olga Syzonenko, International Environmental Consultant,  
Gentek International Engineering and Consulting Ltd.  
Jumaliev Talantbek, Local environmental specialist,  
Gentek International Engineering and Consulting Ltd.  
Bishkek, Kyrgyzstan: July 2024

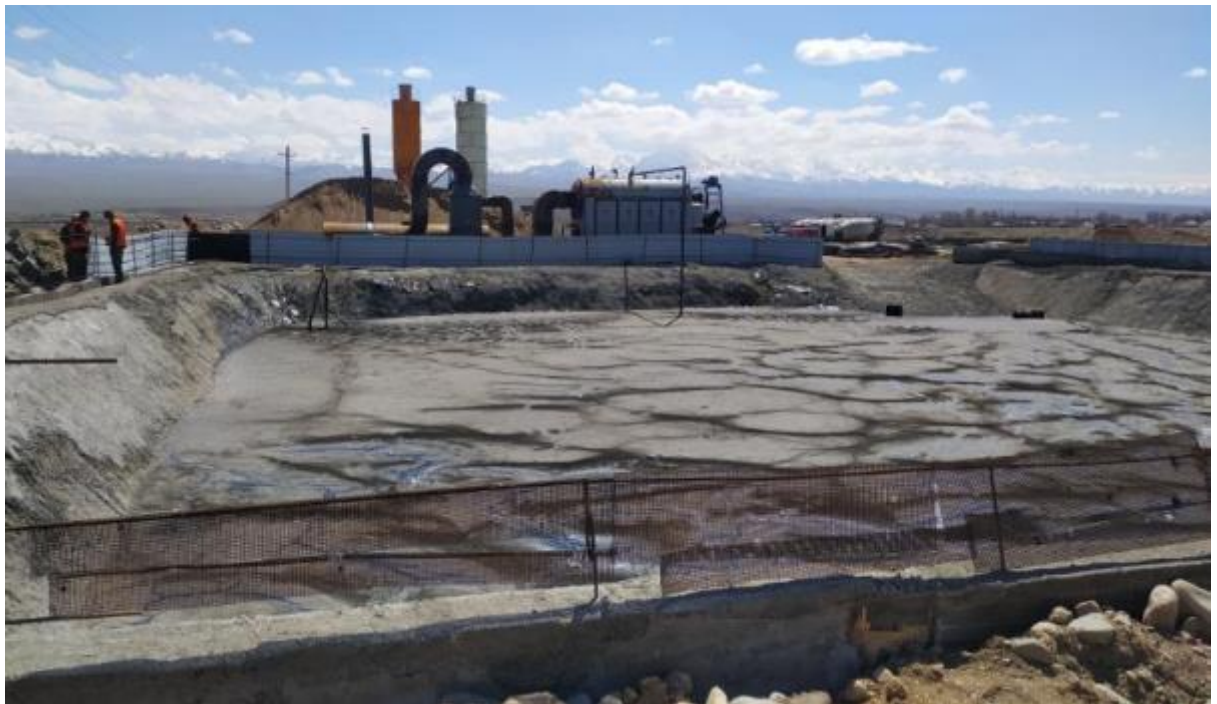
66. The bitumen pit is equipped with a reinforced concrete liner and a floor to prevent the infiltration of petroleum products into the soil.

**Figure 20: Bitumen pit at the production site (km 148+630).**

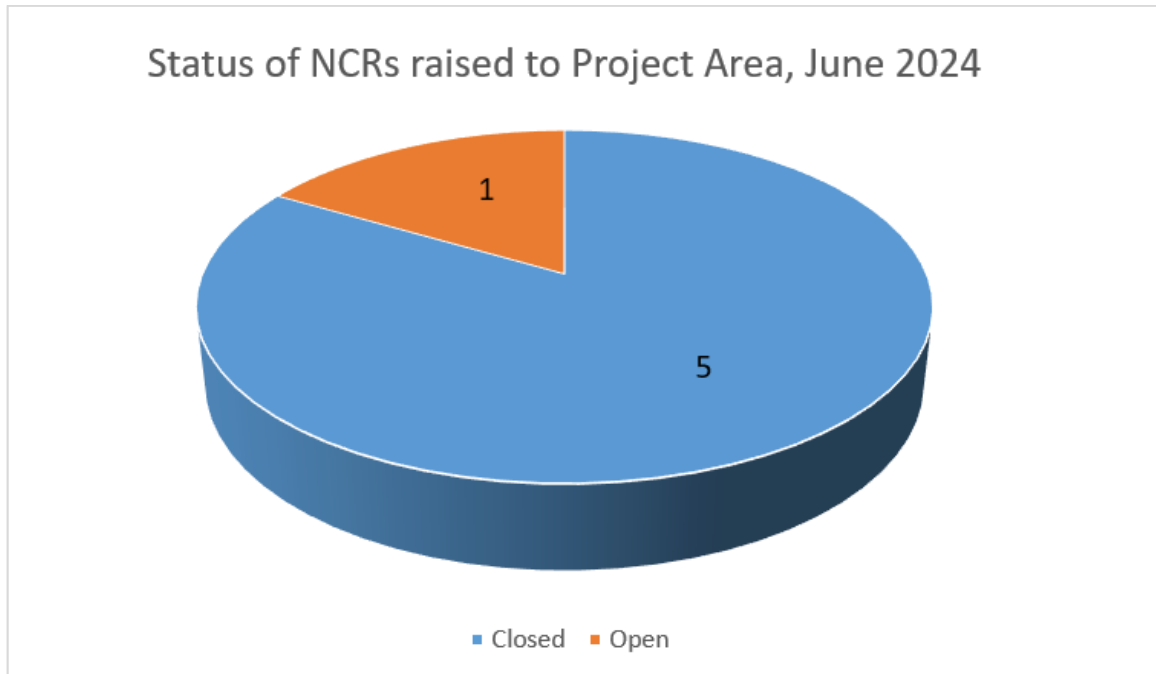
**Figure 26: Status of Non-compliances and Corrective Actions.**
