Semi-annual Environmental Monitoring Report

Semi-annual Environmental Monitoring Report January to June, 2023

CAREC Corridors 1 and 3 Connector Road, Section 2B Epkin-Dyikan [Bashkugandy], Km: 89+500 – 159+200 Project

Olga Syzonenko, International Environmental Consultant, Gentek International Engineering and Consulting Ltd. Zhumaliev Talantbek, local environmental specialist, Gentek International Engineering and Consulting Ltd. Bishkek, Kyrgyzstan: July 2023

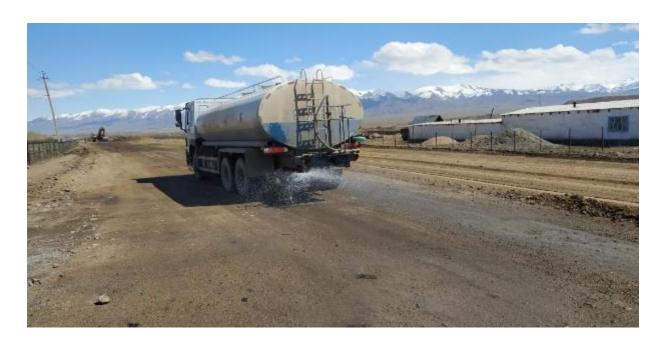
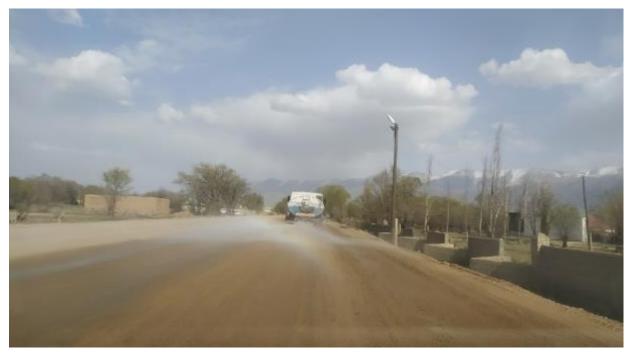
Figure 7: Dust suppression on roads.

- 43. High dust formations due to dry weather are heavily impacting air quality as well as increasing traffic risks. Therefore, dust suppression is carried out to mitigate impact and risks in the areas where construction works are being carried out and in the roads in vicinity of the settlements located along the project site. The dust suppression plan was updated on 30th June 2022 considering increasing number of water tanks utilized in summer. The plan is attached in Annex 1.

- 44. 10 12 water trucks are utilized to suppress a high dust during early spring and summer, whereas 8 trucks were used in the autumn.

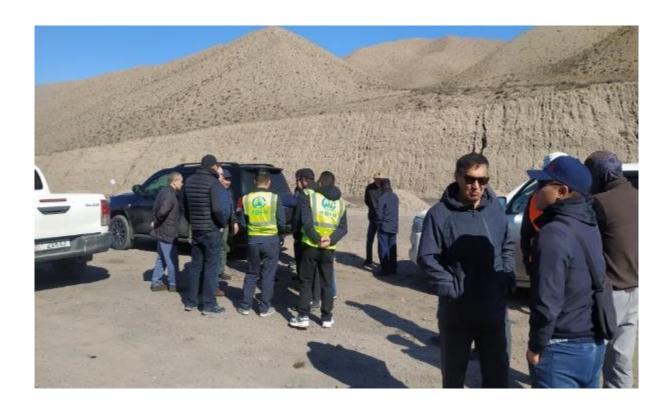
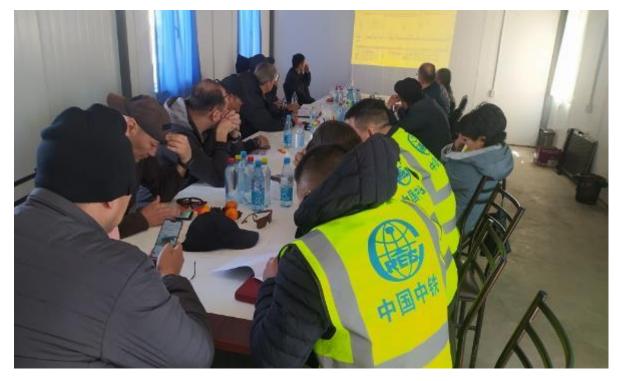
Figure 17: ADB review mission at the project site, May 19, 2023

86. The representatives of ADB conducted the visit to CAREC Corridors 1 and 3 Connection Road Section 2B, Epkin – Bashkuugandy" on 19 May 2023 to review environmental safeguards compliance site-specific environmental management plan (SSEMP) implementation and contract provisions on environment, health and safety. Findings and comments were identified during the mission, and then they were communicated via official letter for subsequent corrective actions. Table 16 summarizes findings observed during the review missions.

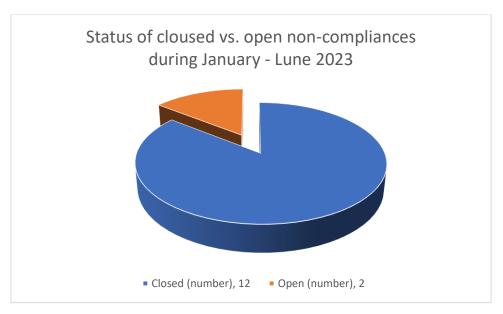
Figure 18 Status of Non-compliances and Corrective Actions.

87. 14 findings were observed, out of them 12 were closed, 2 remained open/ongoing; summary overview is shown in the table below.
