Semi-annual Environmental Monitoring Report

Semi-annual Environmental Monitoring Report
July to December 2024

CAREC Corridors 1 and 3 Connector Road Project, Section 2B Epkin-Dyikan [Bashkuugandy], Km: 89+500 – 159+200 Project

Olga Syzonenko, International Environmental Consultant,
Gentek International Engineering and Consulting Ltd.
Jumaliev Talantbek, Local environmental specialist,
Gentek International Engineering and Consulting Ltd.
Bishkek, Kyrgyzstan: January 2025

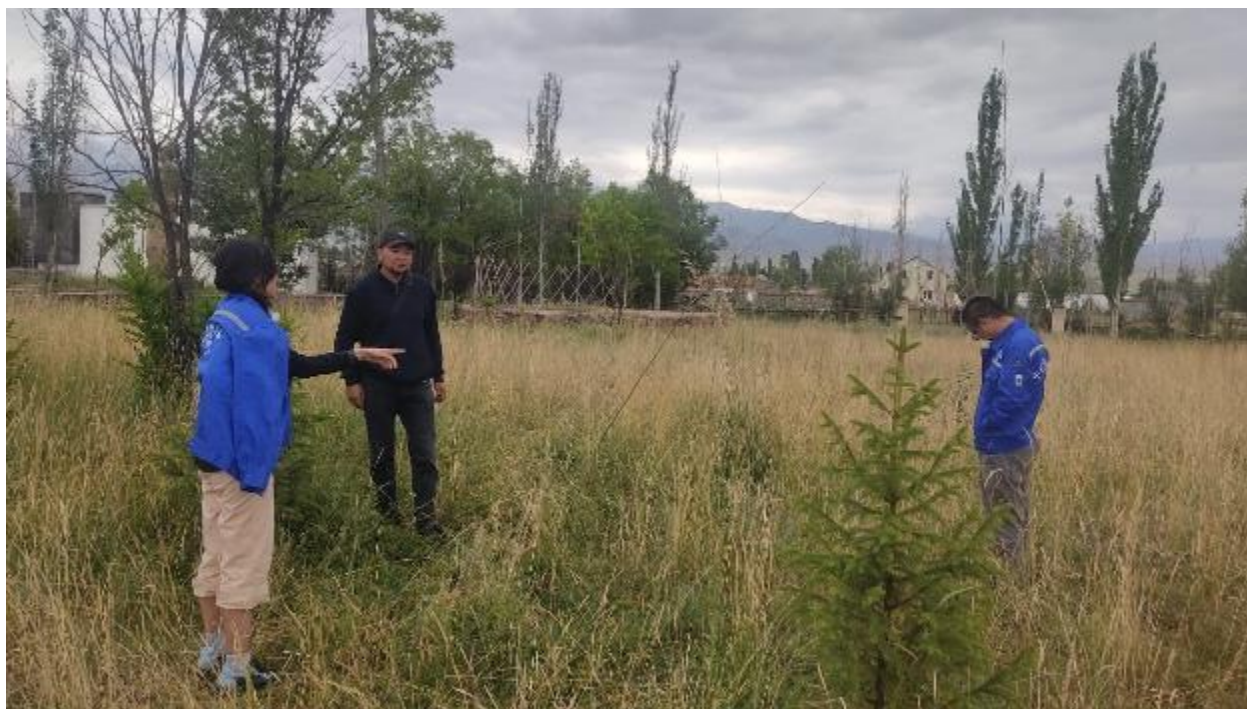
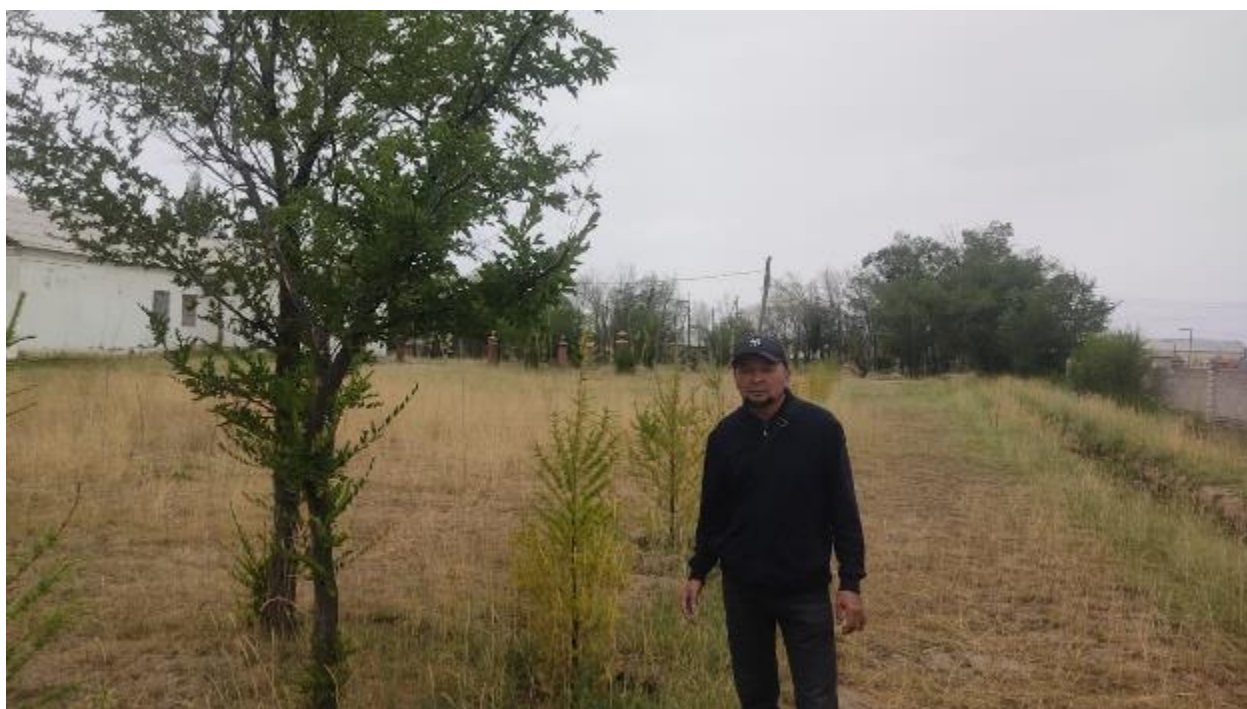
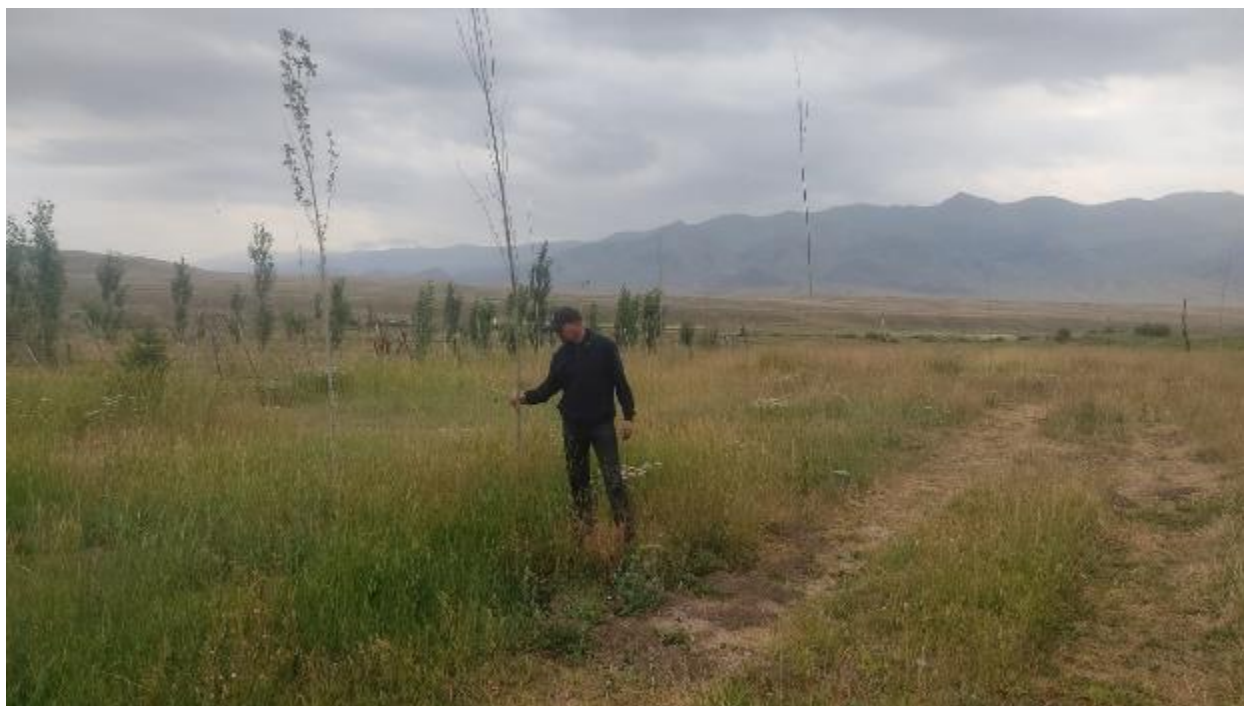
97. The representative of the Naryn Forestry Department did not identify any diseases in the seedlings during the inspection and approved the watering intensity.

Figure 27: On-site inspection of compensatory tree plantings with the participation of a representative of the Naryn Forestry Department (02.08.2024).

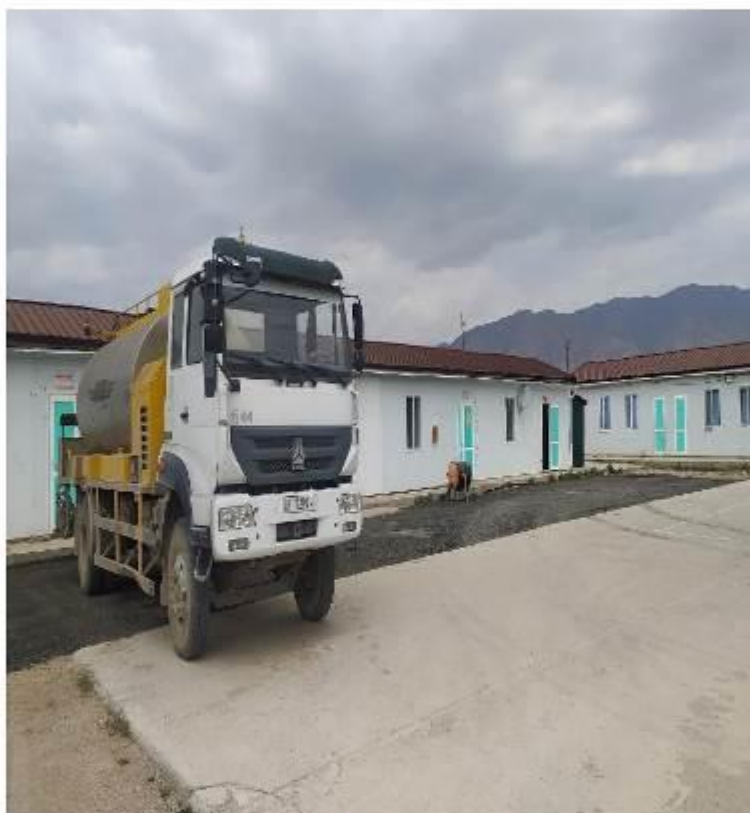
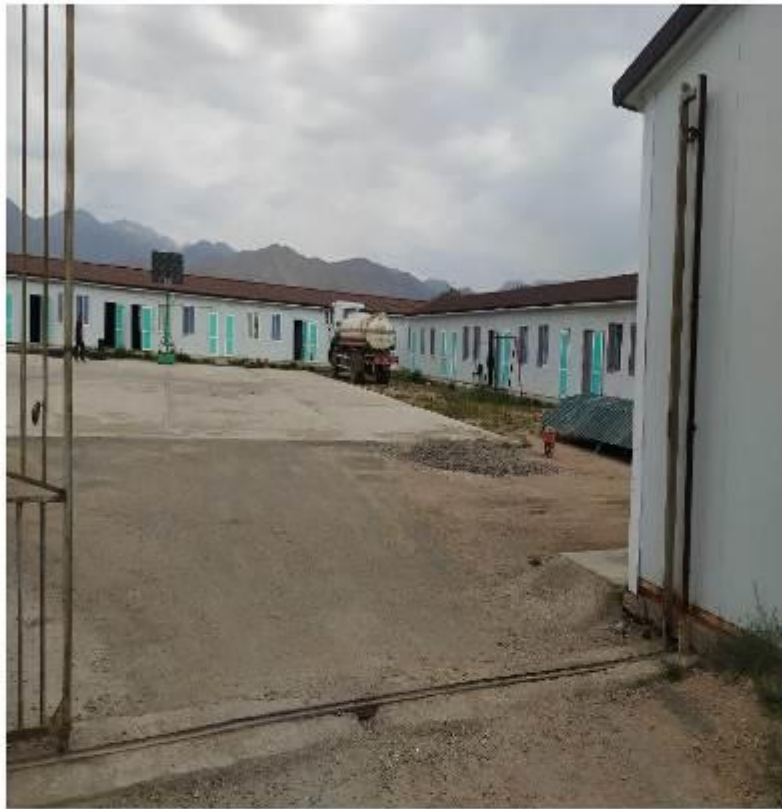
Photo 1, 2. On the territory of the camp, fuel trucks are still near the kitchen and the dormitory of the working staff

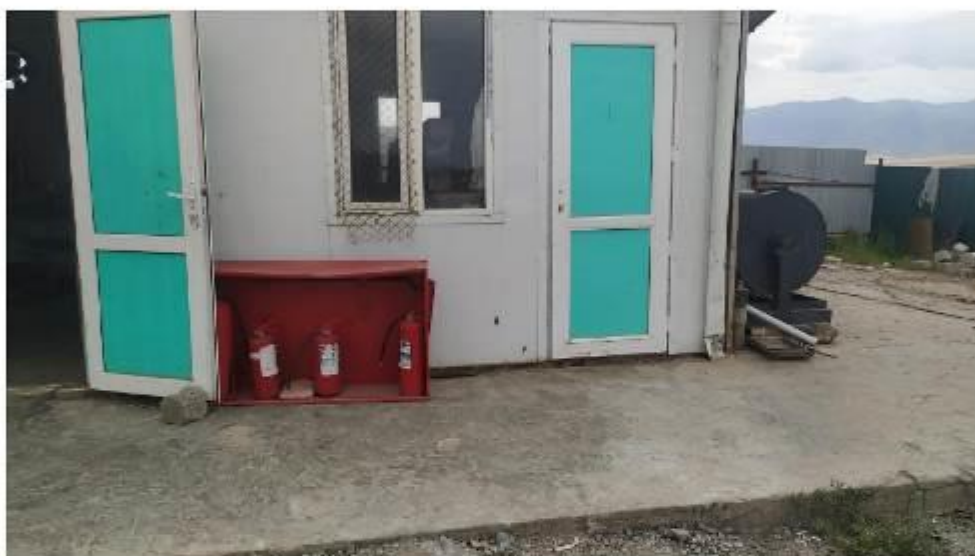
Фото 3. Противопожарные щиты до сих пор не доукомплектованы и отсутствует бочка с песком возле лаборатории

Photo 3. Fire extinguishing panels are still not completed and there is no barrel with sand near the laboratory

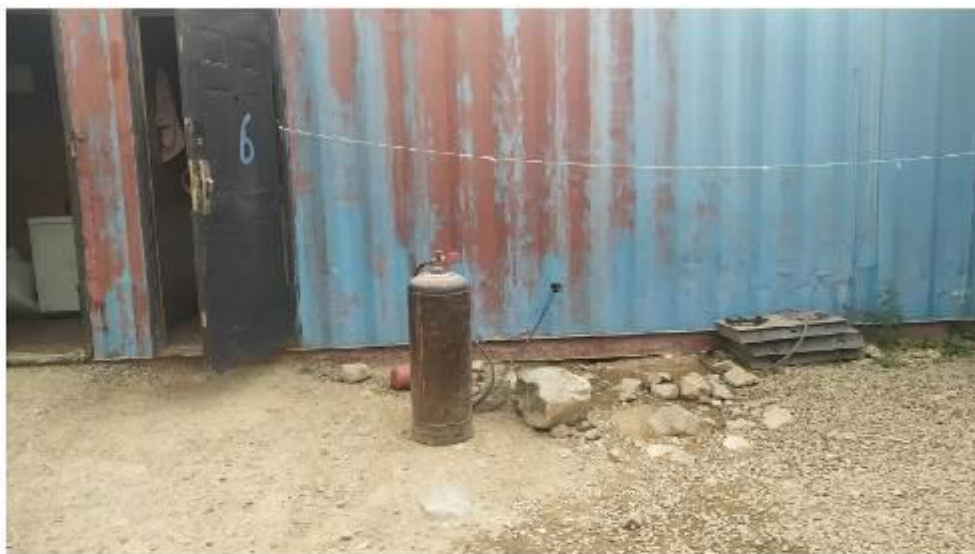
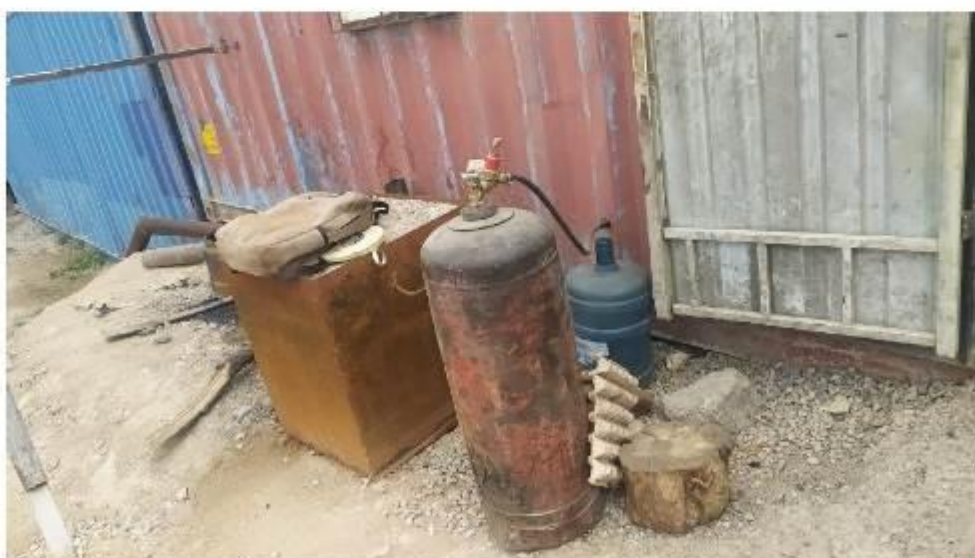
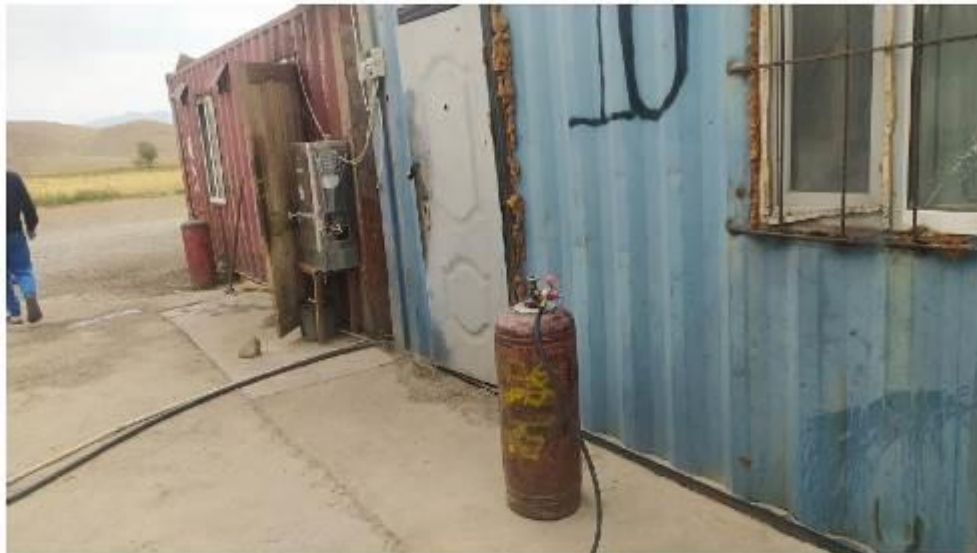
Фото 4, 5, 6. Газовые баллоны до сих пор не прикрыты от прямого попадания солнечного луча

Photos 4, 5, 6. Gas cylinders are still not covered from direct sunlight

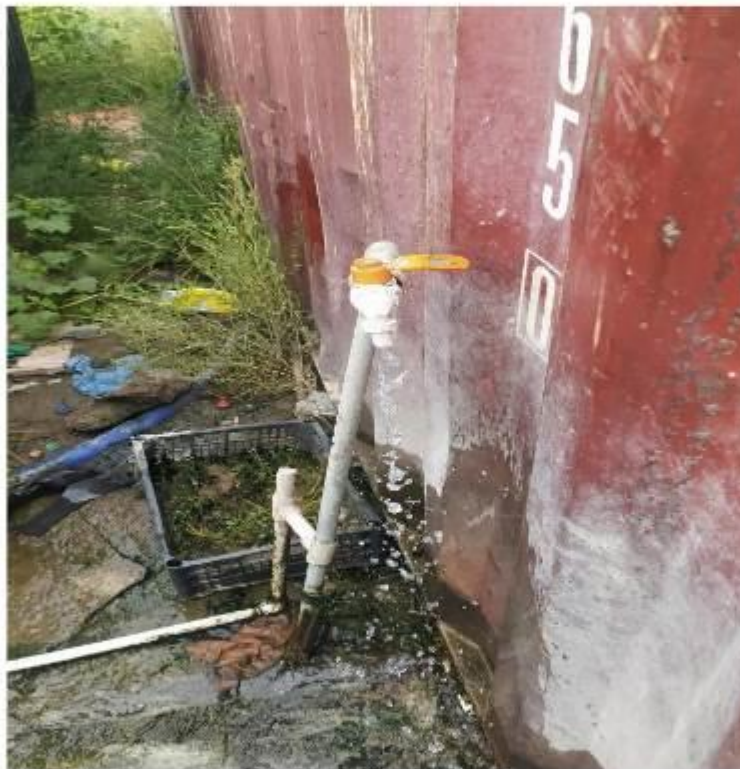
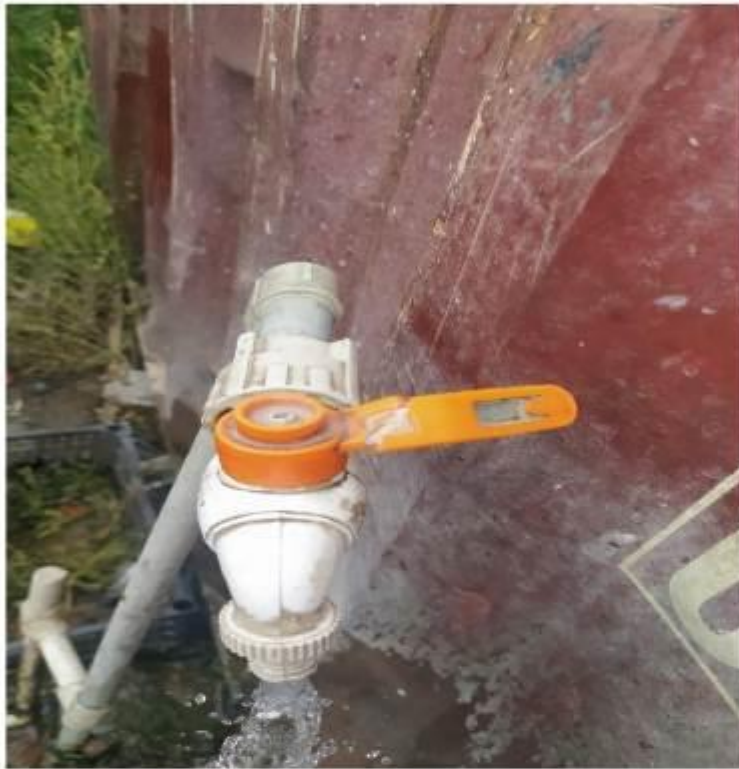
Фото 7,8. На территории лагеря в км 148+630, рядом кухни и душевой в лагере для местных рабочих сломан кран и вода постоянно течет, вследствие этого образовалась лужа, тем самым загрязняя окружающую среду

Photo 7,8. On the territory of the camp at km 148+630, next to the kitchen and shower for local workers, the faucet is broken and the water is constantly flowing, as a result, a puddle has formed, thereby polluting the environment

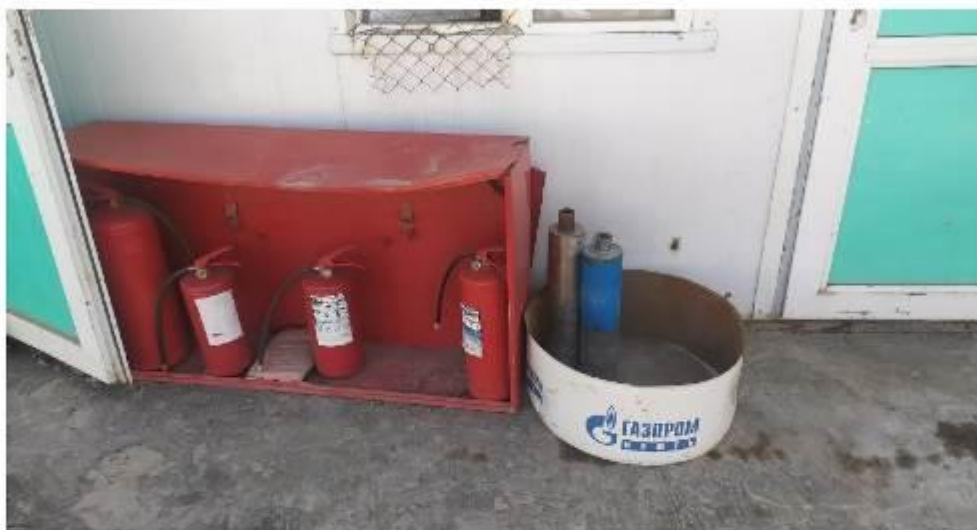
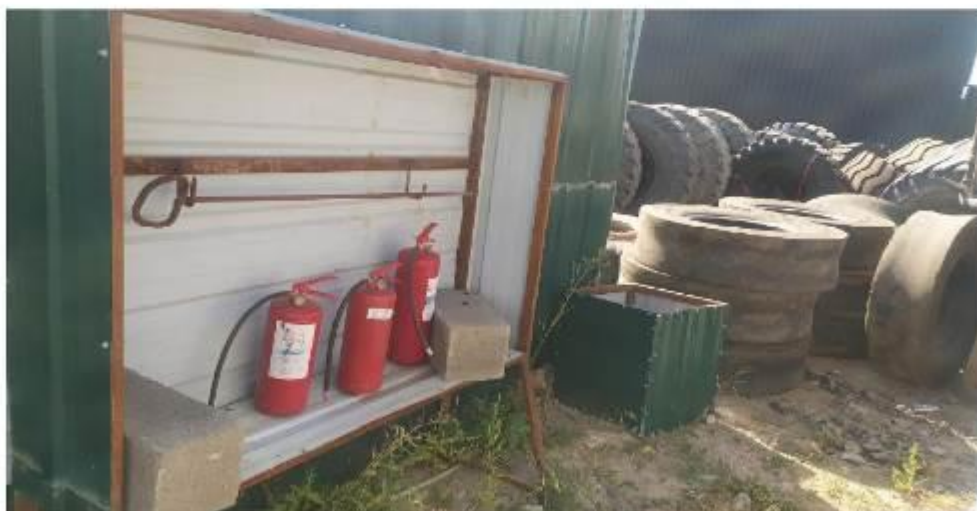
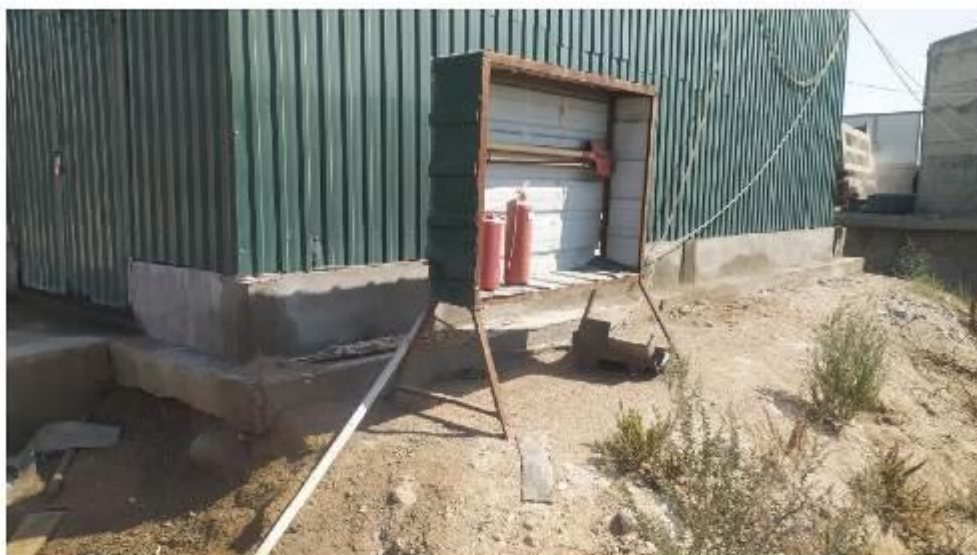
Photos 1,2,3. Fire extinguishing panels are still not fully equipped and there is no sand barrels

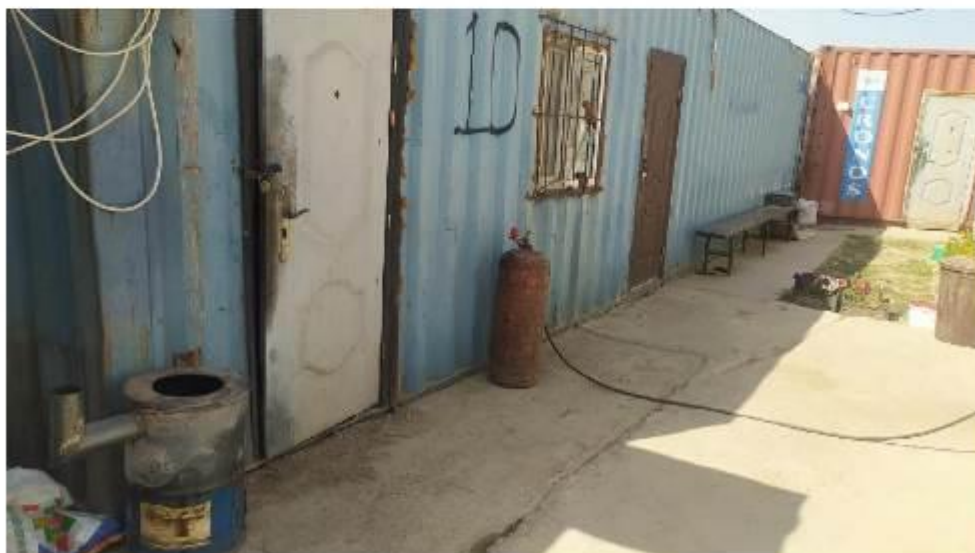
Фото 4. Газовые баллоны до сих пор не прикрыты от прямого попадания солнечных лучей

Photo 4. Gas cylinders are still not covered from direct sunlight

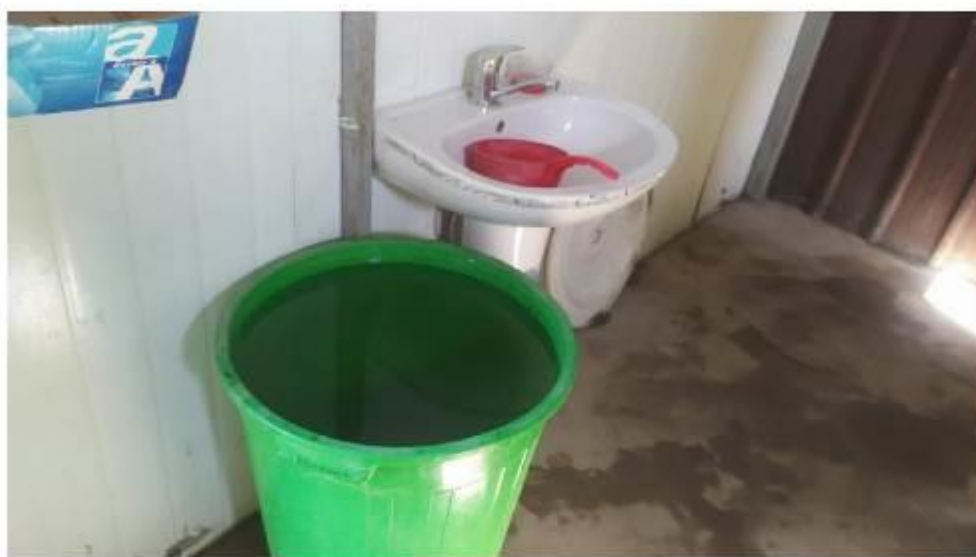
Фото 5. На территории лагеря в км 148+630, в мужском туалете сломан кран и рабочим приходится мыть руки из таза

Photo 5. On the territory of the camp at km 148+630, the faucet is broken in the men's toilet and workers have to wash their hands in a basin

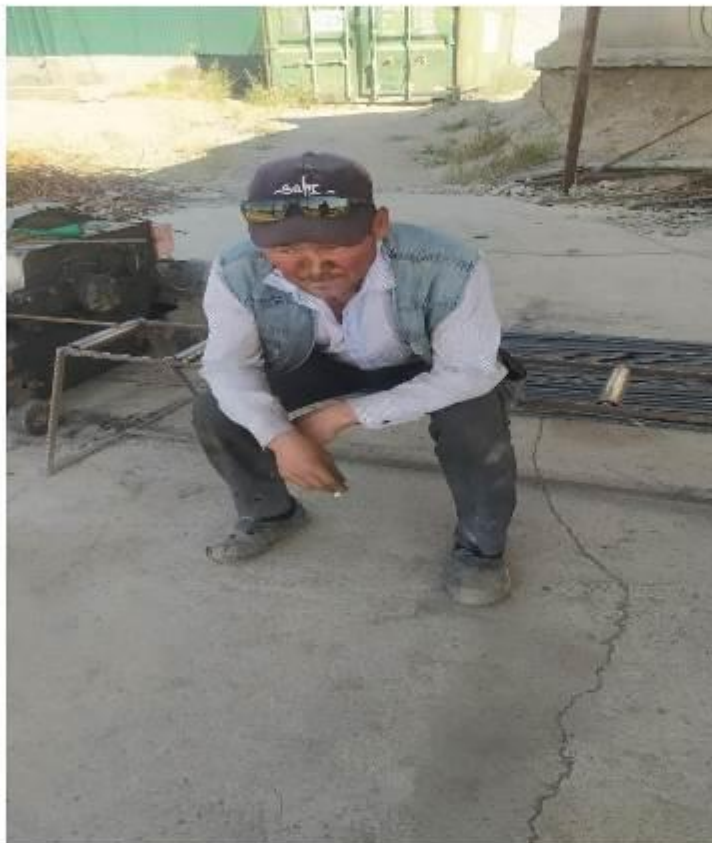
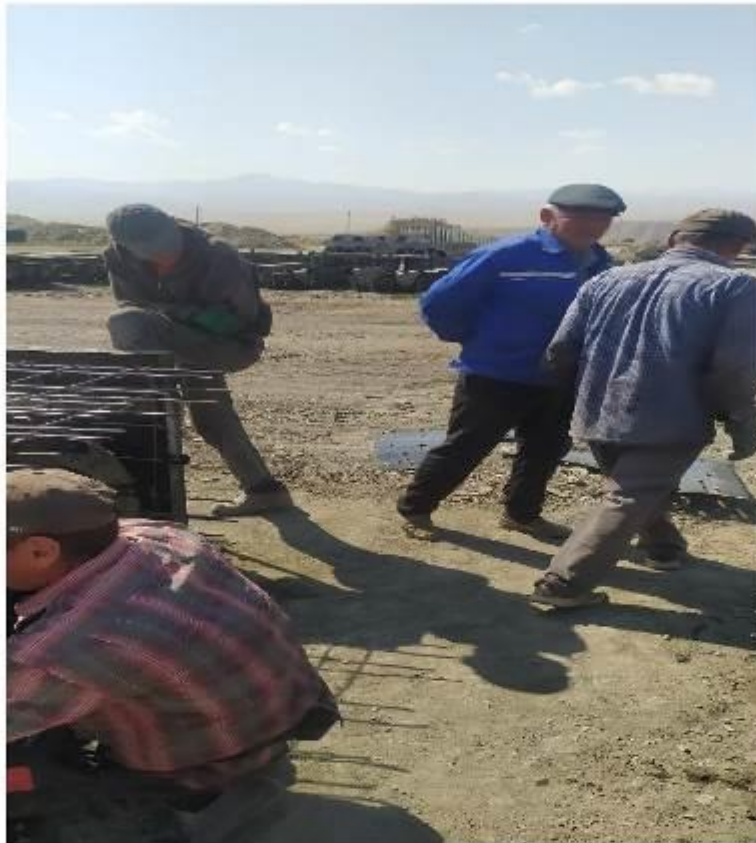
Фото 6,7. Рабочие работают без спец. одежды

Photo 6,7. Workers work without special clothing.

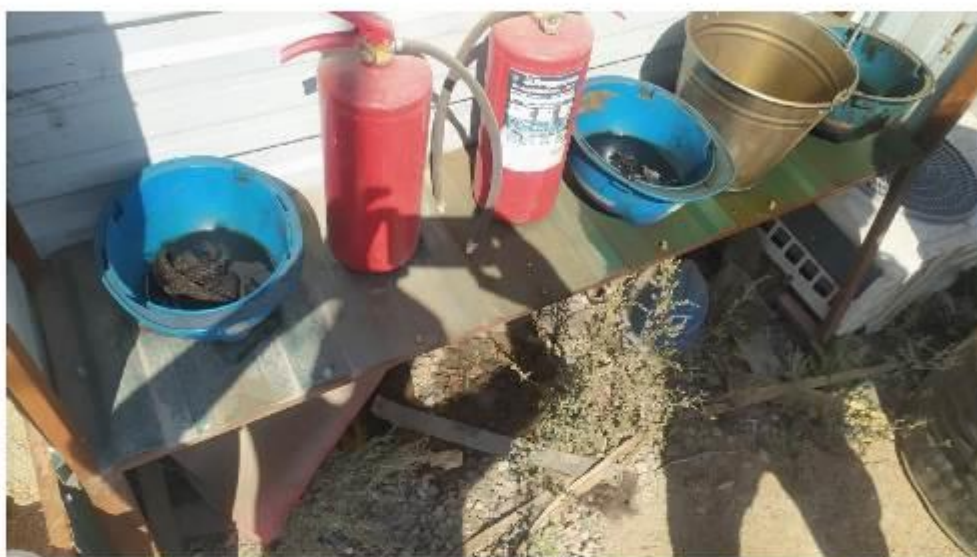
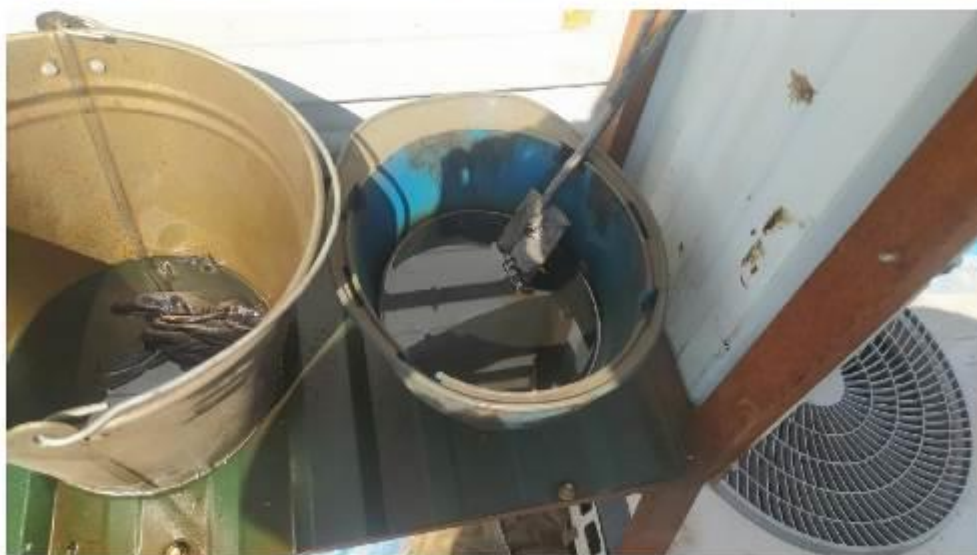
Фото 8,9. Каски рабочих почему-то наполнены горючими маслами и тряпками

Photo 8,9. For some reason, the workers' helmets are filled with flammable oils and rags.

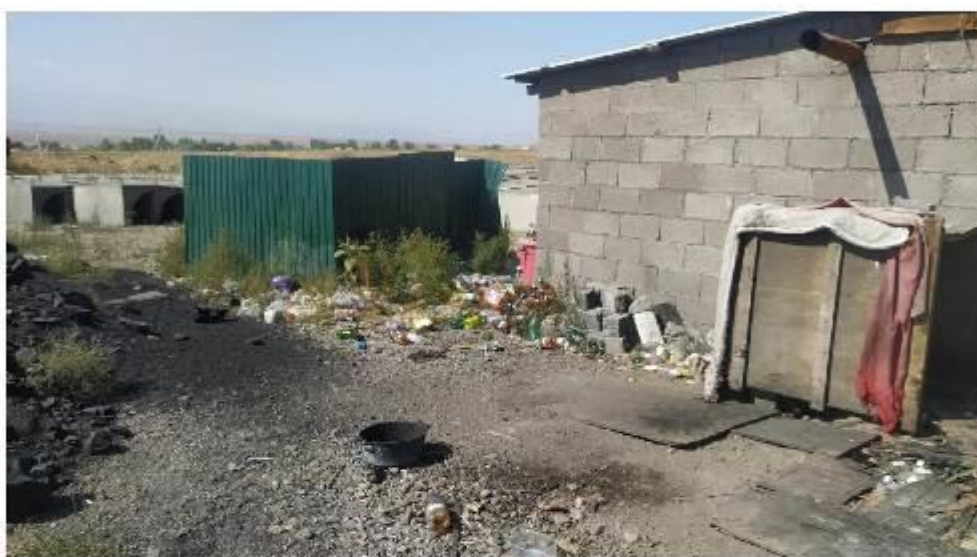
Фото 10. Территория производственной площадки в км 106+300 не убирается от мусора

Photo 10. The territory of the production site at km 106+300 is not cleared of garbage

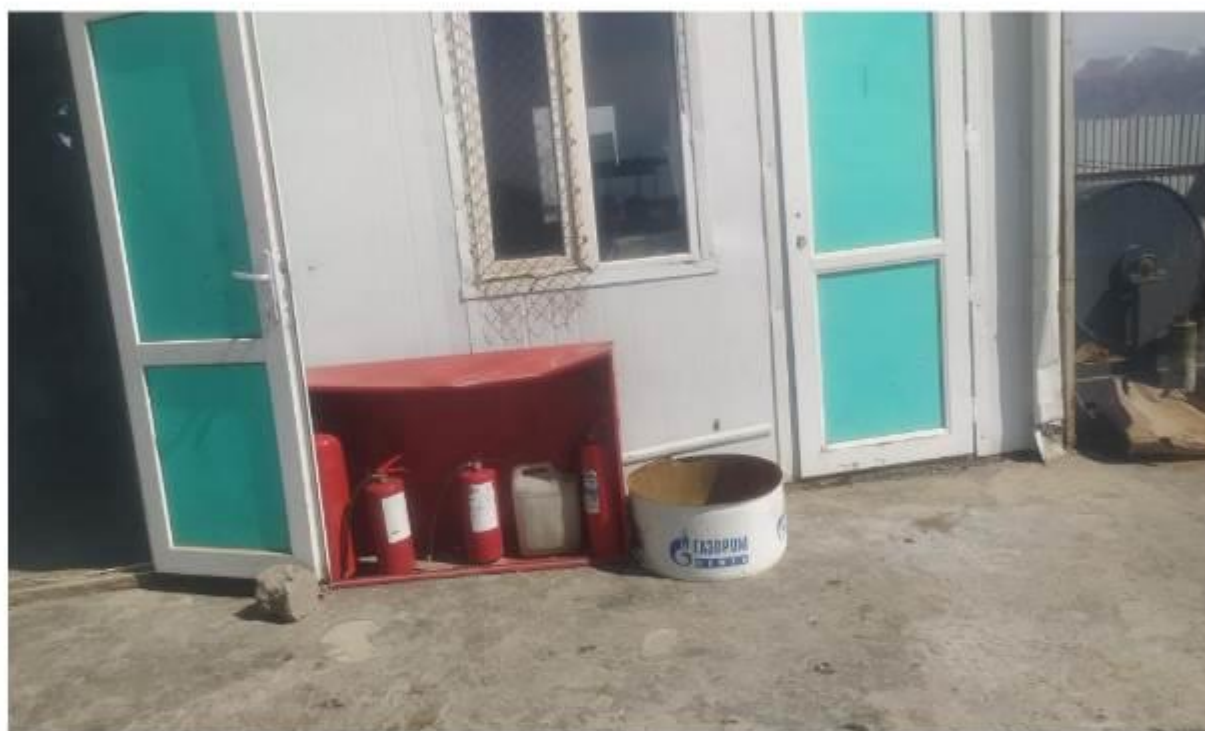
Photos 1. Fire extinguishing panel is still not fully equipped and there is no sand barrel next to the laboratory

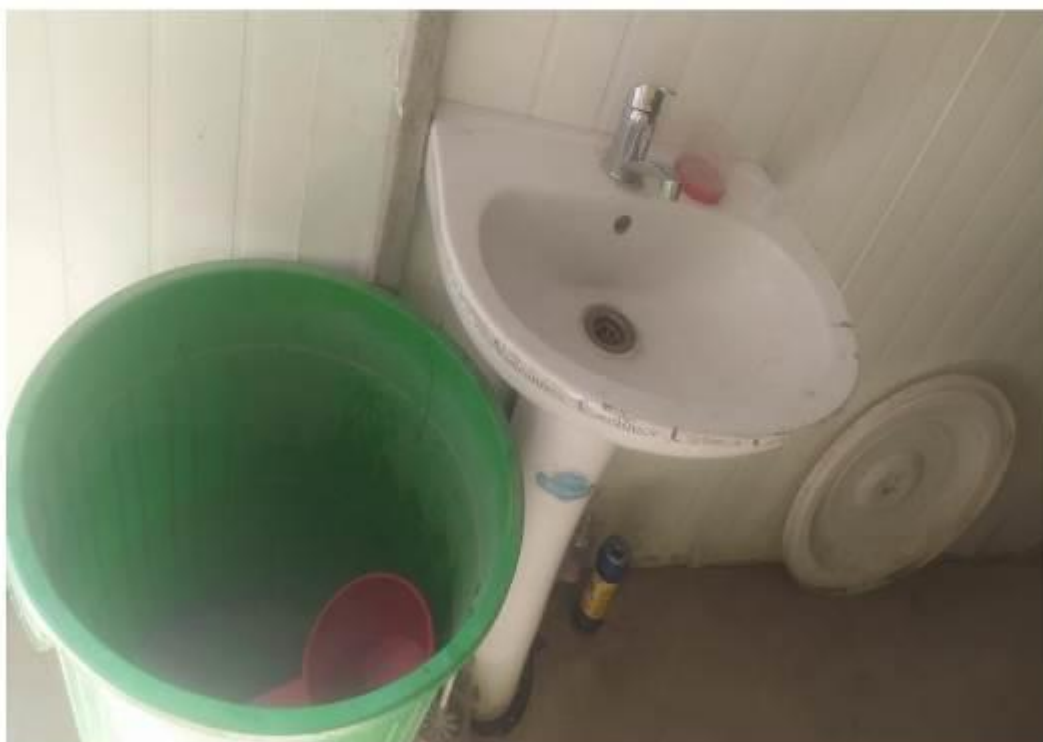
Фото 3. На территории лагеря в км 148+630, в мужском туалете сломан кран и рабочим приходится мыть руки из таза

Photo 3. In the camp at km 148+630, workers have to wash their hands from the basin in the men's toilet

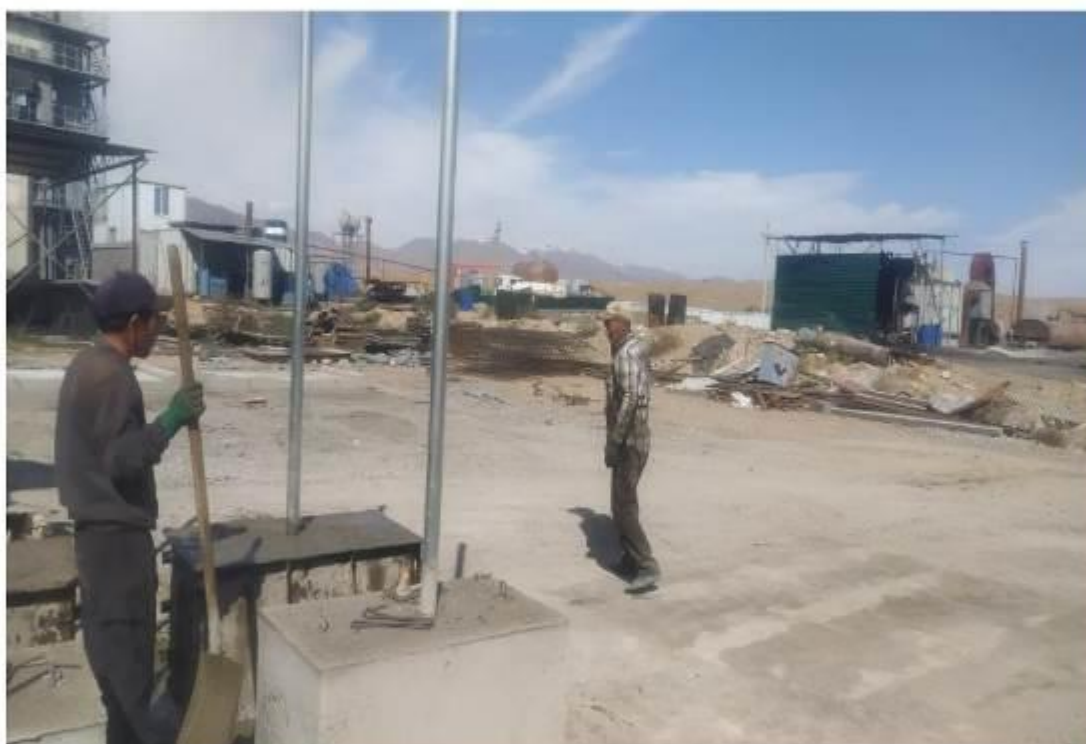
Фото 4. Рабочие работают без спец.одежды

Photo 4. Workers work without special clothing.

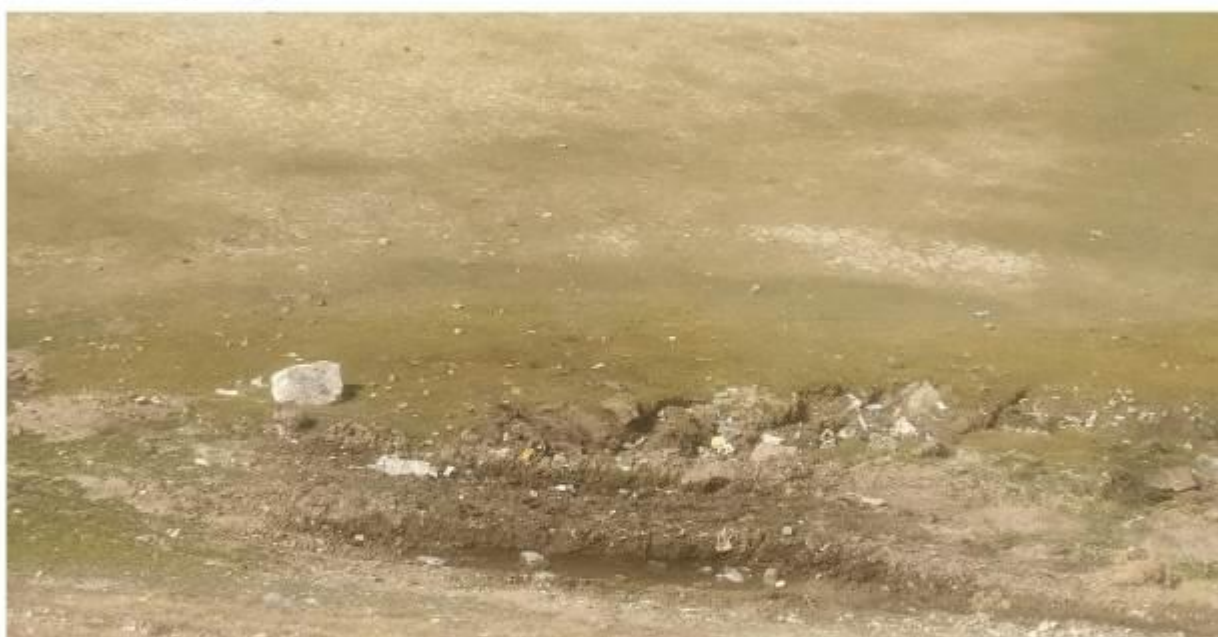
Photo 5. The garbage is not removed properly in the camp area at km 106+300. At the end of the camp, where the spring is located, household waste has accumulated, the local residents are outraged and ask to remove the garbage.

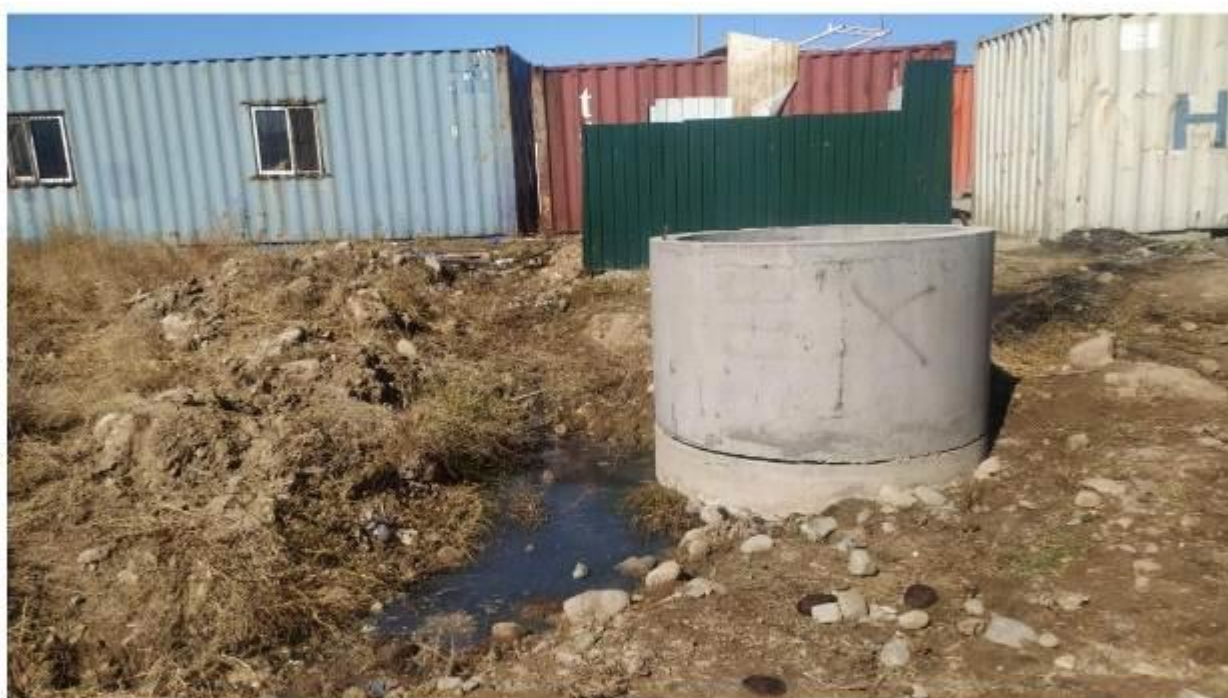
Photos 1,2. The wastewater in the storage tank is overfilled and flows out, thereby polluting the environment.
