# Semi-annual environmental monitoring report

Project number: TA-8887 KGZ

## January-June 2023

### Kyrgyz Republic: Central Asia Regional Economic Cooperation Corridors 1 and 3 Connector Road Project (Phase 2) - Additional Financing

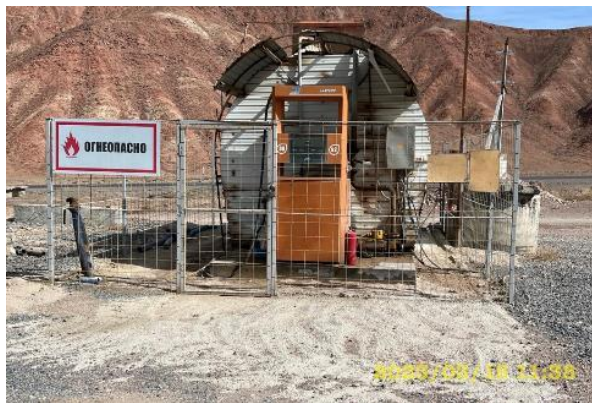
Photo 59. Lot 1. March. Sanitary condition of fuel station territory is satisfactory, no oil product contamination was observed.

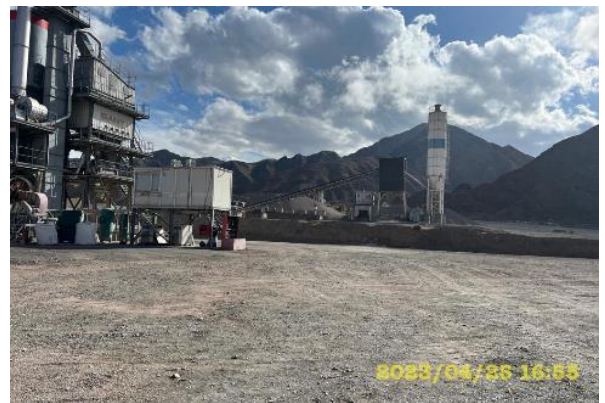
Photo 60. April. Sanitary condition of the industrial base territory is satisfactory. no oil product pollution was observed.

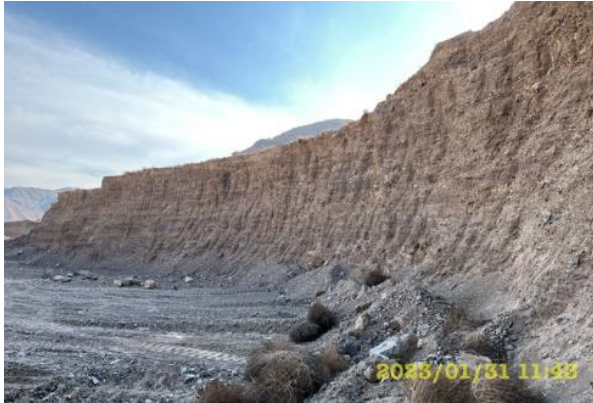
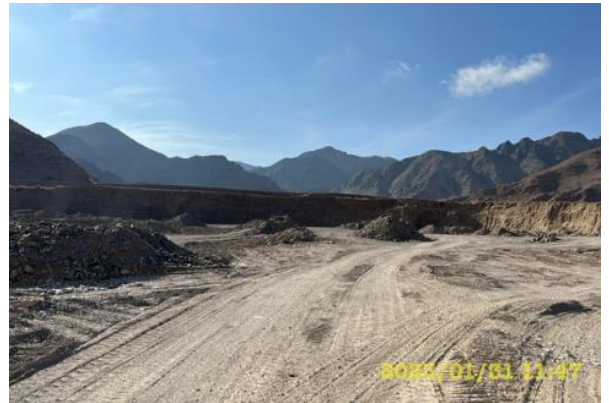
Photos 62 and 63. Lot 1. Quarry km 16+600. It is required to bring stability of quarry sides to a safe condition, i.e. the angle of inclination of quarry side should be equal to 70° (not more).

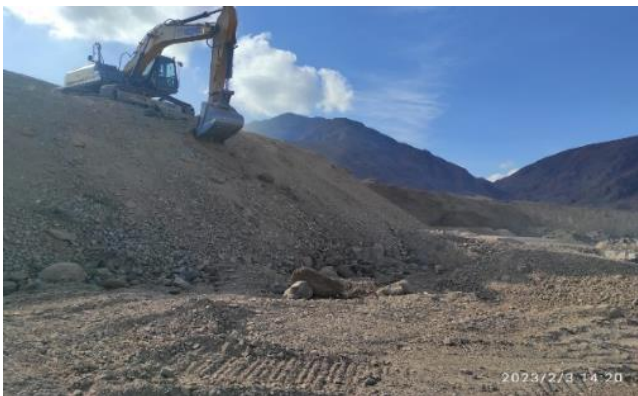
Photo 64. Quarry km 16+600. Work is underway to ensure stability of quarry sides.

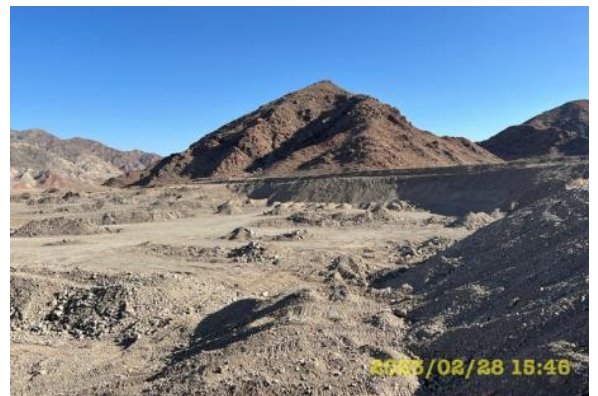
Photo 65. Quarry sides of km.16+600 have been brought to a safe condition

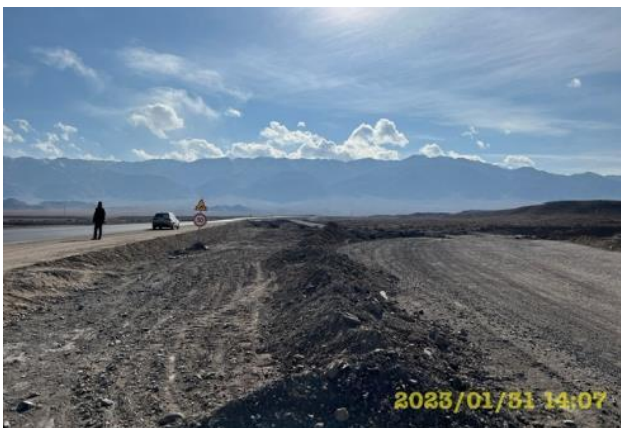
Photo 66. Lot 1. Bypass road on the section km. 22+000-23+000. Subject to reclamation.

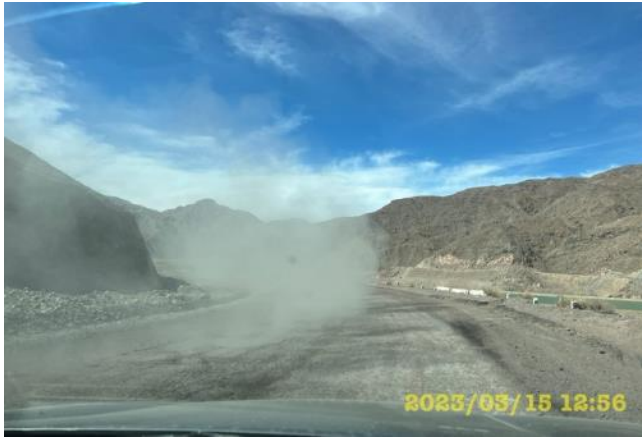
Photo 68. March. Dust on the unpaved road section at km. 37+000-38+000

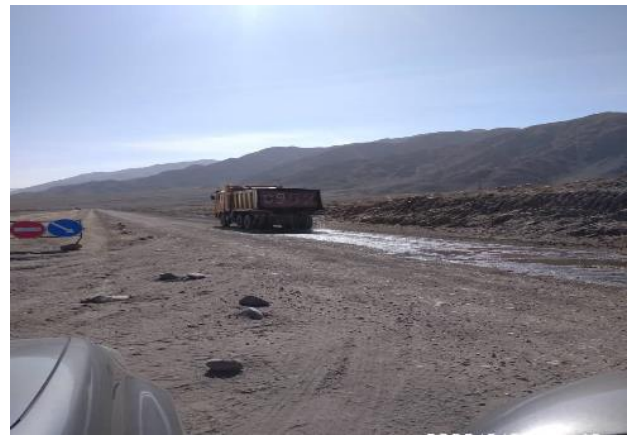
Photo 69. Lot 1. Hydro-irrigation of unpaved road sections at km. 37+000-38+800

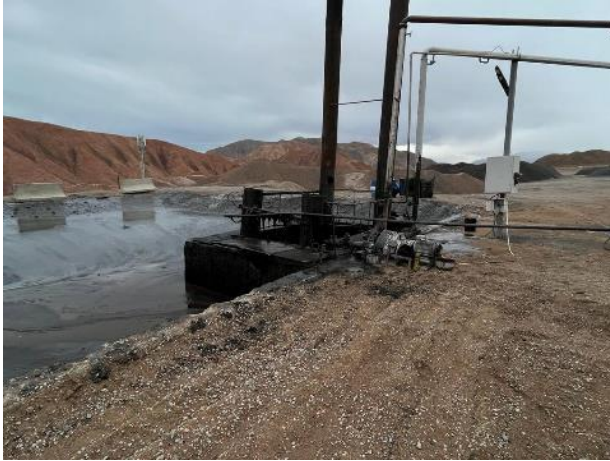
Photo 76. Production base of AC plant. Fencing around the bitumen storage area to be completed

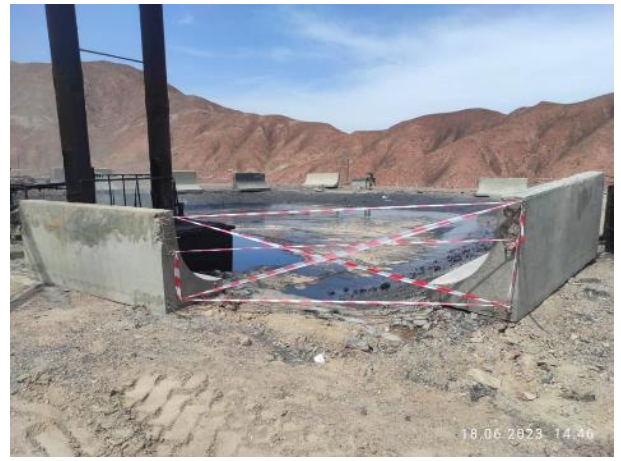
Photo 77. Production base of AC plant. Completion of full fencing of bitumen storage area is ensured.

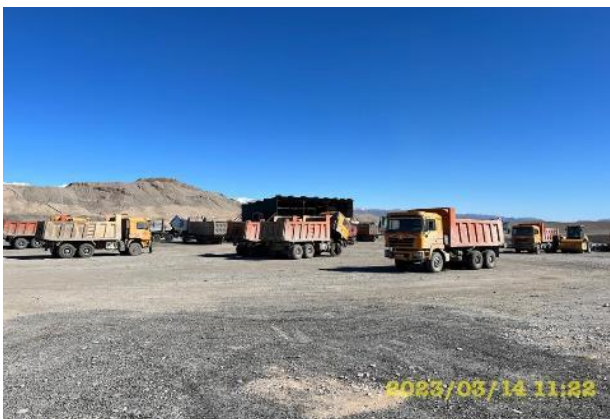
Photo 80. March. Sanitary condition of the construction equipment parking area is satisfactory, no oil pollution was observed.

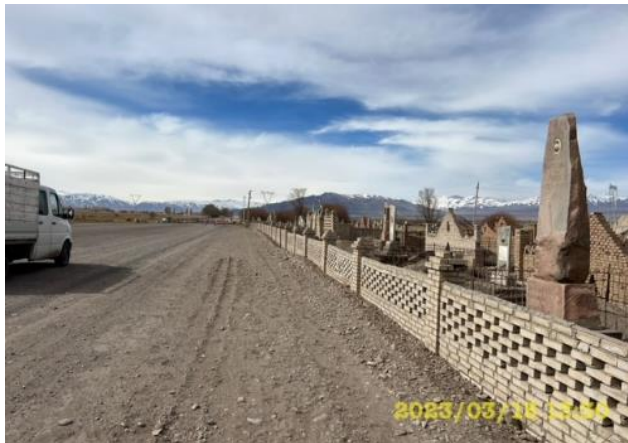
Photo 84. Lot 2. March. Cemetery km 68 RHS, foundation of cemetery fence along road is backfilled with soil as a result of roadside construction.

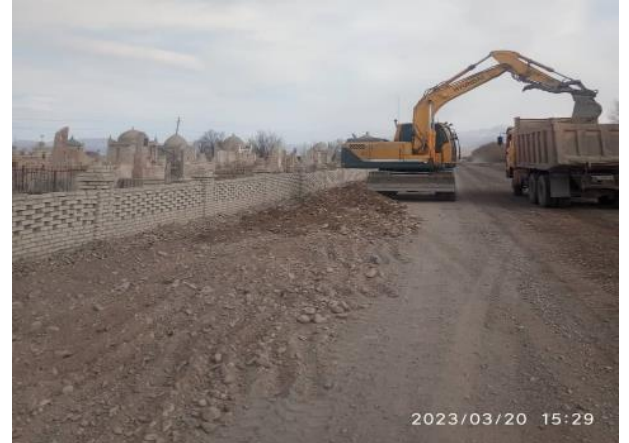
Photo 85. Lot 2. March. Cemetery km 68 road RHS: area along cemetery fence cleared of backfilled soil

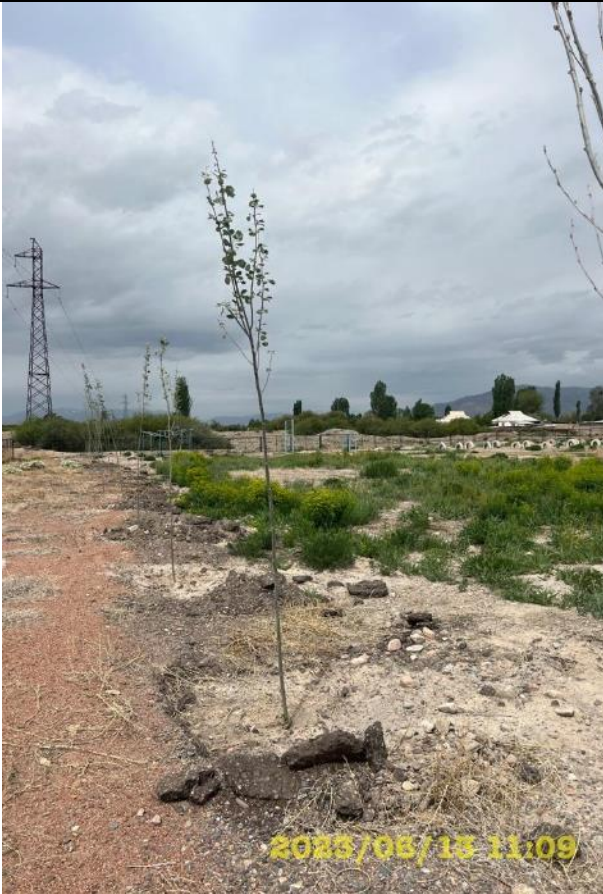
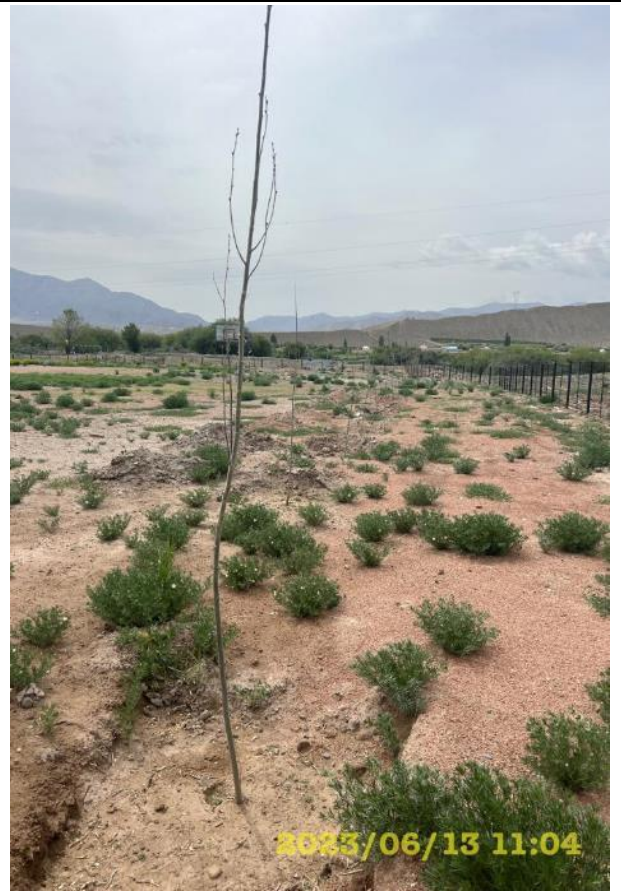
Photos 104 and 105. Watering of seedlings planted on the school grounds in Chekildek village is required

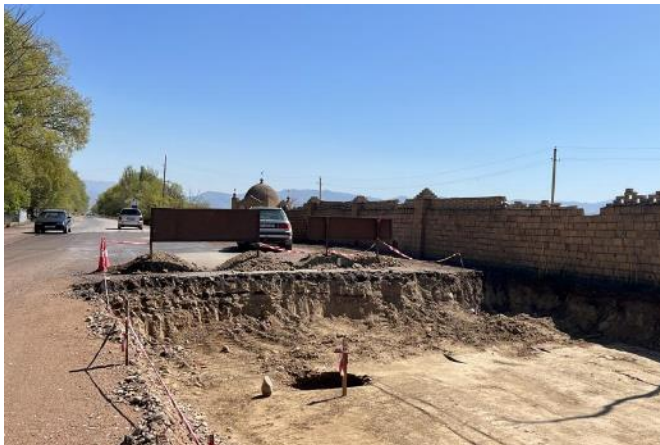
Photo 127. Lot 2. Found burial, under existing road base at km 62+500, Tendik v.
