Semi-Annual Environmental Monitoring Report

January – June 2024

Central Asian Regional Economic Cooperation Corridor 3 Improvement Project (Bishkek-Osh Road), Phase 4, Bishkek-Kara-Balta section (km 8.5 - km 61).

Prepared by: Project Implementation Unit of the Ministry of Transport and Communications of the Kyrgyz Republic and the Asian Development Bank.

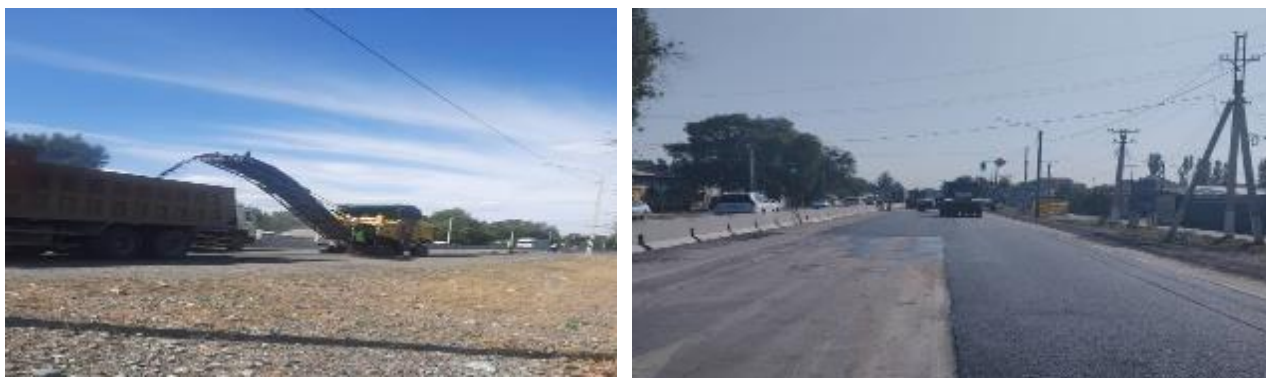
Figure 3 Milling and laying wearing course, removing rutting

34. Work was carried out to remove deformed asphalt and lay new asphalt where rutting was developed.

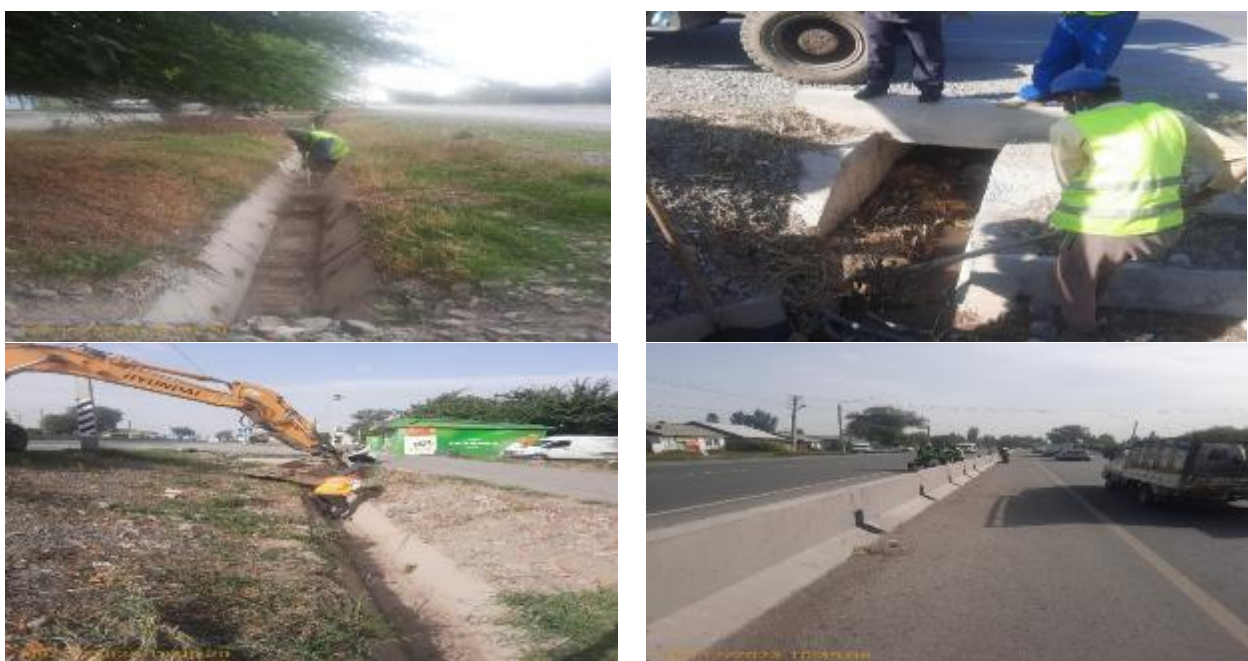
Figure 4 Cleaning of culverts and parapets from accumulated soil

33. The material has accumulated as a result of winter road maintenance. Inert material is used for backfilling in the winter period to avoid icy conditions on the project site.

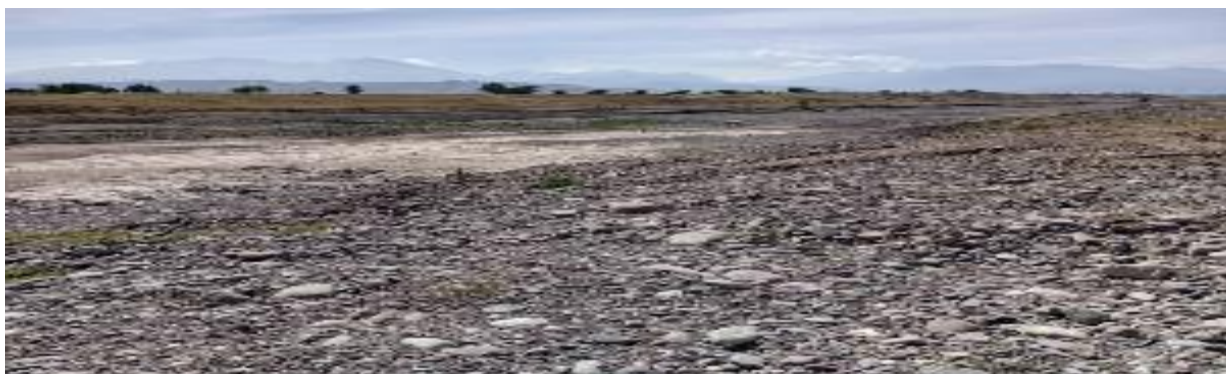
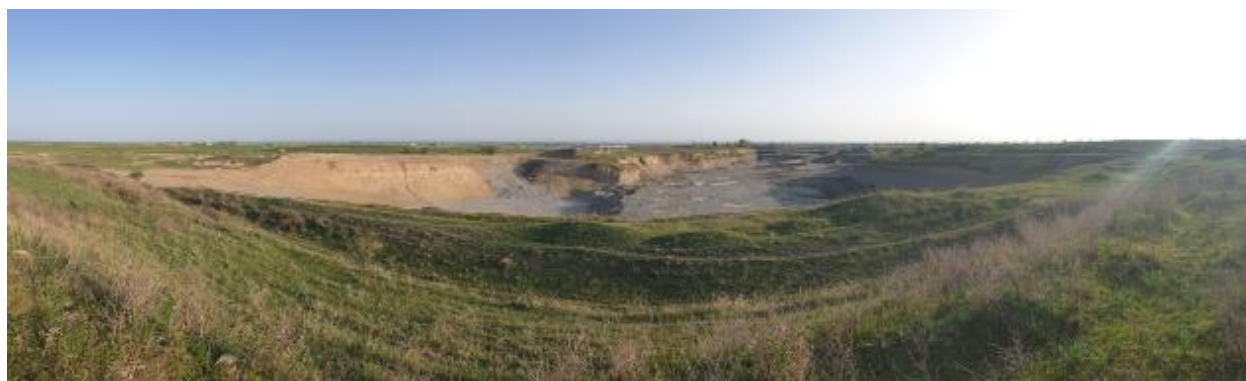
Figure 5. Ak-Suu 2 borrow pit and Belek borrow pit after reclamation

Ak Suu2 borrow pit

Belek borrow pit

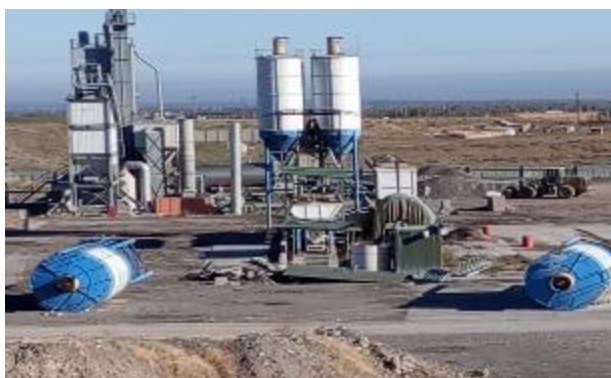
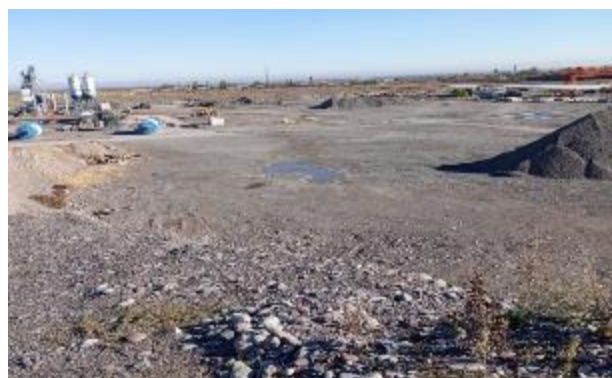
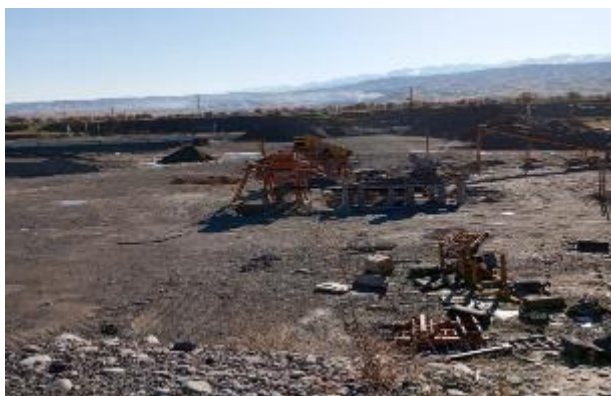
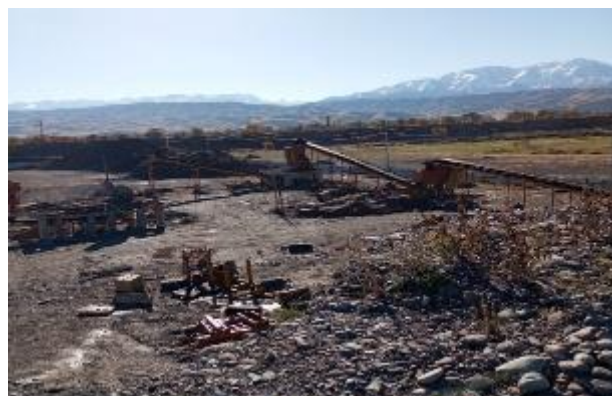
Figure 7 Dismantling of equipment on the production site

39. The contractor carried out partial dismantling of structures at the plant. In December 2023, the Contractor entered into an additional agreement with the owner of the site (the owner of the site is the Ministry of Emergency Situations of the Kyrgyz Republic) to extend the lease and use further this site for the needs of the Contractor, outside the project activities.

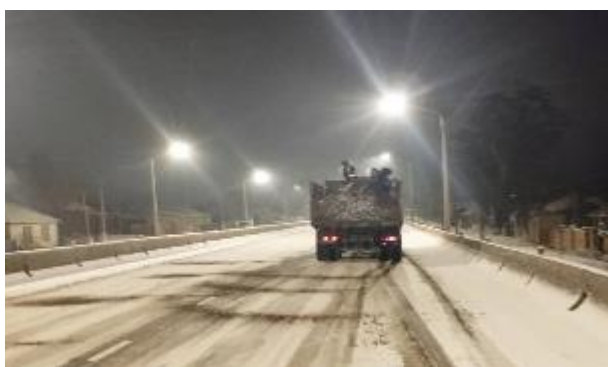
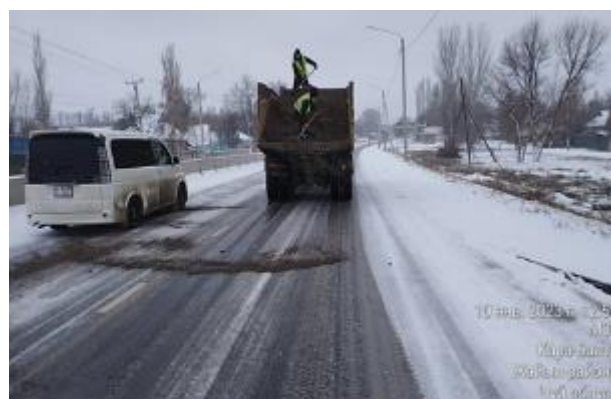
Figure 8 Sand sprinkling on the road. Control of ice

- protection of road from snow drifts;
- clearing road from snow; control of winter slipperiness;
- control ice on the road.

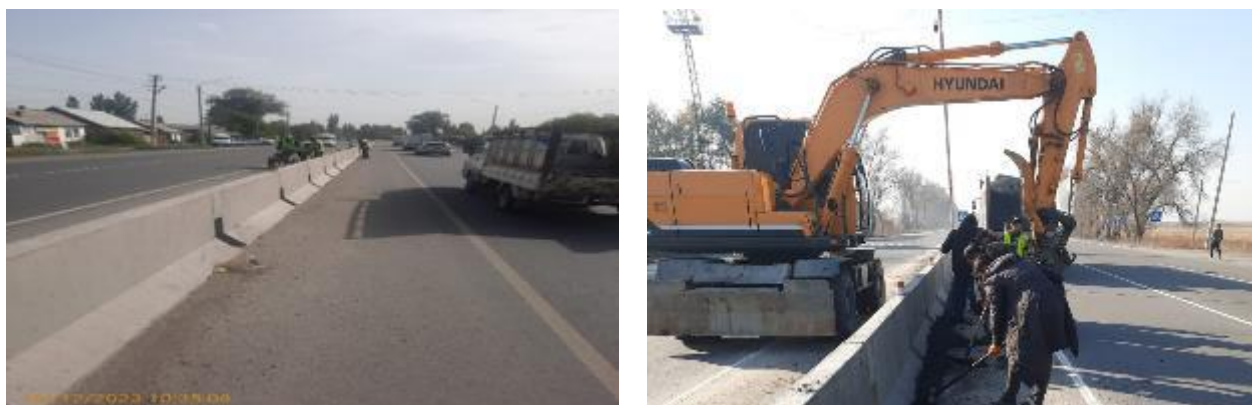
Figure 9 Cleaning and removal soil waste near parapets

55. During monitoring in April, earth waste was found on the roadsides, where works were carried out to clear gutters, parapets, culverts and bus stops. Collected earth waste, stored in small piles,

which the Contractor was unable to remove in a timely manner due to insufficient manpower. After discussing this issue with the Contractor, the earth waste was collected from the roadside and removed. Subsequently, the accumulated soil was cleaned and removed in a timely manner.

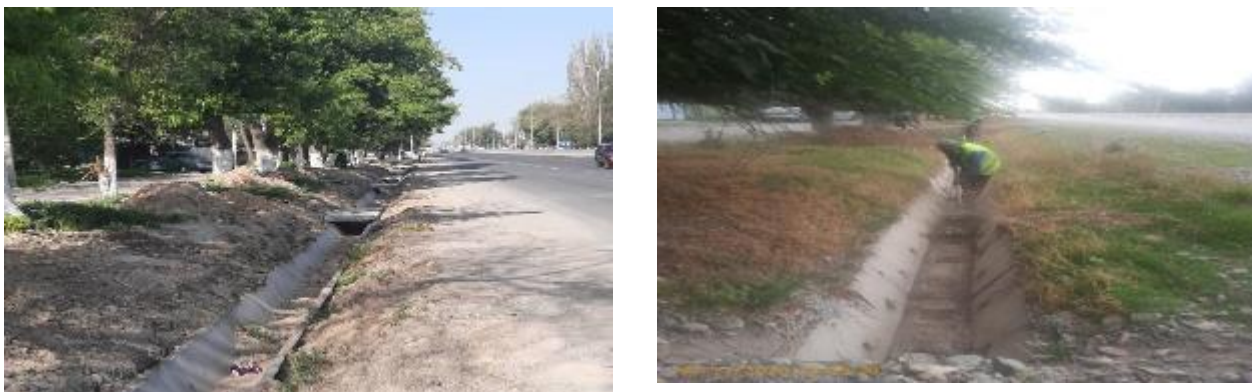
Figure 10 Cleaning drainage ditches

56. In May, drainage ditches were cleaned of stones and debris.

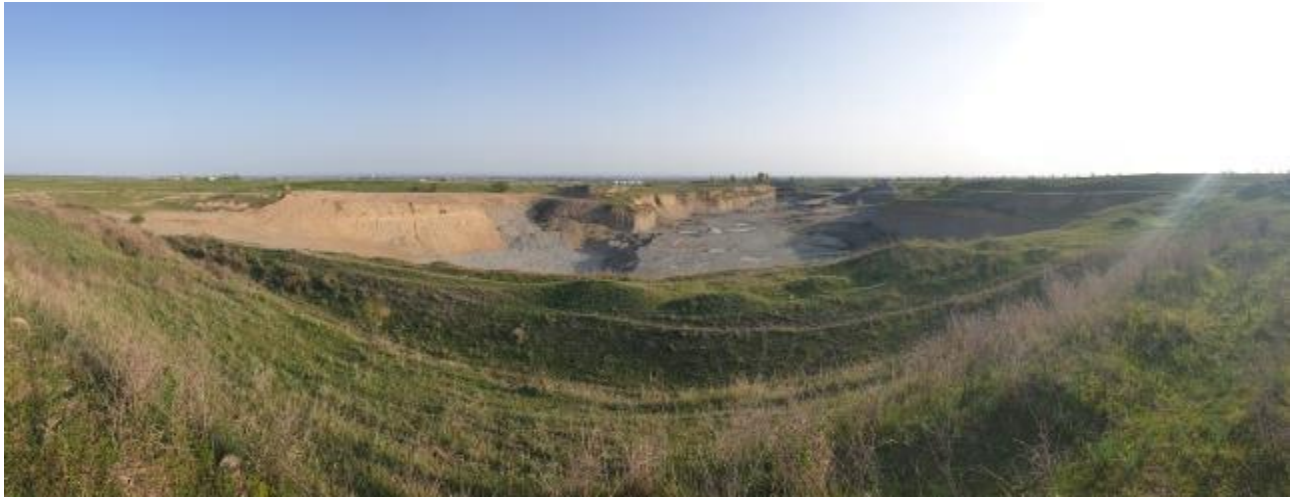
Figure 11 Belek borrow pit after reclamation

57. The last remaining borrow pits Belek and Ak-Suu 2 were reclaimed. Both borrow pits were handed over with the certificate to the raion commissions as per the national legislation.

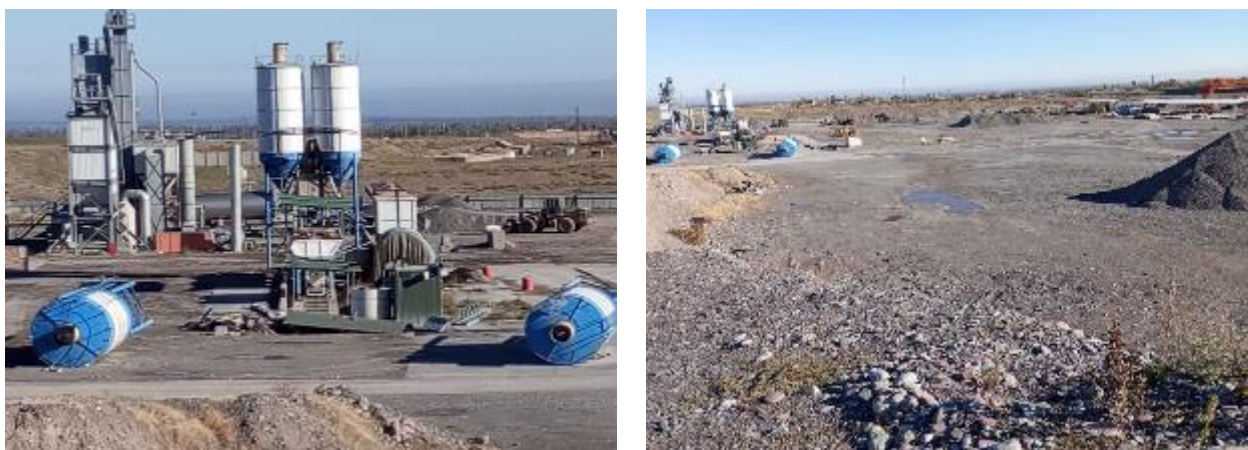
Figure 13 Dismantling of equipment on the production site

58. After dismantling the equipment (crushing plant, etc.), the Contractor does not carry out any work. Considering that the contractor has entered into a new lease agreement with the owners of this site, Chins Railway No. 5 plans to use this site outside of our project.

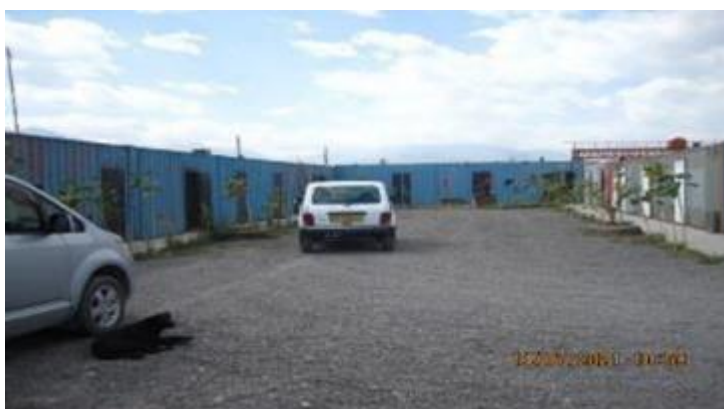
Figure 14 Camp

59. *In the Sokuluk residential camp*, household waste and sewage from septic tanks are removed in a timely manner, all protective measures for sanitary hygiene are observed.
