# Semi-annual environmental monitoring report

Project number: 45169-001

January - June 2022

Central Asian Regional Economic Cooperation Corridor 3 Improvement Project (Bishkek - Osh road), Phase 4, Bishkek-Kara-Balta section (km 8.5 - km 61).

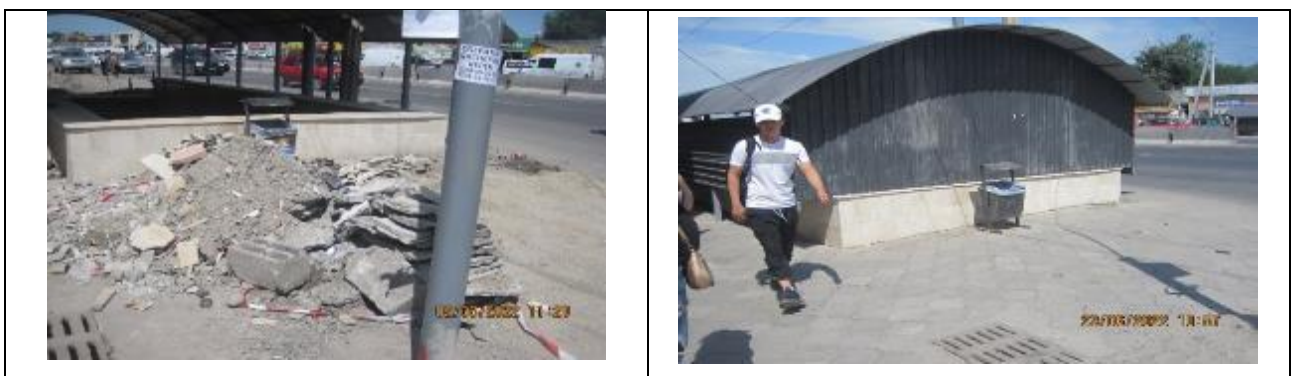
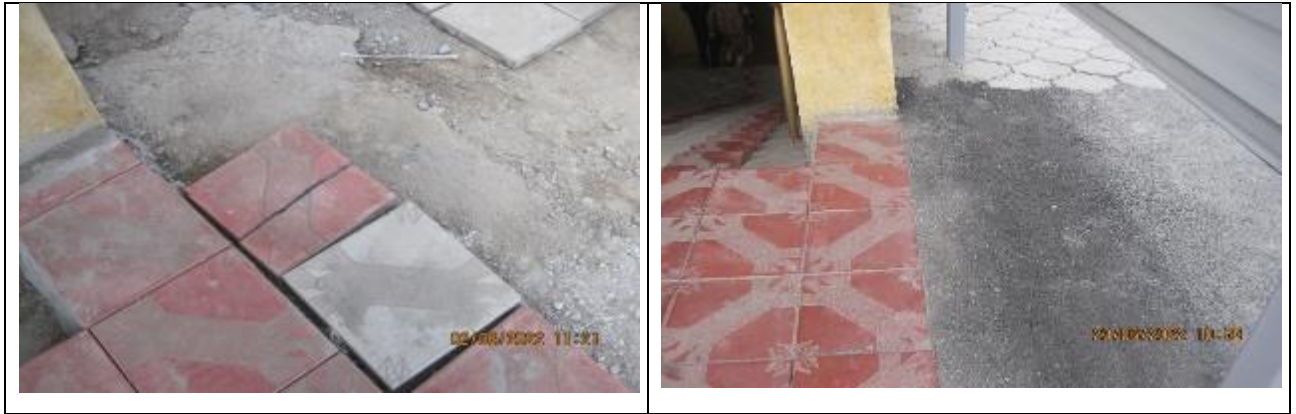
116. In the center of the Sokuluk, near the underpass under construction, a large amount of construction waste remained uncollected. Incorrectly laid paving stones are already cracked.

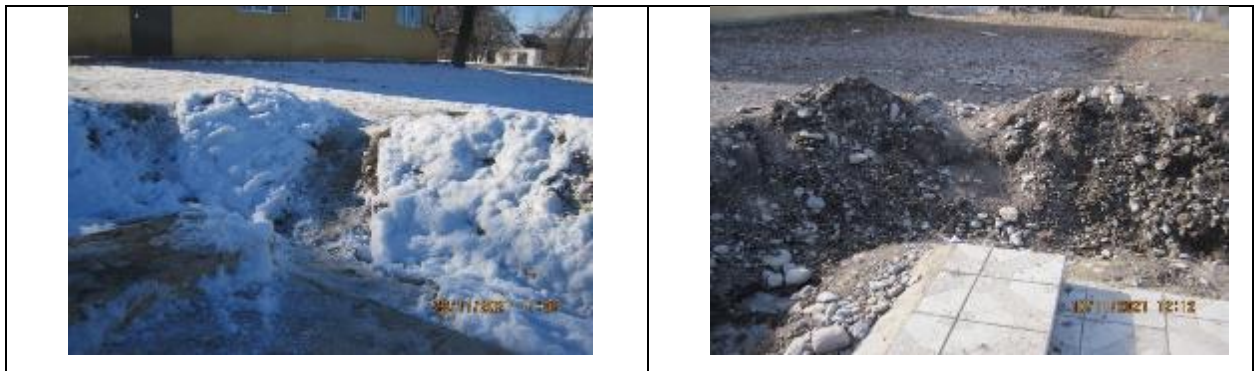
117. Also, construction waste was not removed, and the territory was not leveled near the underpass located opposite the school in the village of Novonikolaevka.

Figure 32 Construction waste around the underpass located near the school in the village of Novonikolaevka.

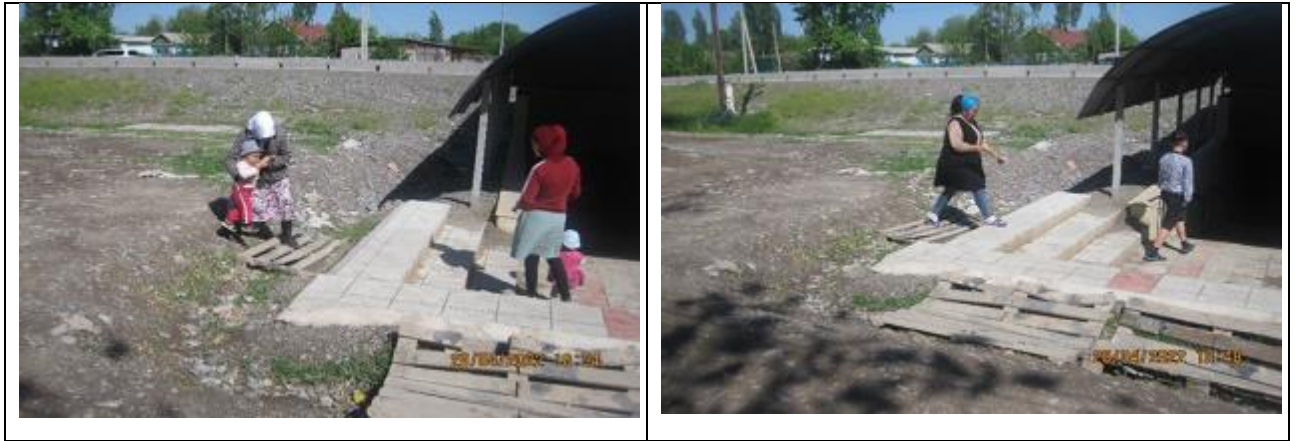
118. The area around the underpass near the school in the Novonikolaevka (km 59+640) is in an unsatisfactory condition. It was difficult for students to go down to this underpass, especially in icy conditions, which could cause falls and injuries. A letter was sent to the contractor to fix these violations. Violations were not fixed within the given deadlines.

119. A trench has been dug around the underpass to divert storm water, which complicates the approach to the underpass. It is difficult for residents to go down to this underpass, which can cause falls and injuries.

Figure 33 Violations near the underpass located opposite the school in the village of Novonikolaevka

120. A letter was sent to the contractor, until May 15th, to install drainage ditches with covering slabs in order to drain stormwater, to remove construction waste, level the area, make a gentle descent to the underpass. But so far, the violations have not been eliminated.

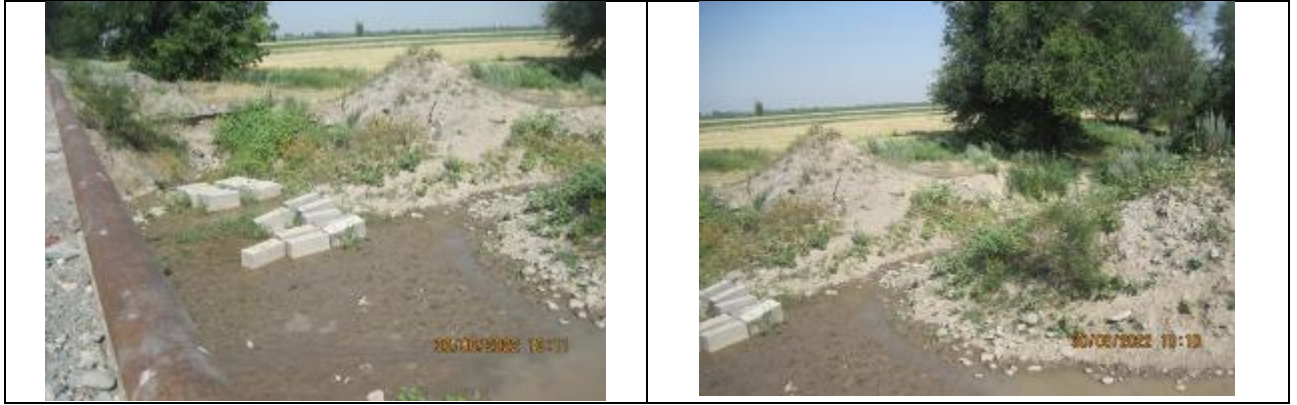
117 Near the Jelamysh River (km 18 + 360), wheel-safety parapet barriers of BO2 type were constructed. After the completion of the construction work, a large amount of soil, construction waste, and reinforced concrete structures remained in the Jelamysh riverbed.

Figure 35 Construction waste in the Jelamysh river

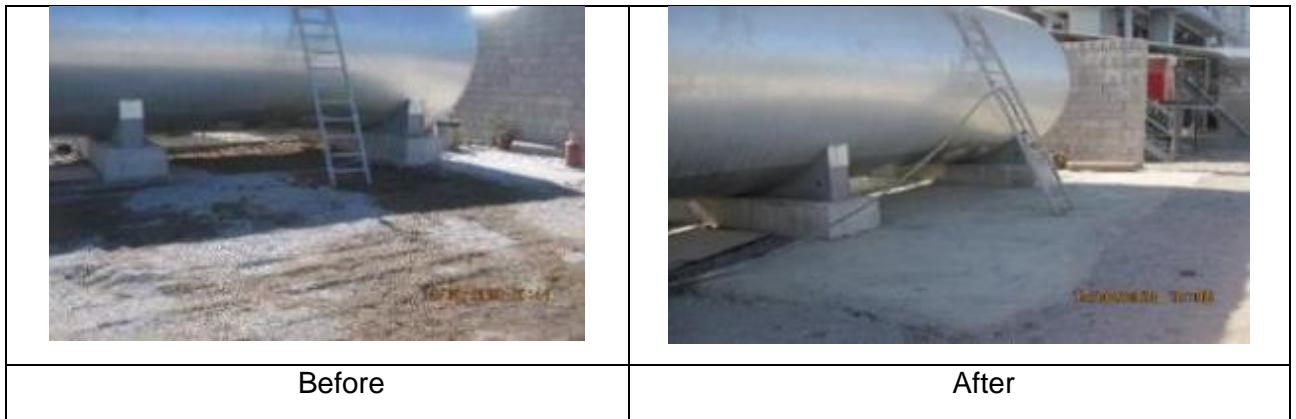
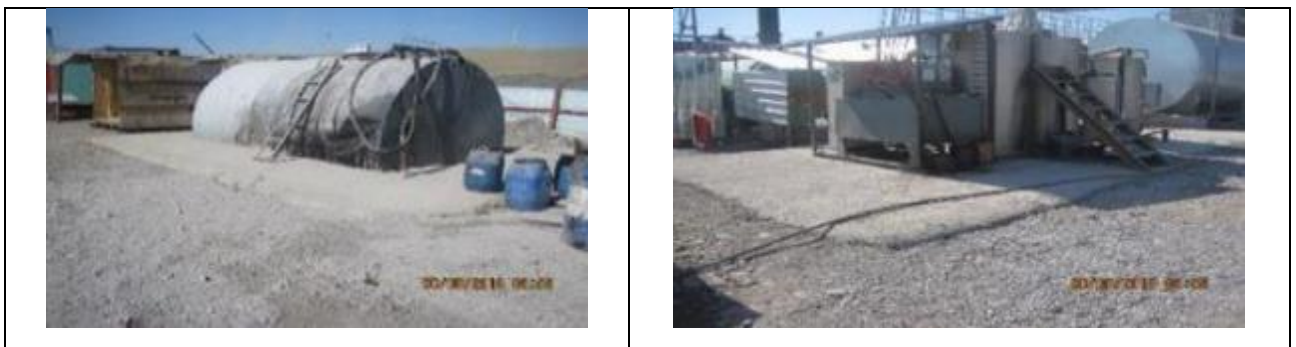
124. The territory of the plant is located in the bed of the Ak-Suu River on a pebble foundation, which is characterized by a high value of the filtration coefficient. To exclude soil contamination on the production site with bitumen and other chemical reagents that can get into the underground aquifer, the contractor was given clear instructions on the need to immediately clear the areas of bitumen and other chemical reagents leaks. This issue is under constant control by the Consultant.

Figure 37 Impermeable protective coating around chemical containers.

125. During the operation of the plant, all soil around the containers with chemicals should be protected from leaks and spills of hazardous materials with an impervious protective coating.

126. The contractor was recommended to protect the soil around the tanks with chemical reagents from spills and leaks of hazardous materials with an impenetrable protective coating. These recommendations were taken into account and implemented by the Contractor.

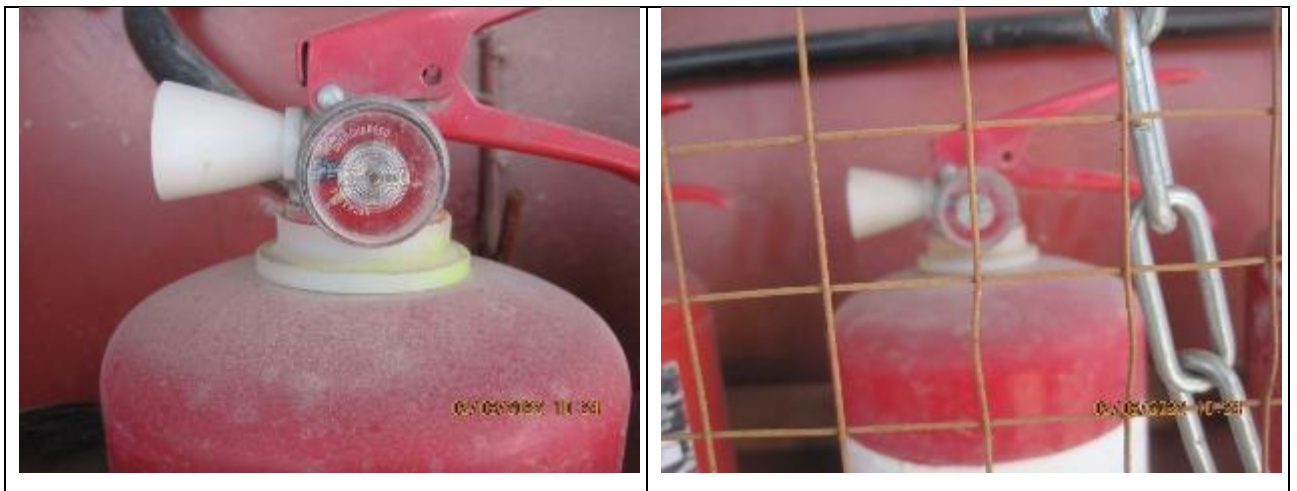
138. During monitoring at the workers' camp, it was found that two out of four fire extinguishers were out of order, out of date, it was necessary to recharge or purchase new ones. Despite the warnings in the reporting period the fire extinguishers were not replaced.

Figure 47 Fire extinguishers installed with violations on the territory of the production site.

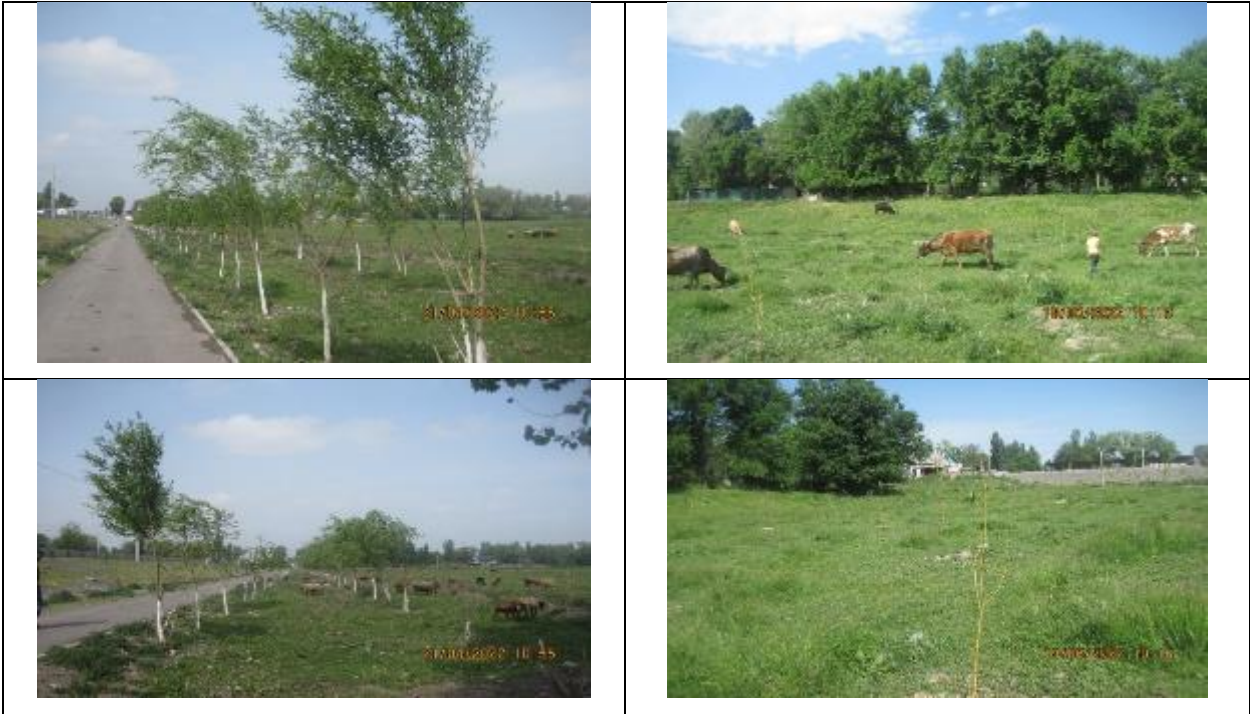
Figure 49 Livestock grazing on the plots of planted seedlings in the villages of Poltavka and Petrovka

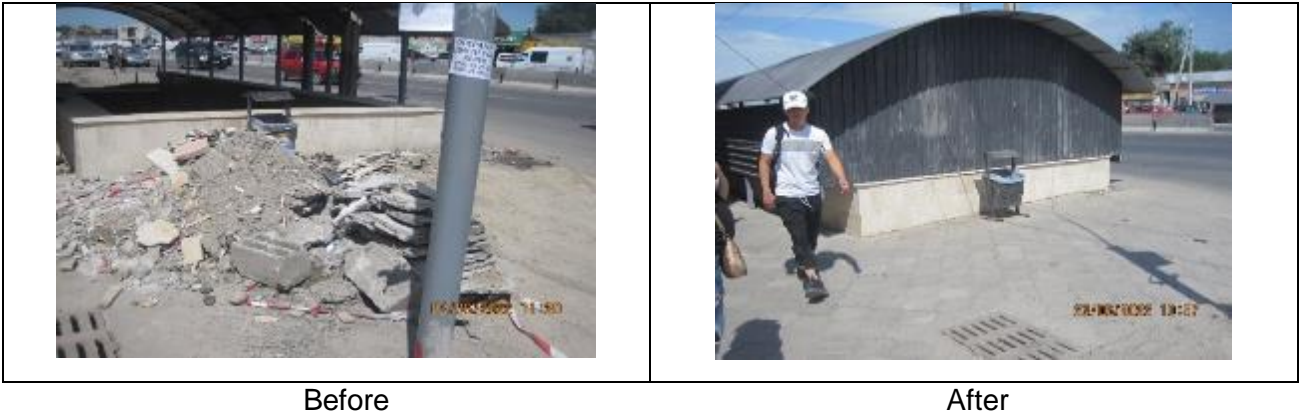
Figure 57. Construction waste near the underpass under construction in the center of the Sokuluk.
