Semi-annual environmental monitoring report

Project number: 45169-001

January - June 2022

Central Asian Regional Economic Cooperation Corridor 3 Improvement Project (Bishkek - Osh road), Phase 4, Bishkek-Kara-Balta section (km 8.5 - km 61).

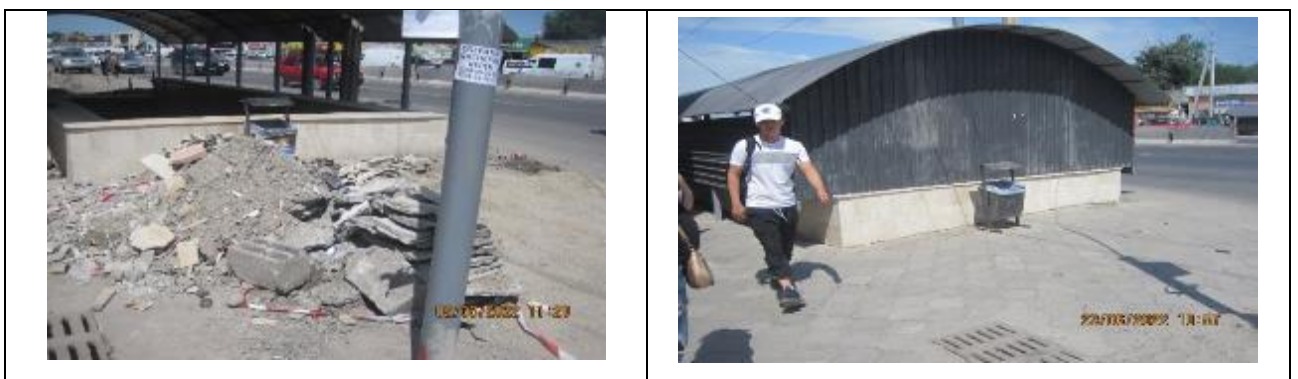
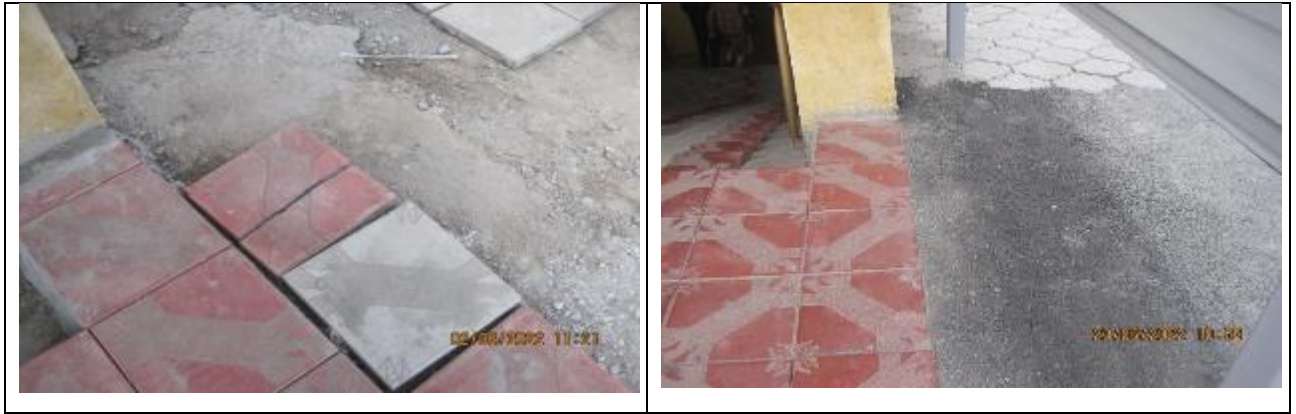
115. In the center of the Sokuluk, near the underpass under construction, a large amount of construction waste remained uncollected. Incorrectly laid paving stones are already cracked.

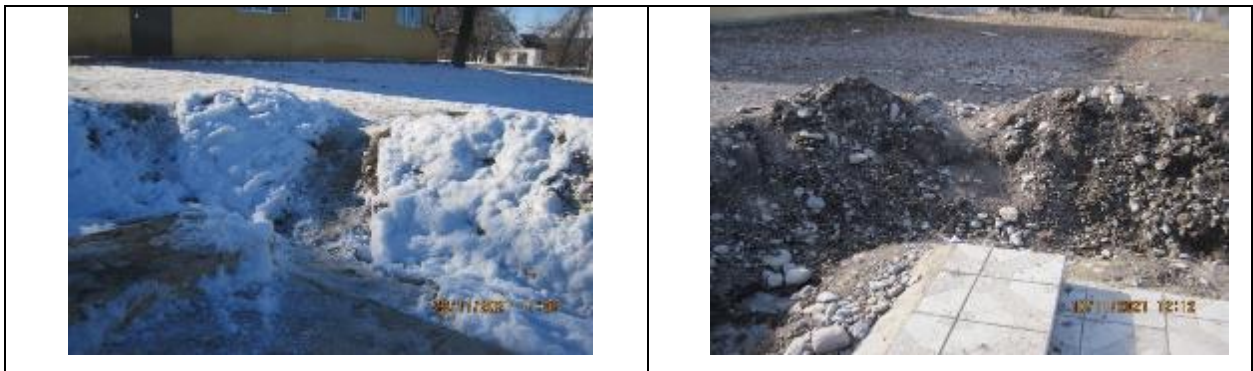
Figure 32 Construction waste around the underpass located near the school in the village of Novonikolaevka.

116. Also, construction waste was not removed, and the territory was not leveled near the underpass located opposite the school in the village of Novonikolaevka.

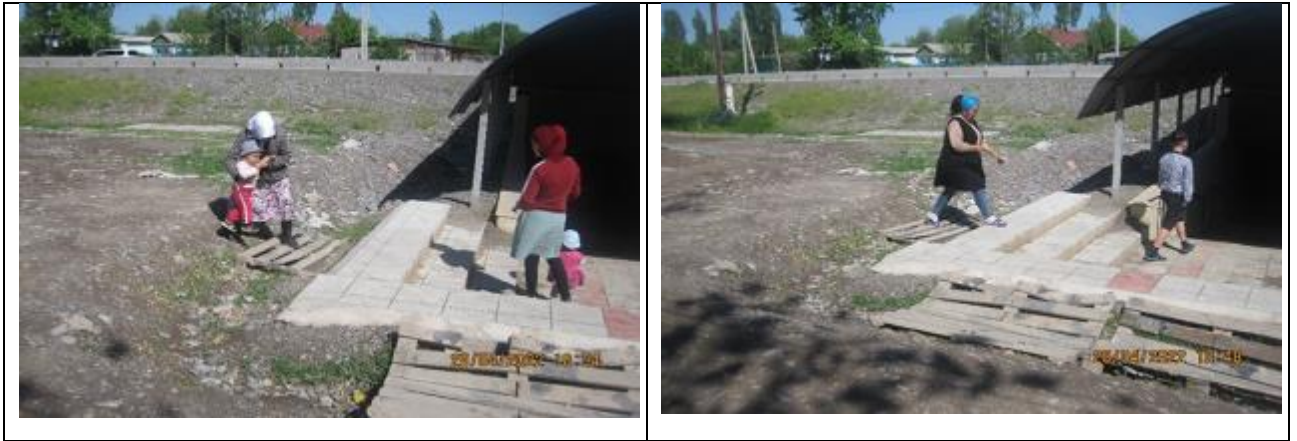
Figure 33 Violations near the underpass located opposite the school in the village of Novonikolaevka

117. The area around the underpass near the school in the Novonikolaevka (km 59+640) is in an unsatisfactory condition. It was difficult for students to go down to this underpass, especially in icy conditions, which could cause falls and injuries. A letter was sent to the contractor to fix these violations. Violations were not fixed within the given deadlines.

118. A trench has been dug around the underpass to divert storm water, which complicates the approach to the underpass. It is difficult for residents to go down to this underpass, which can cause falls and injuries.

119. A letter was sent to the contractor, until May 15th, to install drainage ditches with covering slabs in order to drain stormwater, to remove construction waste, level the area, make a gentle descent to the underpass. But so far, the violations have not been eliminated.

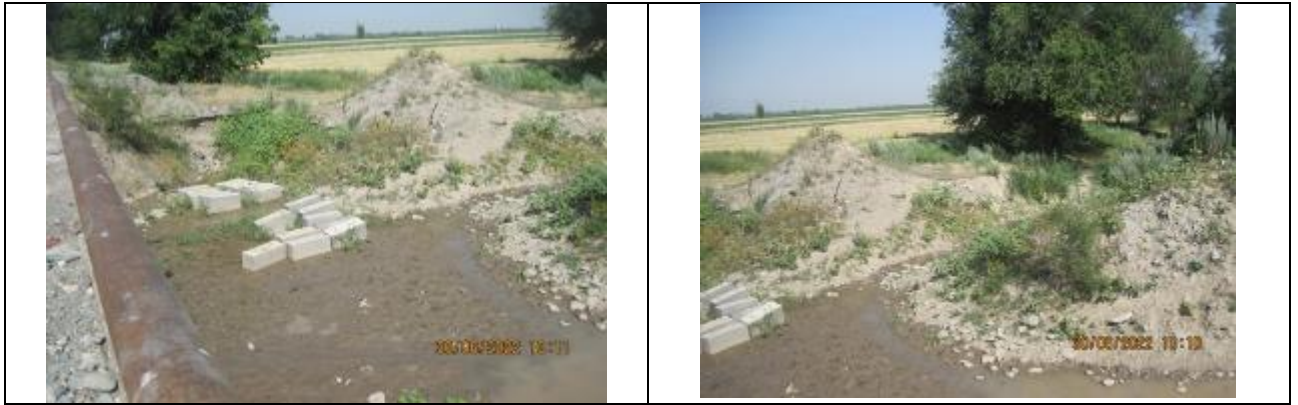
Figure 35 Construction waste in the Jelamysh river

117 Near the Jelamysh River (km 18 + 360), wheel-safety parapet barriers of BO2 type were constructed. After the completion of the construction work, a large amount of soil, construction waste, and reinforced concrete structures remained in the Jelamysh riverbed.

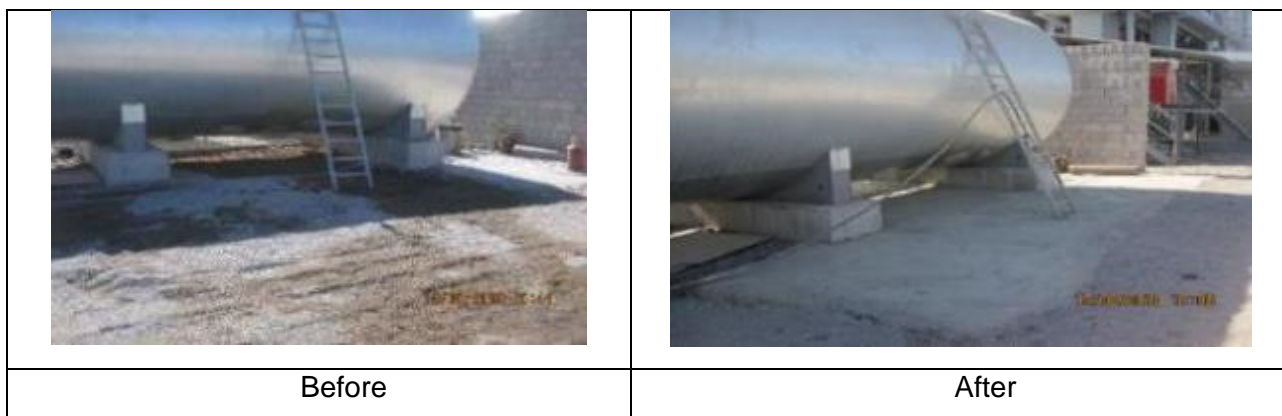
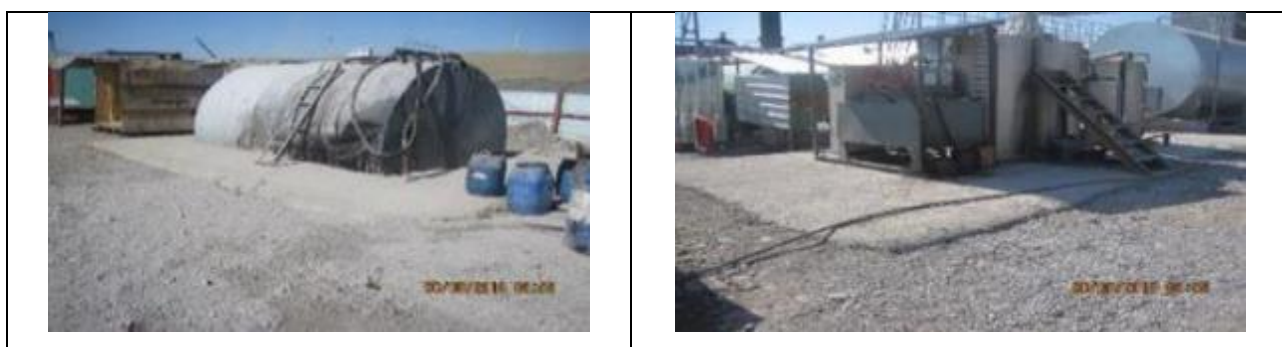
Figure 37 Impermeable protective coating around chemical containers.

123. The territory of the plant is located in the bed of the Ak-Suu River on a pebble foundation, which is characterized by a high value of the filtration coefficient. To exclude soil contamination on the production site with bitumen and other chemical reagents that can get into the underground aquifer, the contractor was given clear instructions on the need to immediately clear the areas of bitumen and other chemical reagents leaks. This issue is under constant control by the Consultant.

124. During the operation of the plant, all soil around the containers with chemicals should be protected from leaks and spills of hazardous materials with an impervious protective coating.

125. The contractor was recommended to protect the soil around the tanks with chemical reagents from spills and leaks of hazardous materials with an impenetrable protective coating. These recommendations were taken into account and implemented by the Contractor.

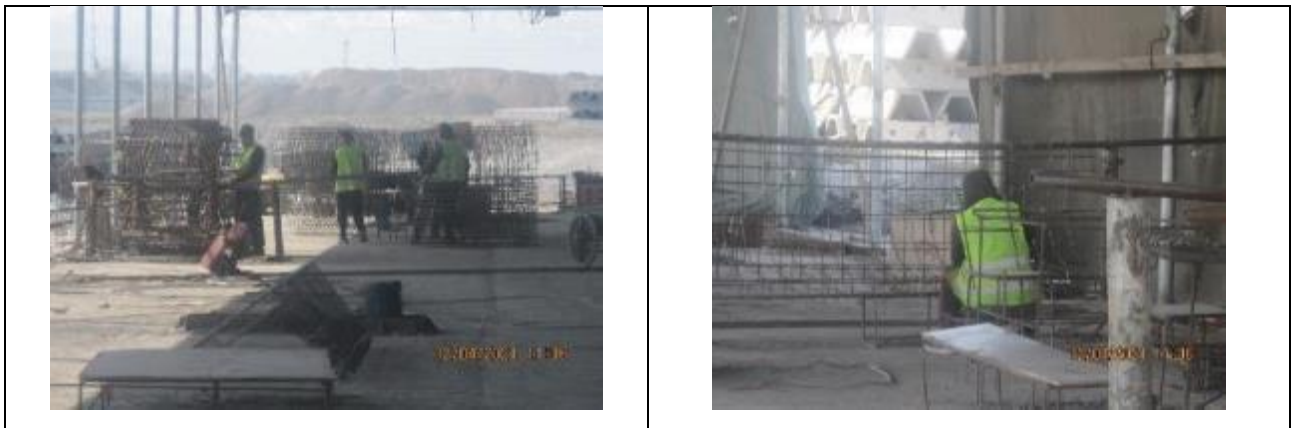
Figure 40 Production of reinforcing welded meshes, frames for the production of reinforced concrete structures

128. At the production site, manufacture of welded reinforcing meshes, frames for the production of reinforced concrete structures, pouring of various reinforced concrete products for the road needs (concrete rings, ditches, curbs, New Jersey-type fences, etc.) was also carried out. Workers are not provided with sufficient personal protective equipment.

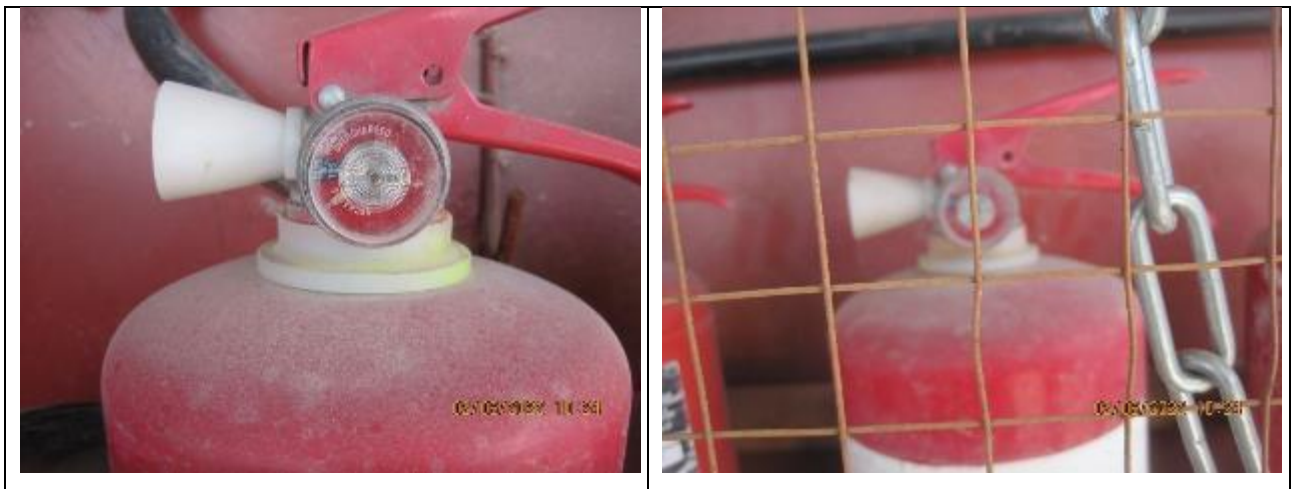
Figure 47 Fire extinguishers installed with violations on the territory of the production site.

137. During monitoring at the workers' camp, it was found that two out of four fire extinguishers were out of order, out of date, it was necessary to recharge or purchase new ones.

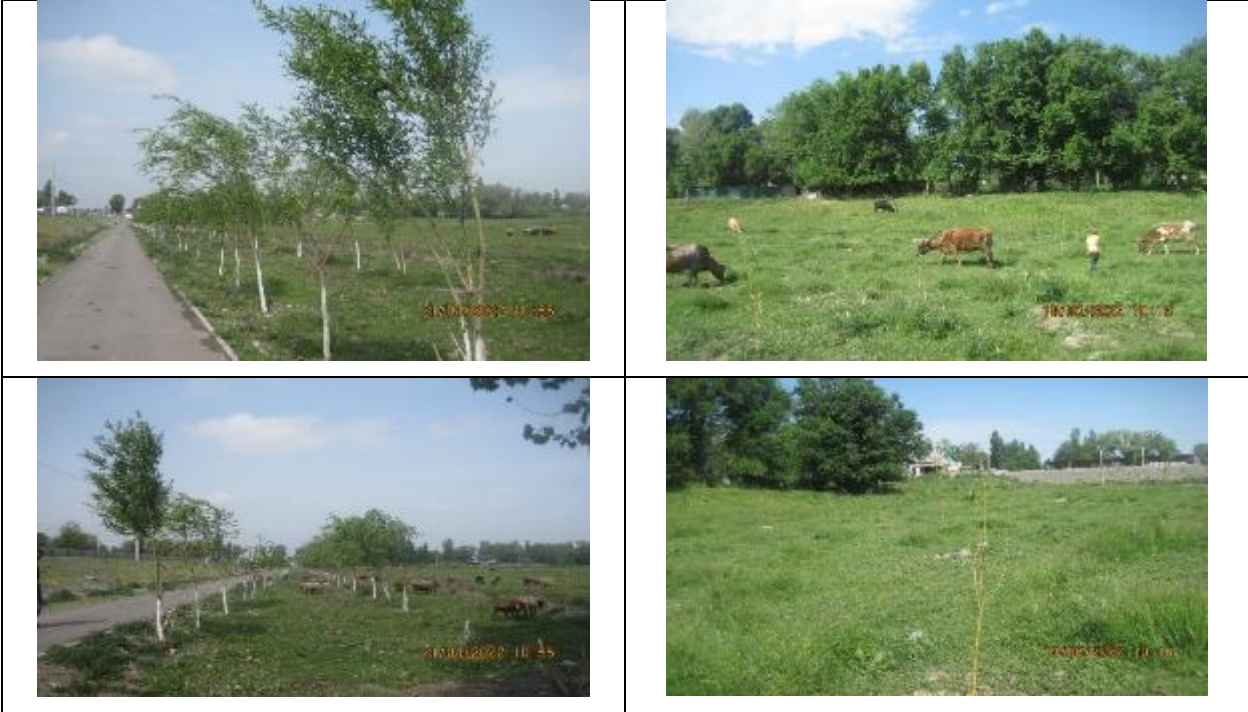
Figure 49 Livestock grazing on the plots of planted seedlings in the villages of Poltavka and Petrovka

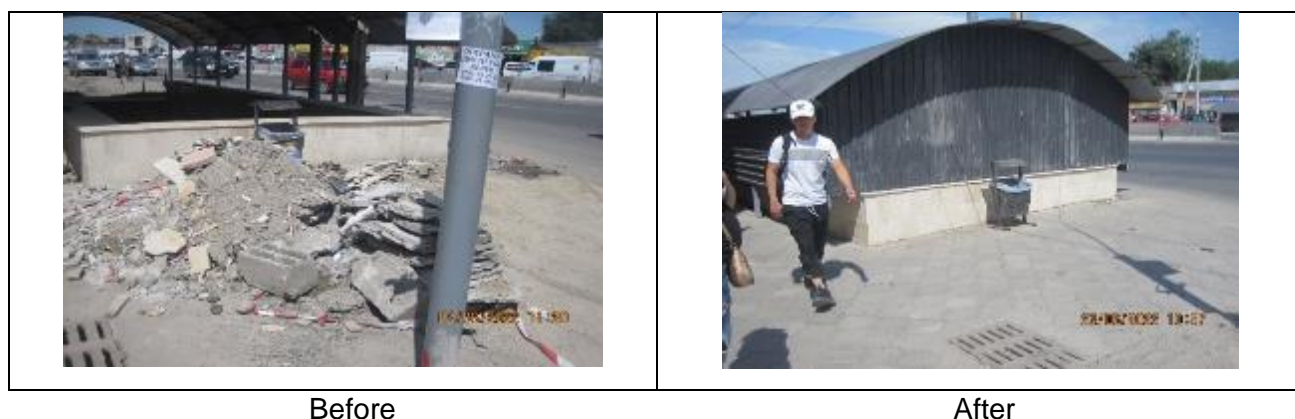
Figure 57. Construction waste near the underpass under construction in the center of the Sokuluk.
