Environmental Monitoring Report

January–June 2022

Kyrgyz Republic: Central Asia Regional Economic Cooperation Corridors 1 and 3 Connector Road Project (Phase 2) - Additional Financing

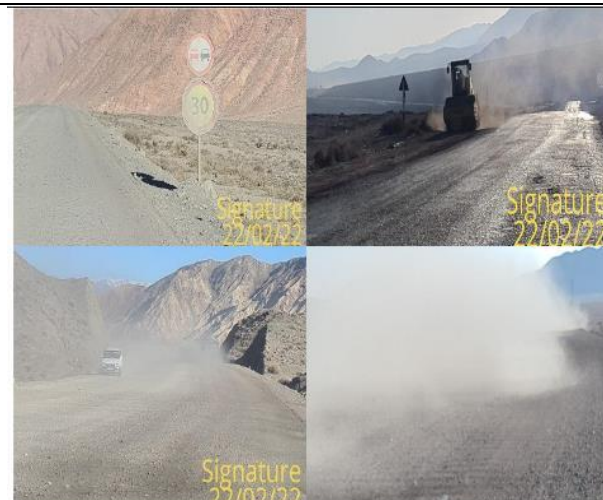
Photo 55: Dust at km 15+900, Km 41+750, km 16-36.

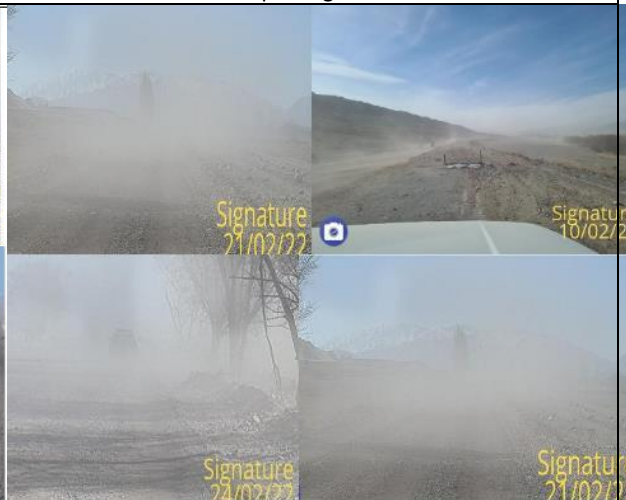
Photo 56: Dust at km 71+500, km 72+680, km 81 to km 86,

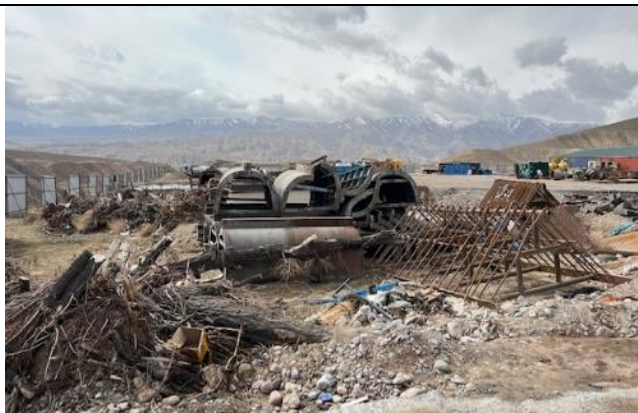
Photo 61 Scrap materials around the fabrication area.

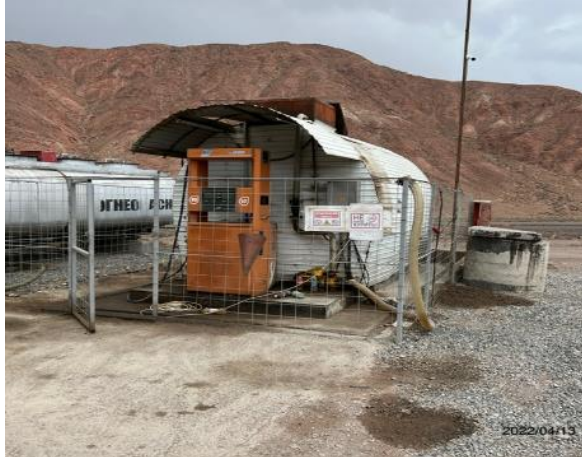
No n/n	Observed Non-compliance or Violations	Proposed Corrective Measures (PCM)	Deadline for Compliance	Status (as of 30 June 2022)
Lot 1				
1	Pollution of the area around the gas station (photo 63)	Ensure that the area is cleaned up from oil contamination.	17 June 2022	Done (photo 64)
2	Storage conditions for waste equipment, spare parts do not meet the sanitary and environmental requirements (photo 65).	Ensure separate storage in accordance with environmental requirements	17 June 2022	Done (photo 66)
3	Complete the construction of a concrete septic tank to collect wastewater from the Concrete Mixing Plant.		April 2022	Done (photo 67).
Lot 2				
5	An additional diesel fuel storage tank has been installed in the fuel depot without providing measures to collect diesel fuel in case of emergency leakage/spillage	The area under the tank, in the area of possible fuel leaks (the place where the hose is connected to the tank)- must have a hard waterproof surface, fenced along the perimeter with a 200 mm high rim. A container for collecting emergency fuel spills should be installed. The capacity of this container should not be less than the capacity of the fuel storage tank (Construction standards of the Kyrgyz Republic "Fillin stations" dated 12.11.2018)	Due by 25 Nov. 2021 Extended until March 2022.	Due to the impossibility of performing concrete work related to the cold weather, the Contractor committed to correct the issue by the end of March 2022. Current status: not done. The fuel tank is owned by the subcontractor which was recently replaced. Tank has not been operated. If the tank will be operated in future,

<p>Photo 63. Spills of fuel ion the ground.</p>	<p>Photo 64. Contaminated soil was removed and area cleaned.</p>

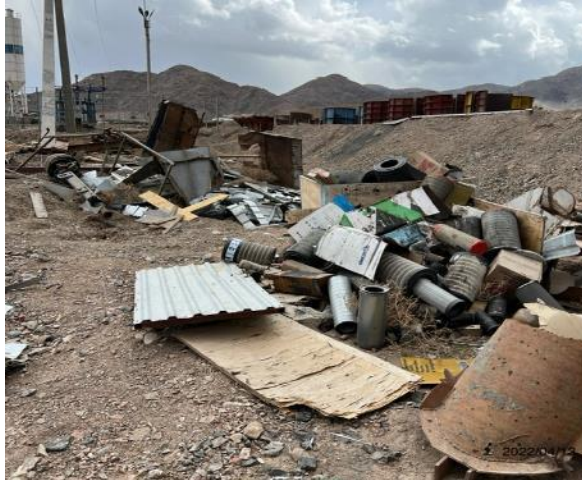
<p>Photo 65. Scrap materials around the site.</p>	<p>Photo 66. Scrap materials removed and the site cleaned.</p>

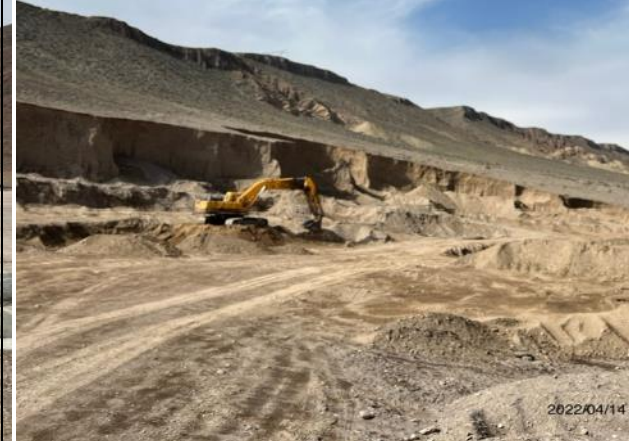
No n/n	Observed Non-compliance or Violations	Proposed Corrective Measures (PCM)	Deadline for Compliance	Status (as of 30 June 2022)
				the CSC will give a new deadline for compliance.
6	At Lot 2, during the development of the open pit at km.71+500 and 81+200, the requirements of industrial safety in terms of ensuring stability of the sides of the open pit are not met: there is a risk of collapse, i.e. the angle of slope of the wall of the pit is 90 °, according to "Methodological instructions to determine the slope angle of the boards, slopes, benches and dumps, construction and operated open pits are equal to 70 ° - which ensures the stability of the boards (photo 68)	The Contractor was issued Instructions on the need to ensure stability of the pit walls during quarrying (letter KGZ4267/02/01/JPL/109 dated 23.11.2021).	Continuously throughout the development period	Done by the last quarter of 2021 for the quarry at km 81+200. Done by June 2022 for the quarry at km71+500 (photo 69)

<p>2022/04/14</p>
<p>Photo 67. A 3-chamber holding tank has been provided for the concrete batching plant.</p>	<p>Photo 68. Methodology of soil quarrying at km71+500 is not meeting the required angle for stability and safety.</p>

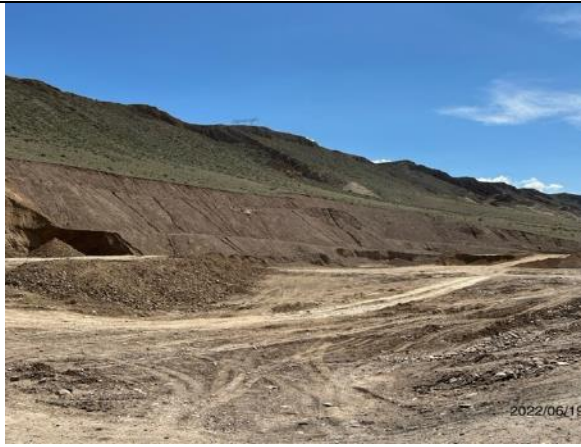
Photo 69. Methodology for soil quarry has been changed to prevent erosion and ensure safety.

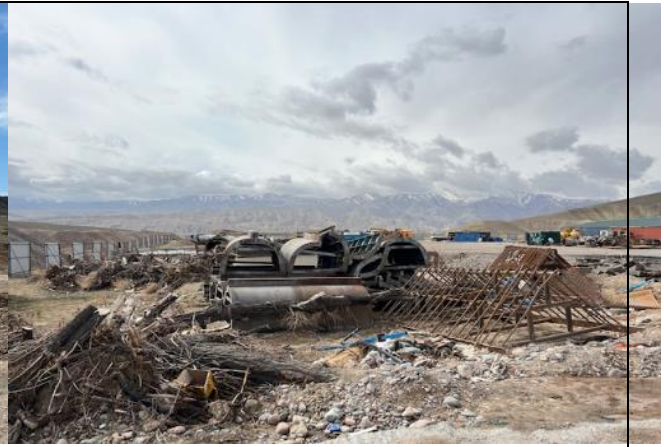
Photo 70. Storage of scrap materials not meeting the environmental requirement.

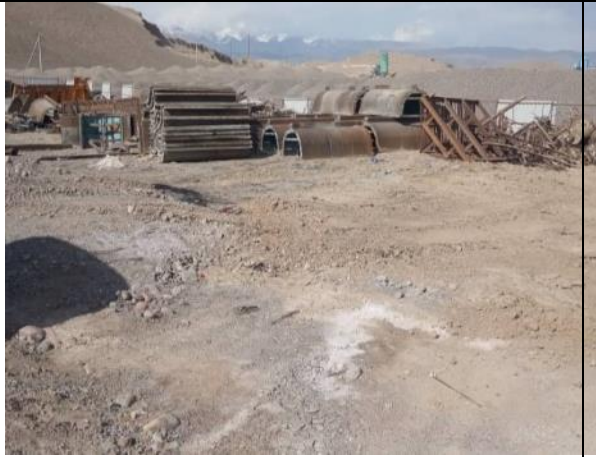
Photo 71. Scattered scrap materials have been removed and the site has been cleaned.

7	There are emissions coming from some parts of the asphalt plant which are not fully sealed, and due to damages in the connecting hoses	Inspect connection hoses, gate valves, joints on the process equipment and the concrete mixing plant and ensure that these are properly sealed before operation.	immediately	Done
8	Provide a watertight holding tank for collecting wastewater from the concrete mixing plant in Lot 2.		Before 15 Aug 2022	
9	Bitumen adhesive additive is stored under direct sunlight, which is unacceptable and can lead to its unserviceability and, consequently, the formation of waste	Ensure storage conditions of the adhesive additive, preventing direct sunlight	By June 17, 2022	Done
10	The conditions of collection and storage of garbage and equipment do not meet the sanitary and environmental requirements (photo 70).	Ensure separate storage in accordance with environmental requirements	By 17 June 2022	Done (photo 71)
