Semi-annual environmental monitoring report

Project number: TA-8887 KGZ

July-December 2022

Kyrgyz Republic: Central Asia Regional Economic Cooperation Corridors 1 and 3 Connector Road Project (Phase 2) - Additional Financing

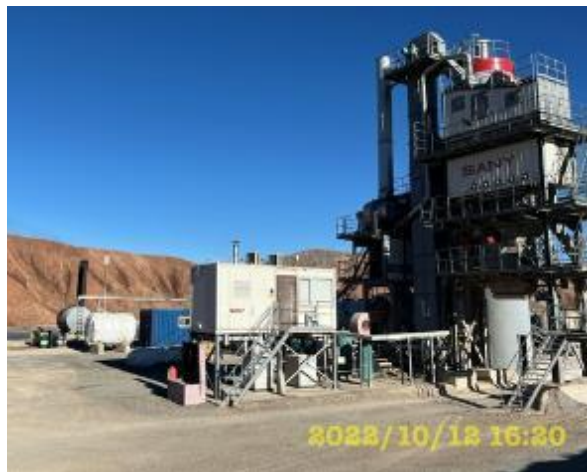
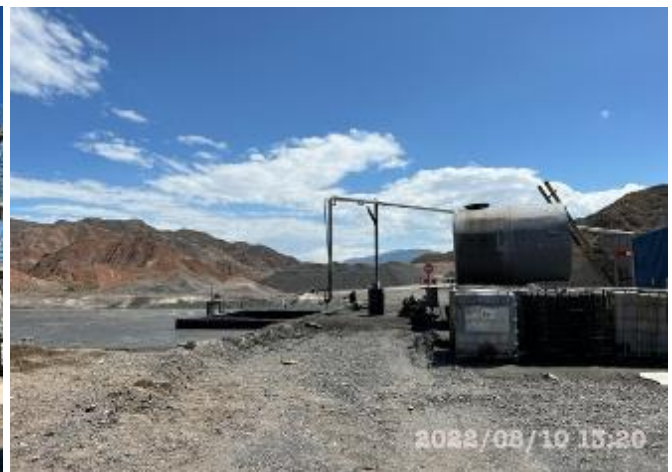
Photos 54. Lot 1. Production base. ABS and fuel oil storage

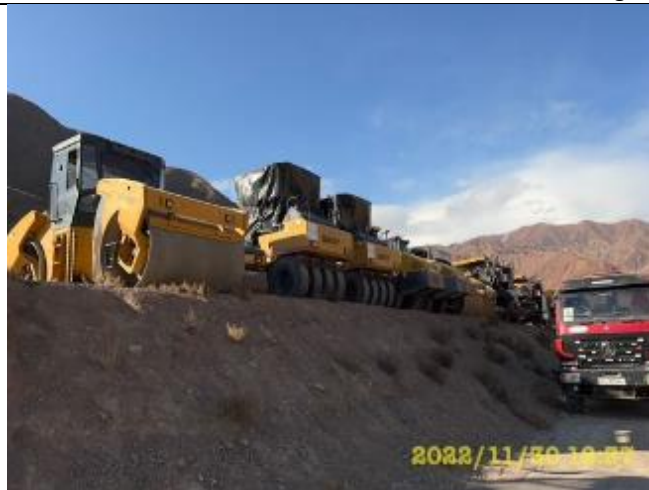
Photos 55. Lot 1. Parking of vehicles and equipment.

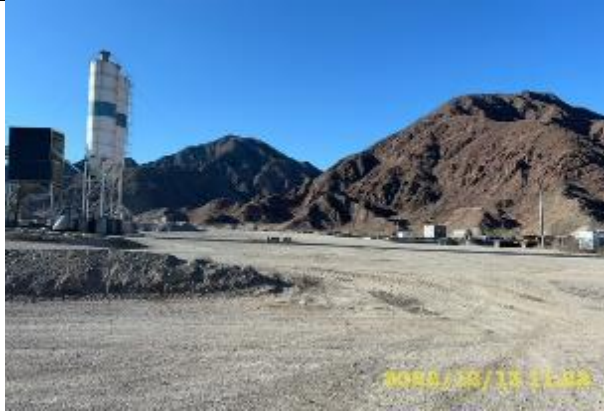
Photos 56. Lot 1. Production base. PRODUCTION FACILITY. Sanitary condition of the territory of the industrial base is satisfactory.

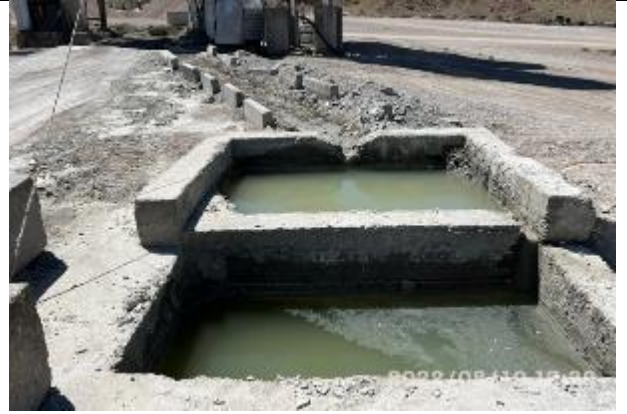
Photos 57. 3-chamber primary wastewater treatment tank BSU Lot 1.

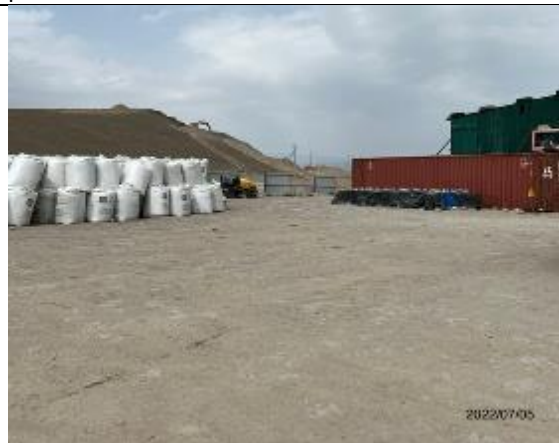
Photos 70. Sanitary condition of the territory of the production base is satisfactory

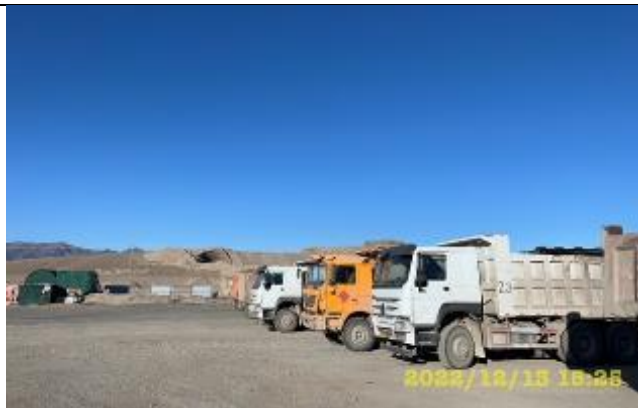
Photos 71. Lot 2. Sanitary condition of the territory of the production base of the parking lot is satisfactory

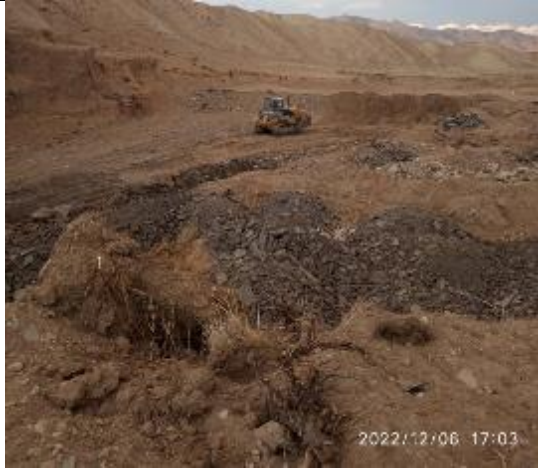
Photos 74. Planning of the old asphalt dump at km 89+500

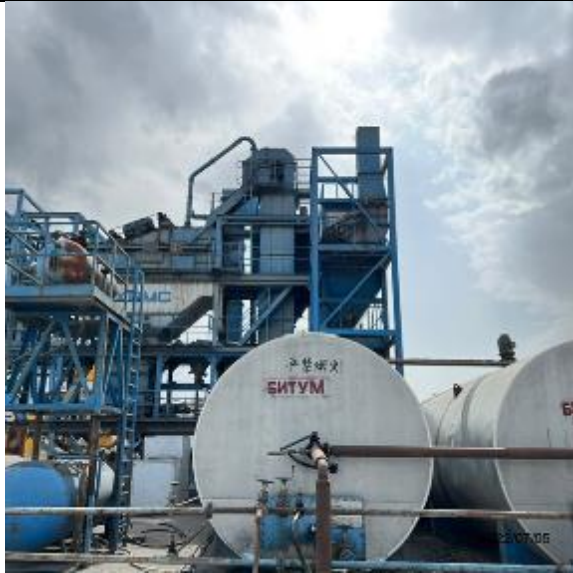
Photos 76. The AC plant on Lot 2. Tanks and reservoirs are marked

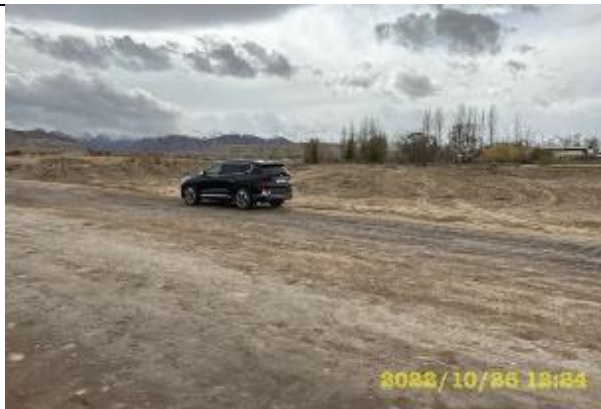
Photos 78. Behind the bypass road reclaimed unusable soil dump located at km.65+520

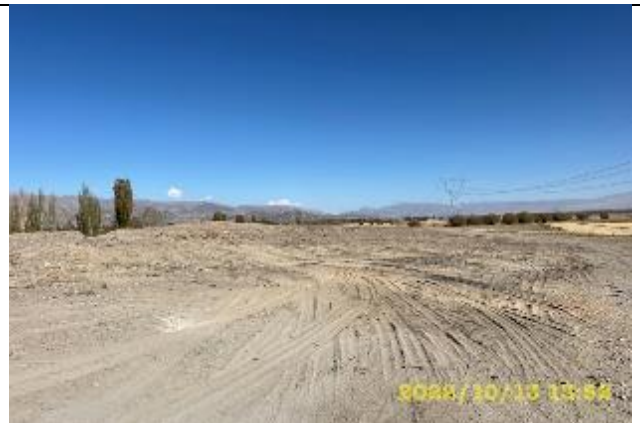
Photos 79. Recultivated old asphalt dump, located at km 70+180, on the left side of the road
