Semi-annual Environmental Monitoring Report

Semi-annual Environmental Monitoring Report
July to December 2025

CAREC Corridors 1 and 3 Connector Road, Section 2B Epkin-Dyikan [Bashkugandy], Km: 89+500 – 159+200 Project

Olga Syzonenko, International Environmental Consultant,
Gentek International Engineering and Consulting Ltd.
Jumaliev Talantbek, Local environmental specialist,
Gentek International Engineering and Consulting Ltd.
Bishkek, Kyrgyzstan: January 2026

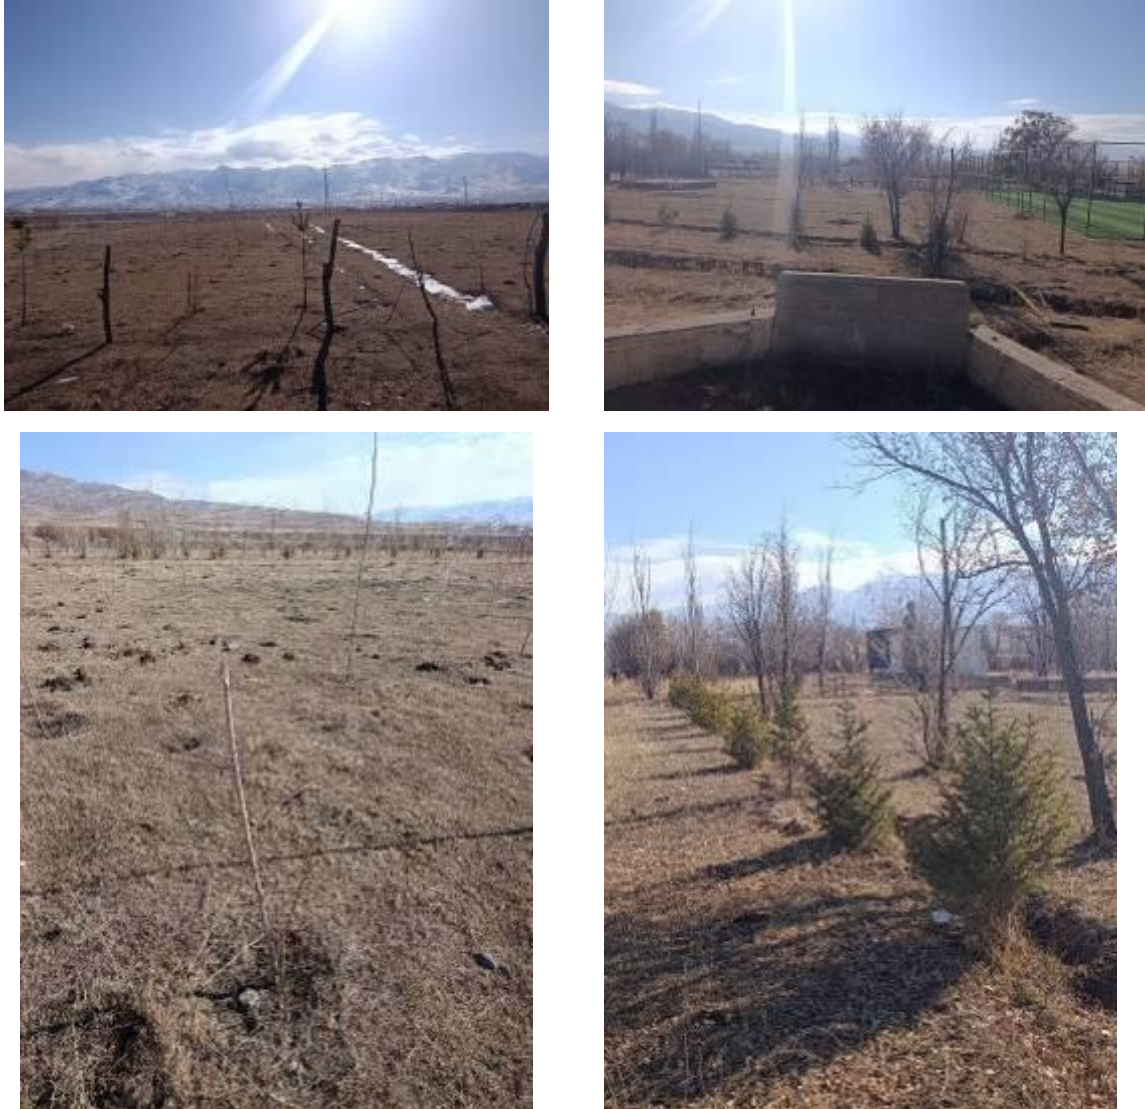
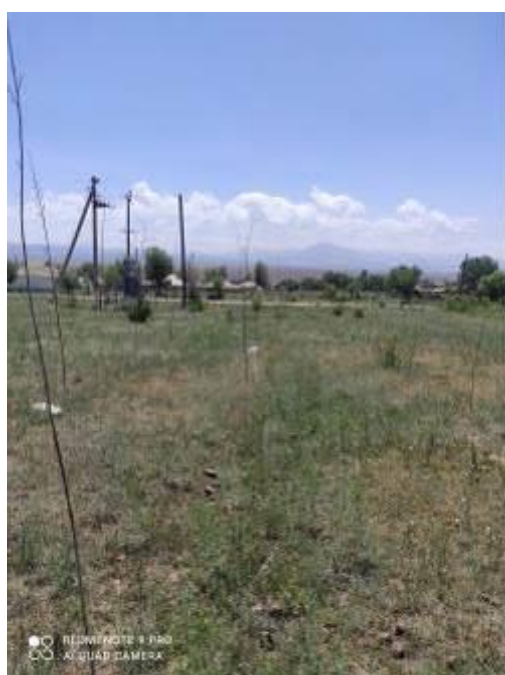
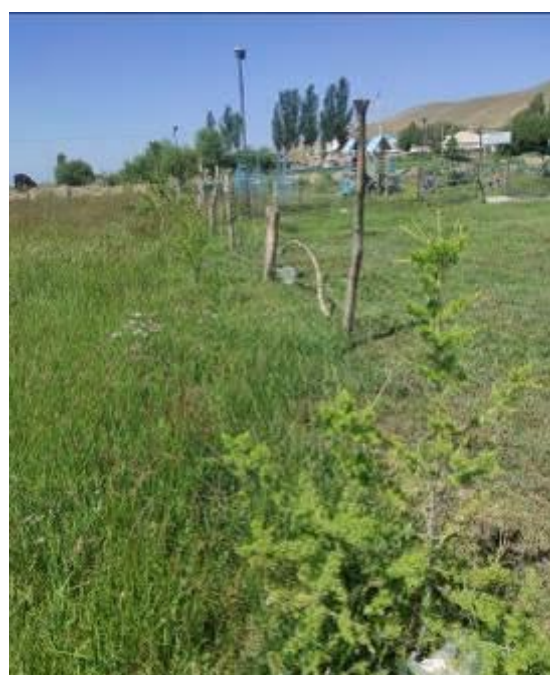
Figure 26: State of compensatory trees, autumn 2025

8. At the same time, one open and critical issue remains - compensatory tree planting. A spring inspection showed that 71% of the saplings planted in 2024 failed to survive due to inadequate maintenance. The Contractor confirmed its intention to carry out mass replanting in April 2026, with a follow-up inspection scheduled for March 2026. This activity remains the only long-term corrective measure under continuous monitoring.

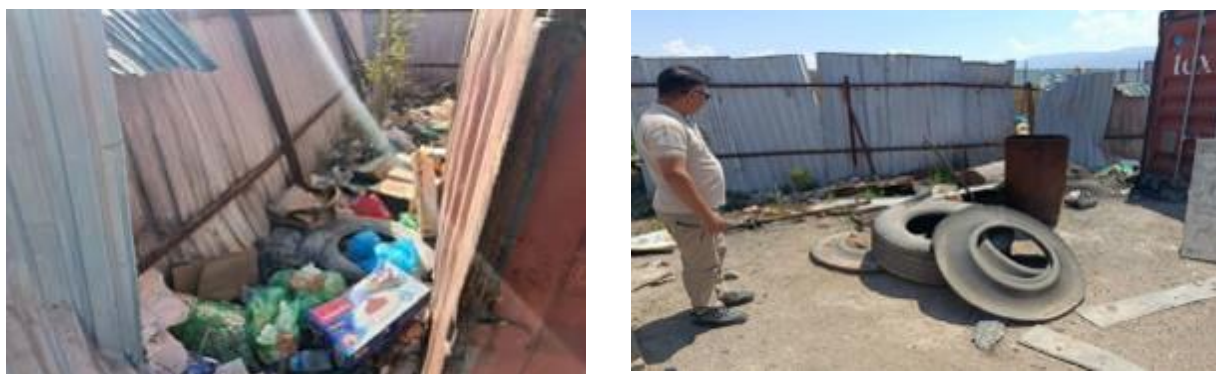
Figure 32: Chronic accumulation of household and construction waste

261. Chronic accumulation of household and construction waste. The construction camp (km 148+630) is not systematically cleared of household and construction waste. Inspections have recorded the accumulation of various types of waste directly near waste sites, rather than in containers or designated areas (see the figure below).

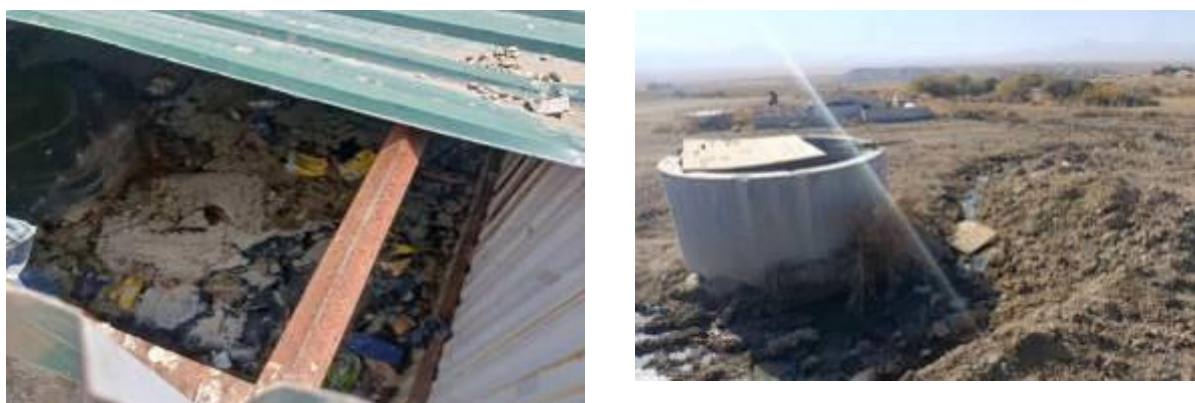
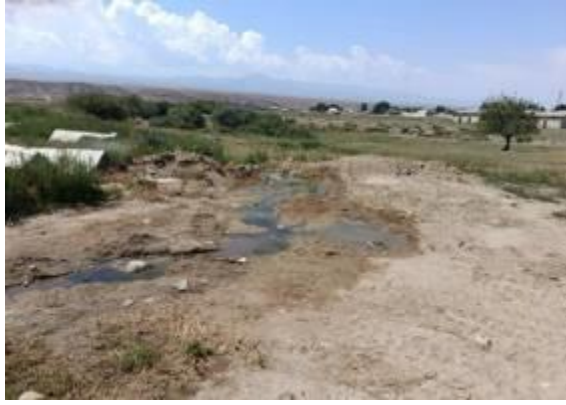
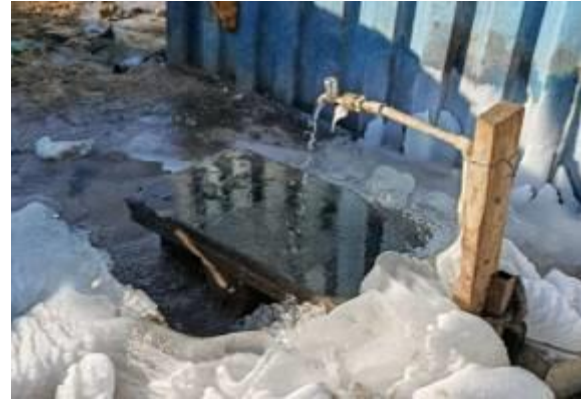
Figure 33: Improper operation of septic tanks

- Overflow and clogging: Septic tanks for wastewater (particularly from showers) are constantly overflowing, which prevents their normal functioning.
- Direct soil contamination: Due to overflowing or malfunctioning septic tanks, dirty water is discharged directly onto the ground, polluting the environment.
- Lack of sealed collection: By November, it was recorded that water from showers was being discharged directly onto the ground, bypassing the septic system (see the figures below).

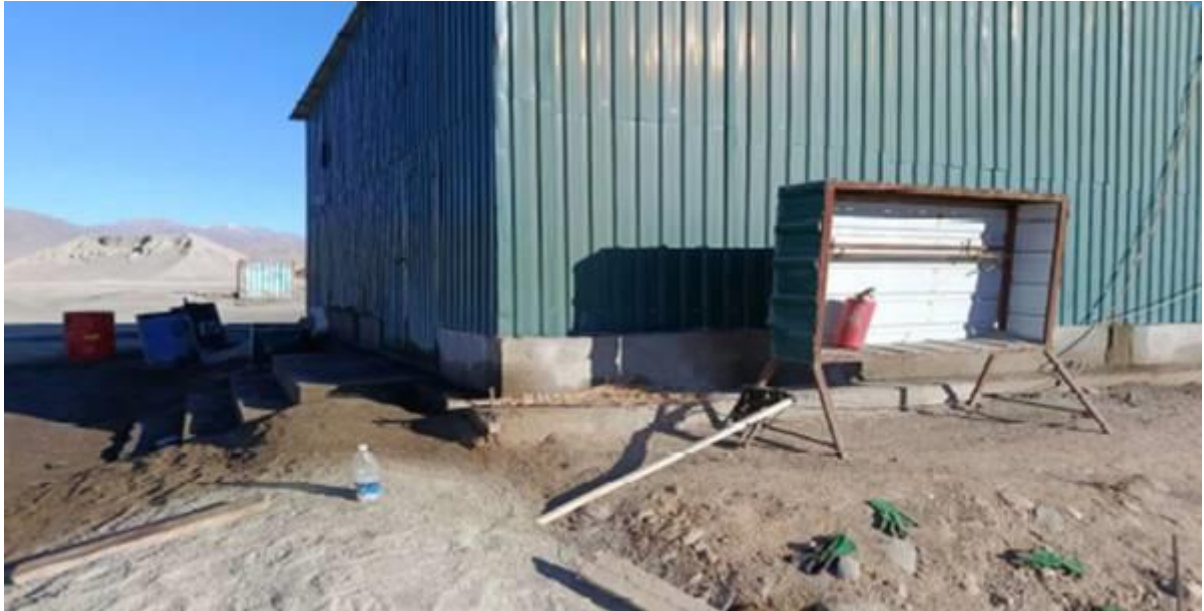
Figure 36: Incomplete fire shields

- Incomplete fire shields: Fire shields in the camp and at the production site (km 148+630) were consistently in poor condition.
- Lack of inventory in critical areas: Empty or incomplete fire shields were recorded near the fuel depot (fuel depot) and near the laboratory (see figure below).

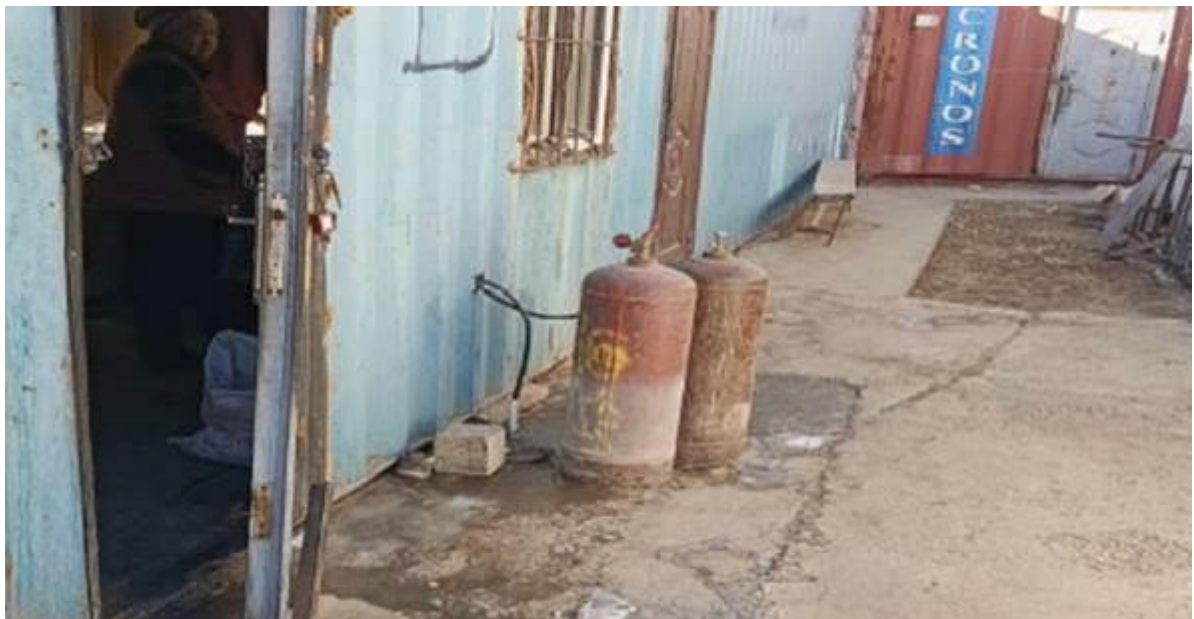
Figure 37: Violation of gas cylinder storage

277. Violation of gas cylinder storage: From September to the end of November, improper storage of gas cylinders was recorded. They were not protected from direct sunlight and precipitation, which constitutes a serious safety violation when working with pressure vessels (see figure below).

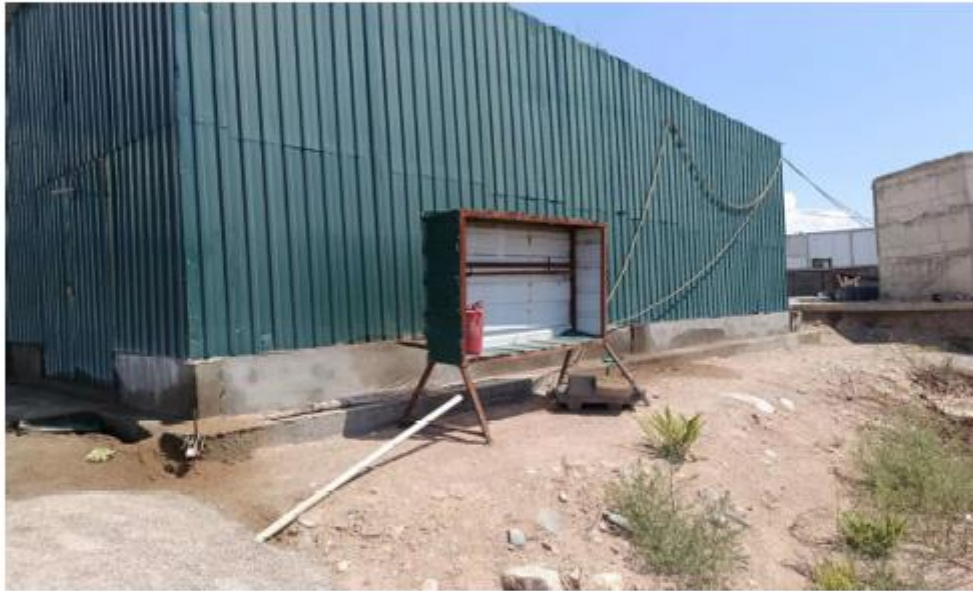
Photo 1. The fire safety panel near the fuel storage facility is not fully equipped.

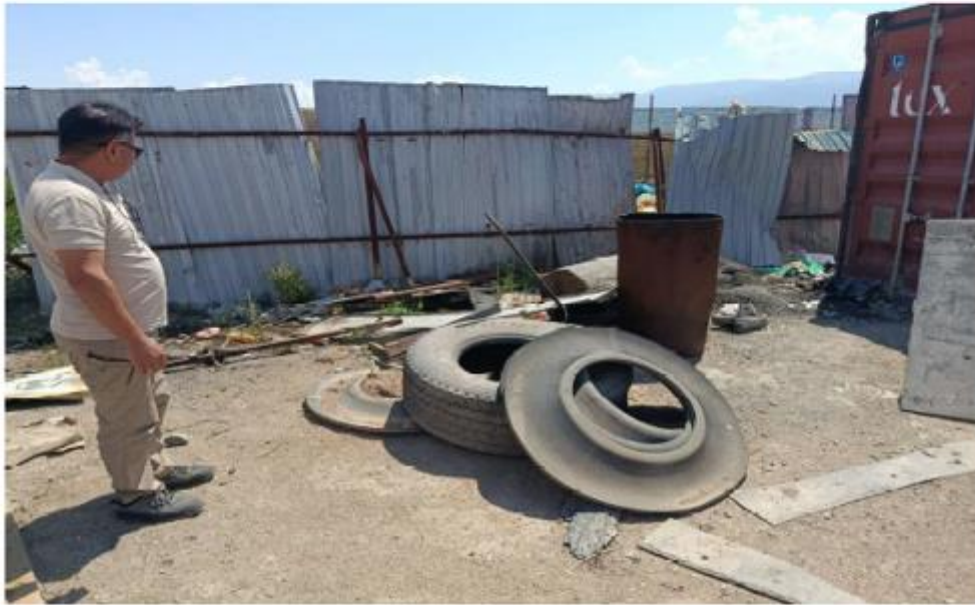
Photo 2. Various kinds of waste have accumulated near the garbage area.

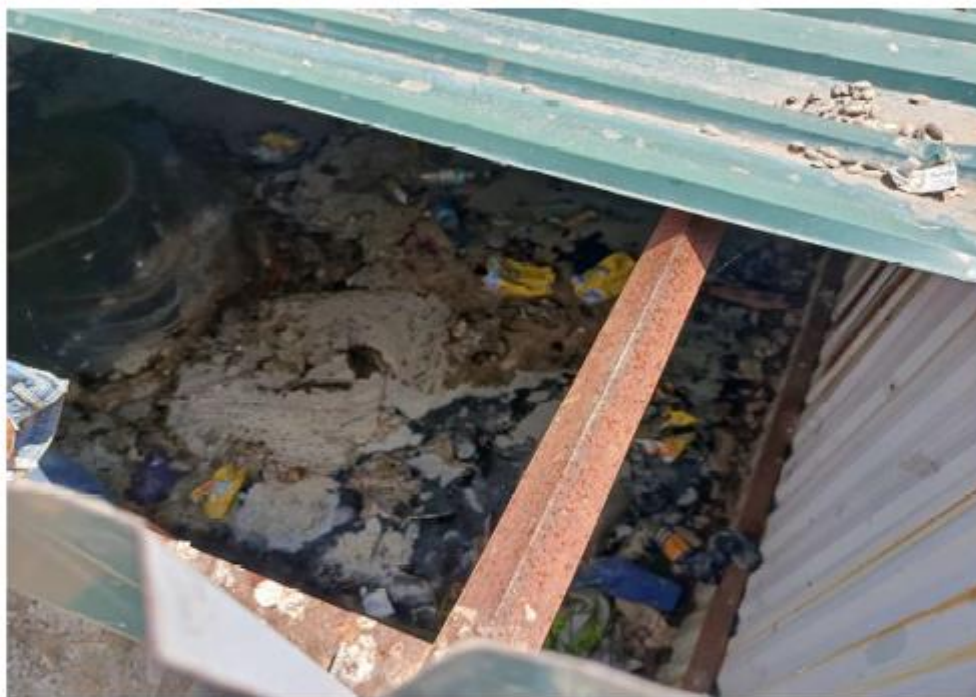
Photos 3. The septic tank is overflowing, filled with garbage.

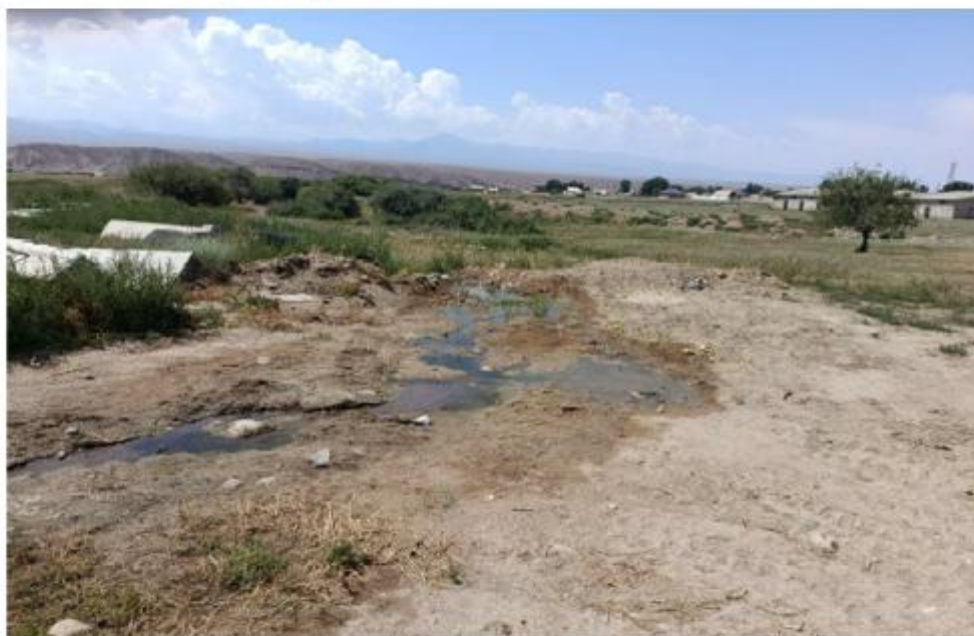
Photo 4. The septic tank is full and dirty water flows directly onto the terrain and pollutes the environment.

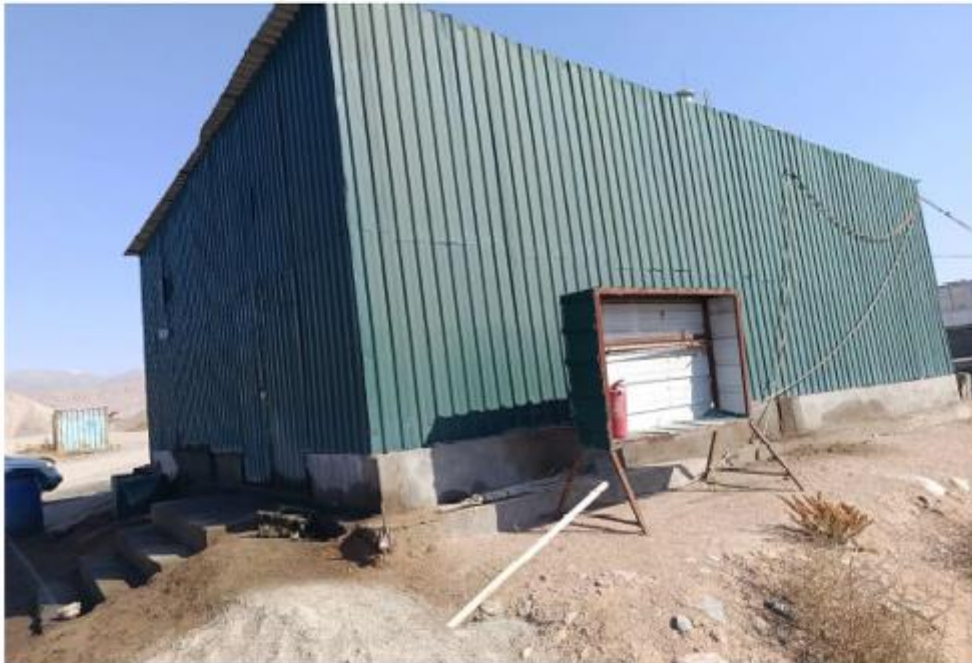
Photo 1. The fire extinguishing panel near the refueling warehouse is not equipped.

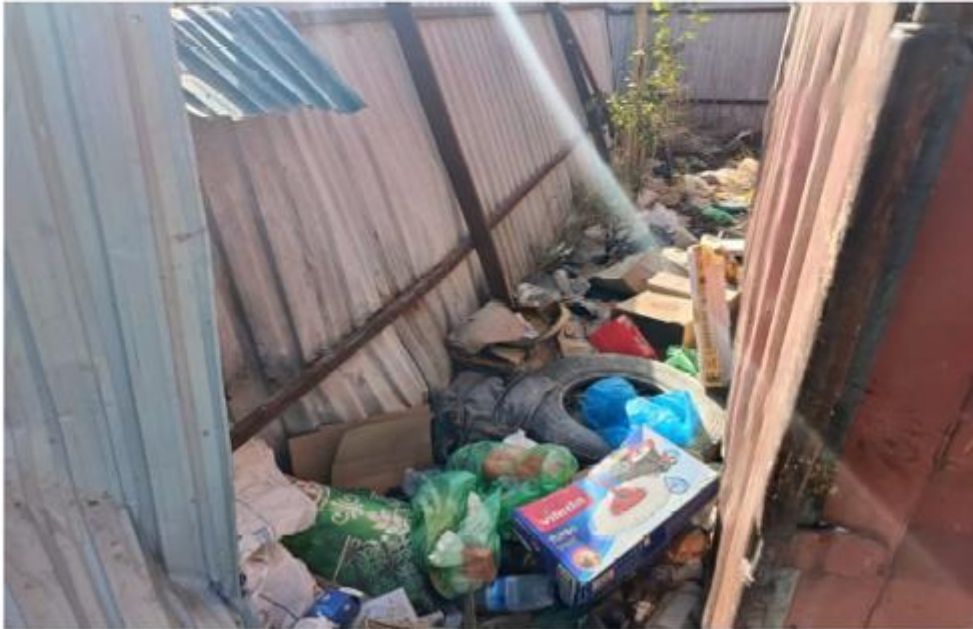
Photos 2. Waste accumulated near the garbage platform.

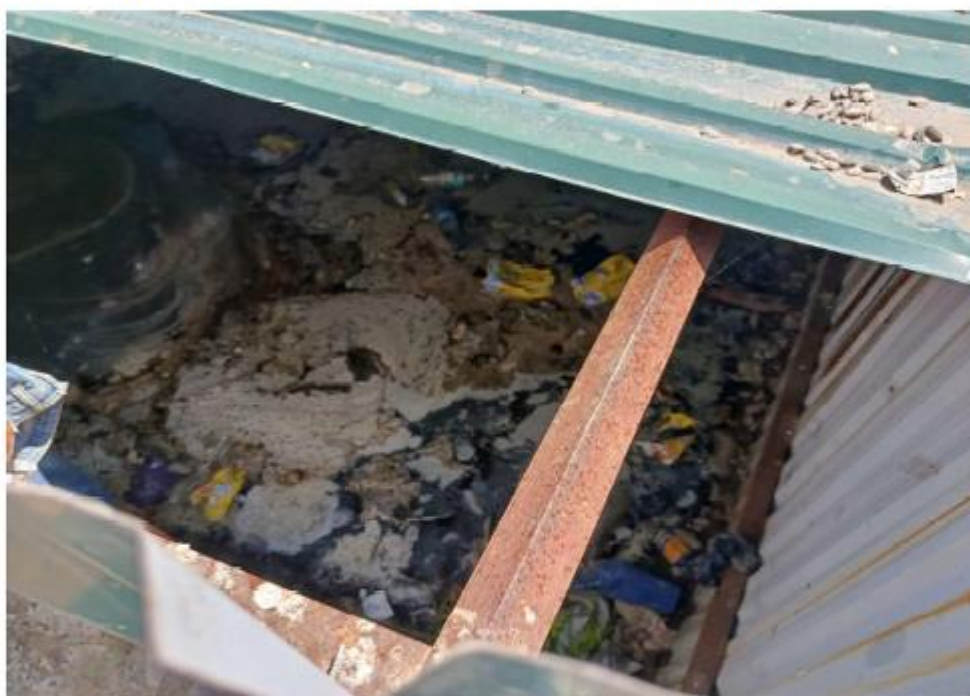
Photo 3. The septic tank is overflowing, littered with garbage.

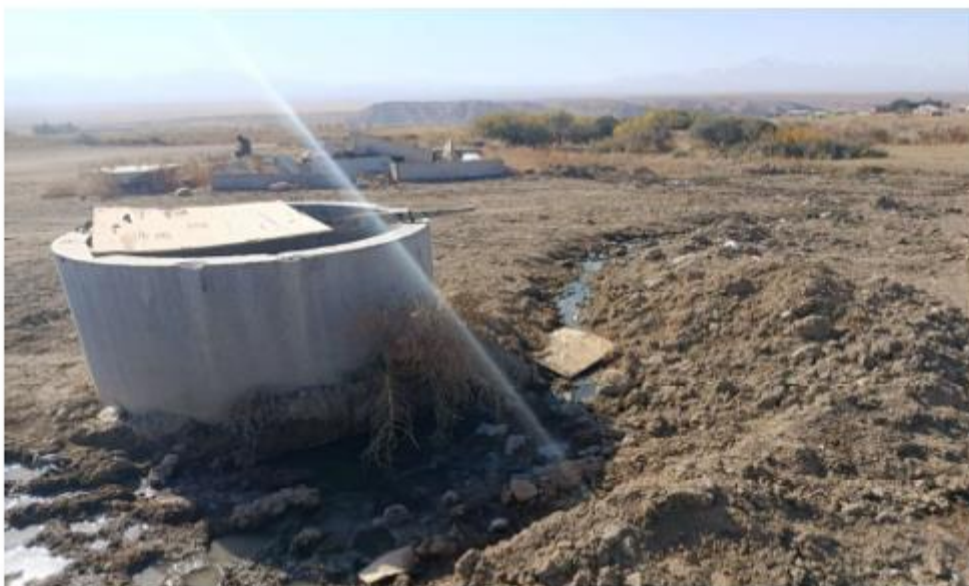
Photo 4. The septic tank is full and dirty water flows directly onto the terrain and pollutes the environment.

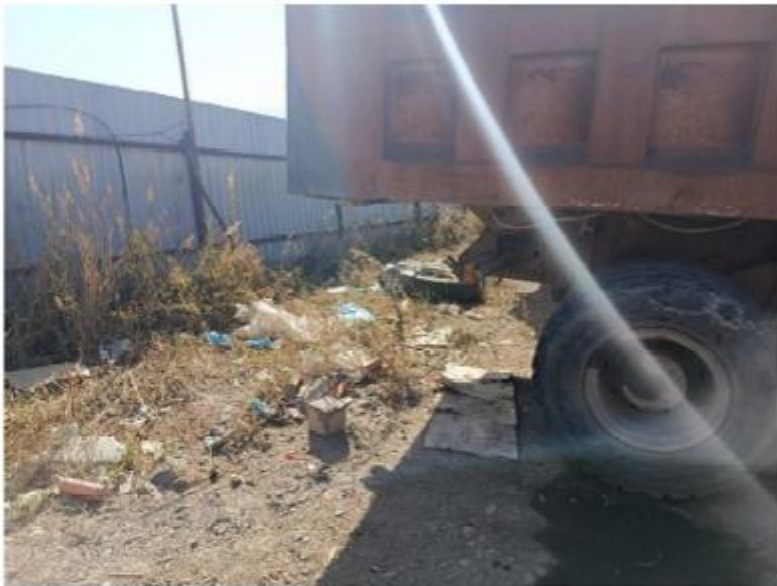
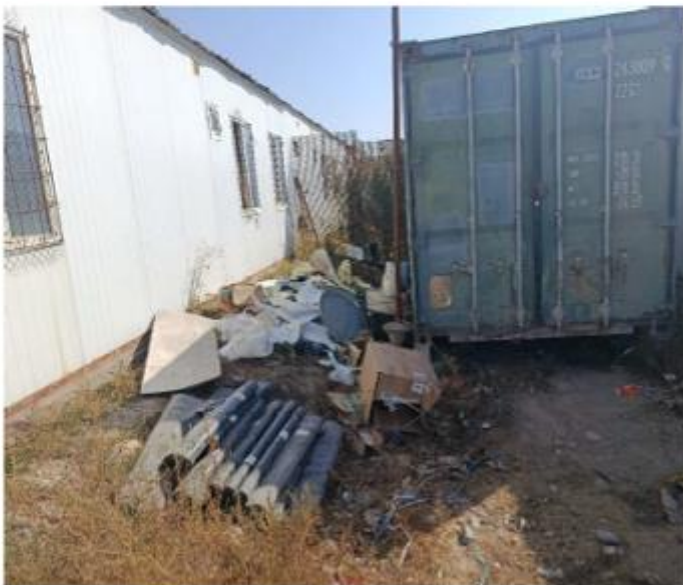
Photo. 5,6. The camp territory is not cleared of household waste

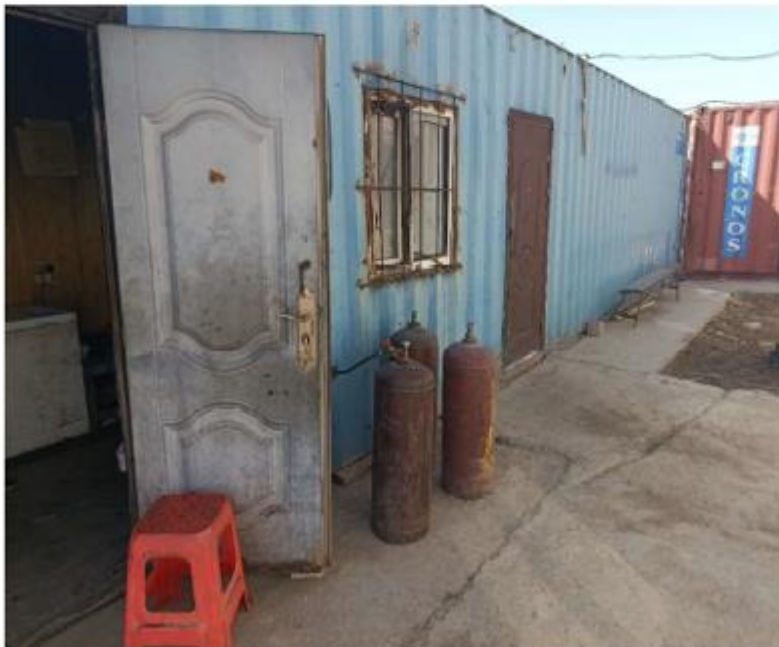
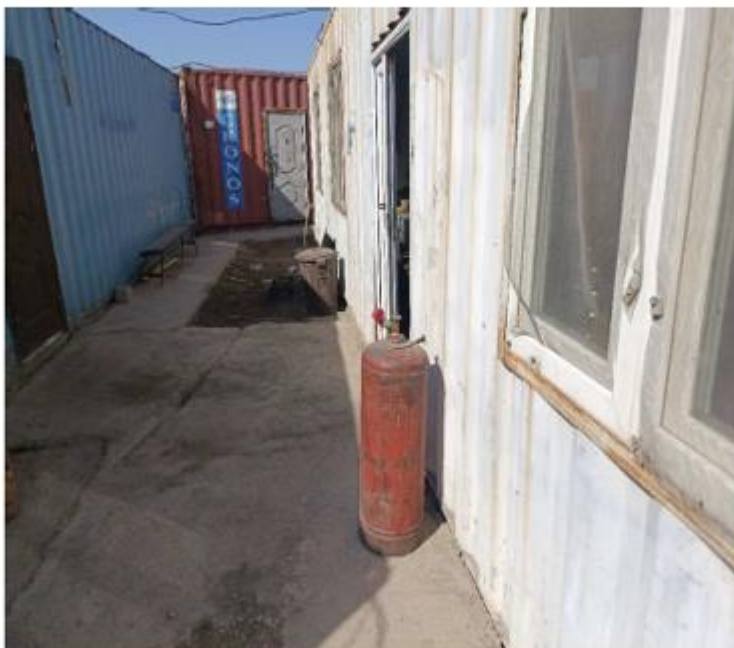
Photo 7,8. Gas cylinders are not covered

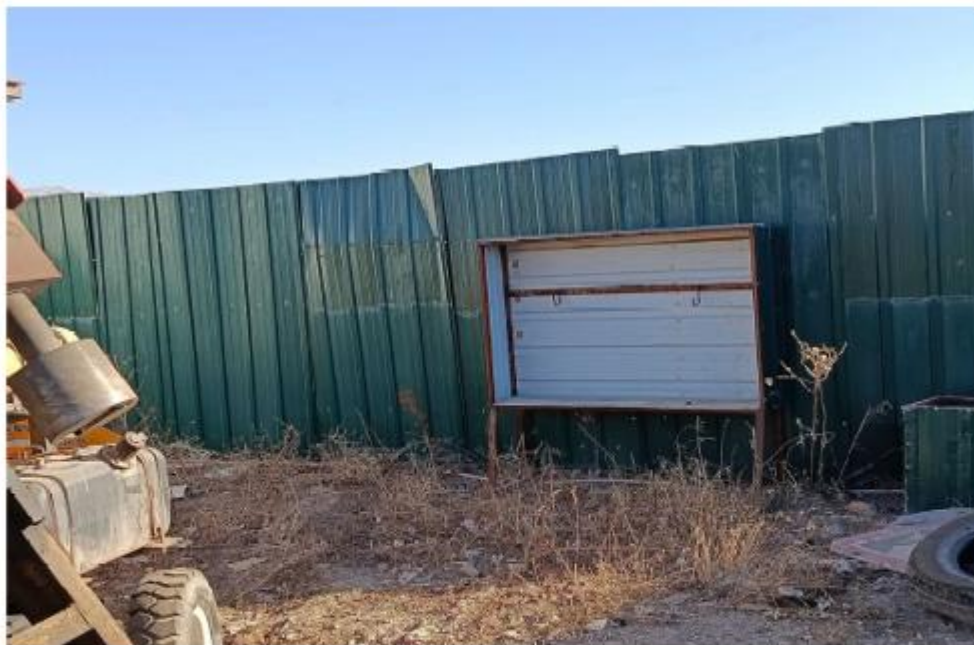
Photo 1. The fire extinguishing panel near the laboratory is empty.

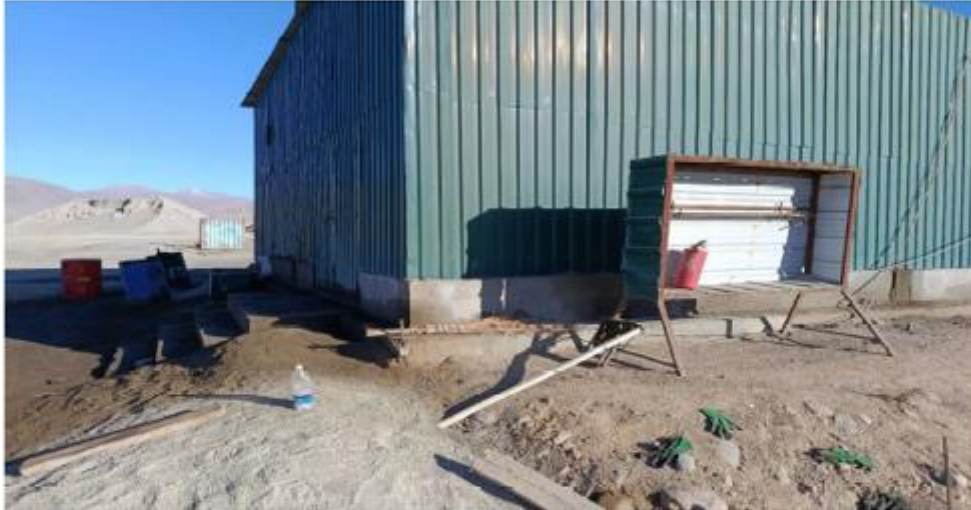
Photo 2. The fire extinguishing panel near the refueling point on the production site is not fully equipped.

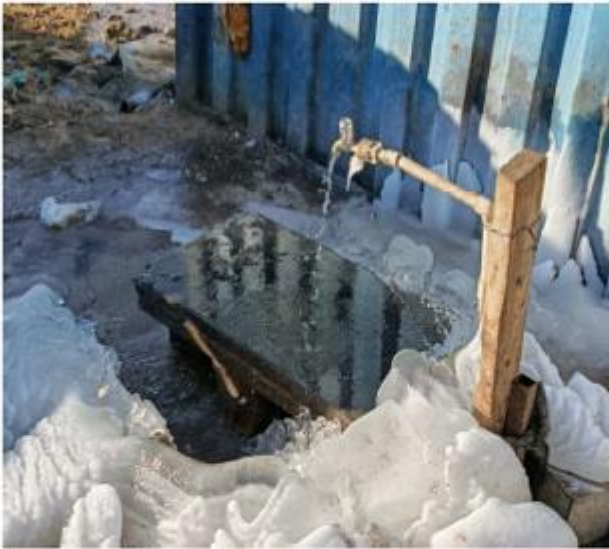
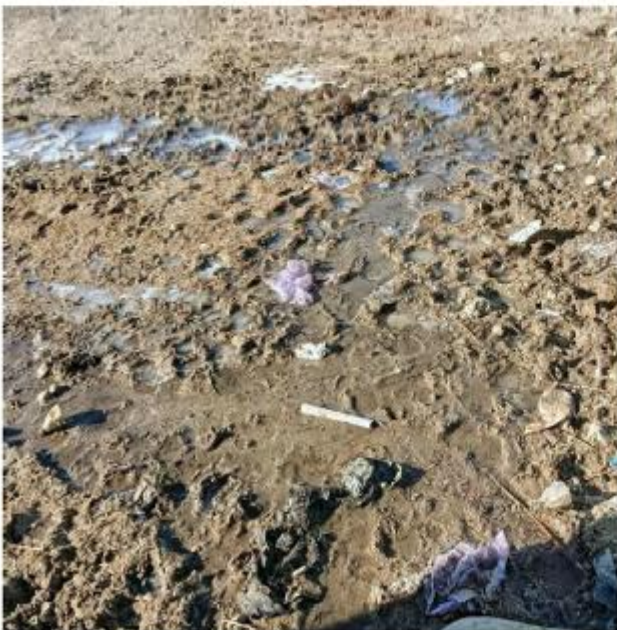
Photo 3, 4. The faucets are broken, the pipes are burst, and water is leaking constantly, forming a puddle.

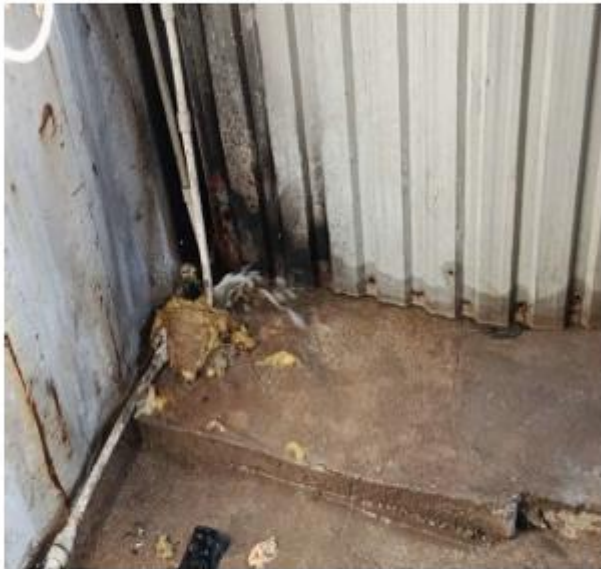
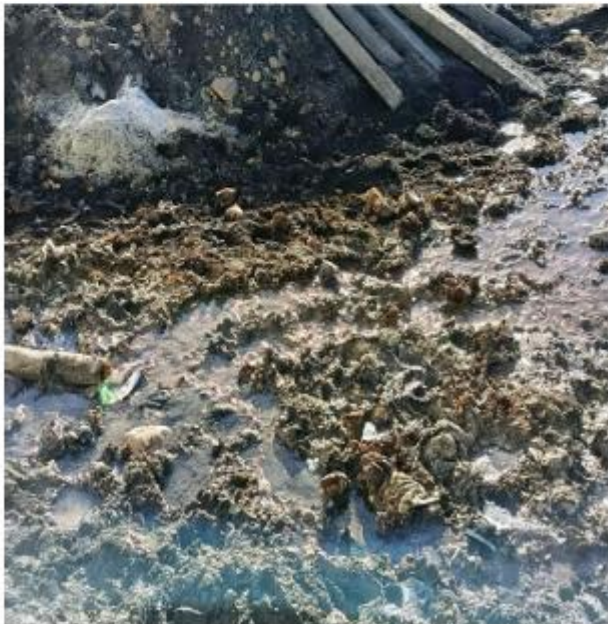
Photo. 5,6. Water from the shower drains directly onto the ground/terrain, rather than into a septic tank

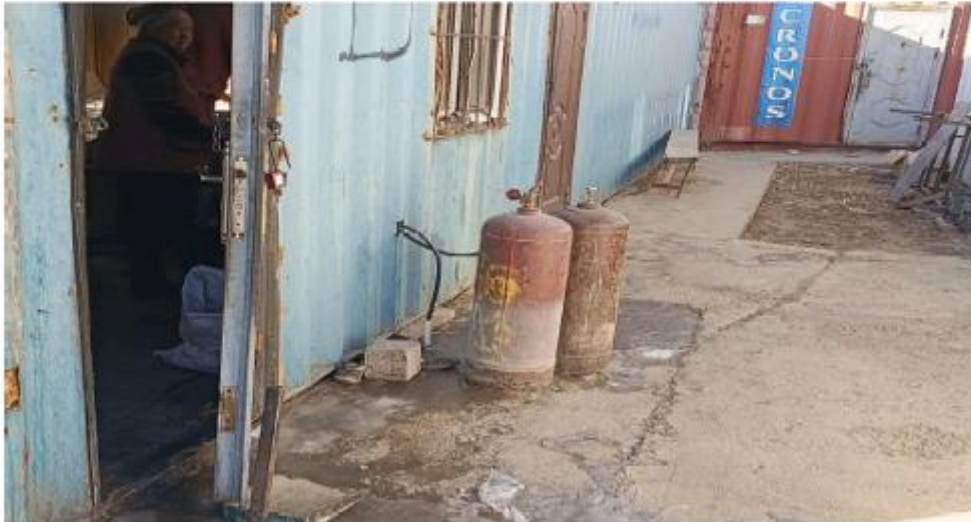
Photo 7. Gas cylinders are not covered

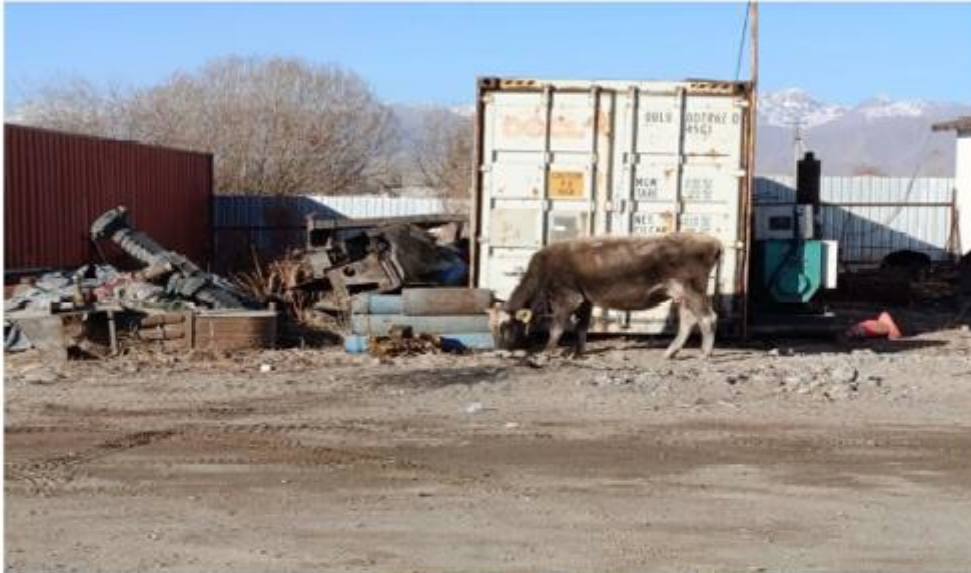
Photo 8. A cow is grazing within the camp's territory
