# Semi-annual environmental monitoring report

# July-December 2023

Kyrgyz Republic: Central Asia Regional Economic Cooperation Corridors 1 and 3 Connector Road Project (Phase 2) - Additional Financing Section 1 (Lot 1) "Balykchy - Kochkor km. 0-km. 43", Section 2A (Lot 2) "Kochkor-Epkin (km 62+400-km 89+500)".

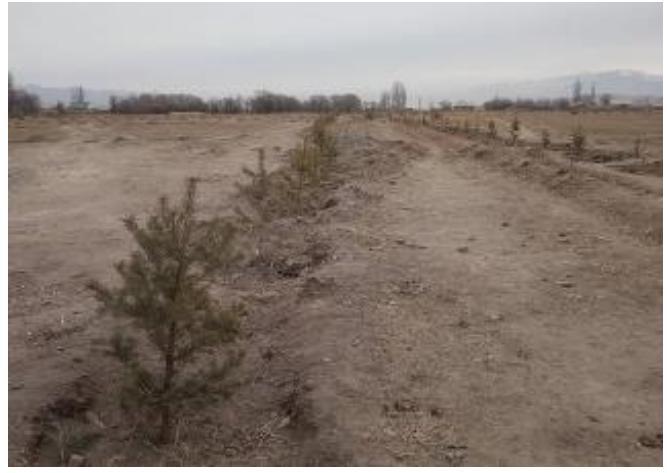
The cause of seedling death is untimely and insufficient watering, which was determined during visual monitoring of the planted seedlings. In accordance with Engineer's Instruction KGZ4267/02/01/TM/255 dated 14 August 2023, the Contractor shall rehabilitate dead saplings during spring tree planting period in 2024.

Photo 1. Lot 2. Cholpon village. Condition of pines in January 2023.

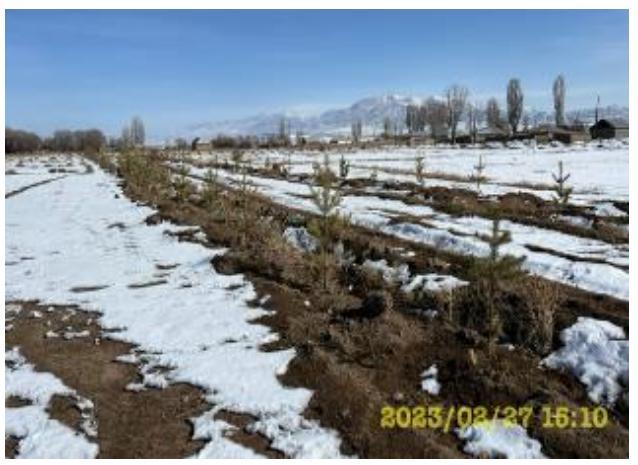
Photo 2. Lot 2, Cholpon village. Condition of pines in March 2023

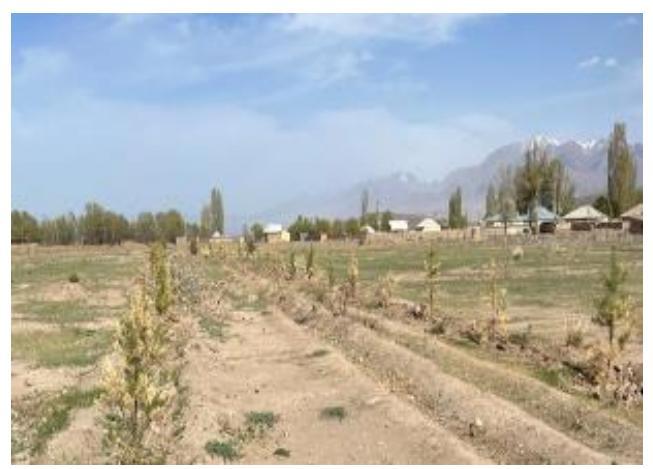
Photo 3. Lot 2, Cholpon village. Condition of pines in May 2023

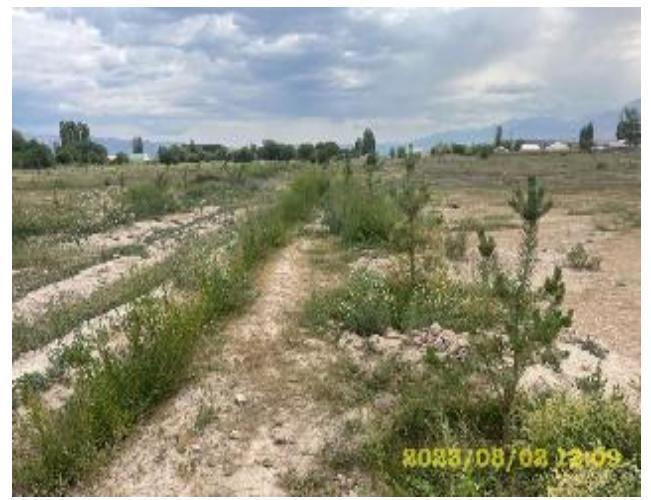
Photo 4. Cholpon village. Condition of pine seedlings in August 2023

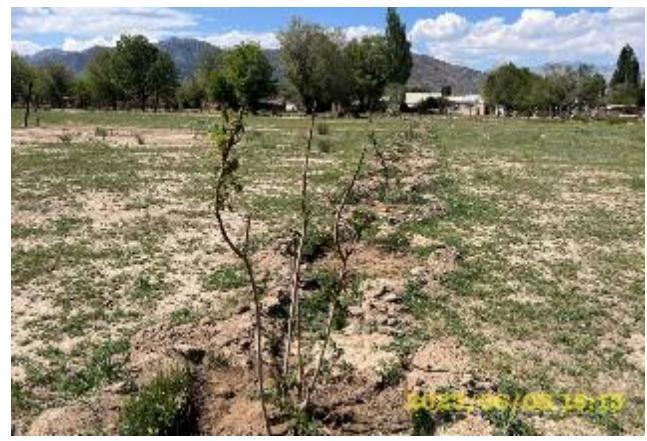
Photo 5. Lot 2, Cholpon village. Condition of sumac seedlings in June 2023.

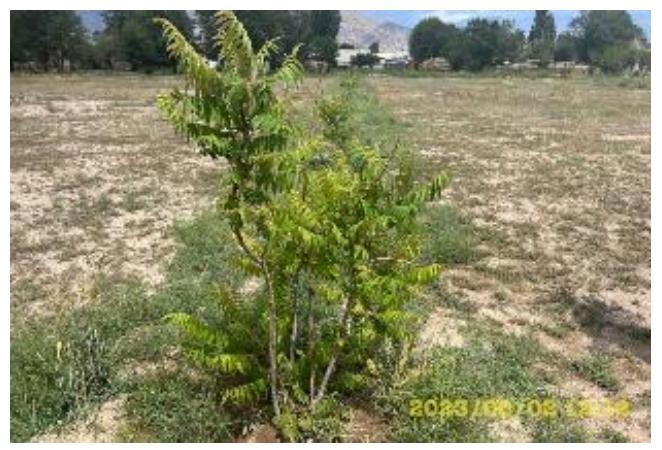
Photo 6. Cholpon village. Status of sumac seedlings in August 2023.

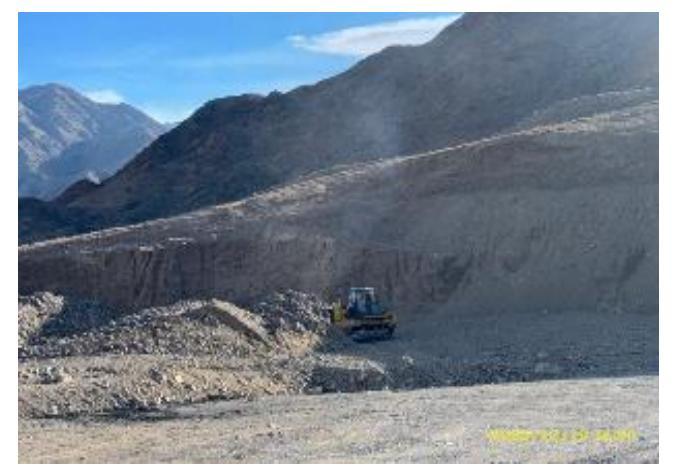
Photo 66. Quarry's technical levelling at km 34+240 and stabilizing quarry's slopes a safe condition. December

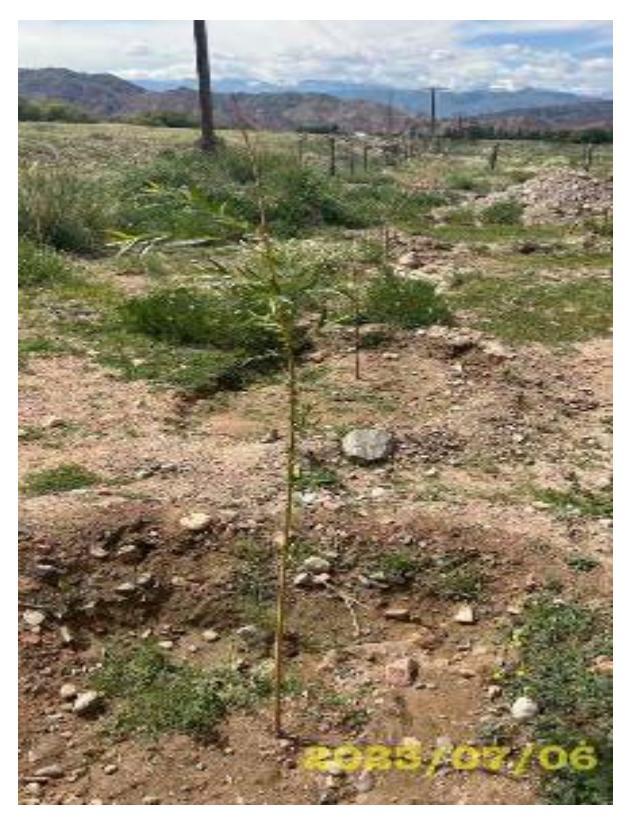
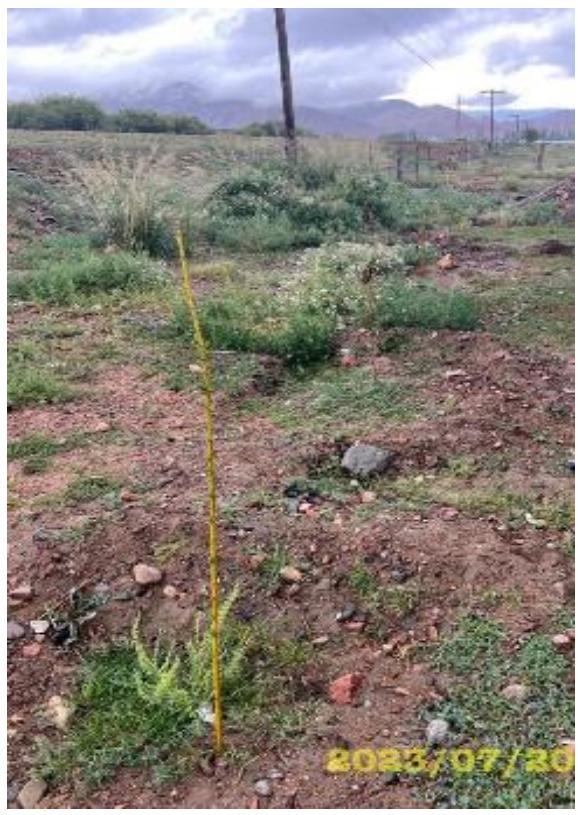
Photo 77. Seedling condition: as a result of proper watering the seedlings started to grow (6<sup>th</sup> July), after untimely/continued watering the seedling lost its foliage and stopped growing.

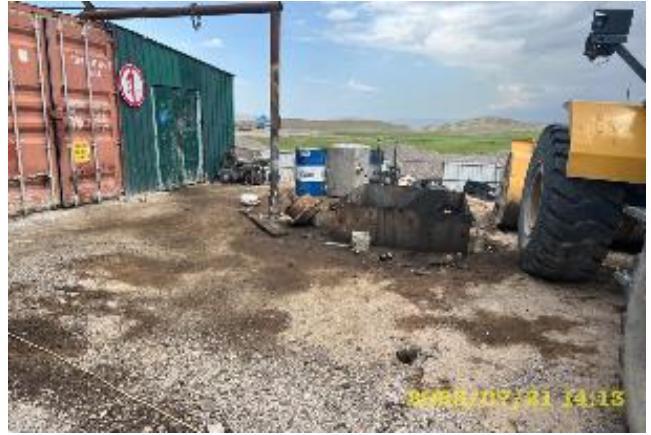
Photo 85. Production base, site adjacent to oil storage warehouse contaminated with oil products

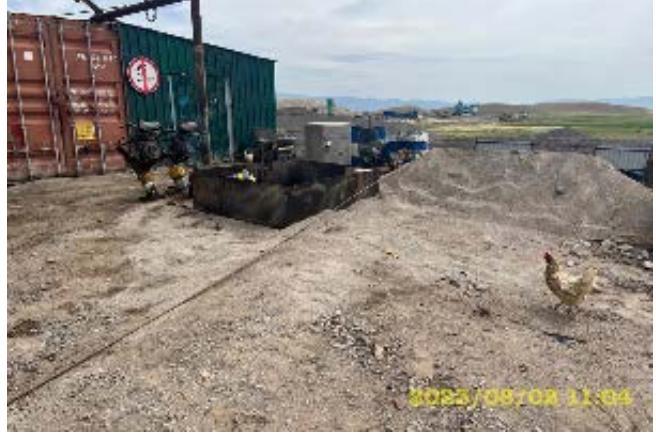
Photo 86. Lot 2. Production base, site adjacent to the oil storage warehouse after cleaning

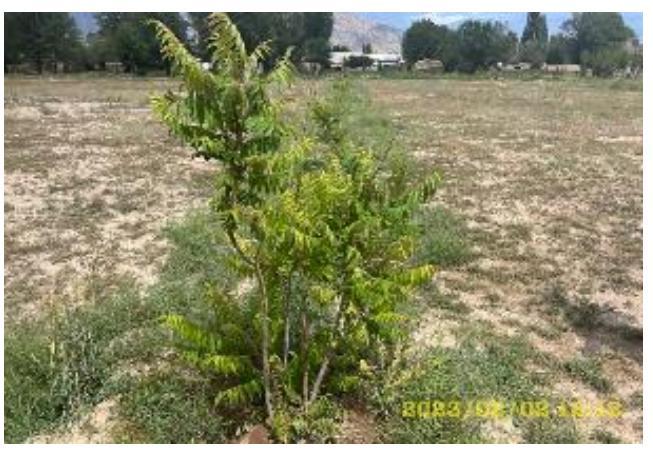
Photo 104. Cholpon village. Status of sumai seedlings in August 2023: started to grow as a result of proper watering.

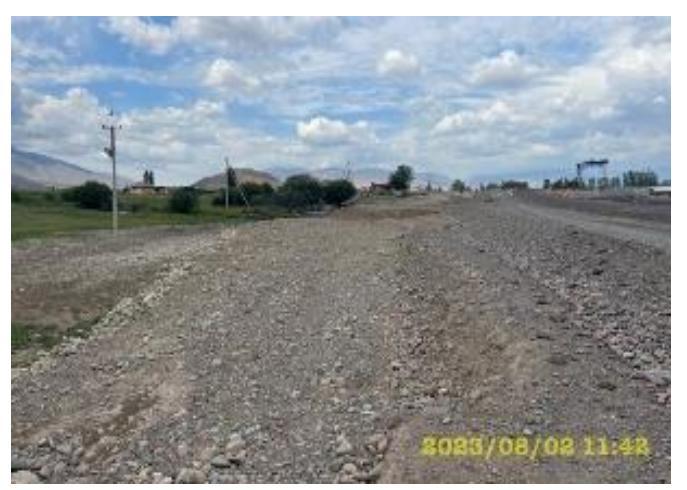
Photo 114. Site of the bypass road, after reclamation and drainage of the adjacent flooded site.
