Semi-annual Environmental Monitoring Report

Project Number: 48401-008
Loan Number: ADB Loan 3432-KGZ (SF)
Grant Number: 0496-KGZ (SF)

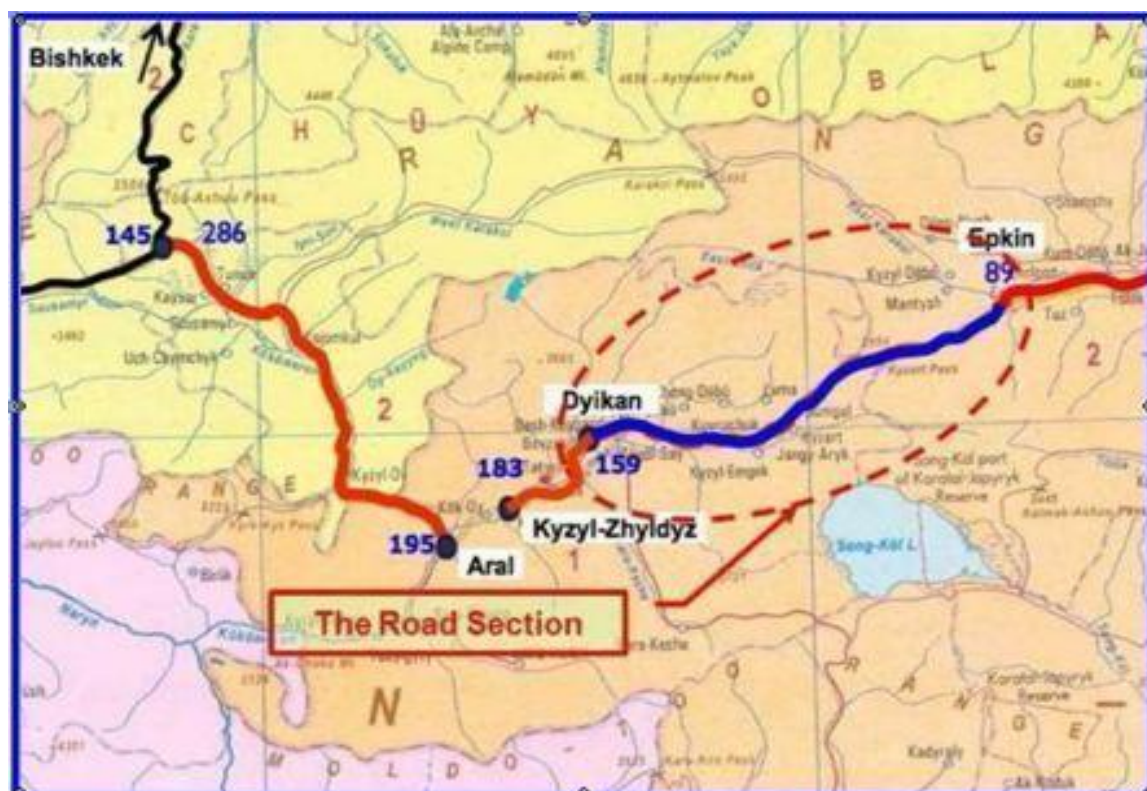
Figure 1. Map of Epkin-Dyikan (Bashkuugandy) Location.

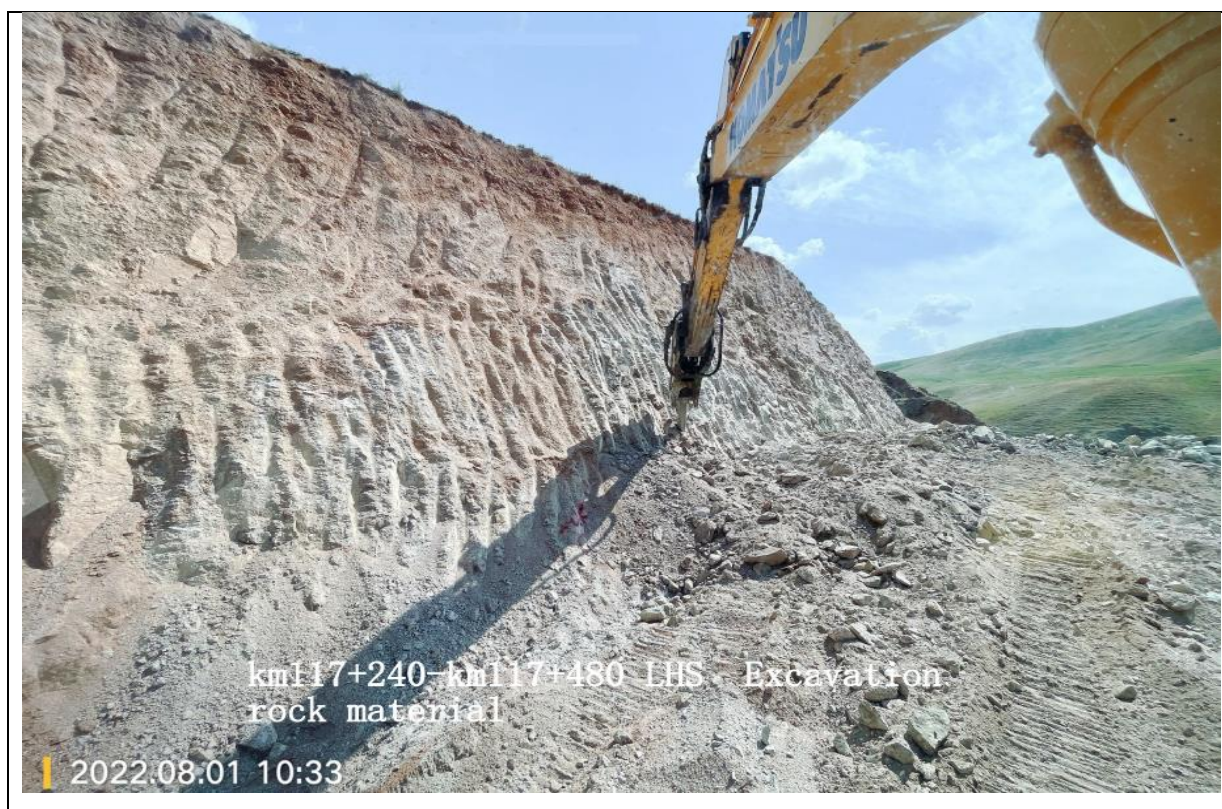
Figure 3 Site Works.

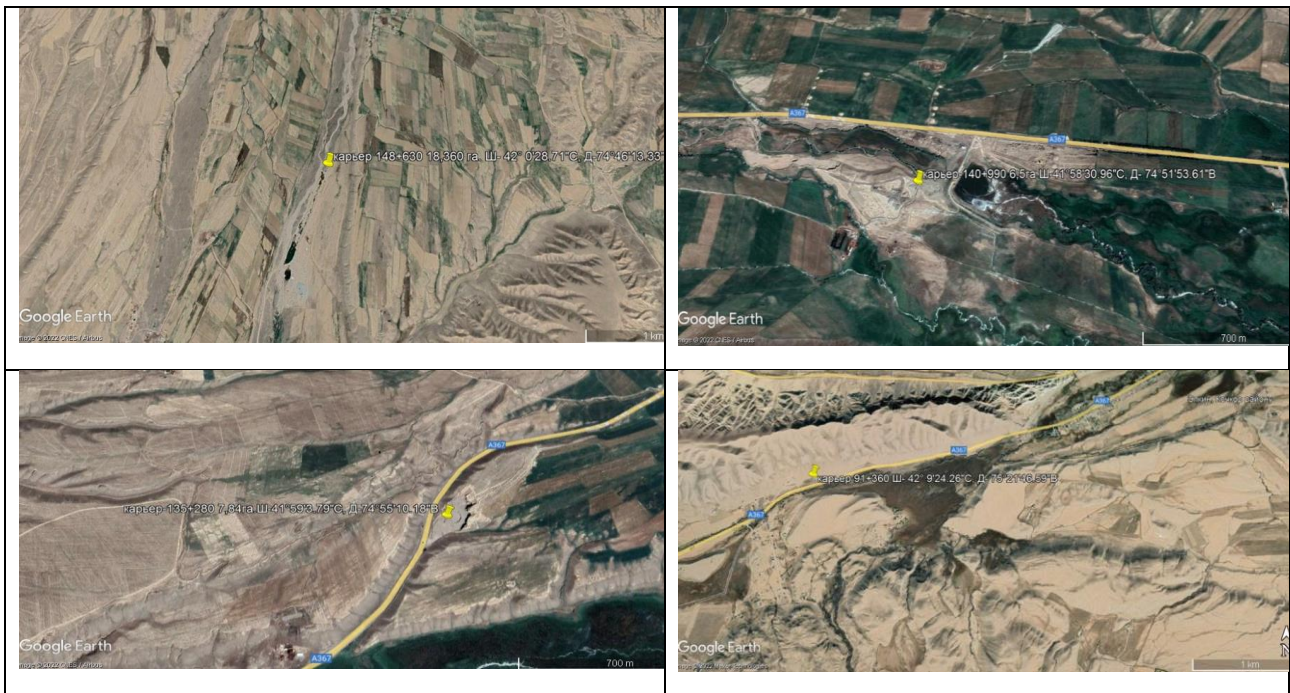
Figure 7 GIS locations of the quarries' areas.

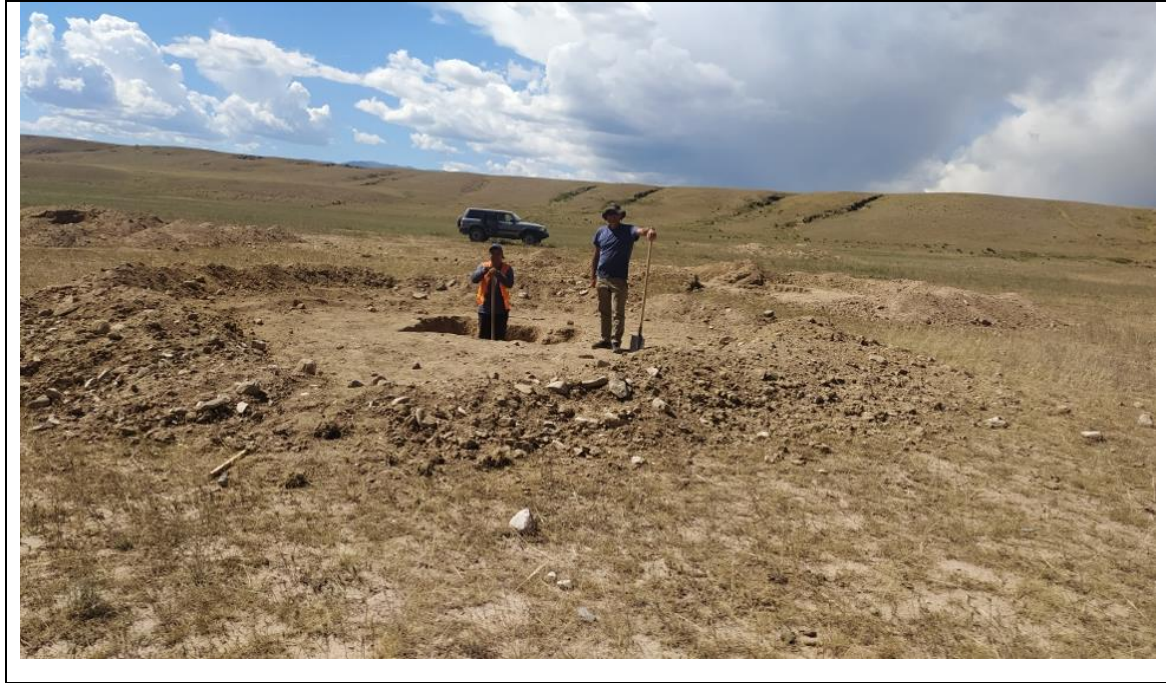
Archaeological Objects of Historical and Cultural heritage.

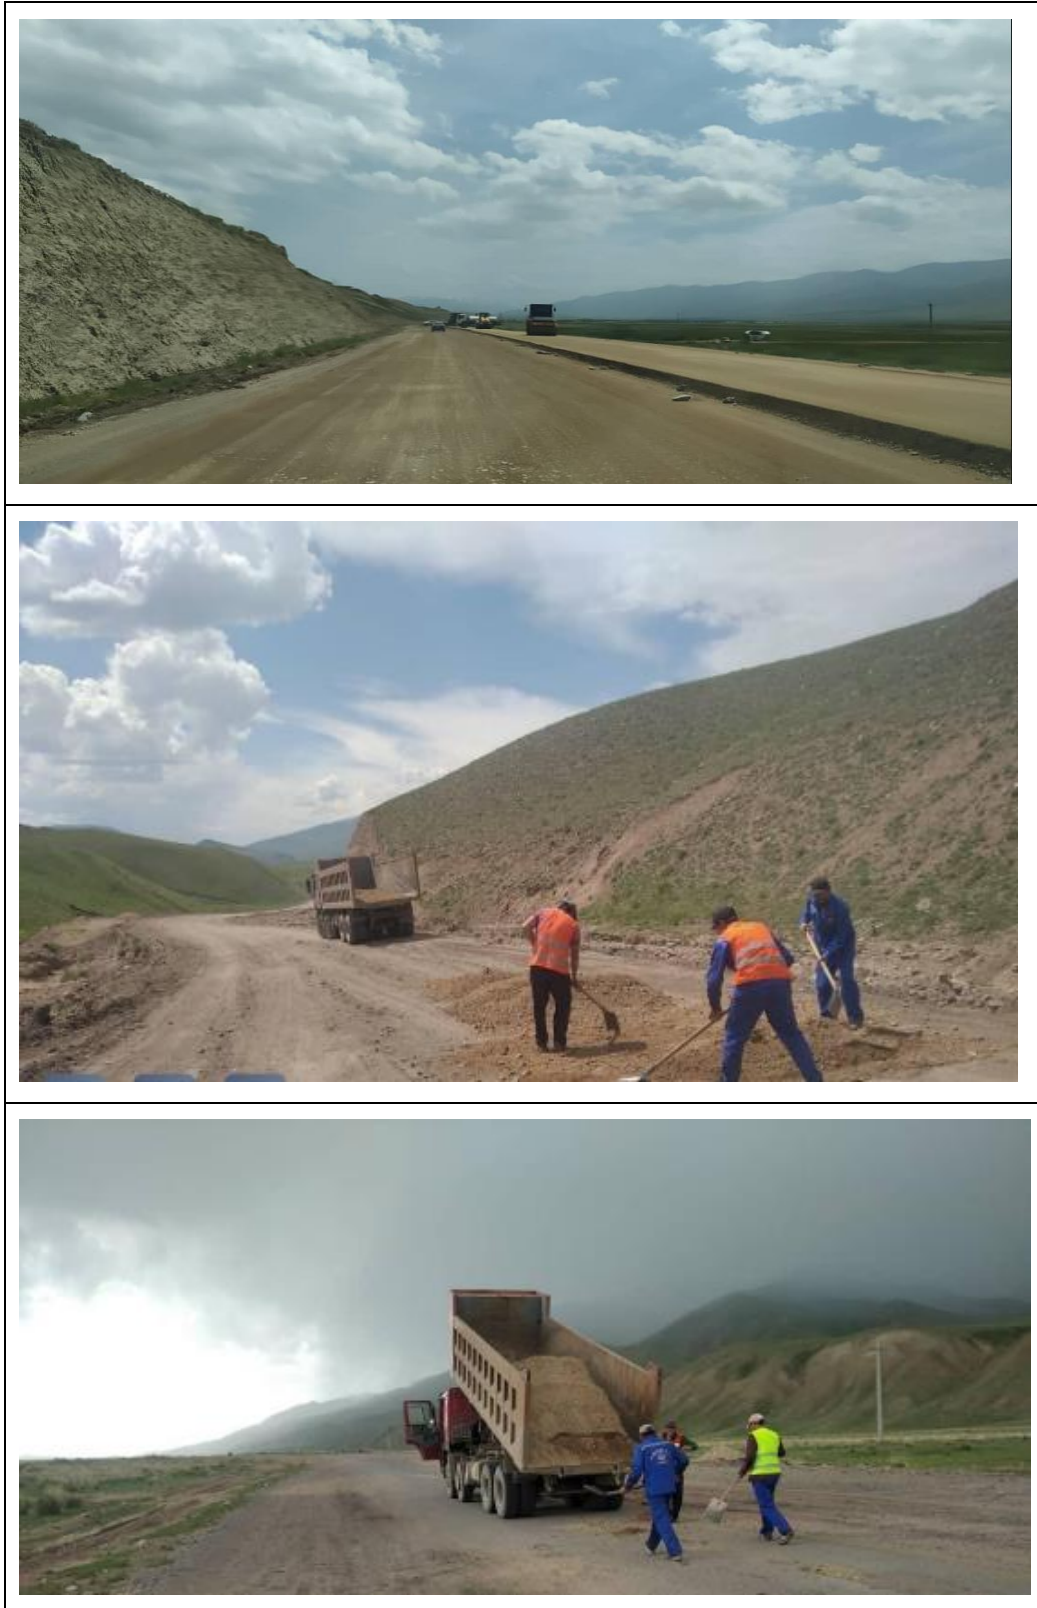
Figure 14 Road Maintenance Work

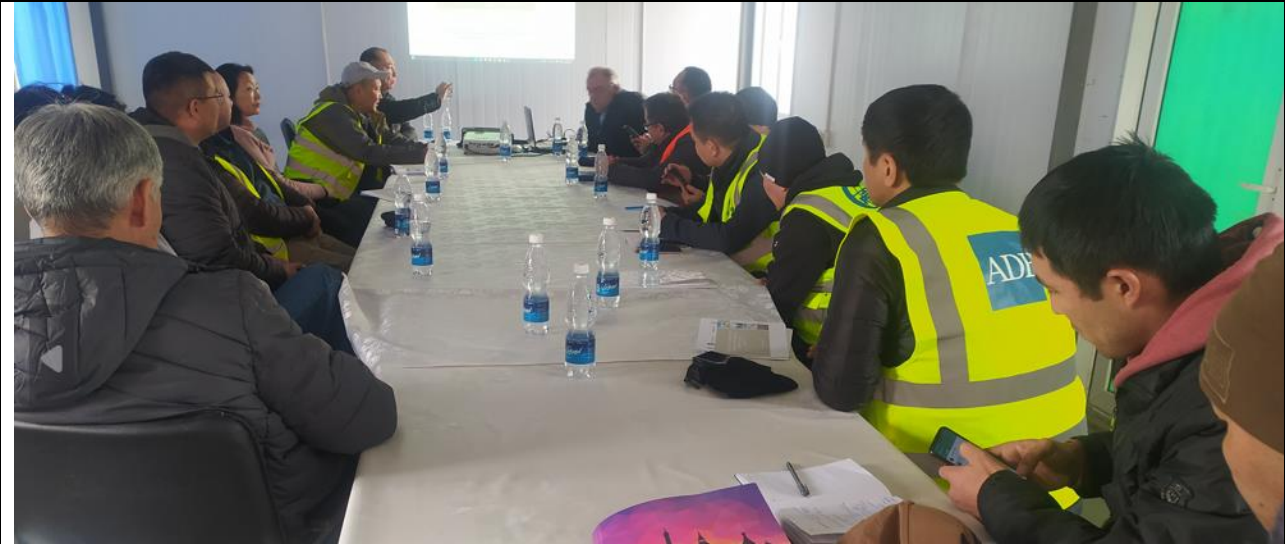
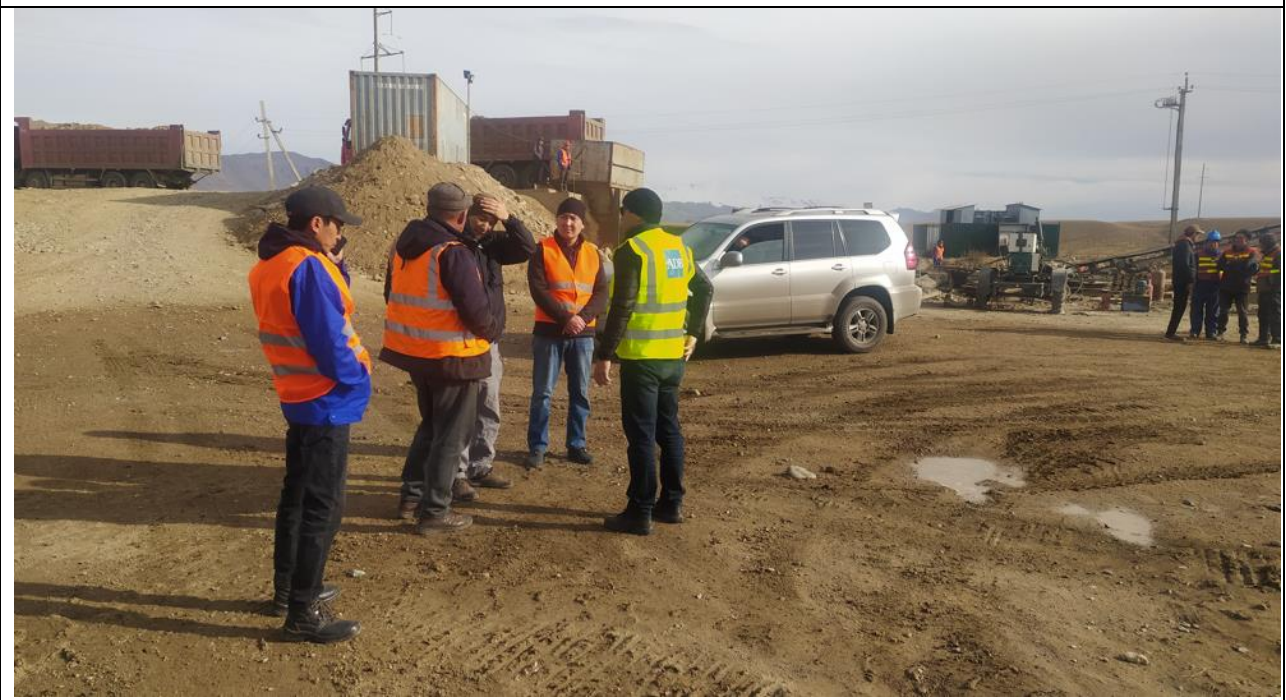
Figure 15 ADB review mission at the project site, November 2, 2022.

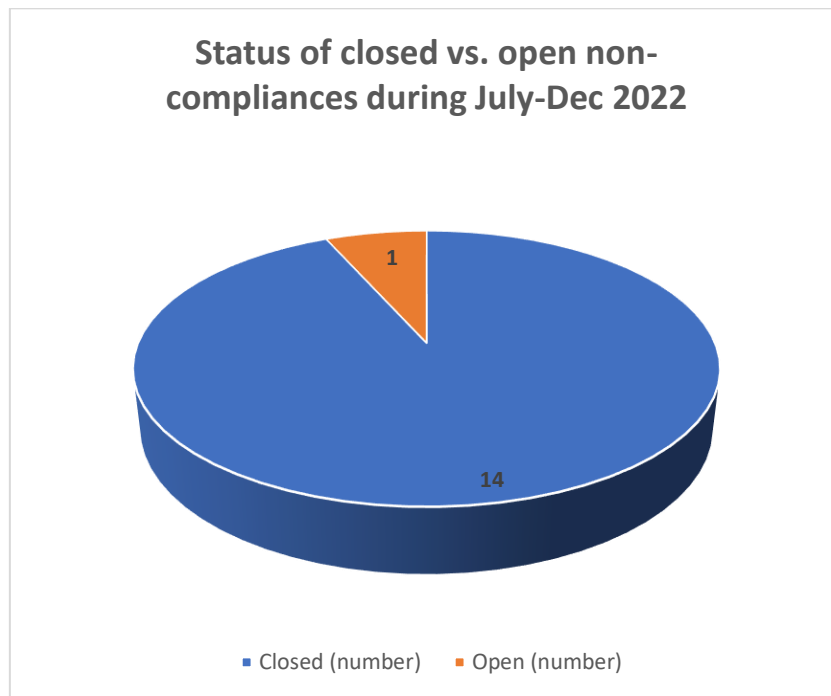
Figure 16 Status of Non-compliances and Corrective Actions.

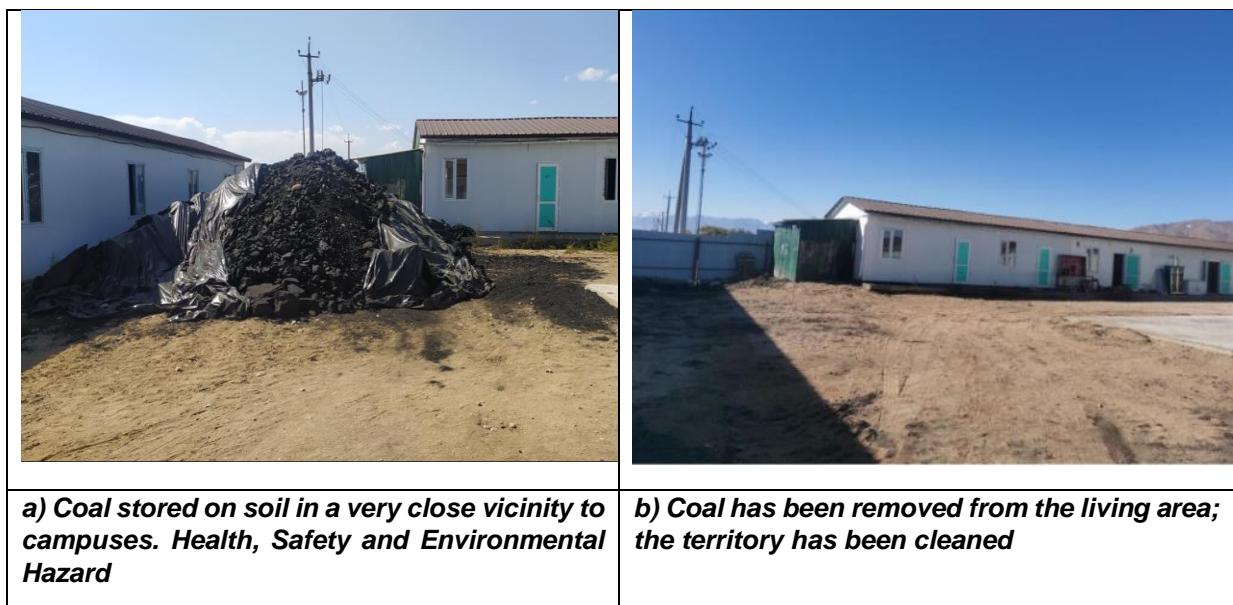
Figure 17 Observation of improper storage of coal at the Camp

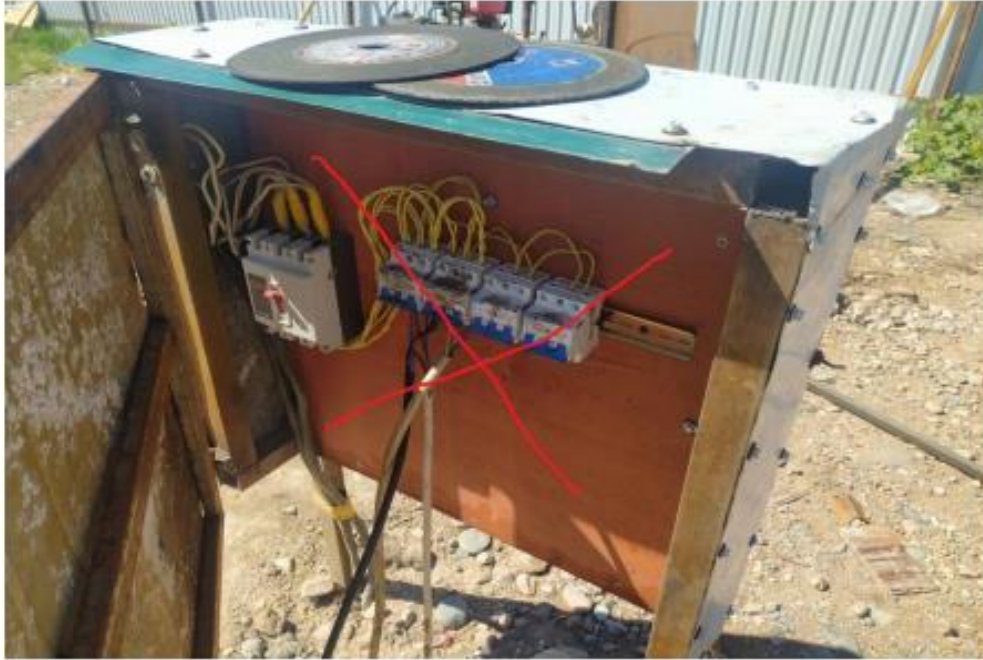
Photo 7: At the production base, oil barrels are not covered and the foundation platform is not concreted

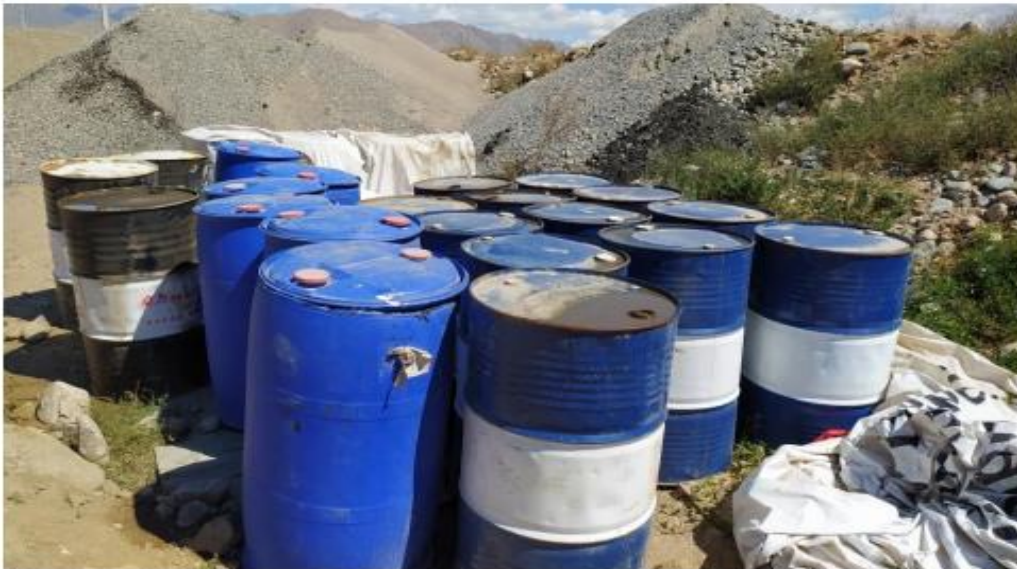
Photo 8: The generator is not fenced at the production base

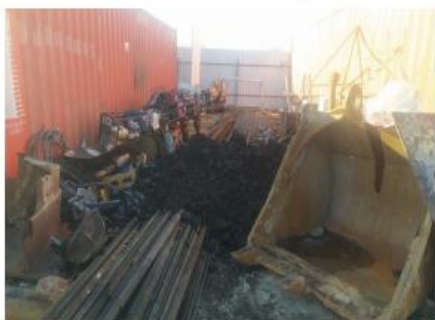
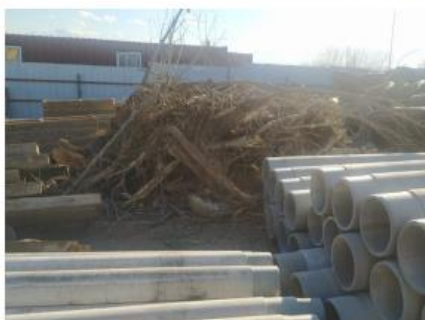
Фото 3, 4: Дрова и уголь складированы вперемешку со строительным материалом/
Photo 3, 4: Firewood and coal are stored mixed with building material

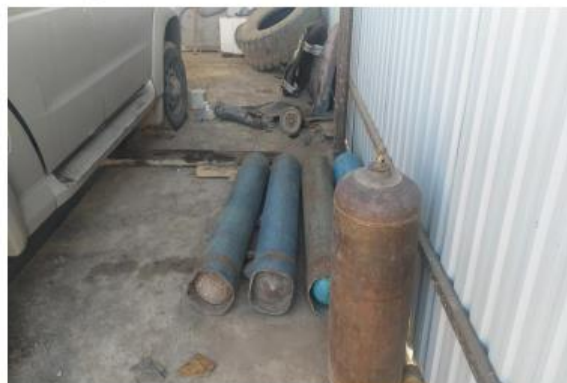
Фото 5: В ангаре для ремонта автомашины разбросаны кислородные баллоны, тем самым, в случае сварочного ремонта автомашины создается опасность взрыва/
Photo 5: Oxygen cylinders are scattered in the car repair work-shop, thus creating a risk of explosion in the event of a welding
