# INITIAL ENVIRONMENTAL EXAMINATION

Project Number: 45169

## **CAREC Transport Corridor 3 (Bishkek – Osh Road)** **Improvement Project, Phase 4** **Engineering and construction supervision**

This Initial Environmental Examination Report was prepared for the Ministry of Transport and Communications of the Kyrgyz Republic and updated in 2015 and 2018 by EPTISA Servicios De Ingenieria S.L./Eptisa Muhendislik/RAM Engineering in accordance with the Kyrgyz Republic Environmental Protection Legislation and ADB requirements. It is a document of the Borrower.

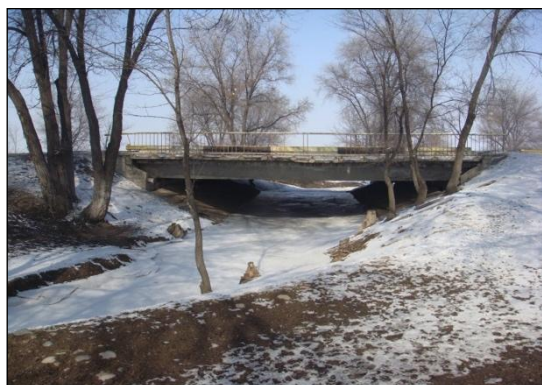
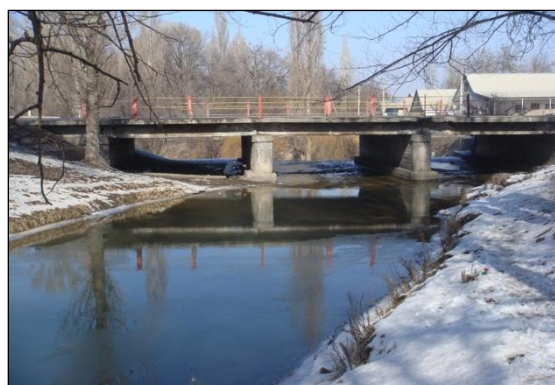
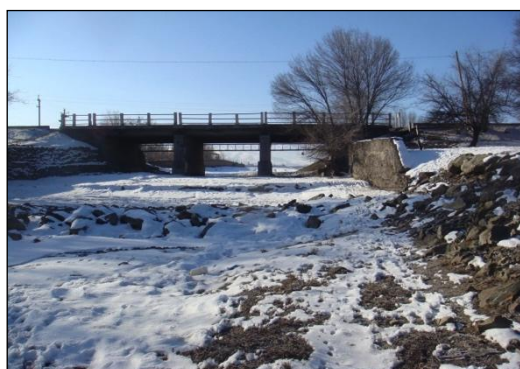
**Figure 4** The three natural rivers (Table 8) flow north under the road into the Chu River.

87. Hydrography of the project road area consists of three permanent streams originating in the northern slopes of the Kyrgyz ridge and crossing the project road. These are the Dzhelamysh, Sokuluk and Ak Suu rivers belonging to the Chu river basin. The rivers scarp slopes covered with trees and shrubs. The width of riverbeds in the mountains is 10-15 m. Bottoms are composed of pebble and boulders and are deformed significantly. When coming out of the mountains, the most river flow is distributed for irrigation. As a result, for most of the year (growing season) there are no flows in the places where the rivers cross the road.

88. The hydrological regimes of the Dzhelamysh, Sokuluk and Ak-Suu Rivers have been recorded since 1928 and 1998, and these data are presented as the percentage of total annual streamflow in any given month (Table 9). Unfortunately more recent data are not available and since the gauging stations were located much further upstream from where the road crosses the rivers, the values provide are not really representative of conditions at the crossing points.

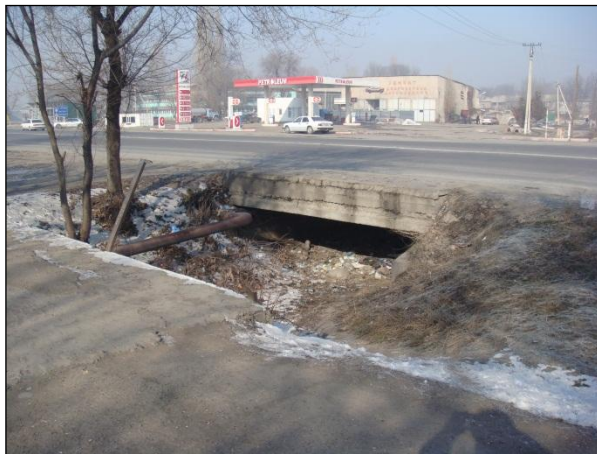
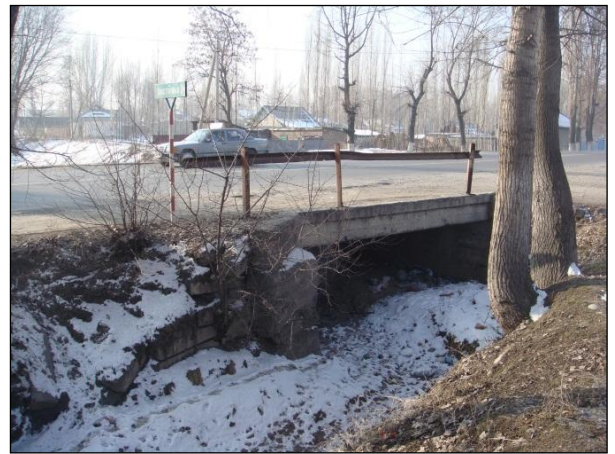
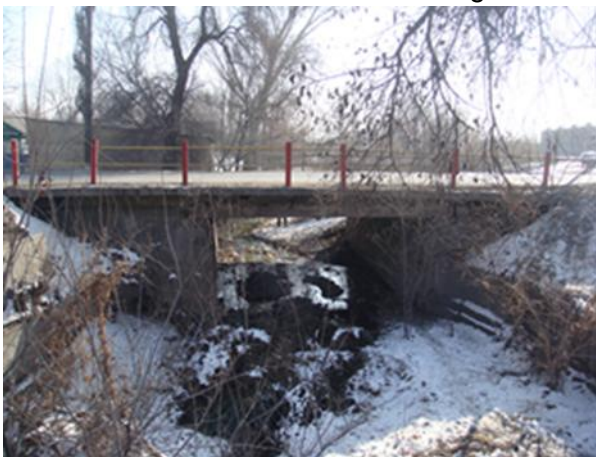
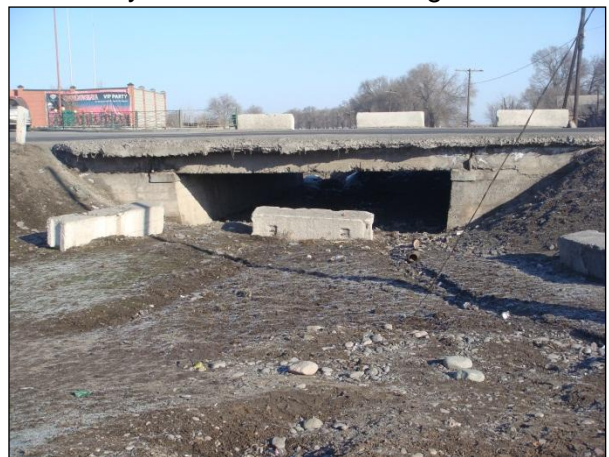
**Figure 5. Canals crossed by the road upgrading work.**

89. Three irrigation canals are also crossed by the road (Figure 5). They are the Novo-Pavlovka flood control canal, Zhantay2 and the Krepostnoy canal. A Novo-Pavlovka village canal was used as a flood bypass canal, emptying the runoff pond located upstream of the road and the village. Currently the canal is out of operation.

90. The Zhantay canal originating in the water intake structure on the Sokuluk river (in the piedmont zone) goes through the boundary of Romanovka and Sokuluk villages. The canal is designated for passing of water to irrigate backyards and agricultural fields of villages located downwards the road. This canal has been designed also for passing of mud streams formed in the piedmont zone after rain showers. The canal capacity is about 6-8 m3/sec. However, currently the functions of the canal are significantly limited since the canal bed is silted with debris and built-up with dwelling houses.

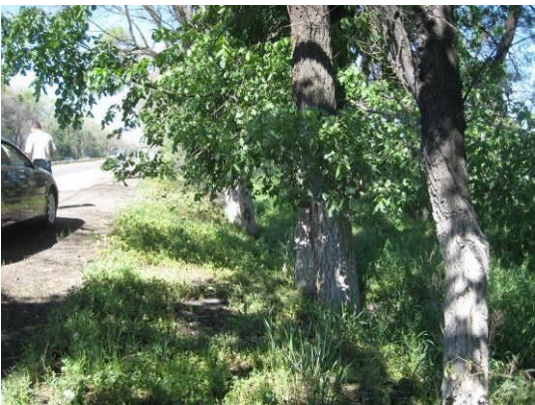
<p>Mosque</p>	Dust, Noise, Vibration, SO2 NOx CO
5	Along the Project road	17	<p>Below picture show tree plantation of Elms at km 17, right hand side of road. Nearly alongside the whole Project road tree plantations are stretching on both sides. Trees need to be newly planted for compensation.</p>

Number of trees to be cut, approx. 4500-7000

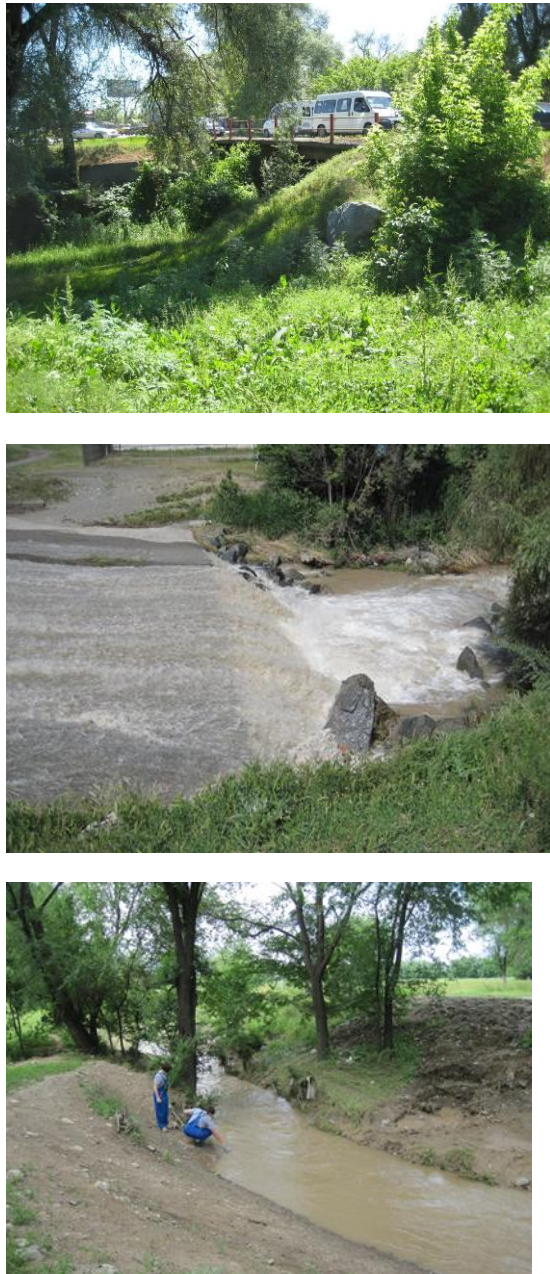
No.	Location	KM	Issue / Picture	Baseline Data Parameters
12	River Crossings	28.3, 43 and 44.65	<p data-bbox="611 237 1259 389">Crossings of River Sokuluk, temporary creek and River Ak-Suu, Zhalamysh river by Project road. Below picture shows relict of floodplain vegetation, e.g. willow (<i>Salix alba</i>) alongside the temporary creek at chainage km 43.</p>

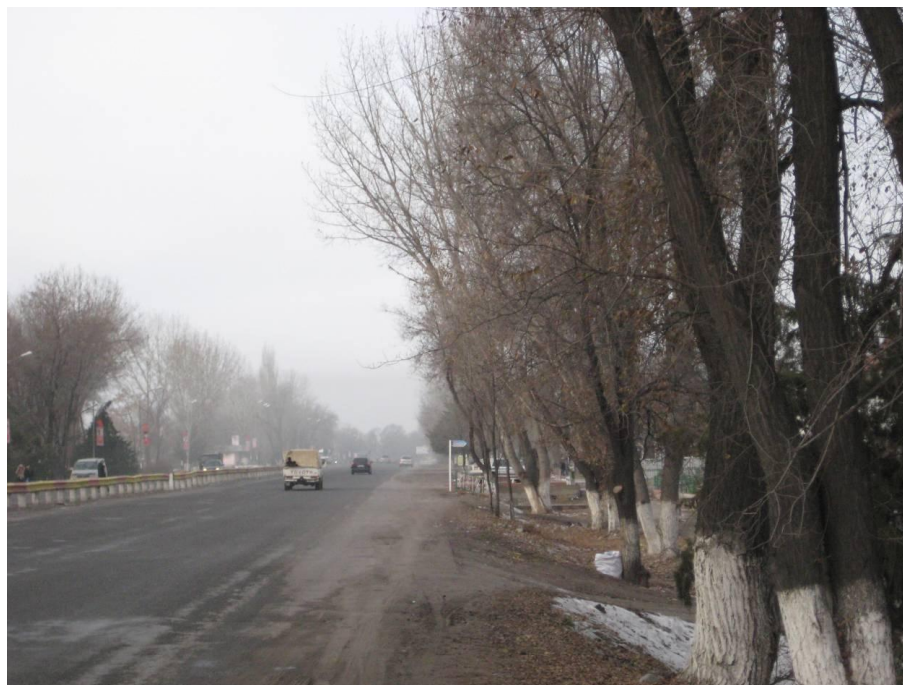
**Figure 8:** Elms, poplar and black locust trees lining Project Highway (now cut)

171. **Tree Management Plan-** The most obvious ecological feature along the road is the extensive shelter and shade tree belt planted along both sides of project road for much of the road, starting at km 15.9 and extending t to the end of the work at Kara Balta (Figure 8). These are mature elm, poplar, cherry, oak and black locust trees 40-70 years of age

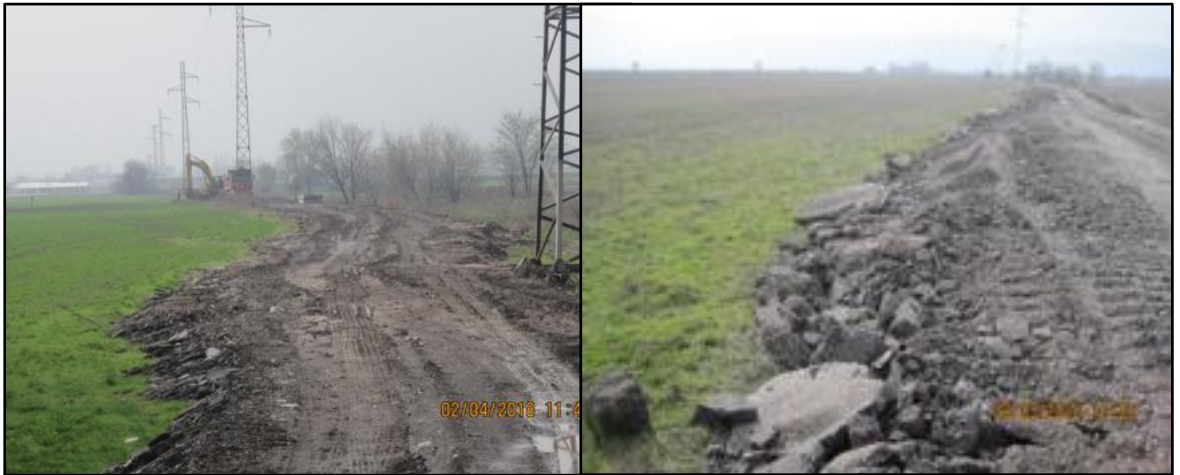
**Figure 9. Illegal haul road under construction ( 04/2018) along old farm track and transmission line access track.**

- 
- Old asphalt pieces were placed on the existing farm track (Figure 9) and extended at least 2 m into the farm fields on either side;
- The traffic through a small community generates noise, dust, vibration and safety concerns since local people are unaccustomed to having high volumes of traffic through their communities;
- The placement of the old asphalt did not consider surface drainage and surface flow issues, such as poor drainage are possible;
- The narrow track contained shrub and tree windbreaks which were buried by the work.

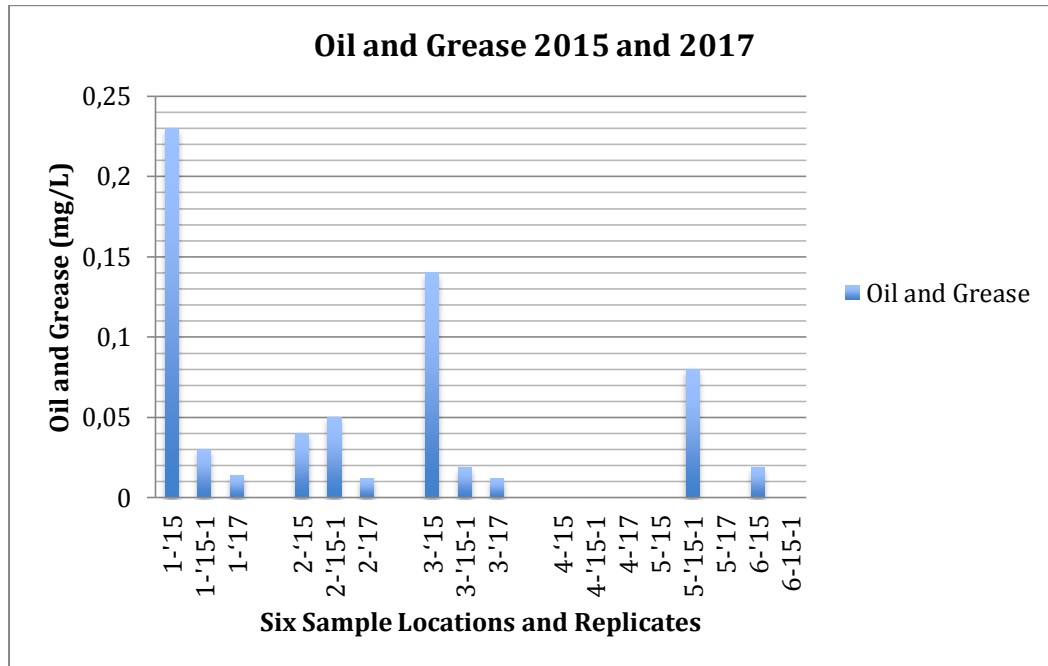
Figure 19. Oil and grease concentrations at six locations 2015 and 2017

Oil and grease may become an issue during construction as a large fleet of vehicles and equipment will be constantly travelling the project alignment. For this reason, the continued measurement of this parameter will be very useful.

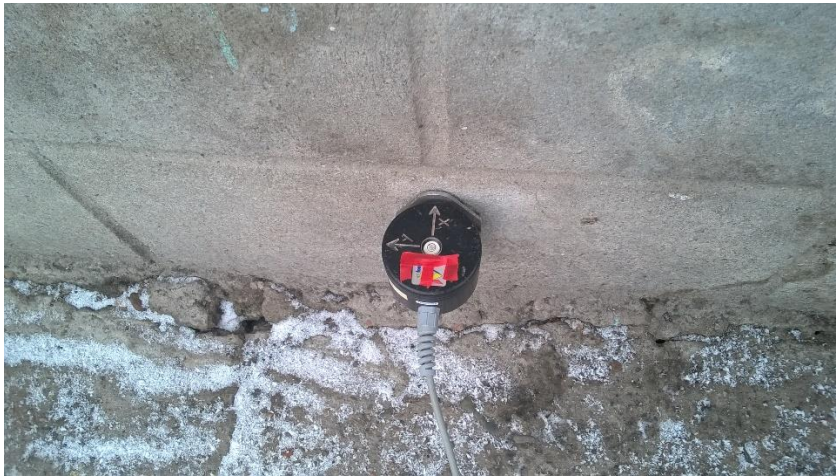
*Figure 1. Location of Geophone on Foundation of Building*

Vibration monitoring equipment comprised two Profund Vibra + vibration loggers, time synchronised, and 2 triaxial geophones. Geophone mounting procedures followed guidelines set out in British Standard BS ISO 4866 [5]. The reference geophone was mounted on the section of building foundation nearest the road by means of a bracket glued to the façade using structural adhesive (see Figure 1). The second geophone was mounted on a concrete paving slab, levelled and well bedded onto the ground surface using building sand (see Figure 2). At each building the geophone was initially mounted adjacent to the building, enabling the coupling loss between ground and building to be measured, and then moved to intermediate positions closer to the road as circumstances permitted. At all locations, the X and Y axes of the geophones were aligned transversely and parallel to the road, with the Z axis vertical.

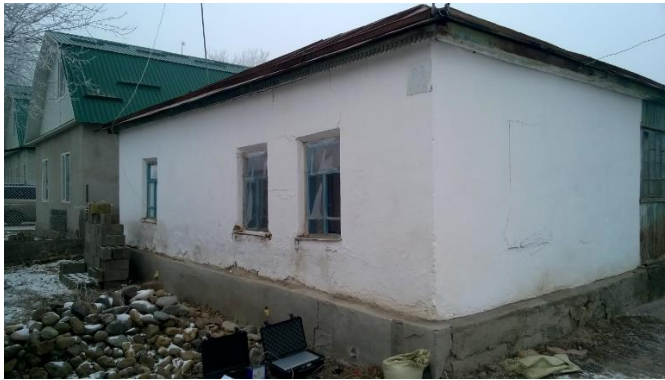
*Figure 4. No. 85 Centralnaya Street, Petrovka*

Construction: Clay/adobe construction with damage to external walls. The Institute [15] reported that the foundation is concrete and that the building has suffered medium damage.

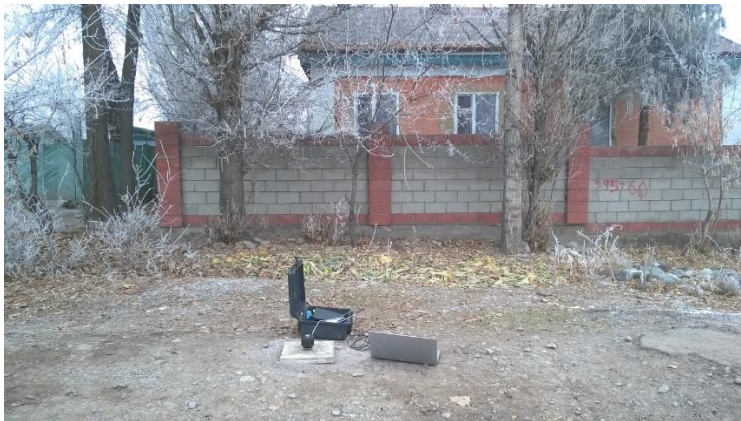
*Figure 5. No.225 Centralnaya Street, Petrovka*

Construction: Clay/adobe construction with brick foundation. The Institute [15] reported that the foundation is concrete and that the building is weakly damaged. The nearest part of the area where rolling had been carried out here was adjacent to a culvert and the sub-base appeared to be shallow. Static deflection of the ground was visible during roller pass-by.

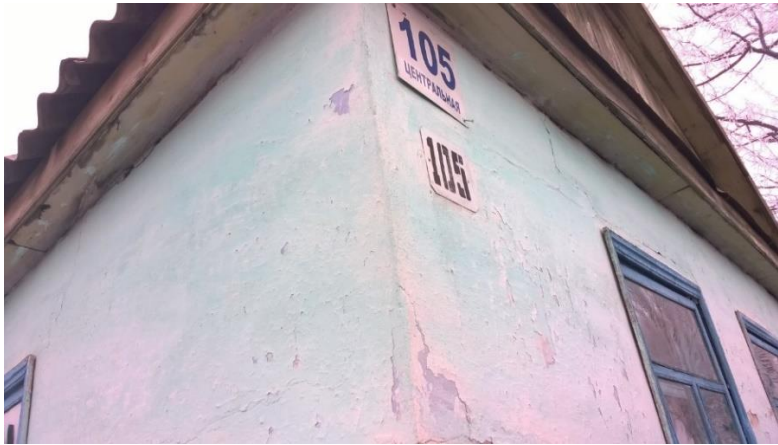
*Figure 6. No. 105a Centralnaya Street, Petrovka*

Construction: Clay/adobe construction. The Institute [15] reported that the foundation is constructed from reinforced concrete bands, and that the building has suffered medium damage.

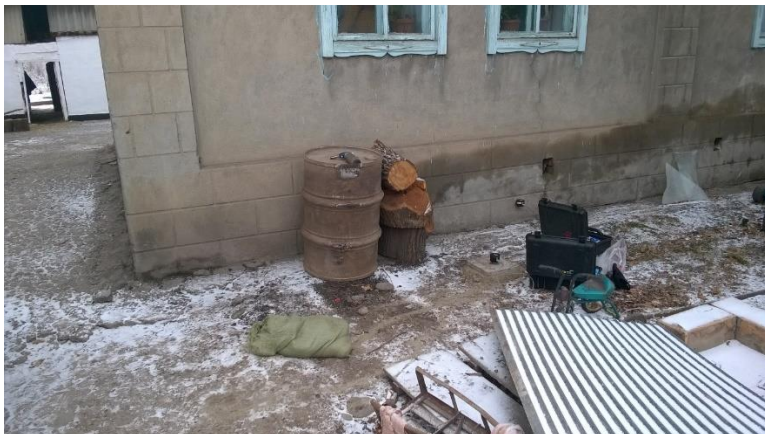
*Figure 7. No 109 Centralnaya Street, Petrovka*

Construction: brick built but appeared to have some rubble in foundations.

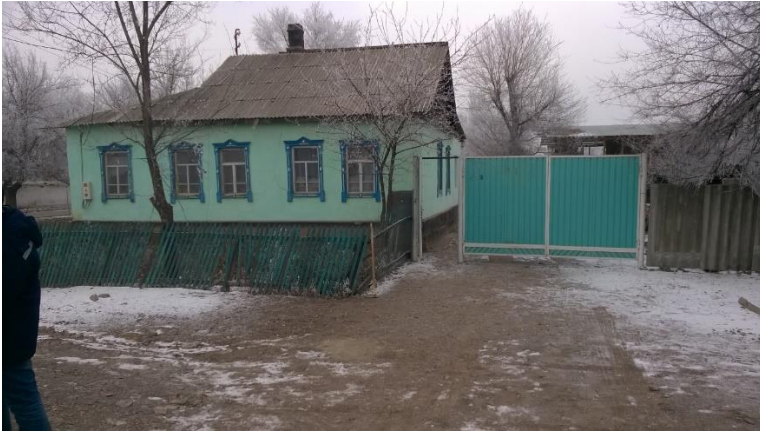
*Figure 8. No.393 Centralnaya Street, Petrovka*

Construction: Clay/adobe construction. Unusually high levels of vibration both at the foundation and on the ground adjacent to the foundation led to limiting of tests to low vibration.

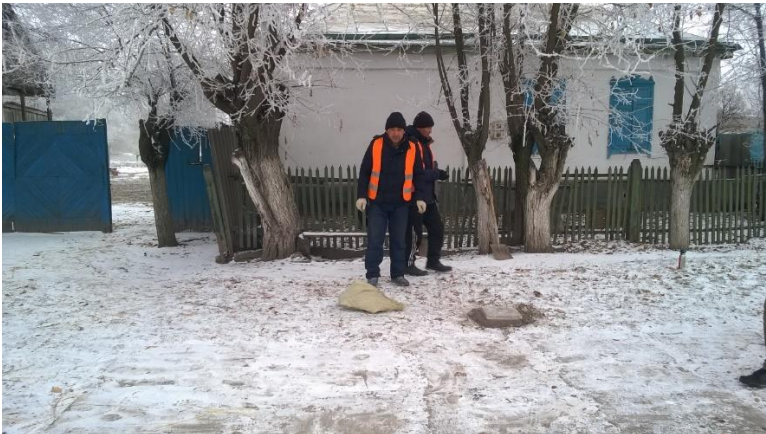
*Figure 9. No. 268 Centralnaya Street, Petrovka*

Construction: Mixed brick clay/adobe construction.

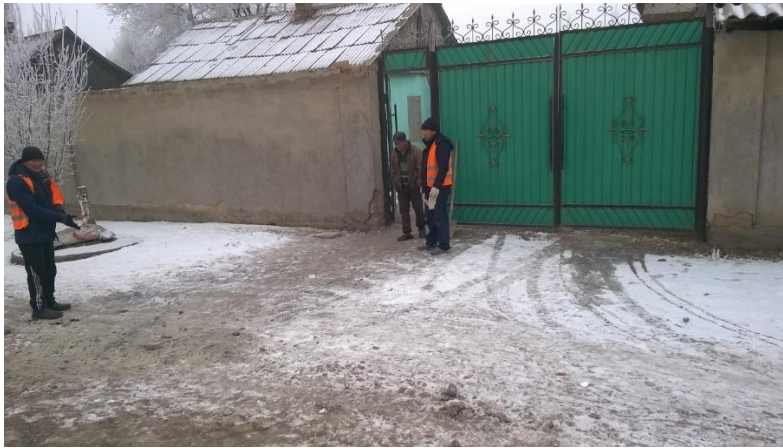
Construction: Clay/adobe construction.

*Figure 11. No. 122 Centralnaya Street, Petrovka*

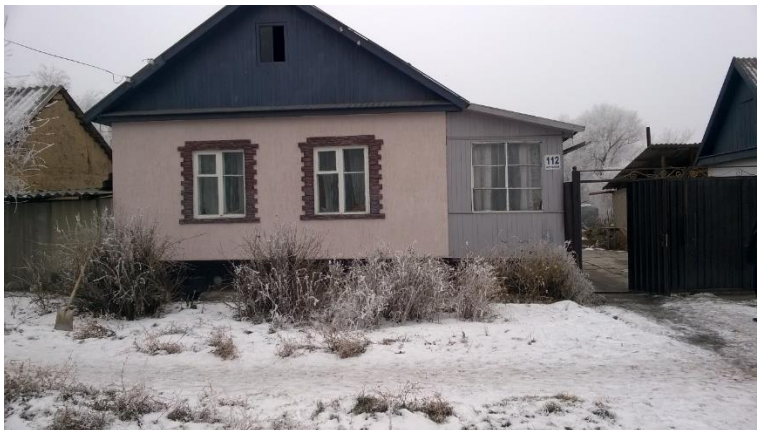
Construction: unknown however no visible sign of cracking and foundation appeared to be concrete.

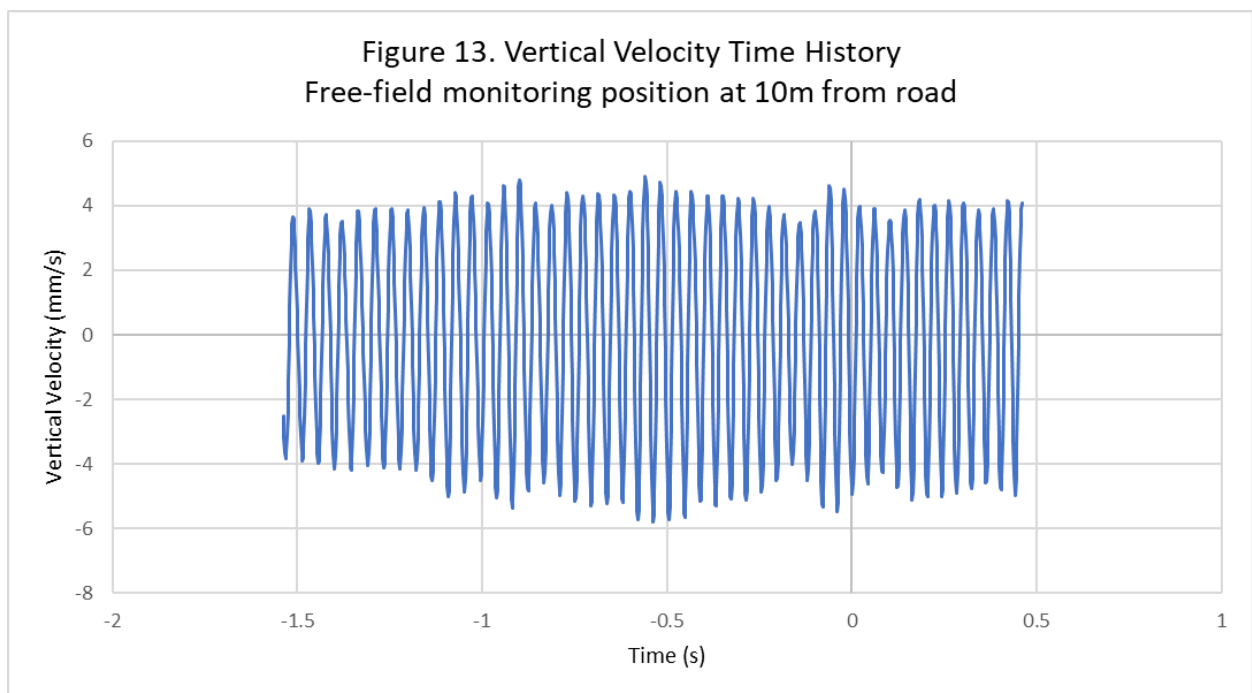
The vibration time histories of roller pass-by were processed to provide the maximum peak particle velocity (ppv) for each pass-by thus giving c. 3 data points for each roller vibration setting/geophone configuration. A combined plot of vibration and dominant frequency against time (see Figure 12 below) was examined for each data point to ensure that the roller had reached normal operating frequency and that the higher levels occurring during start up were not contaminating the measured data. This was supplemented by looking at more detailed vibration frequency information contained in the Fourier transform (FFT) of the individual measurements made during pass-by. Examples of these are presented in Figures 13 and 14 overleaf.

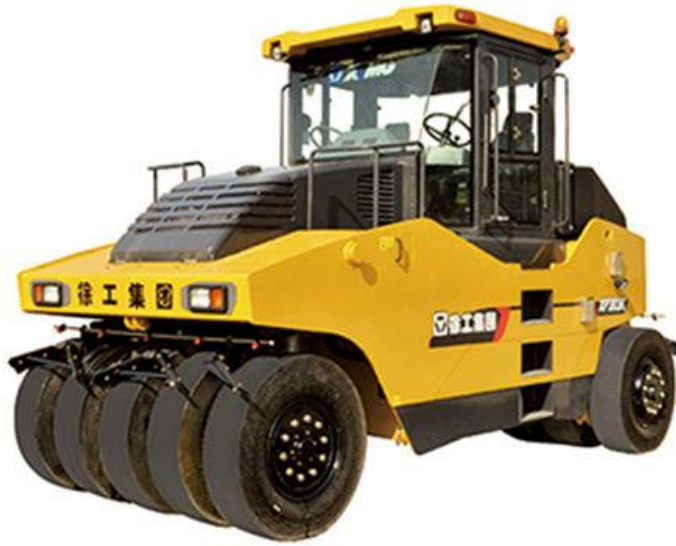
XCMG XP303K Pneumatic Tyred Road Roller

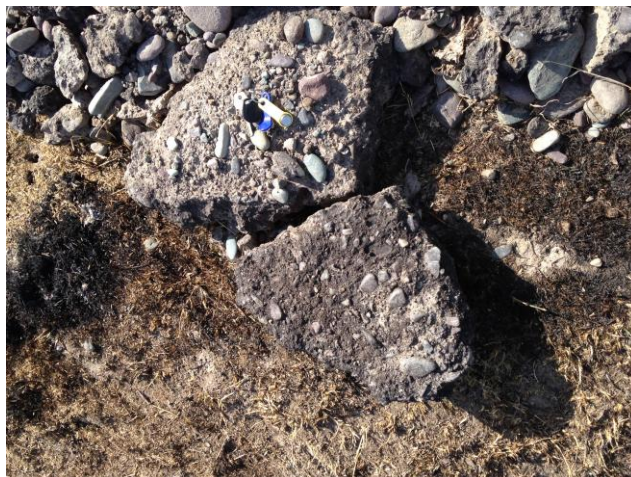
Figure 21. Close up of size of larger waste asphalt pieces; approximately 10cm x 5cm, which is crushed to a much smaller size after several bulldozer passes

Waste asphalt and a portion of the subgrade gravel was removed from the highway using backhoes (not other heavy equipment was used). The material up to 0.8m<sup>2</sup> was loaded onto the contractor's trucks and transported to the designated roads. Once deposited it was crushed by passes from a large bulldozer, resulting in pieces generally no larger than 0.2 m<sup>2</sup> (Figure 21). The asphalt slabs were removed with enough subgrade gravel that the combination created a relatively smooth road surface (Figure 22), i.e. a mixture of crushed asphalt and gravel.

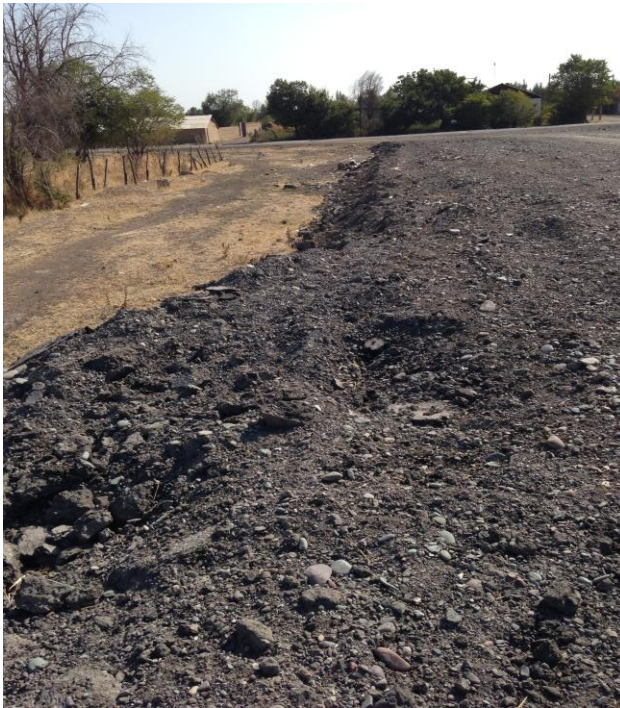
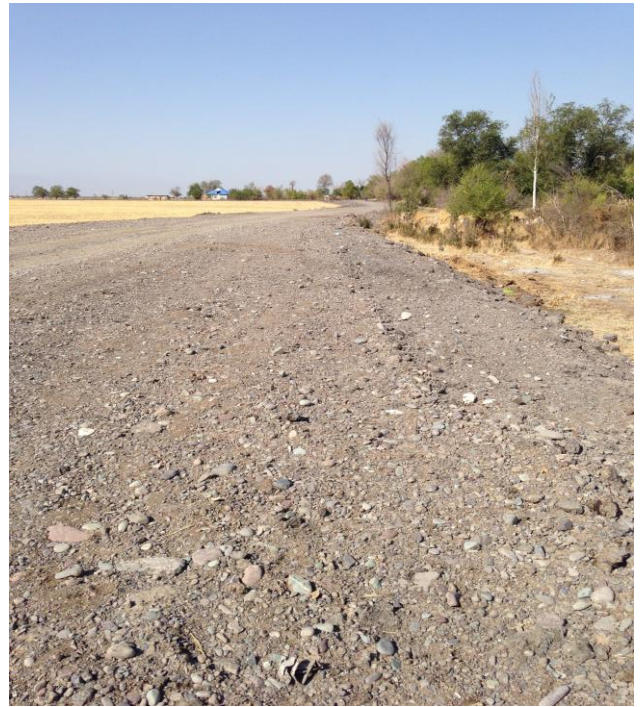
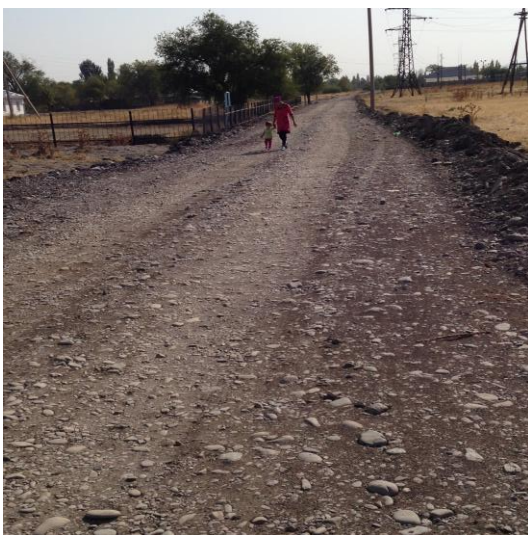
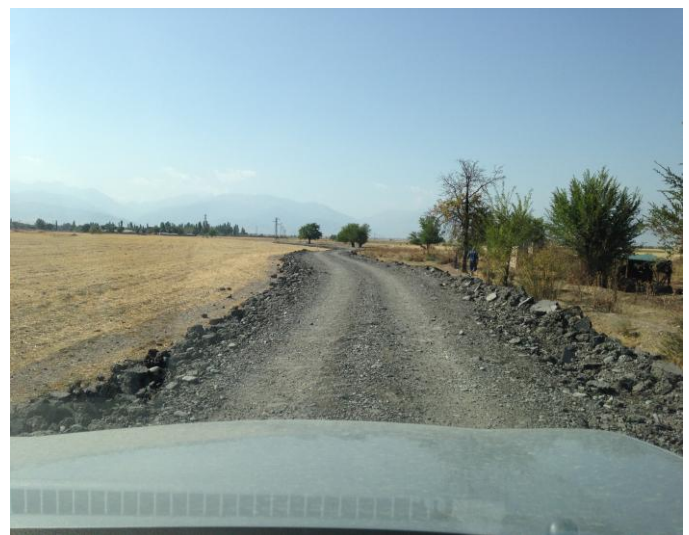
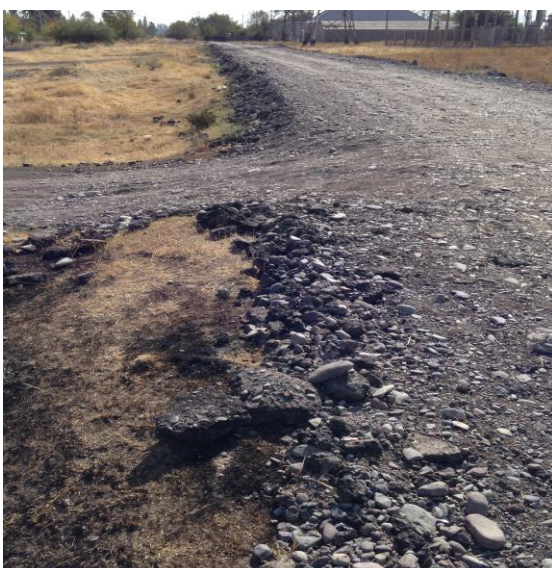
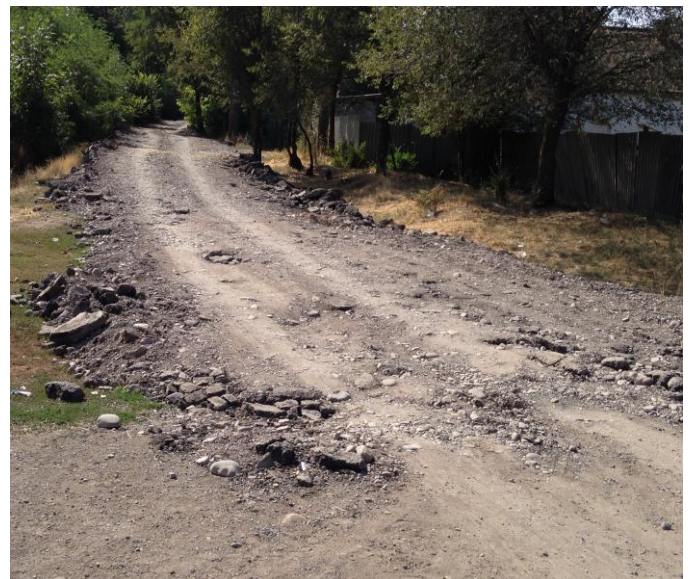
Figure 22. Six examples of waste asphalt and subgrade gravel placed on rural roads by the contractor. Transport placement and grading usually took 6-14 days.

- 6) The contractor trucked in the material which contained waste asphalt, but also subbase gravel and sand, resulting in a more stabile and smoother surface (Figure 22).

Note: roads in red font inspected during Sept. 2018 field visit and photos included (Figure 22)

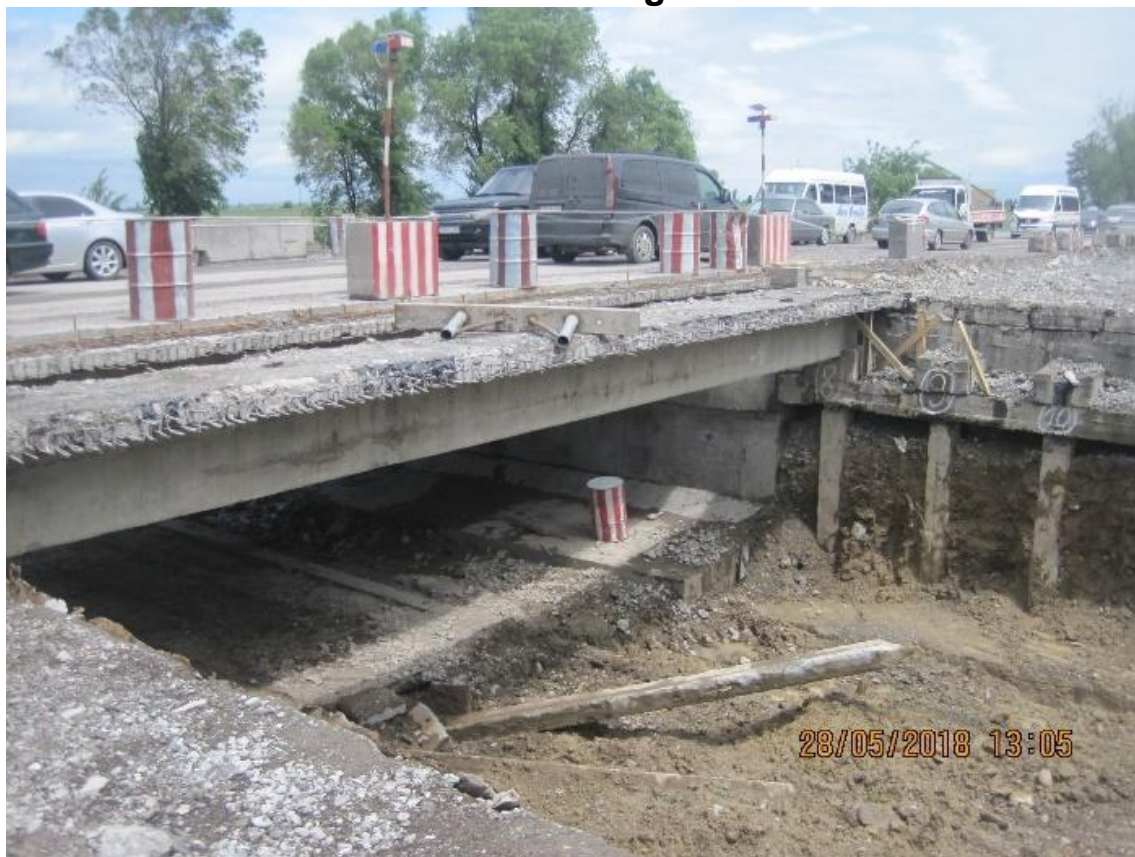
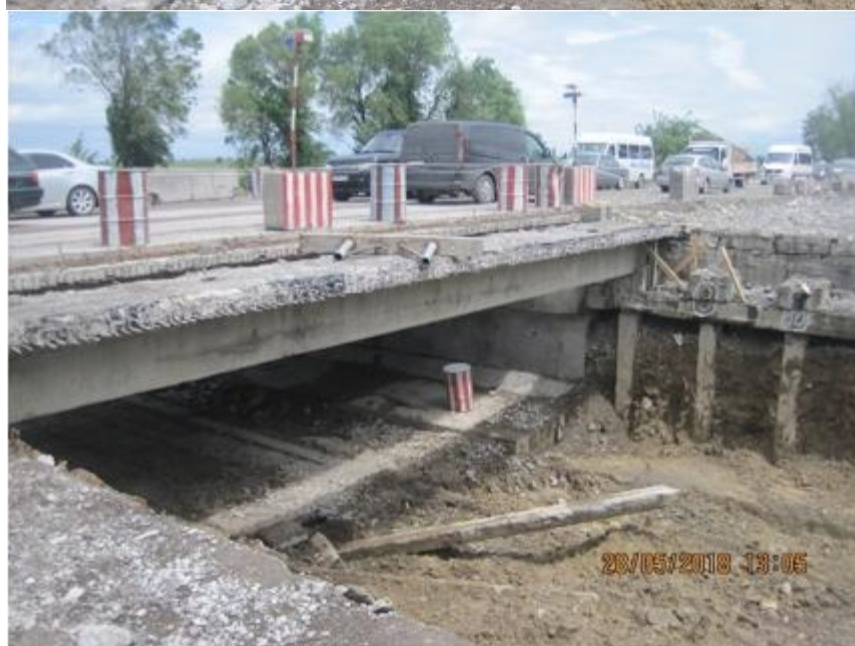
Jelamysh Bridge construction

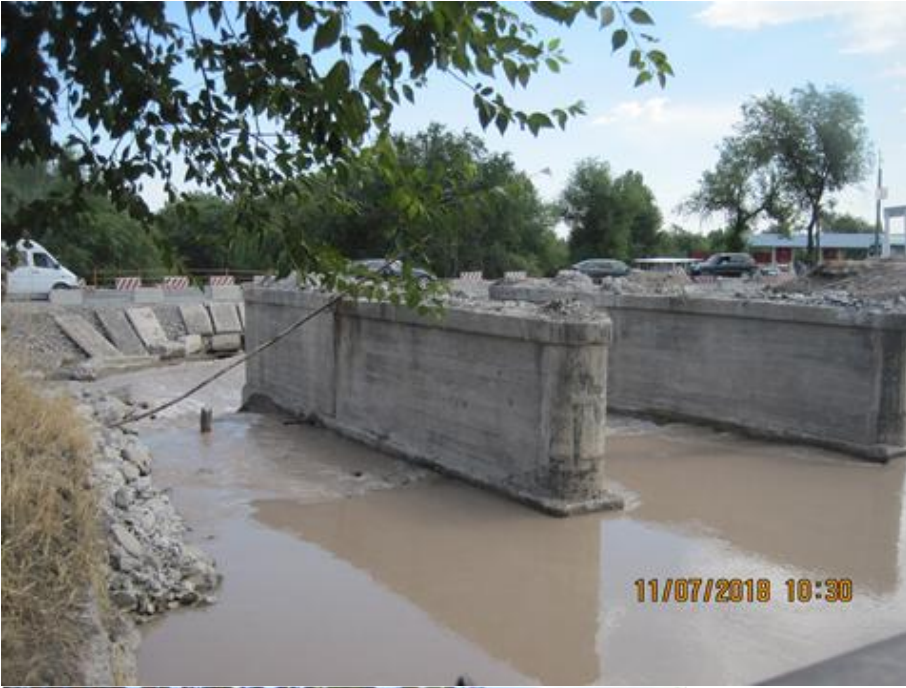
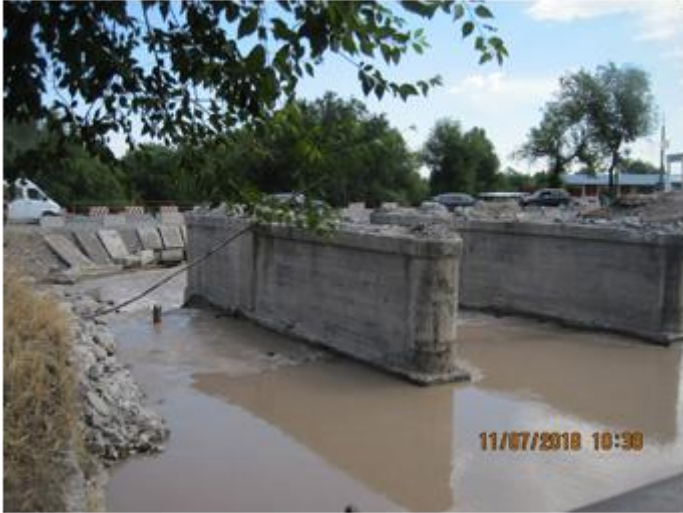
Ak Suu Bridge Site

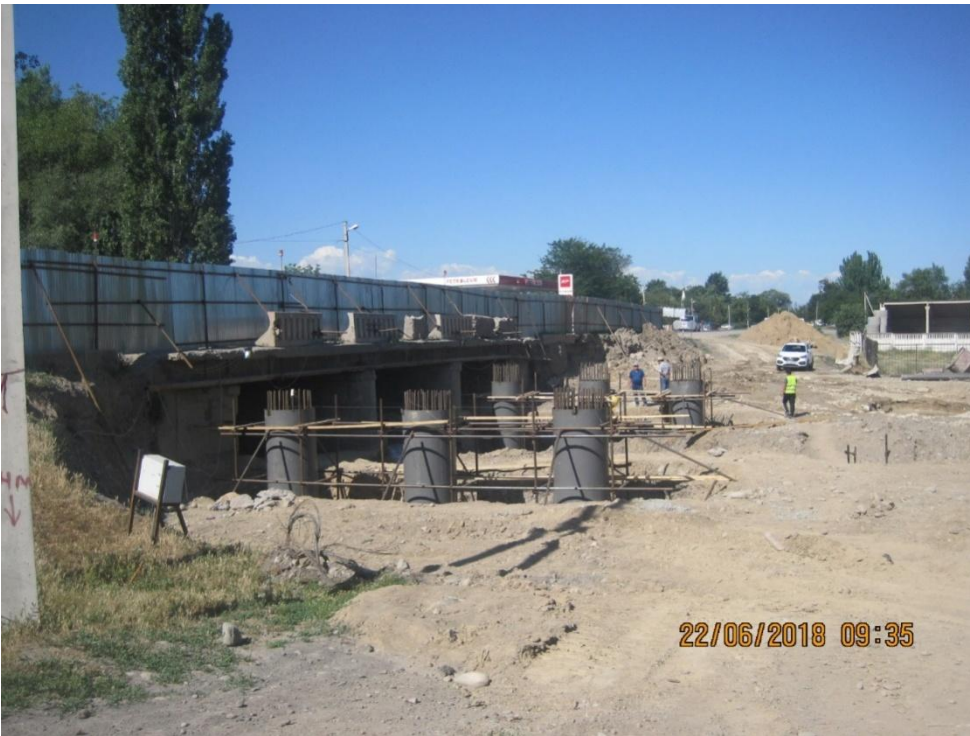
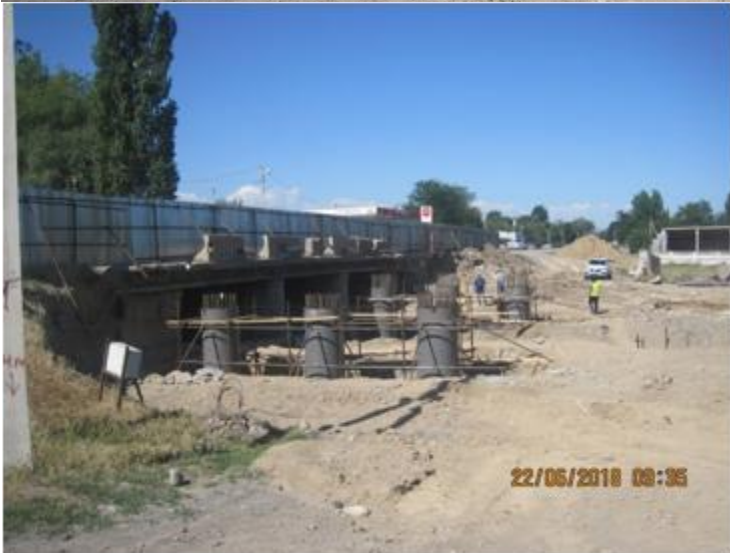
Sokuluk River bridge Construction site, June 2018

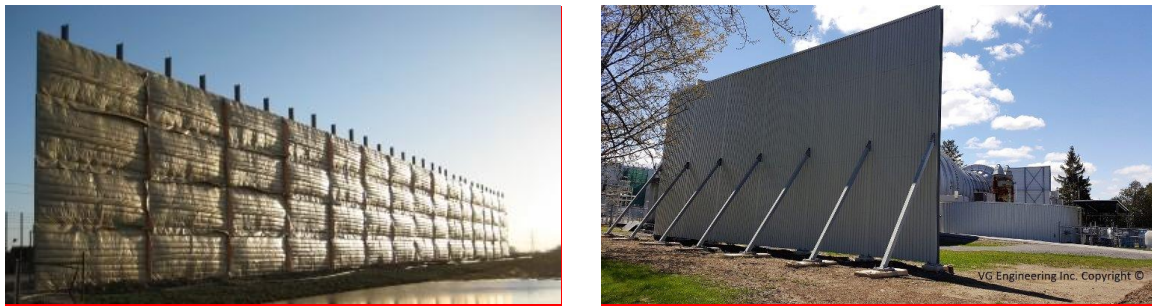
**Figure 5.1: Examples of Temporary Noise Barriers**

- The contractor will maintain a training plan for all equipment operators that, among other will, shall also include techniques for reduction in noise.
- No operator shall be allowed to operate an equipment, unless he/she has received training on its operation.
- **Temporary Noise Barriers.** Until the permanent noise barriers are installed, temporary noise barriers can be installed between the apartments and the construction zone. Examples of noise barriers are shown in **Figure 5.1**.
- **Night Construction.** Any type of construction activity during the night will not be allowed.
- **Distance Attenuation:** As construction equipment is considered as the point source and the standard reduction for point source noise is 6 dBA per doubling of distance from the source.
