Reporting Period: Environmental Report # 5 (to end March 2013)

The Kyrgyz Republic: CAREC Regional Road Corridor Improvement Project Environmental Report # 5

ENVIRONMENTAL MONITORING AND EVALUATION REPORT
KARAMYK-SARY TASH ROAD
March 2013

Report on visiting the Site by the Local Environmental Consultant in March 27-28, 2013

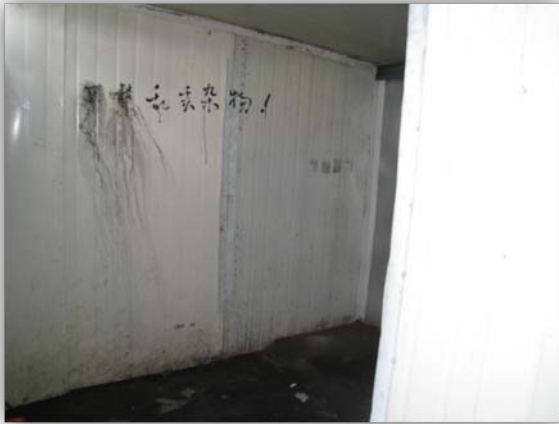
1. Team 1 workers have not been fully deployed at the site yet. The China Roads company Project Manager is waiting for the arrival of the workers. The toilet and latrine facilities were judged to be in an acceptable condition in terms of cleanliness. The water reservoir, located behind the residential houses is also clean and does not create any apparent sanitary problems. However, the reservoir, which had been used for dust suppression contains solid waste and garbage. The Consultant instructed to clean it up before the works for this year's season start.

Picture 1. Toilet at Team 1 is clean

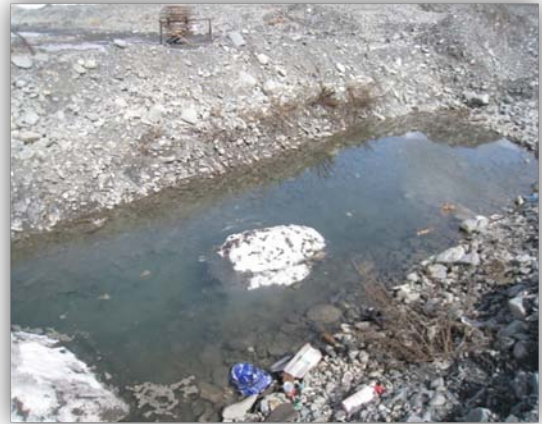
Picture 2. Water reservoir for dust suppression at the Team1 that contains garbage

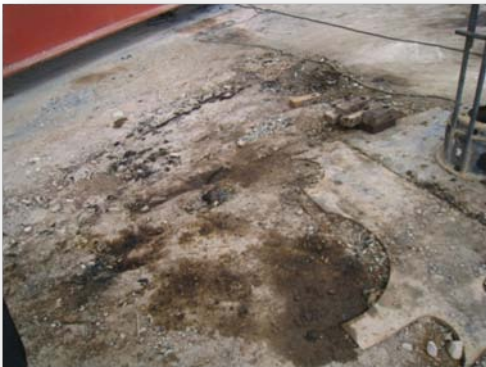
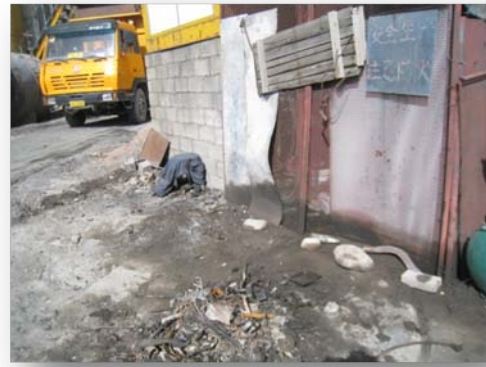
5. Visiting the site for the production of bitumen and fillers - Team 2, revealed that the situation with the spillage of industrial oils and tar has worsened when compared to last year's conditions. The Consultant identified numerous and large enough spots

of tar spill and industrial oils in places where the covering protection (concrete bottom or protective film) is not provided.

Picture 3. Team 2: Spots of oil are numerous and big

Picture 4. Team 2: Spots of oil are numerous and big

7. After consultation with staff SAEPF, it was decided that all contaminated soil will be collected in one place on an impermeable layer until a decision is made on the appropriate method for disposal, treatment, or remediation. Alternative decision more appropriate in terms of ecology may include treatment of polluted soil by fuel and oil spillage with glaukrite polluted soil should be covered by this material 3 cm thick layer and 2 cm thick layer of gravel to prevent glaukrite's blow-off by wind.

3. Soils and grounds polluted by the oil and fuel spillages at the work camps and asphalt plants must be cleaned up with glaukonite. The glauknite should be brought from its deposit in Batken Province (south of Kyrgyzstan) and all the spots of fuel pollution should be covered by this material with 3 cm thick layer and 2 cm thick layer of gravel to prevent glauknite's blow-off by the wind.

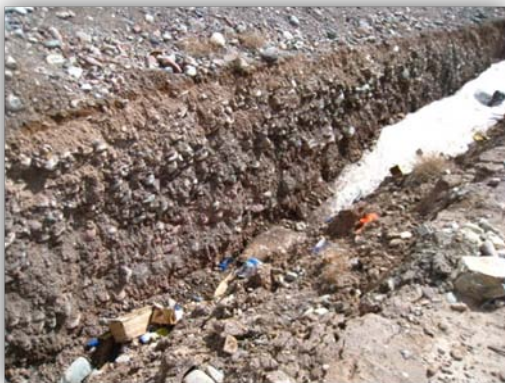
2. At the Team 2 worker camp: Everything is clean, and the places where the works on repairing machines or refueling oil is conducted are properly covered by concrete. Soils are well protected against the penetration of industrial oils and fuels. The only observation made by the Consultant related to the fact that the enclosing ditch around the perimeter of the camp, contains household garbage along its entire length (especially the parts close to the gate).

3. The remaining parts of the pit do not contain waste and are clean. It was noted that local worker staff had been using this trench for garbage collection and disposal. The Consultant pointed out the need to clean out the garbage from the trench. Also, the Consultant pointed out that it was not permissible if the waste would remain at the bottom of the trench, and would be covered with a thick layer of soil. The disposed solid waste was noted to contain many items made of plastic and foam, which are not biodegradable. Therefore, this waste should be collected in one place and destroyed/burnt according to the national standards and requirements. Those parts that are subject to decomposition in the environment can be buried or burned.

Picture 5. The enclosing ditch at Team 2 gates with garbage

1. Quarry location must be put into a safe condition; its slopes should be leveled to prevent future erosion processes and possible accidents. The surface of the leveled slopes should be planted with local grass/crops.
2. Garbage at the work camps should be properly collected and disposed in a single place free of risk

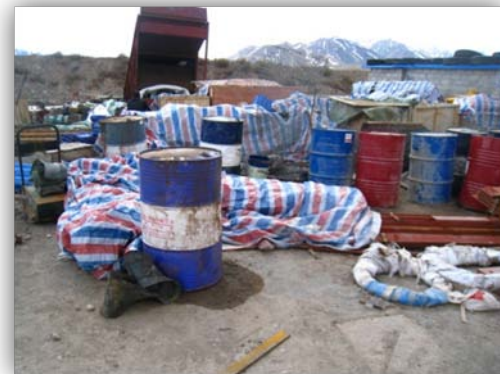
Picture 6. Team 2 example: ground is properly covered with concrete to protect against oil and tar spillage

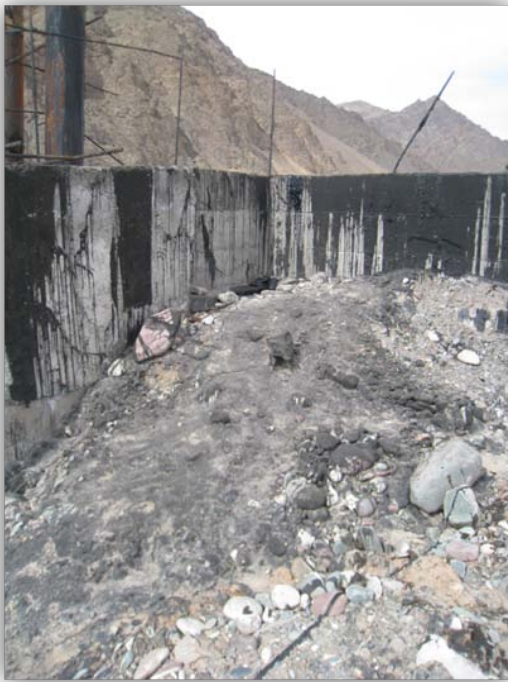
Picture 7. Asphalt plant at Team 2: numerous and big enough spots of tar at the ground

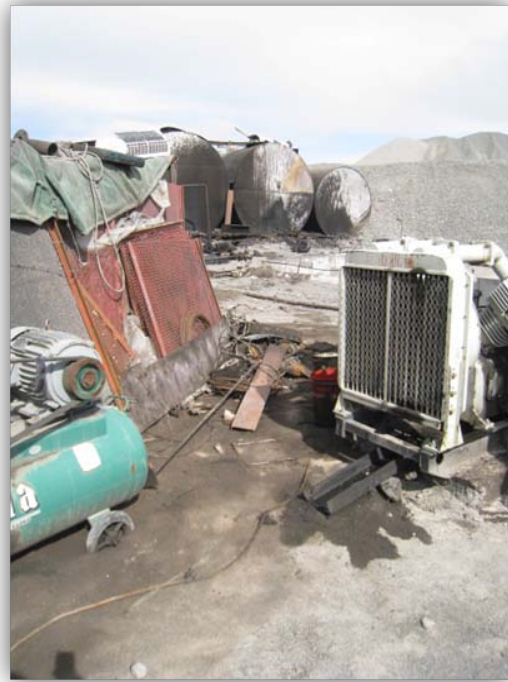
Picture 8. Team 2 ground: numerous and big spots of oil were found where there were not any protective coverage/cement coating

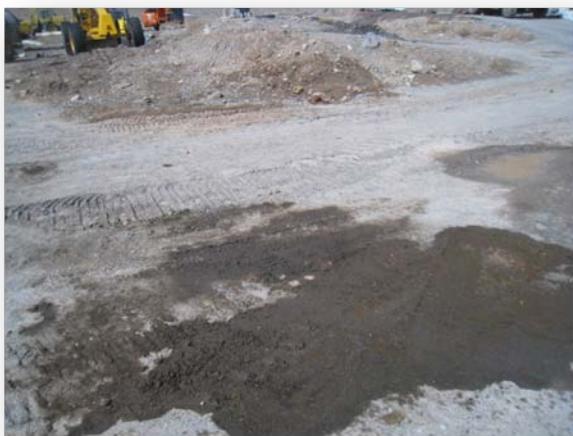
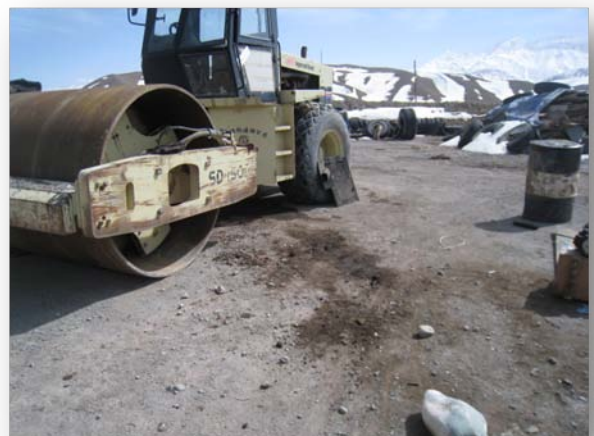
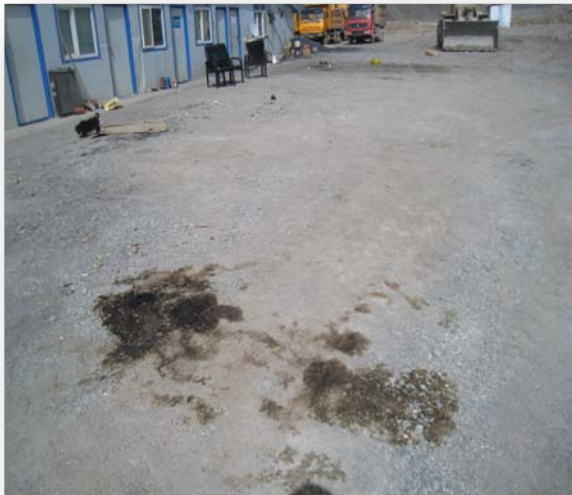
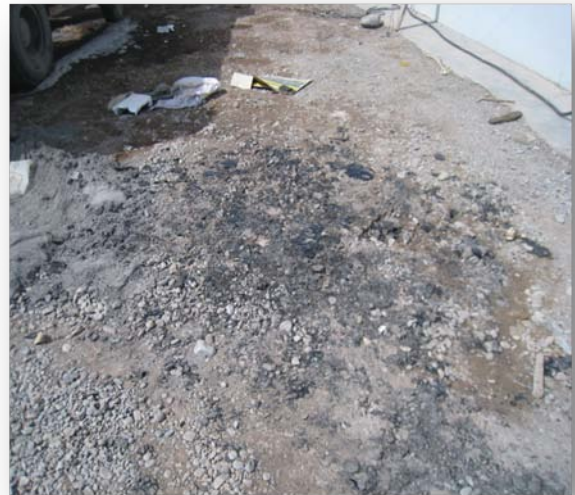
First of all, a certain concern is oil and fuel spillages that were observed in many places of Team-2 area, as well as at Asphalt Plant Team-1. In comparison with the 2012 situation, they have become more in number and bigger in size. The CRBC responsible staff has to observe all the environmental requirements and treat the soil and ground pollution issues appropriately. Nevertheless, now the situation in terms of spillages has worsened (see pictures below).

Picture 9. Spillages of fuel and oil materials at Team-2 location.

Picture 10. Spillages of fuel and oil materials at Team-2 area

Picture 11. Spillages of fuel and oil materials at Team-2 area

Picture 12. Spillages of fuel and oil materials at Team-2 area

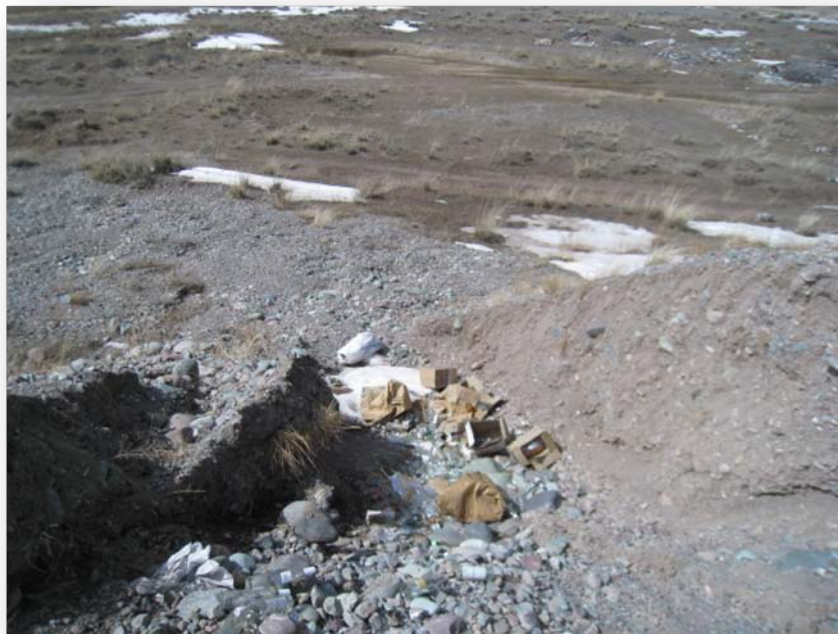
The National Environmental Consultant also found that glass (numerous empty alcohol bottles) and paper box garbage was disposed at an improper place right near the road in a trench going down towards the river flood land (see picture 13 below).

Picture 13. Empty alcohol bottles and paper box garbage disposed near the road

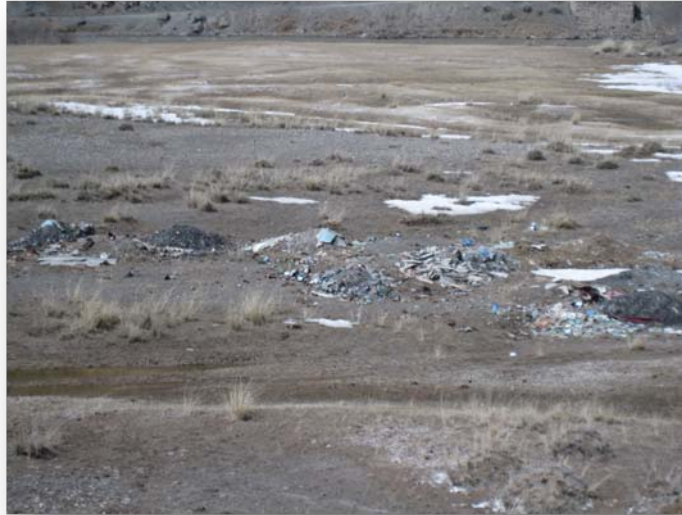
Landfill established in the flood land of the river (see picture 14) has to be re-cultivated. Until it is not brought into environmentally appropriate conditions, it creates a risk of its washing-out into the river during high-water periods and polluting the river and lands downstream.

Picture 14. Landfill at the left bank of the Kyzyl-Suu River

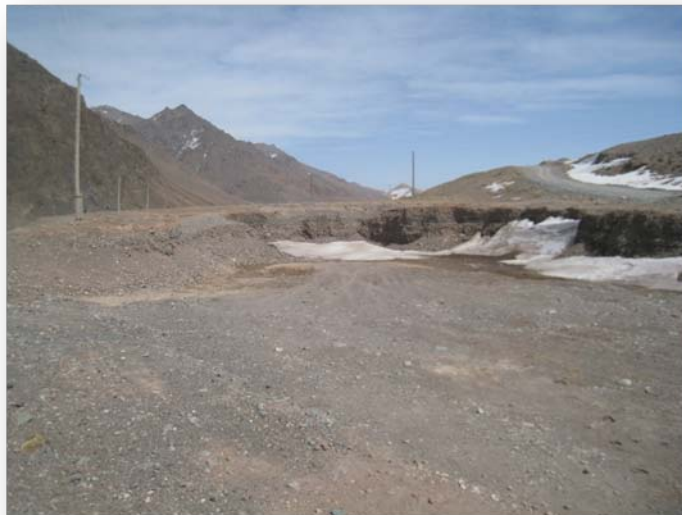
Another area of concern is a quarry with rather steep slopes that needs to be leveled with a grader. The current condition causes possible risks in terms of human health, ground and soil erosion due to weathering, and safety for the electric transmission line. Also a small road for servicing the transmission line passes in the direct vicinity of the quarry.

Picture 15. Quarry at the left bank of the River.
