# Environmental Monitoring Report

Project Number: 42399-02  
 Grant Number: ADB Loan No. 2755-KGZ (SF)  
 Reporting Period: July to December 2014

Kyrgyz Republic  
 CAREC Transport Corridor -1  
 (Bishkek – Torugart road) Project 3  
 SECTION KM479 to 539

Prepared By the Ministry of Transport and  
 Communications of the Kyrgyz Republic

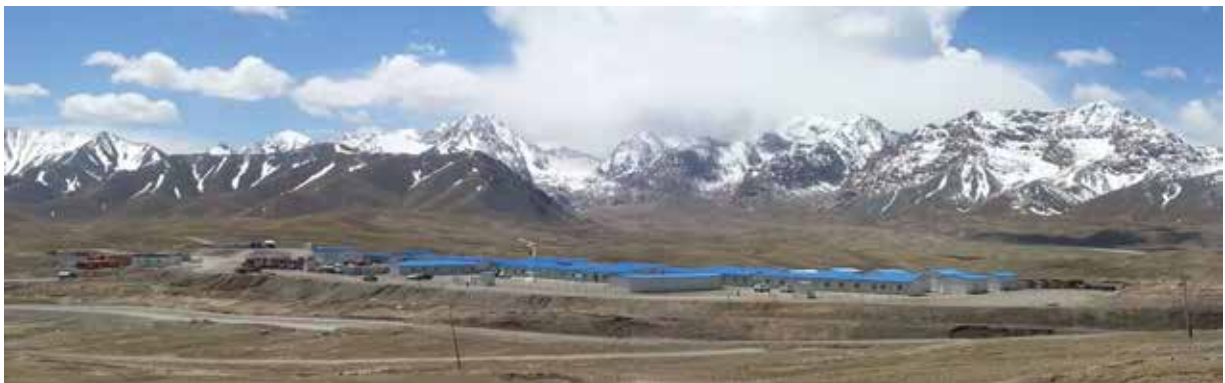
**Figure 6: Construction Camp at Km501 - Looking South across Tuz Bel Pass**  
(June 2014)

6. In 2013 the Contractor established a dedicated construction camp at Km501, on the west side of the existing road (Figure 6 and Figure 6) at Tuz Bel Pass. The camp is located outside the border of the Karatal-Japaryk State Nature Reserve (KJSNR). The Camp comprises site offices for Contractor and Consultant and accommodation and canteen for staff working on the Project. There are mobile phone connections available at the camp but 3G broadband is not available. The camp includes a maintenance yard, laboratory and refueling facility.

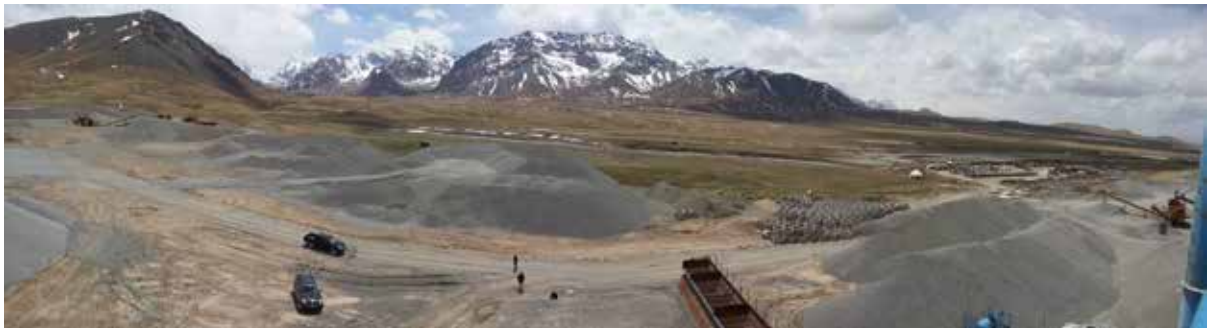
**Figure 8: Manufacturing Area looking south-west from Asphalt Plant across Muz Tor River**

8. A Manufacturing Area comprising crushers, stockpiles, asphalt plant and precast yard is sited around 3km south of the Camp, immediately east of the Muz Tor River.

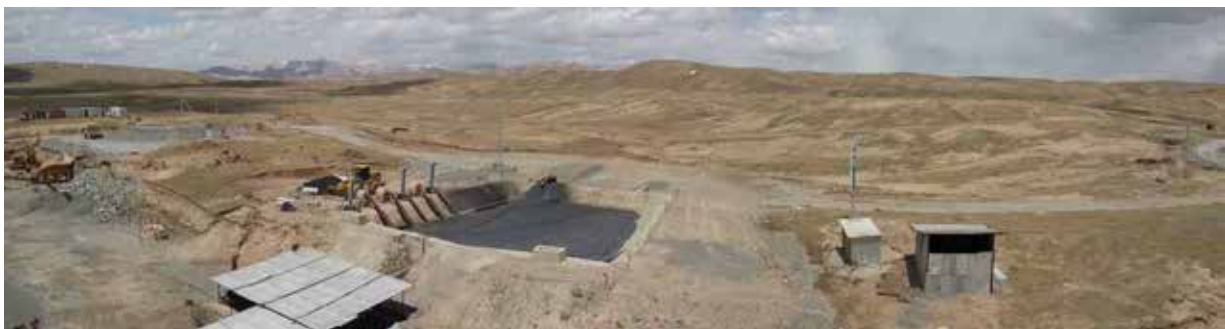
**Figure 9: Manufacturing Area looking north-east from the asphalt plant**

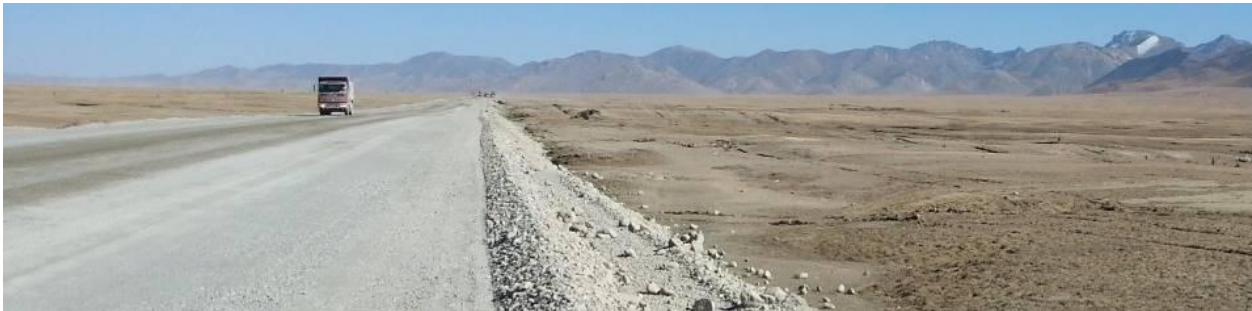
**Figure 11: Typical Road Alignment after works creating road foundation (around Km 502)**

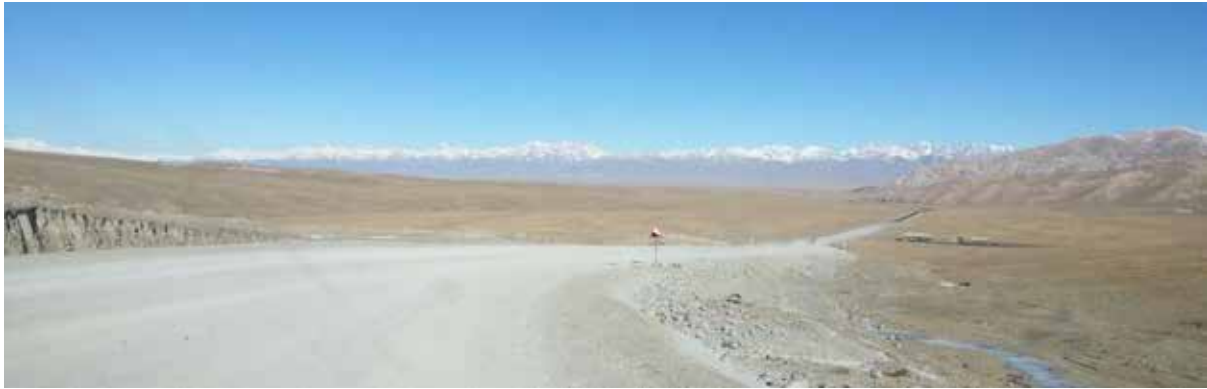
**Figure 12: Looking North from Tuz Bell Pass - Note start of Asphalt beyond RMU buildings**

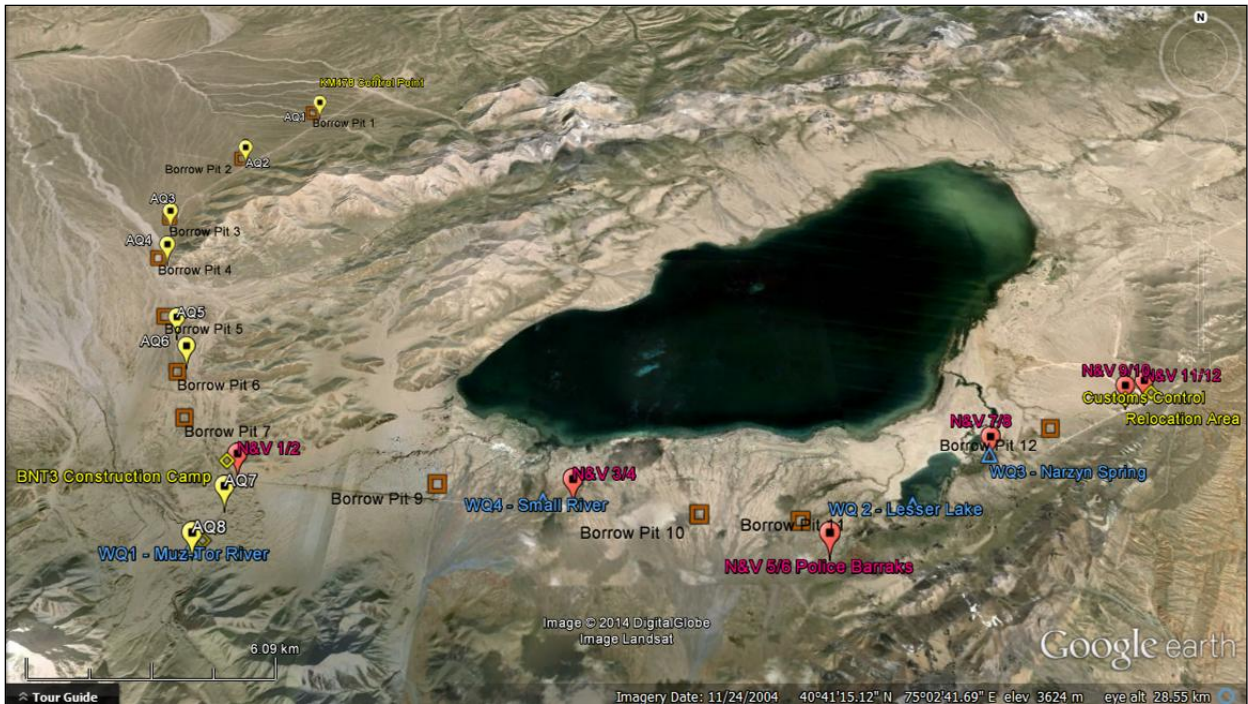
**Figure 14: Location of the noise & vibration, air quality and water quality monitoring stations**

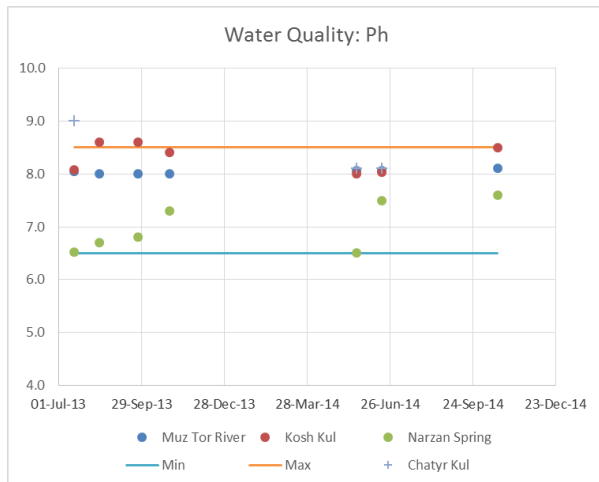
**Figure 20: Air Quality Monitoring plots - Ph**

3. The results for pH (Table 8, pg37), sulfates (Table 9, pg38), suspended substances (Table 10, pg40), chlorides (Table 11, pg41) and dissolved oxygen (Table 12, pg43) are all within permissible levels. The current works are unlikely to be having any impact on water quality in the lakes due to the distance from works areas. It is noted that results of nitrate and oil product testing were compliant and below detection limits. The current results

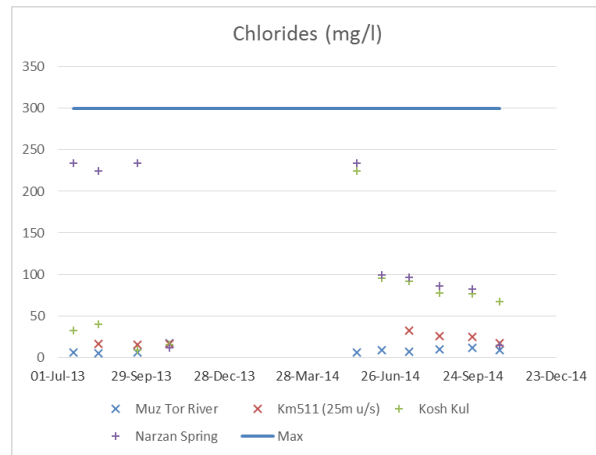
**Figure 24: Air Quality Monitoring plots - Chlorides**

**Figure 25: Air Quality Monitoring plots - Chlorides (Annual variation)**

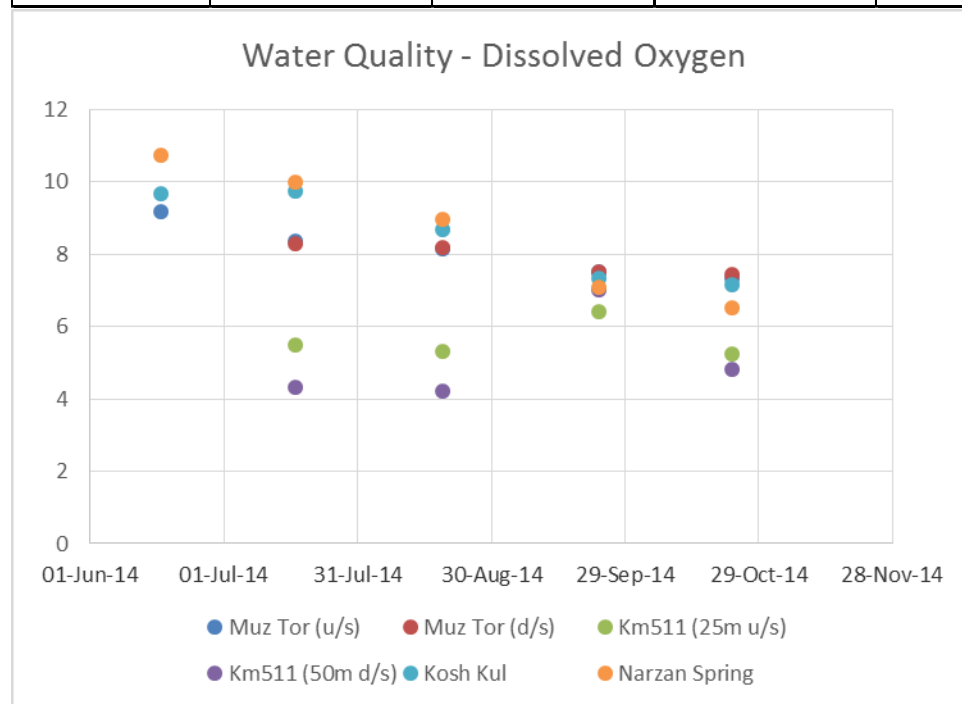
**Figure 26: Air Quality Monitoring plots - Dissolved Oxygen**

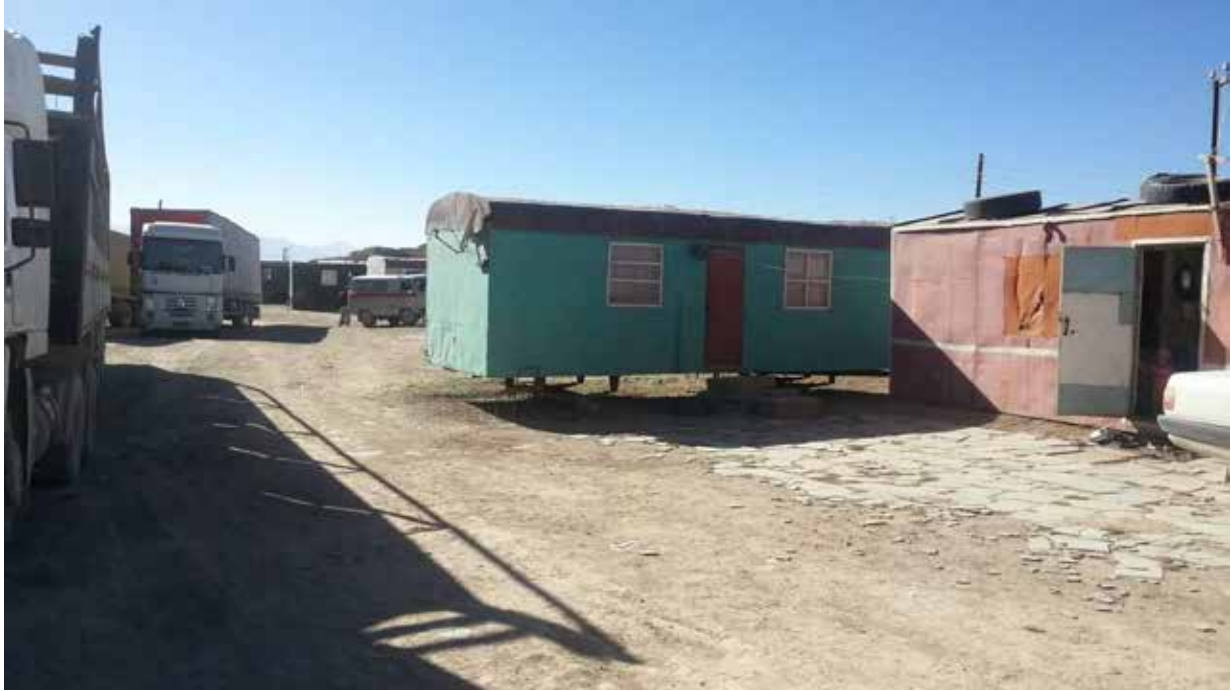
**Figure 30: Trailers at Border Holding Area (Km 530)**

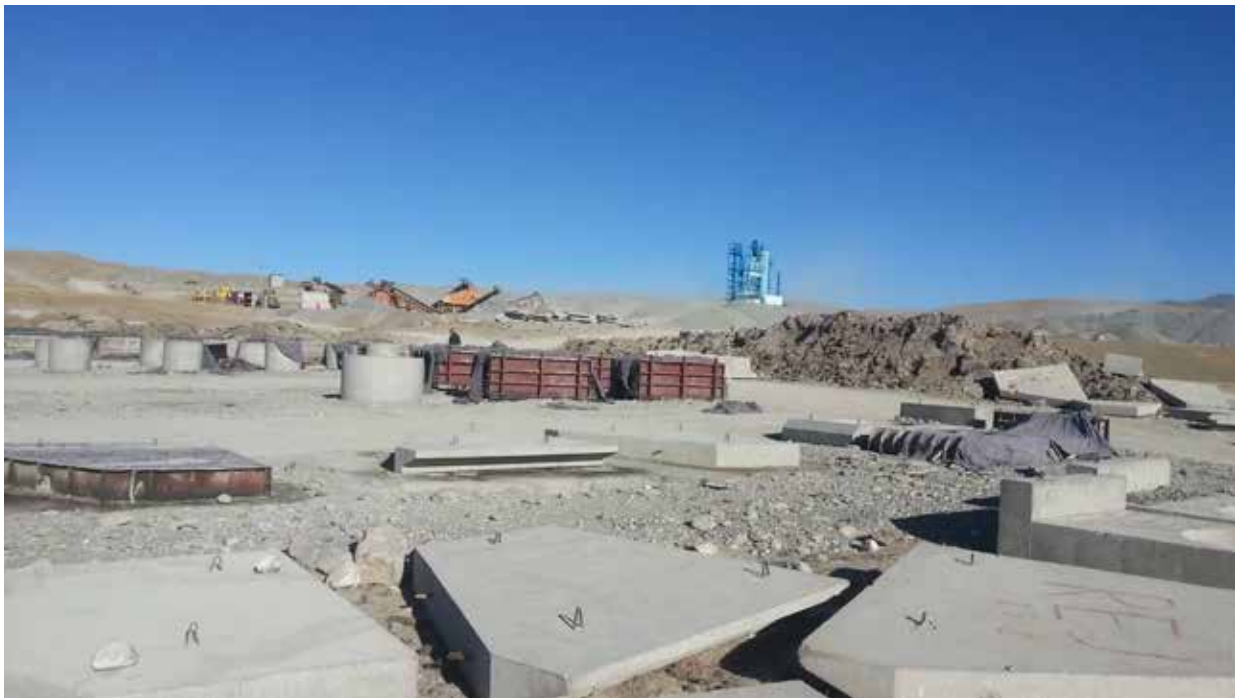
**Figure 31: Precast Concrete production, asphalt plant, crushing and grading areas**

12. The crushing and screening of material and the manufacture of precast concrete sections was carried out at the Manufacturing area.
13. The asphalt plant was commissioned and was active though the second half of the 2014 construction season.
14. By mid-November 2014 weather conditions were becoming too cold for regular work and the vehicles, camp and manufacturing area were prepared for winter closedown.

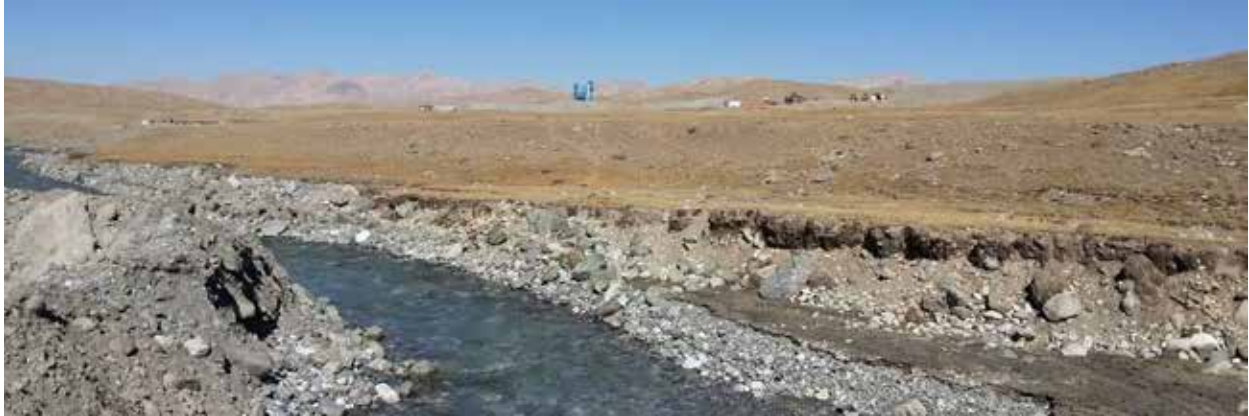
**Figure 32: Borrow Pit #8 on Muz Tor River – Note Asphalt and Crushing Plant in distance**

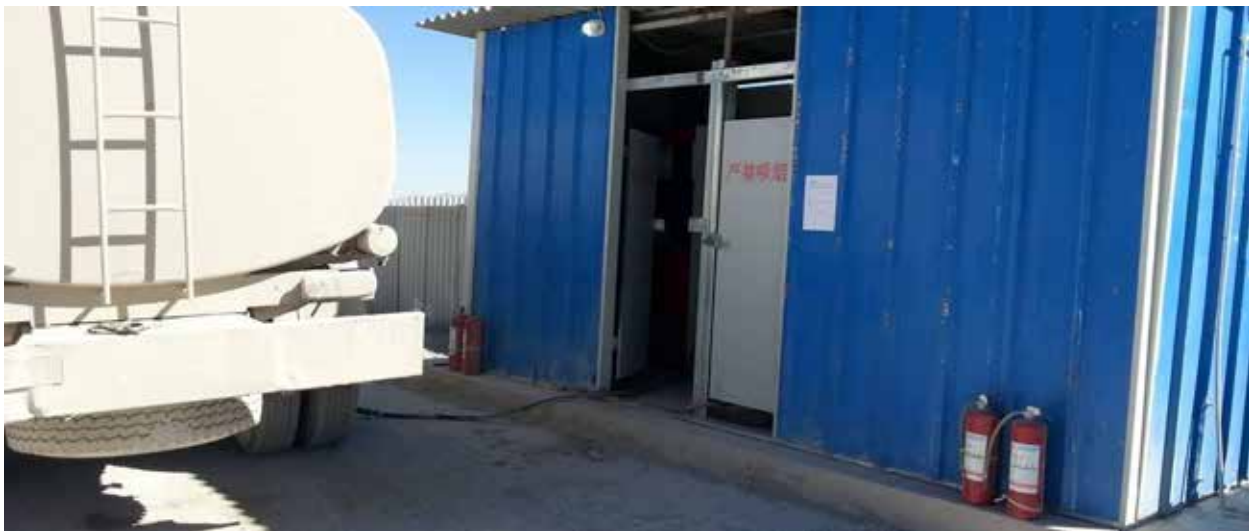
**Figure 33: Truck refuelling at dedicated camp facility**

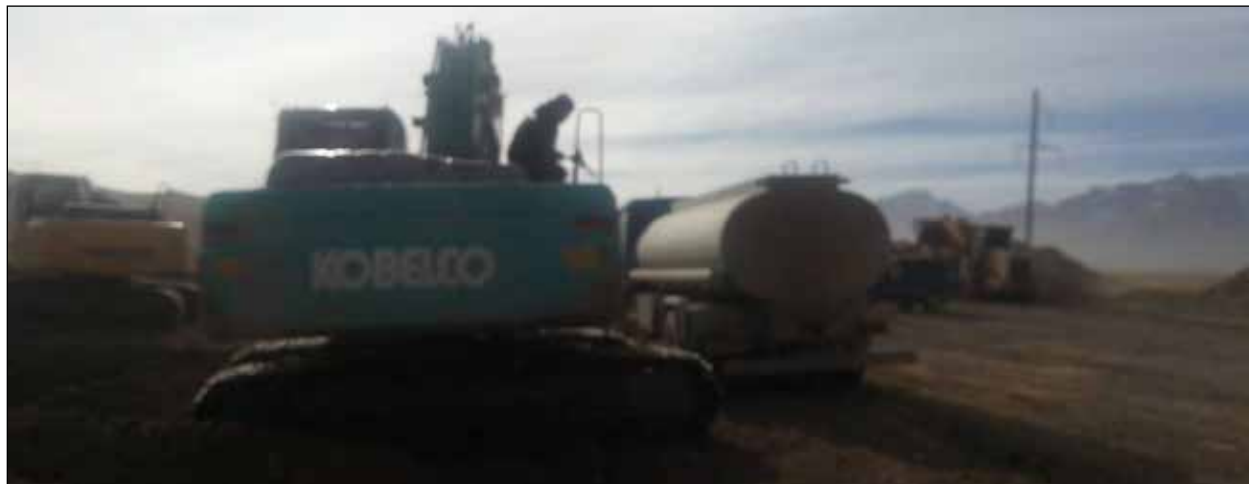
**Figure 34: Onsite refuelling of plant by dedicated refuelling truck**

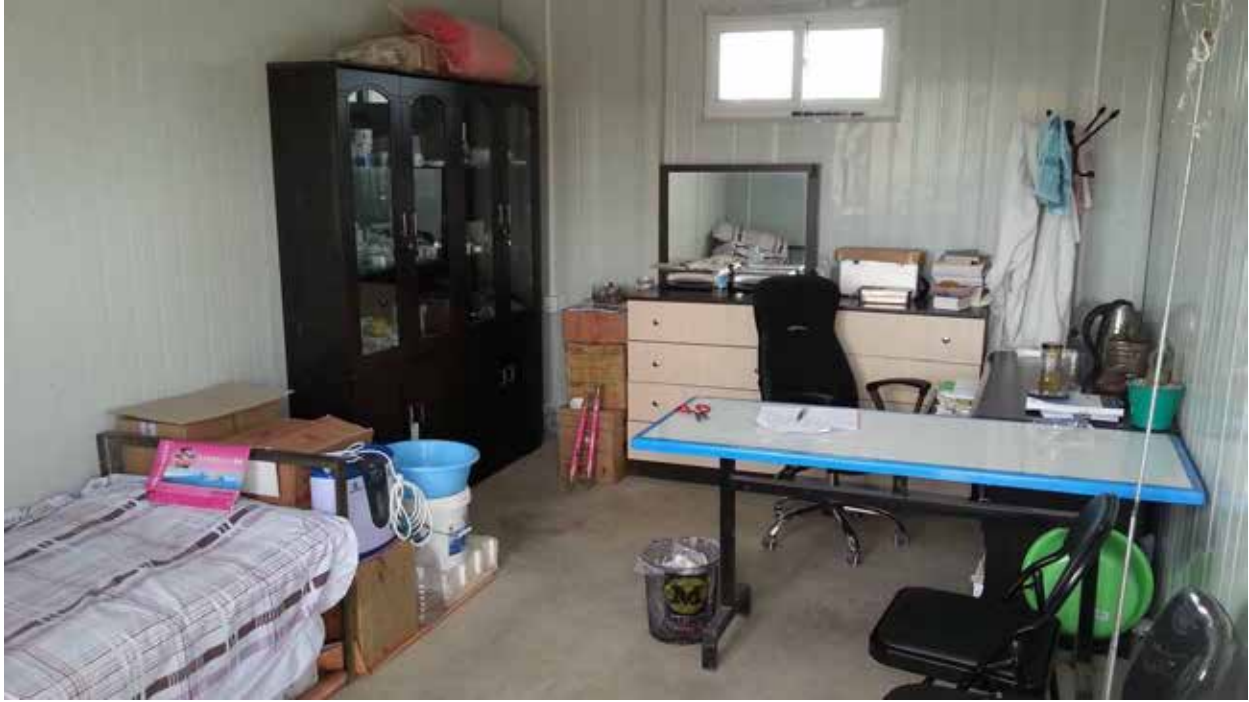
**Figure 35: Dedicated On-site Medical Clinic at the Camp**

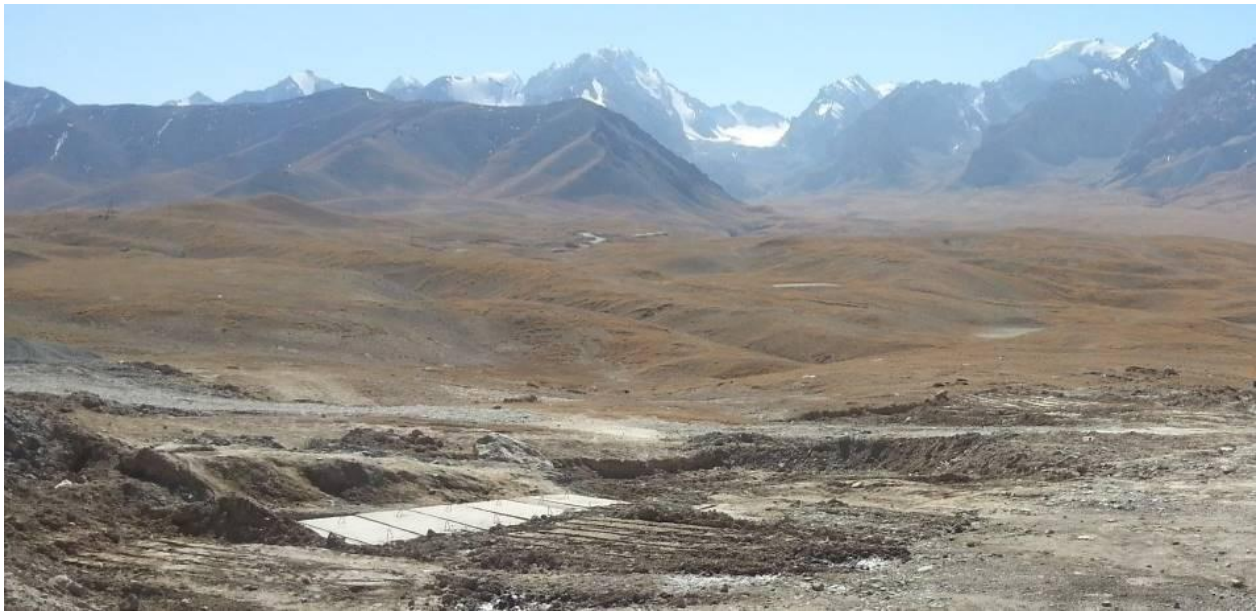
**Figure 36: Septic Tank installed behind Camp – Emptied to facility at Naryn**

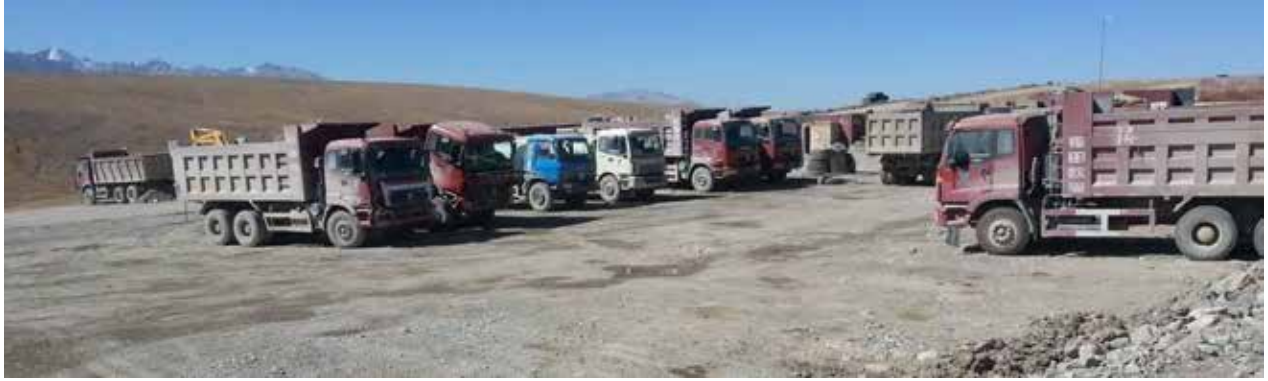
**Figure 37: Overnight vehicle parking on rolled hardstanding**

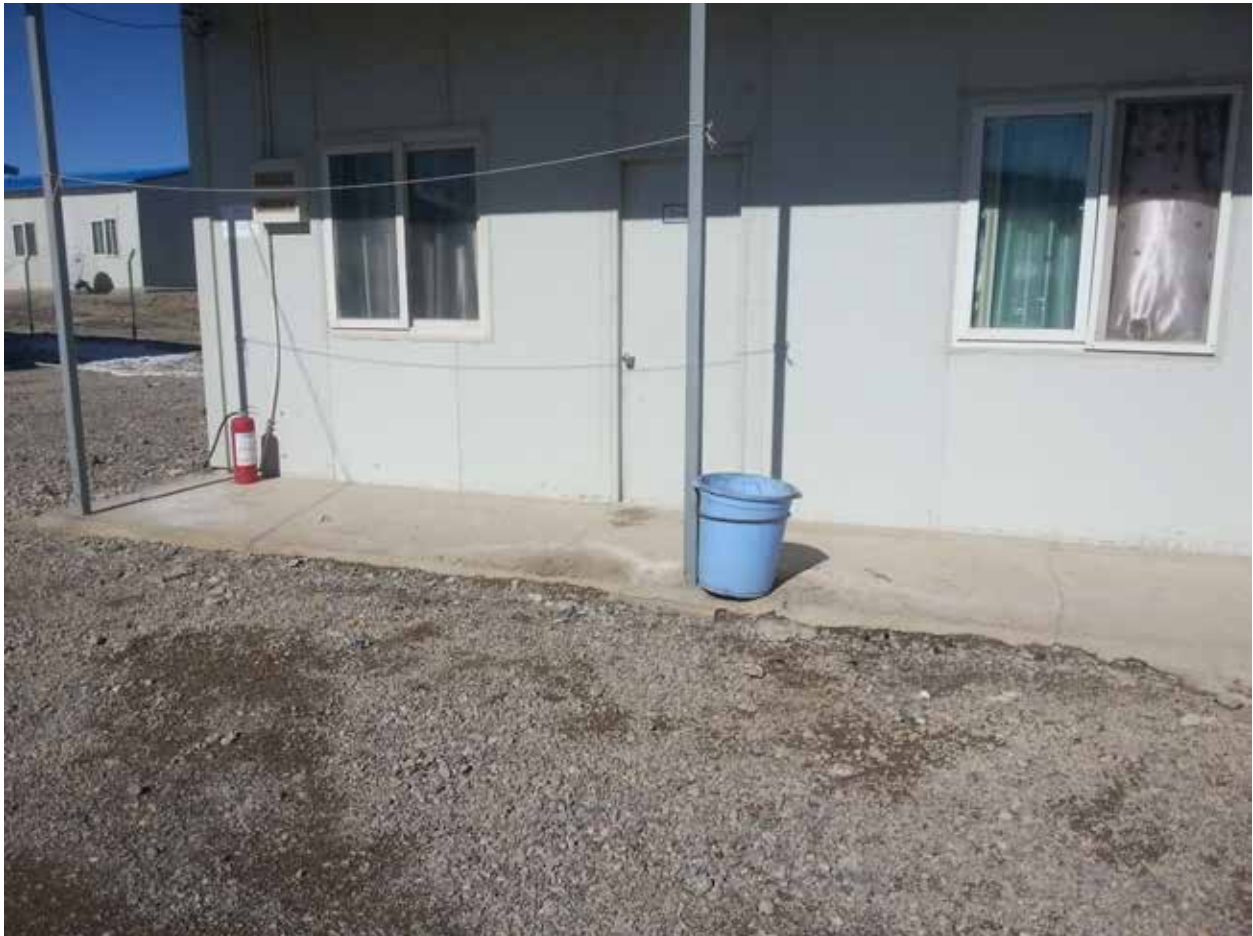
**Figure 38: Waste bins in camp compound– Solid waste collected and disposed to At-Bashy**

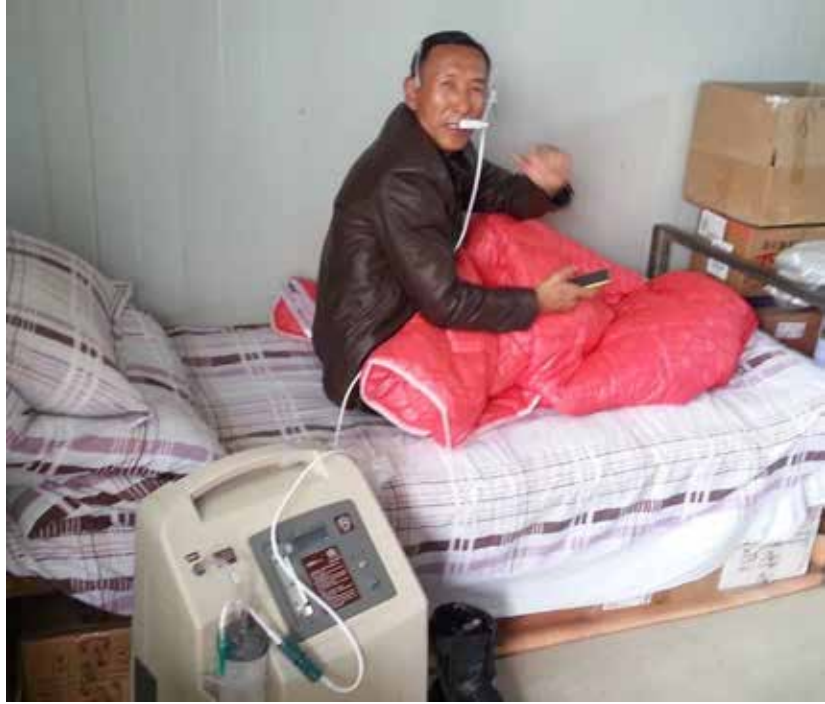
**Figure 39: Oxygen equipment available at Camp medical centre**

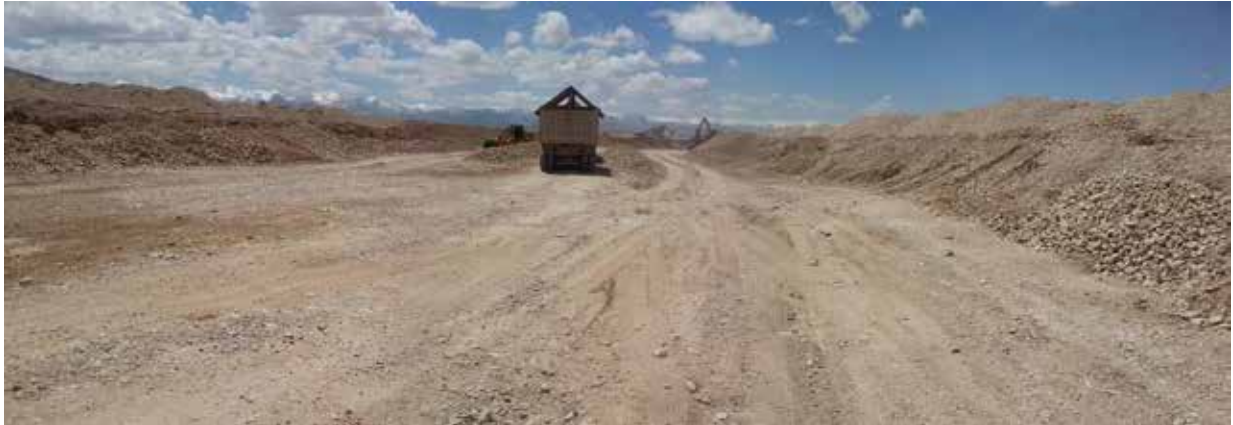
| <b>Borrow Pit # / Location</b> | <b>Date</b> | <b>Status</b> | <b>Photo – Status</b> |
|--|---|---|--|
| <b>#1</b><br><hr/> 480+750<br>RHS<br><hr/> <b>Volume</b><br>150,000m <sup>3</sup><br><hr/> 100 x 600 m<br><hr/> 200m from<br>road | June 2014 | Not started<br><input type="checkbox"/><br>In progress<br><input type="checkbox"/><br>Extraction complete<br><input checked="" type="checkbox"/><br>Restoration phase<br><input type="checkbox"/> | <p><b>Figure 41: Borrow Pit #1 – Extraction now completed</b></p> |

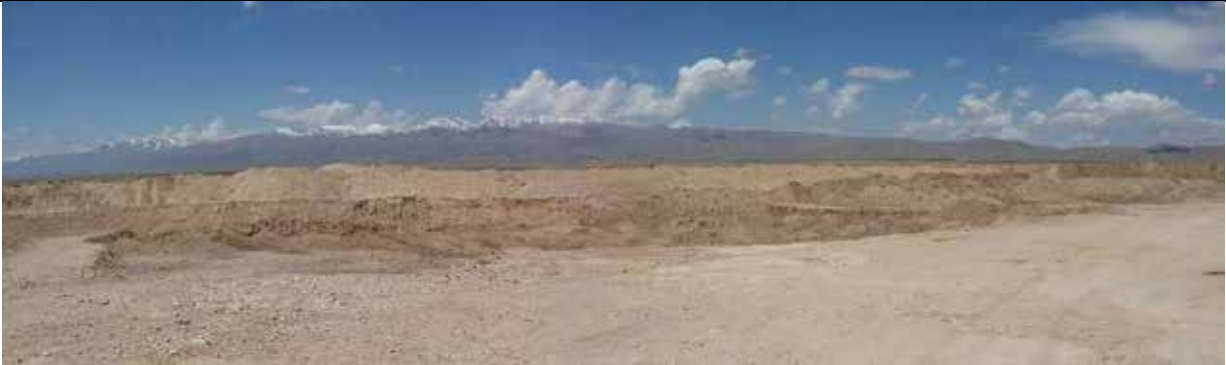
| <b>Borrow Pit # / Location</b> | <b>Date</b> | <b>Status</b> | <b>Photo – Status</b> |
|--|---|---|--|
| <b>#2</b><br><hr/> 484+400<br>RHS<br><hr/> <b>Volume</b><br>240,000 m <sup>3</sup><br><hr/> <b>Area</b><br>600 x 200m<br><hr/> 150m from<br>road | June 2014 | Not started<br><input type="checkbox"/><br>In progress<br><input type="checkbox"/><br>Extraction complete<br><input checked="" type="checkbox"/><br>Restoration phase<br><input type="checkbox"/> | <p><b>Figure 42: Borrow Pit #2 – Note active, topsoil stored on edge of pit for recontouring</b></p> |

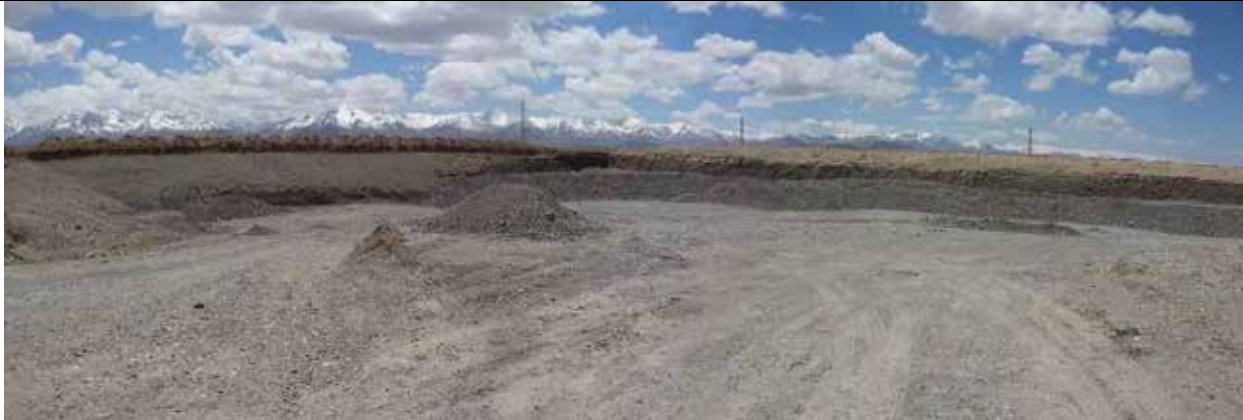
| <b>Borrow Pit # / Location</b> | <b>Date</b> | <b>Status</b> | <b>Photo – Status</b> |
|--|---|--|---|
| <p><b>#3</b></p> <hr/> <p>480+750<br/>RHS</p> <hr/> <p><b>Volume</b><br/>120,000m<sup>3</sup></p> <hr/> <p>300 x 200 m</p> <hr/> <p>200m from<br/>road</p> | <p>June<br/>2014</p> | <p>Not started<br/><input type="checkbox"/></p> <p>In progress<br/><input checked="" type="checkbox"/></p> <p>Extraction<br/>complete<br/><input type="checkbox"/></p> <p>Restoration<br/>phase<br/><input type="checkbox"/></p> | <p data-bbox="762 686 1808 711"><b>Figure 43: Borrow Pit #3 – Material extraction continued - Note stockpiles of topsoil</b></p> |

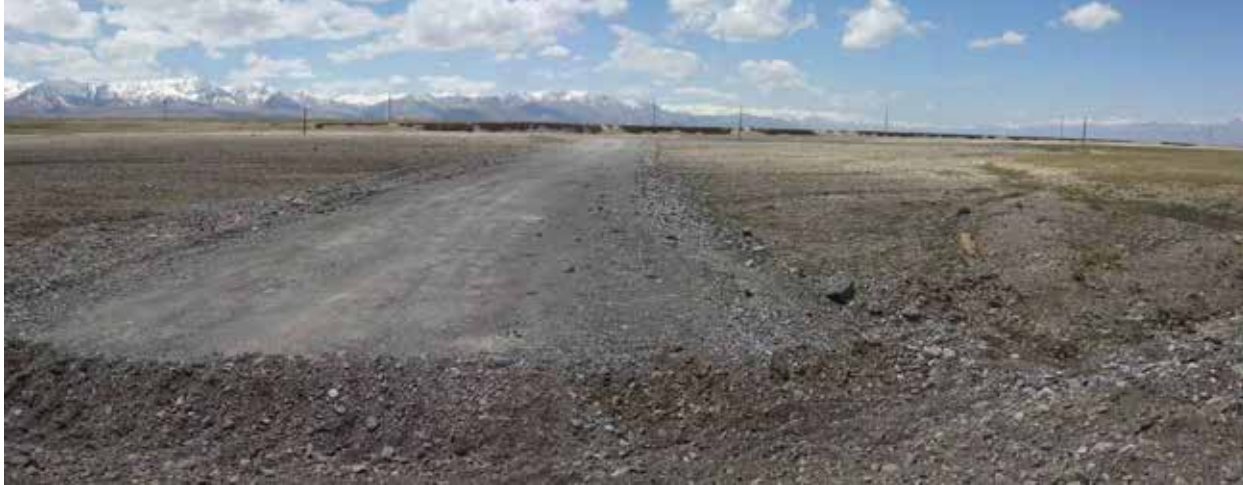
| <b>Borrow Pit # / Location</b> | <b>Date</b> | <b>Status</b> | <b>Photo – Status</b> |
|--|---|--|---|
| <p><b>#4</b></p> <hr/> <p>491+100<br/>RHS</p> <hr/> <p><b>Volume</b><br/>480,000m<sup>3</sup></p> <hr/> <p>800 x 300 m</p> <hr/> <p>200m from<br/>road</p> | <p>June<br/>2014</p> | <p>Not started<br/><input type="checkbox"/></p> <p>In progress<br/><input type="checkbox"/></p> <p>Extraction<br/>complete<br/><input checked="" type="checkbox"/></p> <p>Restoration<br/>phase<br/><input type="checkbox"/></p> | <p data-bbox="730 1206 1839 1230"><b>Figure 44: Borrow Pit #4 – Material extracted in 2014 but now complete - access road cut</b></p> |

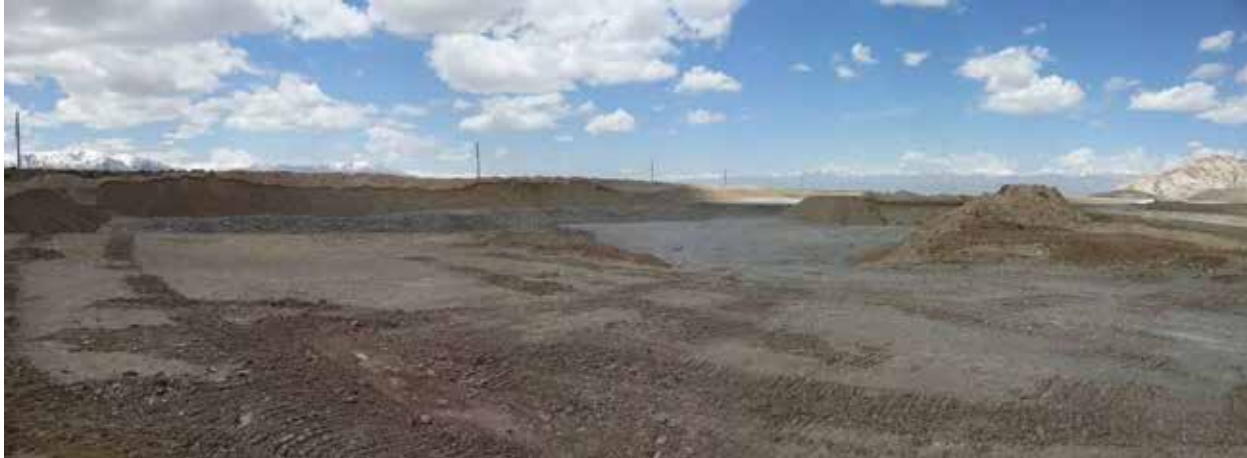
| <b>Borrow Pit # / Location</b> | <b>Date</b> | <b>Status</b> | <b>Photo – Status</b> |
|--|---|--|---|
| <p><b>#5</b></p> <hr/> <p>493+000<br/>RHS</p> <hr/> <p><b>Volume</b><br/>120,000m<sup>3</sup></p> <hr/> <p>300 x 200 m</p> <hr/> <p>100m from<br/>road</p> | <p>June<br/>2014</p> | <p>Not started<br/><input type="checkbox"/></p> <p>In progress<br/><input type="checkbox"/></p> <p>Extraction<br/>complete<br/><input checked="" type="checkbox"/></p> <p>Restoration<br/>phase<br/><input type="checkbox"/></p> | <p data-bbox="806 724 1772 750"><b>Figure 45: Borrow Pit #5 – Extraction in progress - Note stockpiles of topsoil</b></p> |

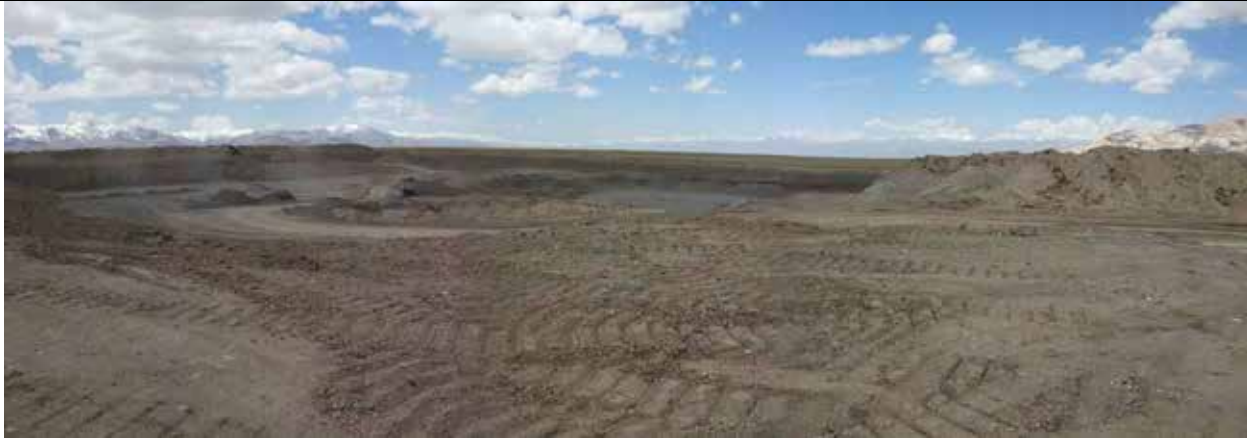
| <b>Borrow Pit # / Location</b> | <b>Date</b> | <b>Status</b> | <b>Photo – Status</b> |
|--|---|--|---|
| <p><b>#6</b></p> <hr/> <p>495+500<br/>RHS</p> <hr/> <p><b>Volume</b><br/>120,000m<sup>3</sup></p> <hr/> <p>300 x 200 m</p> <hr/> <p>100m from<br/>road</p> | <p>June<br/>2014</p> | <p>Not started<br/><input type="checkbox"/></p> <p>In progress<br/><input checked="" type="checkbox"/></p> <p>Extraction<br/>complete<br/><input type="checkbox"/></p> <p>Restoration<br/>phase<br/><input type="checkbox"/></p> | <p data-bbox="806 1195 1772 1221"><b>Figure 46: Borrow Pit #6 – Extraction in progress – Note stockpiles of topsoil</b></p> |

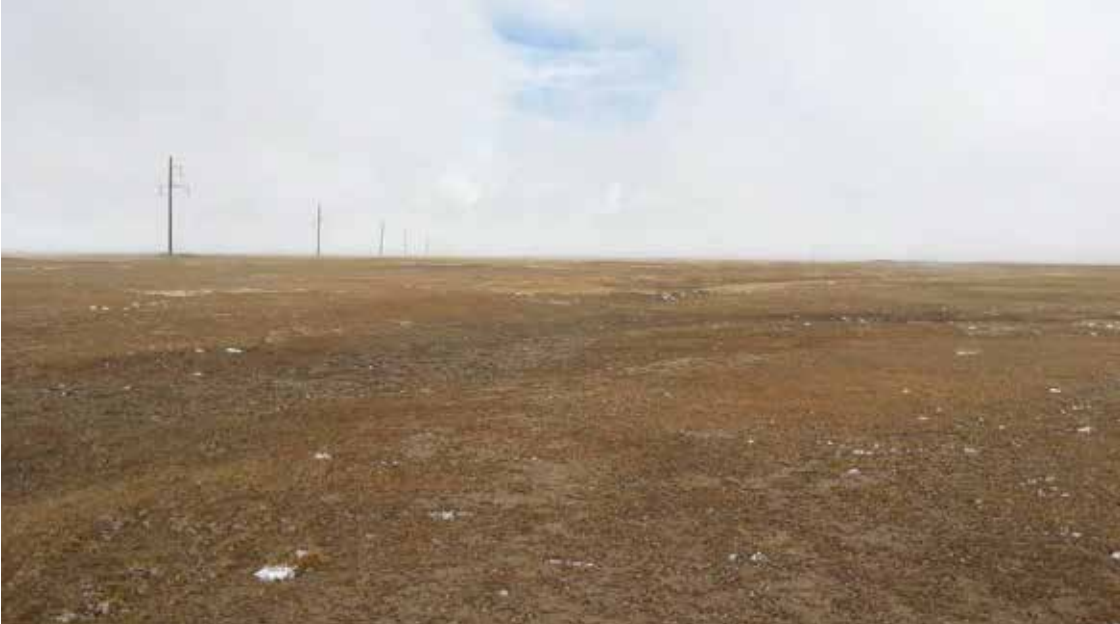
| <b>Borrow Pit # / Location</b> | <b>Date</b> | <b>Status</b> | <b>Photo – Status</b> |
|--|---|--|---|
| <p>#9</p> <hr/> <p>In KJSNR</p> <hr/> <p>507+600<br/>RHS</p> <hr/> <p><b>Volume</b><br/>225,000m<sup>3</sup></p> <hr/> <p><b>450 x 250 m</b></p> <hr/> <p>200m from<br/>road</p> <hr/> <p><b>Decision</b><br/>“not to<br/>use”<br/>following<br/>trial pitting</p> | <p>May<br/>2014</p> | <p>Not started<br/><input checked="" type="checkbox"/></p> <p>In progress<br/><input type="checkbox"/></p> <p>Extraction<br/>complete<br/><input type="checkbox"/></p> <p>Restoration<br/>phase<br/><input type="checkbox"/></p> | <p>Figure 48: Borrow Pit #9 – NW corner looking east before work (This pit will not be used)</p> |

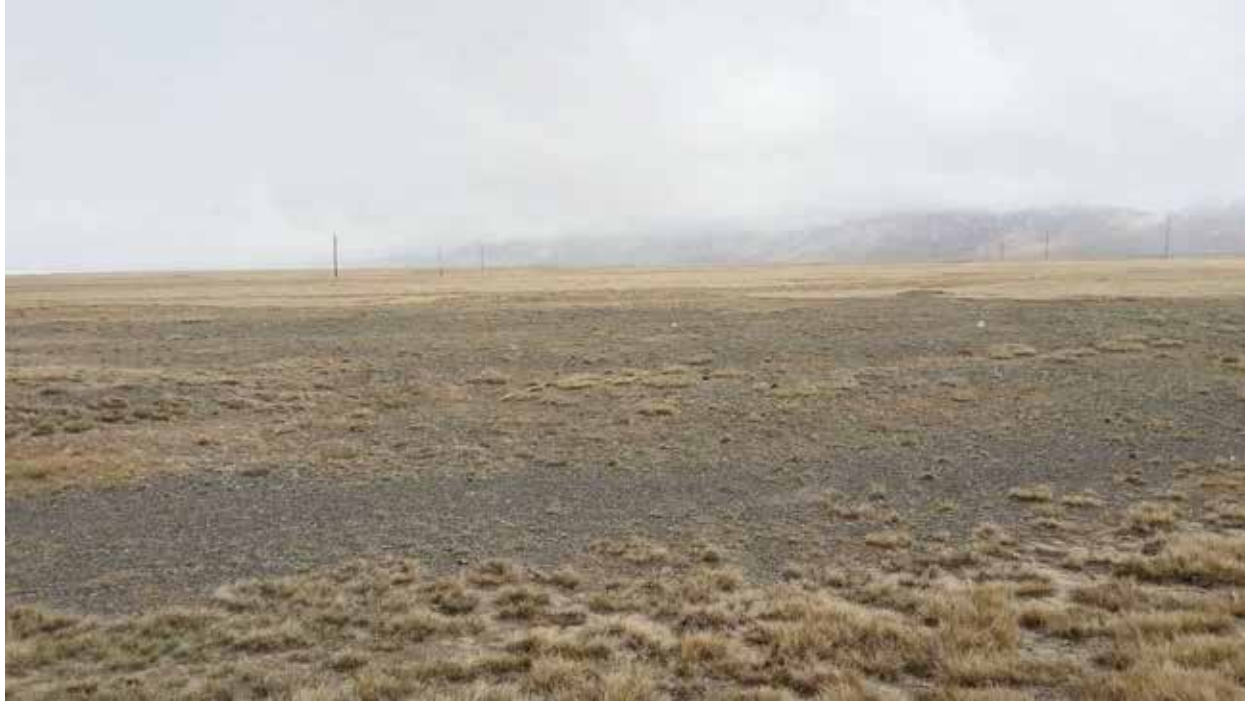
| <b>Borrow Pit # / Location</b> | <b>Date</b> | <b>Status</b> | <b>Photo – Status</b> |
|---|---|--|---|
| <p><b>#10</b></p> <hr/> <p>In KJSNR</p> <hr/> <p>514+600<br/>RHS</p> <hr/> <p><b>Volume</b><br/>250,000m<sup>3</sup></p> <hr/> <p>500 x 250 m</p> <hr/> <p>150m from<br/>road</p> | <p>21<br/>May<br/>2014</p> | <p>Not started<br/><input checked="" type="checkbox"/></p> <p>In progress<br/><input type="checkbox"/></p> <p>Extraction<br/>complete<br/><input type="checkbox"/></p> <p>Restoration<br/>phase<br/><input type="checkbox"/></p> | <p data-bbox="869 963 1709 993">Figure 49: Borrow Pit #10 – NW corner looking east (prior to work)</p> |

Figure 50: Borrow Pit #10 – Extraction in Progress (10 June 14)

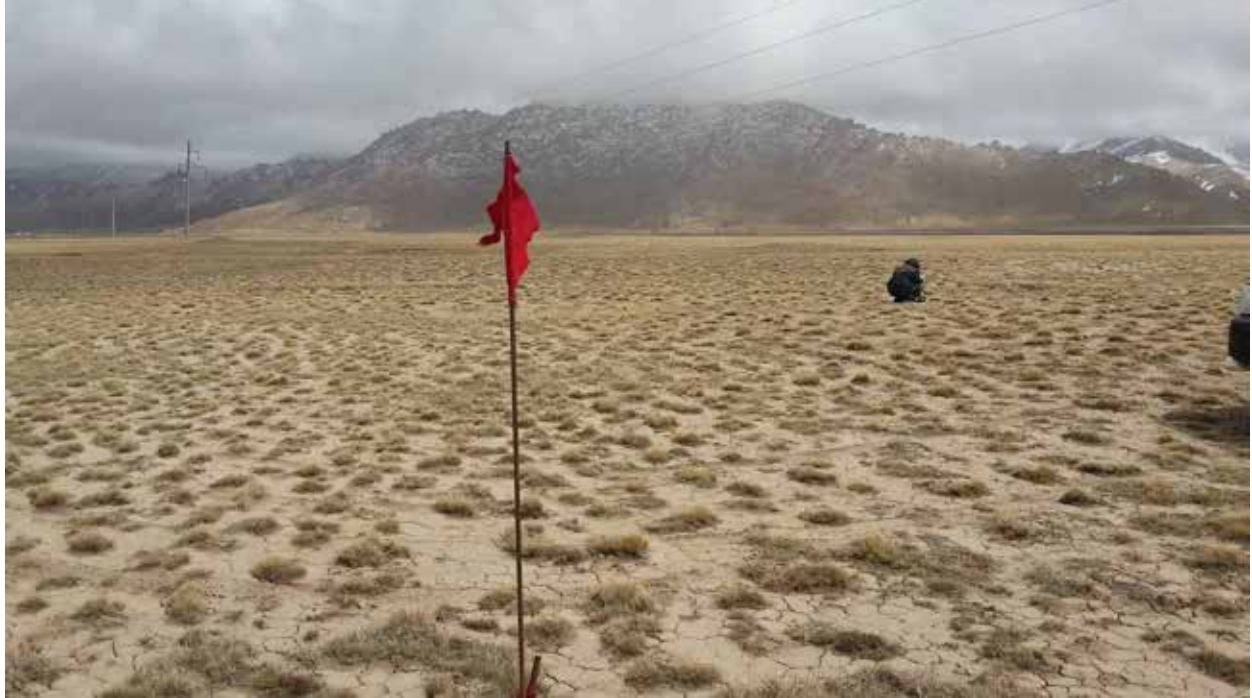
| <b>Borrow Pit # / Location</b> | <b>Date</b> | <b>Status</b> | <b>Photo – Status</b> |
|---|---|--|---|
| <p><b>#11</b></p> <hr/> <p>In KJSNR</p> <hr/> <p>518+000<br/>RHS</p> <hr/> <p><b>Volume</b><br/>325,000m<sup>3</sup></p> <hr/> <p>650 x 250 m</p> <hr/> <p>100m from<br/>road</p> | <p>21<br/>May<br/>2014</p> | <p>Not started<br/><input checked="" type="checkbox"/></p> <p>In progress<br/><input type="checkbox"/></p> <p>Extraction<br/>complete<br/><input type="checkbox"/></p> <p>Restoration<br/>phase<br/><input type="checkbox"/></p> | <p data-bbox="737 963 1839 993">Figure 51: Borrow Pit #11 – NW corner look east (air &amp; noise monitoring - prior to work)</p> |

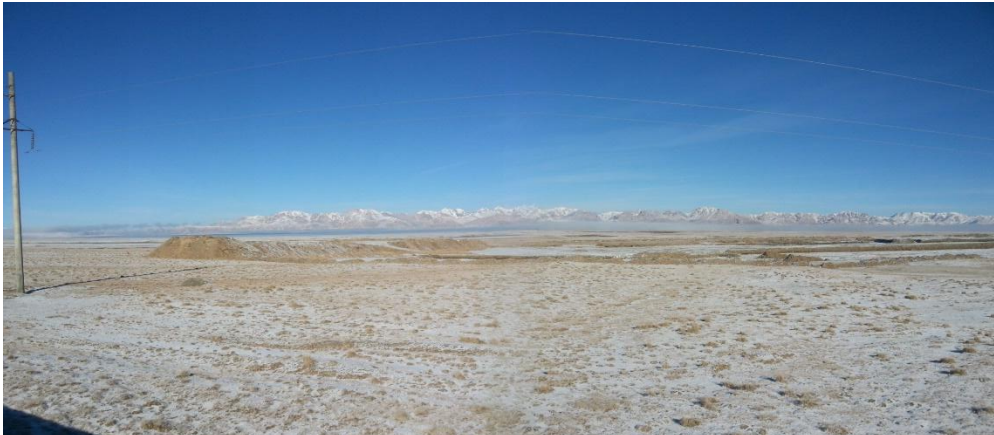
| <b>Borrow Pit # / Location</b> | <b>Date</b> | <b>Status</b> | <b>Photo – Status</b> |
|--|---|--|--|
| <p data-bbox="243 267 302 297">#11</p> <hr/> <p data-bbox="205 334 340 363">In KJSNR</p> <hr/> <p data-bbox="212 401 333 462">518+000<br/>RHS</p> <hr/> <p data-bbox="197 488 348 550"><b>Volume</b><br/>325,000m<sup>3</sup></p> <hr/> <p data-bbox="191 570 354 599">650 x 250 m</p> <hr/> <p data-bbox="205 638 340 699">100m from<br/>road</p> | <p data-bbox="390 267 457 329">Oct<br/>2014</p> | <p data-bbox="491 303 638 365">Not started<br/><input type="checkbox"/></p> <p data-bbox="491 401 638 462">In progress<br/><input checked="" type="checkbox"/></p> <p data-bbox="491 498 638 596">Extraction<br/>complete<br/><input type="checkbox"/></p> <p data-bbox="491 631 638 729">Restoration<br/>phase<br/><input type="checkbox"/></p> | <p data-bbox="814 703 1759 732"><b>Figure 52: Borrow Pit #11 - Progress in October 2014 – North / West corner</b></p> |

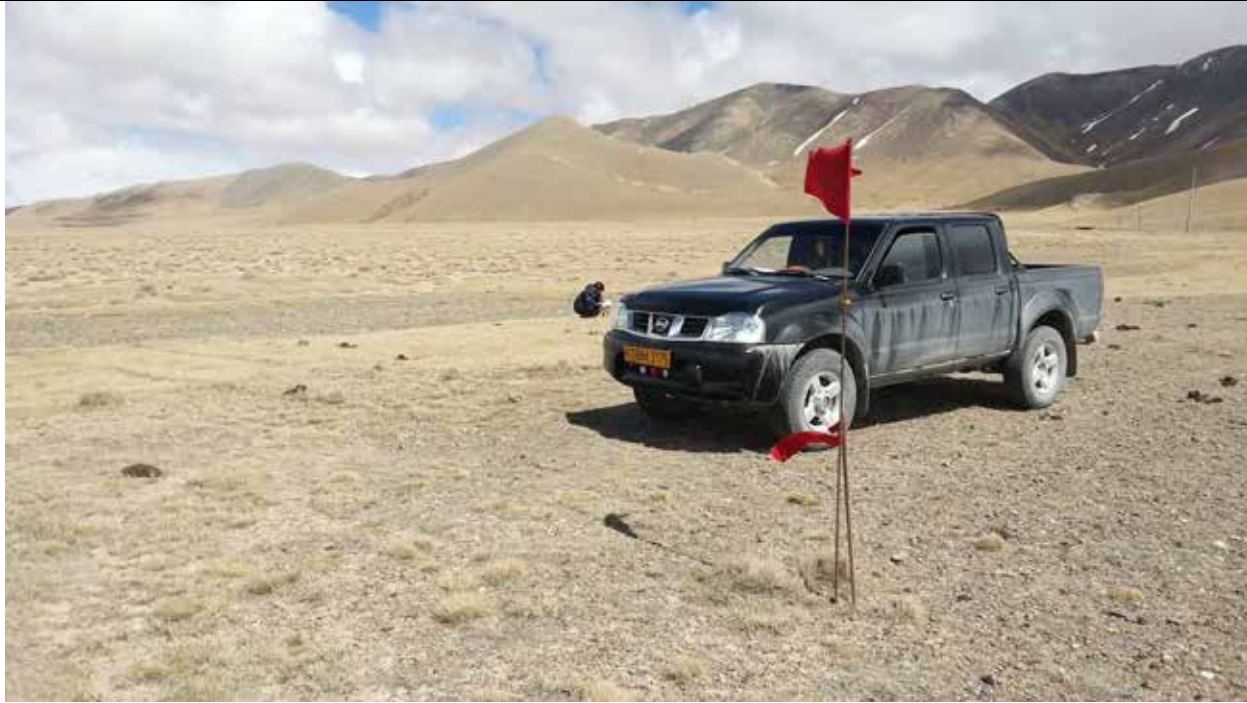
| <b>Borrow Pit # / Location</b> | <b>Date</b> | <b>Status</b> | <b>Photo – Status</b> |
|---|---|--|---|
| <p><b>#12</b></p> <hr/> <p>In KJSNR</p> <hr/> <p>528+200<br/>RHS</p> <hr/> <p><b>Volume</b><br/>325,000m<sup>3</sup></p> <hr/> <p>650 x 250 m</p> <hr/> <p>160m from<br/>road</p> | <p>21<br/>May<br/>2014</p> | <p>Not started<br/><input checked="" type="checkbox"/></p> <p>In progress<br/><input type="checkbox"/></p> <p>Extraction<br/>complete<br/><input type="checkbox"/></p> <p>Restoration<br/>phase<br/><input type="checkbox"/></p> | <p data-bbox="667 987 1774 1019"><b>Figure 53: Borrow Pit #12 – NW corner look east (air &amp; noise monitoring - prior to work)</b></p> |

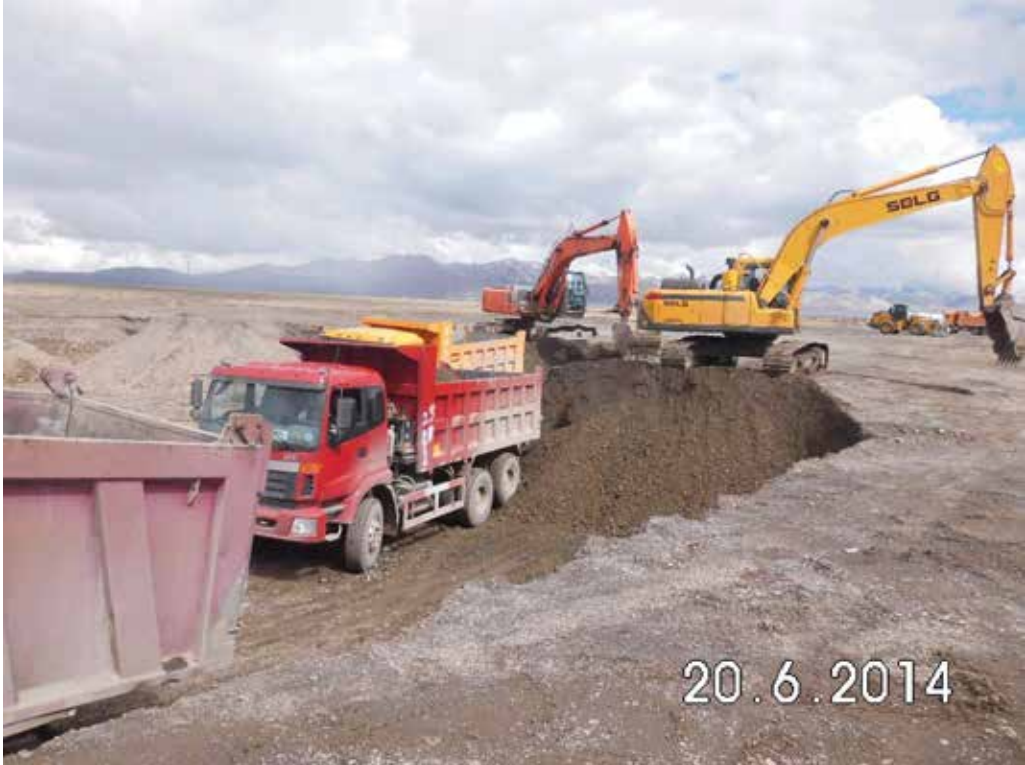
| <b>Borrow Pit # / Location</b> | <b>Date</b> | <b>Status</b> | <b>Photo – Status</b> |
|---|---|--|--|
| <p><b>#12</b></p> <hr/> <p>In KJSNR</p> <hr/> <p>528+200<br/>RHS</p> <hr/> <p><b>Volume</b><br/>325,000m<sup>3</sup></p> <hr/> <p>650 x 250 m</p> <hr/> <p>160m from road</p> | <p>June 2014</p> | <p>Not started<br/><input type="checkbox"/></p> <p>In progress<br/><input checked="" type="checkbox"/></p> <p>Extraction complete<br/><input type="checkbox"/></p> <p>Restoration phase<br/><input type="checkbox"/></p> | <p>20.6.2014</p> |

Figure 54: Borrow Pit #12 - Extraction in Progress
