# Environmental Monitoring Report

Project Number: 42399-02  
 Grant Number: ADB Loan No. 2755-KGZ (SF)  
 Reporting Period: July to December 2014

Kyrgyz Republic  
 CAREC Transport Corridor -1  
 (Bishkek – Torugart road) Project 3  
 SECTION KM479 to 539

Prepared By the Ministry of Transport and  
 Communications of the Kyrgyz Republic

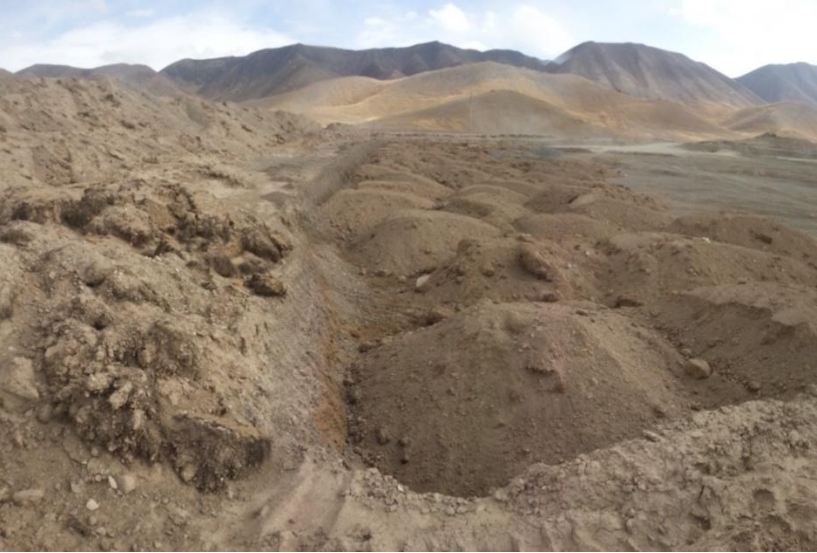
| <b>Borrow Pit # / Location</b> | <b>Date</b> | <b>Status</b> | <b>Photo – Status</b> |
|--|---|--|---|
| <p><b>#12</b></p> <hr/> <p>In KJSNR</p> <hr/> <p>528+200<br/>RHS</p> <hr/> <p><b>Volume</b><br/>325,000m<sup>3</sup></p> <hr/> <p><b>650 x 250 m</b></p> <hr/> <p>160m from<br/>road</p> | <p>Oct<br/>2014</p> | <p>Not started<br/><input type="checkbox"/></p> <p>In progress<br/><input type="checkbox"/></p> <p>Extraction<br/>complete<br/><input type="checkbox"/></p> <p>Restoration<br/>phase<br/><input checked="" type="checkbox"/></p> | <p data-bbox="884 818 1696 847"><b>Figure 55: Borrow Pit #12 - Progressive restoration in Progress</b></p> |
