# Quarterly Environmental Monitoring Report

Quarterly Environmental Monitoring Report  
October to December 2025

## **Issyk-Kul Ring Road Improvement Project (Barskoon - Karakol section, 75.2 km)**

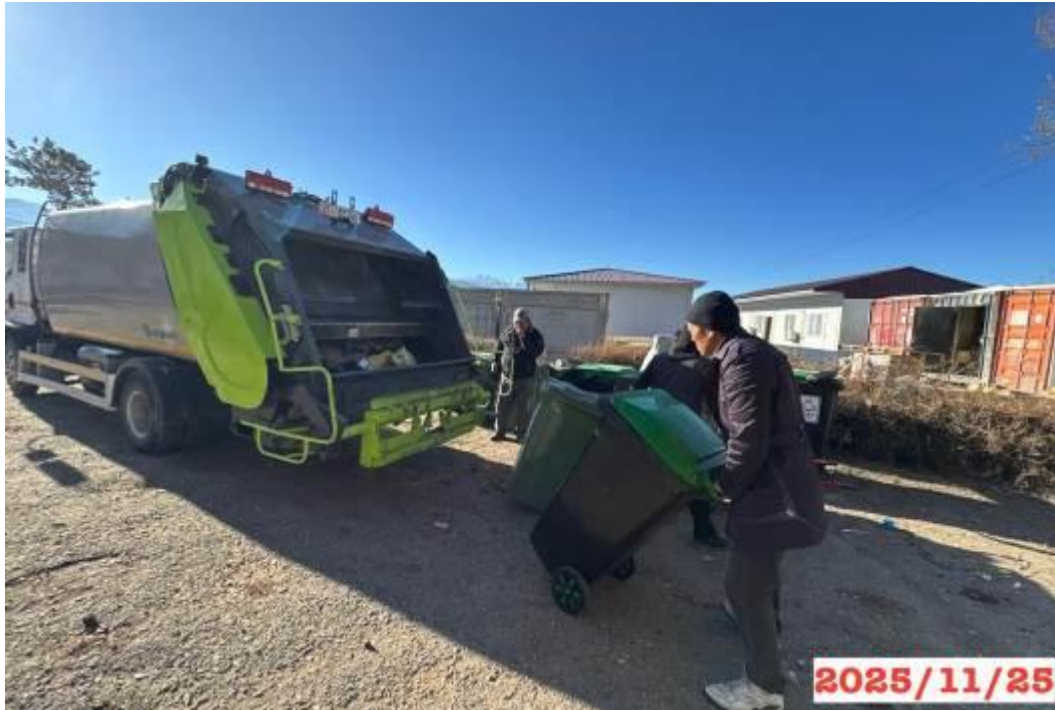
**Figure 7: Solid waste removal. Ak-Terek Camp at km 152+700 LHS.**

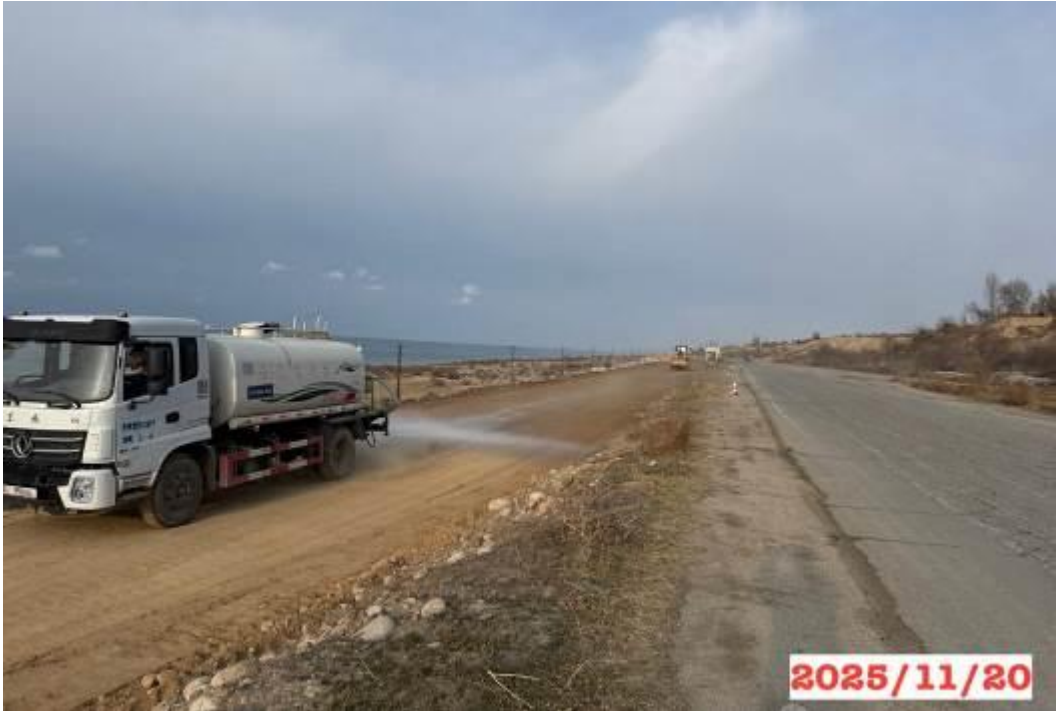
**Figure 11: Dust suppression of construction sites at km 155+000 – km 156+000, LHS.**

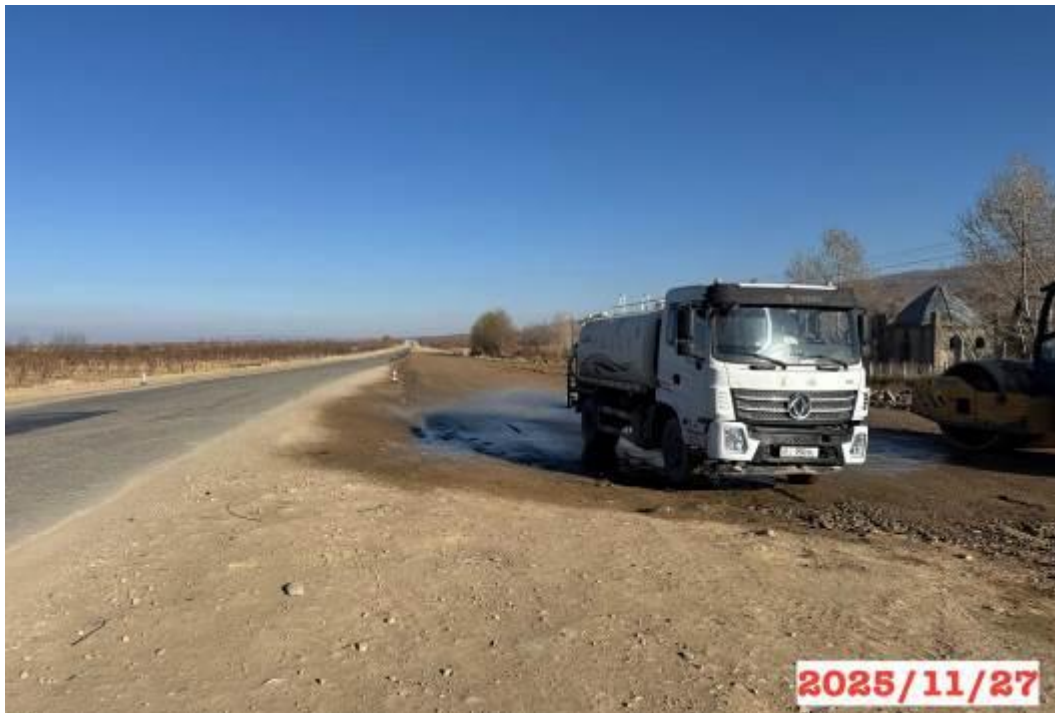
**Figure 12: Dust suppression of construction sites at km 195+000, LHS.**

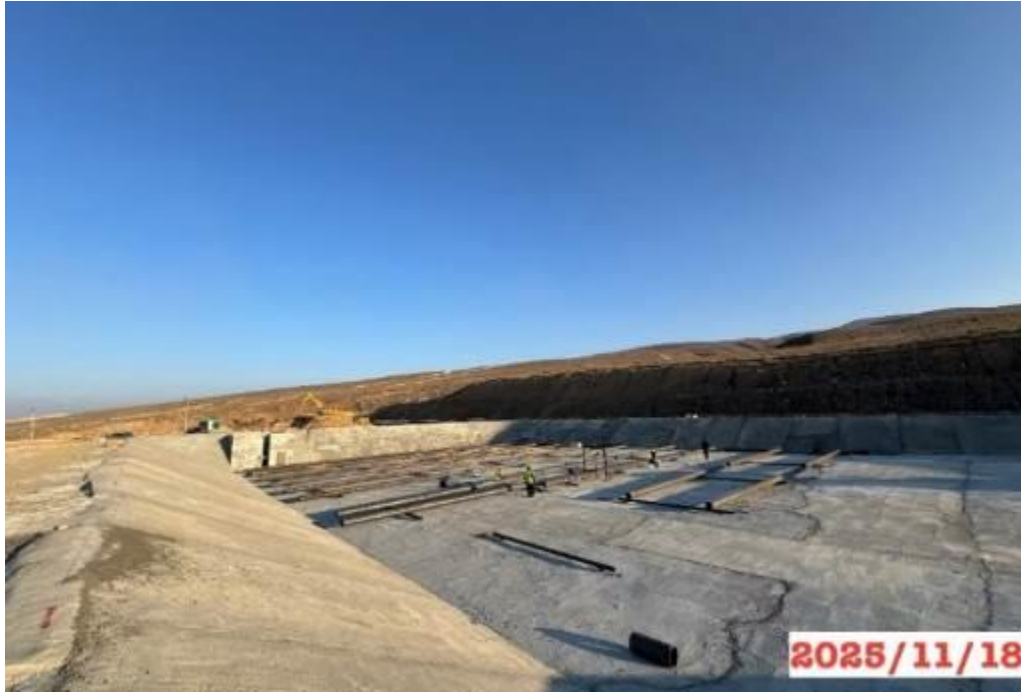
**Figure 15: Production site, km 167+360 RHS, construction of a bitumen storage pit.**

79. The project capacity of the bitumen storage pit is 8000 tons; the actual capacity is 7000 tons.

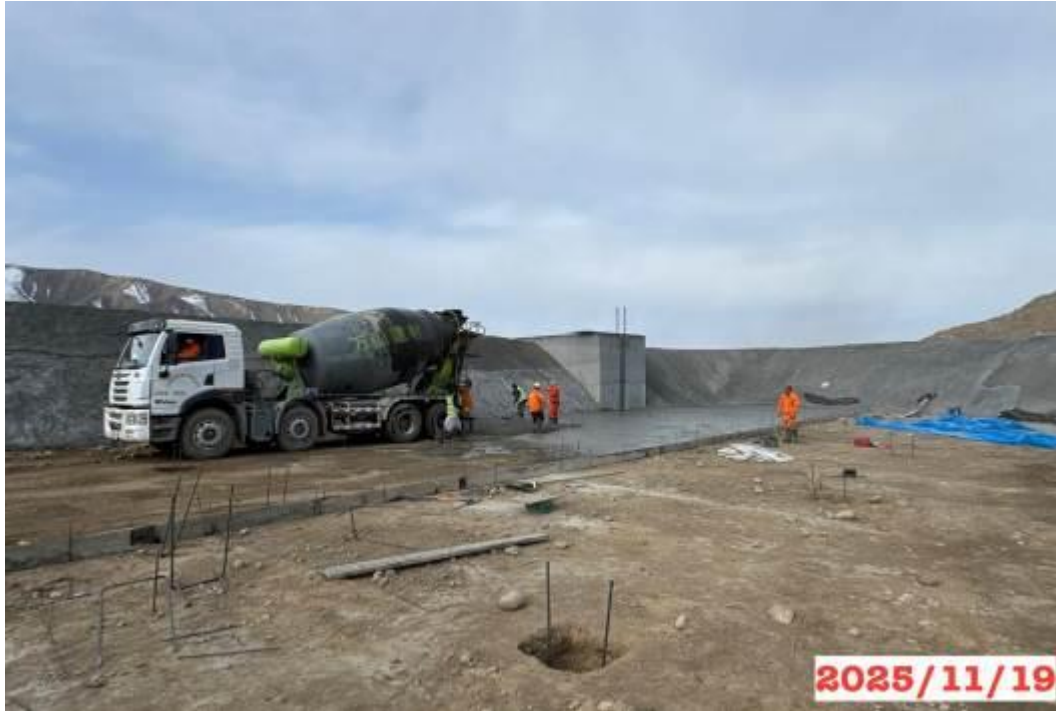
**Figure 19: Production site, km 202+220 RHS, construction of a bitumen storage pit.**

82. The bitumen storage pit is under construction; in accordance with industrial safety requirements, barriers will be installed upon completion of construction. To control access to the bitumen storage facility during the construction phase, the contractor will be instructed to install temporary fencing to improve the safety of the contractor's workforce.

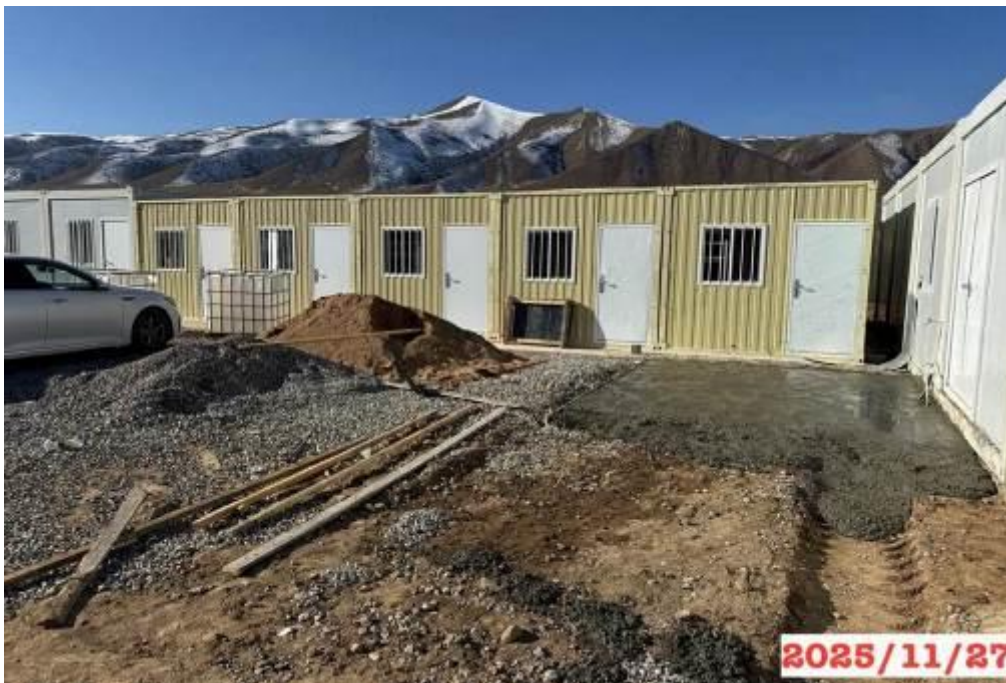
**Figure 20: Chyrak Camp, km 202+220 RHS. The camp's area is being backfilled with inert material.**

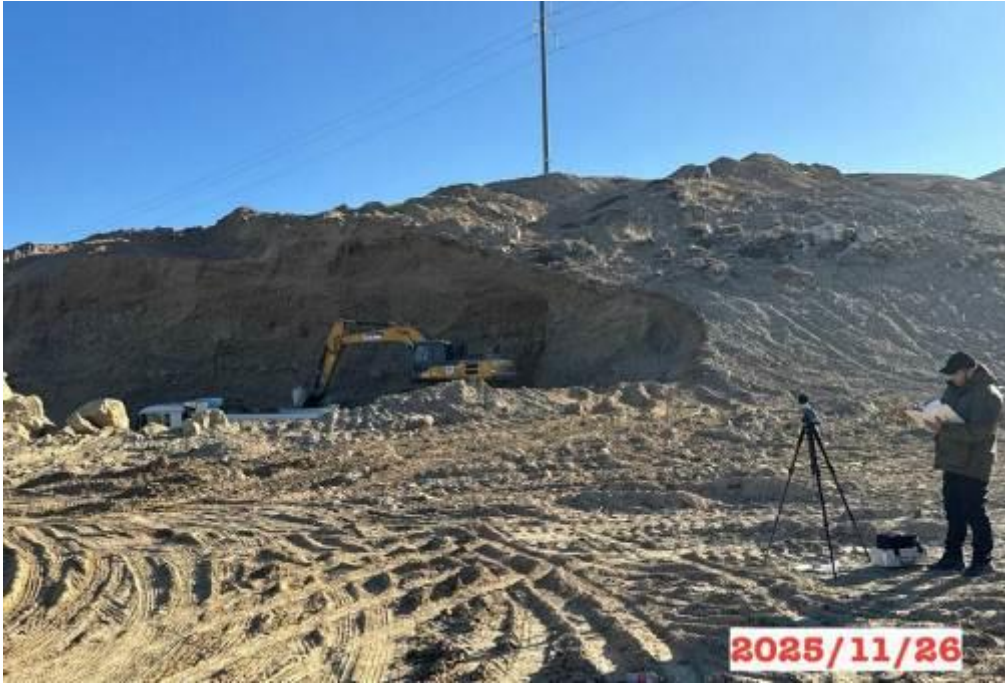
**Figure 37: Noise and vibration measurements during quarry development at km 142+580, Lot 1**

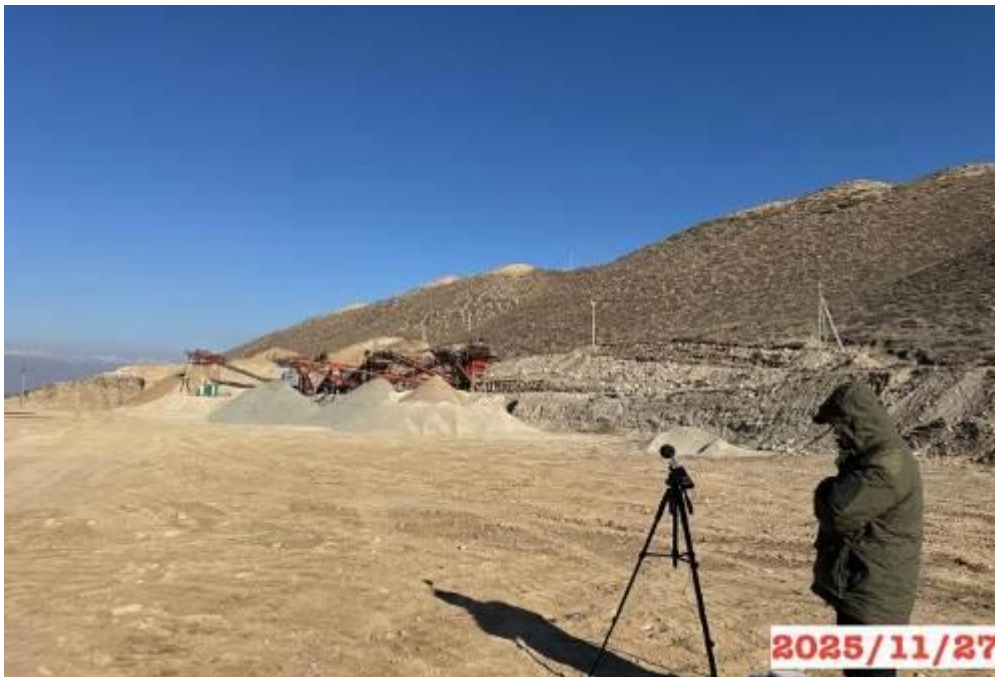
**Figure 38: Noise and vibration measurements at the production site, CSP, Lot 2, km 202+220**

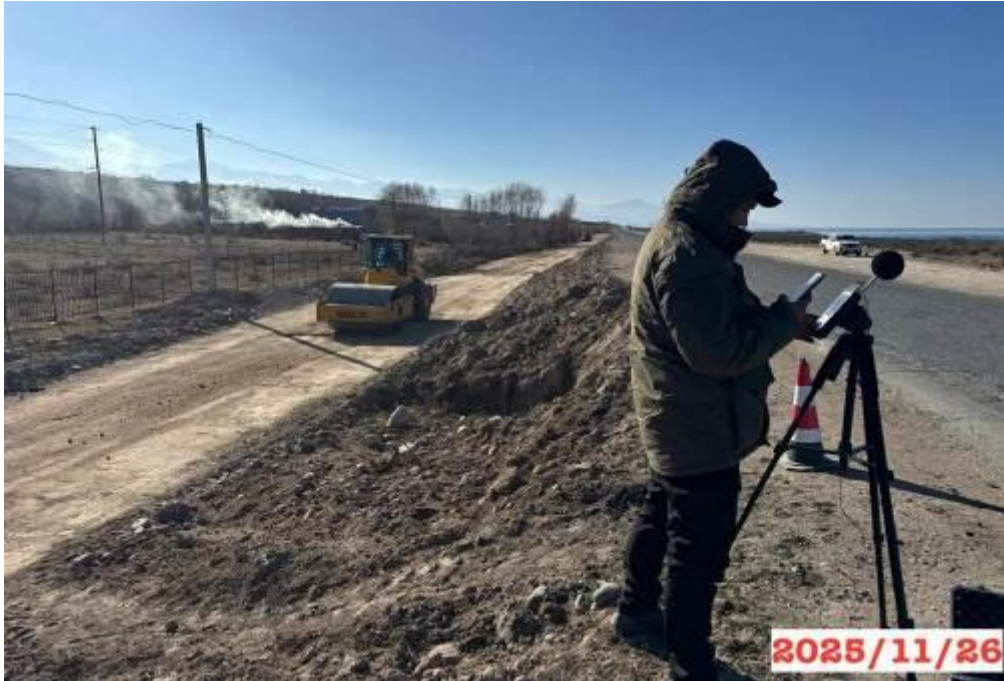
**Figure 39: Noise and vibration measurements at the road site at km 160+120, Lot 1**

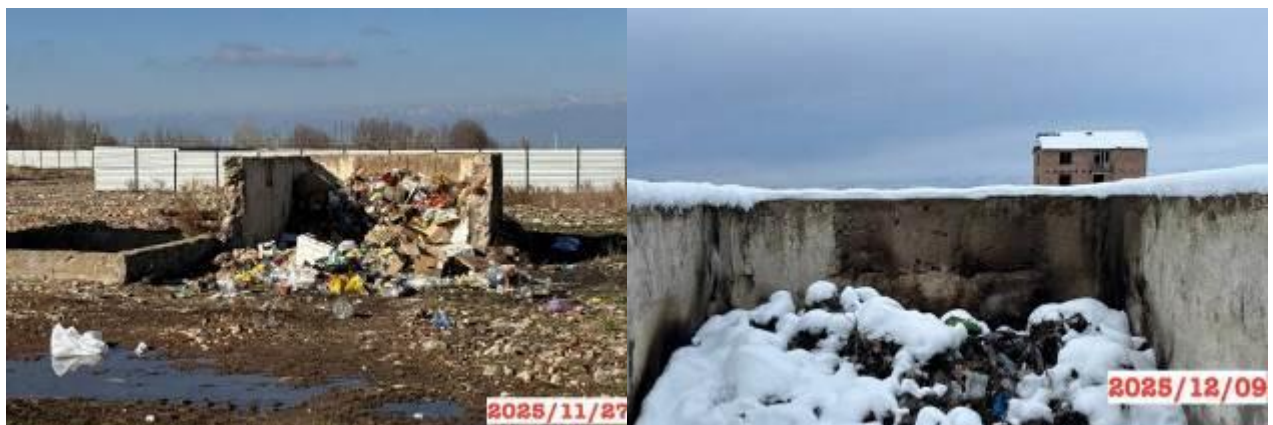
**Figure 43: The Chyrak camp, km 199+460, LHS. The storage conditions for solid waste do not meet environmental and sanitary requirements**

230. The Contractor’s Environmental Protection Officer Daniyar Kaiduev is responsible for implementation of these measures. Immediate cessation of burning was required upon notification, while the remaining measures are to be completed no later than 30/03/2026. Compliance will be verified during follow-up inspections.

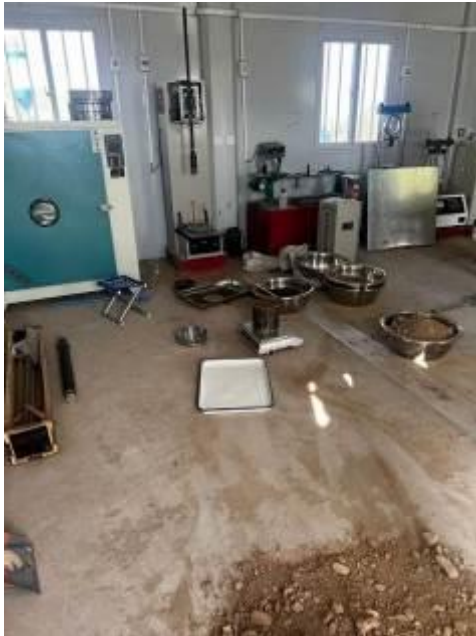
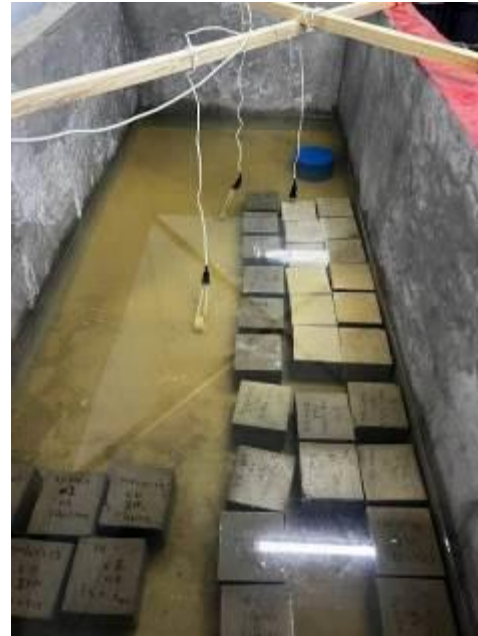
- First Aid: The laboratories lack first aid kits, which is unacceptable given the risk of thermal/chemical burns and poisoning. No practical first aid training was conducted during the reporting period.

**Figure 48: Laboratory of the Chyrak camp, km 202+220, Lot 2**

- Life-Safety Hazards: Immediately rectifying dangerous electrical setups in site laboratories to eliminate the fatal risk of electric shock and installing required ventilation.

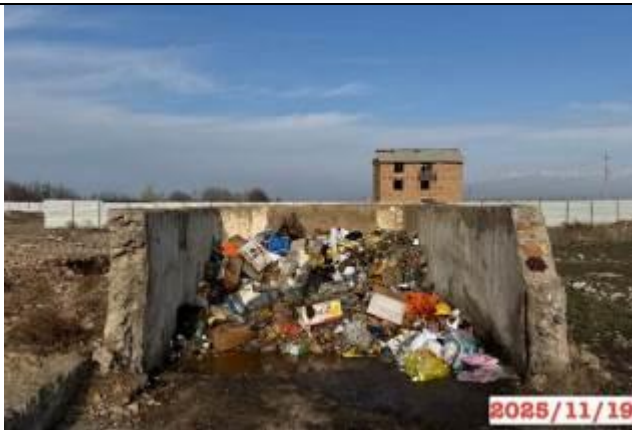
Photo 9. The Chyrak camp, km 199+460 LHS. The storage conditions for solid waste do not comply with environmental and sanitary requirements.

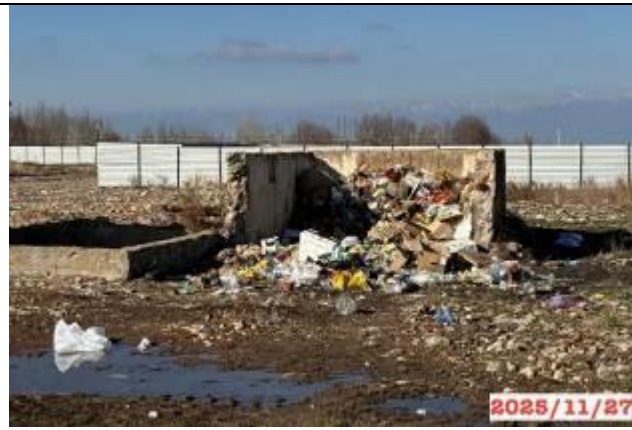
Photo 10. The Chyrak camp, km 199+460 LHS. The storage conditions for solid waste do not comply with environmental and sanitary requirements.

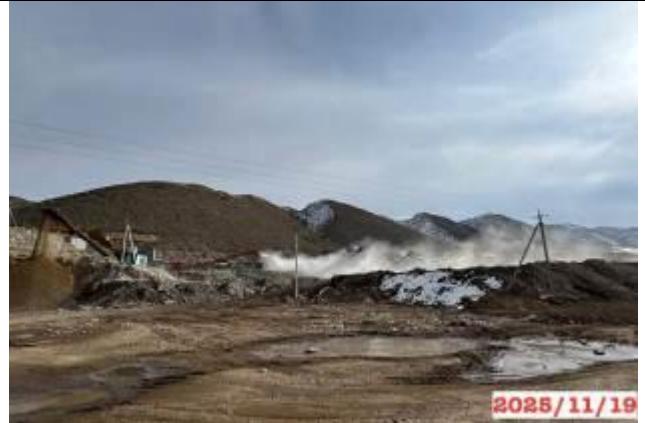
Photo 20. Production site, km 202+220 RHS: significant dust emissions are visually observed during CSP operation.

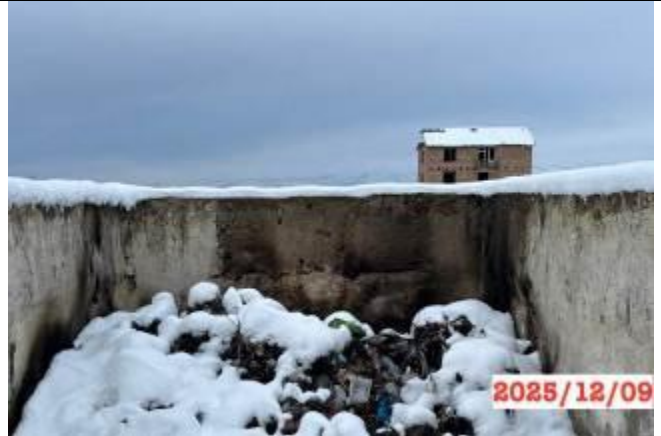
Photo 38. The Chyrak Camp, km 199+460 LHS. Traces of soot on the walls indicate that waste was burned.

- Operational Discipline on Lot 2: Ensuring a total ban on waste burning at the Chyrak camp and maintaining the physical demarcation of quarry and dump boundaries.

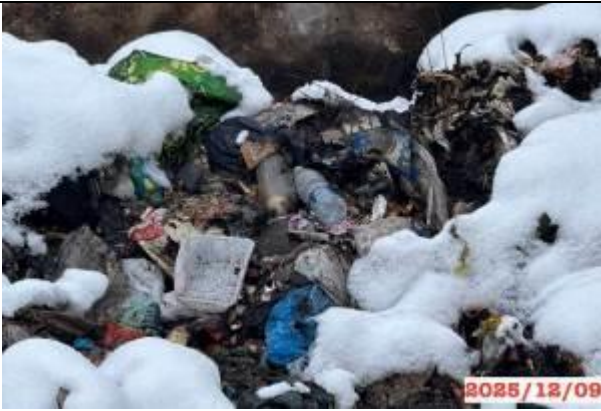
Photo 39. The Chyrak Camp, km 199+460 LHS. The storage conditions for solid waste do not comply with environmental and sanitary requirements.

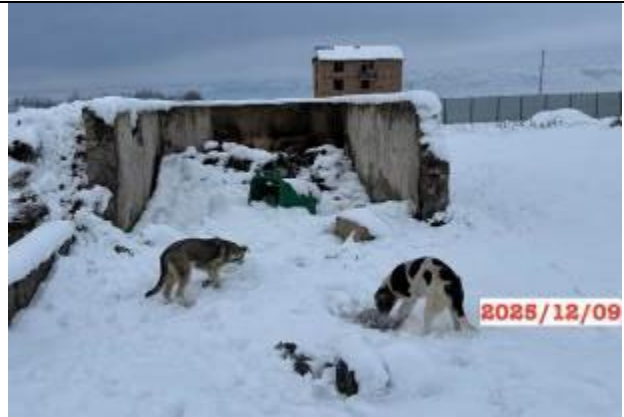
Photo 40. The Chyrak Camp, km 199+460 LHS. The storage conditions for solid waste do not comply with environmental and sanitary requirements.

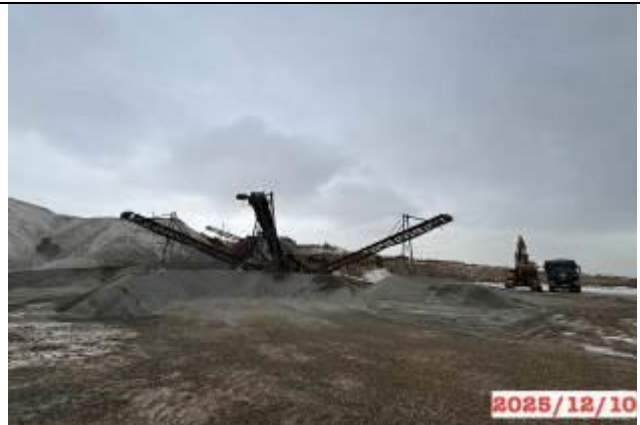
Photo 41. Production site, km 167+360 RHS, The CSP was not working.
