# Semi-annual Environmental Monitoring Report

Semi-annual Environmental Monitoring Report  
July to December, 2023

## **CAREC Corridors 1 and 3 Connector Road, Section 2B Epkin-Dyikan [Bashkugandy], Km: 89+500 – 159+200 Project**

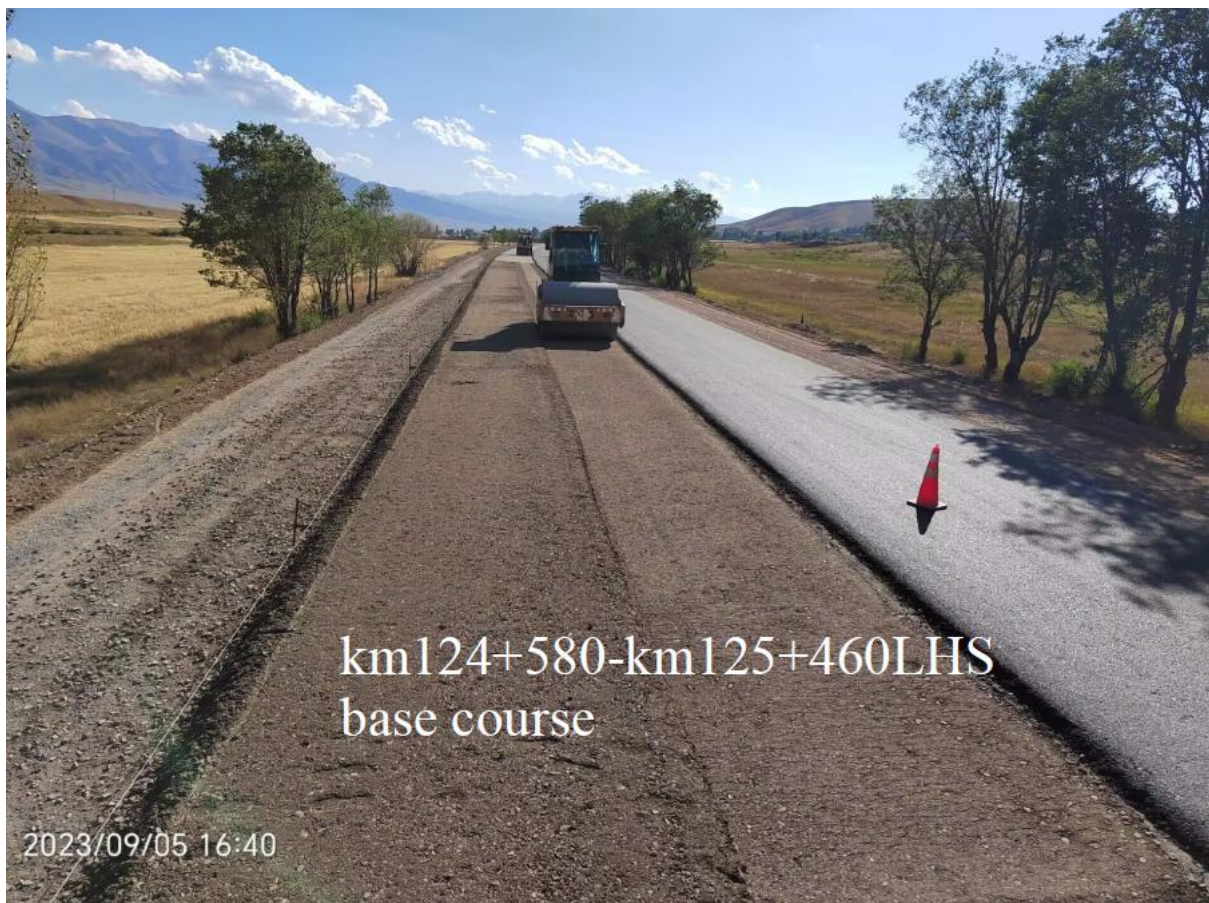
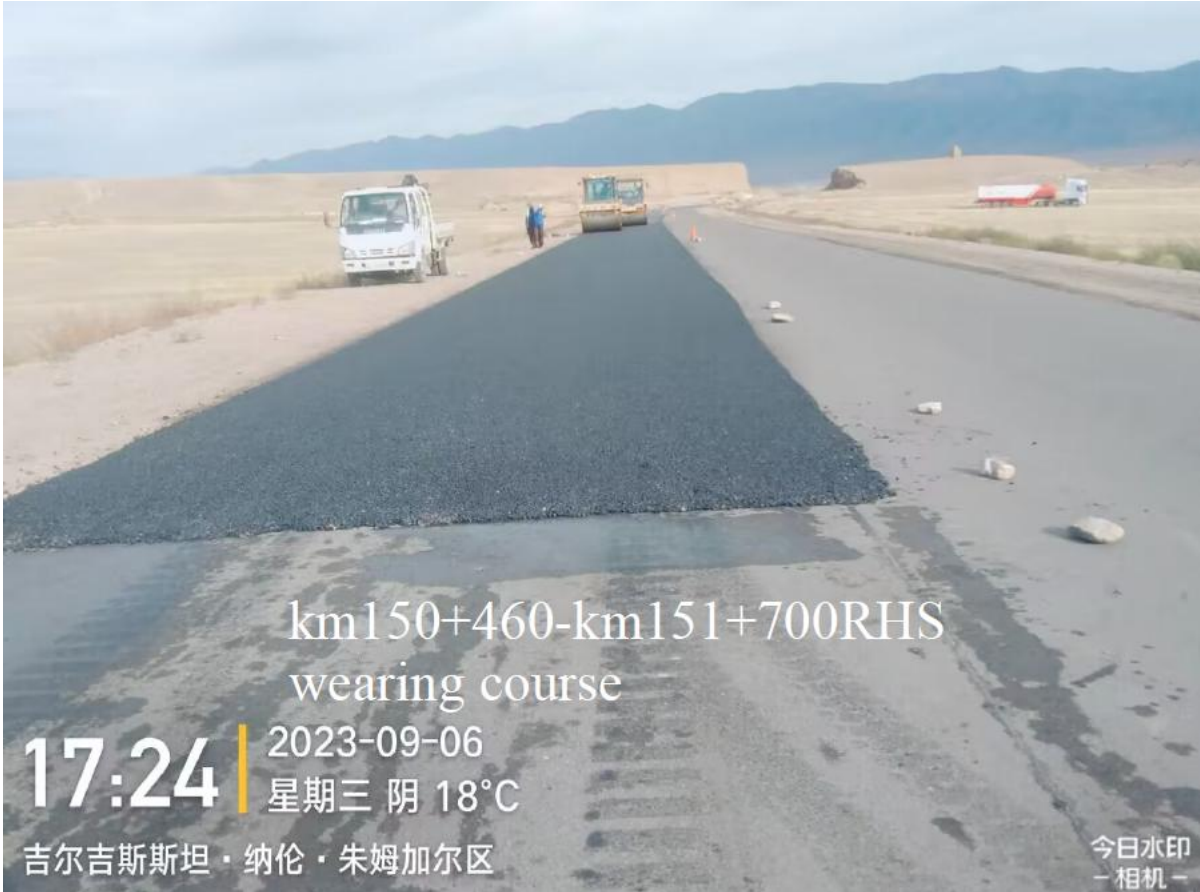
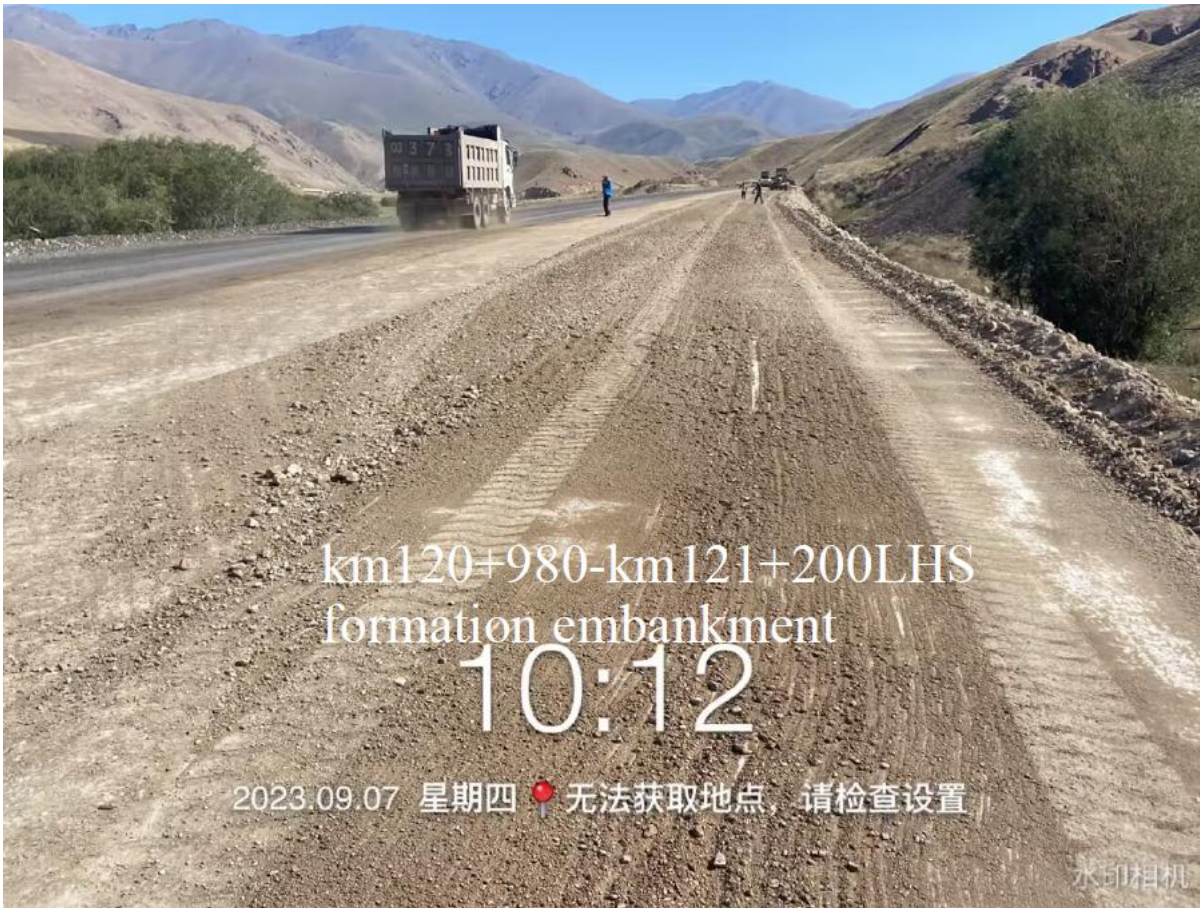
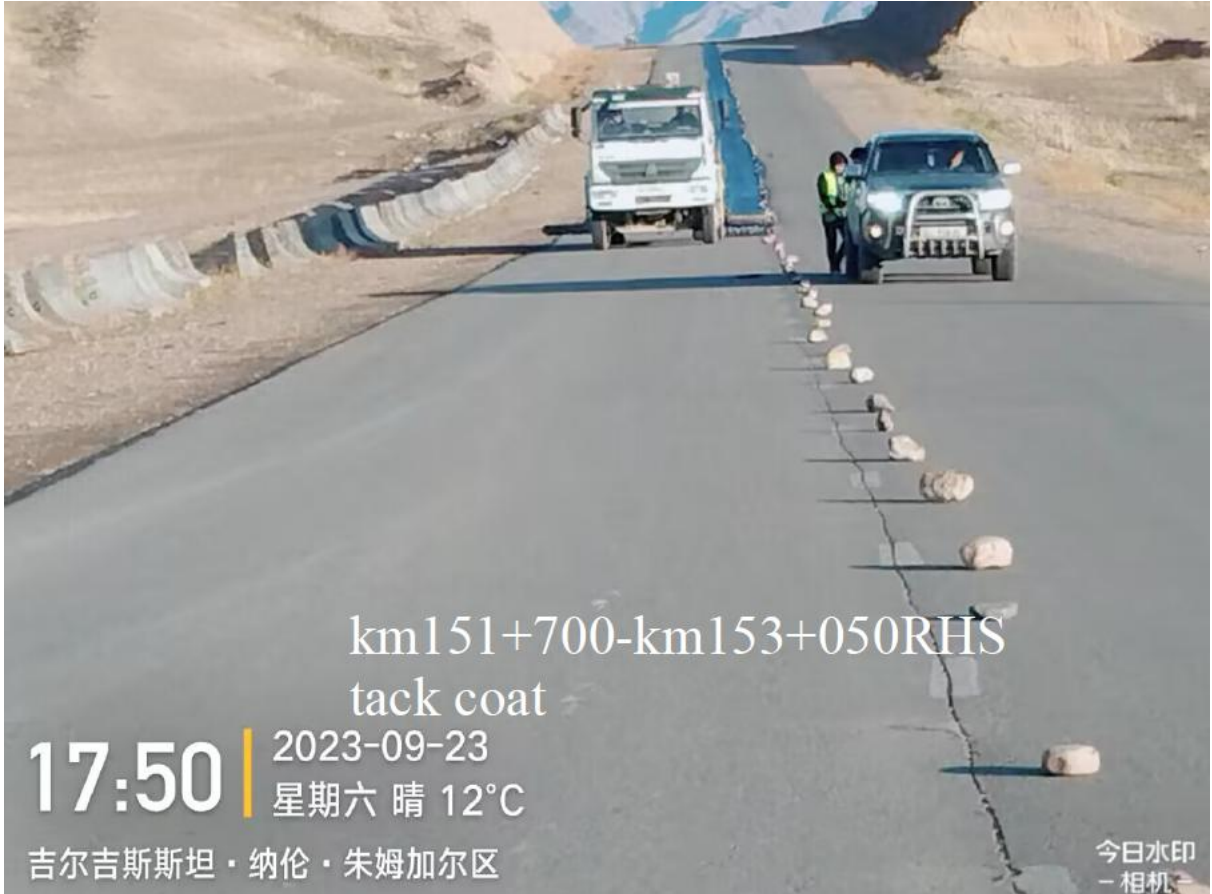
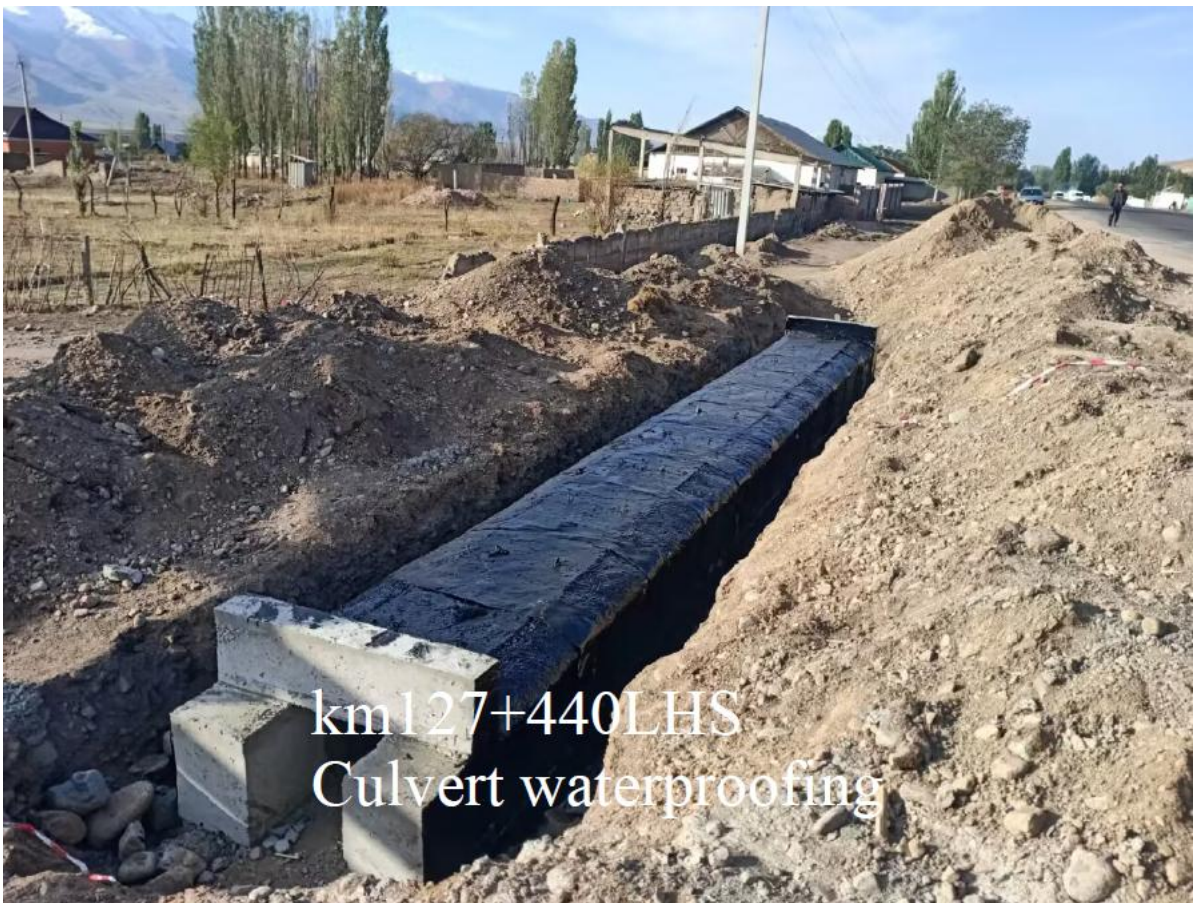
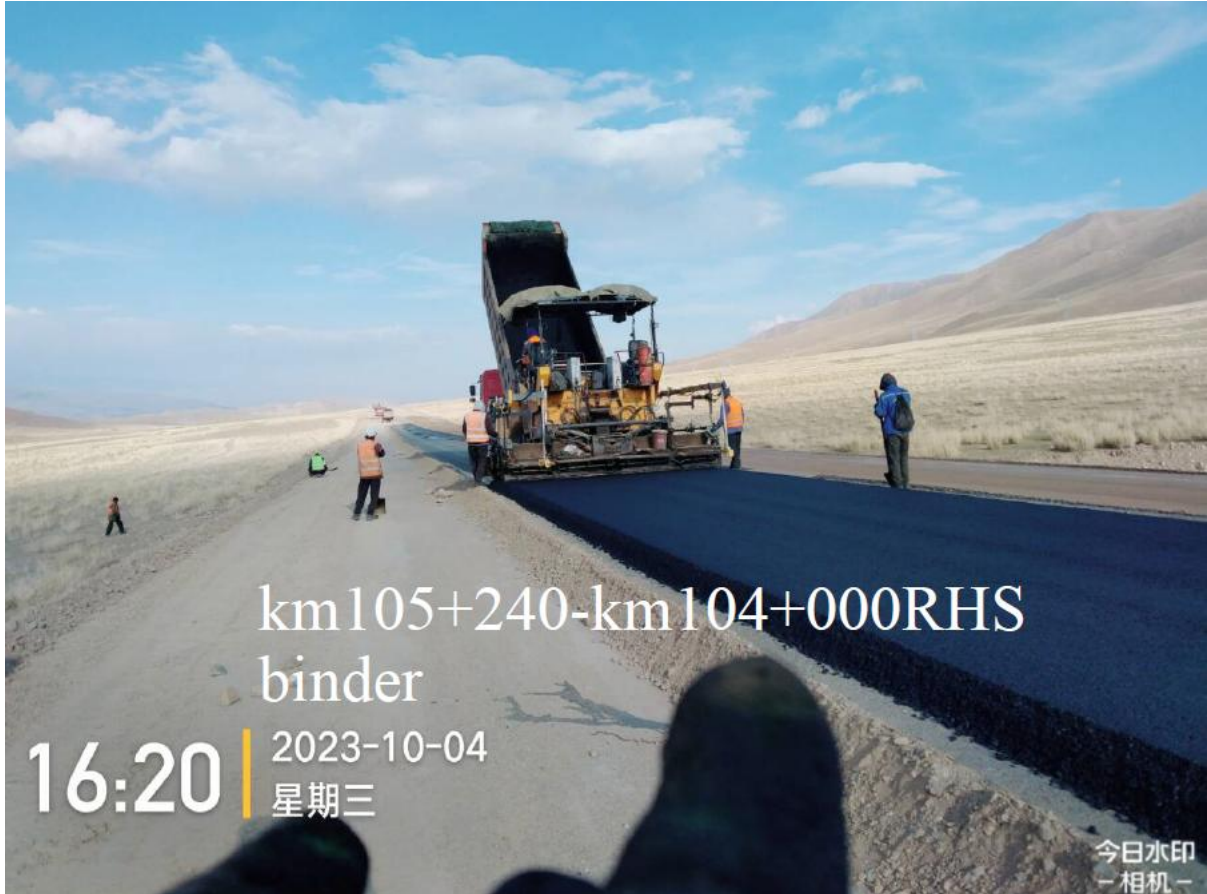
Figure 5: Site Works

Below are the photo materials of the work being carried out.

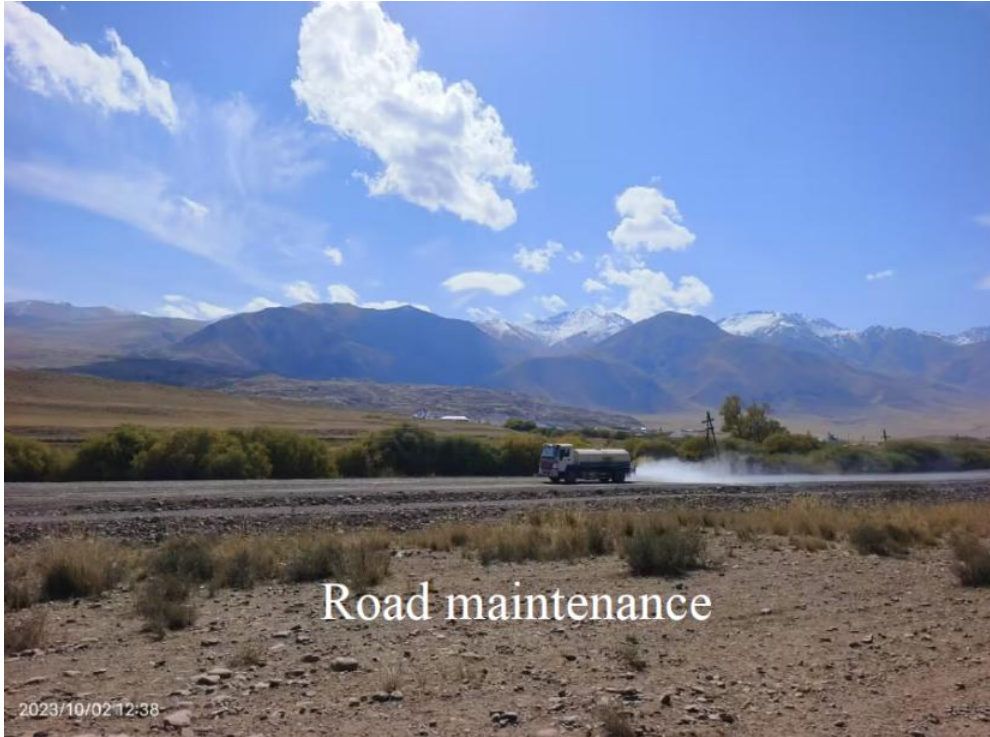
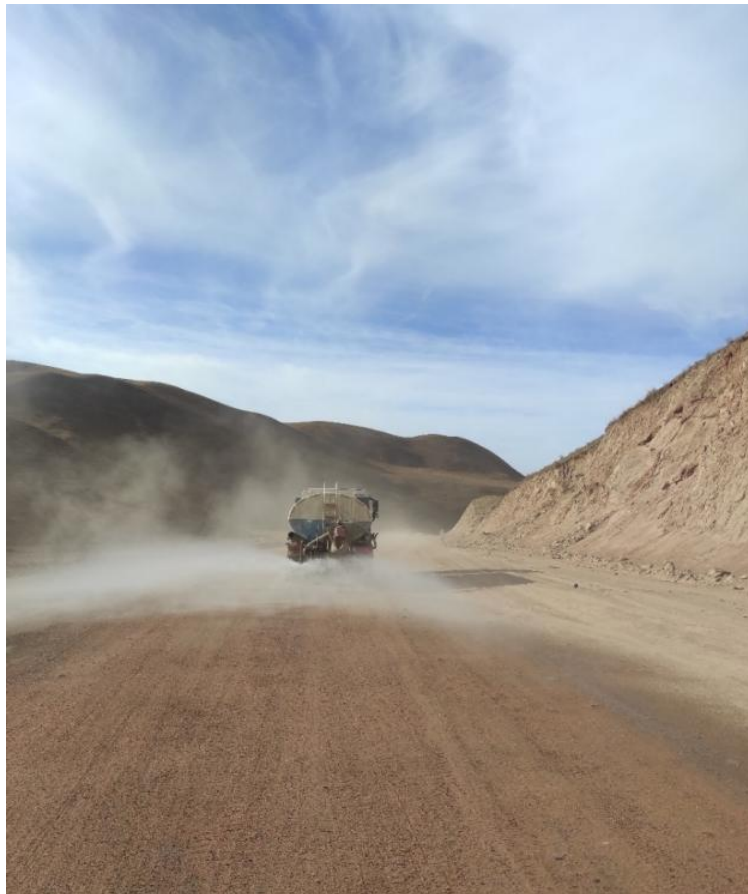
Figure 5: Dust suppression on roads.

44. 8-10 water trucks were utilized to suppress high dust during summer, whereas 4-6 trucks were used in the autumn; in winter dust suppression is being executed using 3 water trucks. In winter, water tankers are used at the project site depending on weather conditions, i.e. daily if necessary.

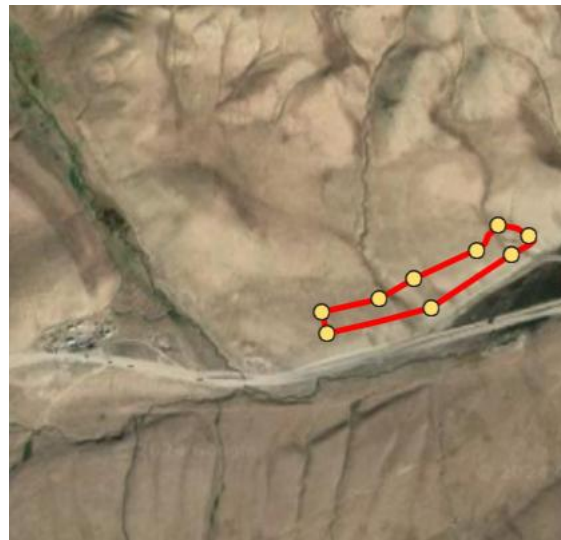
Quarry №14 (km 100+800)

48. The quarries' areas are in suitable condition. During the reporting period, seven quarries are operated: at km 148+630 (located in the Tugol-Sai village area), at km 140+990 (the Kuyruchuk village area), at km 135+280 (the Jany-Aryk village area), at km 119+300 (the Jungal village area), at km 110+900 (the Cholpon village area), at km 106+420 (the Cholpon village area), and at km 100+800 (the Cholpon village area). GIS locations of the quarries' areas are shown below.

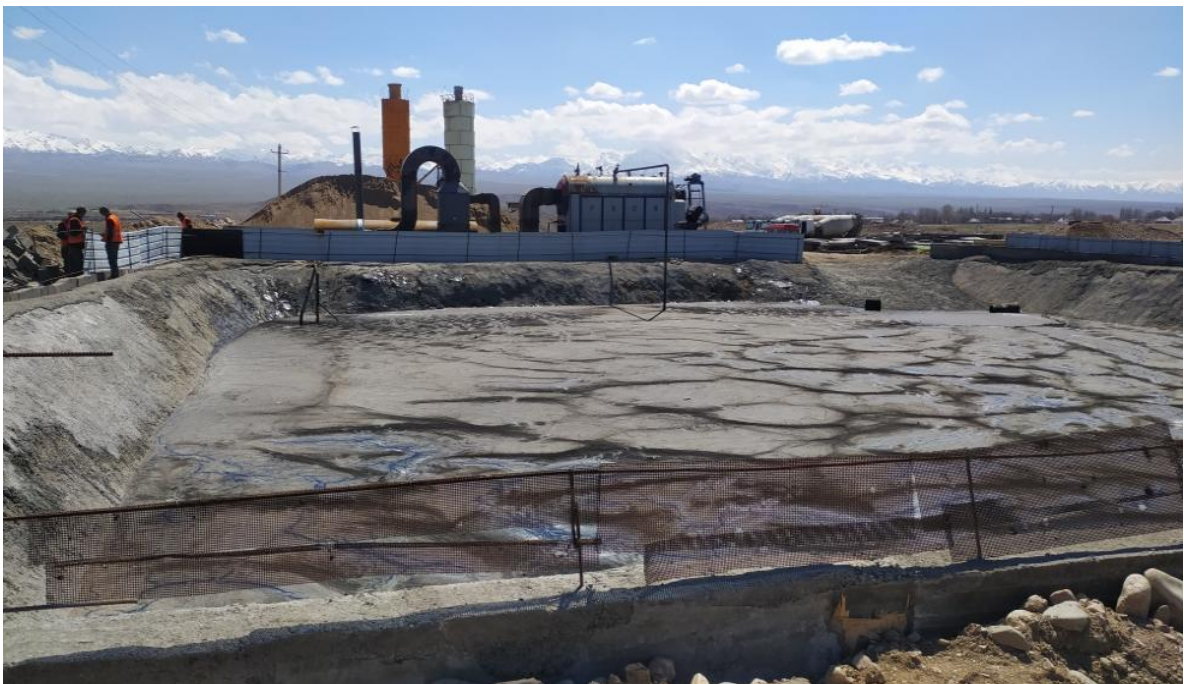
Figure 10: Bitumen pit. The bitumen pit is equipped with reinforced concrete liner and a floor to prevent the infiltration of petroleum products into the soil.

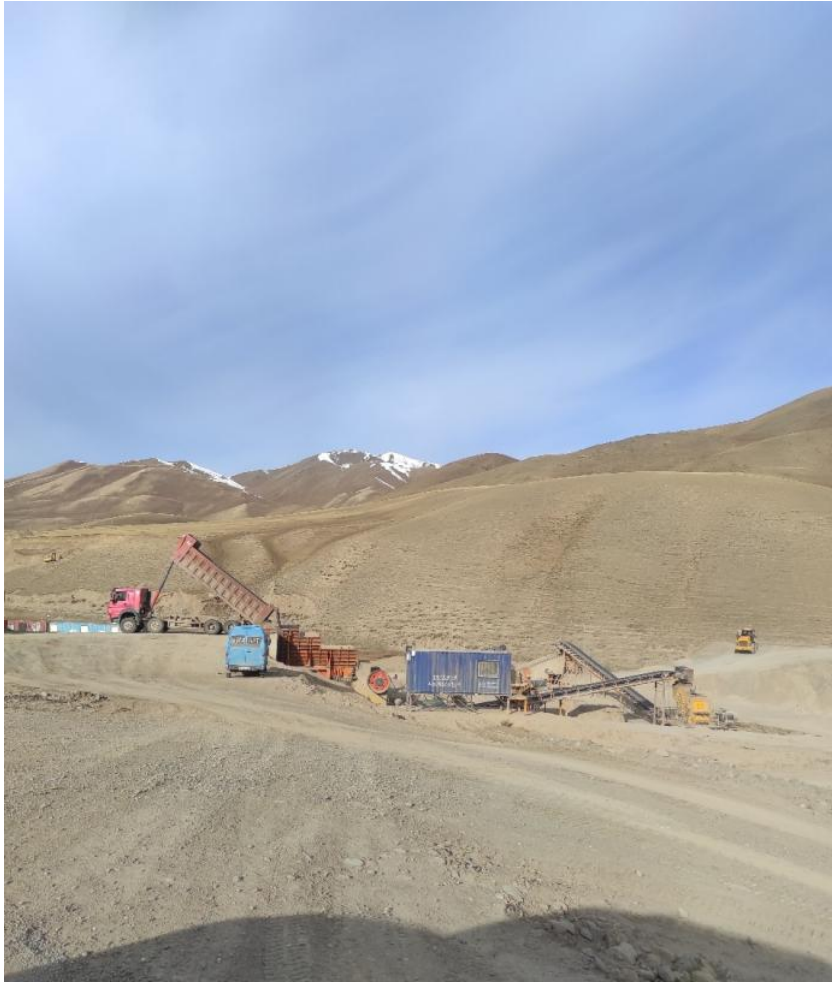
Figure 11: The production site (km 106+300)

57. Currently, the Contractor installed a crushing and sorting plant (CSP) at km 106 - 300 of the project road, with an area of 1.57 hectares. The Contractor has obtained the necessary permits from the Cholpon Ata ayil-okmotu of the Kochkor district and the Issyk-Kul-Naryn Regional

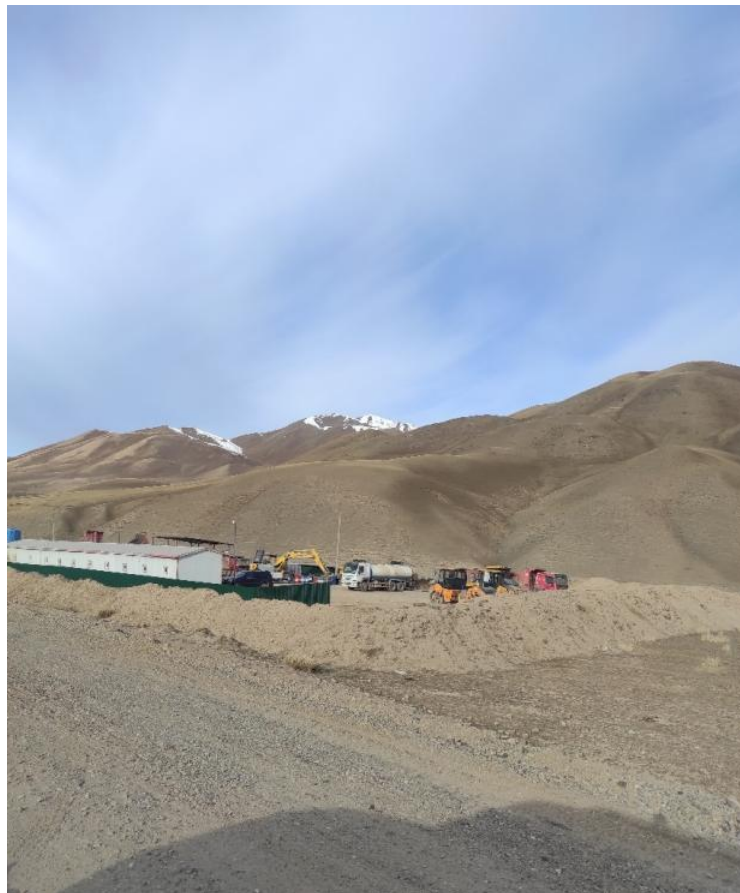
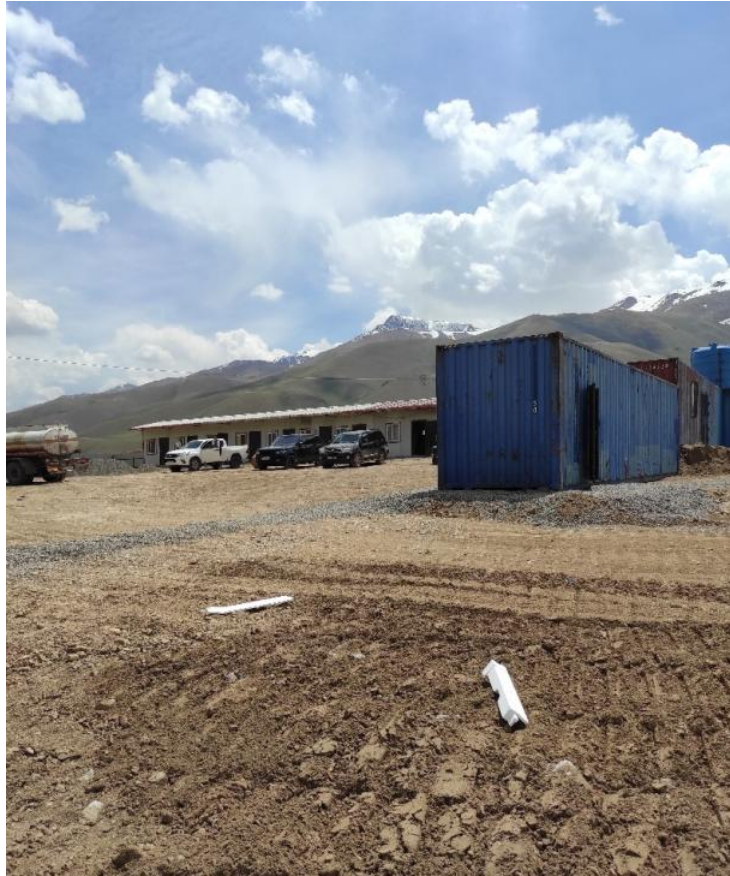
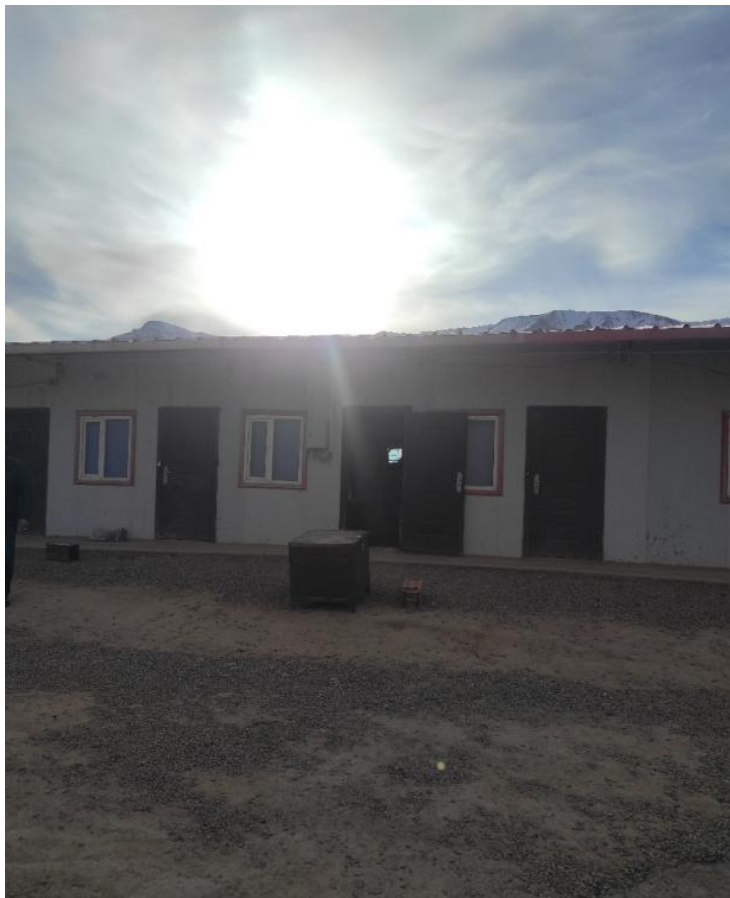
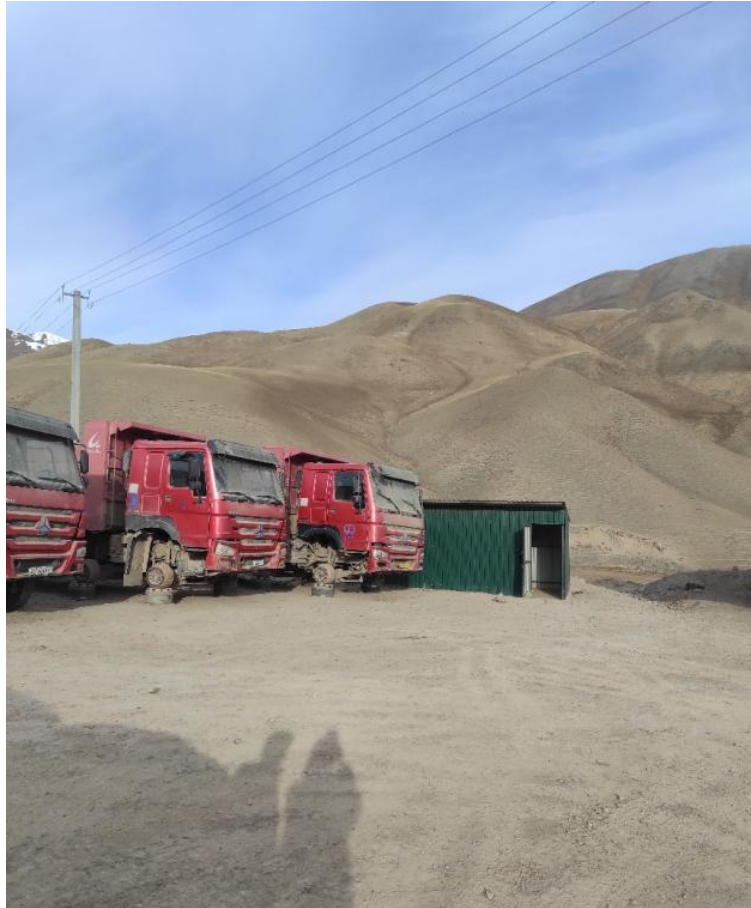
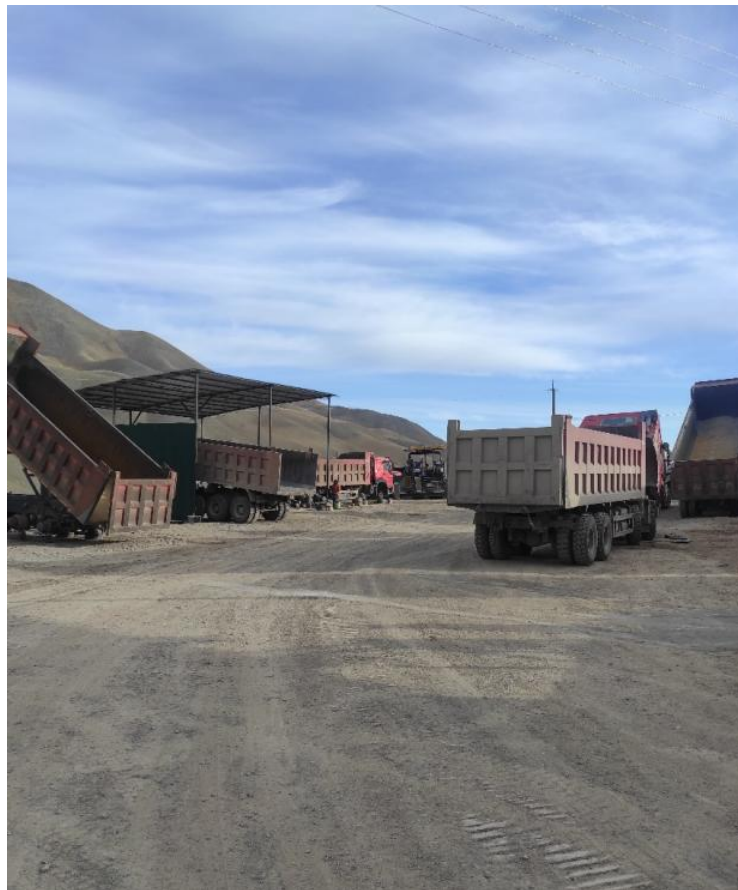
Figure 13: The area of the additional construction camp (km 106+300)

64. The additional camp area already includes offices, a kitchen, a dining hall, accommodation for the Contractor's workers, the Contractor's office, a security room, a parking lot, a generator, a water reservoir, temporary waste bins, a septic tank, toilets, and showers.

68. This area is also planned to accommodate a warehouse and repair zone, and the production area will include an asphalt-concrete plant and a crushing and sorting plant.

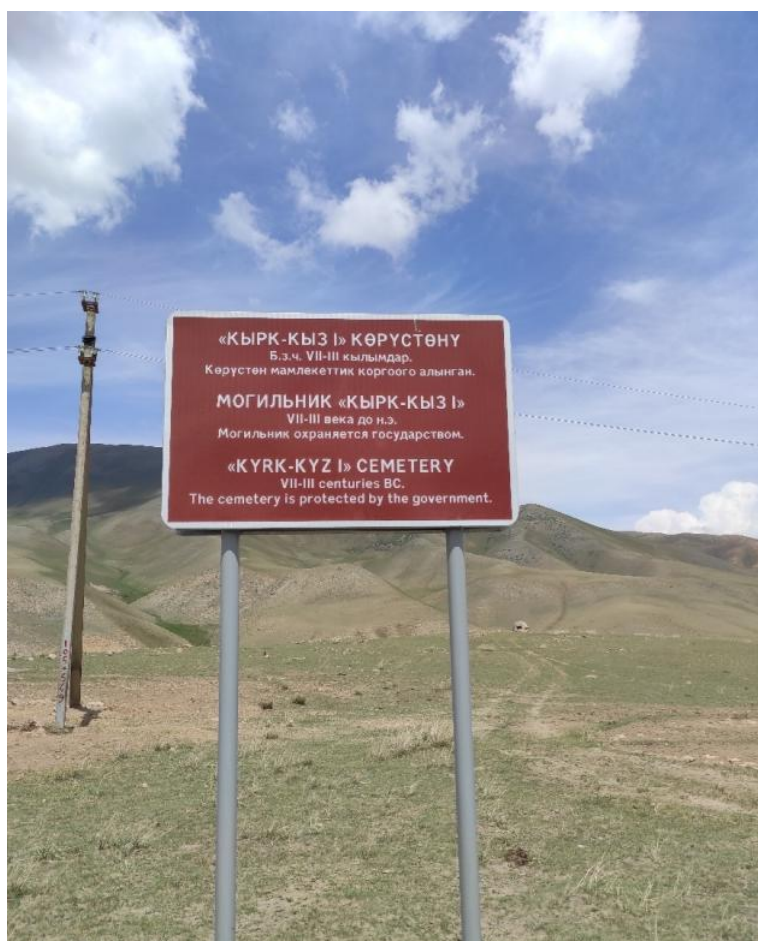
Figure 14: CHHS information board

104. In order to prevent any potential direct or indirect impact on historical and cultural heritage sites located along the construction areas of the project road, after the completion of excavation works, information boards were installed at 16 archaeological sites. These boards are in three languages (Kyrgyz, Russian, and English) and provide information about the type, name, chronological attribution, and protected zones of the monuments. This fully complies with the requirements of the national legislation, specifically the Law of the Kyrgyz Republic "On the

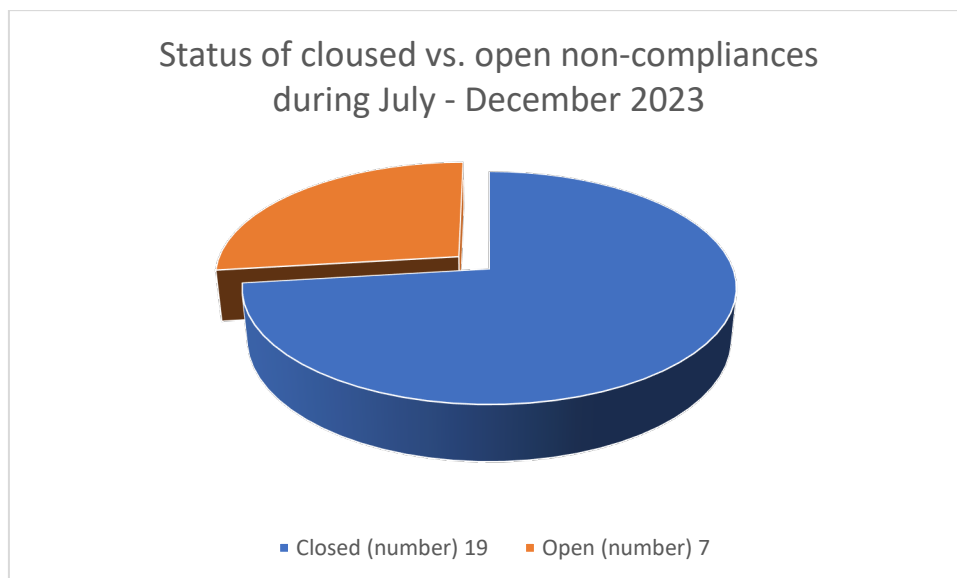
Figure 16 Status of Non-compliances and Corrective Actions.

106. Findings observed during the Consultant's audit were communicated to the contractor for corrective actions. Total 26 non-compliances were raised from them 19 were corrected (closed), 7 actions are remained open/ongoing and their developments should be monitored during the future inspections/audits. Status of non-compliances and corrective actions is also shown in figure 16.

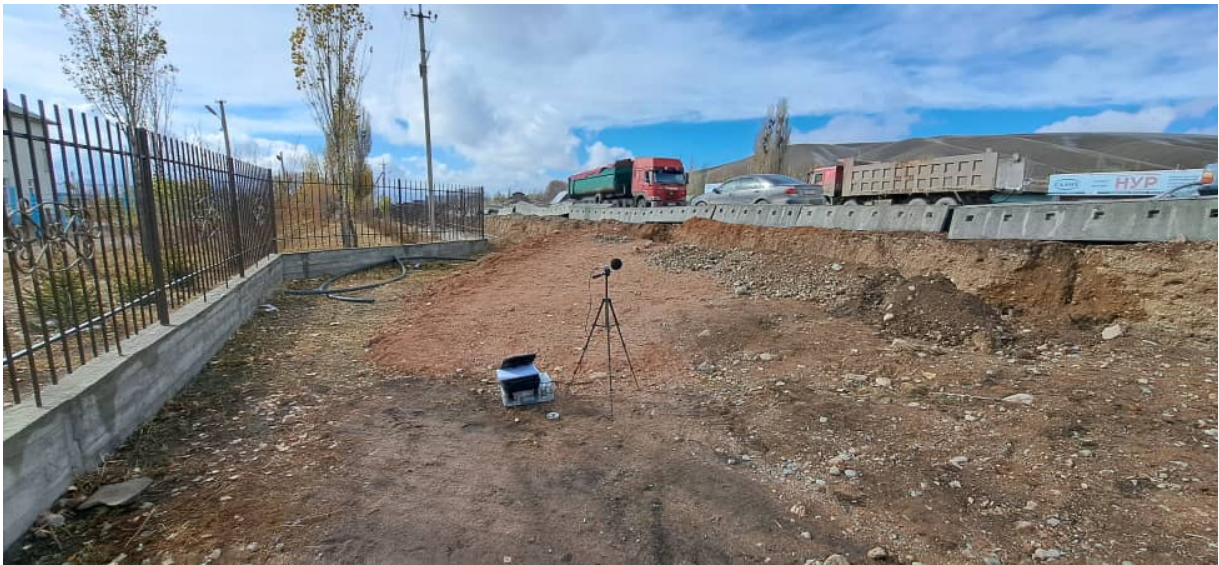
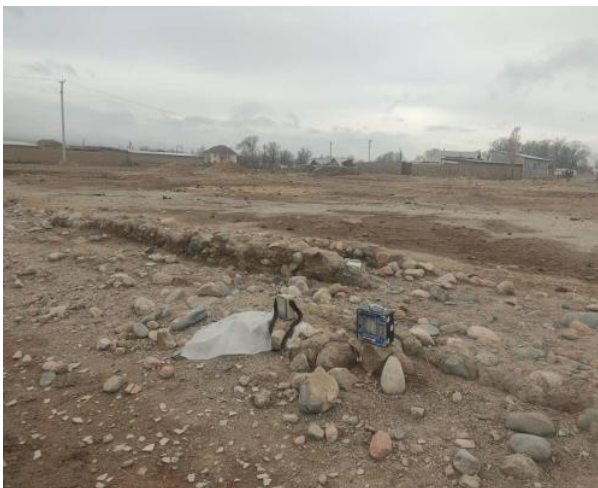
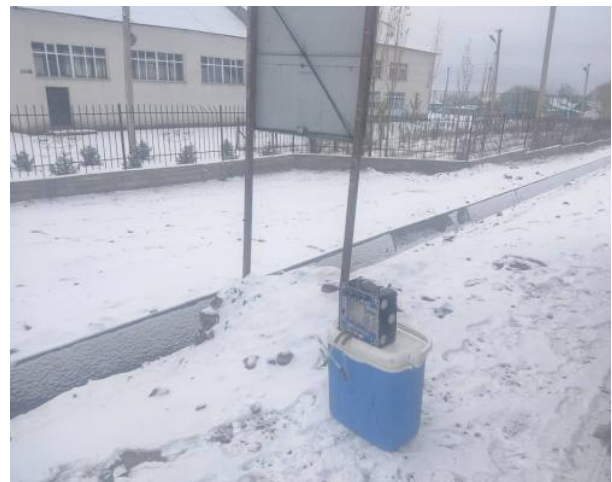
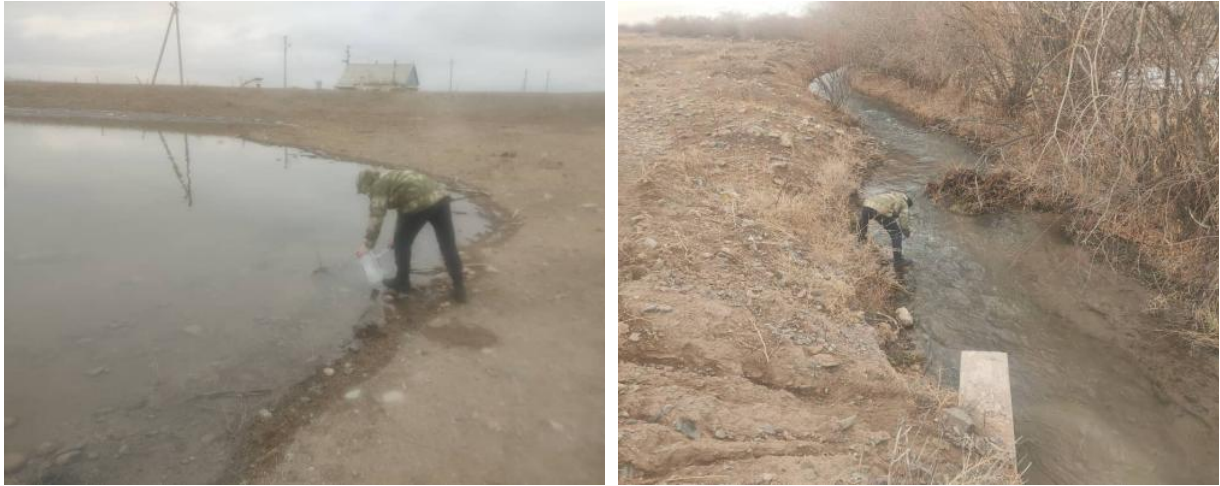
Figure 17: Instrumental Monitoring on Project Road

125.The outcomes of instrumental measurements of vibration from traffic flow on road showed levels between 84 dB to 98 dB in August and 79 dB to 94 dB in November. The detailed results of noise and vibration impact monitoring are given in Annex 4.

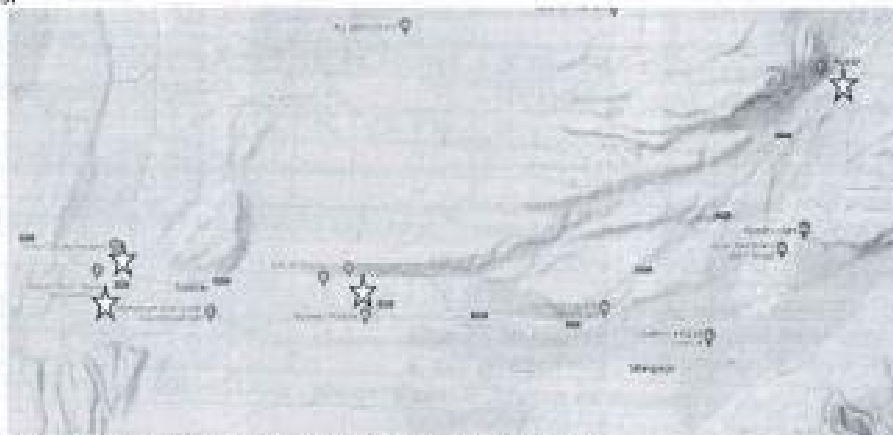
Места где были произведены замеры. Контрольная точка – ☆  
10. Дата произведение измерения: «10» ноября 2023 г
