# Semi-annual Environmental Monitoring Report

Semi-annual Environmental Monitoring Report  
January to June, 2022

## **CAREC Corridors 1 and 3 Connector Road, Section 2B Epkin-Dyikan [Bashkugandy], Km: 89+500 – 159+200 Project**

Nargiz Garajayeva, International Environmental Consultant,  
Gentek International Engineering and Consulting Ltd.  
Bishkek, Kyrgyzstan: July 2022

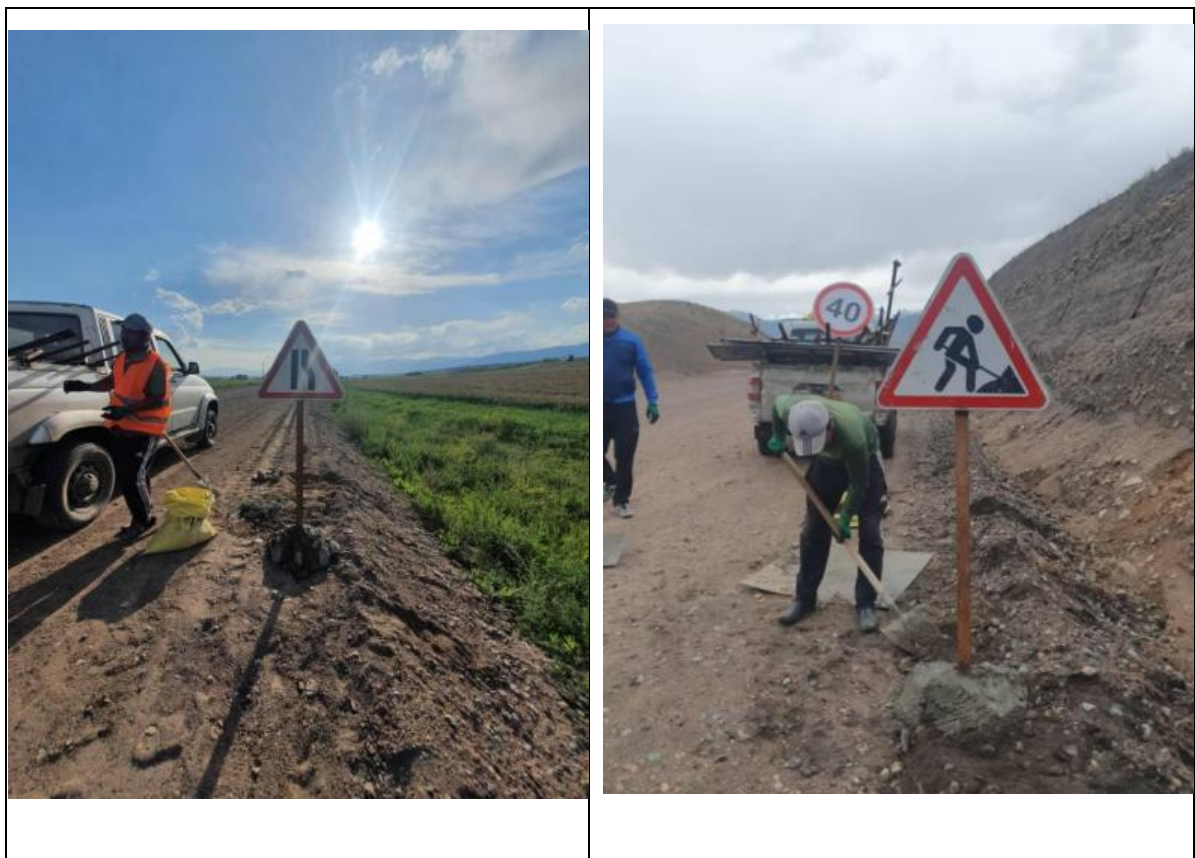
**Figure 3 Temporary road signs installation.**

- Mobilization and installation of plants and equipment for the production of asphalt concrete mix, concrete and crushed aggregate fractions;
- Maintenance of the existing road (such as clearing, maintenance of the road and structures, installation of temporary road signs, dust suppression in dry weather);
- Cut excavation;
- Embankment;
- Construction of subgrade, subbase and base layers;
- Construction of binder course layer;
- Completion of installation of previously started culverts, as well as laying of new culverts.

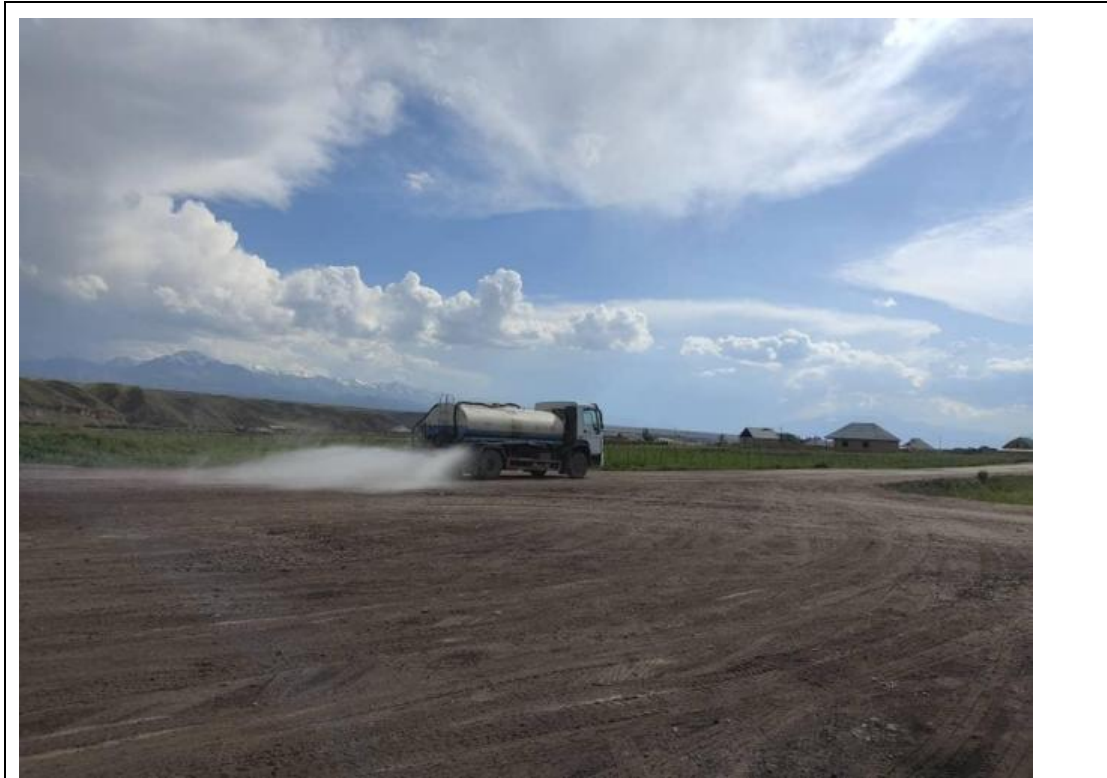
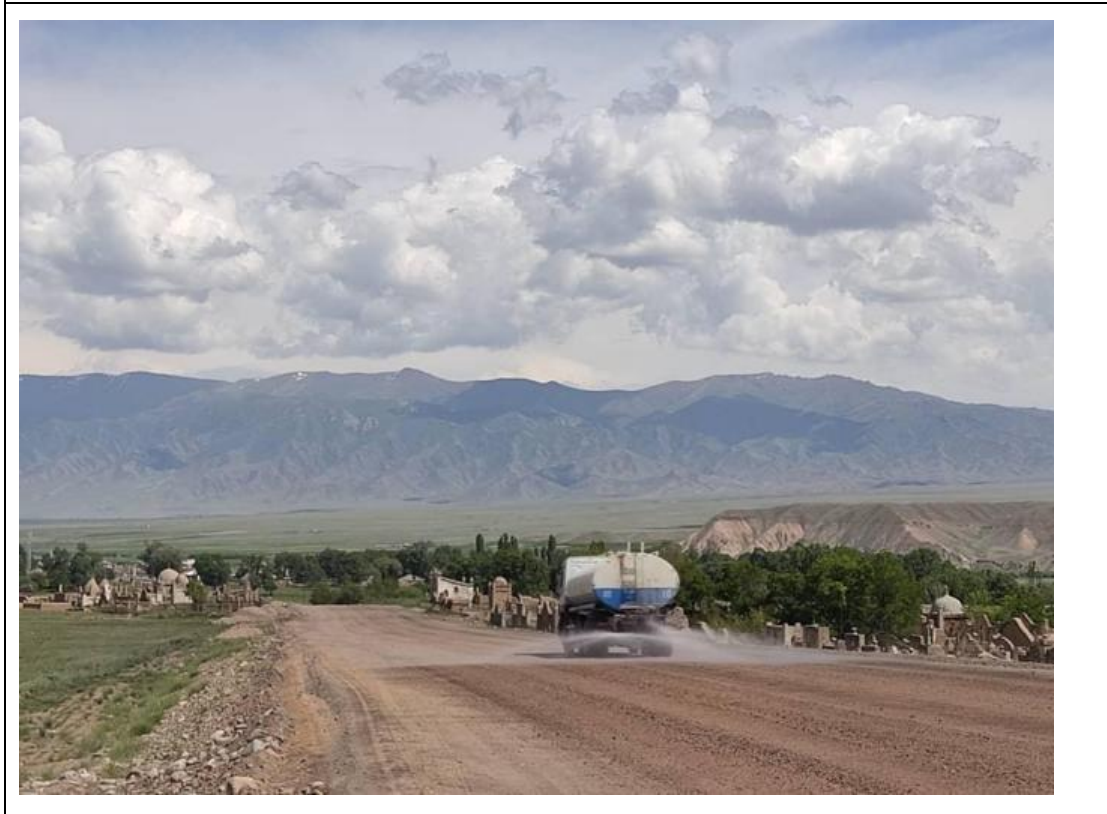
**Figure 7 Dust suppression on roads.**

41. The water used for dust suppression is taken from the Jumgal, Tugol-Sai rivers, from a channel at km 147+540, Kyzart-Suu, Kara-Suu near Bash-Kuugandy Tugol-Sai, Kuyruchuk and Jumgal villages. Dust suppression works are carried out from 7 am to 19:00 pm.

39. At the beginning of the year, work was carried out to suppress dust and use 6 water trucks at the site. During public consultations, local residents requested to increase the intensity of the dust suppression process due to the onset of hot and dry weather. In addition, an increase in dust was noted on the road during the project road visit by the international and local environmental consultants on May 24-25, 2022. The request for more intensive dust suppression was communicated to the Contractor.

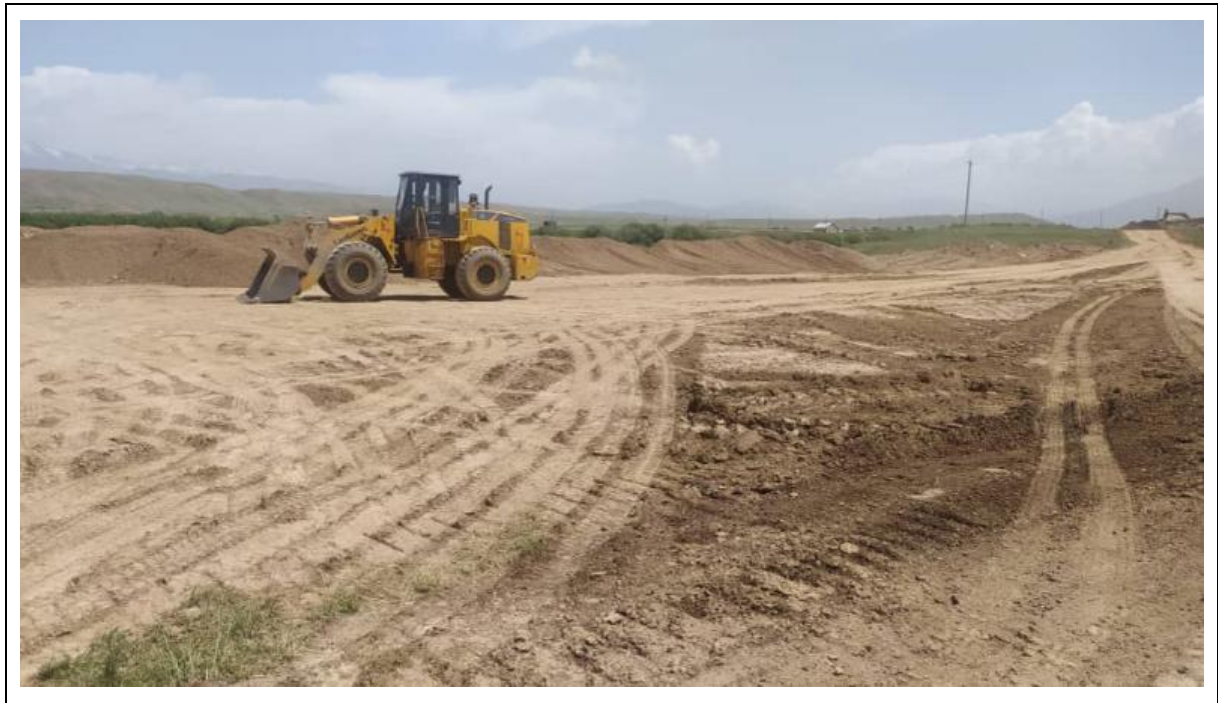
**Figure 8 Quarry development (km.140+990).**

45. The results of visual inspection of the quarries' areas showed their satisfactory condition. Thus, the remaining 12 quarries will be utilized by a new Contractor. Three quarries are currently being developed: quarry No. 13 (at km 148+630), located in the Tugol-Sai village area, quarry No. 11 (at km 140+990) in the Kuyruchuk village area, and quarry No. 10 in the Jany-Aryk village area.

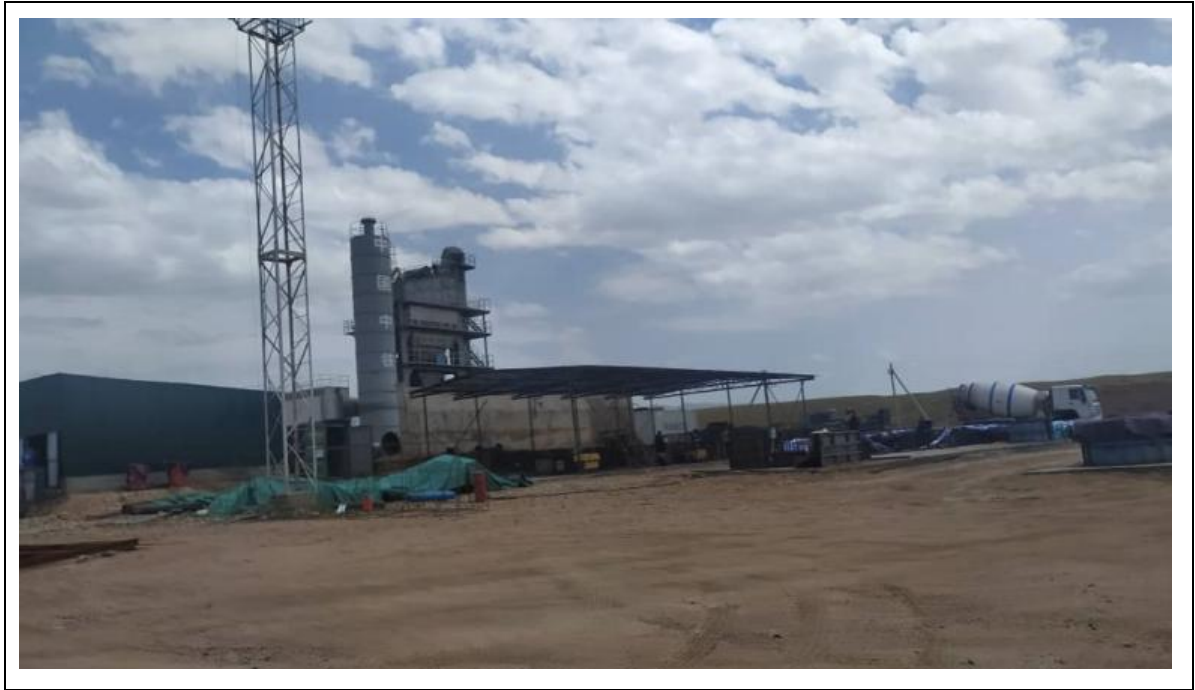
**Figure 10 Asphalt plant at the production site.**

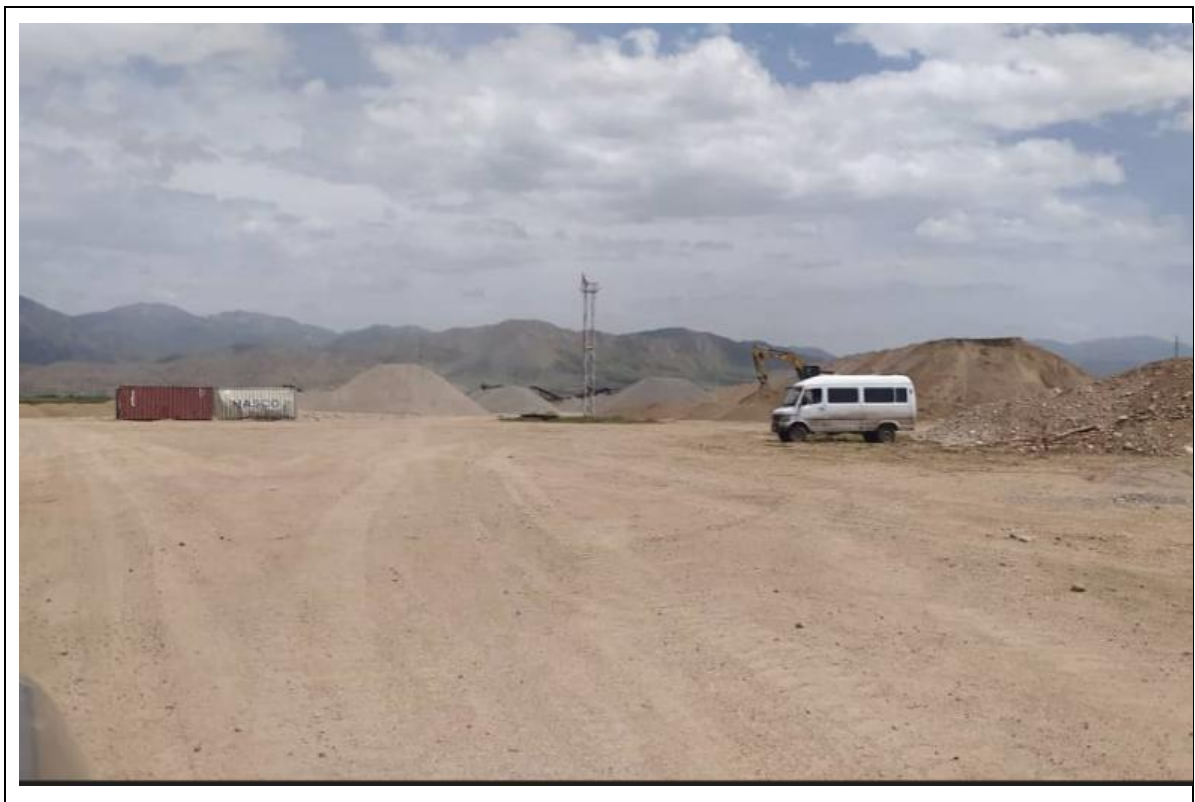
**Figure 11 Land clearing.**

53. During the reporting period, the territory was cleared and leveled for the construction and installation of structures in accordance with the approved plan; The asphalt plant is being installed, trial runs and verification work are currently being carried out to produce the material; Crusher has been installed and is operating (km 148+63). Several residential and utility

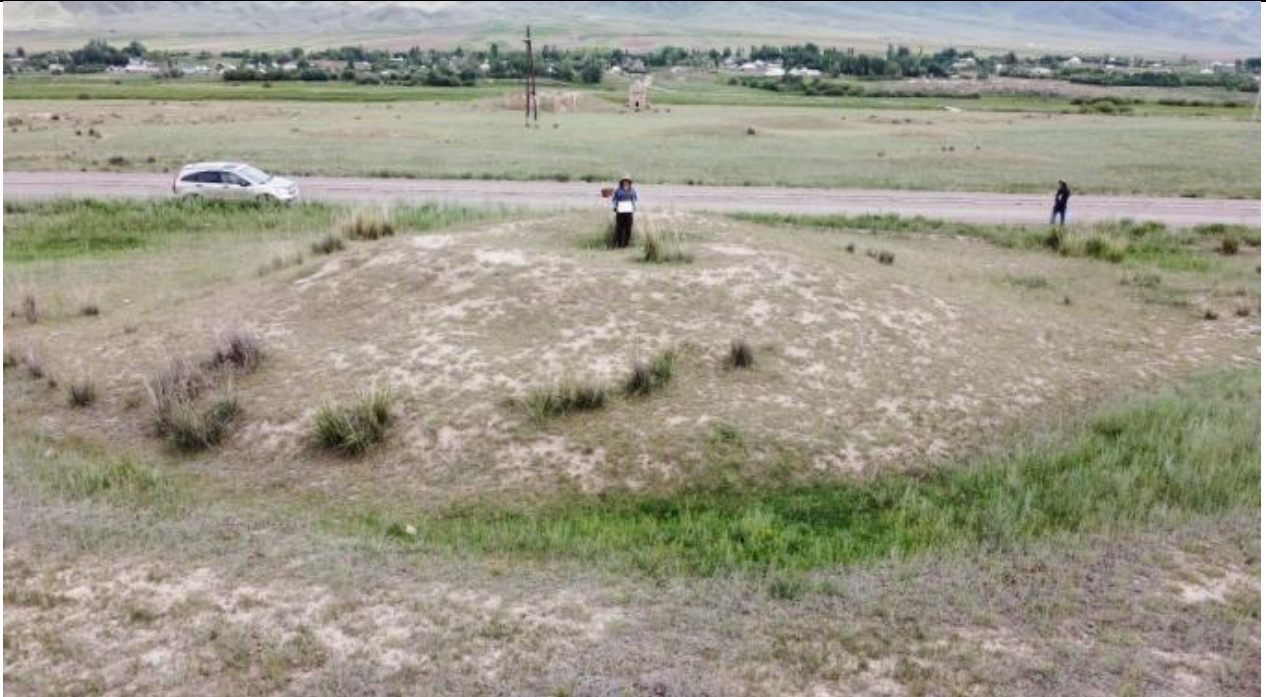
Mound 12 of the burial ground Altyn-Aryk 1 / 136+000 - 136+900 km. View before excavation

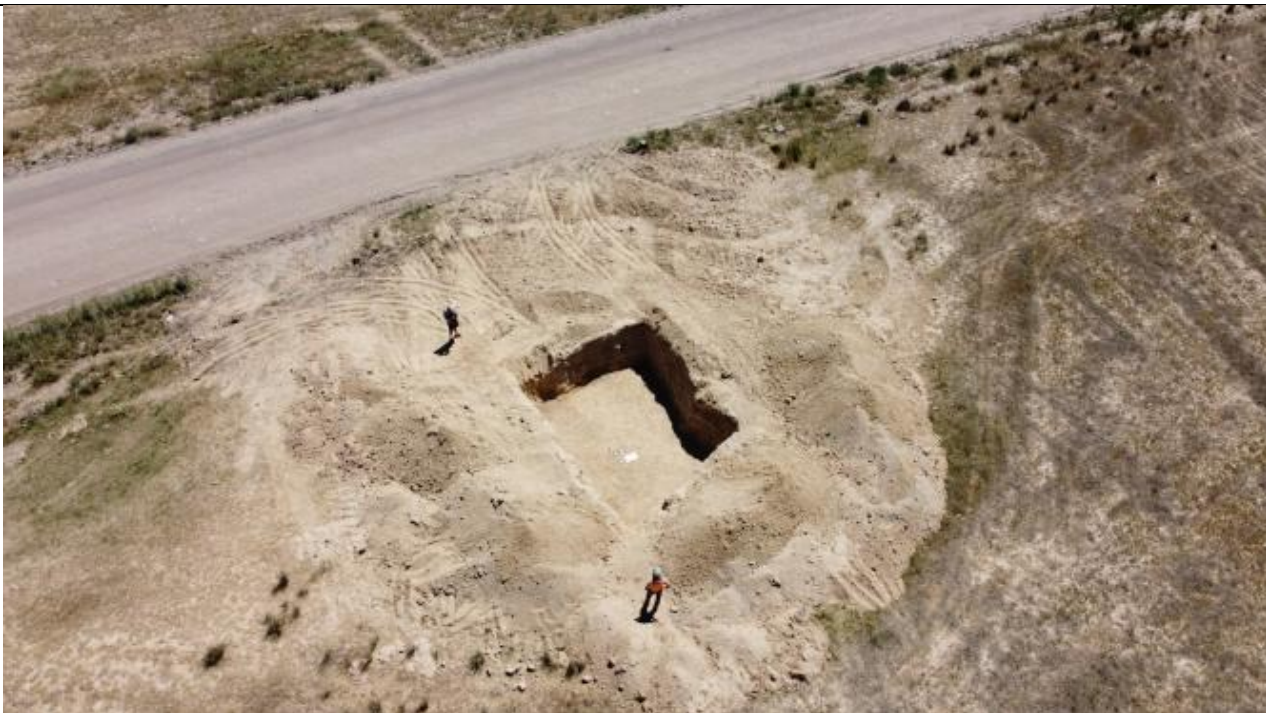
Mound 12 of the burial ground Altyn-Aryk 1 / 136+000 - 136+900 km. View after control excavations.

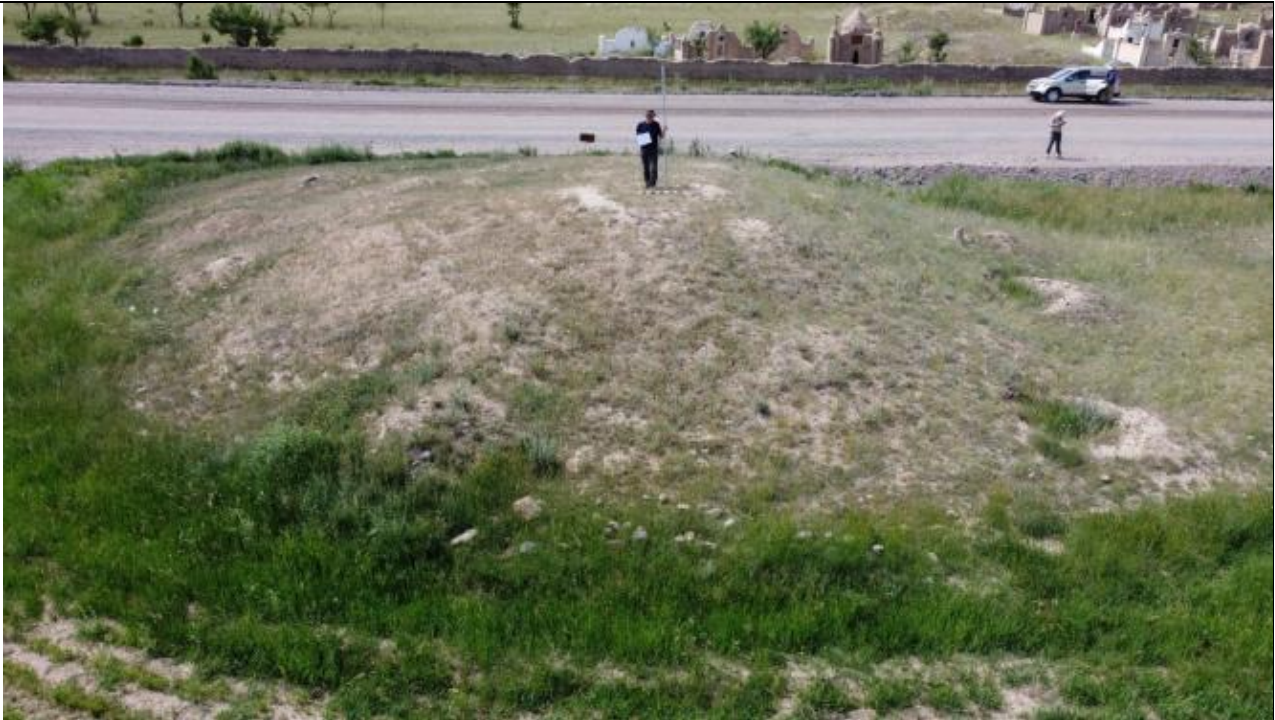
Mound 1 of the burial ground Altyn-Aryk 5 / 139+500 - 139+850 km. View before excavation

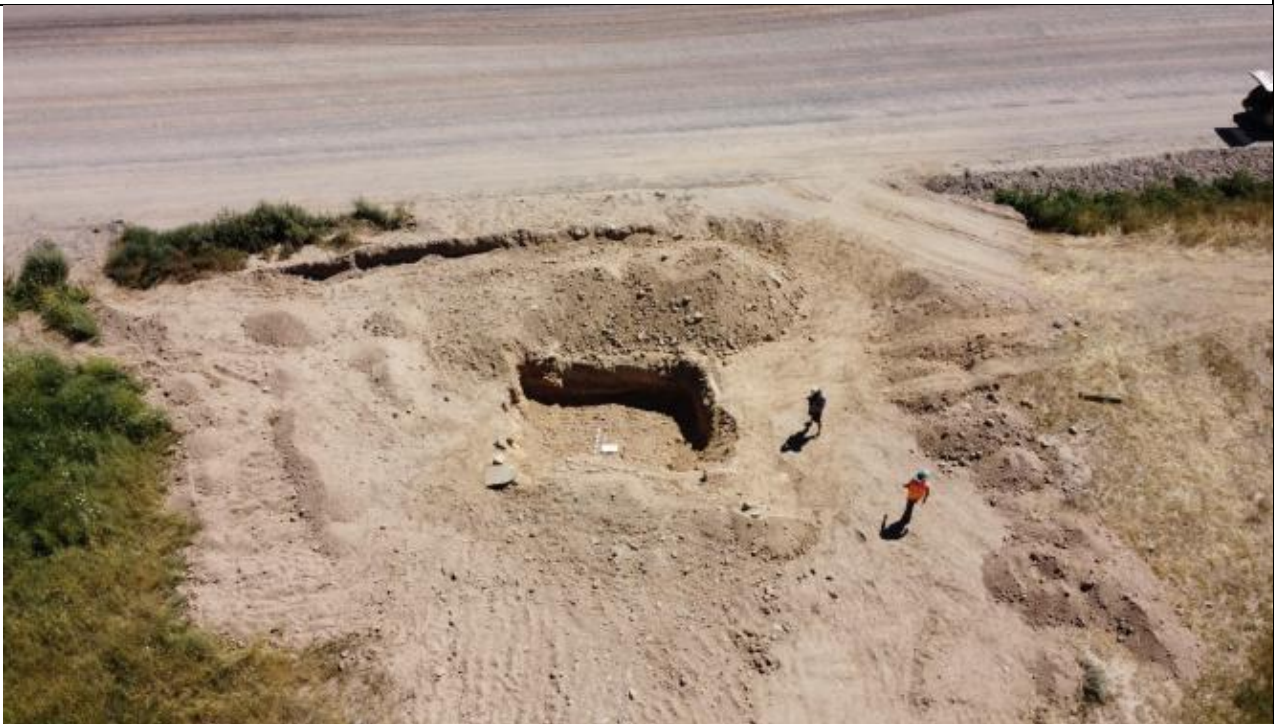
Mound 1 of the burial ground Altyn-Aryk 5 / 139+500 - 139+850 km. View after the excavation.

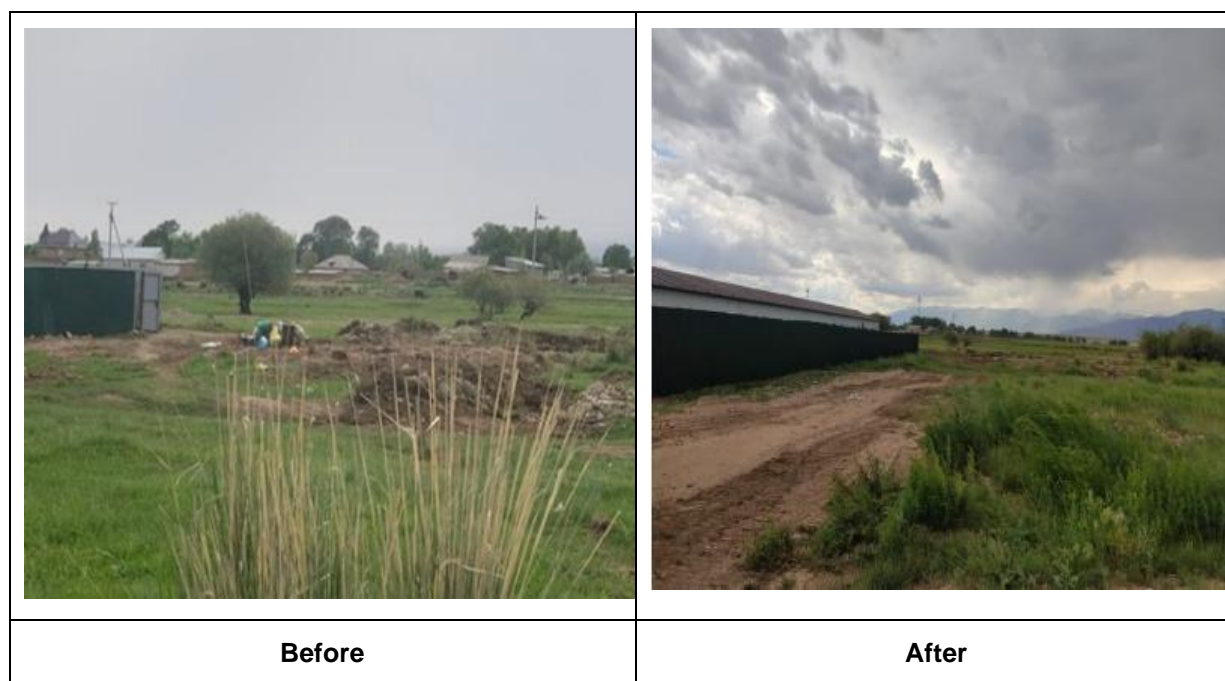
114.Waste sometimes is accumulated, including both construction and household waste, on the production base and the camp. Reinforced concrete construction waste is generated during the dismantling of bridges and culverts. The contractor is constantly instructed about the need to remove all construction waste so that waste is not accumulated in the areas not designated for this purpose.

**Figure 19 Solid household waste at the site (Before and After the audit).**

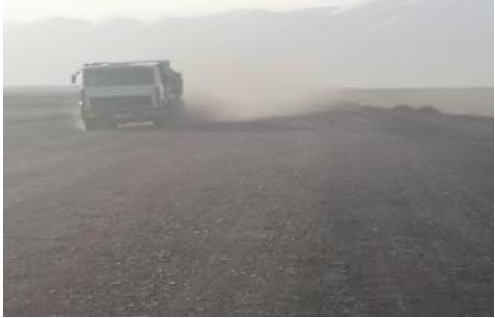
| # | Observations/Non-conformances/Corrective Action | Photos | Description of Corrective Action by Railway No.5 Contractor | Status | Target date to close Non-conformance by Contractor | Corrective Action Evidence (please, attach photos, document) |
|---|---|--|---|---|--|--|
| 4 | <p><b>Dust Control:</b> There is increased dust formation on the road with the summer season approach. It is necessary to revise the Dust Suppression Plan taking into account the increase in watering road intensity and the increase in the number of water trucks.</p> <p>During a public hearing held on May 14, 2022 with the participation of a local Environment Consultant, a Safety</p> | | To insert | Open | To insert | To insert |

| | <p>Consultant with representatives of local communities, the local residents requested to start dust control from 7 AM. (currently it starts at 9 AM).</p> <p><b><u>Correction Action:</u></b></p> <p>To prepare a new Dust Suppression Plan for the summer, indicating where the water trucks will operate, the number of water trucks, the frequency of dust suppression, who will supervise the process, etc.</p> | | | | | |

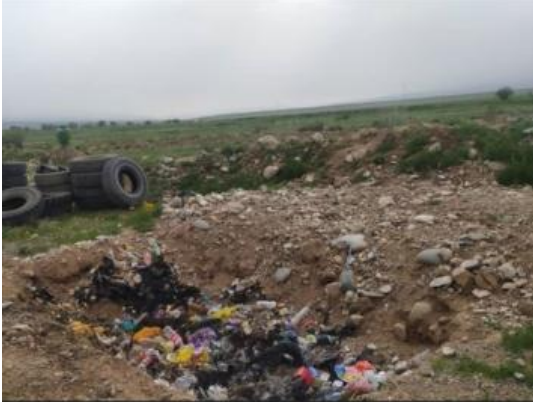
| 7 | <p><b>Waste Management:</b></p> <p>Info: Waste segregation is not carried out – there are no regulatory mechanisms. Household waste is disposed of by the Contractor through local authorities, but not systematically, remnants of burnt waste were observed in dug pits on the territory of the production site;</p> <p>Used fuel and lubricants are transferred to the local residents at their request.</p> <p>Household waste is stored in plastic bags directly on the ground - there is no specially designated area for collecting this waste.</p> <p><b><u>Correction Action:</u></b></p> <ol style="list-style-type: none"> <li>1) To establish waste control in accordance with the SSEMP requirements and the obligations assumed by the Contractor.</li> </ol> | | To insert | Open | To insert | To insert |

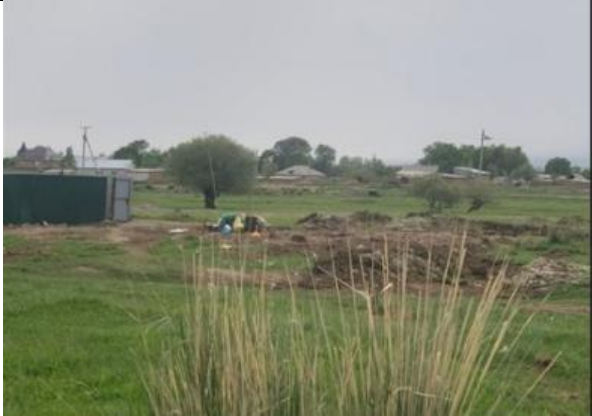
| | <p>2) It is necessary to create a registration log for non-hazardous and hazardous waste and record all waste activities.</p> <p>3) To provide evidence of all types of waste collection from the camp</p> | | | | | | |

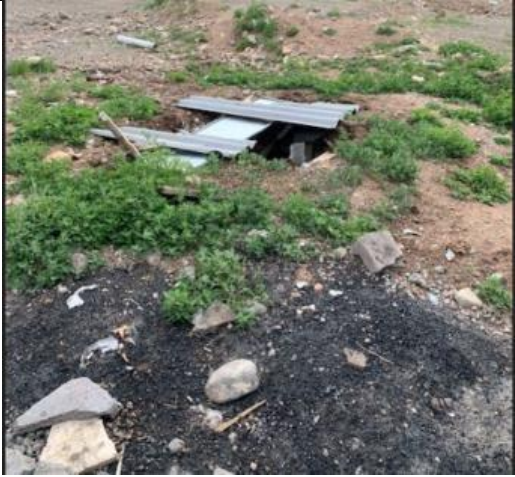
| 8 | <p><b>Sanitary and Hygienic Inconsistencies</b></p> <p>The septic tank (sanitary tank) on the production site territory does not meet sanitary and technical standards.</p> <p><b>Correction Action:</b> To bring it in compliance with the obligations under the SSEMP.</p> | | | To insert | Open | To insert | To insert |

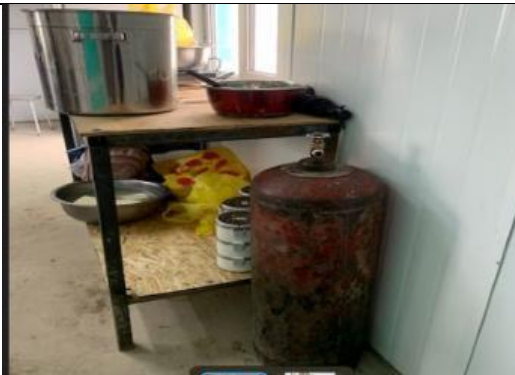
| 9 | <p><b>Sanitary and Hygienic Inconsistencies</b></p> <p>There are a lot of uncovered dishes with food in the kitchen. There are things that are not related to cooking on the table with food (for example, an umbrella. See Photos).</p> <p><b>Correction Action:</b> To remove all extraneous things, to keep only what is related to the cooking process in the kitchen.</p> | | | To insert | Open | To insert | To insert |

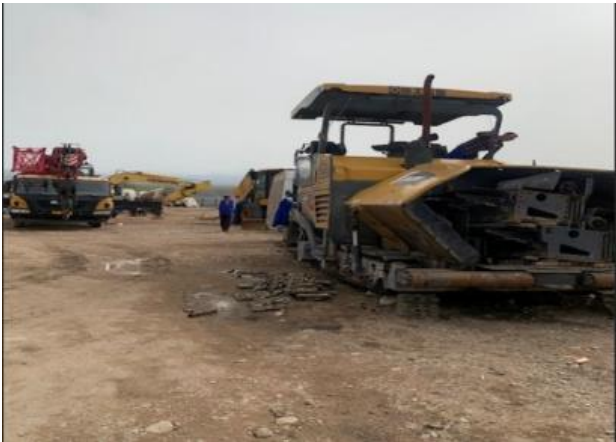
| 11 | <p><b>Camp Territory.</b></p> <p>The repair of construction equipment and heavy vehicles is carried out directly on the ground on the territory of the camp (there is no concrete coating), thereby increasing the negative impact on the ground.</p> <p>Oil spills on the ground were observed in some places. There is no evidence that any control was carried out, there are no records of the spill incident. Cleaning of the soil surface, in accordance with the obligations, has not been carried out.</p> <p><b>Correction Action:</b> To investigate these inconsistencies and bring them into line with the obligations.</p> | | To insert | Open | To insert | To insert |

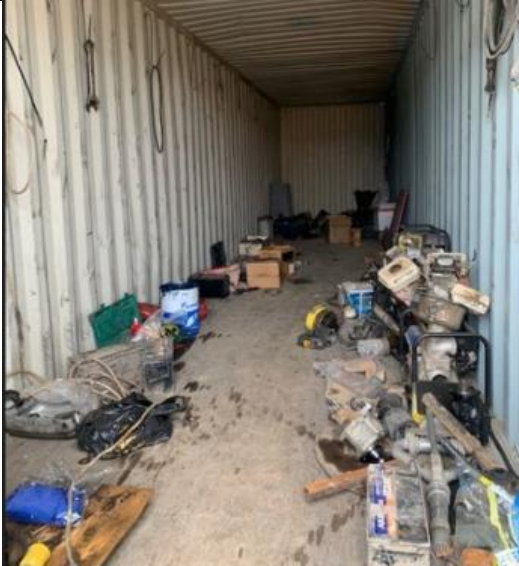
| 12 | <p><b>Camp Territory.</b></p> <p>The repair of construction equipment and heavy vehicles is carried out directly on the ground on the territory of the camp (there is no concrete coating), thereby increasing the negative impact on the ground.</p> <p>Oil spills on the ground were observed in some places. There is no evidence that any control was carried out, there are no records of the spill incident. Cleaning of the soil surface, in accordance with the obligations, has not been carried out.</p> <p><b><u>Correction Action:</u></b> To investigate these inconsistencies and bring them into line with the obligations.</p> | | To insert | Open | To insert | To insert |

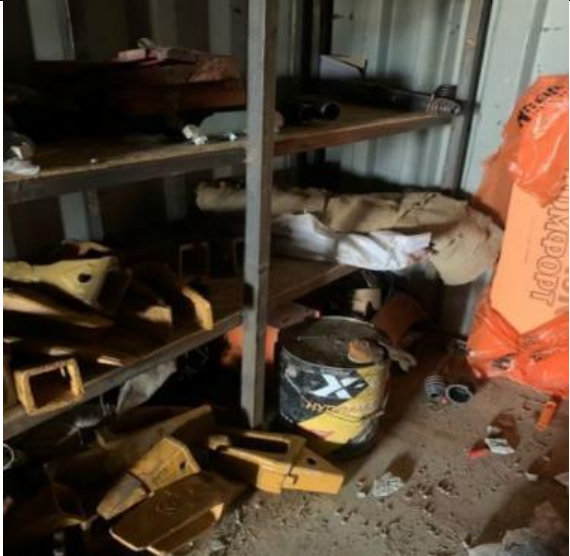
| 13 | <p><b>Containers</b></p> <p>In containers the tools are stored together with lubricants, disposable water glasses and cigarette butts are on the floor.</p> <p><b><u>Correction Action:</u></b></p> <p>1) To attach labels to containers according to their purpose;</p> <p>2) To attach safety signs (where it is forbidden to smoke, eat, and drink)</p> | | To insert | Open | To insert | To insert |

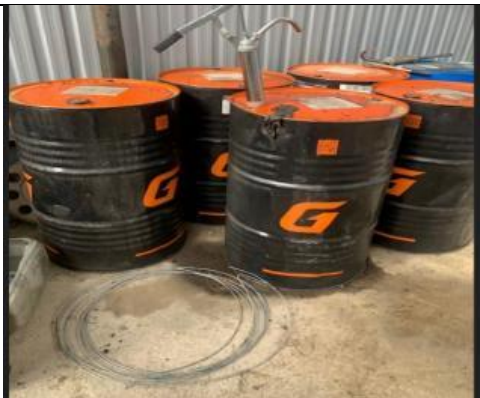
| 14 | <p>Fuel and lubricant tanks are kept in a container without a pallet, spilling under the tank creates a potential risk of falling and damage. Tanks with waste fuel and lubricants are kept in the same place. No markings or any information. There are cigarette butts on the floor of the containers.</p> <p><b><u>Correction Action:</u></b> Hazardous waste shall be stored in a designated waste area.</p> | | To insert | Open | To insert | To insert |

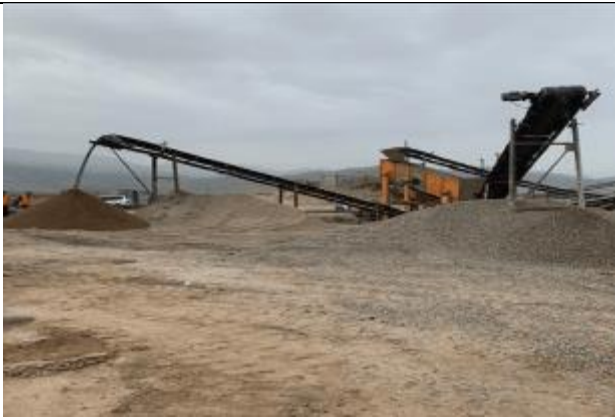
| 16 | <p><b>Crushing Plant</b></p> <p>The crushing plant has been installed and is in operation.</p> <p>The location is selected in accordance with the approved plan and is located far from social facilities. The distance to the nearest settlement and residential buildings is at least 500 m</p> | | N/R | N/R | N/R | N/R |

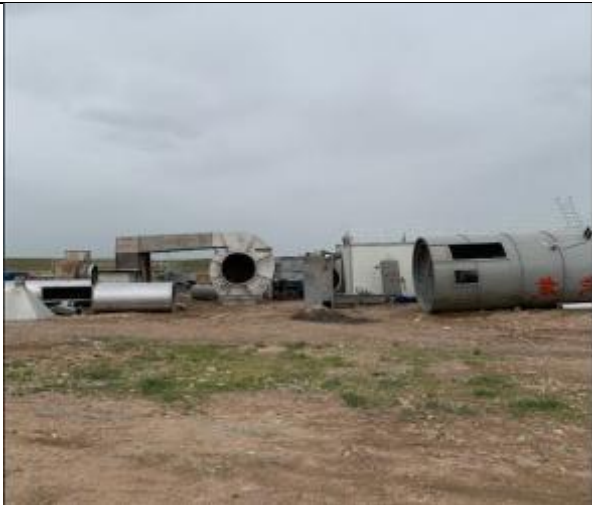
| 17 | <p><b>Asphalt Plant Operation</b></p> <p>The Asphalt Plant is still at the stage of mobilization. The location of the plant is planned in accordance with the approved plan.</p> <p><b><u>Correction Action:</u></b> The Contractor shall have spill and fire protection equipment and submit an Emergency Response Plan (in case of spills, accidents, fires, etc.) prior to the plant operation</p> | | To insert | Open | To insert | To insert |

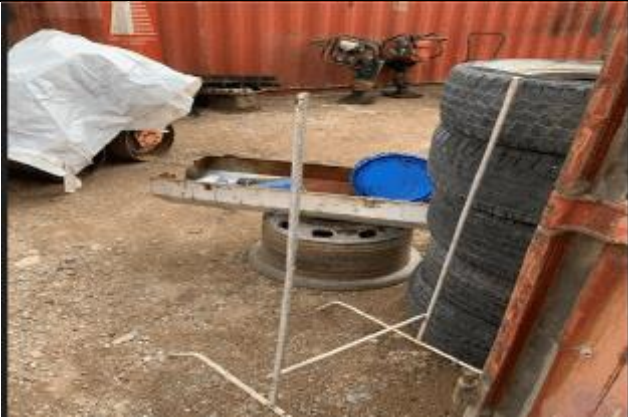
| 20 | <p>Items of potential injury hazard were found: cases of open, sharp metal end up - cut/injury threat (structure in the territory and a chair in the office)</p> <p><b><u>Correction Action:</u></b> To bring it in compliance with safety regulations</p> | | To insert | Open | To insert | To insert |

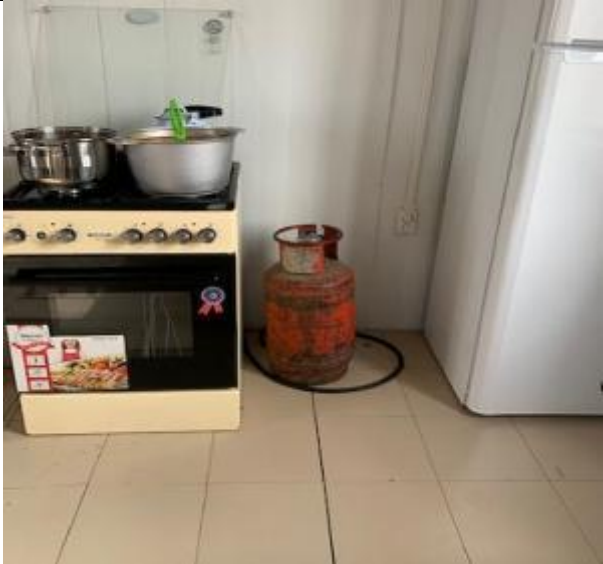
| 21 | <p>A gas cylinder is next to an open flame in the kitchen. There is also storage of empty, used gas cylinders in the kitchen.</p> <p><b>Correction Action:</b> To take the cylinders out into the open air to a specially designated place in accordance with safety regulations</p> | | To insert | Open | To insert | To insert |

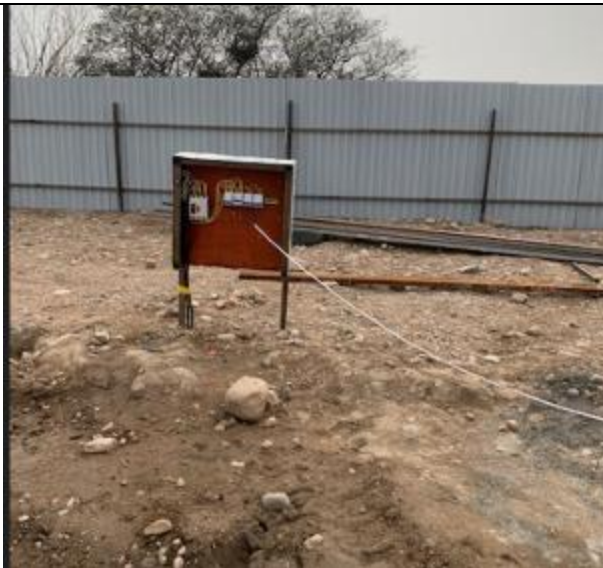
| 22 | <p><b>Electrical Safety:</b> Uncovered electrical shield, access to the shield is not fenced.</p> <p><b>Correction Action:</b> To bring it in compliance with safety regulations</p> | | To insert | Open | To insert | To insert |

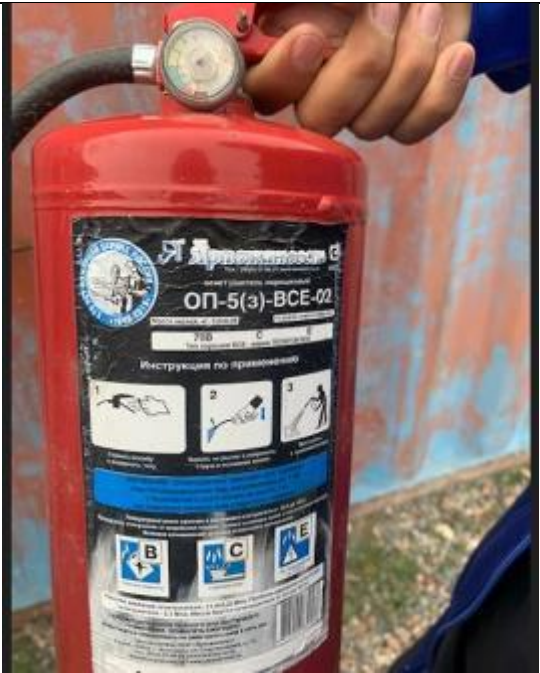
| 24 | <p>There are no first aid kits on the territory. There are no trained</p> | | To insert | Open | To insert | To insert |

| | <p>personnel to provide first aid, as well as to respond in case of fire safety (working with fire extinguishers). First aid and fire safety trainings were not held.</p> <p><b>Correction Action:</b> To bring it in compliance with safety regulations</p> <p>1) Supply first aid kits</p> <p>2) Organize first aid and fire extinguisher trainings</p> | | | | | |

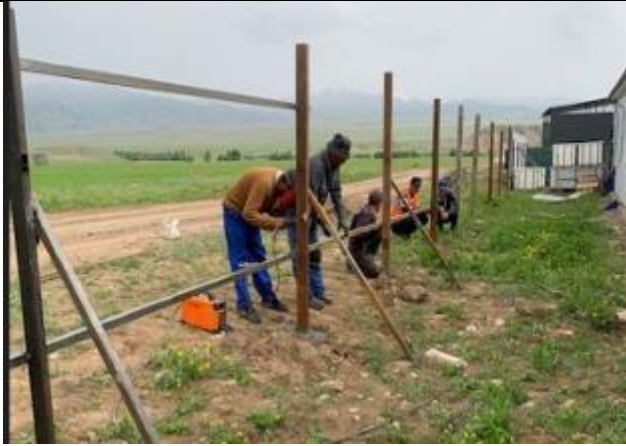
| 26 | <p>Welding work is carried out without proper personal protection - the welder does not have special clothing - an apron, gloves, shoes for the welder</p> <p><b>Correction Action:</b> To bring it in compliance with safety regulations</p> | | To insert | Open | To insert | To insert |

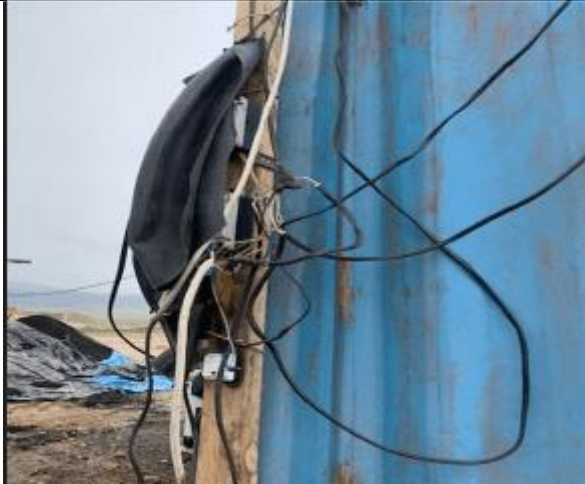
| 27 | <p>Unacceptable insulation of electrical wires is in the place of workers' residence.</p> <p><b>Correction Action:</b> To bring it in compliance with electrical safety regulations</p> | | To insert | Open | To insert | To insert |

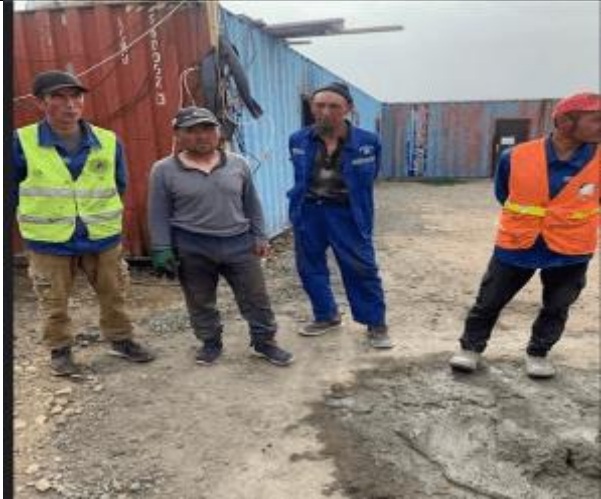
| 28 | <p>A large number of workers are not equipped (or not fully equipped) with the minimum necessary personal protective equipment (uniform, helmet, gloves, shoes, and goggles).</p> <p><b><u>Correction Action:</u></b> To bring it in compliance with personal protection regulations</p> | | To insert | Open | To insert | To insert |

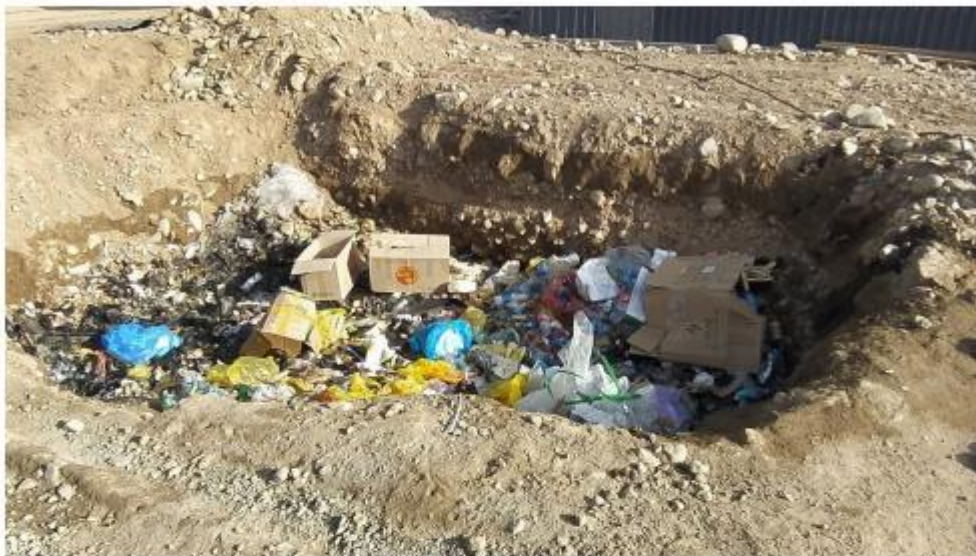
фото 1: На яме сжигали мусор

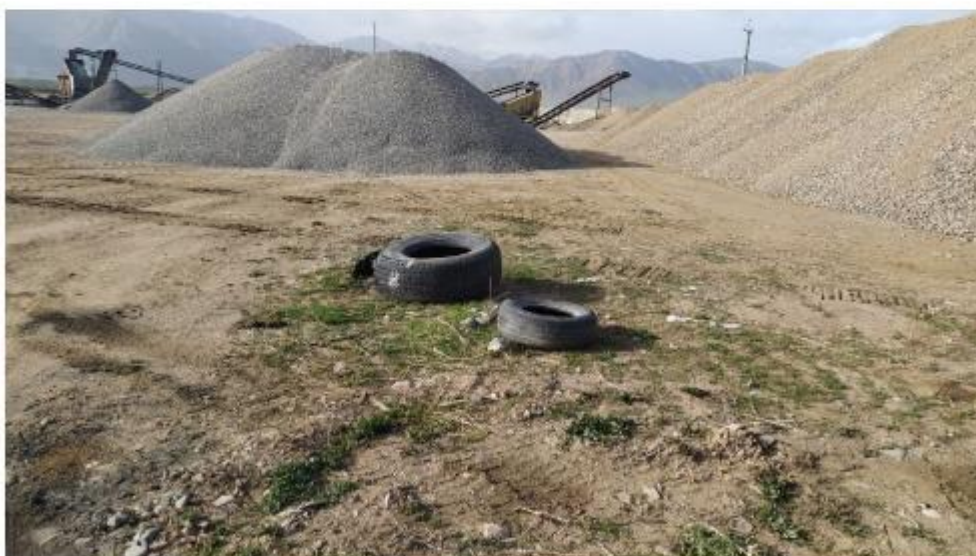
Фото 2 Разбросанные шины автомашин

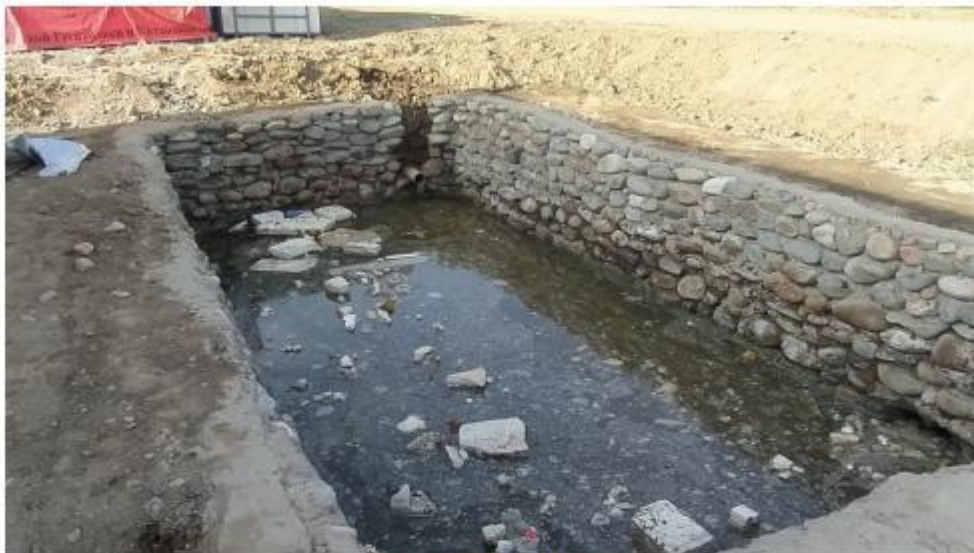
Фото 3. Не закрытый септик

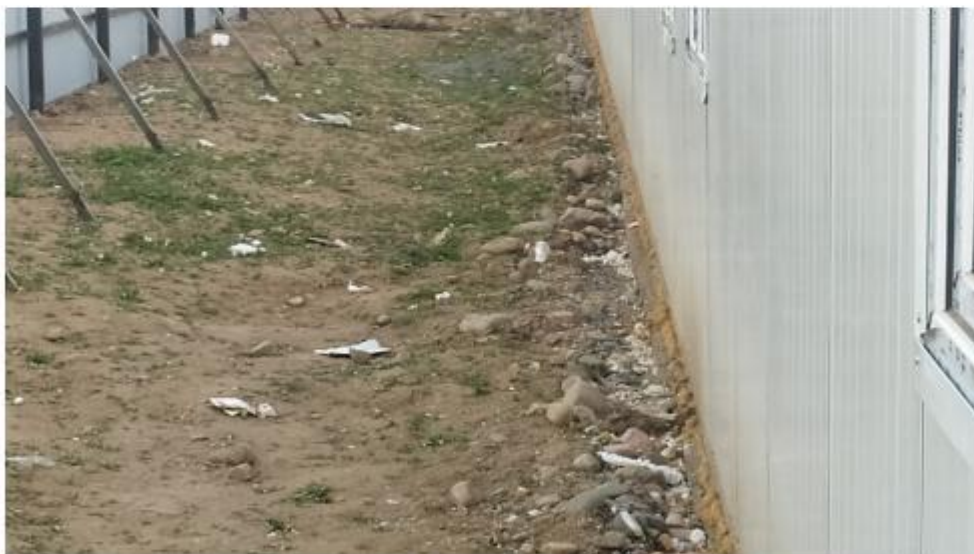
Фото 4: не соблюдается чистота на участке
