Semi-annual environmental monitoring report

Project number: 45169-001
Loan number: ADB Loan 3056-KGZ (SF)
Grant number: 0366-KGZ (SF)

January – June 2021

KGZ: Central Asia Regional Economic Cooperation
Corridor 3 (Bishkek -Osh Road) Improvement
Project, Phase 4

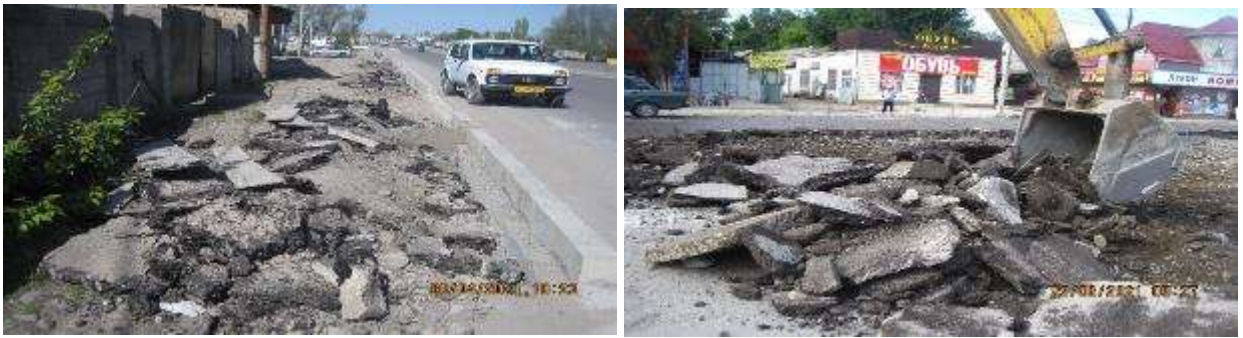
Figure 3 Removal of asphalt

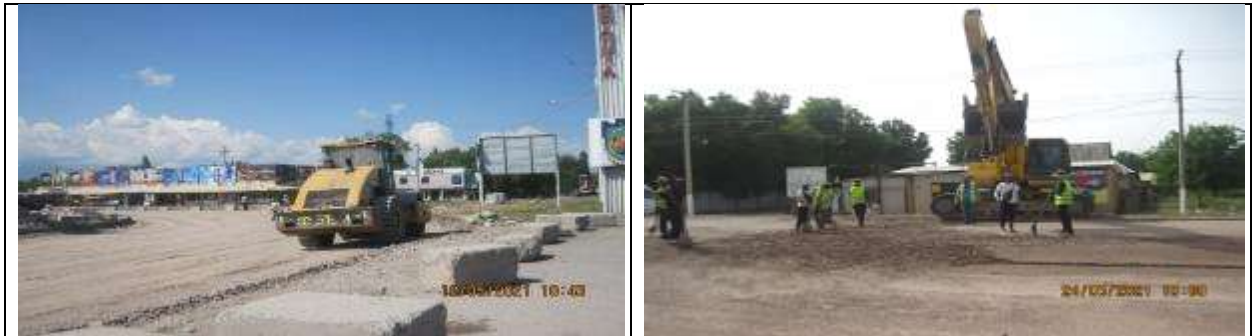
Figure 4 Leveling and compacting of roadbed

30. Soil compaction works according to the direction of ADB (letter dated May 23, 2018) were carried out without vibration at all sections of the road, with the exception of section km 15.9 - km 19.8 where there are no settlements. Supervision over the fulfillment of this requirement was constantly conducted by the inspectors of the Consultant, Construction Supervision Consultant, environmental specialist of the Consultant. Vibration control was also carried out by laboratory monitoring. The results of laboratory monitoring are attached in table 16, page 65.

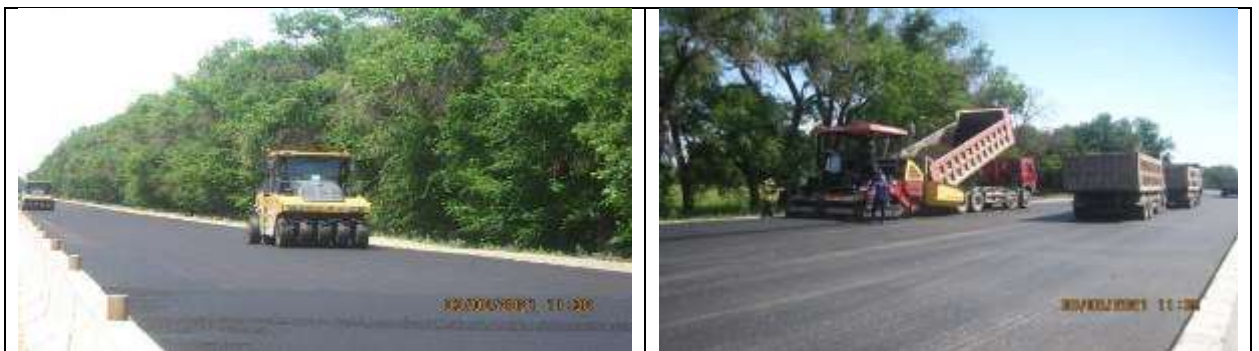
31. Wearing course (5 cm) laying works were carried out at all sections of the road from Gavrilovka to Novo-Nikolaevka.

Figure 5 Asphalt laying

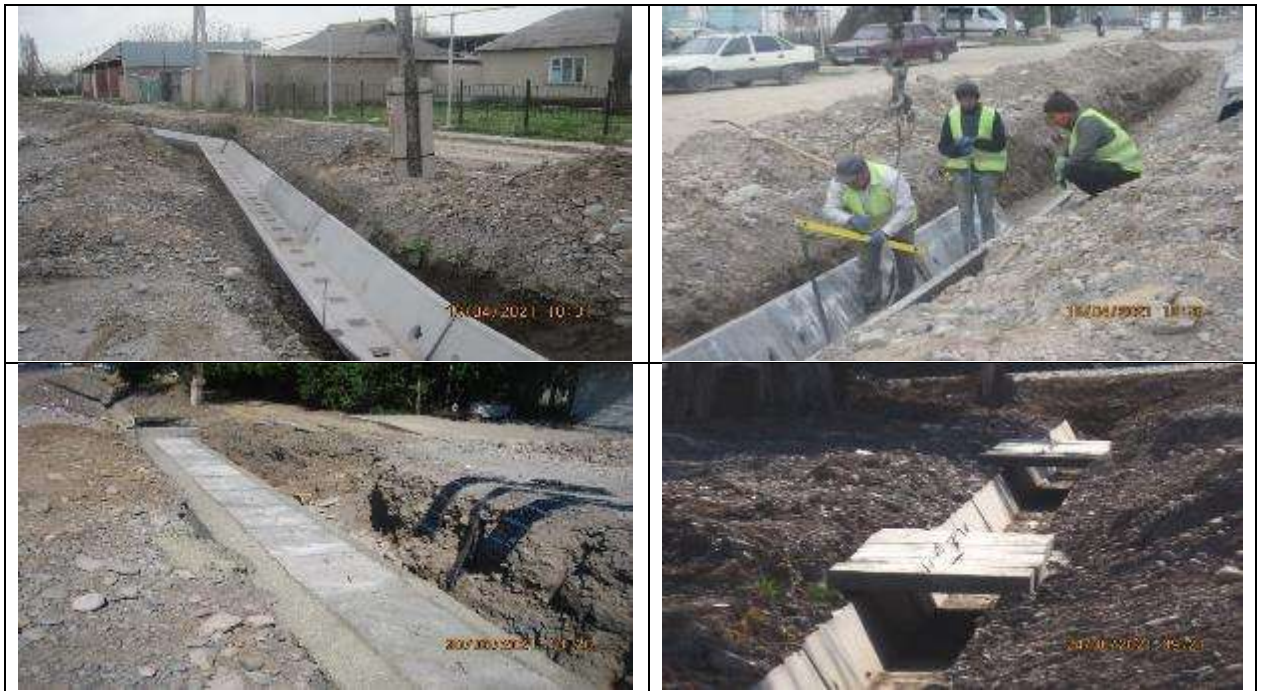
32. Subcontractor carried out work on the installation of roadside culvert chutes. Work continued on the construction of junctions to the streets adjacent to the road.

Figure 6 Installation of roadside culvert chutes and junctions adjustment to the road

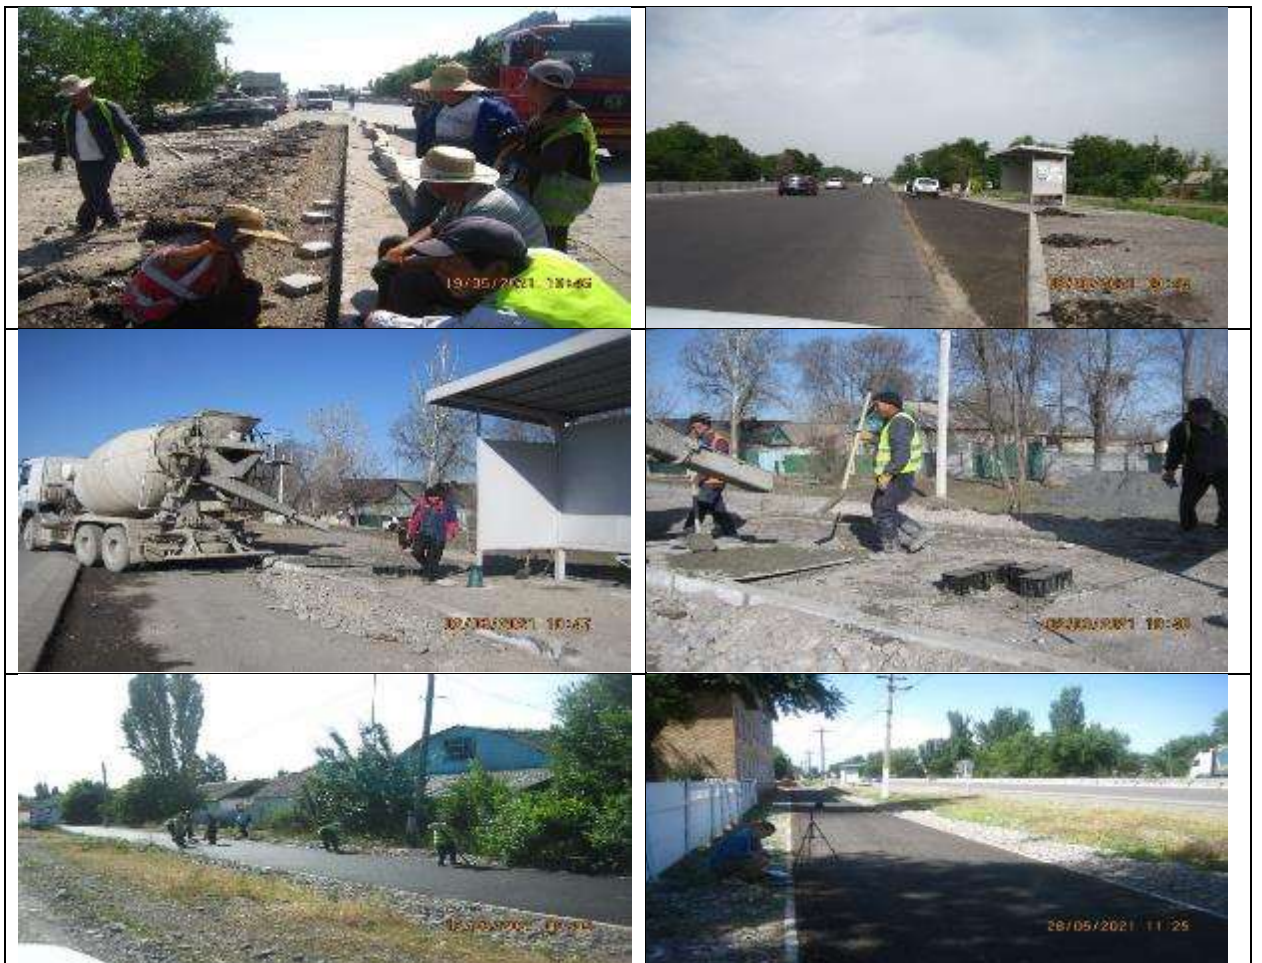
33. Also, work was carried out on the construction of bus stops, construction and asphalt laying of sidewalks, which included installation of curbs, preparation and asphalt laying.

Figure 7 Construction of bus stops and sidewalk

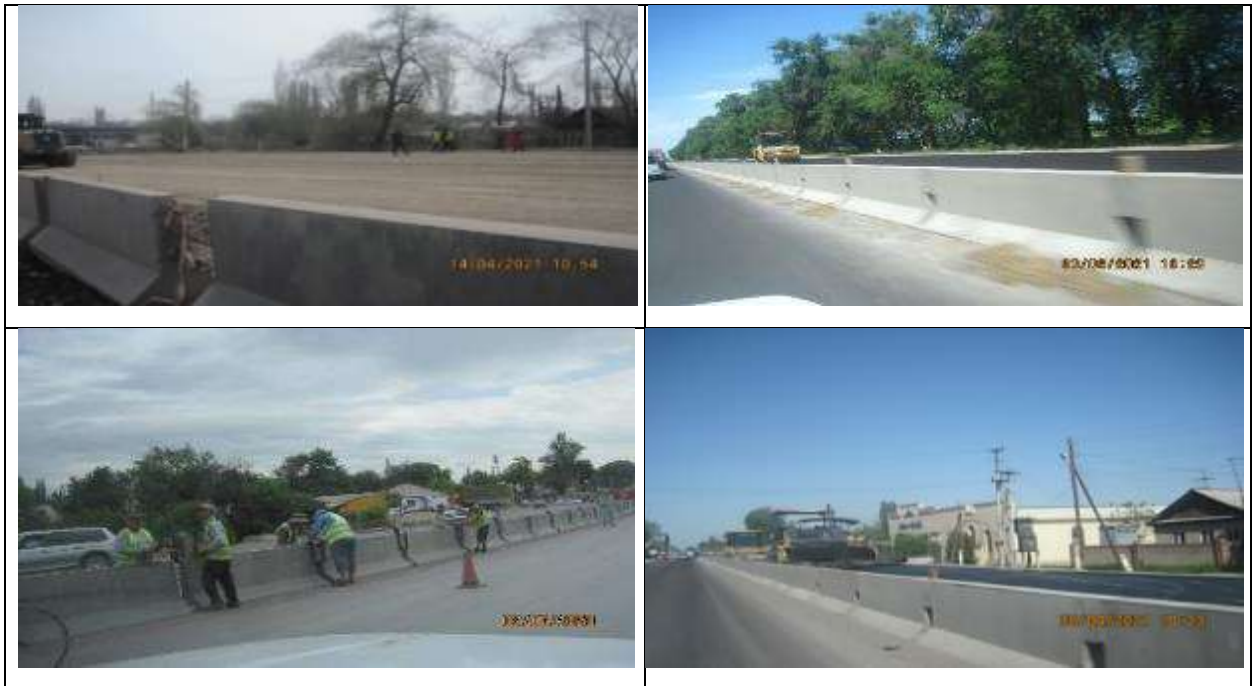
34. During the reporting period, work was also carried out on installation, cleaning and strengthening of "New Jersey" type parapets. Welding works, works on concreting of ditches on passages between parapets were carried out. Soil accumulated near the parapets was cleaned out and taken out.

Figure 8 Installation and strengthening of New Jersey type parapets

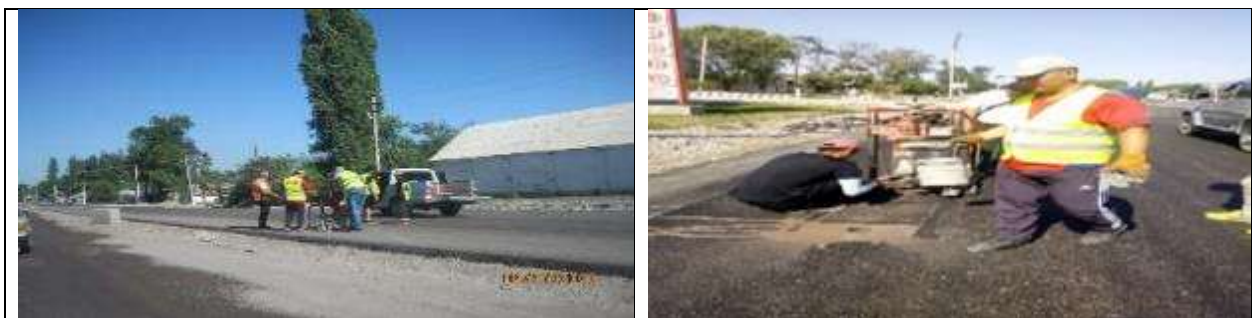
36. Inspectors monitored the performance of site trials on materials of wearing course, asphalt treated base and subgrade.

Figure 9 Sampling works for asphalt quality control

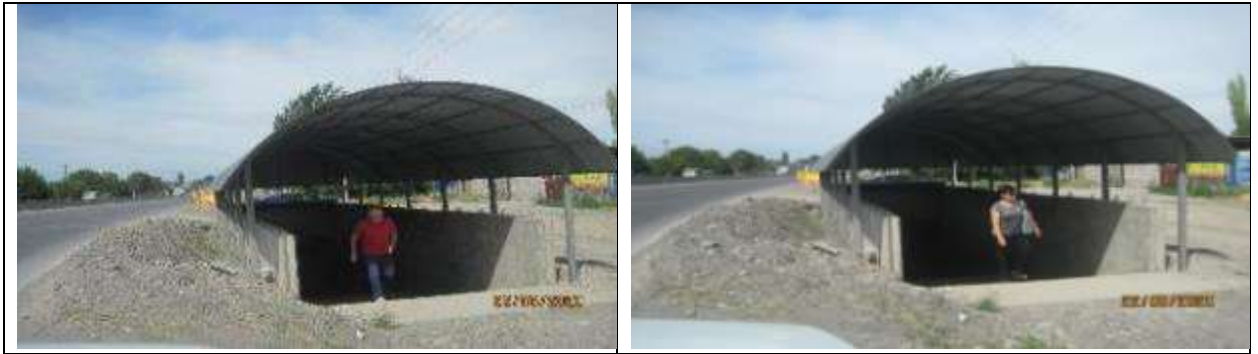
37. Currently, construction of five underground passages is almost completed. Now, adults and children are crossing the road through some underground passages, for this purpose temporary lighting was installed.

Figure 10 Construction and rehabilitation of underground passages

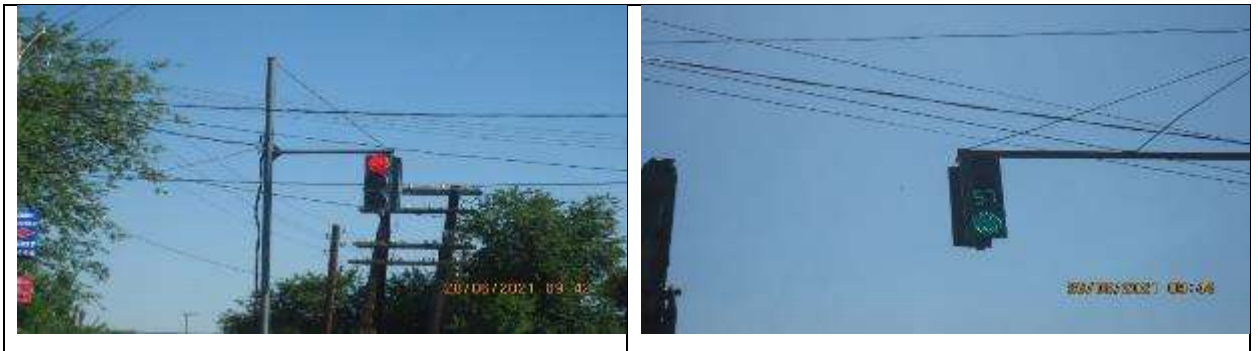
38. During the reporting period, installation of traffic lights has been started on the road section from km 15.9 to km 61.

Figure 11 Installation of traffic lights

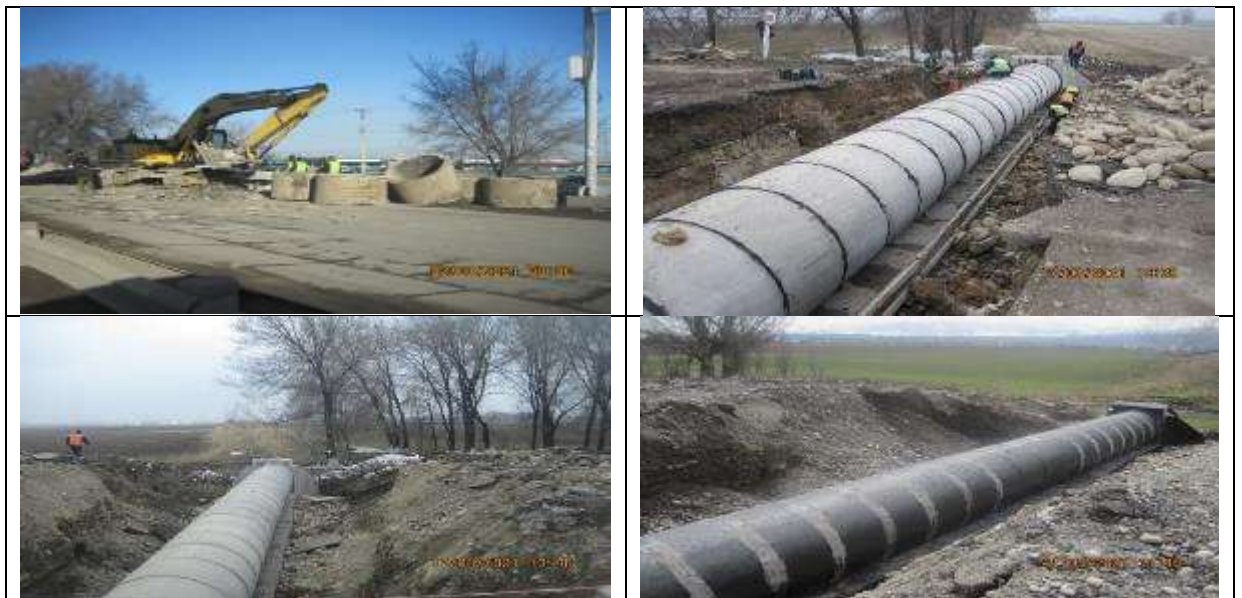
39. In the spring of 2021, at the road section from km 8.5 to 15.9 culvert replacement has been started.

Figure 12 Construction of culvert pipes

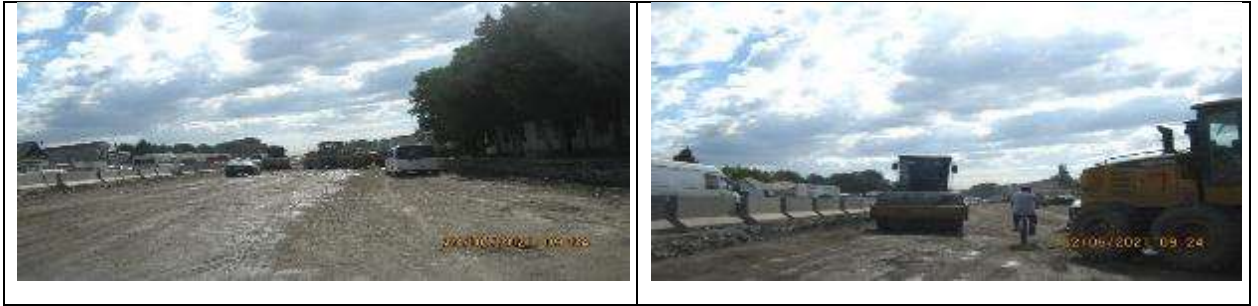
40. Given that this section of the road is overloaded with vehicles and there are no bypass roads, it was decided to remove the old asphalt and prepare for asphaltting alternately along three lanes. The work was started at section km 8 + 511 - km 8 + 800 (south side), the asphalt was removed on the first lane, excess unsuitable soil and old asphalt were removed, the soil was rolled and compacted. As directed by ADB, soil compaction work was carried out without vibration.

Figure 13 Rolling and compaction of soil at section KM 8+511 – KM 8+800

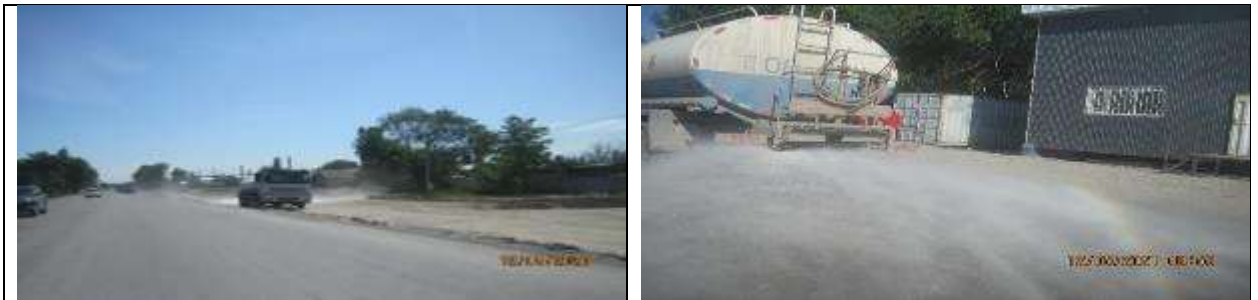
41. Dust control (water sprinkling) works were regularly carried out at all sections of the project road where construction work underway. Dust control works were carried out according to the agreed schedule to exclude dusting.

42. No complaints from the local residents about dust have been recorded so far.

Figure 14 Dust control works (water sprinkling)

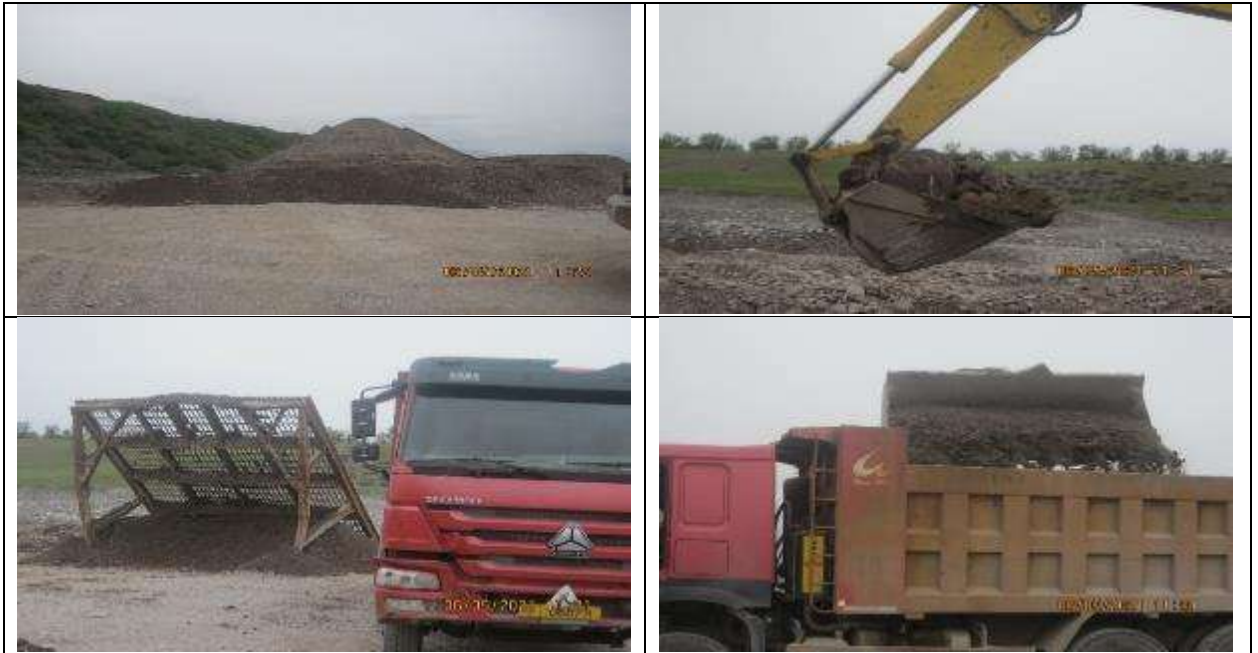
49. **Ak-Suu 2 borrow pit.** Currently, a large volume of inert materials has been accumulated at the borrow-pit, they were transported to the construction of a road on the territory of Moskovsky district, as well as to the territory of the production site for crushing and stockpiling.

Figure 15 Development of Ak-Suu 2 borrow pit

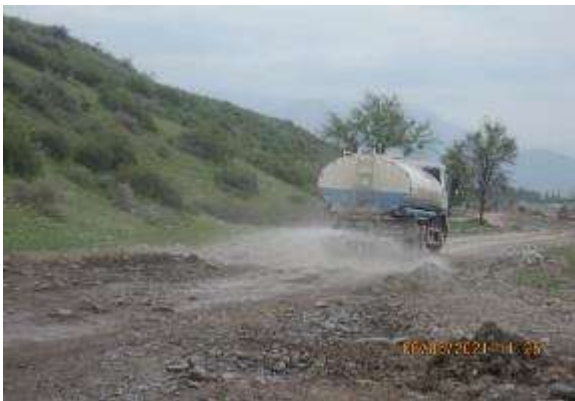
Figure 16 Water sprinkling on the road to Ak-Suu 2 borrow pit to avoid dusting

50. Access roads to the borrow pit are constantly wetted.

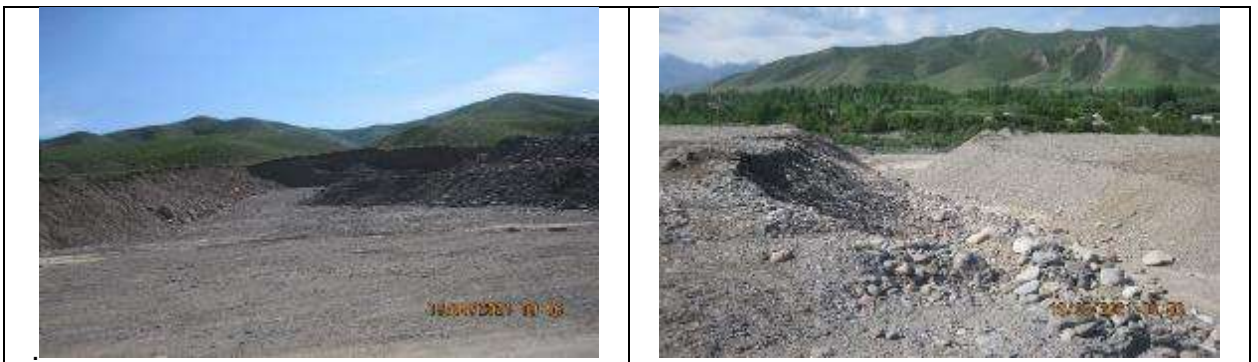
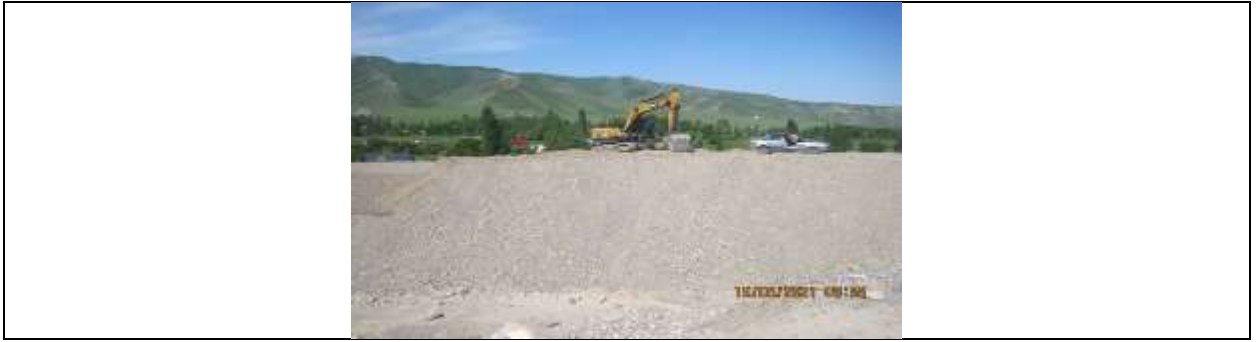
51. **Saz borrow-pit.** Currently, a large volume of inert materials has been accumulated at the borrow pit, which are being transported for the construction of a road in the Sokuluk district.

Figure 17 Development of Saz borrow pit

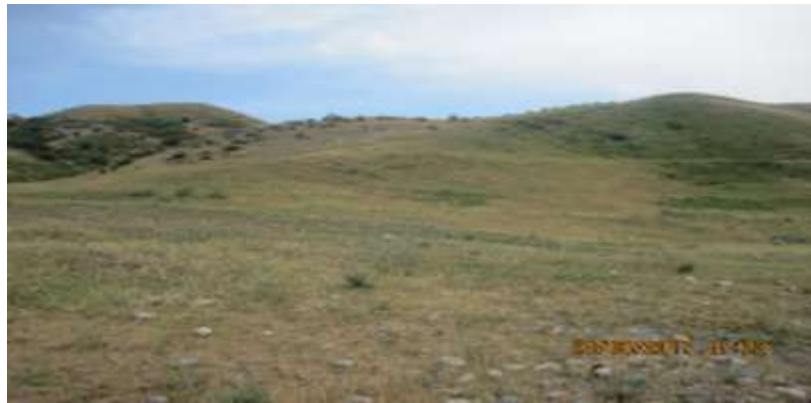
Figure 18 Jelamysh borrow pit before development

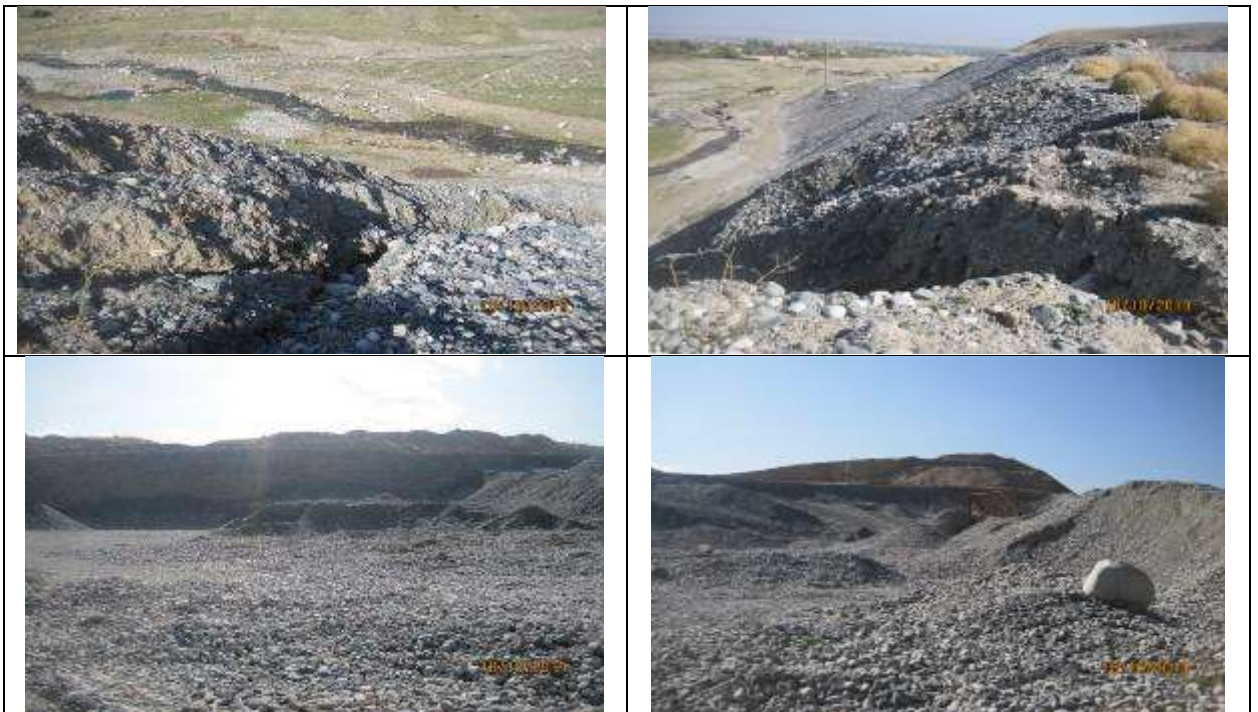
52. **Jelamysh borrow pit.** To date, reclamation of borrow pit work has been completed. The work was carried out according to the Borrow pit Reclamation Plan.

Figure 19 Jelamysh borrow pit after development

53. Reclamation works at the Jelamysh borrow pit were completed in early April. However, the contractor has not completed the formal handover of this site, and the reclamation completion certificate has not yet been signed. The district Commission conducted a visit to the Jelamysh borrow pit on June 14, 2021. Based on the results of the site inspection, the district commission found some problems with leveling the ground, which must be eliminated by the Contractor. The contractor expects to complete the levelling work by the end of July 2021. The commission's repeated visit for the acceptance of the reclaimed borrow pit is scheduled for July 23, 2021.

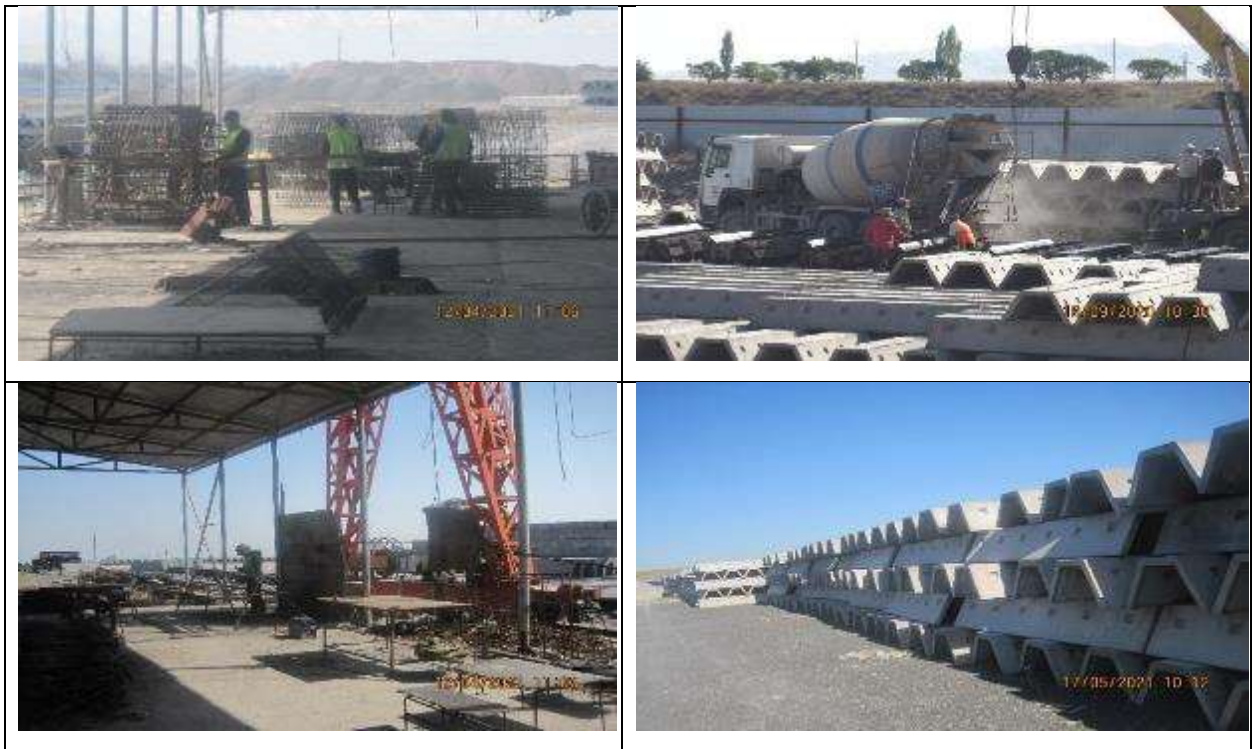
61. Various reinforced concrete products are manufactured for usage on the road (concrete rings, chutes, curbs, New Jersey type fences, etc.).

Figure 21 Production of reinforced concrete structures

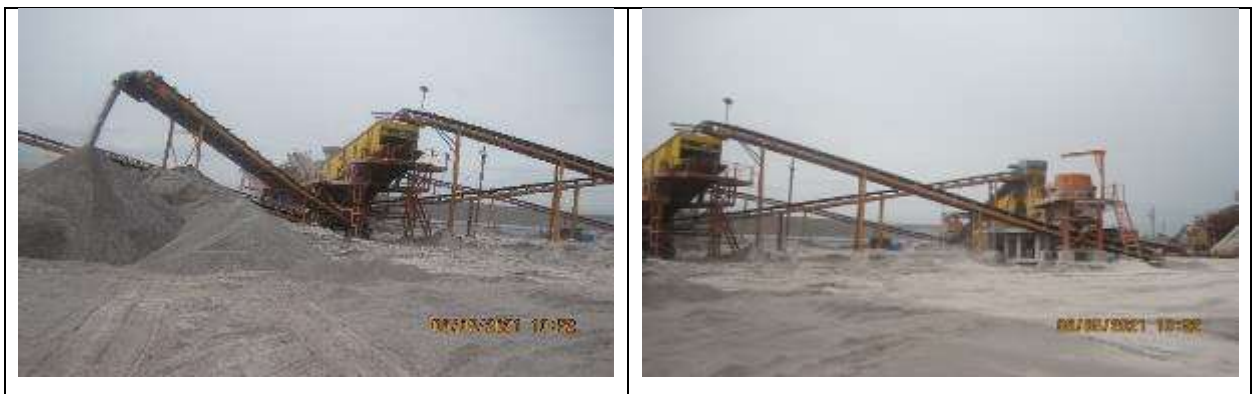
63. Raw materials for production of crushed stone and sand is delivered to the stone-crushing plant from Ak-Suu 2 borrow-pit by dump trucks. Crushing of raw material is carried out in crush lines of crushers. Water sprinkling should be done during the crushing, which reduces the emission of inorganic dust by 70%. Sieving is carried out with washing - on vibrocribble screens, transportation is carried out by belt conveyors.

Figure 22 Stone crushing plant

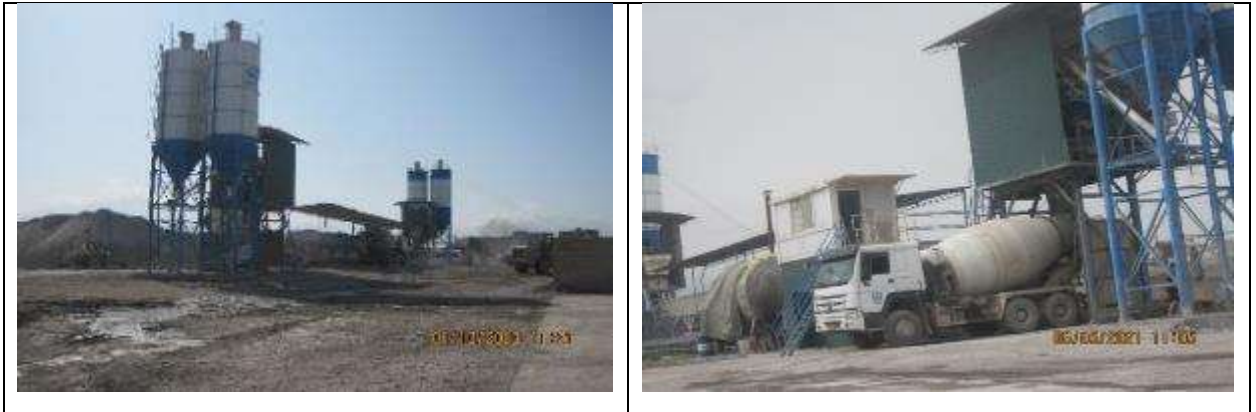
Figure 23 Concrete mixing plant

65. Washing of concrete mixers is carried out on a specially designated area. The flushing water is discharged into a special three-section sump. Further, the flushing water, after settling, is used for water-sprinkling the area of the production site.

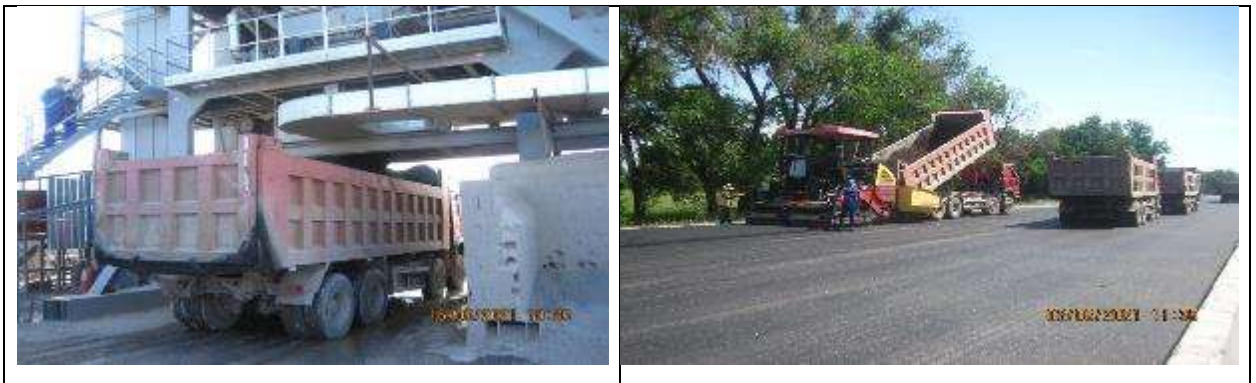
66. Asphalt mixture is prepared in forced mixing asphalt mixers with periodic action and preliminary drying, heating and dosing of mineral materials. The finished asphalt mixture is loaded into dump trucks and transported to road sections.

Figure 24 Loading of asphalt mixture into dump trucks and unloading into asphalt pavers

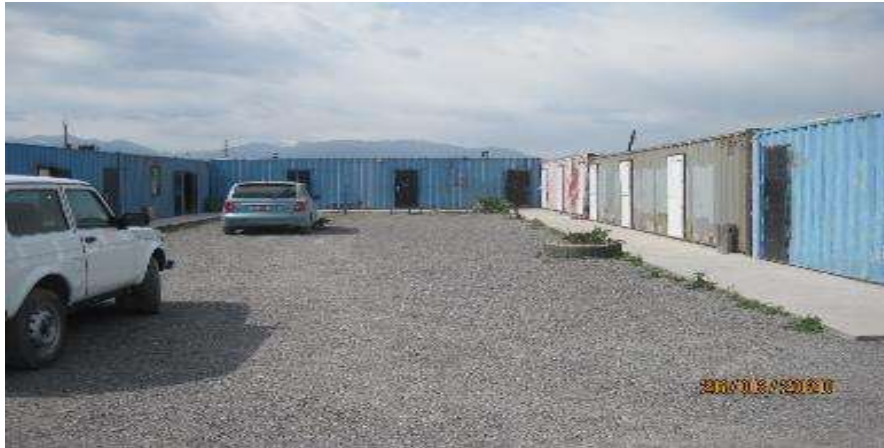
Figure 26 Workers ' accommodation camp on the territory of the production site

69. The worker's camp accommodates 50 people. Each room is designed to accommodate two workers. There are kitchen room, equipped place for eating, shower rooms, washbasins, toilets at the camp.

70. In the new camp sewage water is discharged into an existing septic tank by pipelines.

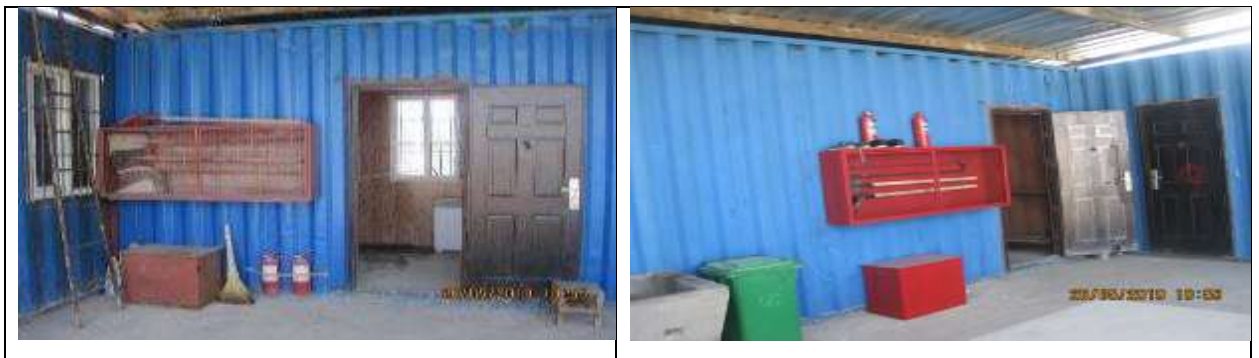
71. After a verbal warning concerning the need for a fire shield equipment, 2 shields were installed in the camp.

Figure 27 Fire shields on the territory of the camp

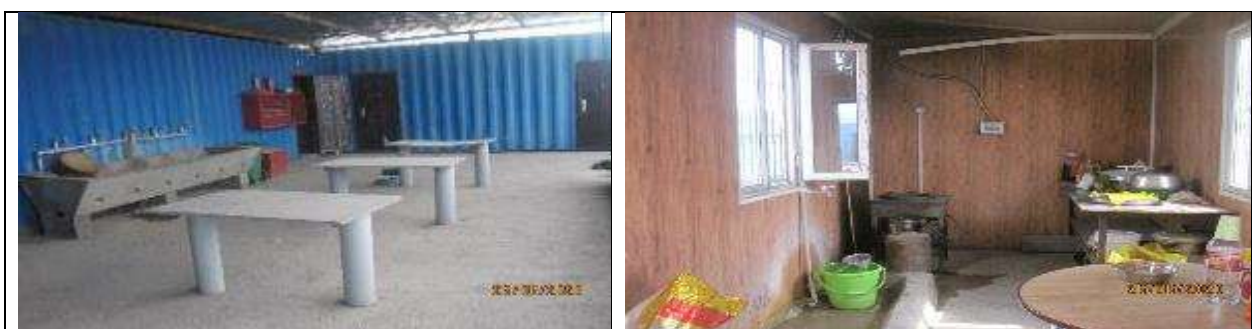
Figure 28 Dining and kitchen area

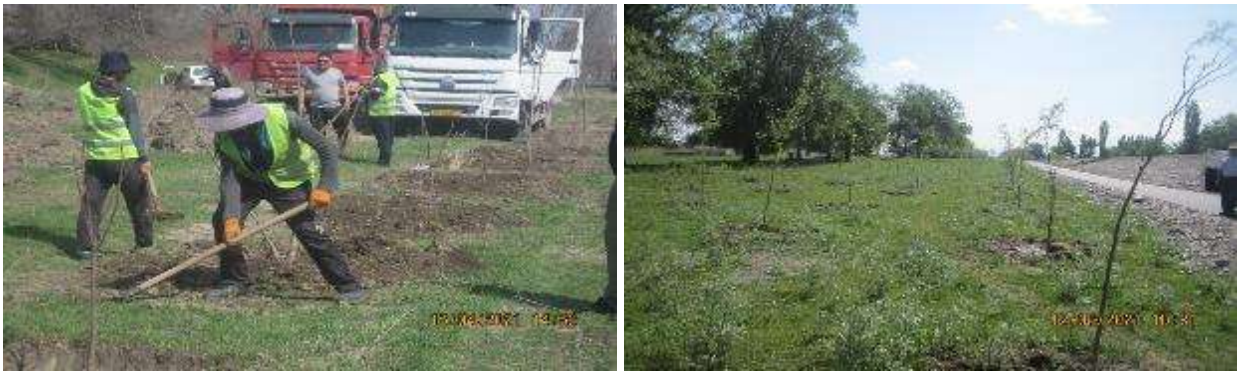
80. To date, 2245 have been planted. young seedlings: (in the autumn of 2019 - 300 pcs; in the spring of 2020 - 300 pcs; in the autumn of 2020 - 625 pcs; in March 2021 - 315 pcs; in April 2021 - 680 pcs.). Saplings of birch, willow (4 varieties), catalpa, honey locust, poplar were planted. Control and monitoring over the seedlings planting and watering, as well as monitoring of the survival rate of seedlings on an ongoing basis is carried out by the environmental specialists of the Construction Supervision Consultant, the contractor and representatives of MoTC KR.

Figure 29 Planting seedlings in the spring of 2021

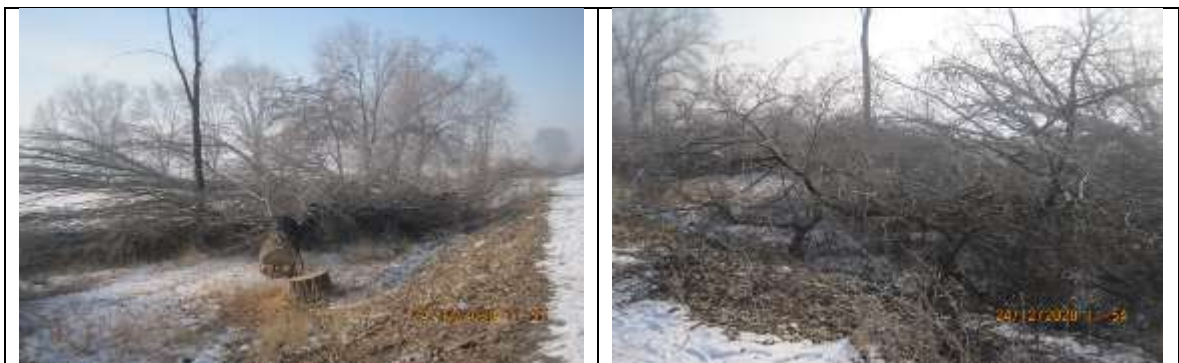
81. On the section of the road, km **8.5 -15.9**, initially 1000 pieces of trees were determined for demolition, which are located on the areas where road will be widened and areas where construction / restoration of sidewalks and drainage system will be carried out. However, this number will be updated as the road axis is completed.

Figure 30 Tree cutting on the road section km 8.5 - 15.9

84. On this section, after the completion of the main types of repair and construction work, considering the initially determined number of trees falling under the "forced cutting", it is planned to plant 2,000 new tree seedlings.

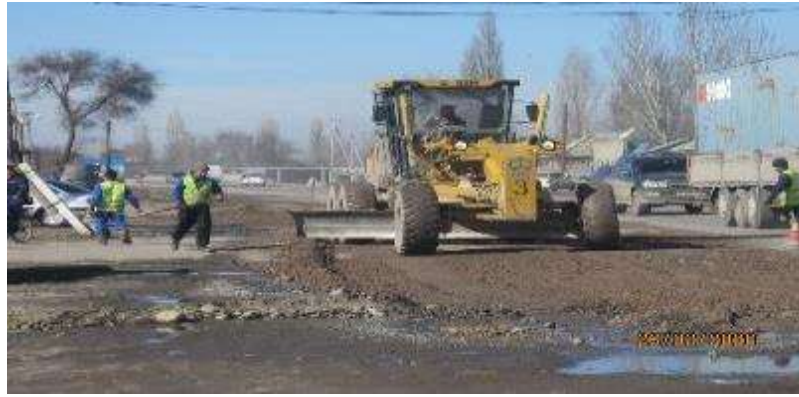
85. In the winter period of 2021, the Contractor carried out road maintenance work, including snow removal, winter slipperiness control, and anti-icing work. These works were aimed at ensuring the smooth and safe movement of vehicles.

Figure 31 Work in winter 2021

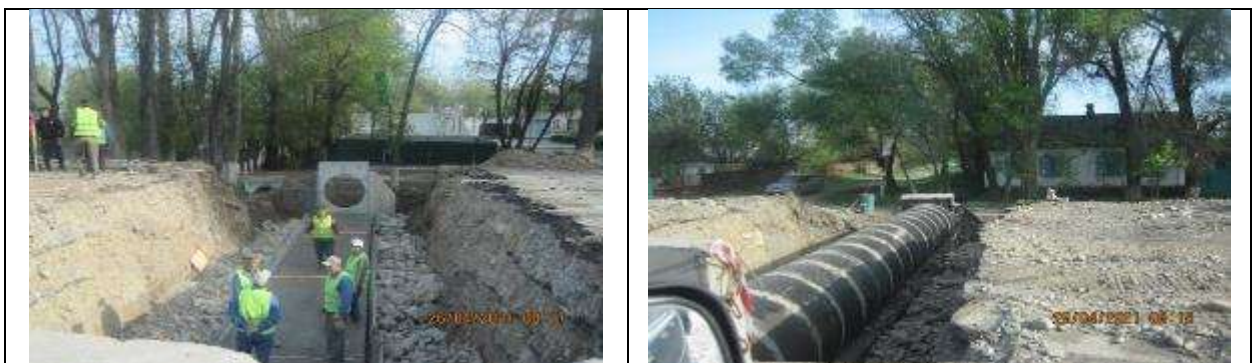
89. The contractor prepared Site-Specific Environmental Management Plan, that was approved in December 2021, after what a permission was obtained to carry out work on this section of the road. 321 trees were cut down. According to preliminary estimates, more than 1,000 trees are to be cut down. In the spring of 2021, culvert pipes replacement works has been started.

Figure 32 Laying of pipes at 7.4 km section

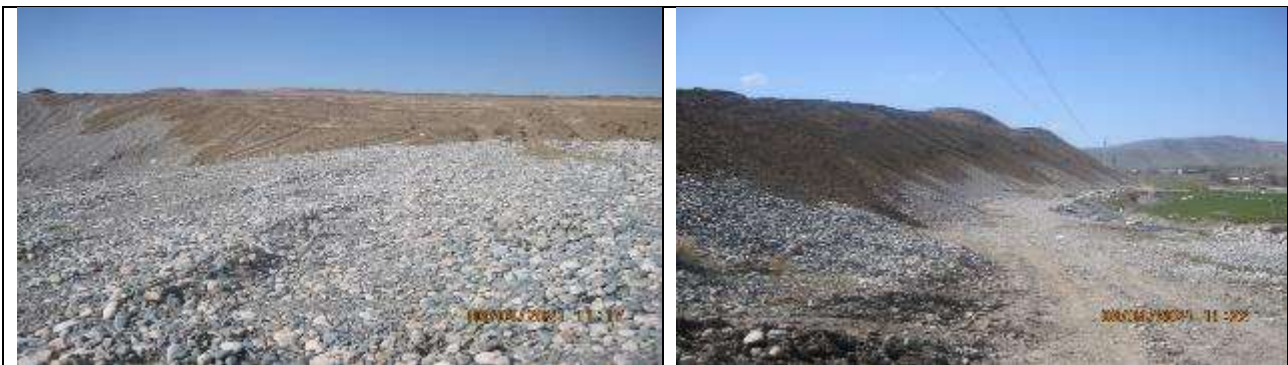
Figure 40 Jelamysh borrow pit after reclamation

126. **Jelamysh borrow pit.** Currently, work on the reclamation of the borrow pit has been completed.

127. The work was carried out in accordance with the Borrow-pit Reclamation Plan.

128. The hand-over Commission worked in June 2021. As a result of the work, some shortcomings were found, which are currently being eliminated by the Contractor. The second visit is scheduled for July 23, 2021. At present, the Ak-Suu1 and Kara-Balta borrow pits have been prepared for hand over to the reclamation Commission. The district commission for the acceptance of the Kara-Balta borrow pit plans to conduct visit on July 15, 2021 for inspection and acceptance.

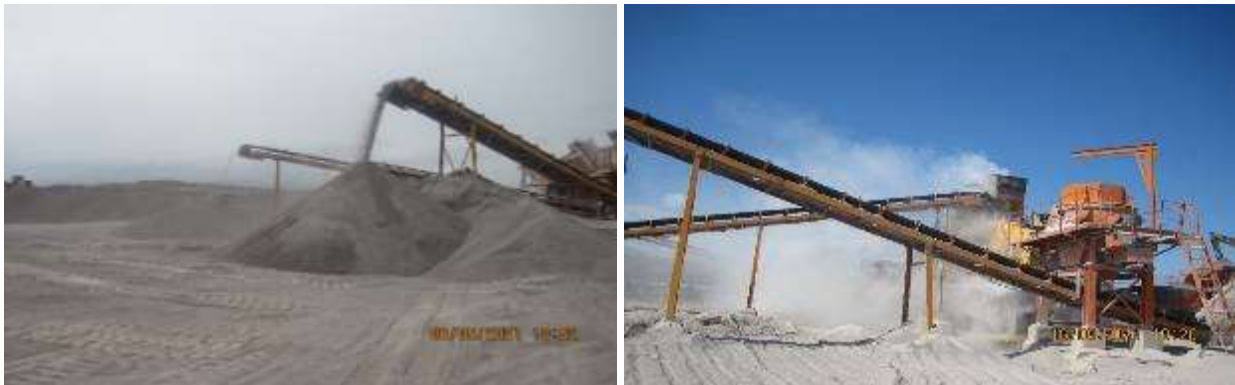
Figure 44 Operation of stone crushing plant

134. Considering that the material at the beginning of the year was wet due to atmospheric precipitation, there was no dusting when crushing the raw material. With the onset of the hot season, there were facts of dusting during the operation of the stone crushing plant. A letter was sent to the contractor to eliminate this violation. The contractor explains that dusting occurs when the plant is started up and that this is inevitable. The contractor has arranged water sprinkling around the stone crushing plant. Workers were provided with respirators.

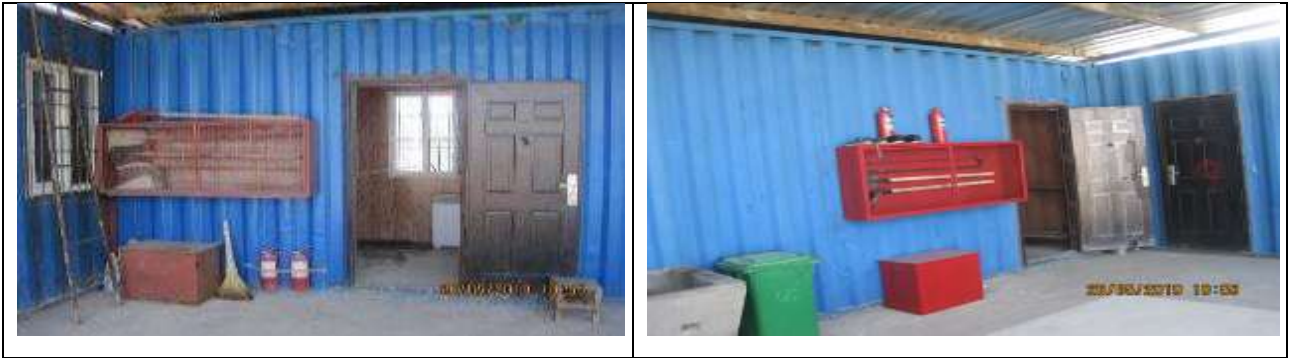
Figure 52 Fire shields on the territory of the camp

147. During monitoring in the workers ' camp, it was found that the fire extinguishers had become unusable, it was necessary to recharge or purchase new ones. It is necessary to fill the sand into the sand box on the fire panel.

148. Also, fire extinguishers are fixed on the sunny side of the living room, which is also unacceptable. Contractor was instructed that the fire extinguishers should be placed in an area protected from the sun in such a way that they are protected from direct sunlight. They can be installed on the floor, with mandatory fixation from a possible fall in case of accidental exposure. A letter was sent to the contractor with the specified deadlines for eliminating the detected violation. The contractor replaced unusable fire extinguishers, the box on the fire shield is filled with sand.

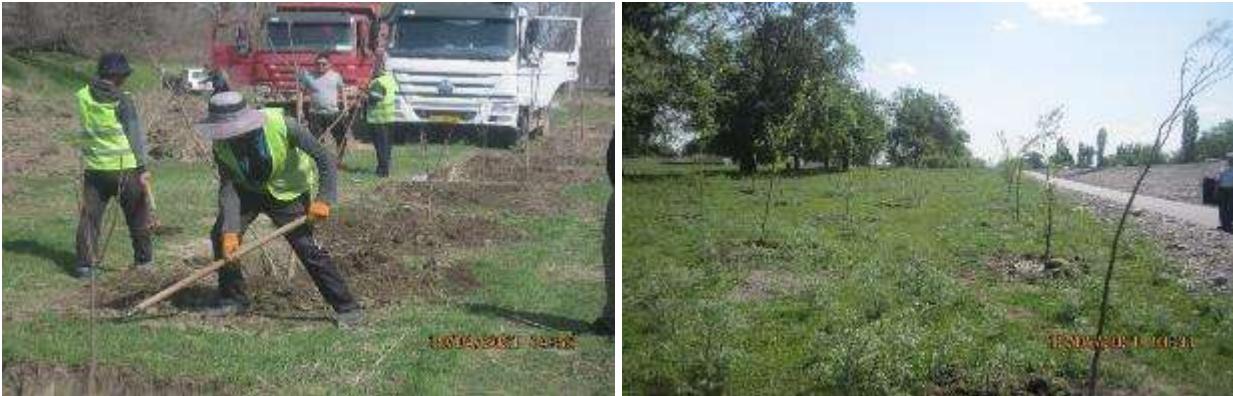
Figure 57 Planting of seedlings in the spring of 2021

162. To date, in total, 2,245 seedlings have been planted.

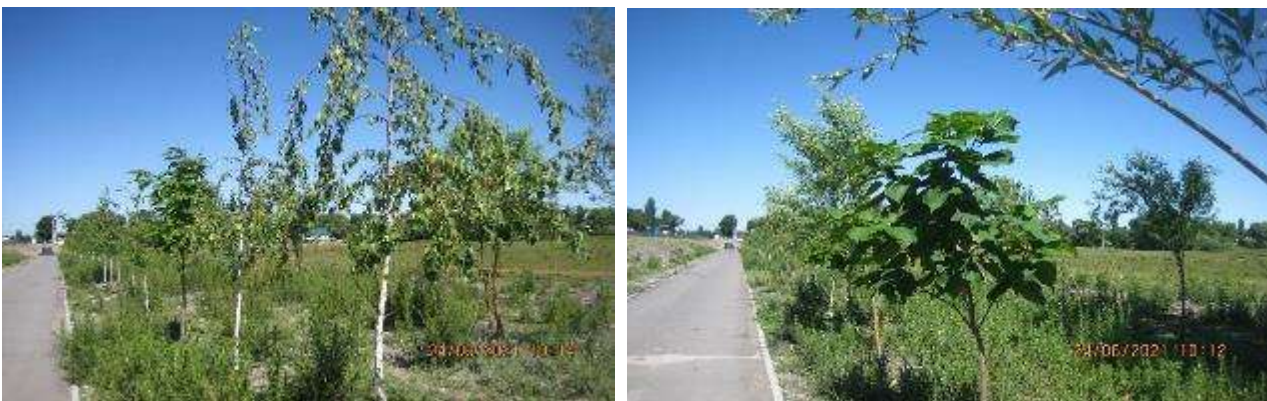
Figure 58 Seedlings planted in 2020

167. Visual monitoring allows us to conclude that the planted seedlings have taken root and are in a satisfactory condition. We would like to note that there are facts of "damage" of the planted seedlings, this is the scrapping of the planted seedlings, some facts of theft by unidentified persons, uncontrolled grazing of domestic animals that eat young shoots. On this issue, MoTC applied to the Local Self-Government Bodies in order to carry out explanatory work among the local residents, since it will be impossible to restore the number of green spaces without the support of local self-government bodies

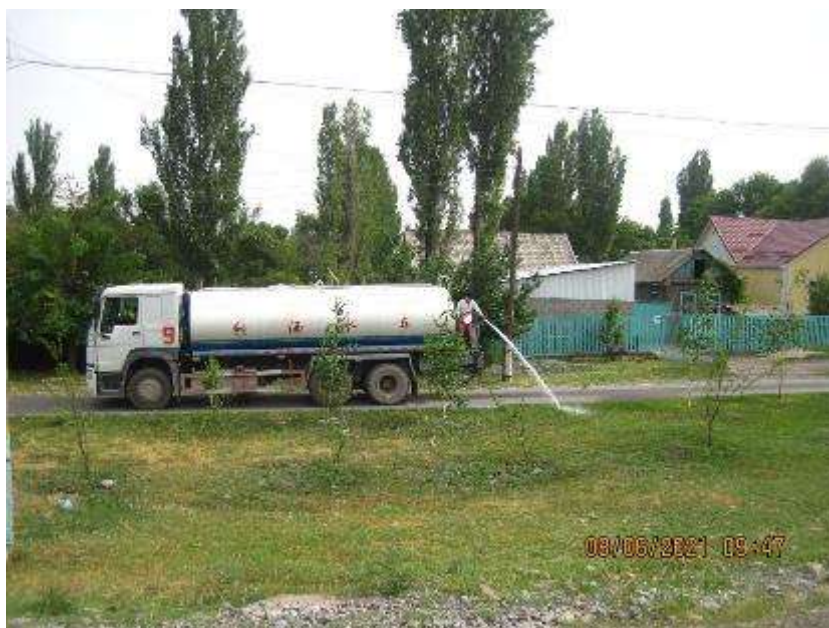
Figure 60 Watering of seedlings

169. During the reporting period, given the high air temperature, regular and abundant watering of seedlings is necessary. For watering seedlings, the Contractor has allocated a watering machine which will be used for seedlings watering only.
