Semi-annual environmental monitoring report

Project number: 45169-001
Loan number: ADB Loan 3056-KGZ (SF)
Grant number: 0366-KGZ (SF)

January – June 2021

KGZ: Central Asia Regional Economic Cooperation
Corridor 3 (Bishkek -Osh Road) Improvement
Project, Phase 4

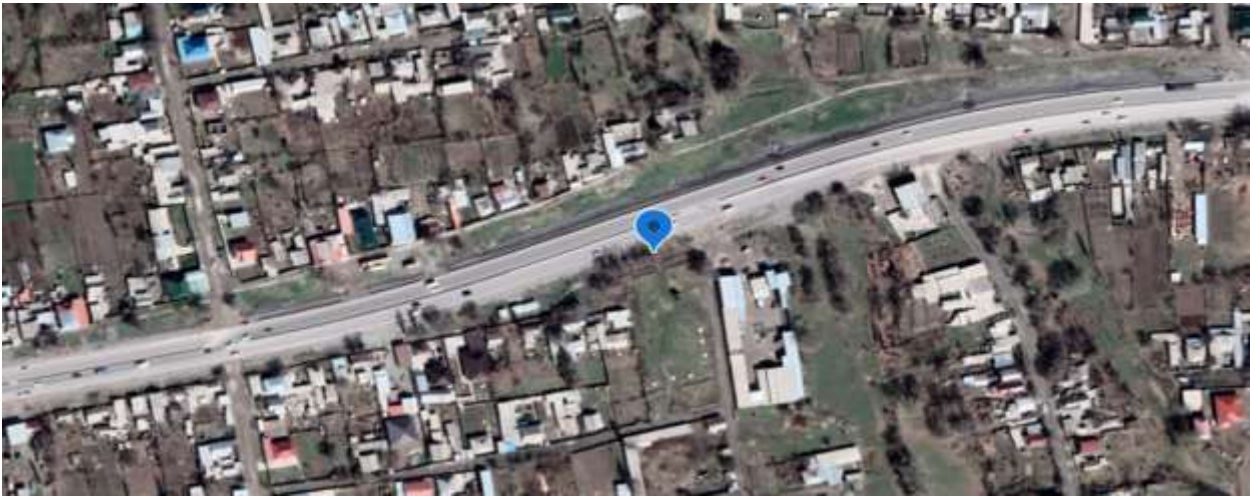
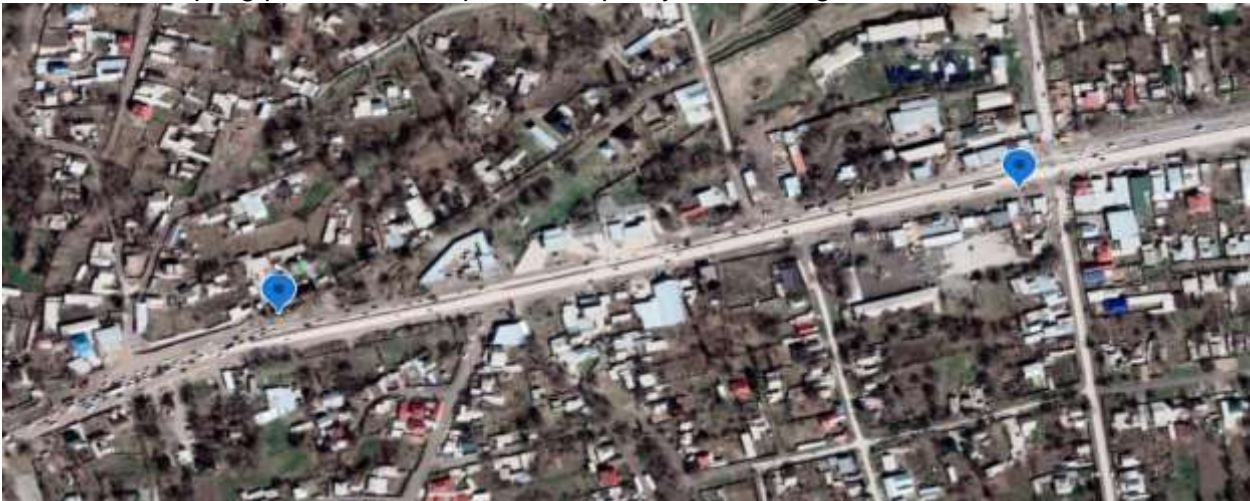
Atmospheric air quality sampling points in Sokuluk village, 23+760 km, 24+360 km
 Figure 61 Sampling points of atmospheric air quality in the places of work of construction equipment at the road section km 15.9 by km 61.

182. **Conclusion:** According to the test results, in the selected atmospheric air samples, the maximum permissible concentration of nitrogen dioxide exceeded by 1.2-1.3 times.

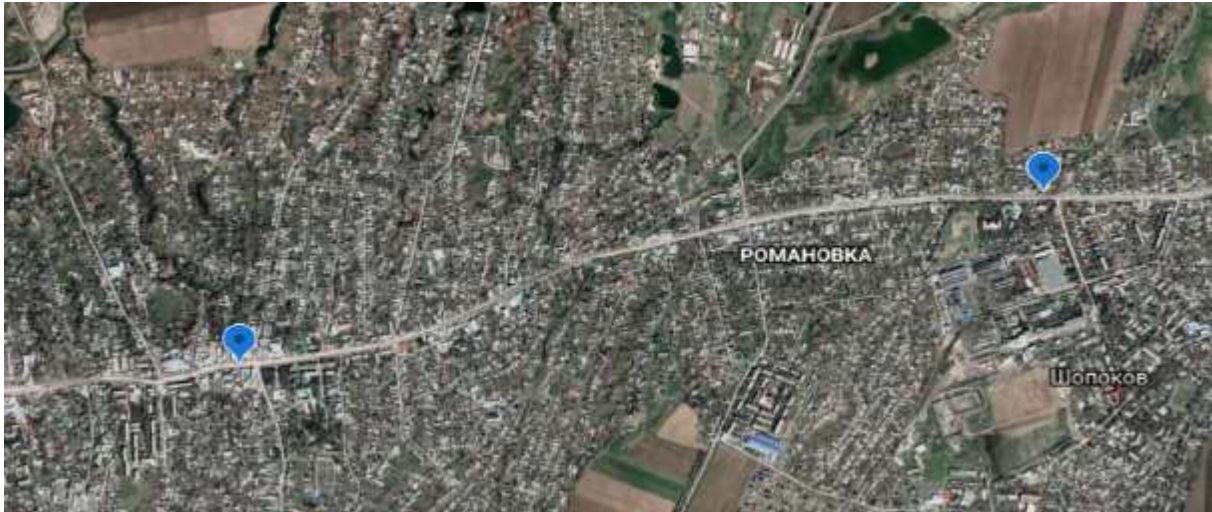
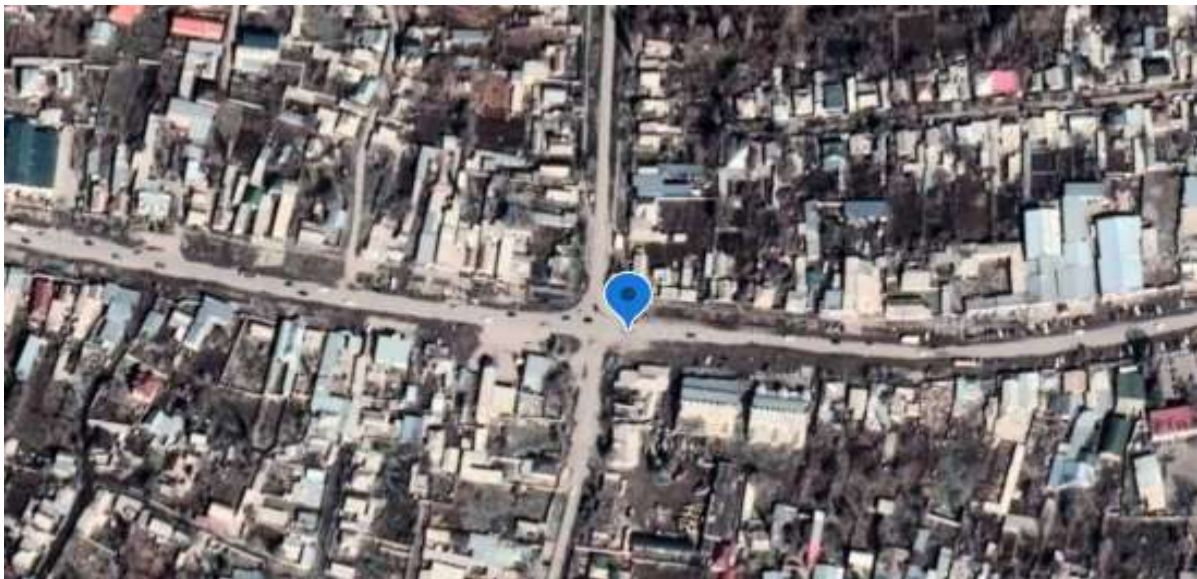
Figure 63 Noise and vibration measurement points on the road section km 15.9 by km 61

193. Conclusion based on the results of the measurements: at the time of the measurements, the background noise level at the measured points when moving vehicles near the road was 70 dBa in the daytime. In the operating mode of the Contractor's equipment, the noise level exceeded the sanitary norm from 1 dBa to 7 dBa, when the equipment was turned off, the noise level exceeded the sanitary norm to 1 dBa, in the Sokuluk, near the market 25+935 km, south side of the road.

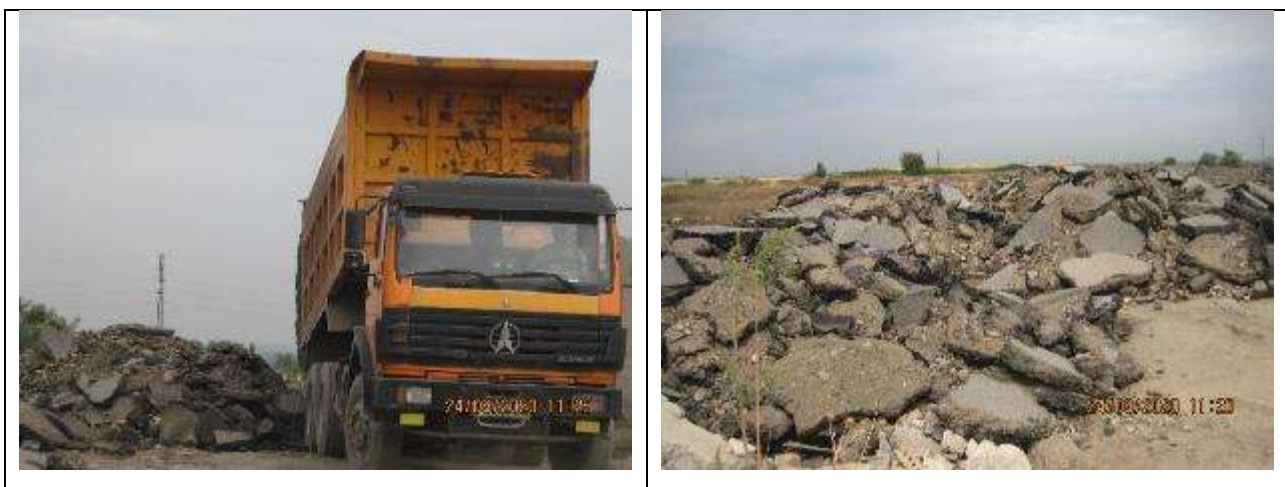
Figure 70 Dumping of old asphalt on designated sites for further use in the Romanovka

225. There were no complaints from the local residents regarding the disposal of the removed asphalt. Currently, the removed asphalt, in agreement with local administrations, is transported and stacked in dumps at the indicated sites.

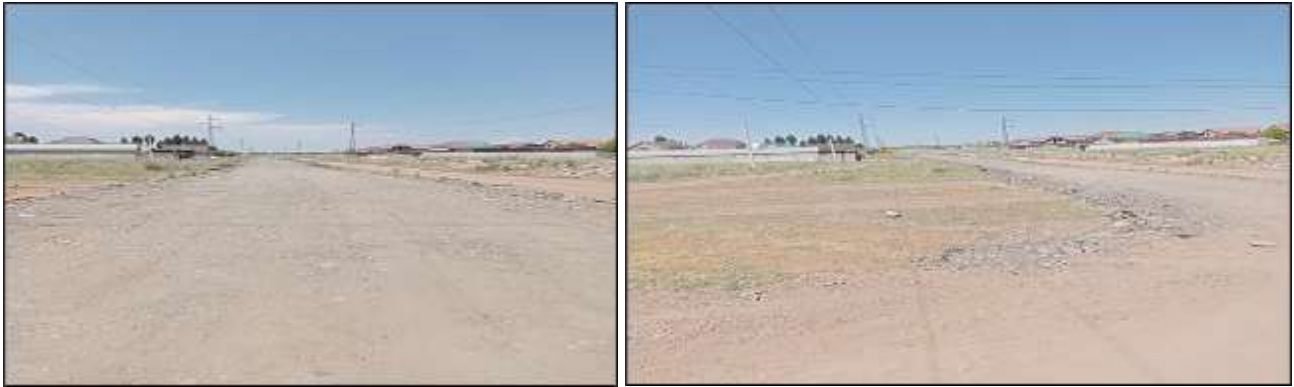
Figure 71 Removal of old asphalt to the territory of the "Altyn Ordo" residential area at the request of residents and representatives of local government

Also, the removed asphalt was taken out to improve the internal roads of the entire residential area "Altyn Ordo".

228. The problem of crushing old asphalt remains unresolved. Since the villages do not have equipment for leveling large pieces of old asphalt, the Contractor level it with its own equipment. The issues of disposal of old asphalt at the 7.4 km section are handled by the Contractor's specialist Koichumanov Adilet.

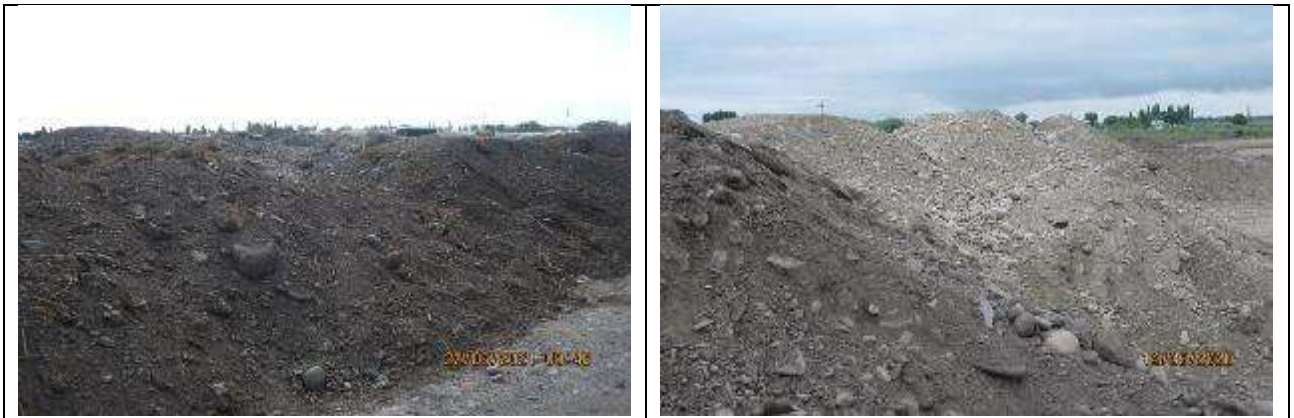
230. Soil unsuitable for the construction of the road is also removed to the sites provided by the local authorities.

Figure 72 Storage of unsuitable soil for further use

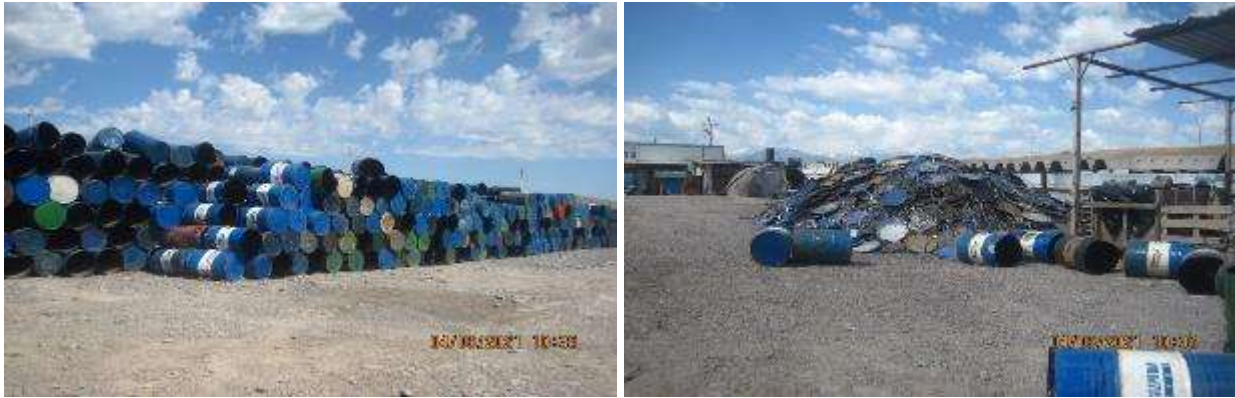
231. Production waste is also generated during road construction. This is used engine oil, old tires, empty bitumen barrels. According to the Contractor's information, the used oil is reused in the operation of some types of equipment, the rest is handed over to a local company for further processing. On the territory of asphalt plant, waste is generated during the production of asphalt. These are mostly empty barrels of used bitumen. In June 2021, a large number of used barrels and metal lids from barrels that need to be disposed of were accumulated on the territory of asphalt plant. According to the Contractor, empty barrels, not crumpled during use, are partially used during construction works on the road, part of the barrels will be used for the needs of the Contractor, mostly barrels are disposed of for scrap metal. A letter was sent to the contractor indicating the terms of disposal of empty barrels and lids. The barrels were removed on time.

Figure 73 Empty barrels and lids from bitumen

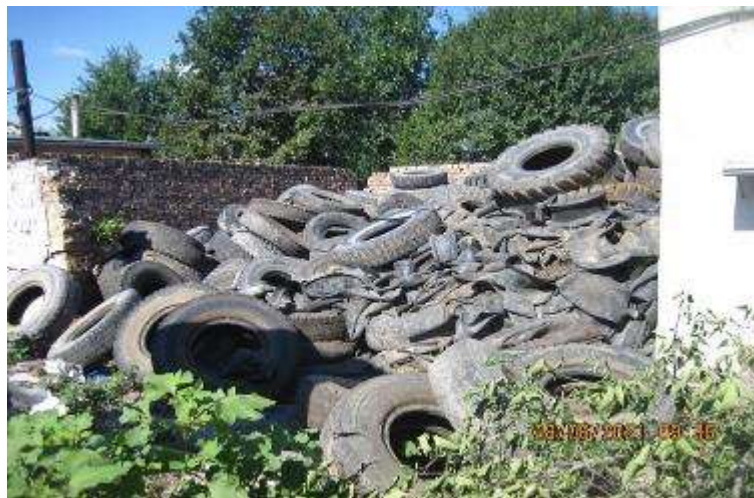
Figure 74 Old car tires in the Belovodskoe

232. On the territory of the base in the Belovodskoe, a large number of old car tires are stored. Contractor took measures to remove and dispose of them. Currently, the base area is cleared of all waste.

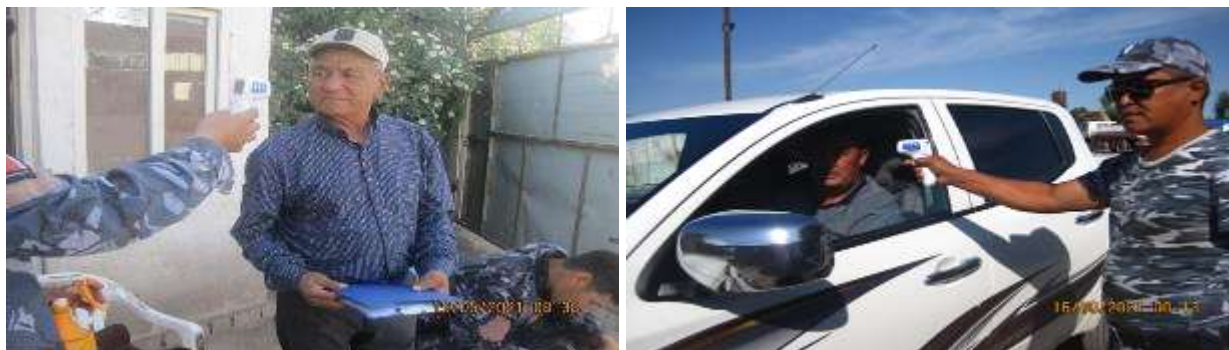
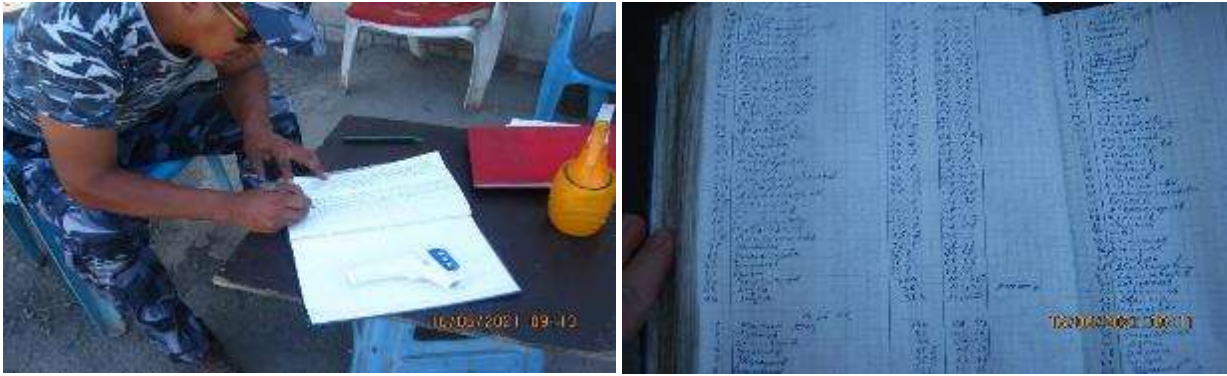
Figure 75 Temperature measurement and registration in the log at the entrance to the base in Sokuluk
