# Semi-annual environmental monitoring report

July - December 2021

Central Asian Regional Economic Cooperation Corridor 3 Improvement Project (Bishkek-Osh road), Phase 4, Bishkek-Kara-Balta section (km 8.5 - km 61).

**Prepared by:** Joint Venture Temelsu International Engineering Services Inc., E.Gen Consultants Ltd., and Desh Upodesh Ltd. in association with Kyrgyz TREC International, Ltd. for the Ministry of Transport and Communications of the Kyrgyz Republic and the Asian Development Bank

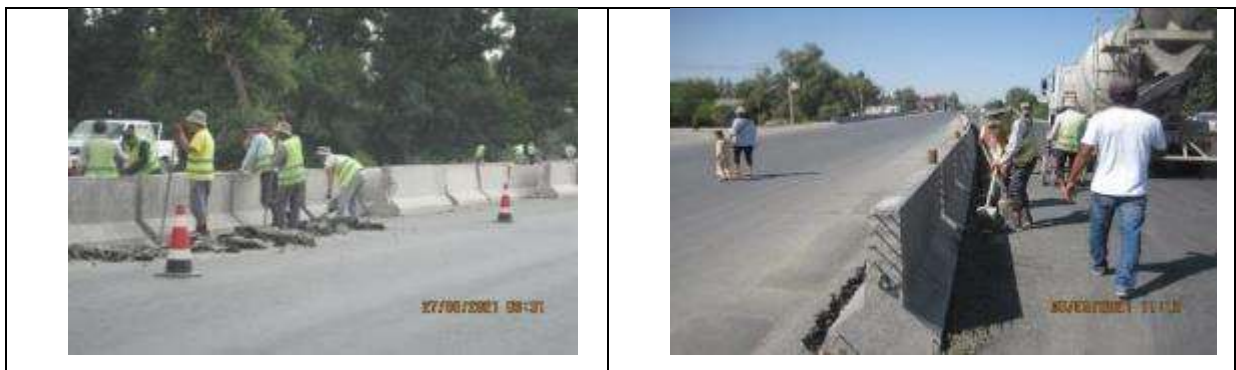
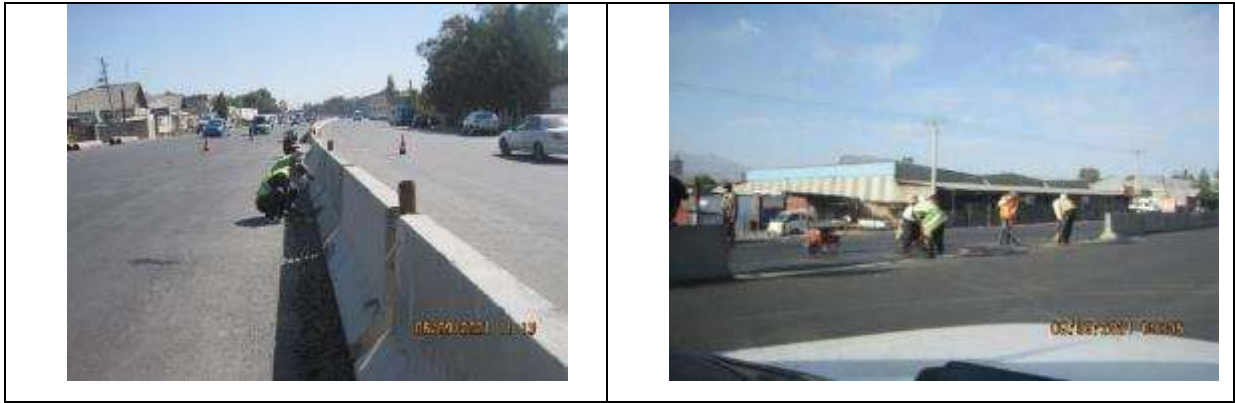
37. During the reporting period, work was also carried out on the installation, cleaning and strengthening of "New Jersey" type parapets. Welding works, work on concreting of ditches on the carriageway between parapets were carried out.

Figure 13 Works on concreting of ditches on the carriageway between the parapets.

111. Work on the installation, cleaning and strengthening of parapets of the "New Jersey" type included welding work, work on concreting ditches on the carriage way between the parapets. During the monitoring, it was found that on the road shoulders, where work was carried out to strengthen the parapets, there were not removed soil waste, stored in the form of small piles. Under the impact of atmospheric precipitation, the waste was eroded and polluted the surrounding area. A letter was sent to the contractor indicating the timing of the elimination of this violation. In due time, the soil waste was collected from the shoulders and removed. In the future, the soil accumulated near the parapets was cleaned and removed in a timely manner.

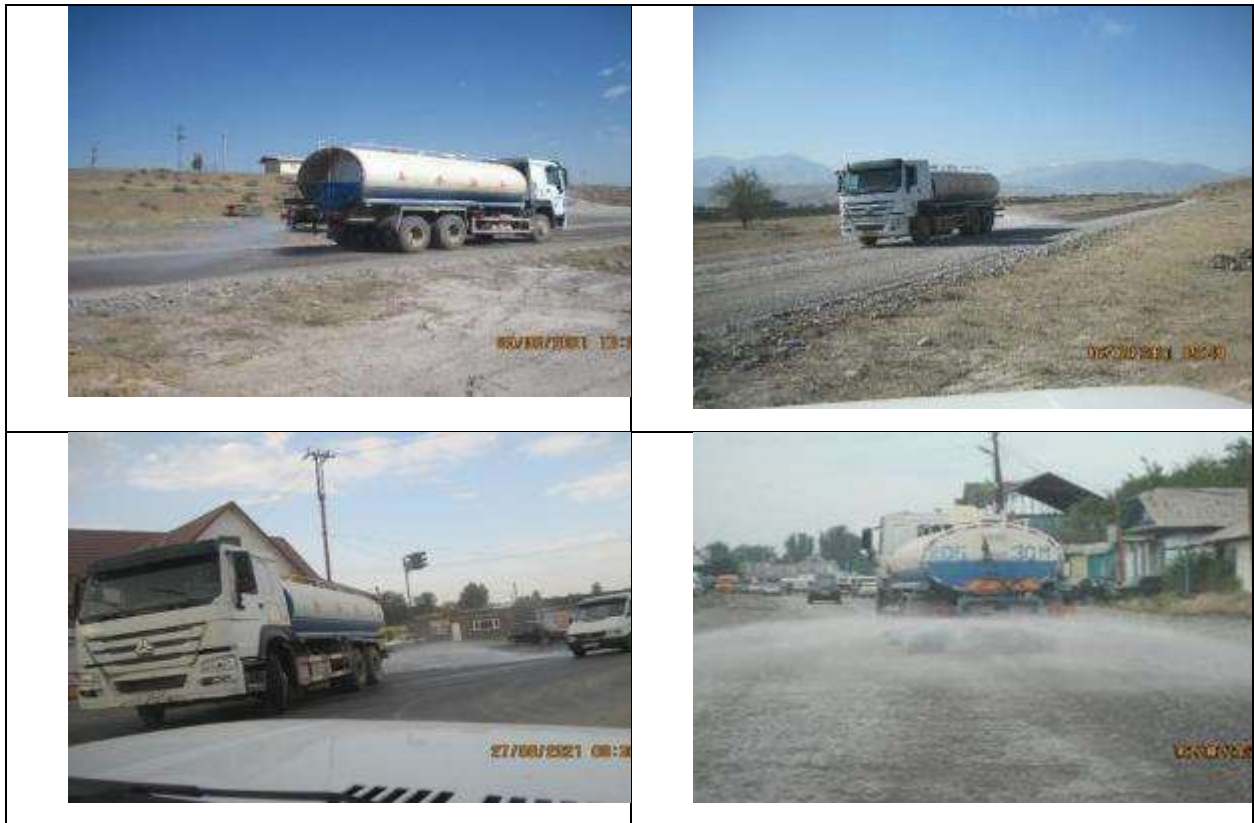
46. On all sections of the project road where construction work was carried out, dust suppression (water sprinkling) works were regularly carried out. Dust control works were carried out according to an agreed schedule to eliminate dusting. There were no complaints from the local population about dust formation to date. Dust control was also regularly carried out on the access road to the Ak-Suu2 borrow pit and on the territory of the production sites.

Figure 23 Water sprinkling works. Road to the Ak- Suu 2 borrow pit and at the construction site in the Sokuluk village.

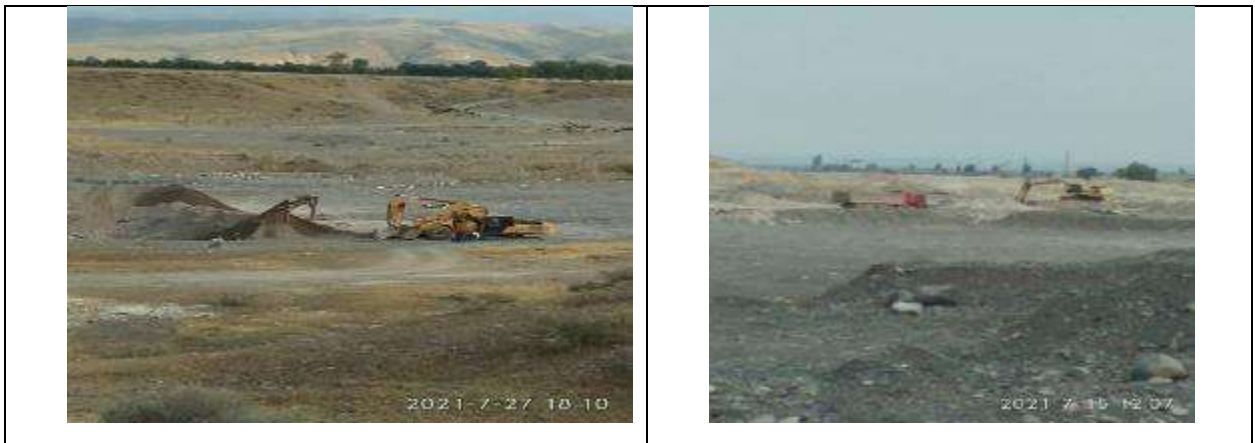
54. During the reporting period, work was carried out on the leveling of used areas at the Ak-Suu 2 borrow pit.

Figure 25 Leveling of used areas at the Ak-Suu 2 borrow pit

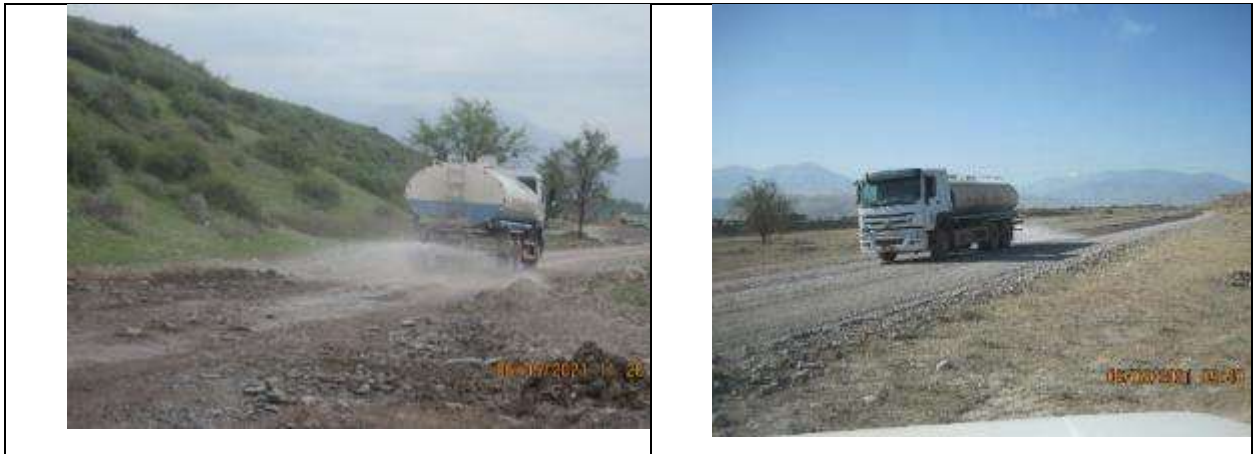
55. Access roads to the borrow pit are constantly wetted.

Figure 26 Water sprinkling on the road to Ak-Suu 2 borrowpit to avoid dusting.

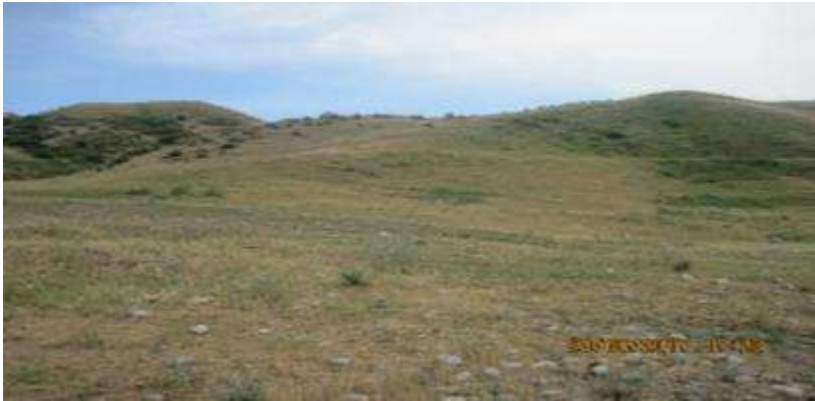
Figure 29 . Jelamysh borrow pit before development

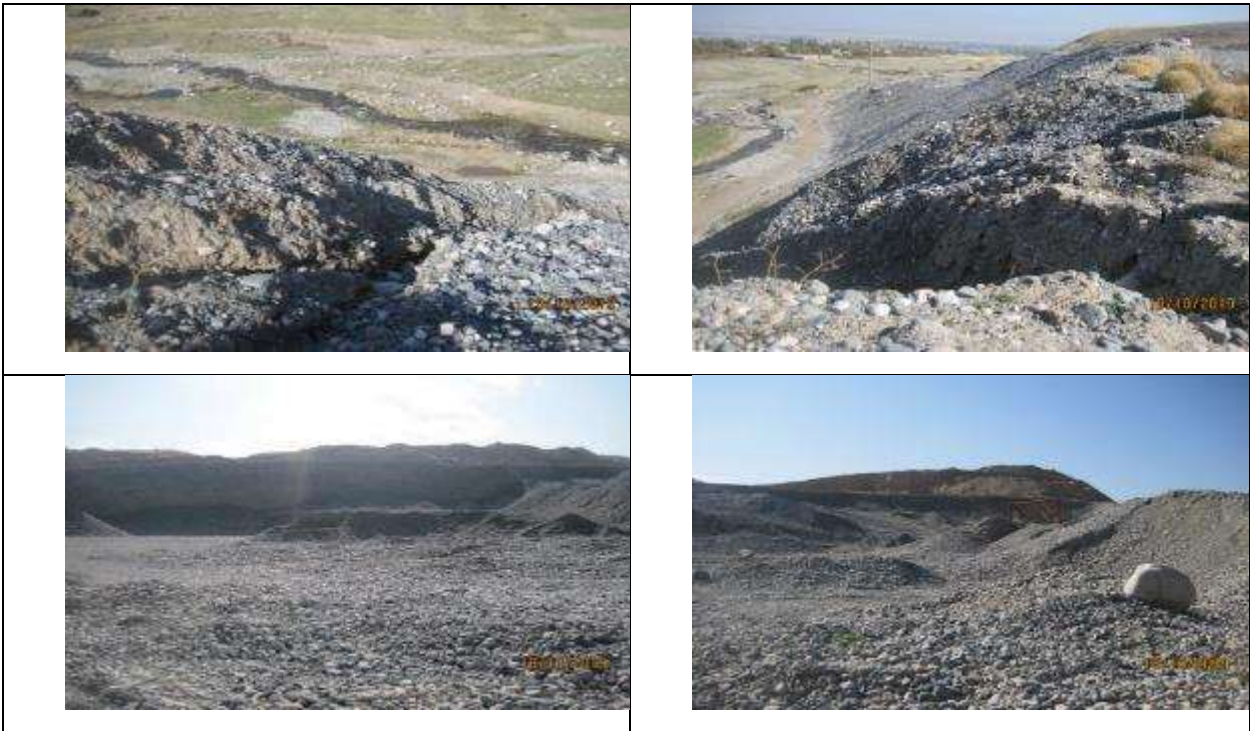
Figure 30 Jelamysh borrow pit after development.

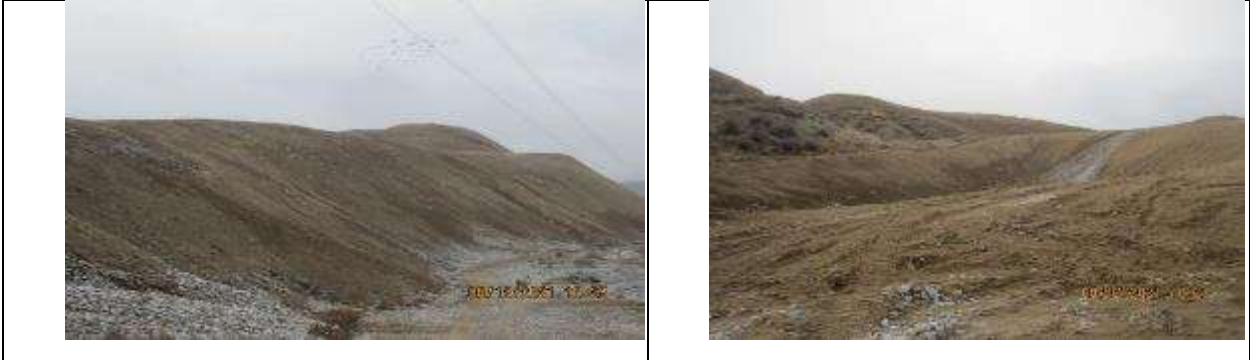
58. **Jelamysh borrow pit.** Currently, the reclamation of the borrow pit has been completed. The work was carried out in accordance with the Borrow-pit Reclamation Plan.

59. Handover of the reclaimed borrow pit to the Commission was conducted in June 2021. The Commission specified some shortcomings that for the date were eliminated. It was needed to additionally level the road to the borrow pit. The main reason for the delay in the Commission's work was some replacements in the commission membership. Currently, the new membership of the Commission has been approved and it is planned that the commission will continue its work

in January 2022. The contractor plans to complete the handover of Jelamysh borrow pit by mid-February 2022.

Figure 31 . Jelamysh borrow pit after the completion of reclamation works.

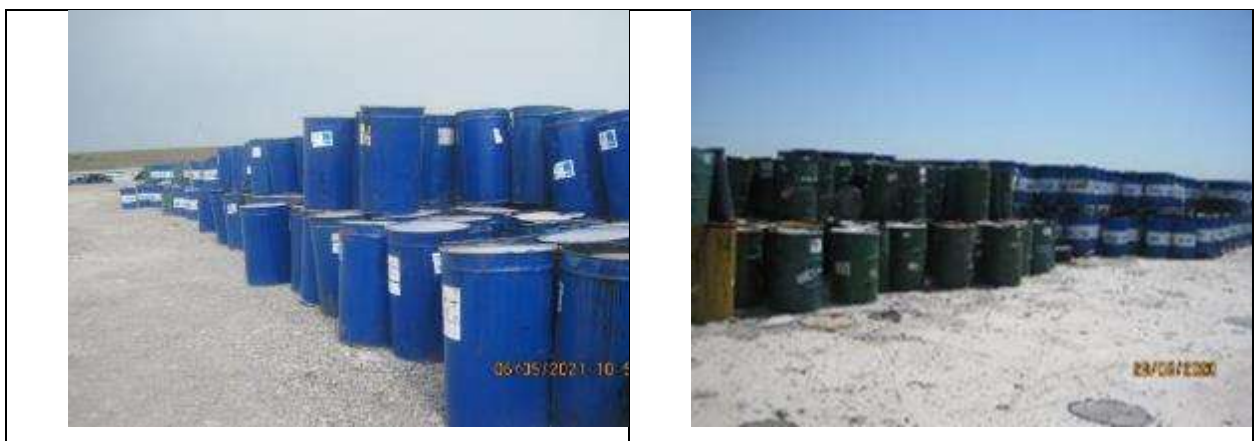
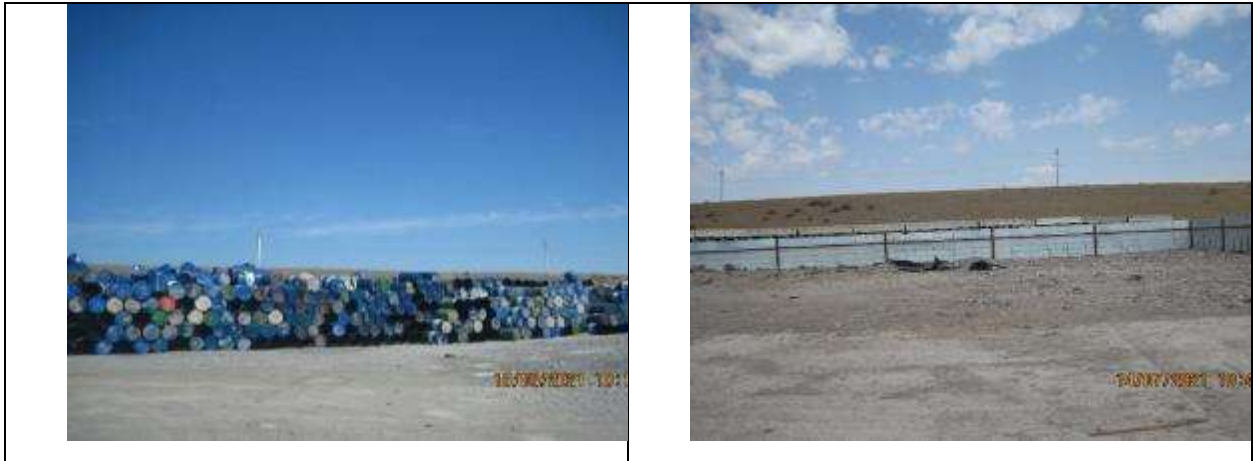
68. To prepare the asphalt mixture, a large number of barrels with bitumen were delivered to the production site, which were partially placed on a specially prepared area. A large number of barrels were installed on the ground, partially covered with waterproofing material.

Figure 38 Barrels of bitumen on a special prepared site. Empty barrels after use and a storage area after the removal of used barrels

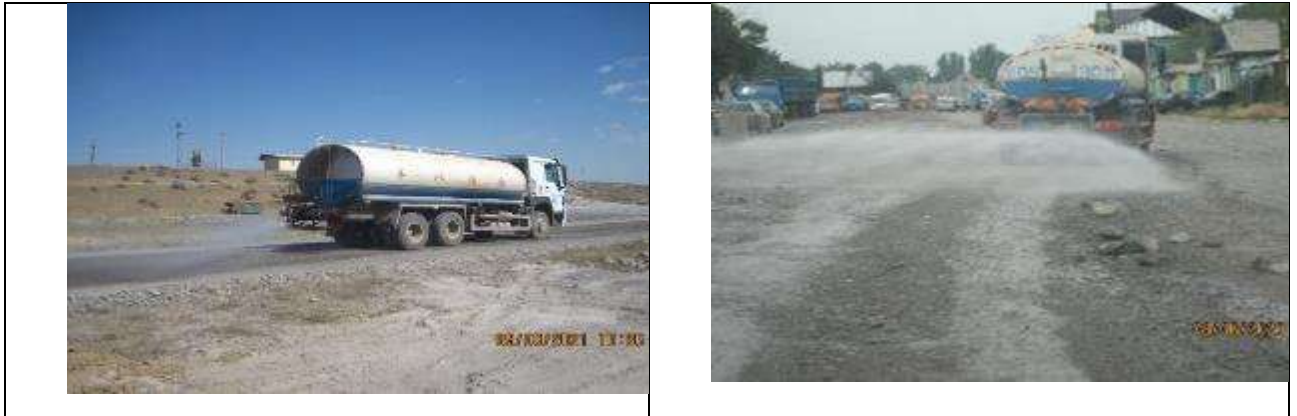
109. The main impact on the environment during excavation work in the previous periods was dust formation. In the reporting period, there were only single cases of dust formation, about which the Contractor was immediately warned. Water sprinkling on the road, including shoulders, in the construction sites was carried out from 7 am to 8 pm without a lunch break. The contractor has drawn up a schedule for watering the road with an indication of the interval between watering of 30 minutes. Considering the small amount of work on the road and the fact that several watering machines were operating on the construction sites, which managed to water the road in time, the facts of increased dust formation were rarely observed at the construction sites. No complaints were received from the local population and local self-government bodies during the reporting period.

Figure 41 . Water sprinkling works. The road to the Ak-Suu 2 borrow pit and the road construction site in the village of Sokuluk.

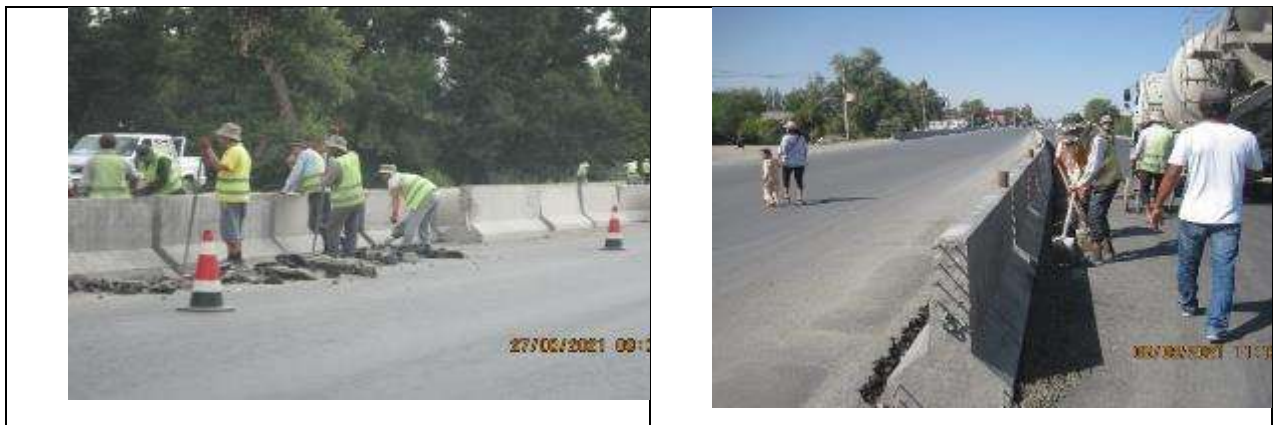
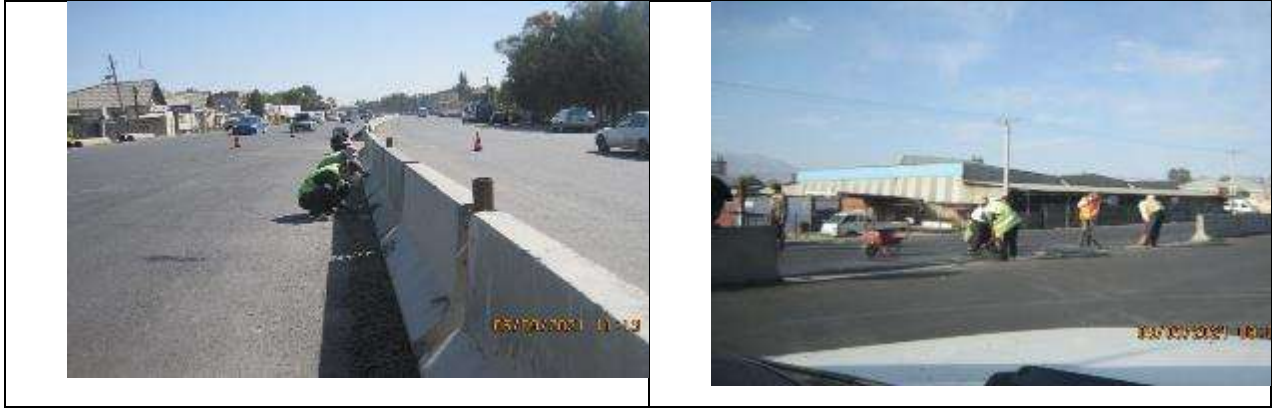
Figure 42. Works on concreting of ditches on the carriage way between the parapets.

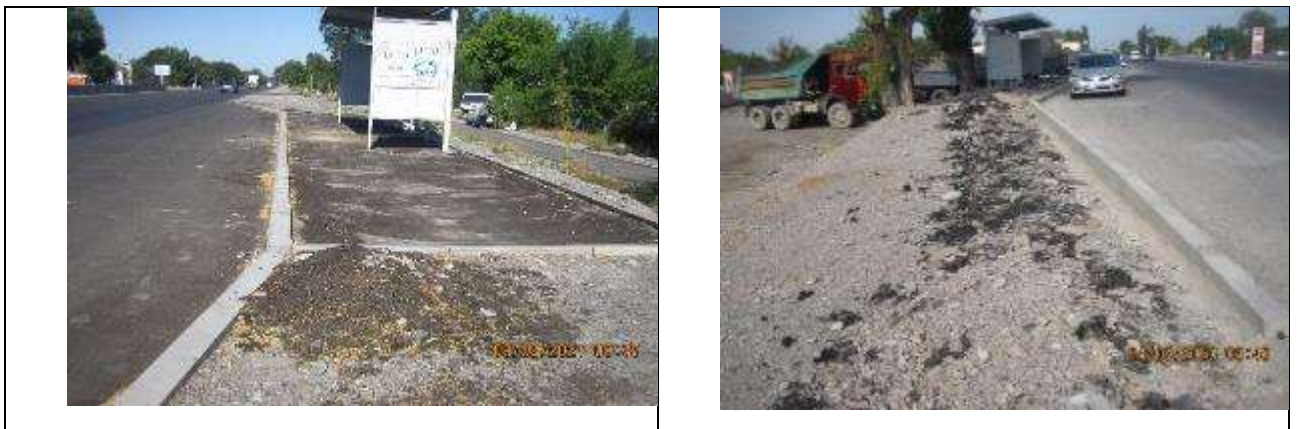
113. During the construction of bus stops, a large number of asphalt scraps were accumulated. The contractor promptly removed waste from the road.

Figure 44 Remnants of asphalt scraps at bus stops.

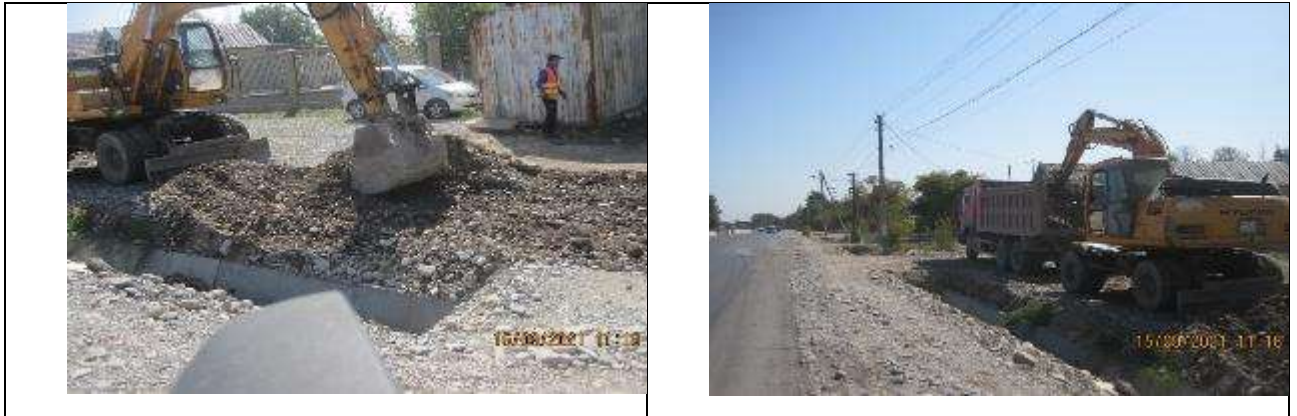
114. After the installation of culvert ditches, the excess soil formed was removed in a timely manner.

Figure 45 Removal of excess soil formed during the construction of culvert ditches.

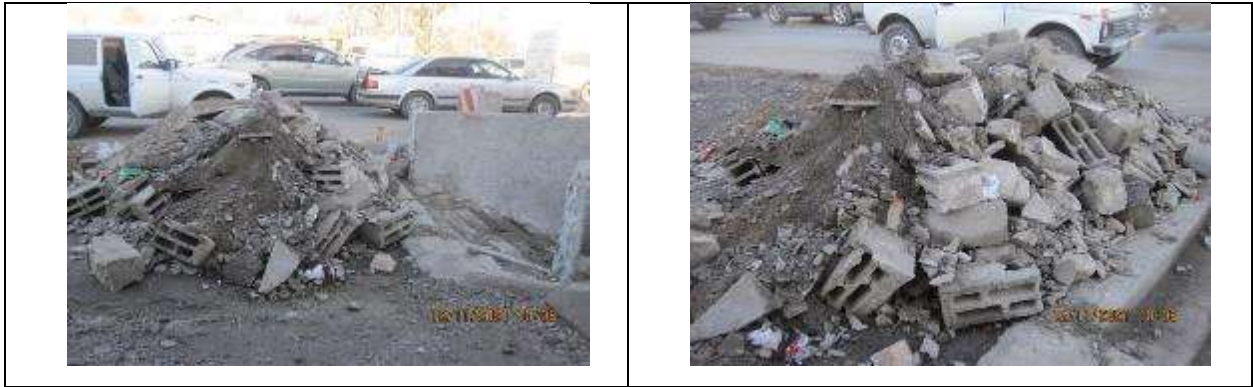
118. In the center of the village of Sokuluk, construction waste in large quantities remained uncollected near the underpass under construction.

Figure 49 Construction waste near the underpass under construction in the center of the village of Sokuluk.

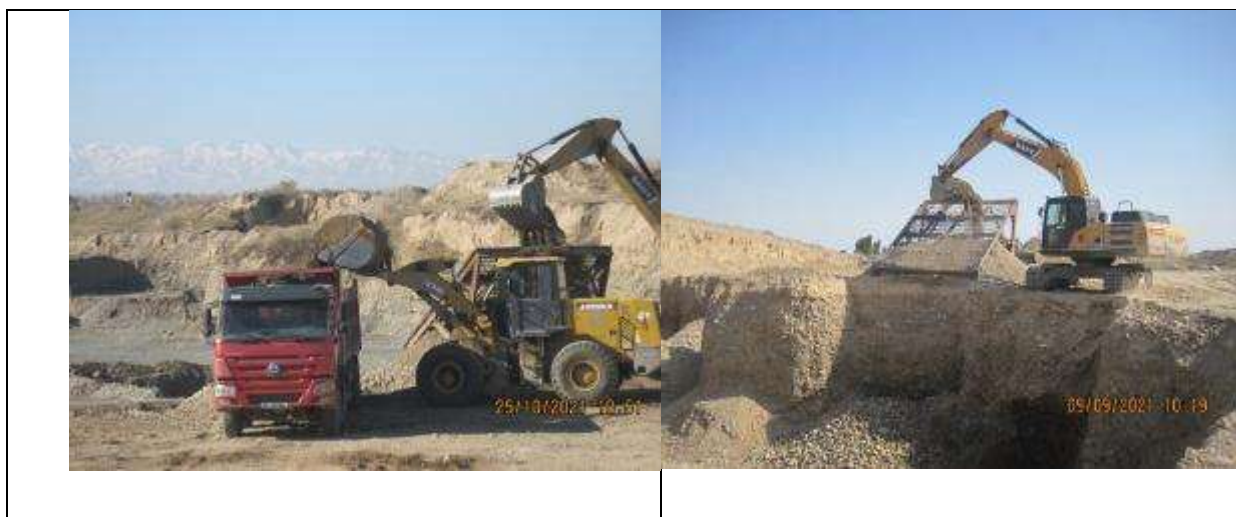
130. **Belek borrow pit.** On the road section km 8.5 - 15.9, a permit for temporary use (2 construction years) of a land plot with an area of 10 hectares for the development of a sand-gravel mixture in the village of Belek was obtained. Currently, the borrow pit is being developed.

Figure 52. Development of Belek borrow pit.

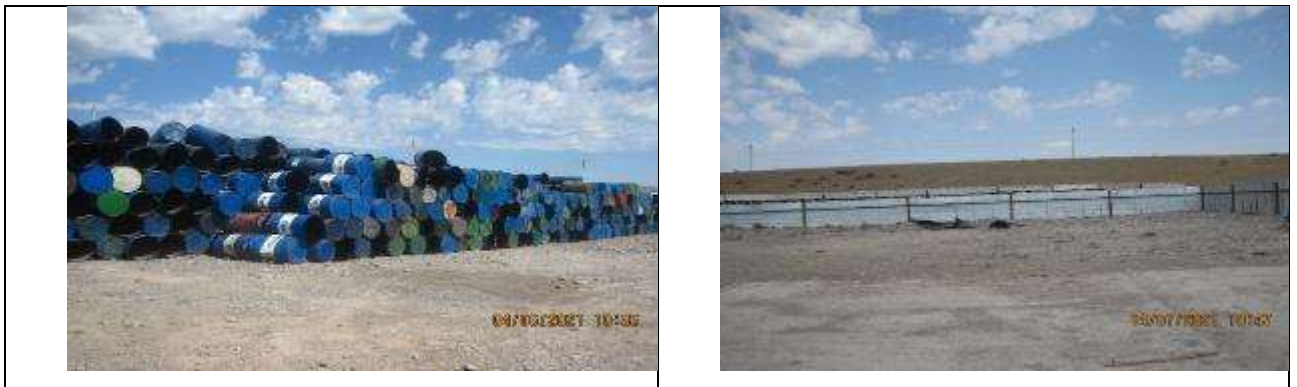
141. Earlier, for the preparation of the asphalt mixture, a large number of barrels with bitumen were delivered to the production site. After using bitumen, the empty barrels were stacked on the territory. Later the empty barrels were removed.

Figure 62 The area occupied by empty barrels before and after the removal of barrels.

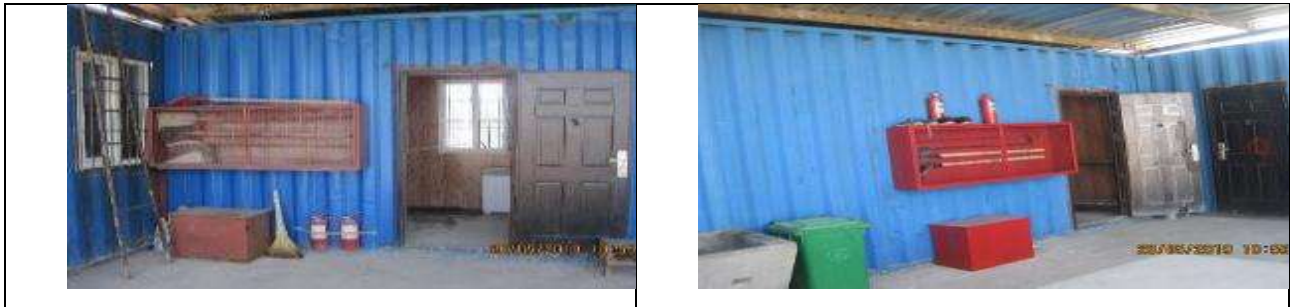
144. In the new camp sewage water is discharged into an existing septic tank by pipelines. 2 fire shields were installed in the camp.

Figure 64 Fire shields on the territory of the camp

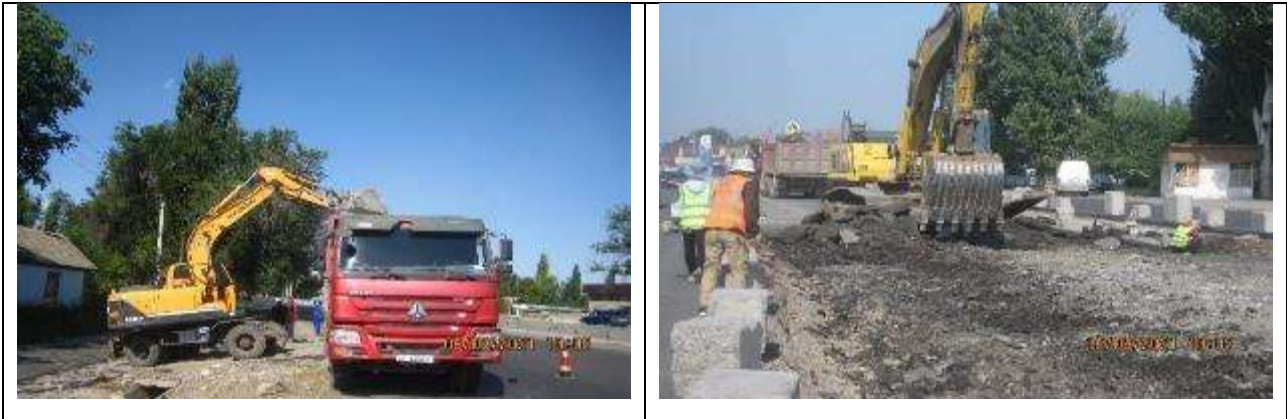
Figure 87 Transportation of removed asphalt to Sadovoye and Novopavlovka villages.

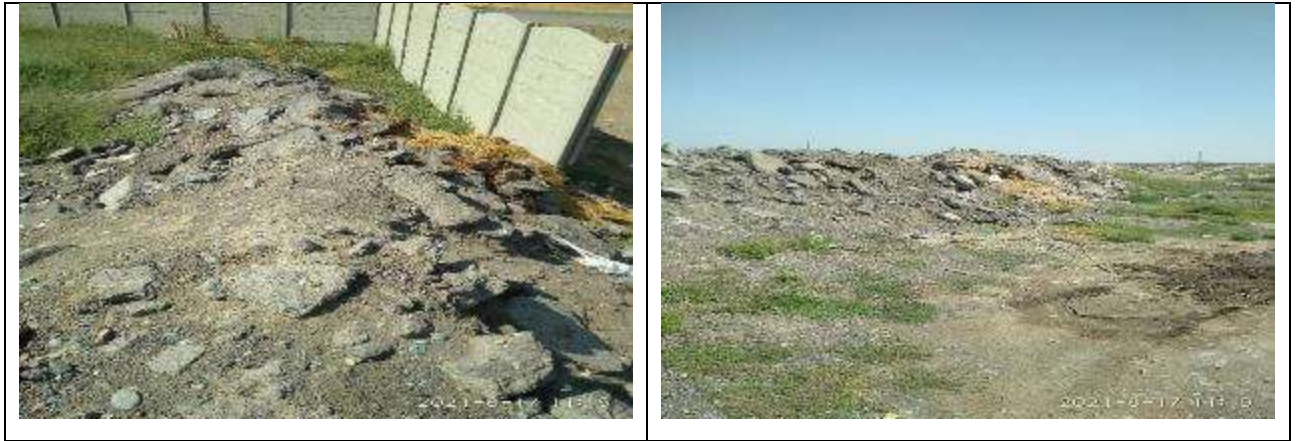
Figure 88 Dumping of old asphalt on designated areas in the Sokuluk village

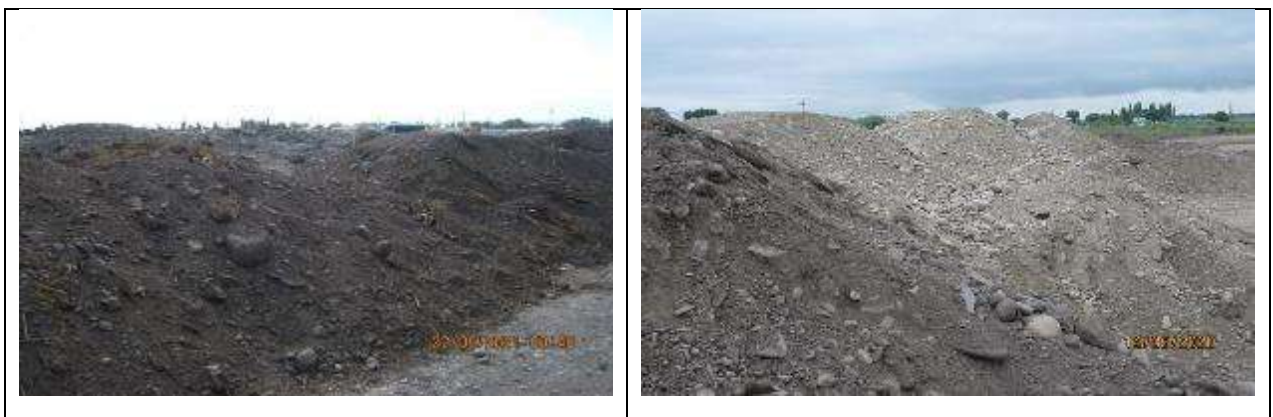
Figure 89 Storage of unsuitable soil for further use in the village of Romanovka.

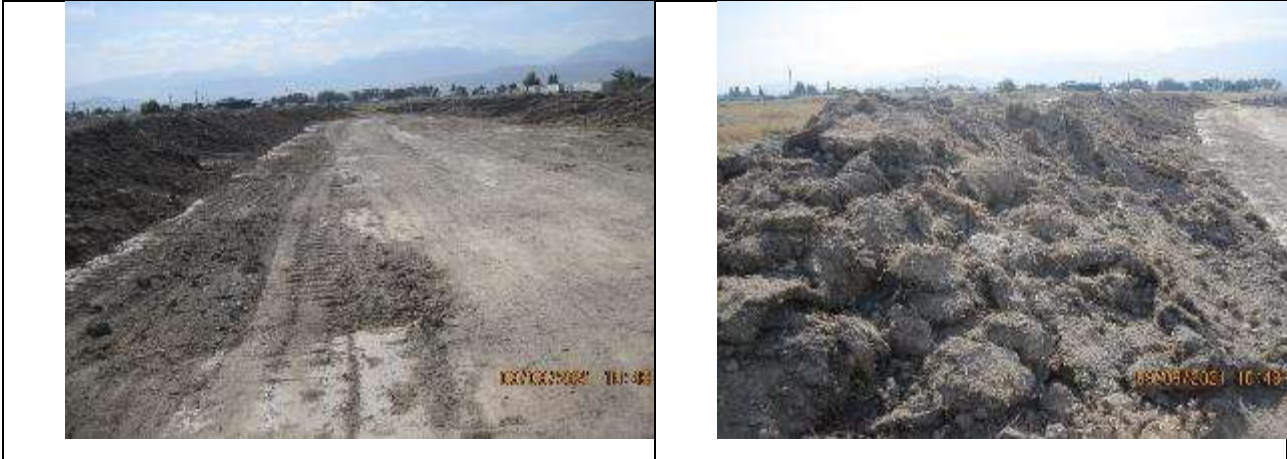
214. Initially unsuitable soil in the Voенно-Antonovka village was stored in dumps. At the site for soil storage, the top layer was removed and stored. Then the unsuitable soil was taken out to the prepared site in the ravine. After completion of all works, the top layer will be evenly spreaded on the surface of dumps.

Figure 92. An area for storing unsuitable soil after removing the top layer. Stored soil.

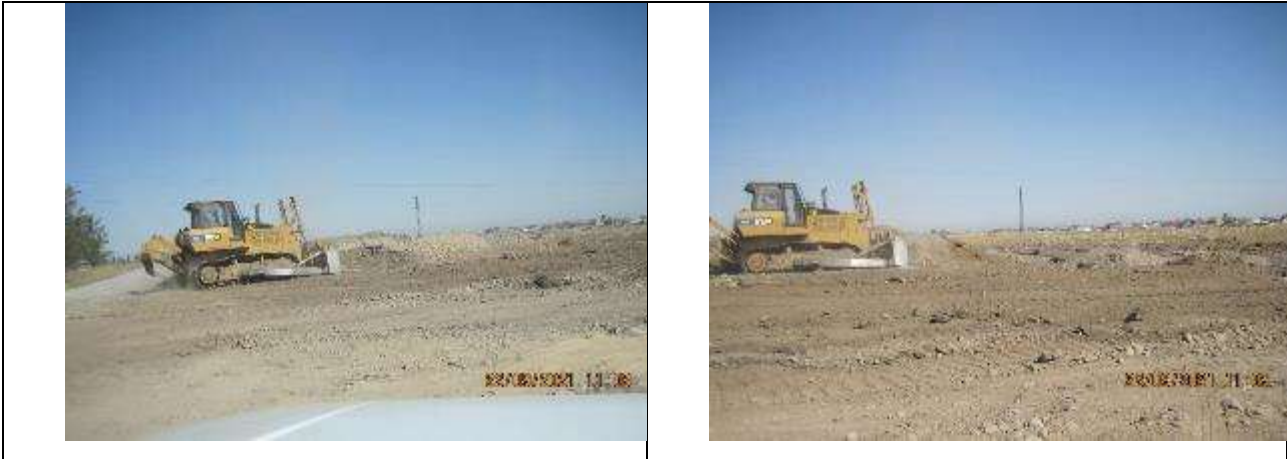
Figure 93 Transportation of unsuitable soil to a prepared area.

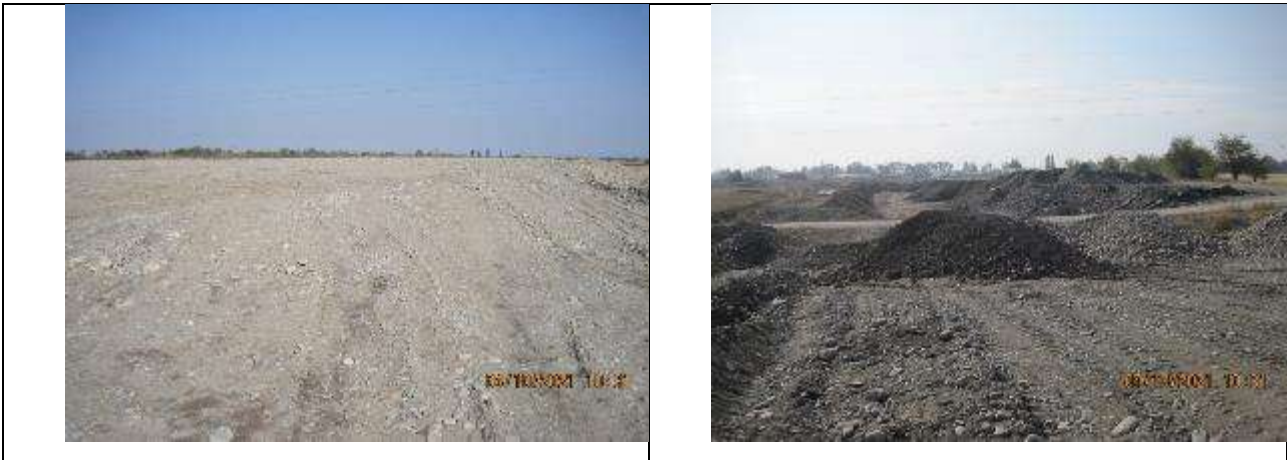
Figure 94 An area for storing unsuitable soil after transportation and levelling the unsuitable soil.

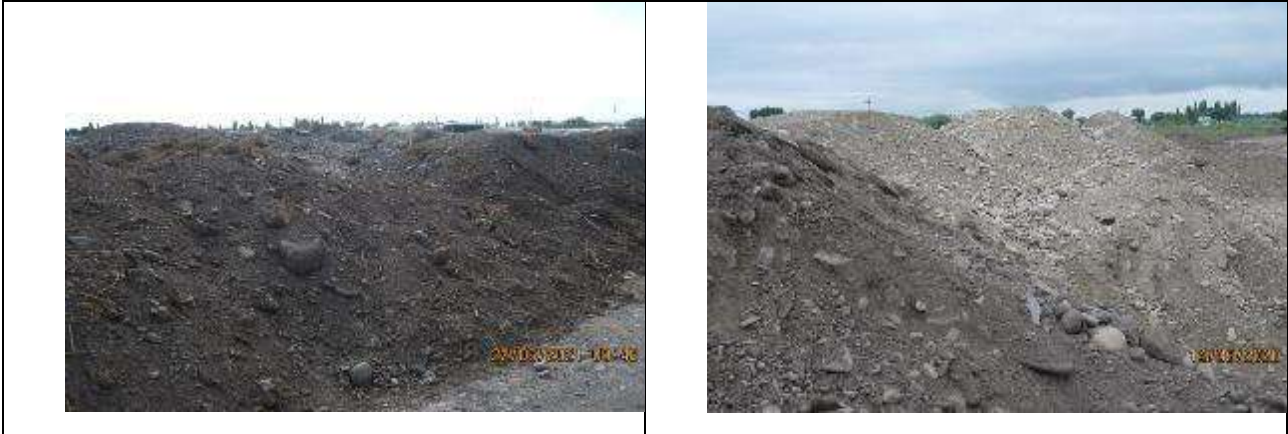
Figure 95 Storage of unsuitable soil for further use.

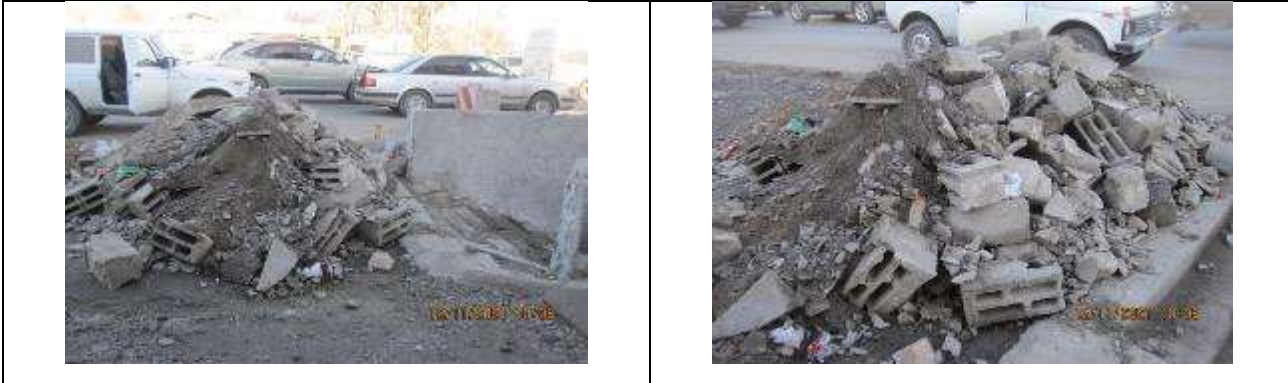
219. In the center of the Sokuluk village, construction waste in large quantities remained uncollected near the underpass under construction.

Figure 96. Construction waste near the underpass under construction in the center of the Sokuluk village.

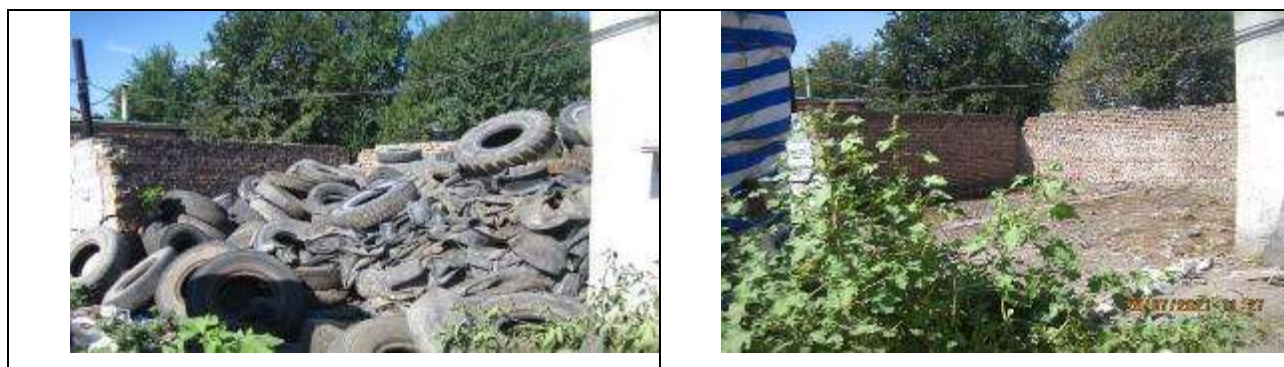
223. On the territory of the base in the Belovodskoe, a large number of old car tires are stored. Contractor took measures to remove and dispose of them. Currently, the base area is cleared of all waste.

Figure 99 An area occupied by old car tires before and after removal.

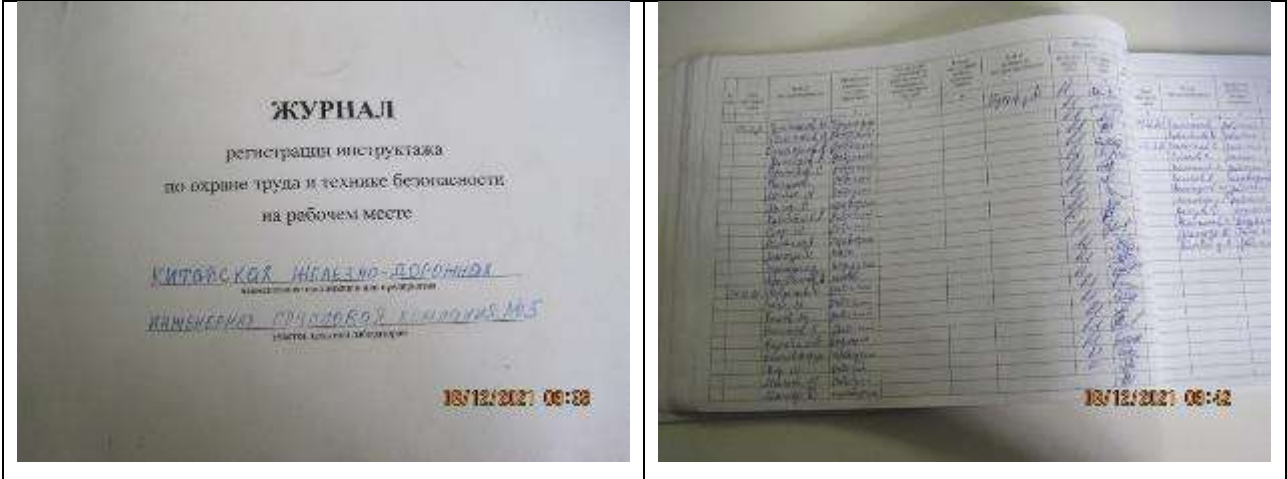
Figure 100 Logs for registration of briefing conducted at the workplace

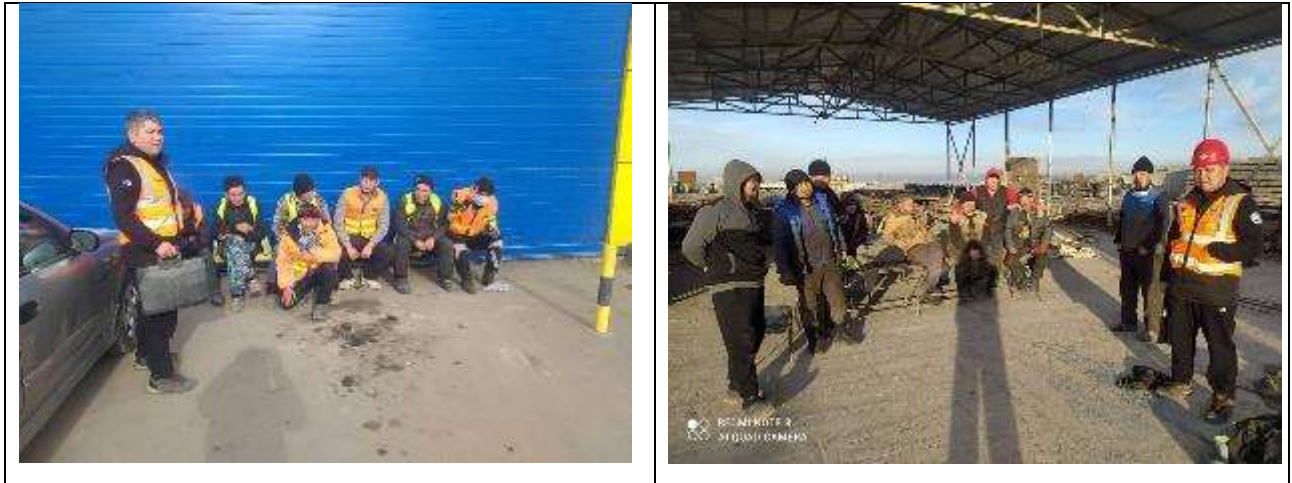
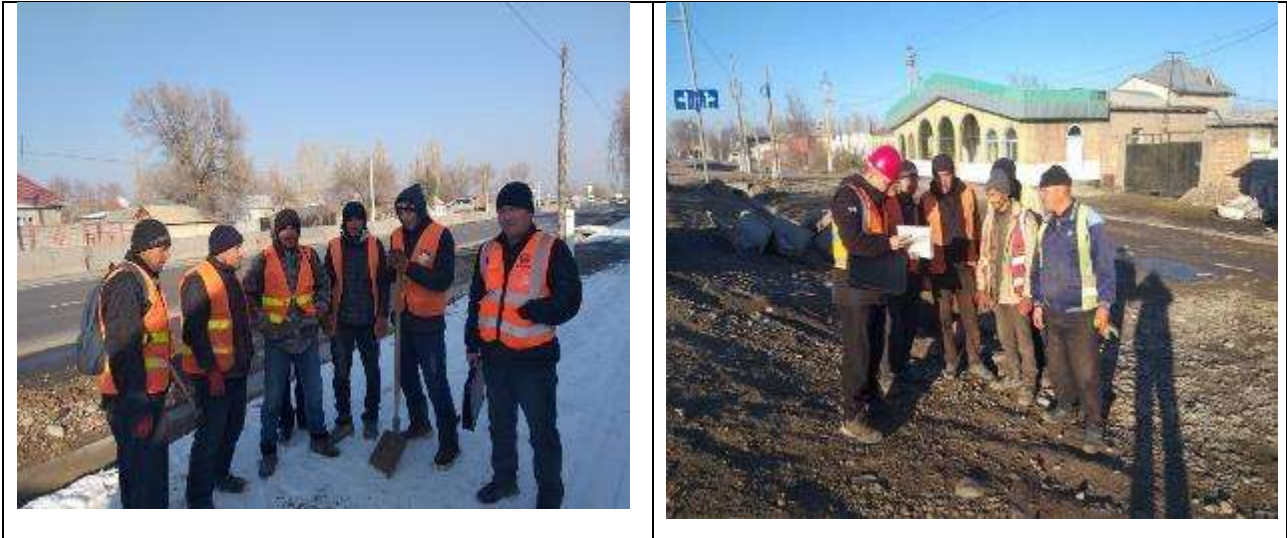
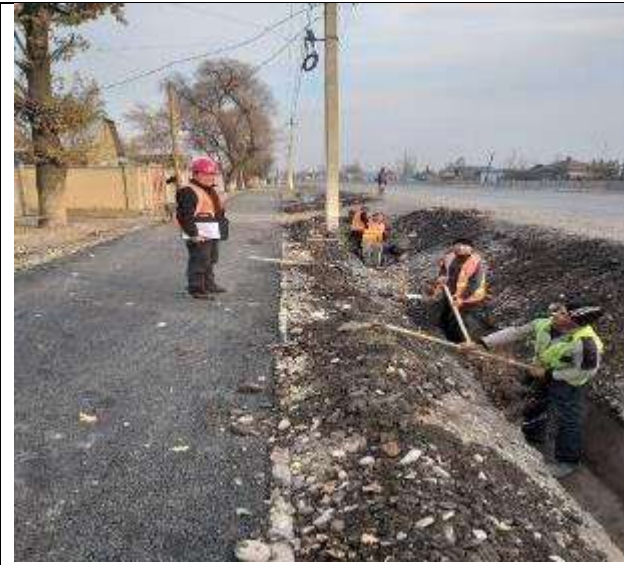
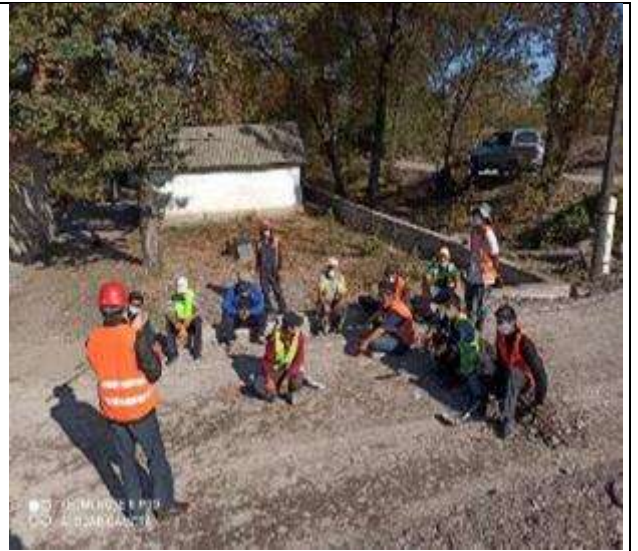
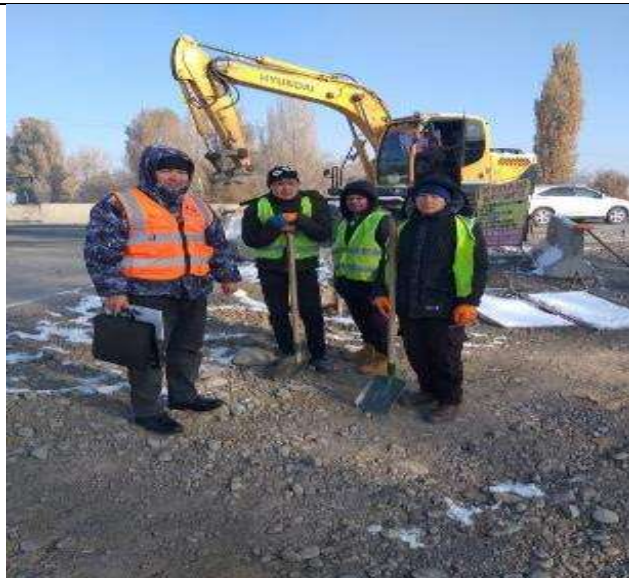
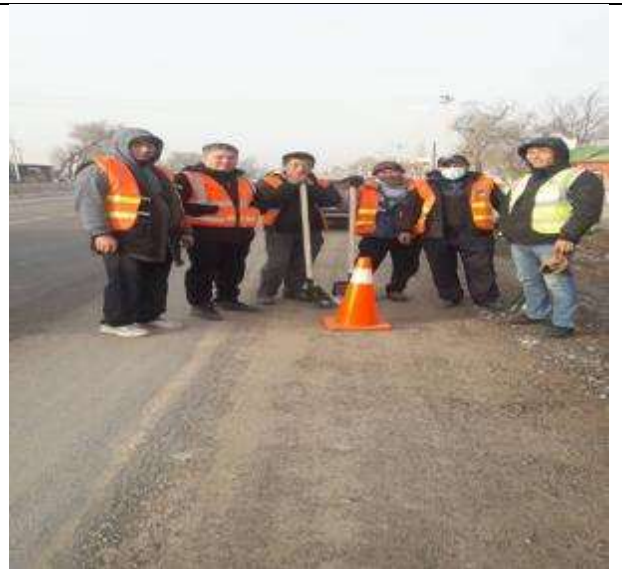
236. During the reporting period, several joint visits were conducted by a local environmental specialist of Consultant with a Contractor's OHS specialist. The briefing was conducted at the construction sites.

Figure 101 Briefings and seminars at the workplaces.

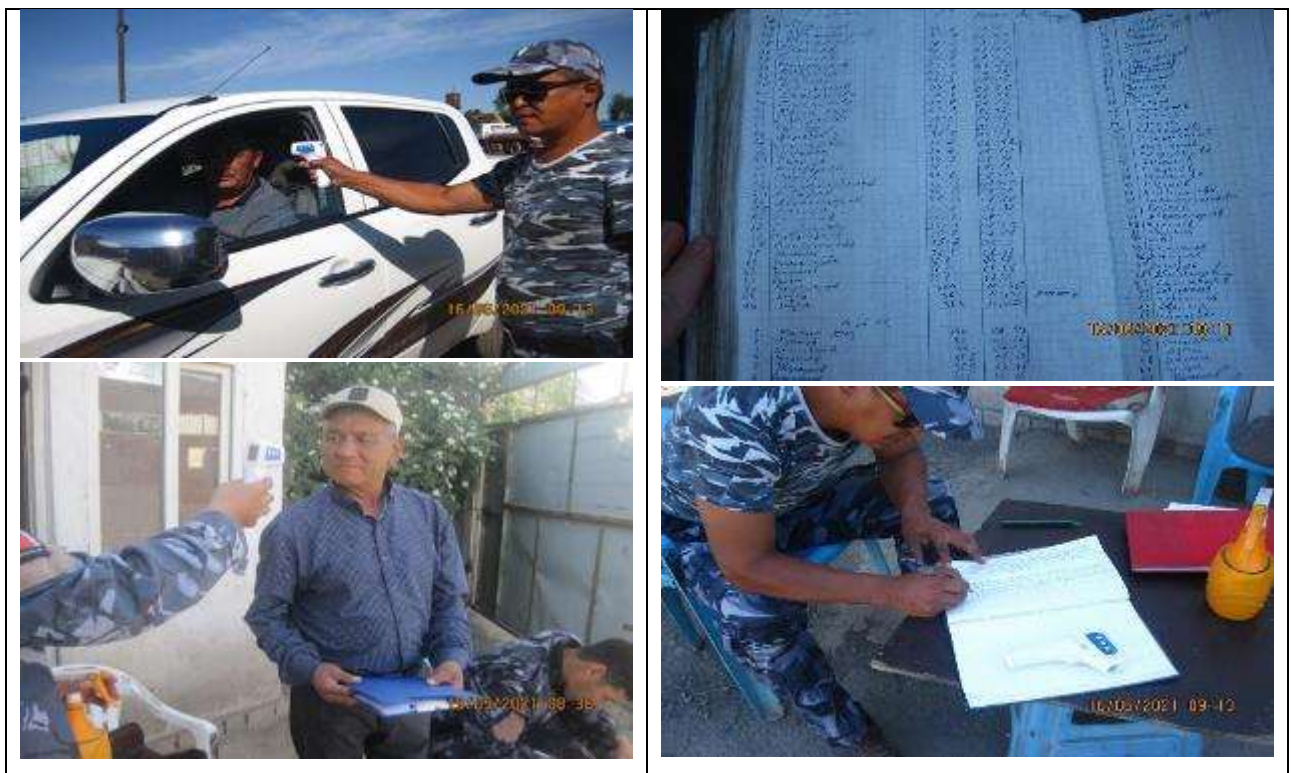
Figure 102 Temperature measurement and registration in the log at the entrance to the base in Sokuluk.

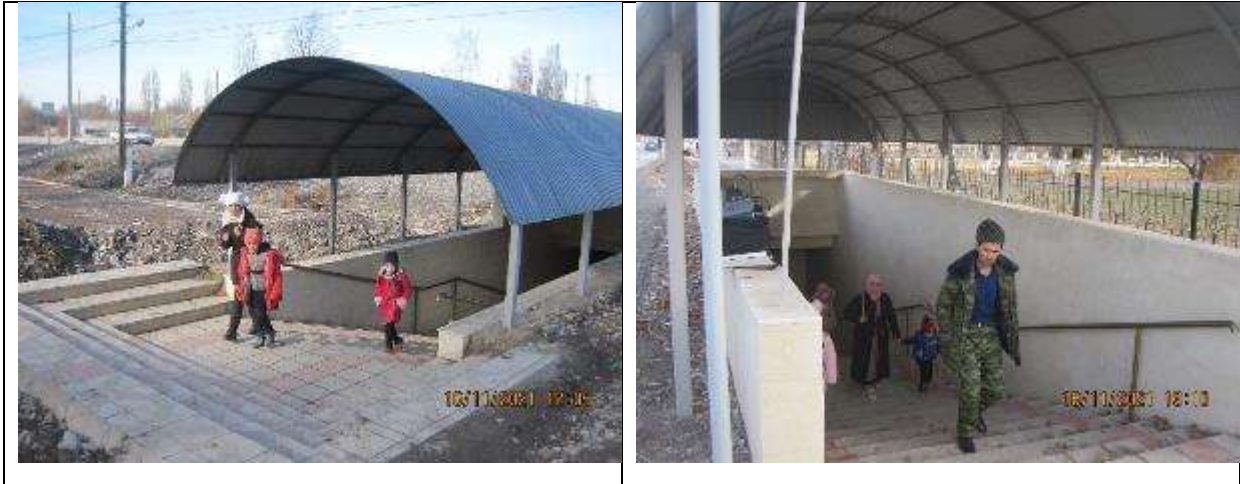
Figure 103 Local people using underpasses.
