Semi-Annual Environmental Monitoring Report

July - December 2021

CAREC Corridors 1 and 3 Connecting Road Project (Phase 2). Additional Financing. Lot 1 "Balykchy km 0 -km. 43", Lot 2 "Kochkor - Epkin (km. 62+400 - km. 89+500)".

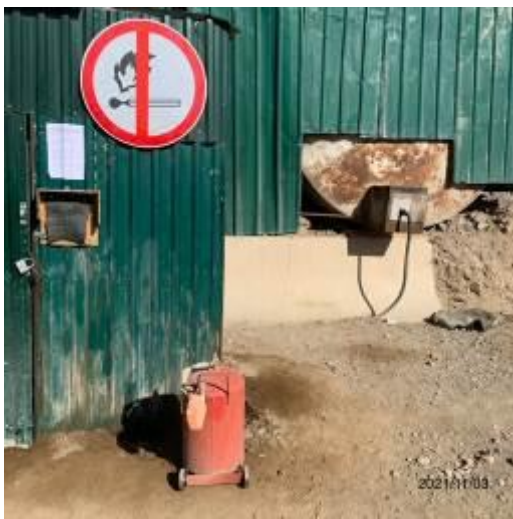
Lot 2				
5	An additional diesel fuel storage tank was installed in fuel depot without measures to collect diesel fuel in case of an emergency leak/spill (photo 59).	Under tank area where possible fuel leaks (place where hose is connected to tank) - must have a hard waterproof surface, fenced along perimeter with a 200 mm high rim. A container for collecting emergency fuel spills should be installed. The capacity of this container should not be less than capacity of fuel storage tank (Construction standards of the Kyrgyz Republic "Filling stations" dated 12.11.2018).	Deadline is November 25, 2021. Extended until March 2022.	Not Fulfilled. Inability to perform concrete work because of cold weather. Contractor undertook to ensure performance by end of March 2022.

Photo 59. Warehouse of fuel and lubricants on Lot 2.

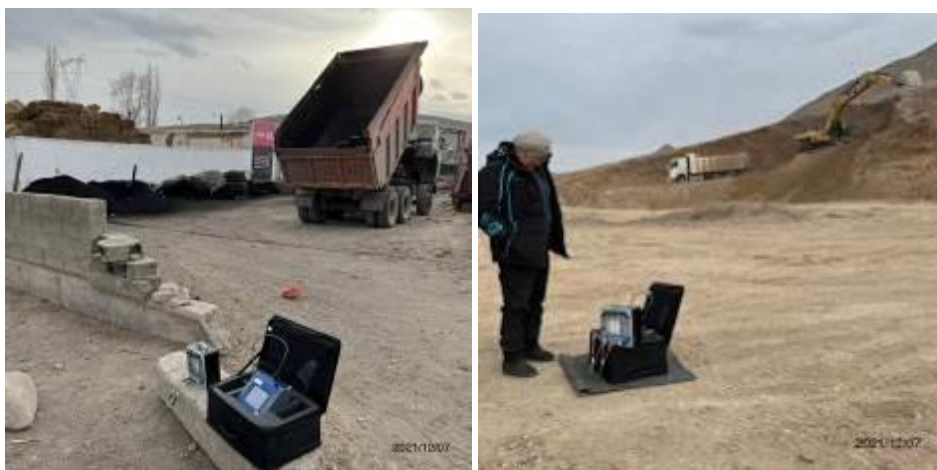
Photo 68 and 69. Measurements of air quality in Chekildek village and quarry 71+500.

55. Air quality was determined by the following indicators: sulfur dioxide, nitrogen dioxide, carbon monoxide and suspended substances. According to results of air quality analyses, the values for the above indicators were within established MPCs. There is no negative impact of construction works on environment. Exceedances are not related to construction works and are background values. Except for concentration of suspended substances in air at production base of Crushing and Screening Unit Lot 2, which exceeded MPC by 6.5 times. The reason is that measurements taken in a strong wind, picking up dust from ground, which is typical for this region in windy weather. Dust suppression at the crushing plant is carried out by watering when loading the material into the bunker. For these purposes, the contractor laid a pipe through which water is supplied to the crushing plant. In general, there is no negative impact of construction works on the air in reporting period. The Contractor was recommended to suspend Crushing and Screening Unit operations during strong winds and provide dust suppression at production site and on surface of bulk construction materials.

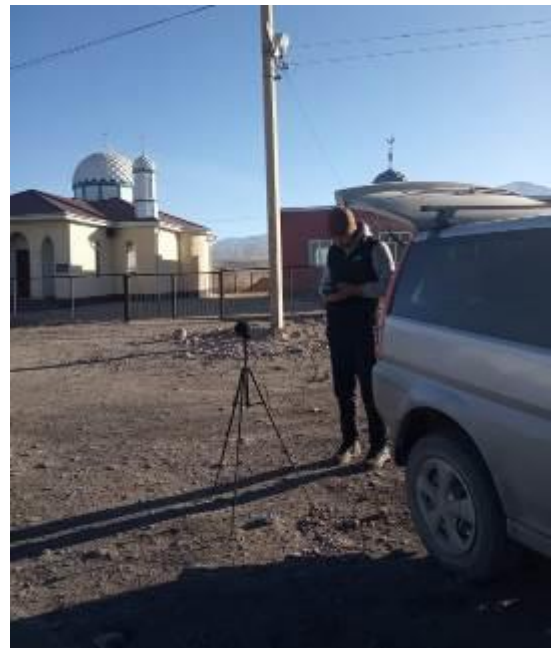
Photo 70. Measurements of vibration and noise levels.

57. Noise and vibration levels. According to the results of instrumental measurements, the noise level during operation of company's vehicles and equipment in quarries and production bases, as well as during construction works on road is within established MPL. The vibration level of operating construction equipment was also within established limits, except for a road roller. During operation of road roller, the vibration level exceeded established MPL by 6 dB. To reduce level of vibration, Contractor is recommended to use a vibration-free road roller during construction works (Letter KGZ4267/02/01/L2/JPL/105 of 16.11.2021).

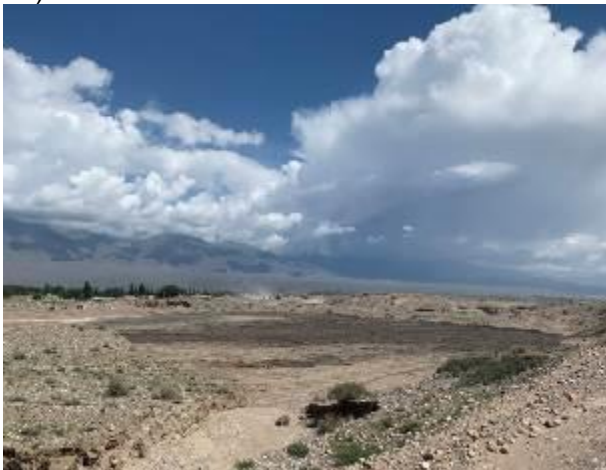
Photo 79, 80. Old asphalt dump at km. 7+100 left prior to placement (April 2021) and right after completion of old asphalt placement (Aug 2021).

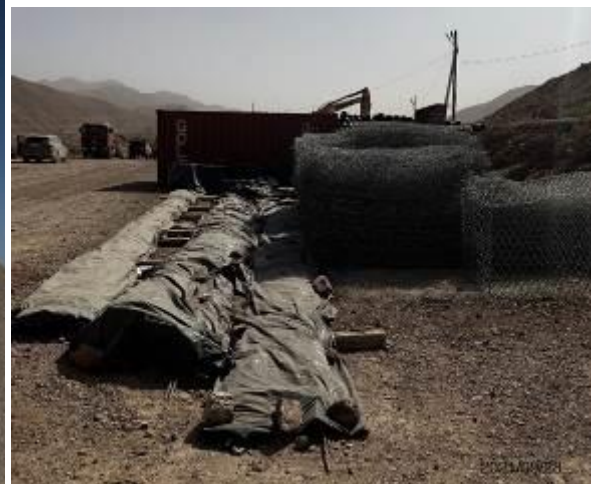
Photo 92. Storage of materials on Lot1.

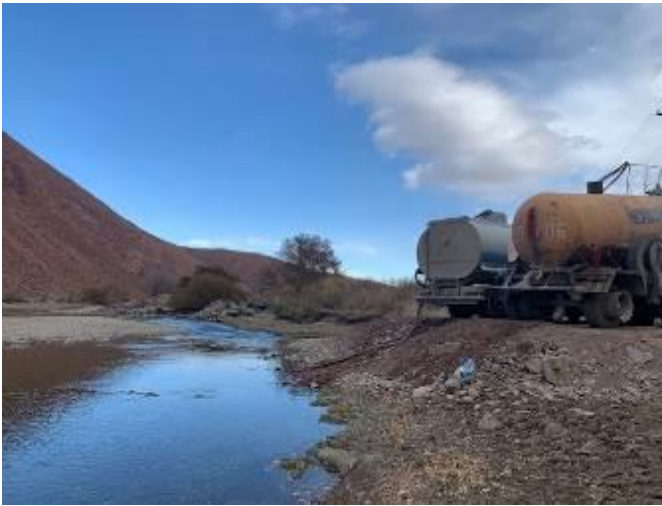
Photo 93. Lot 1. Water intake from Chu River

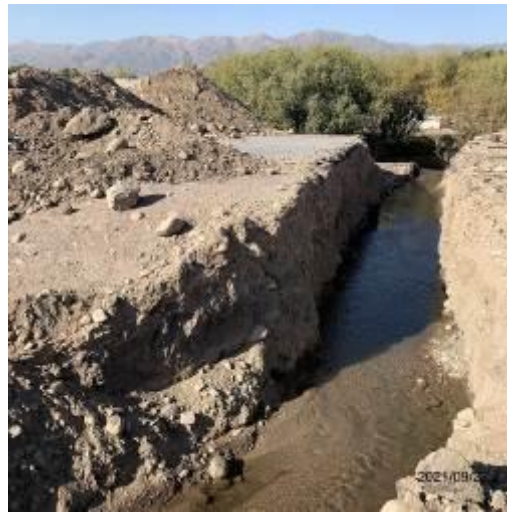
Photo 94. Lot 2. Drainage from sections of new culverts km 86+220.
