Environmental Monitoring Report

Semestral Report (January–June 2021)
July 2021

Kyrgyz Republic: Central Asia Regional Economic Cooperation Corridors 1 and 3 Connector Road Project (Phase 2)-Additional Financing

Section 1: Balykchy–Kochkor Road (km 0–km 43) and
Section 2A: Kochkor–Epkin Road (km 64–km 89)

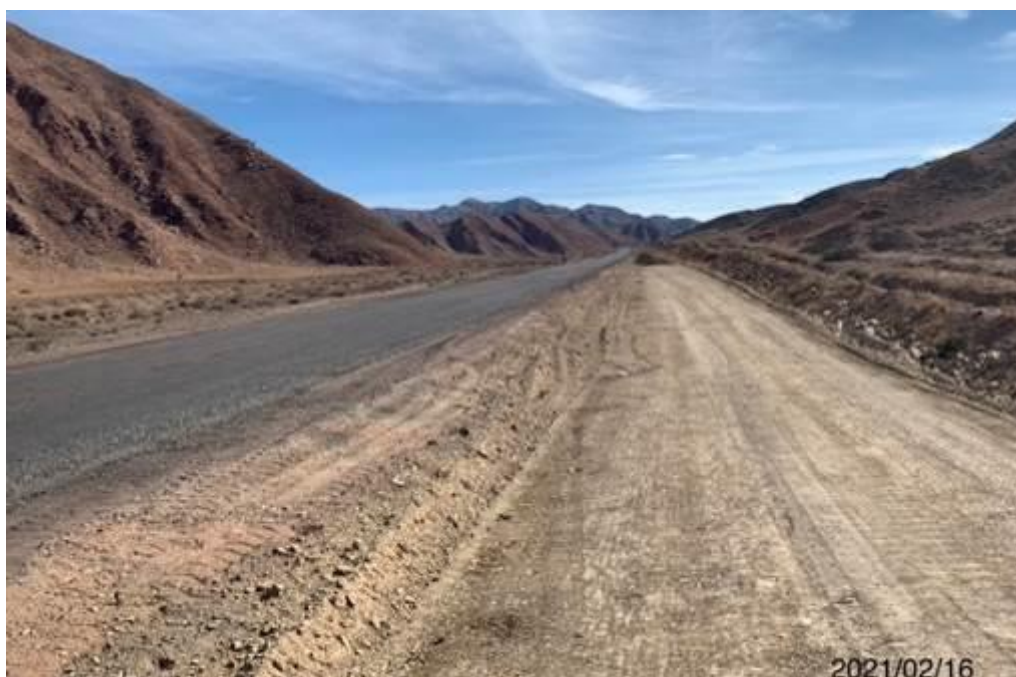
- Road widening. During road widening, the roadside was cleared and grubbed (photo 14). The volume of work performed during the reporting period is 9.1%, from the beginning of the Project implementation - 19%.

Photo 14. Road widening at km 14+050 – 16+500: after clearing and grubbing.

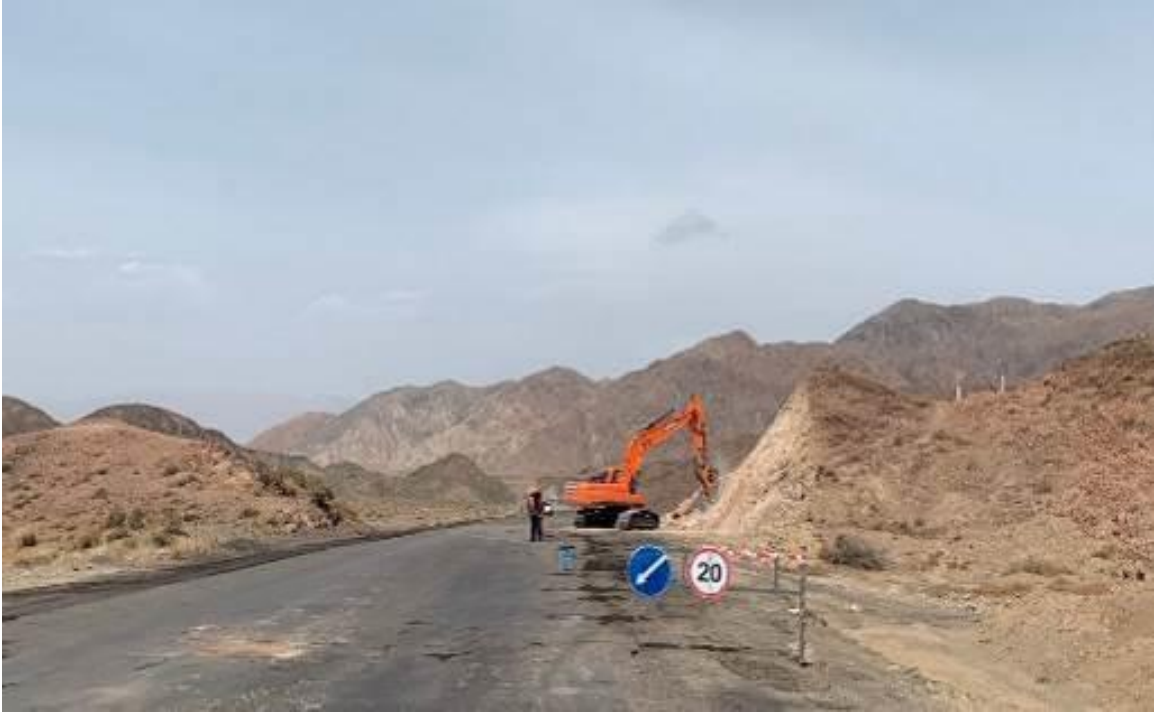
- Excavation of soil (photo 15). The volume of work performed during the reporting period is 16%, from the beginning of the Project implementation - 34%.

Photo 15. Lot 1. Excavation at km 21+000.

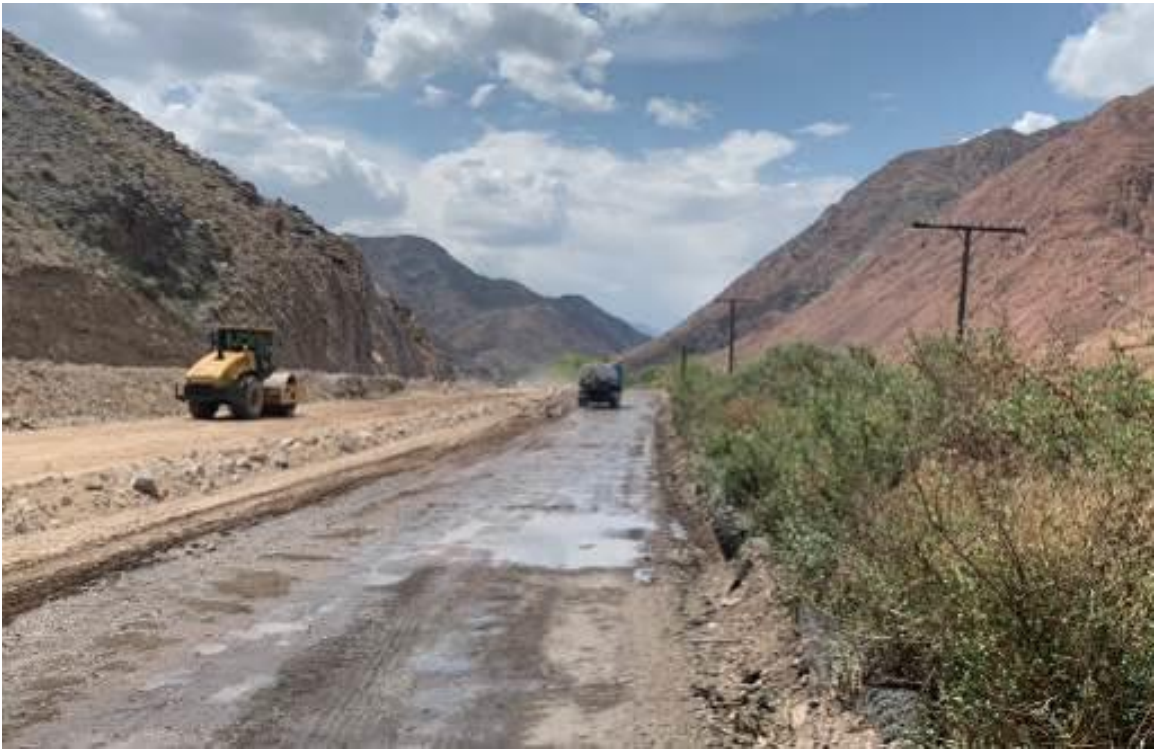
Photo 16. Soil compaction at section km 13 + 280.

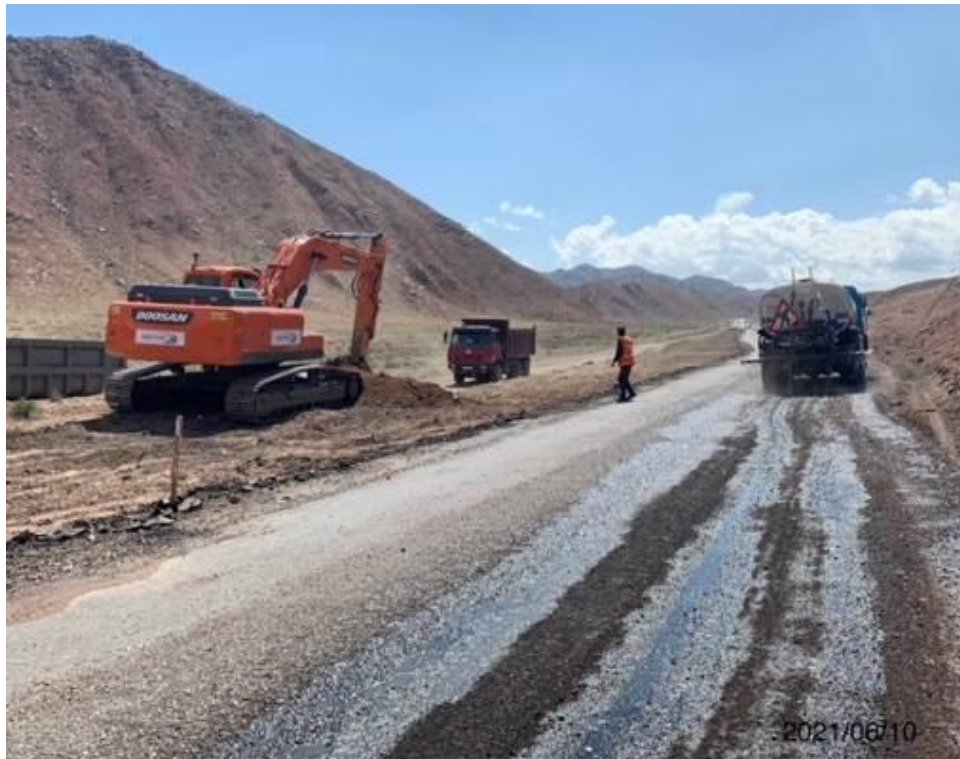
Photo 17. Removal of unusable material km.14 + 482.

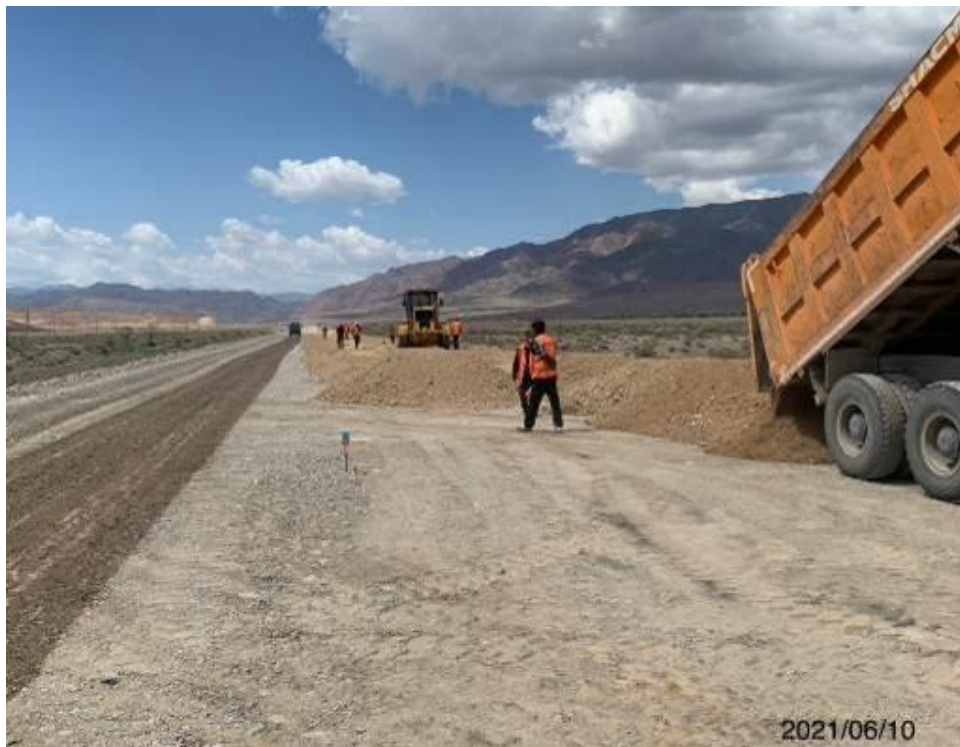
- Embankment construction (photo 18). The volume of work performed during the reporting period is 11%, from the beginning of the Project implementation - 11%.

Photo 18. Lot 1. Earthworks on the embankment at km 4 + 200.

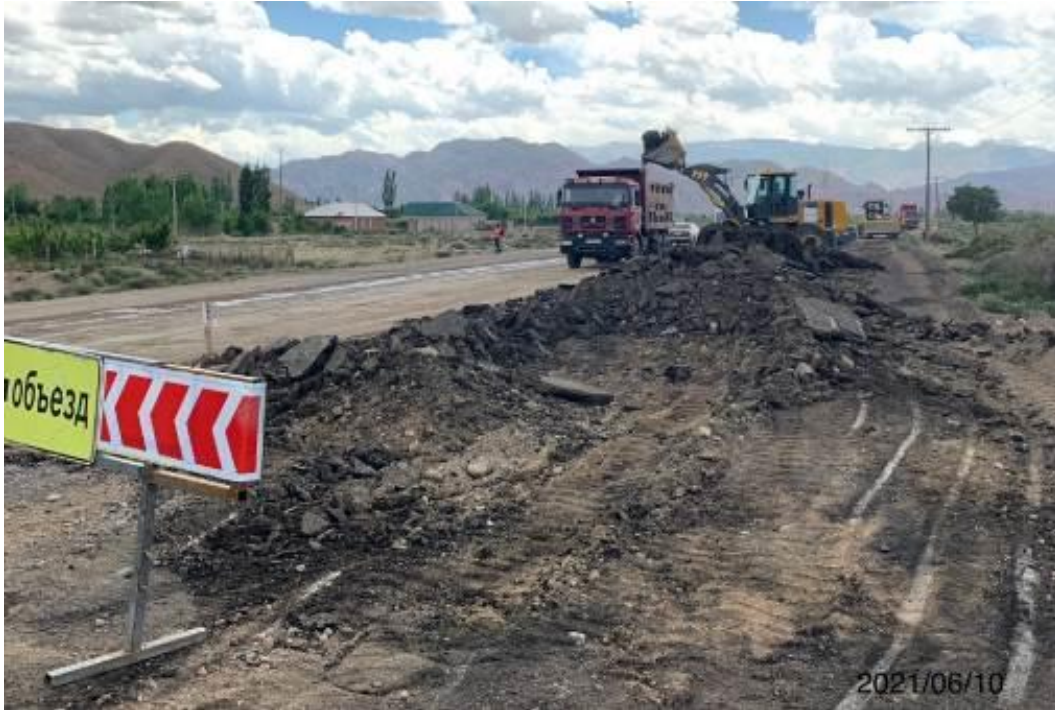
Photo 19. Lot 1. Scarifying and removal of old asphalt concrete at km 7 + 560.

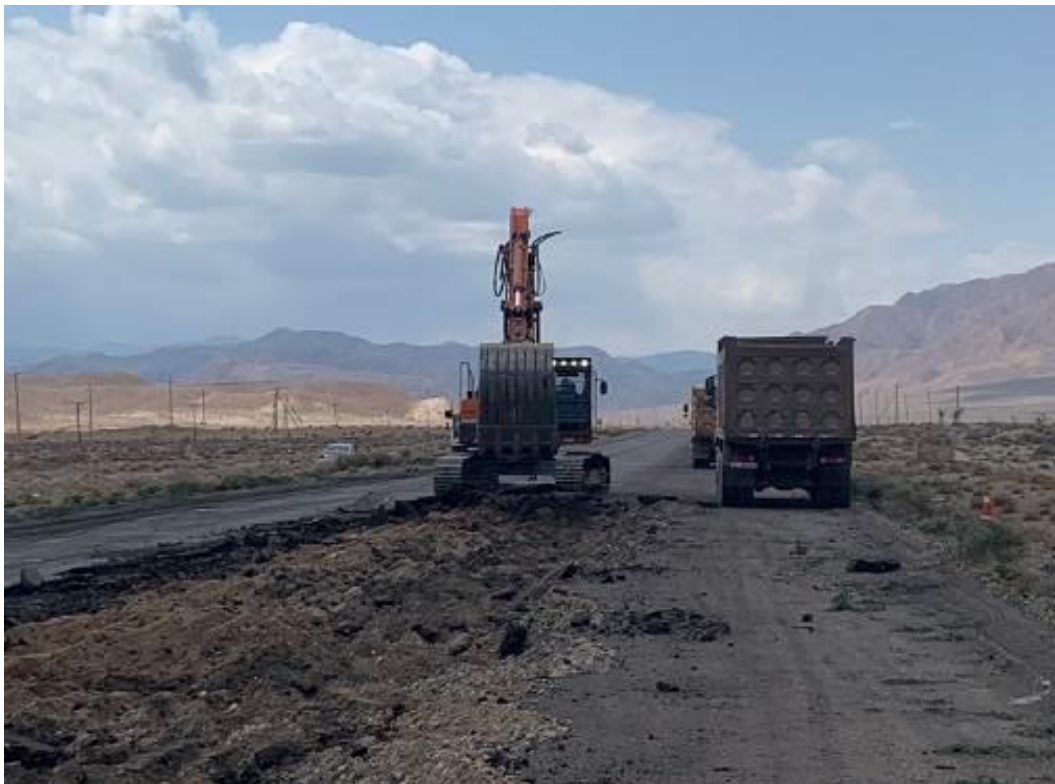
Photo 20. Lot 1. Removal and disposal of old asphalt concrete at km 4 + 800.

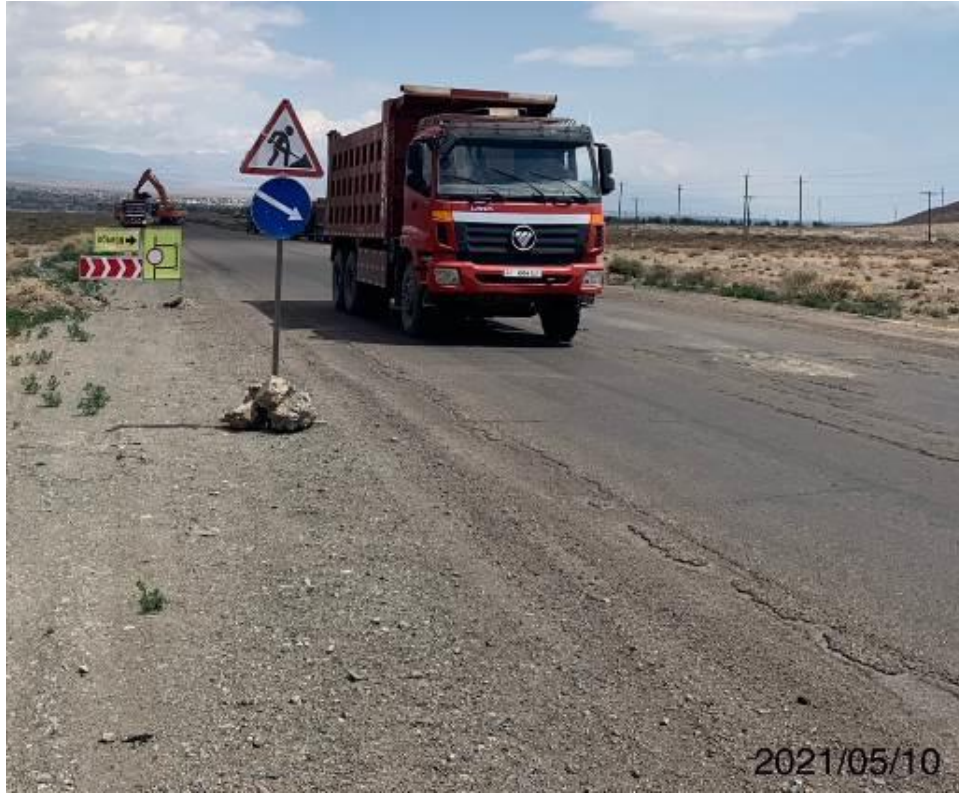
Photo 21. Lot 1. Warning road safety signs at km 4 + 800.

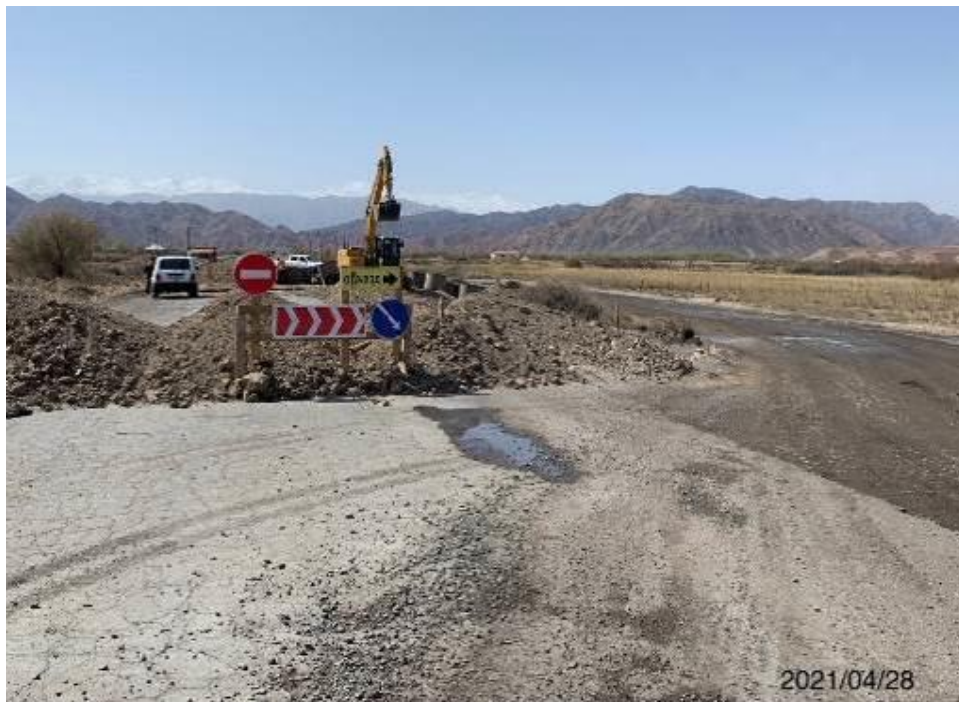
Photo 22. Lot 1. Culvert construction work at km 8 + 159.

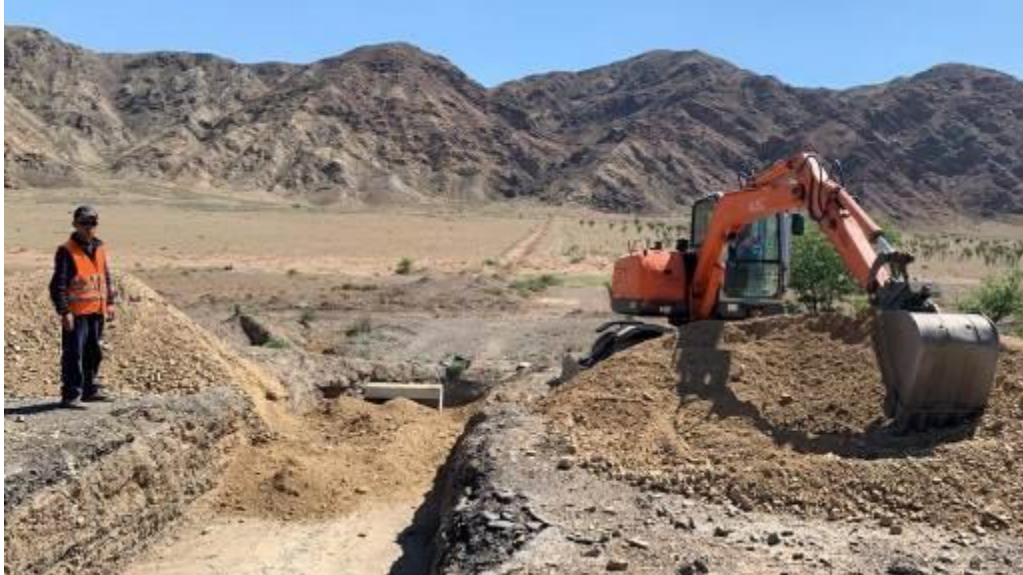
Photo 23. Culvert backfilling at km 18+585.

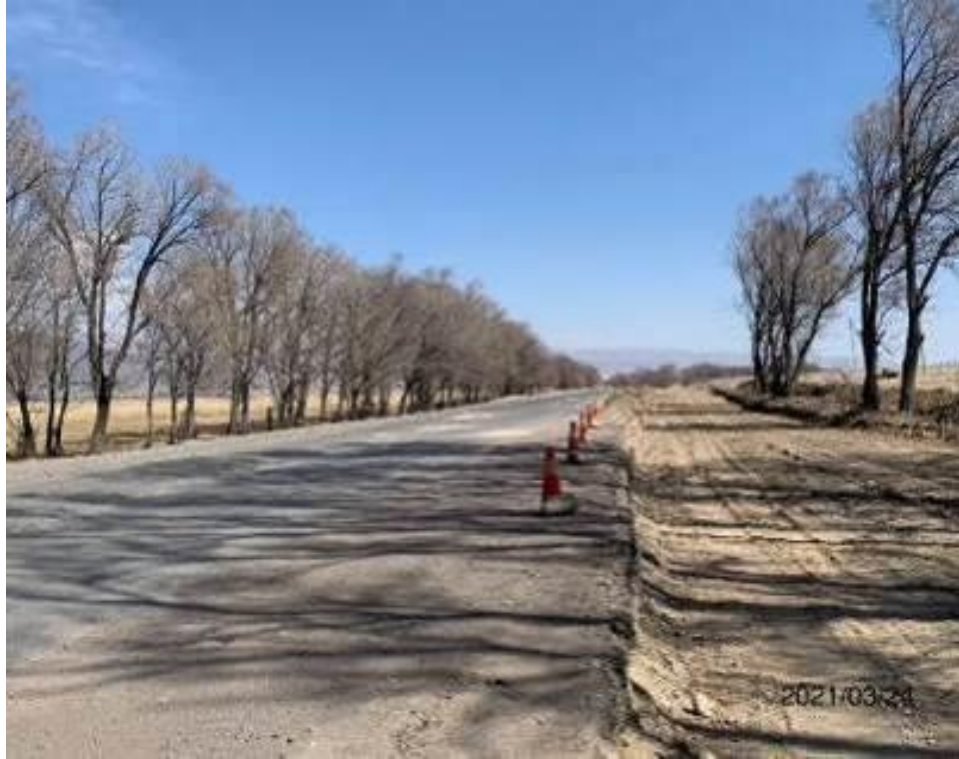
- Road widening. During road widening the roadside was cleared and grubbed (photo 24). The volume of work performed during the reporting period is 6.4%, from the beginning of the Project implementation - 17%.

Photo 24. Road widening at km. 14 + 050 - 16 + 500: after clearing and grubbing.

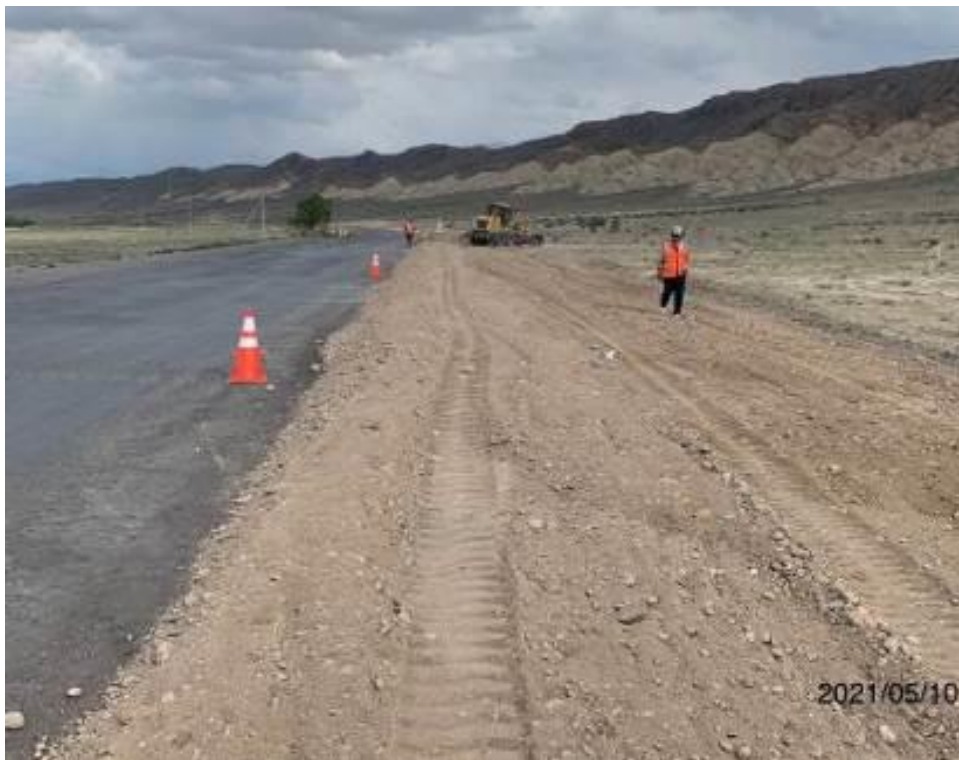
Photo 25. Km 74 + 100. Subgrade leveling.

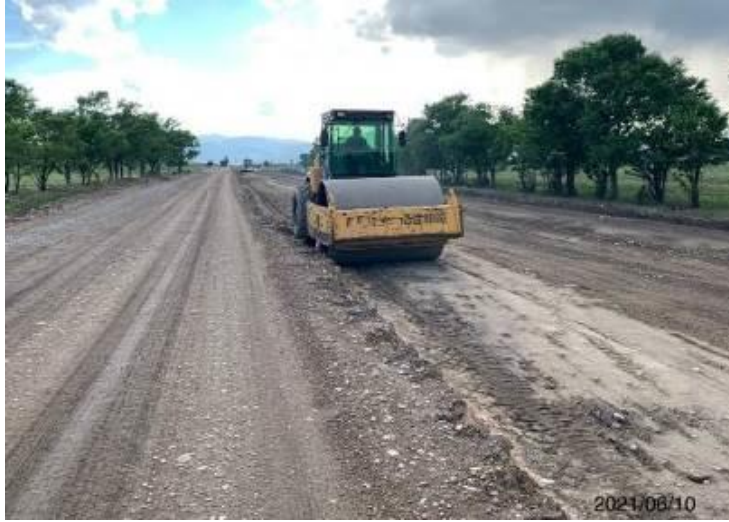
Photo 26. Subgrade soil compaction with moistening at km 79 + 300.

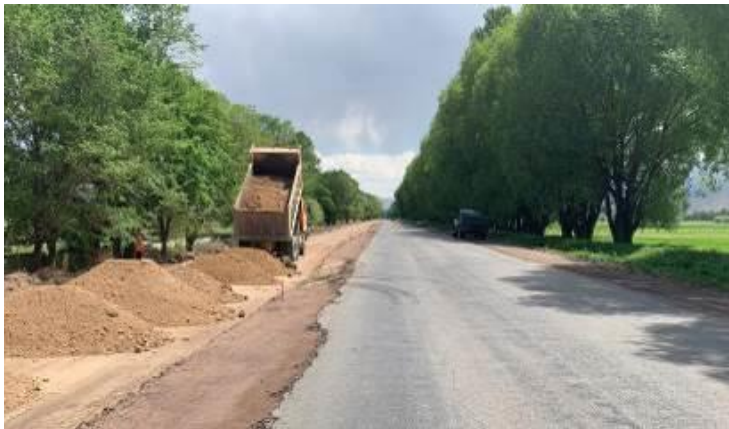
- Embankment construction (Photo 27). The volume of work performed during the reporting period is 24%, from the beginning of the Project implementation - 24%.

Photo 27. Embankment construction at km 64+300.

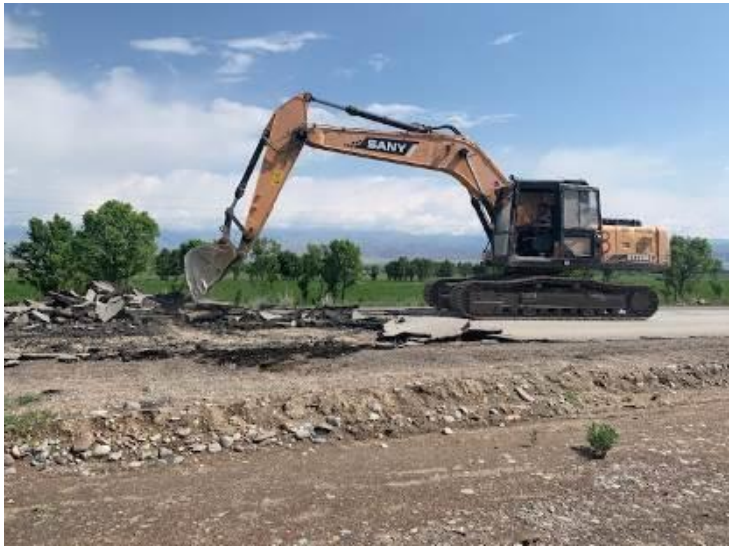
- Removal of existing asphalt (photo 28). The volume of work performed during the reporting period is 28%, from the beginning of the Project implementation - 28%.

Photo 28. Scarifying of asphalt concrete pavement at km. 74 + 550.

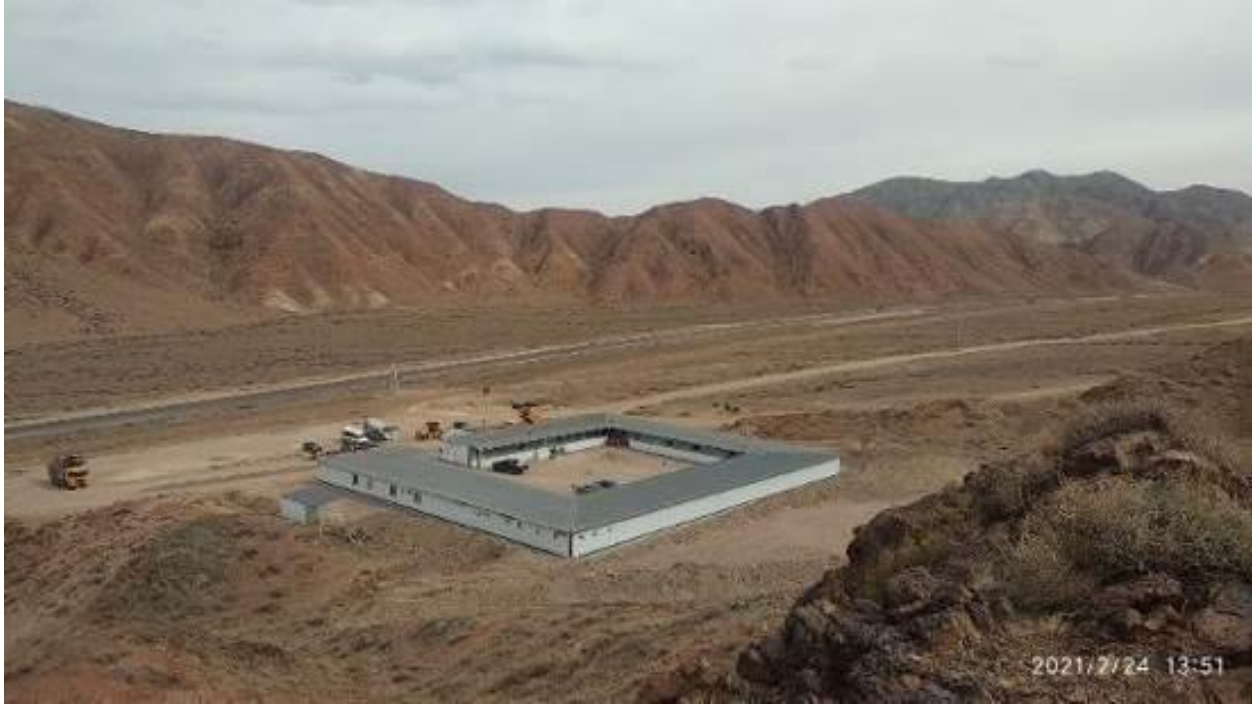
Photo 29. Location of camp road builders at km 16+100.

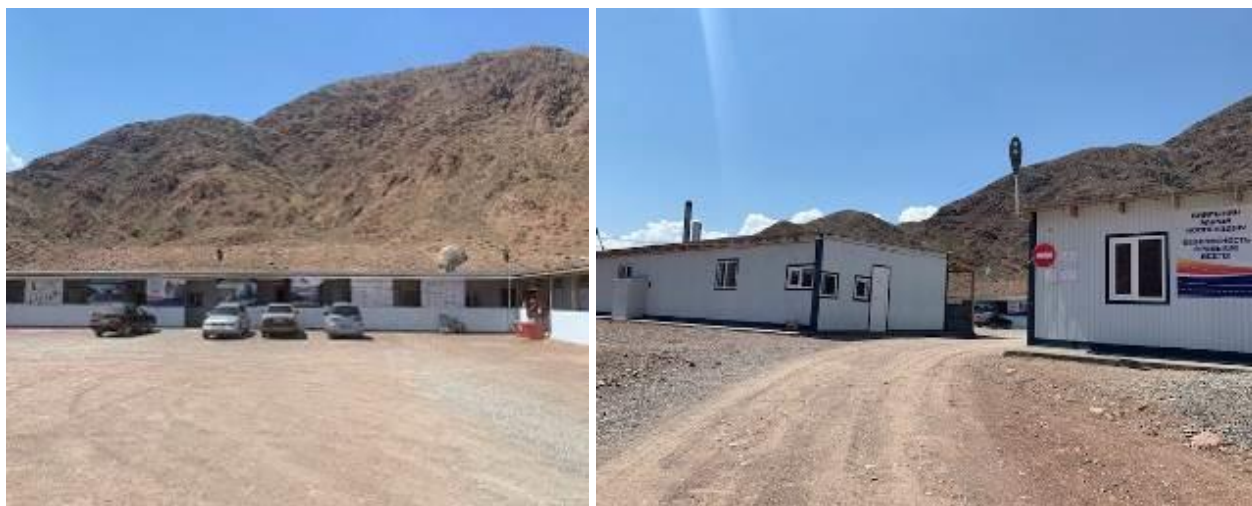
Photos 30, 31. Lot 1. Camp area.

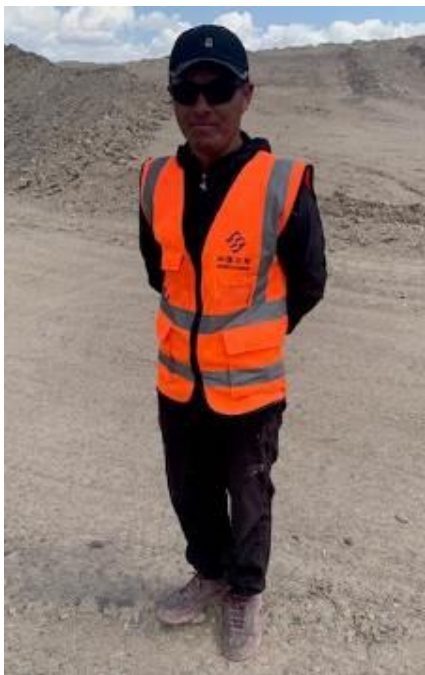
5	Finding workers at construction sites without personal protective equipment (photos 55-56).	Provide all employees with personal protective equipment (special protective clothing, footwear, helmets, noise protection equipment, respiratory protection, etc.) according to work specifics	Contractor "Sinohydro" Urgently	<u>Done</u> Additional monitoring will be conducted on this issue.
Lot 1				
6	On April 26, the storage of old asphalt was found on the area for a dump of unusable soil at km 12 + 000 LHS of the road at 100m distance (Photo 57)	According to verbal instructions, the Contractor, within three days, ensured the removal of the waste of old asphalt to an authorized site for the disposal of waste of old asphalt concrete. Issued April 26, 2021r.	Deadlines Until April 29, 2021	<u>Done</u> (photos 58, 59)
		Submit to Engineer all permits from the relevant local self-government bodies, the territorial administration of the State Committee for Economics and Control. Develop a plan for the	Deadline until May 20, 2021	<u>Done</u>

Photo 55. Crushing and screening plant worker with no appropriate personal protective equipment.

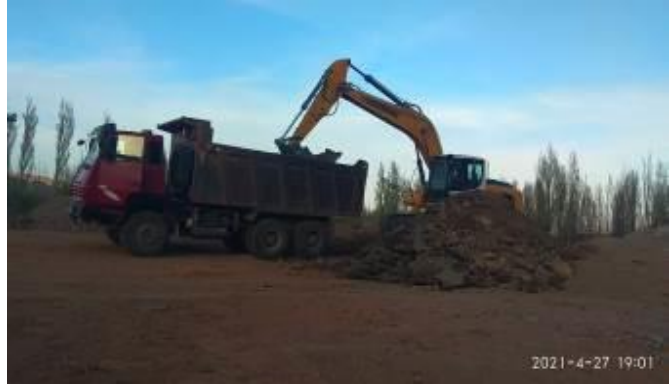
Photo 58. Lot 1. Removal of waste of old asphalt on a concrete.

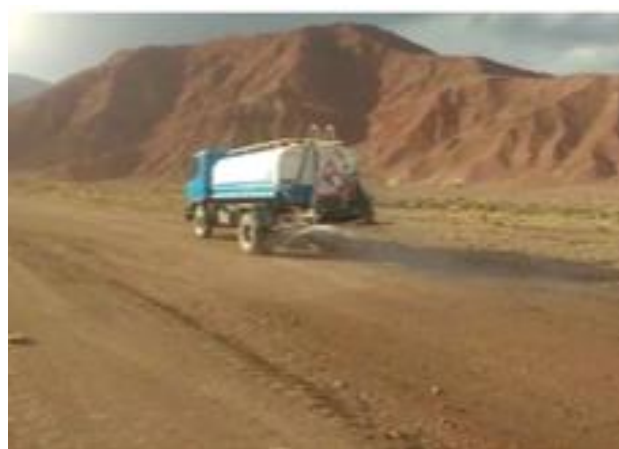
Photo 67. Pressure irrigation system.

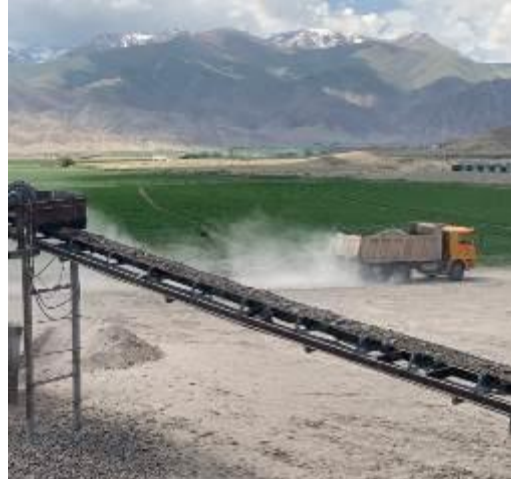
Photo 69. Lot 2. Lack of watering earthen roads.

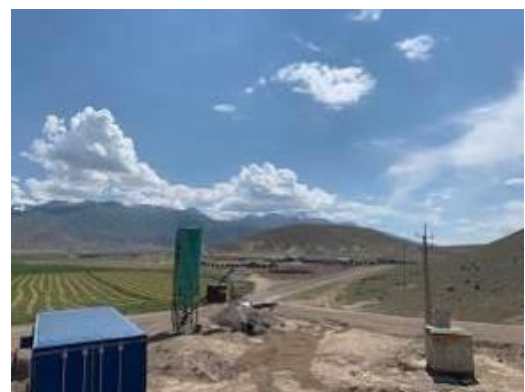
Photo 73. State of the production site of the crusher plant after watering.

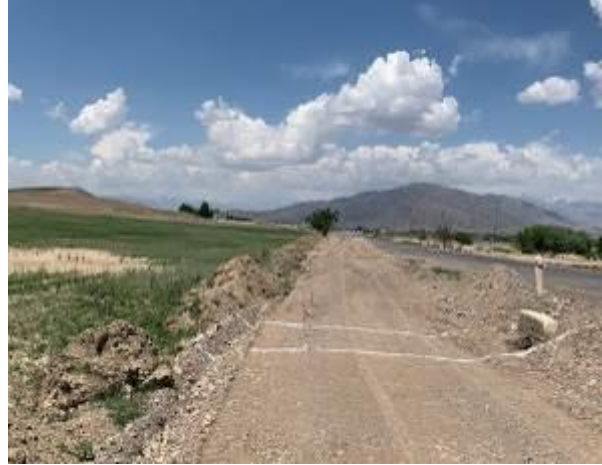
Photo 79. The area after cleaning km 75.

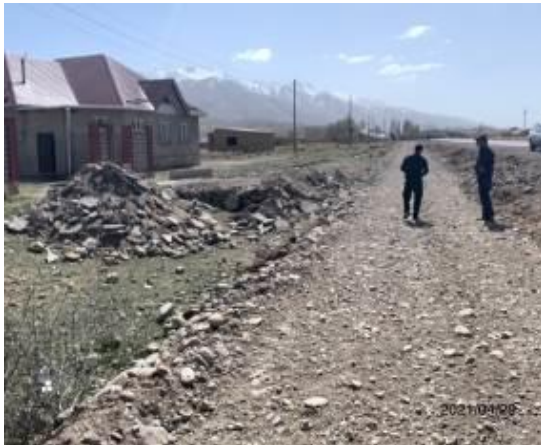
83. During the discussion of this situation with the owner of the house, he informed that he has no claims against the Contractor, since he agreed to partial demolition of the entrance to the house and agrees, for the benefit of the road construction, to temporary inconveniences until the completion of the road construction, since he has an entrance to the house from the other side.

Photo 83. Violated passage to the house.

84. In accordance with the verbal instruction, the Contractor promptly provided safe passage / passage to the house.

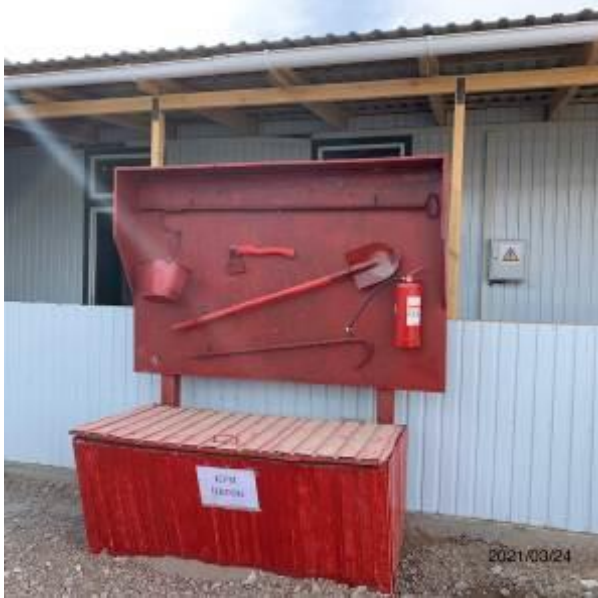
Photo 91. Lot 1 Shield with fire-fighting equipment.

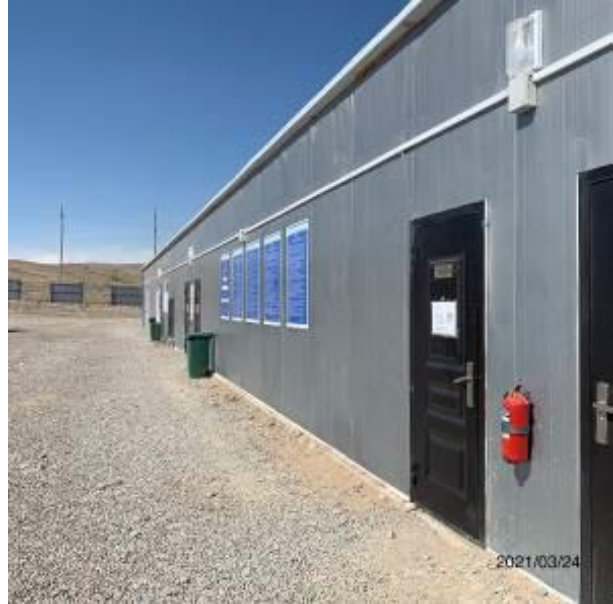
Photo 92. Lot 2. Fire extinguishers.

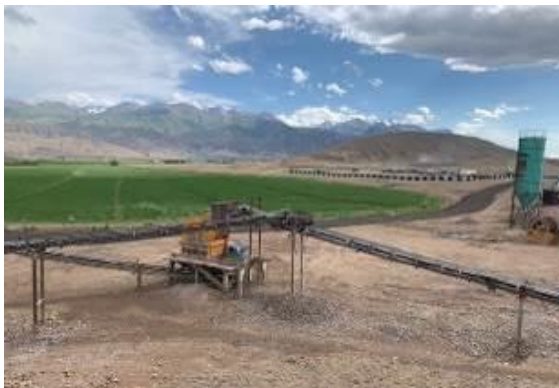
Photo 97 Lot 2. Poured technological earthen road to crusher plant Km 81 + 200.

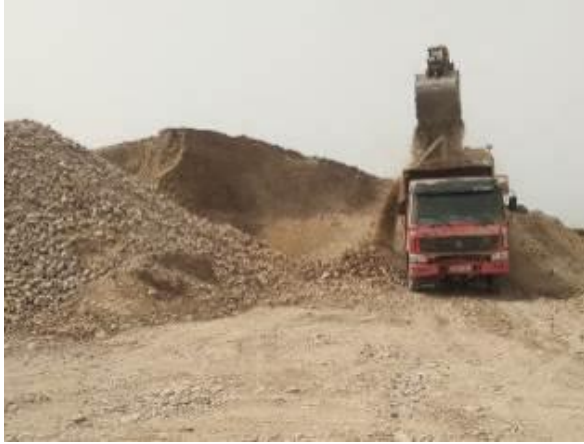
Photo 99. Lot 2. Loading of material at the quarry km. 75 + 400.

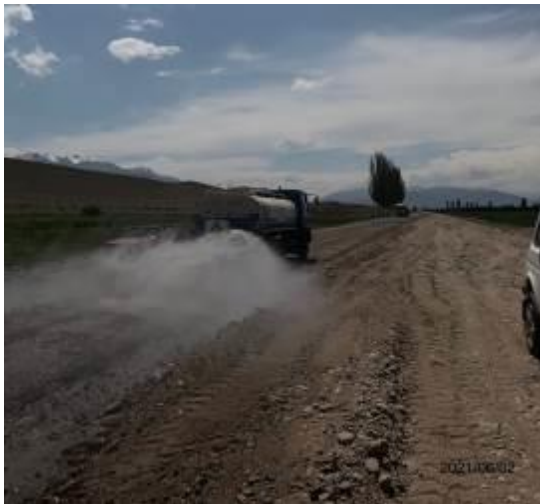
Photo 101. Lot 2. Hydraulic irrigation of the roadbed.

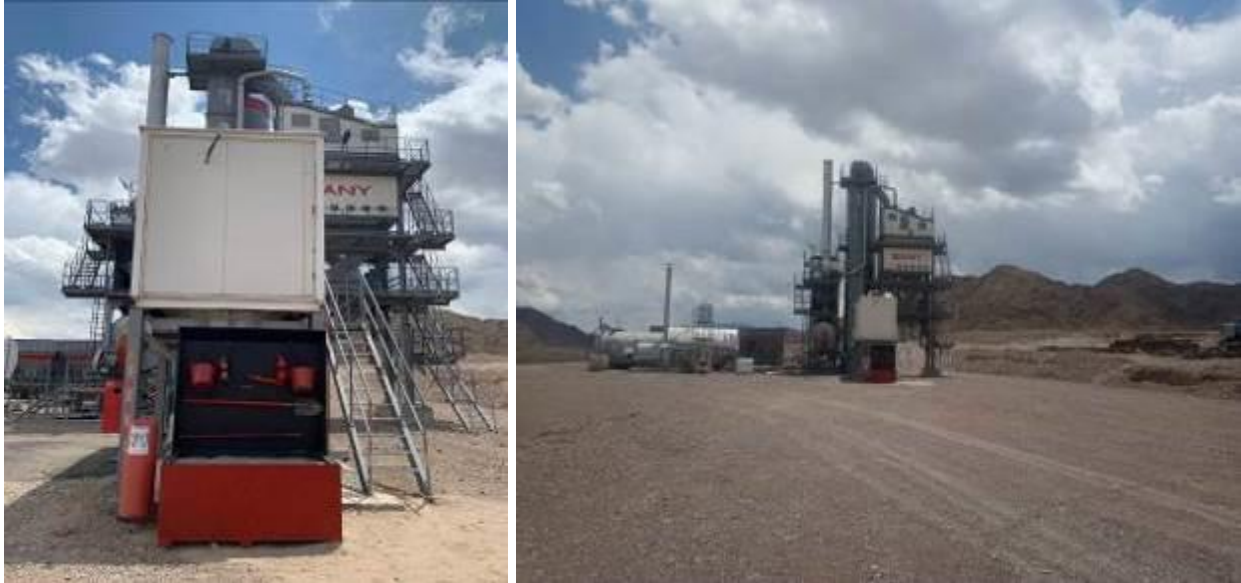
Photo 103-104. The state of the territory after the completion of the arrangement of the concrete plant.

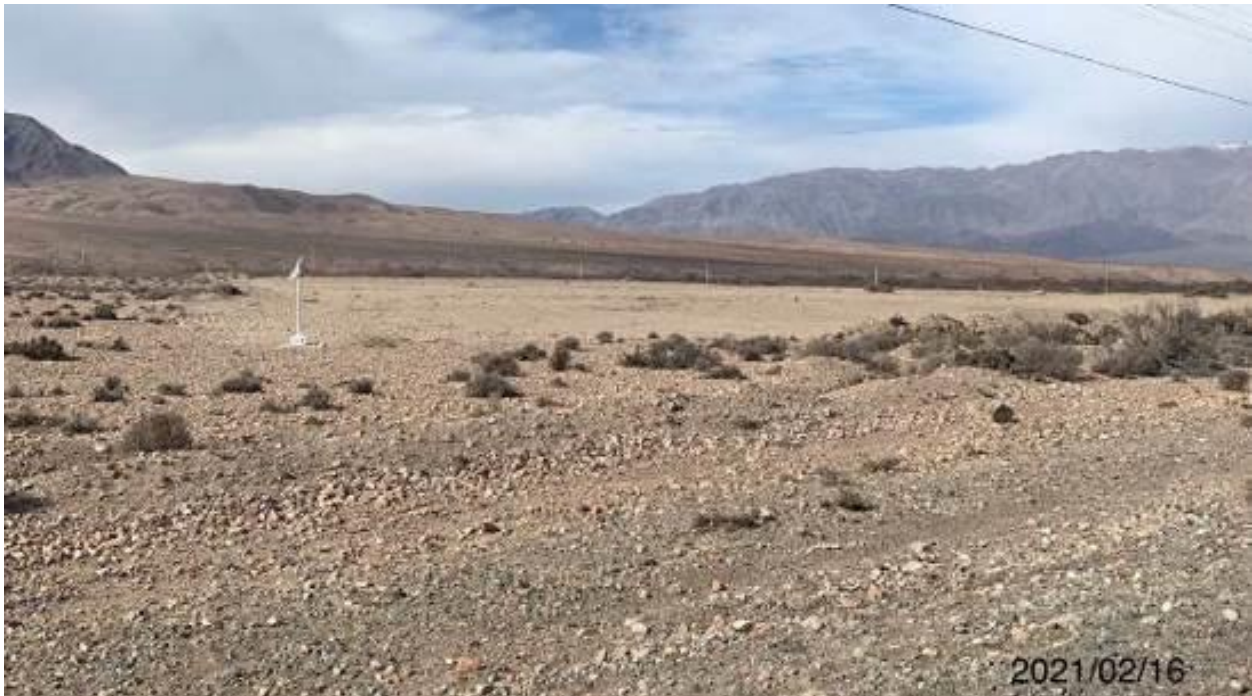
Photo 105. Lot 1. Quarry km. 9 + 000. The soil and vegetation layer were removed, and the boundaries of the quarry territory were marked by installing white racks with flags.
