Project Number: 45169-001
Loan Number: ADB Loan 3056-KGZ (SF)
Grant Number: 0366-KGZ (SF)

Semi-Annual Environmental Monitoring Report
July 1 – December 31, 2019

CAREC Corridor 3 Improvement Project (Bishkek – Osh road), Phase 4 (km
15.9-61)

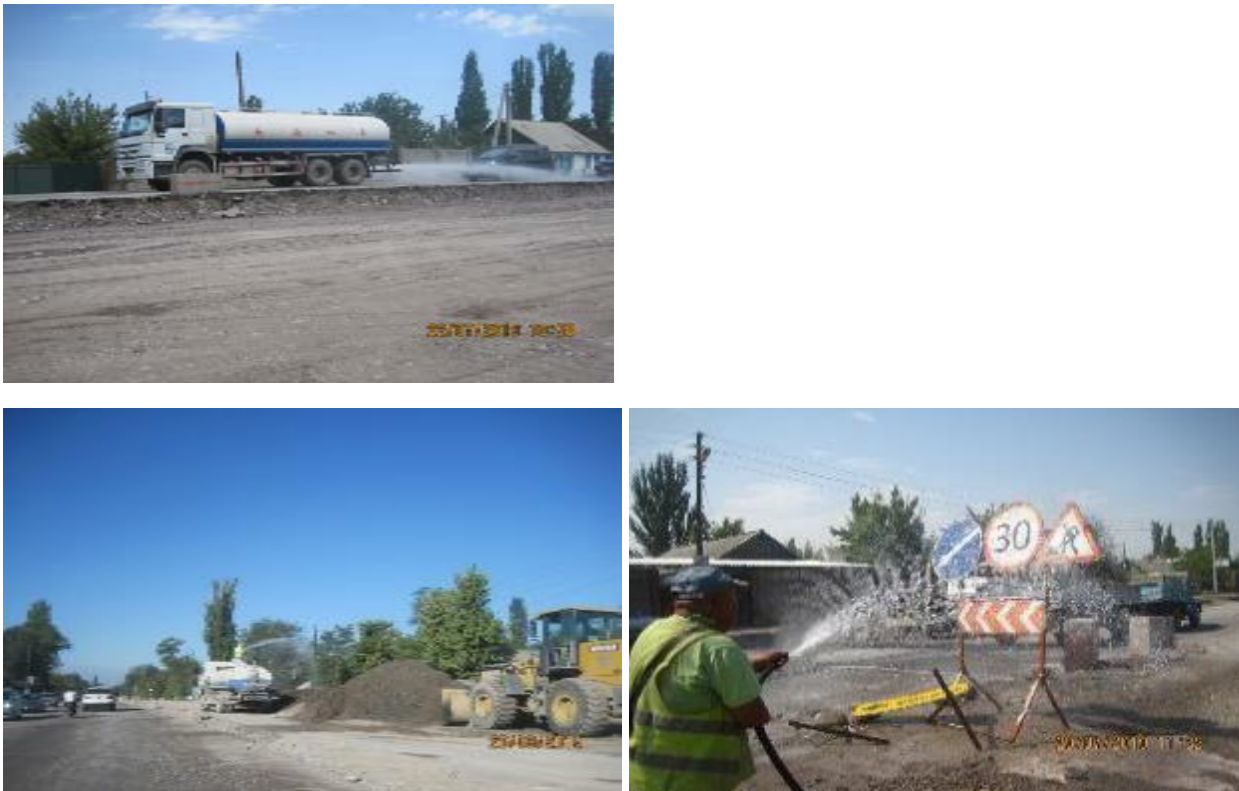
24. With the onset of hot weather, regular water sprinkling of these areas was arranged, but given the hot weather, there was still dusting on the road. 6 water sprinkling machines were operated on the road.

Figure 9 Road water sprinkling

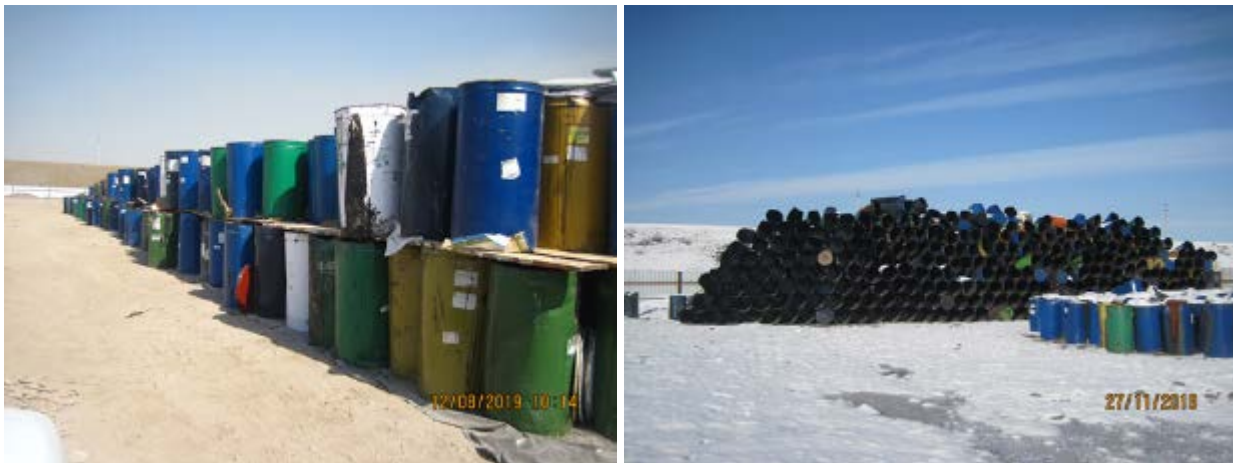
46. Recently, a large number of drums with bitumen have been delivered, which are partially placed on a specially prepared site. A large number of drums are placed on the ground covered with a waterproofing material.

Figure 21 Drums with bitumen and empty drums at the plant area

47. Empty and full drums of bitumen are placed on a specially prepared site. A large number of empty bitumen drums and metal lids have been accumulated (Figure 14) on the site (although not contaminating the ground). The contractor plans to use part of the empty drums as a temporary arrangement in the areas where the work is being done, having previously painted them and covered with reflective tape. The engineer gave the Contractor instructions on the need to dispose unused empty drums. This issue is at the decision stage.

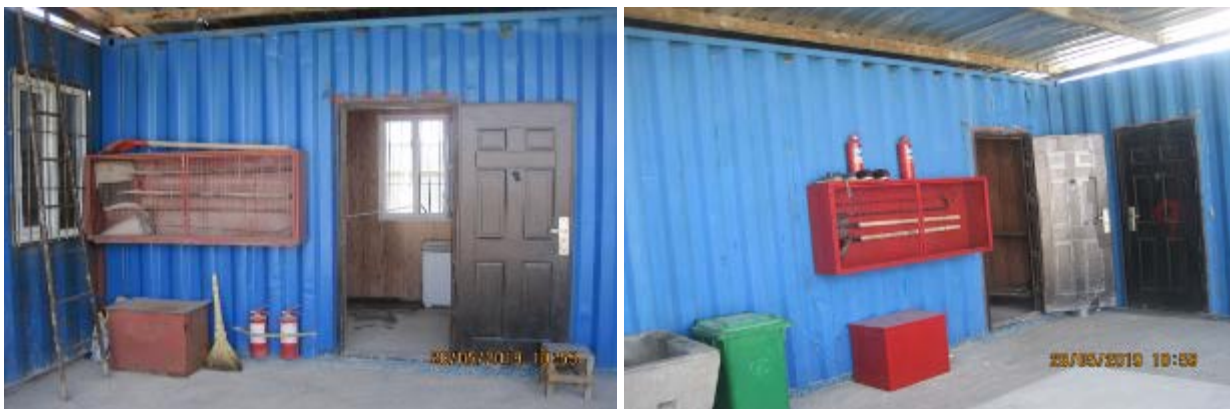
51. After a verbal warning about the need for a fire shield equipment, 2 shields were installed in the camp.

Figure 23 Fireshield equipment at the camp

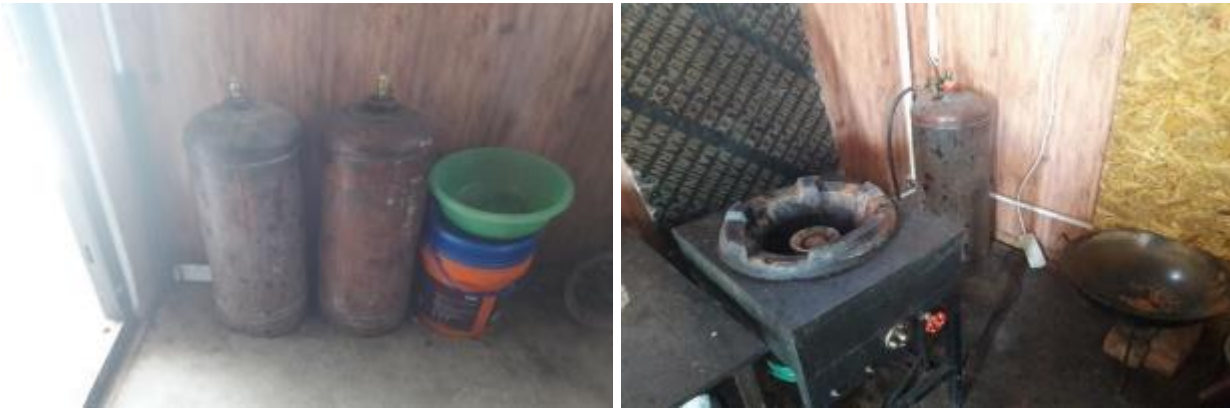
52. A warning was also given to remove gas cylinders from the kitchen and place them in metal cabinets on the street, but this warning was ignored.

Figure 24 Gas cylinders placed at the kitchen room

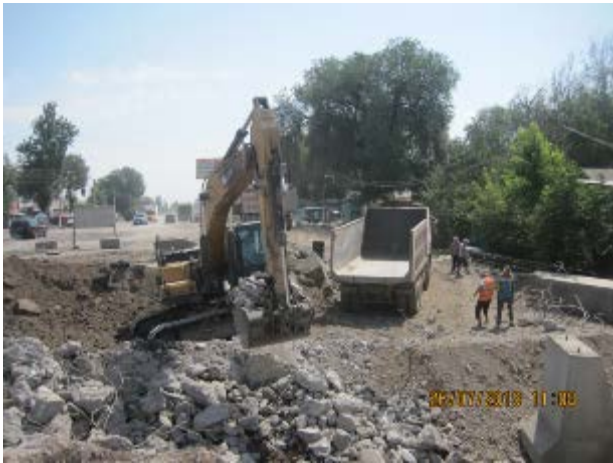
82. During the reconstruction of bridges and pipes, old reinforced concrete products are accumulated on the road shoulder, which are removed and disposed of as soon as construction is completed. Places for disposal were determined by local authorities.

Figure 31 Waste accumulated during the construction of the bridge

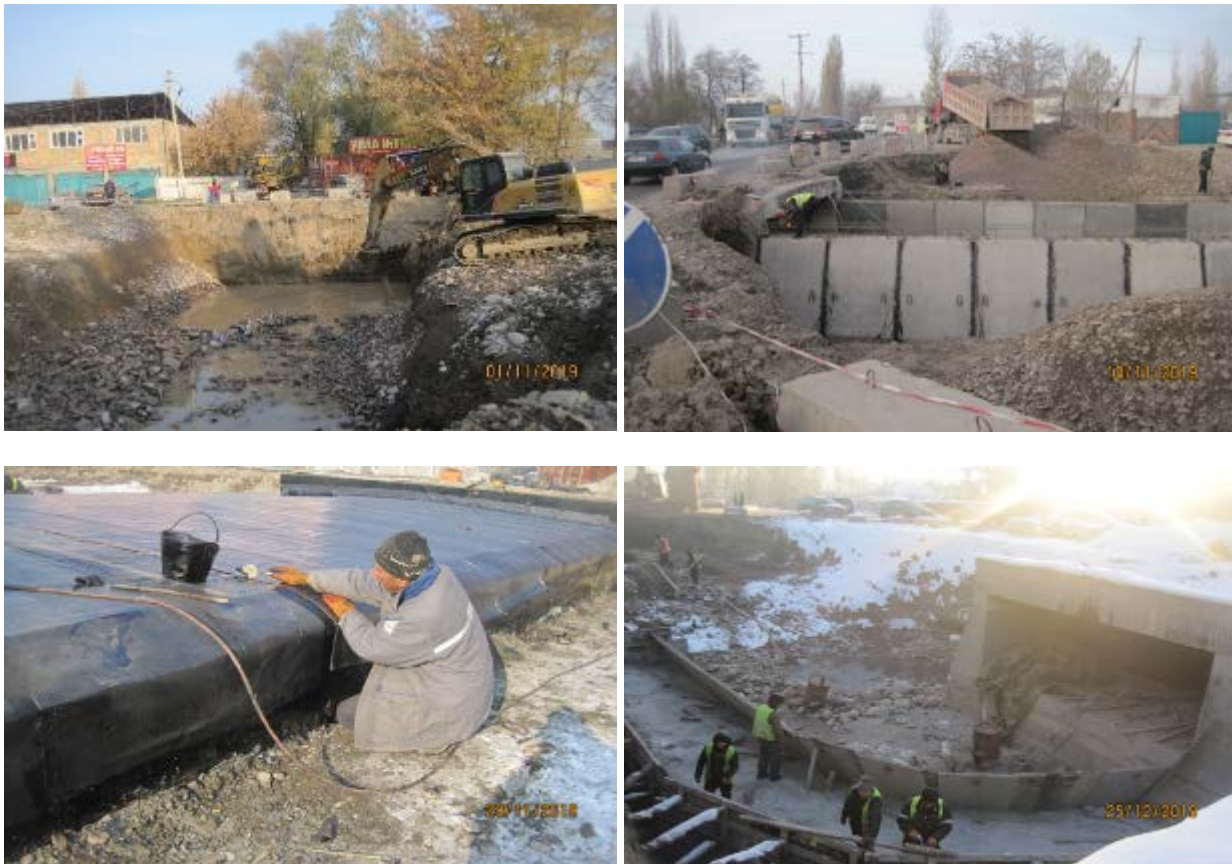
89. Appearance of the ground water in the Jantai canal is complicated construction.

Figure 36 Construction of Jantai bridge

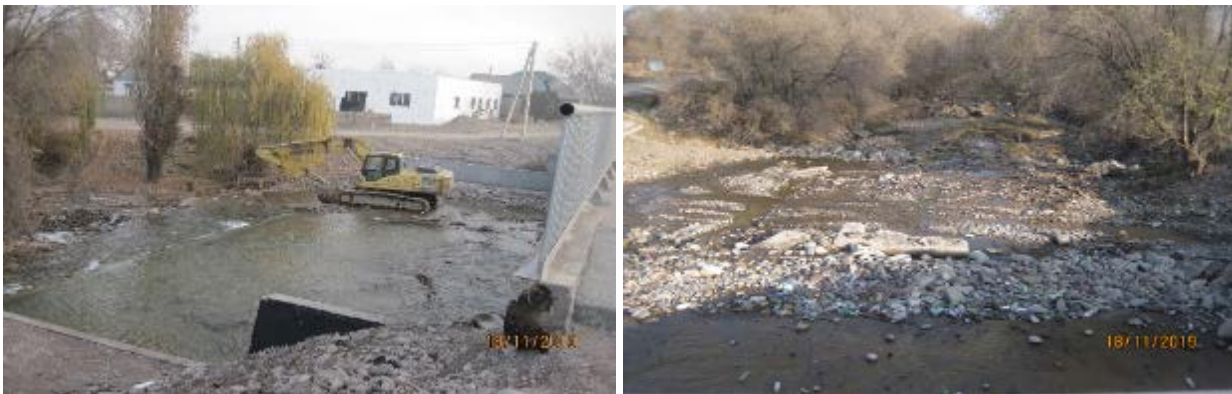
91. Construction of the bridge at the Sokuluk river is almost completed. The riverbed on the north side of the bridge has been cleared from construction waste. On the south side of the bridge, bank protection works were carried out and the riverbed was cleared from construction waste.

Figure 39 Cleaning the Sokuluk riverbed from construction waste (north side)

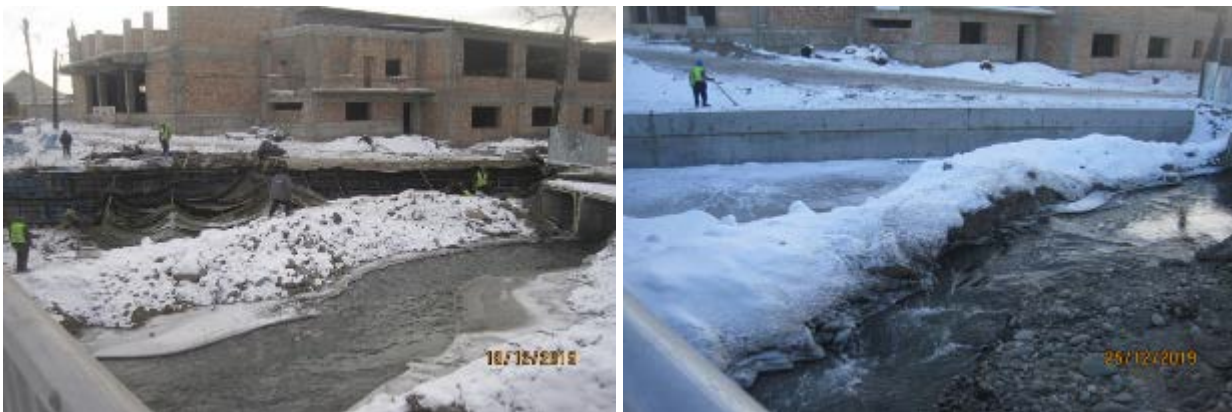
Figure 40 Bank protection works at the Sokuluk river (south side)

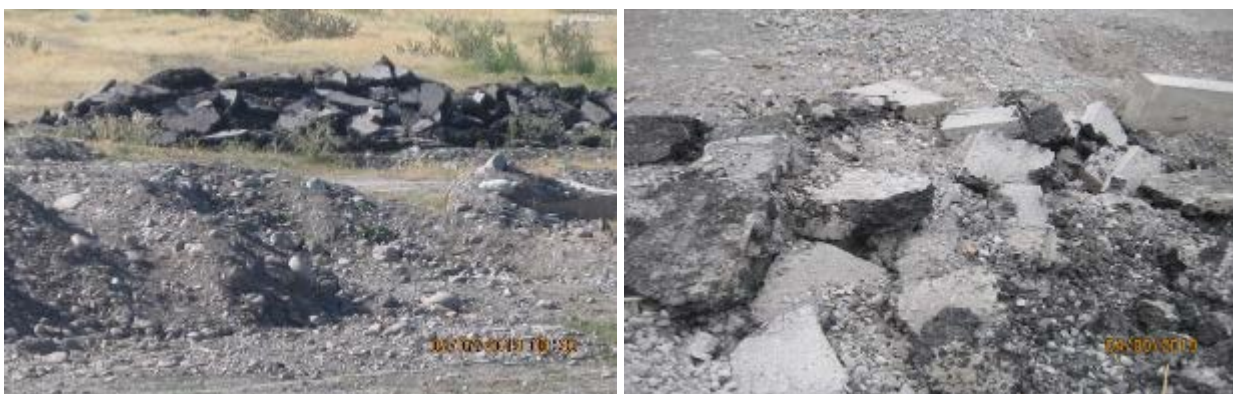
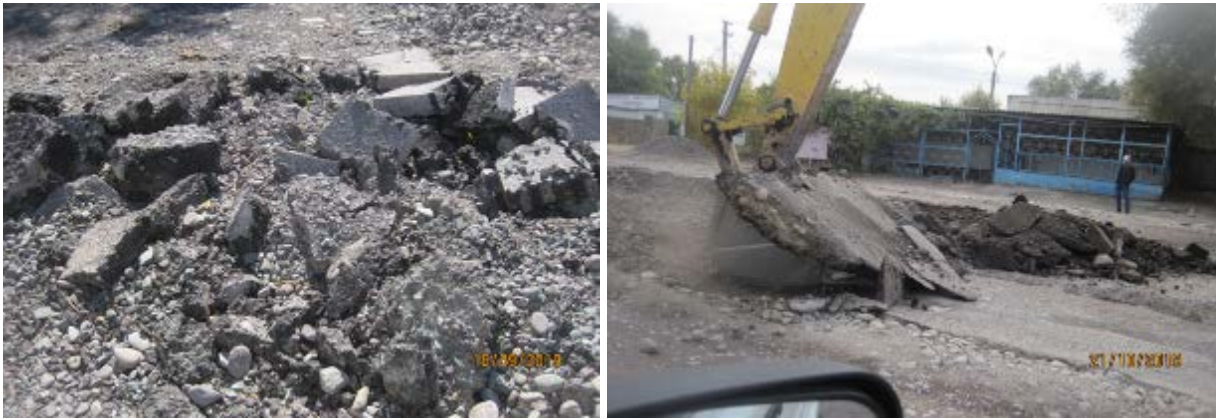
Figure 49 Old asphalt removal

113. The problem of crushing old asphalt to the size of 20x20 remains unsolved. Not crushed old asphalt is taken out to fill rural streets proposed by local authorities. Partially asphalt and unsuitable soil, at the request of the owners, is taken to private land plots oriented / intended for commercial use. The owners level the private plots themselves. The levelling of streets after backfilling is carrying out by Contractor's bulldozer and loader, but the quality of backfilling and leveling of these streets does not always meet the established requirements. Uncrushed pieces of asphalt remain on the road shoulder. There are uncrushed asphalt pieces on the road shoulders also. Contractor is given instructions to correct the identified defects.

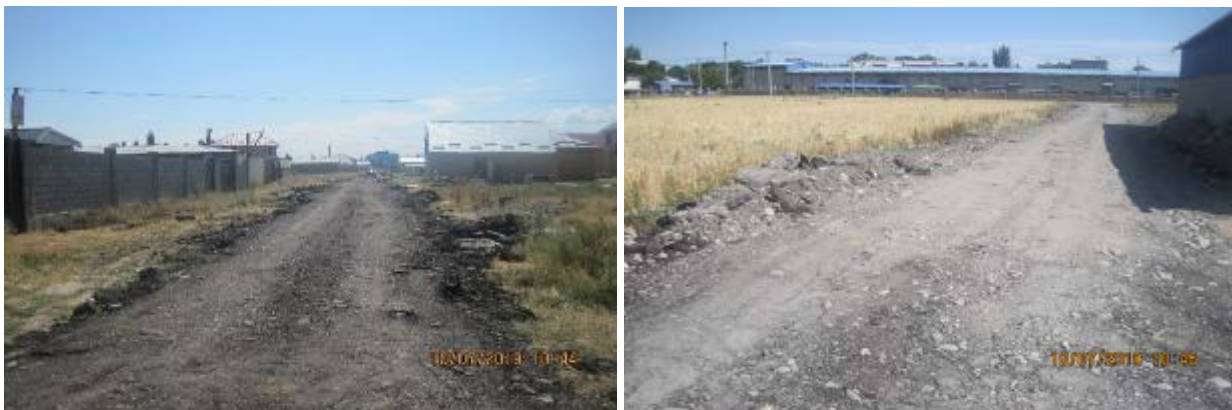
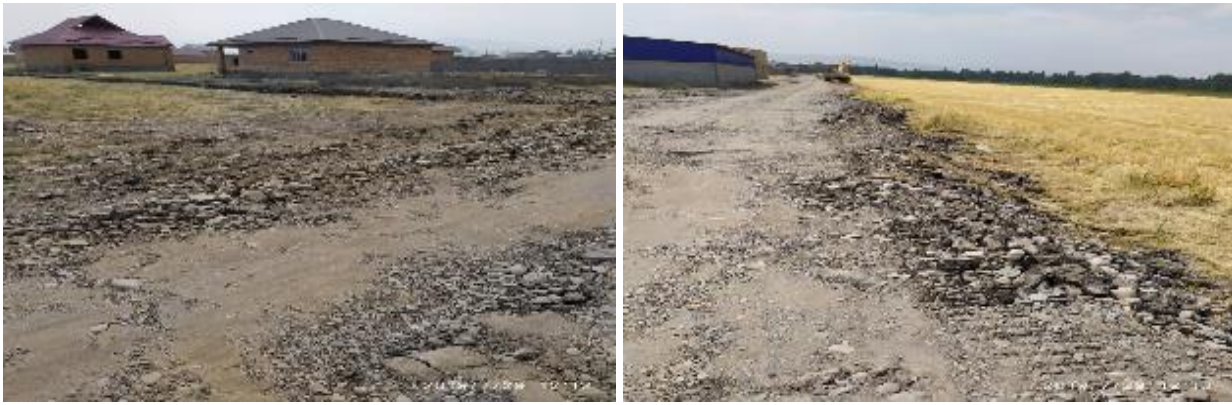
Figure 50 Old asphalt taken out to the area of Yntymak residential area at the request of residents and representatives of the city hall of Shopokov

115. At section 5, local residents and representatives of the aiyl okmotu represented by the head of the Alexandrovka aiyl okmotu, appealed to the Contractor with a letter to take out the old asphalt to the production areas of this aiyl aimak, explaining that they need this old asphalt for patching roads inside the village of Alexandrovka. Therefore, the old asphalt in the village of Alexandrovka was taken out and stored on specially designated places. In the future, this asphalt will be used as necessary for the improvement of streets.

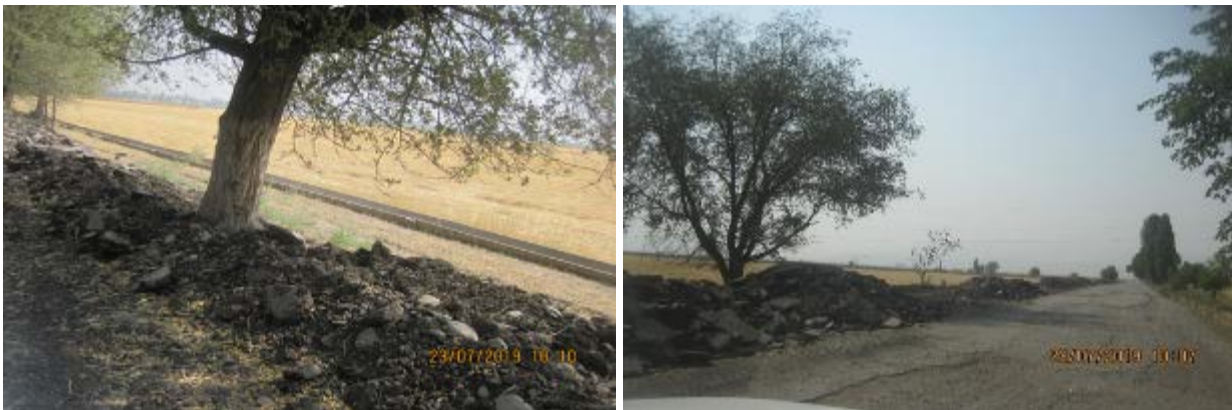
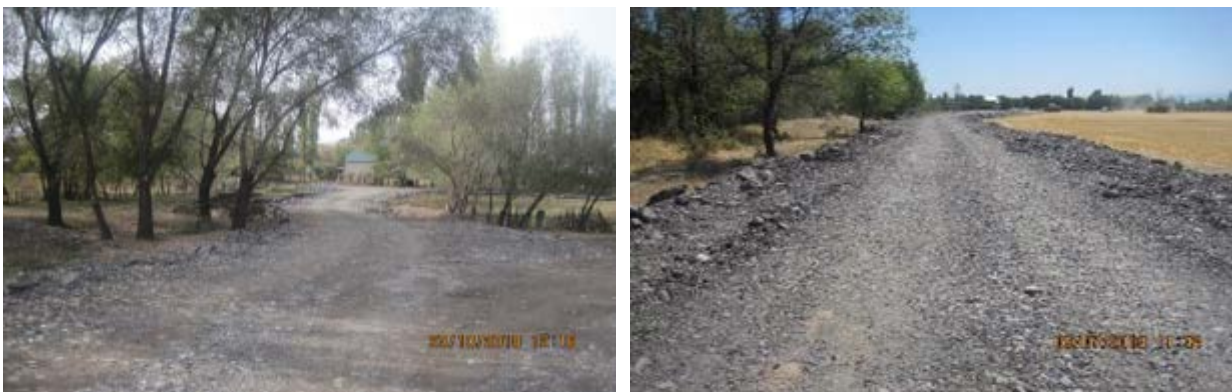
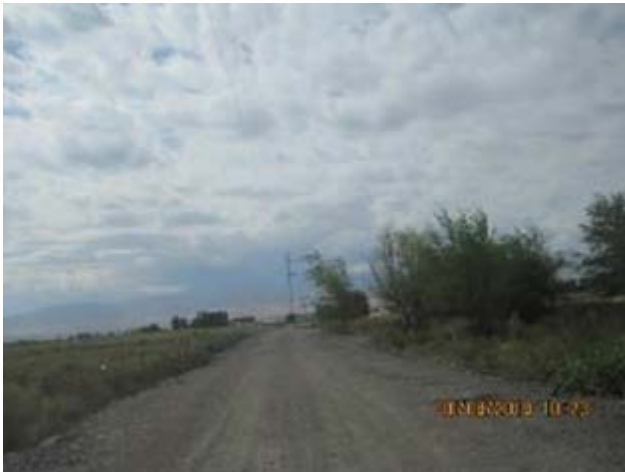
Figure 51 Old asphalt on the rural streets and field roads

116. The old asphalt from the village of Sadovoe was taken to the road leading to the military unit of the Ministry of emergency situations. It was found that some tree trunks were filled when the old asphalt was leveled. A letter was sent to the contractor indicating the violations and the issue was resolved within the specified time frame.

117. The old asphalt in the village of Belovodskoe was taken to the streets specified by the local administration.

118. Also, old asphalt was taken out to field roads. The old asphalt was not taken out to the wetlands. A letter was received from the ADB stating that in order to avoid harm to the health of local residents, it is forbidden to give old asphalt to local residents for their own use. This requirement has been met and will be monitored in the next construction season.

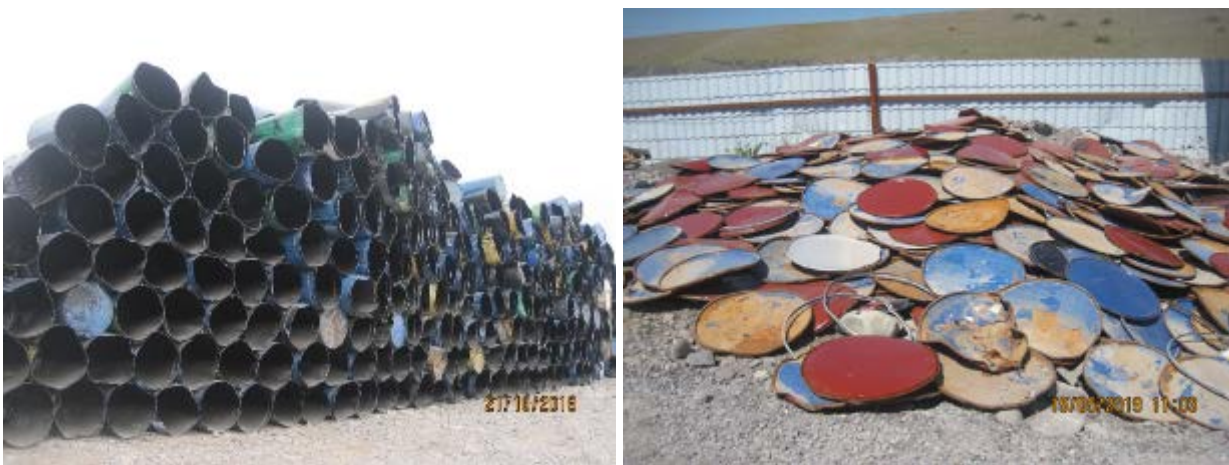
Figure 52 Storage of empty bitumen drums and lids

119. Production waste is also generated during the road construction. These are old tires, empty drums of bitumen. According to the Contractor's information the drums will be sent to the plant for reuse.

120. In the camp of Belovodskoe village, a large number of old car tires are stored on the camp site. It is necessary to take measures for their removal and disposal. If there is no possibility of recycling, Contractor should involve a specialized company. The contractor explains that the issue of old tires will be resolved by April 2020. The contractor is looking for a specialized company that can take out the accumulated tires for the further disposal.

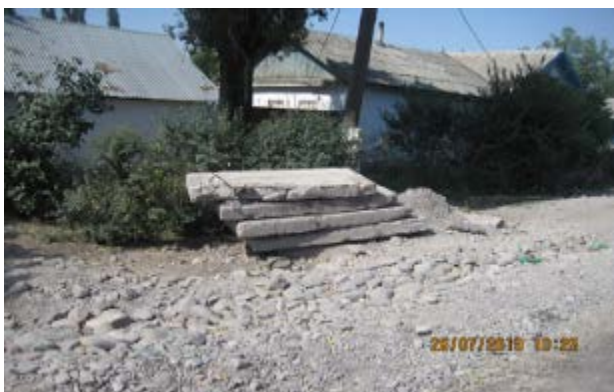
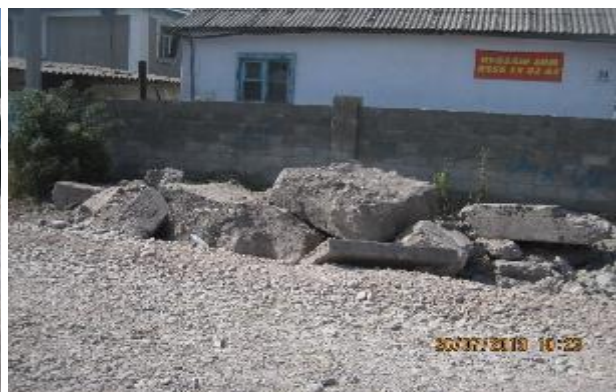
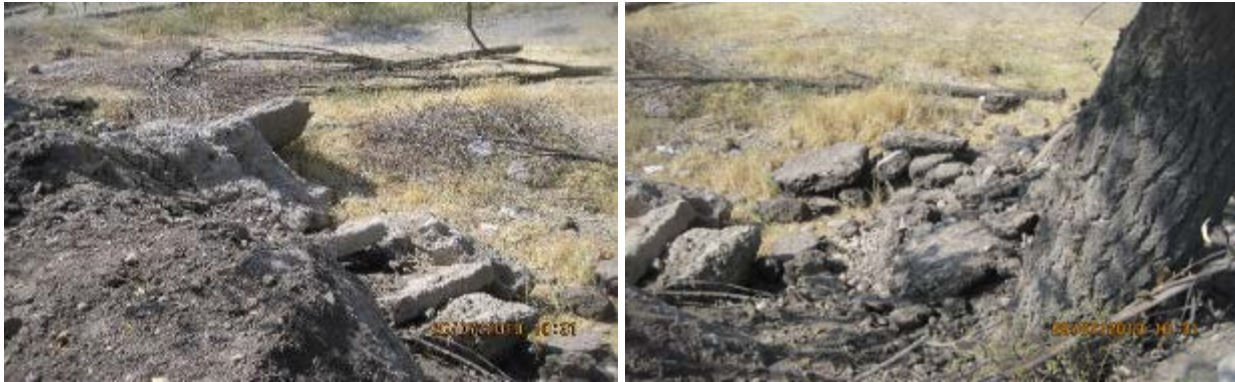
Figure 62 Construction reinforced-concrete waste

149. Reinforced concrete construction waste is generated during the dismantling of bridges and culverts.

150. Initially, construction waste was promptly taken out to the designated RMU-9 sites for the storage of old reinforced concrete products. With the increase of construction work, the allocated sites could not store all the waste, and there was a problem with determining where to store reinforced concrete waste. In the spring of 2019, together with the local authorities, places were determined for the placement of old railway products. Removed unsuitable soil can be taken out to these places.

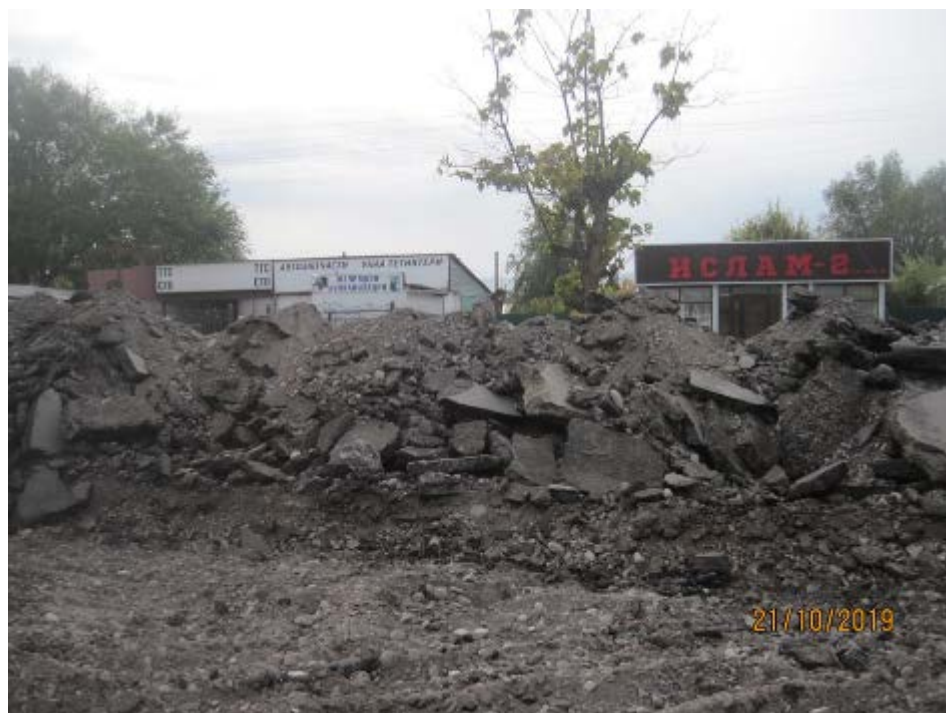
Figure 63 Old asphalt removed from the roadbed

154. During the reporting period, 65051.12 m³ of old asphalt was removed and taken out during construction works. 128805.2102 m³ of unsuitable soil was also removed.

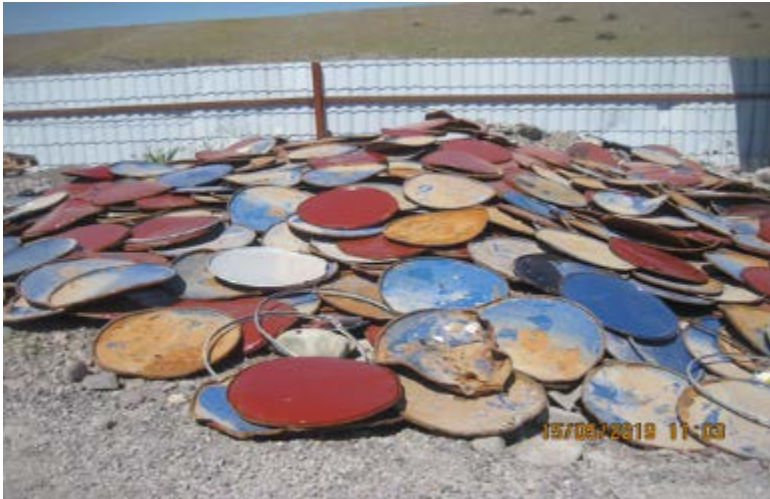
Figure 64 Waste at the asphalt plant area

157. During the production of asphalt, waste is generated on the territory of the asphalt plant. Most of these are empty drums of used bitumen. Empty drums are stored in the plant area. Currently, a large number of used drums and metal lids have been accumulated on the territory, which must be disposed of. According to the Contractor, empty drums that have not been dented during use are returned to the bitumen manufacturer's plant. The remaining drums are partially used during roads construction work, partially sold to the local community.

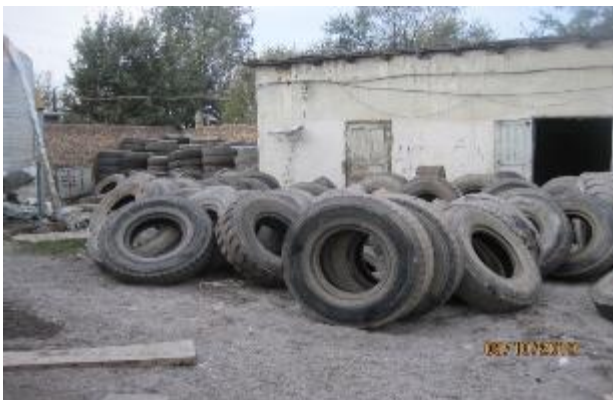
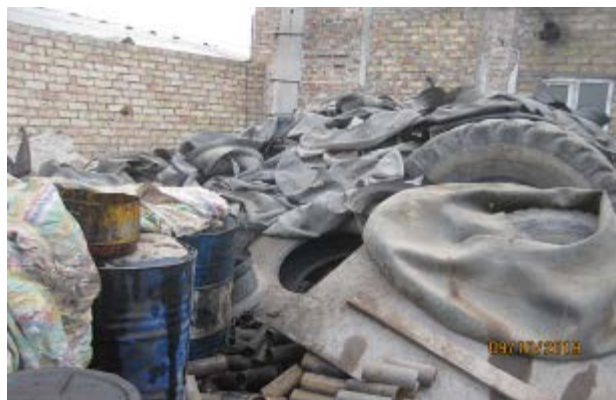
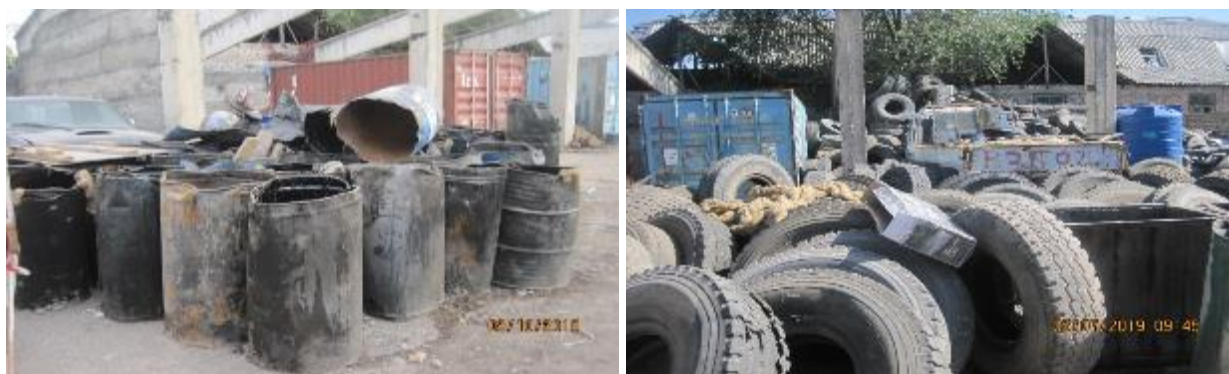
Figure 66 Production waste at the Belovodskoe

158. In Belovodskoe, a large number of old car tires are stored in the area of the plant. It is necessary to take measures for their removal and disposal. If there is no possibility of disposal, Contractor should involve a specialized company.

159. A letter was sent to the contractor about the removal of waste.

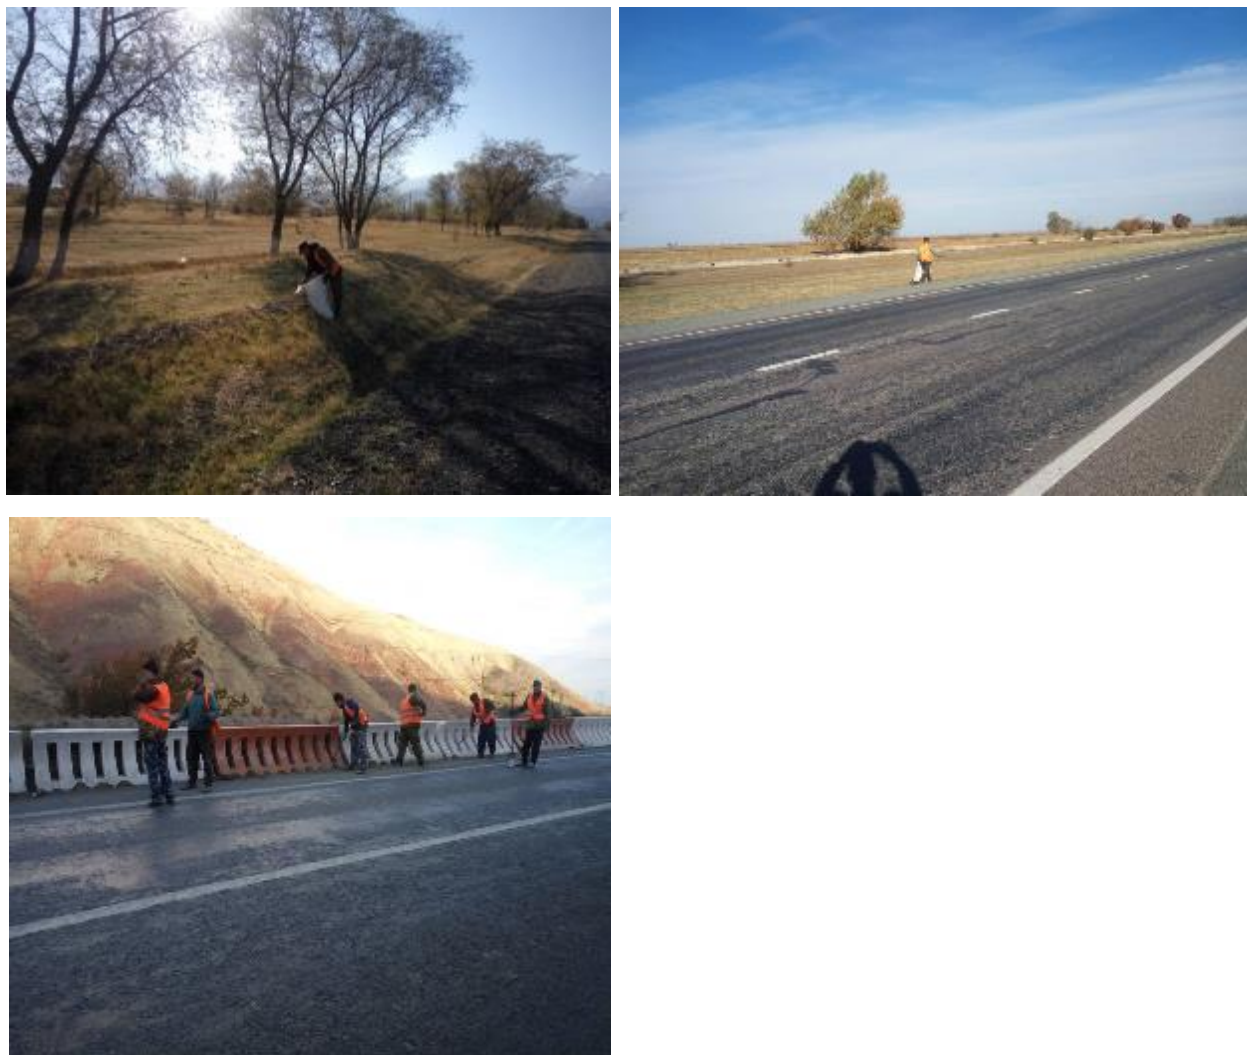
Figure -7. Garbage collection along the road
