Project Number: 45169-001  
Reporting Period: January 10 June 30, 2019

Semi-Annual Environmental Monitoring Report: January 1-June 30, 2019

Kyrgyz Republic:  
CAREC Corridor 3 Improvement Project (Bishkek-Osh  
Road), Phase 4 (Km 15.9-60)

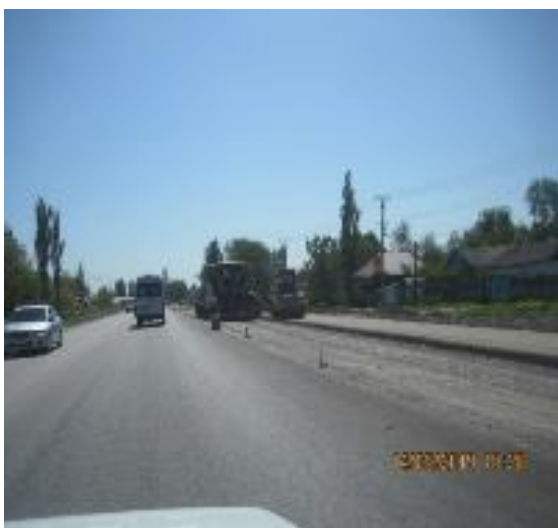
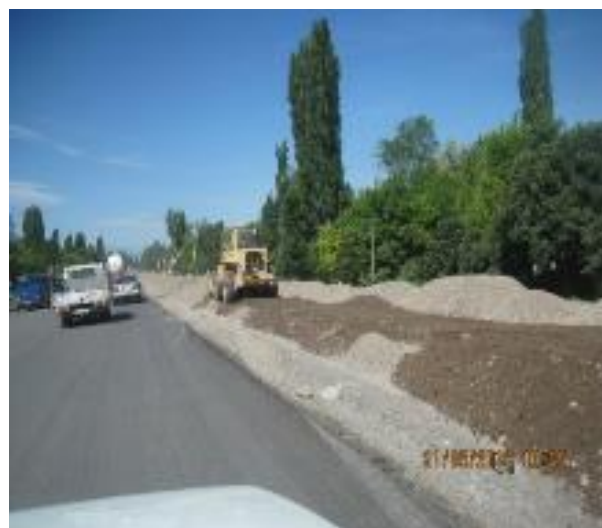
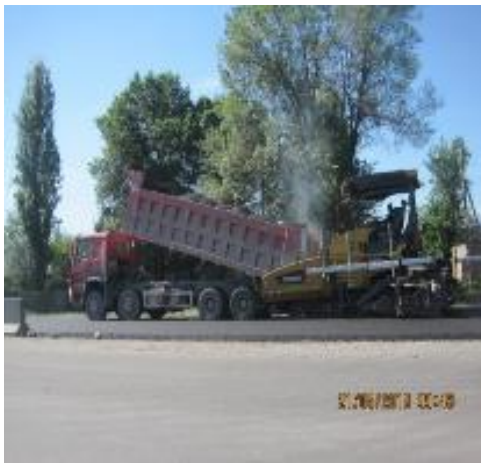
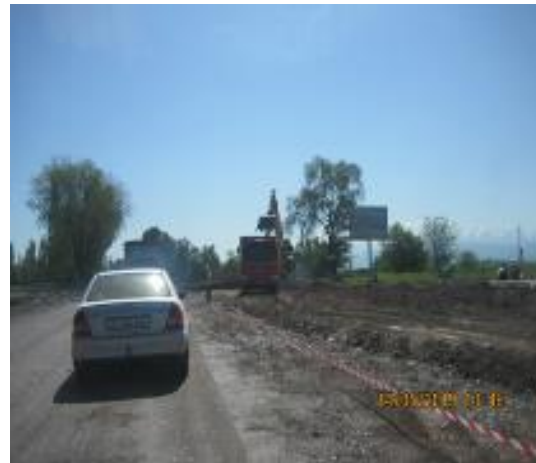
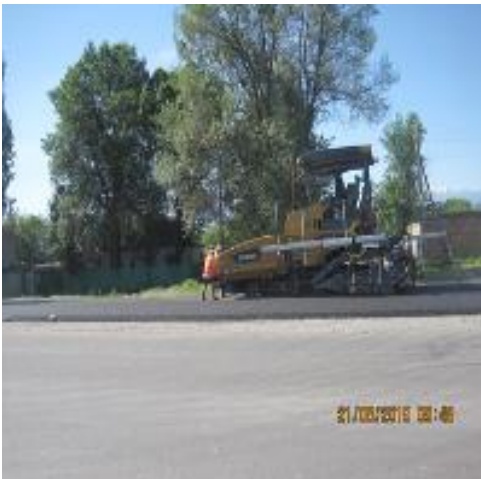
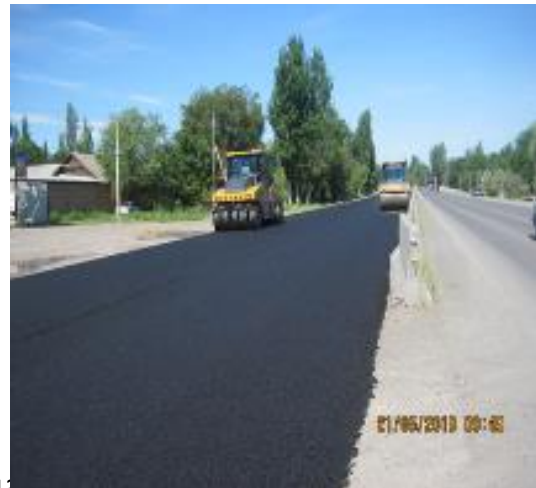
40. **Figure 4)** at all sections of the road (Figure 2). Asphalt is being down in Sections 1.4,2.3 and 2.4.

**Figure 4. Road construction underway.**

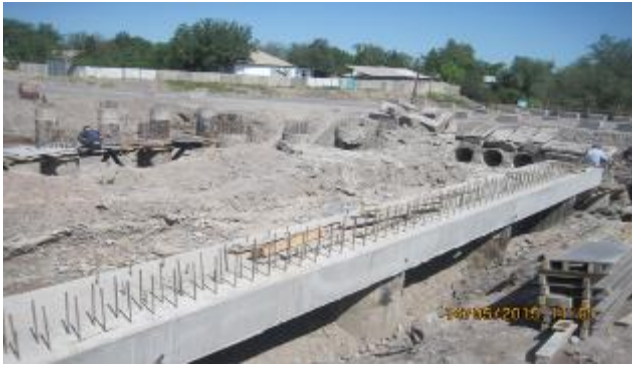
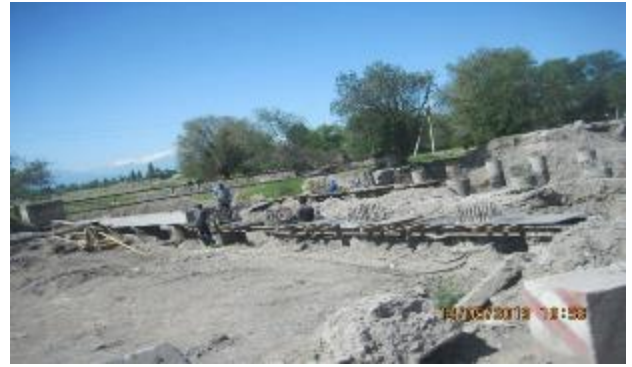
43. During the reporting period, work continued on the construction of bridges over the rivers Ak-Suu and Sokuluk, and mudflow channel from the river Ak-Suu. Bridges over the river Sokuluk and mudflow channel from the river Ak-Suu is almost completed and soon traffic will open along them. Preparatory work began on the construction of the bridge over the bypass channel "Krepostnoy" (Figure 6 and Figure 7).

**Figure 6. Krepostnoy Channel Bridge and Ak-Suu River Crossing**

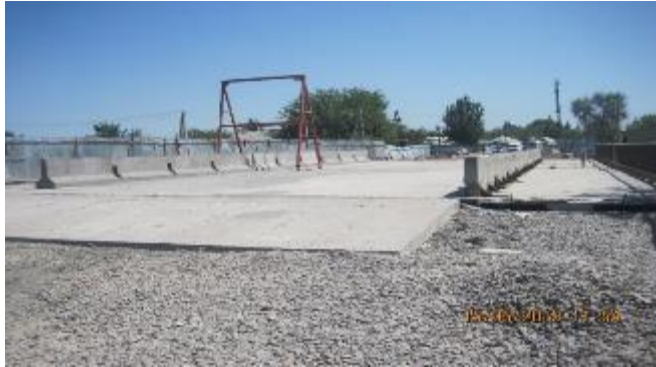
**Figure 7. Bridge construction at the Sokuluk River**

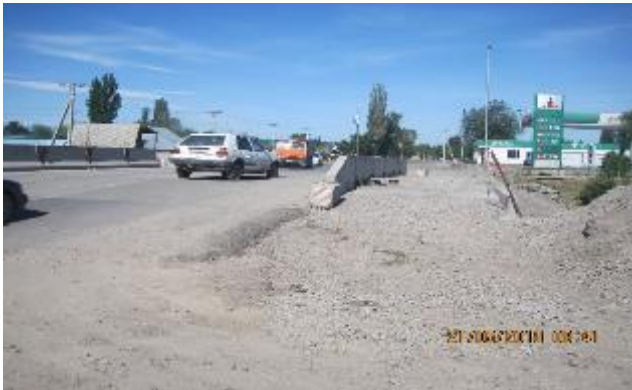
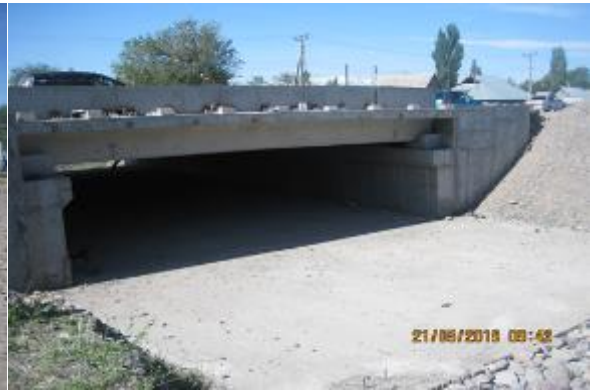
**Figure 8. Bridge construction at the mudflow channel from the Ak-Suu River**

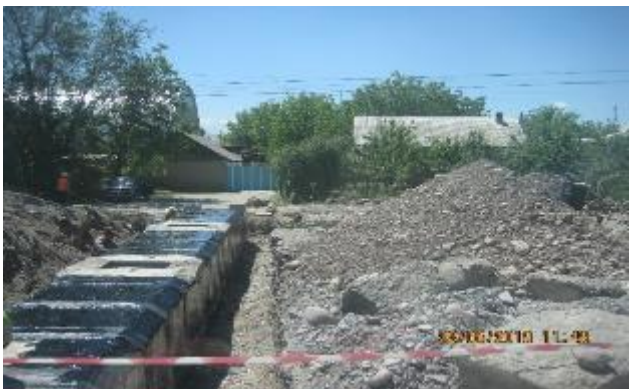
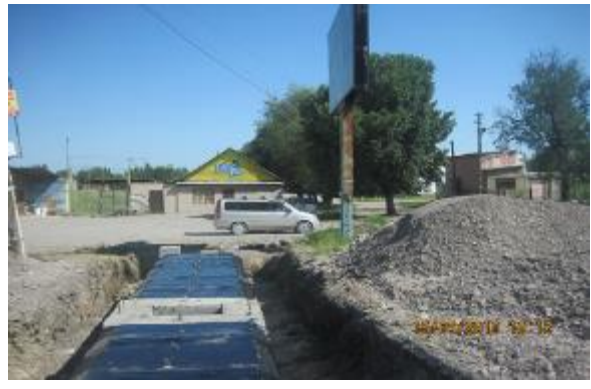
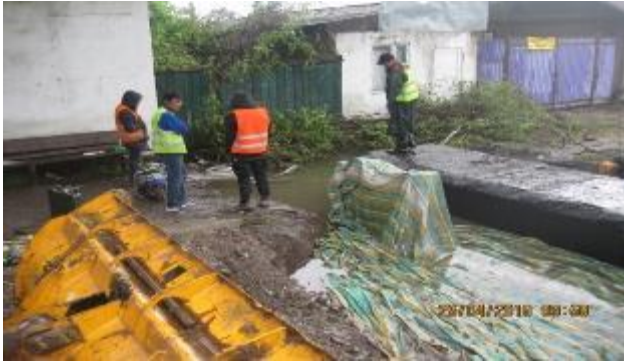
44. Intensive work continues on the reconstruction of culvert pipes in the six sections listed in Table 1. The proximity of groundwater complicates the construction since it must be pumped at all times and

Depletion of nearby wells is a potential problem

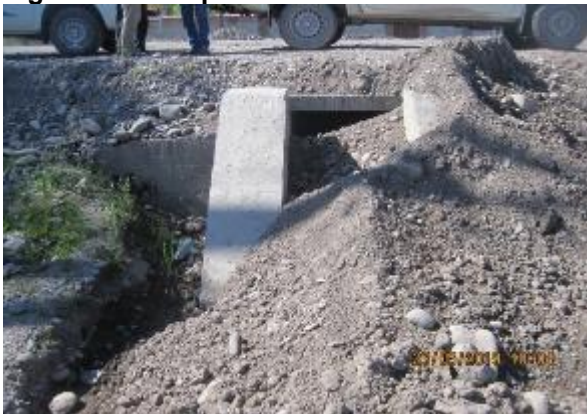
Figure 12. Newly built culvert blocked with construction debris.

49. During the field inspection some culverts remained blocked (**Figure 12**) and the contractor was given instructions and the construction manager has been notified to take immediate action. The contractor began work on cleaning up new culverts. The contractor is monitoring this issue to avoid inconvenience to the local population during the irrigation period.

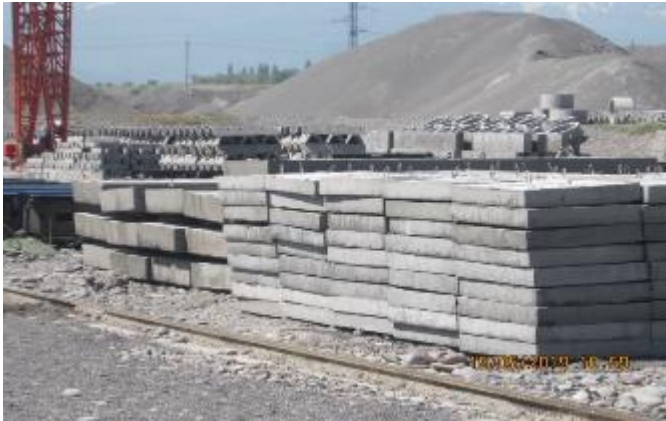
50. At the production sites, works on the crushing of raw materials and the preparation of stocks of materials continues. The casting of various reinforced concrete products for the road needs (concrete rings, chutes, Jersey dividers, supports for retaining walls, etc.) is on-going (**Figure 12**). In May, asphalt laying was carried out at sections 1.4, 2.3 and 2.5 (see Figure 2). As a result, the asphalt plant is working continuously.

**Figure 13. Concrete prefabrication yard.**

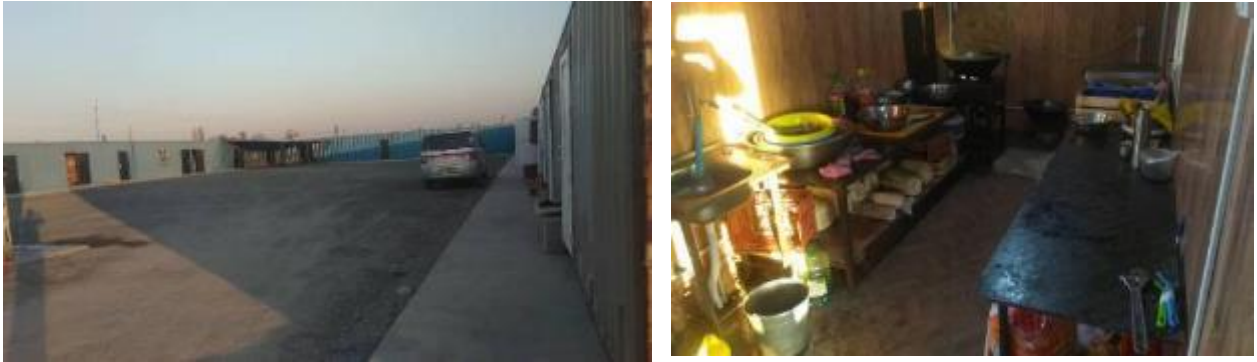
52. The workers' camp at Ak-Suu (**Figure 15**) accommodates 20 people. The camp has two fire fighting equipment stands. Each room is designed to accommodate two workers. The camp has a kitchen unit, equipped place for eating, showers, sinks, and toilets.

**Figure 15 Ak-Suu Construction Camp and Kitchen facility**

54. At the worker camps in the villages of Sokuluk and Belavodsk, household waste and sewage from septic tanks are disposed in a timely manner, and all protective measures for sanitary hygiene are observed. Periodic checks are carried out on compliance with environmental requirements. After an oral warning about the need to equip a fire shield, 2 shields were installed in the camp (**Figure 15**).

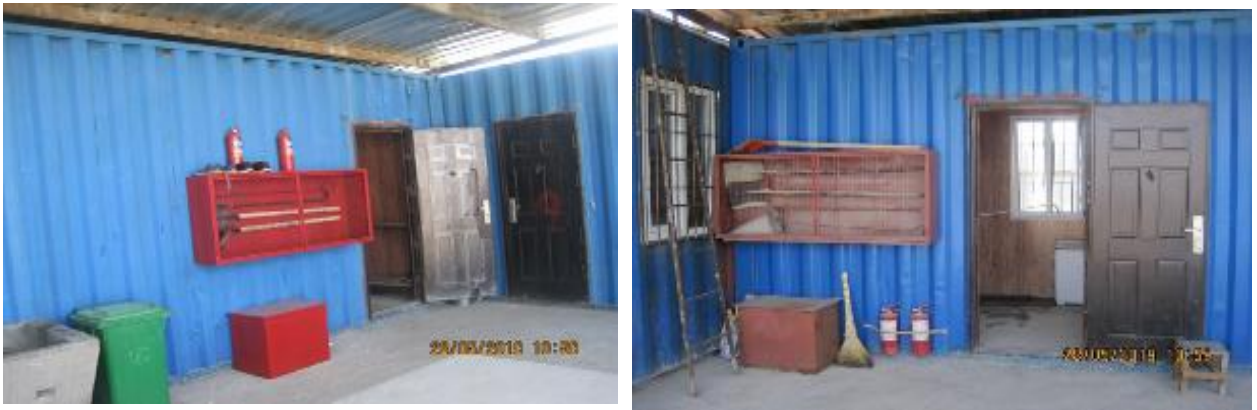
**Figure 16 OHS materials in front of worker Kitchen**

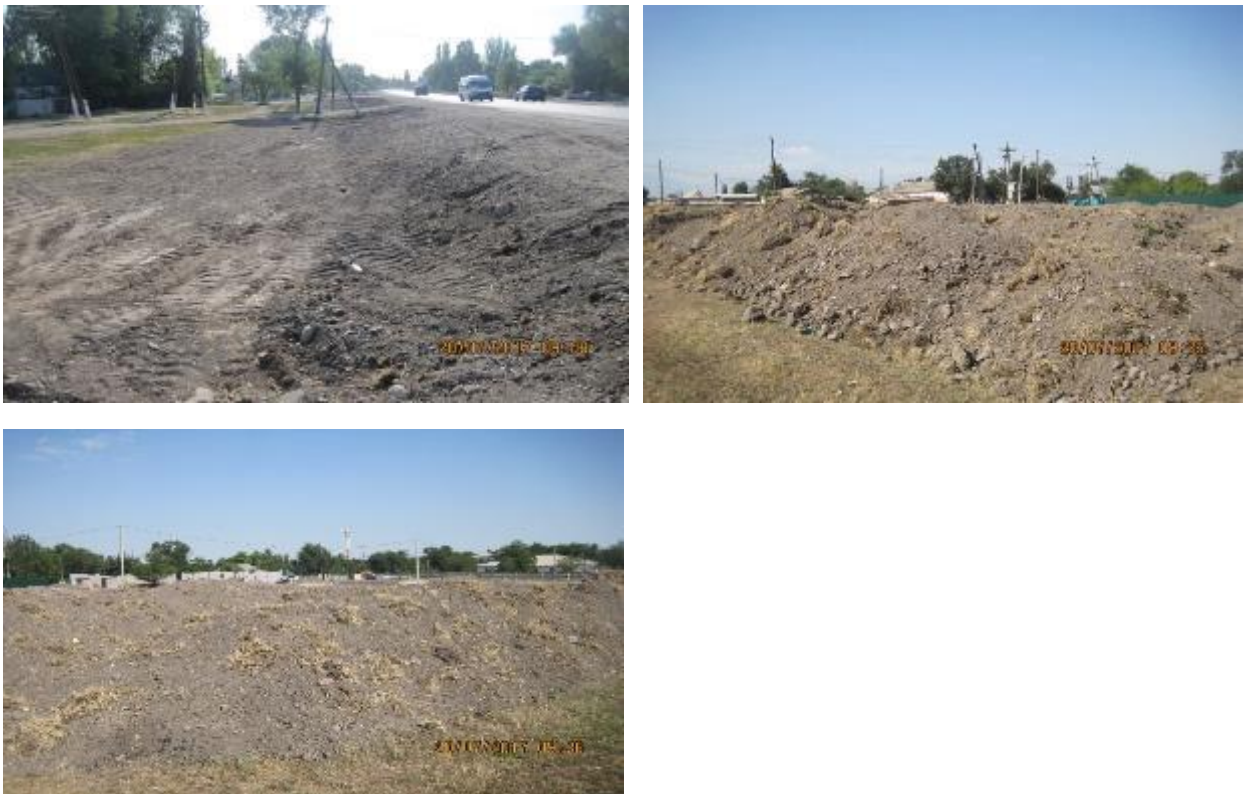
57. Topsoil removed and stored in special areas allocated by the local administration during the last reporting period remains in place, with smaller amount being taken by local contractors. After completion of the construction work, what remains will be used for backfilling slopes and landscaping.
58. Obtaining permission from the environmental authorities to remove topsoil in the construction corridor is not required. The contractor has obtained permission from local authorities to store topsoil in several sections. Embankments of topsoil are kept at a height not exceeding 1.5 m and maximally protected from the impact of elements (**Figure 18**), mainly, from a wind during the dry construction season. Currently, topsoil is removed on an area of 1,5 hectares. Currently, the total volume removed has not changed from the previous reporting period, namely 30, 000 m<sup>3</sup>.

**Figure 18. Topsoil Placement and Storage along the Alignment**

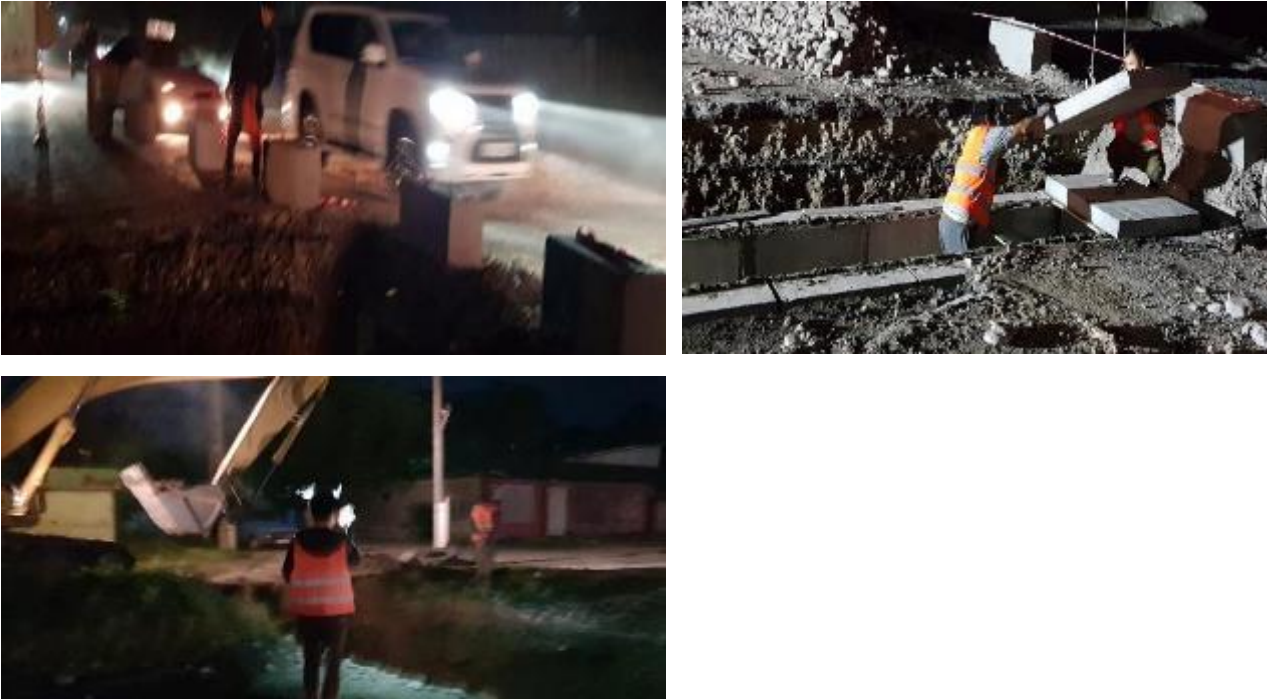
- 63. In Alexandrovka, operations were carried out at night-time, while the safety rules and regulations were not observed, workers were on the work sites at night without safety helmets, some without high-visibility jackets, without a traffic controller present, without fencing and without lighting. The contractor has issued this equipment to the workers, but does not enforce its use, most likely since a subcontractor who does not follow instructions was actually doing the work. At the time of preparing the report, the contractor accepted all the comments and proceeded to eliminate them.

- 64. Also on the part of the Engineer, the contractor was instructed to: When working at night, it is necessary to have a safety engineer and site manager present; supervise workers using the high-visibility jackets; provide rehabilitation or arrangement of temporary pedestrian crossings.

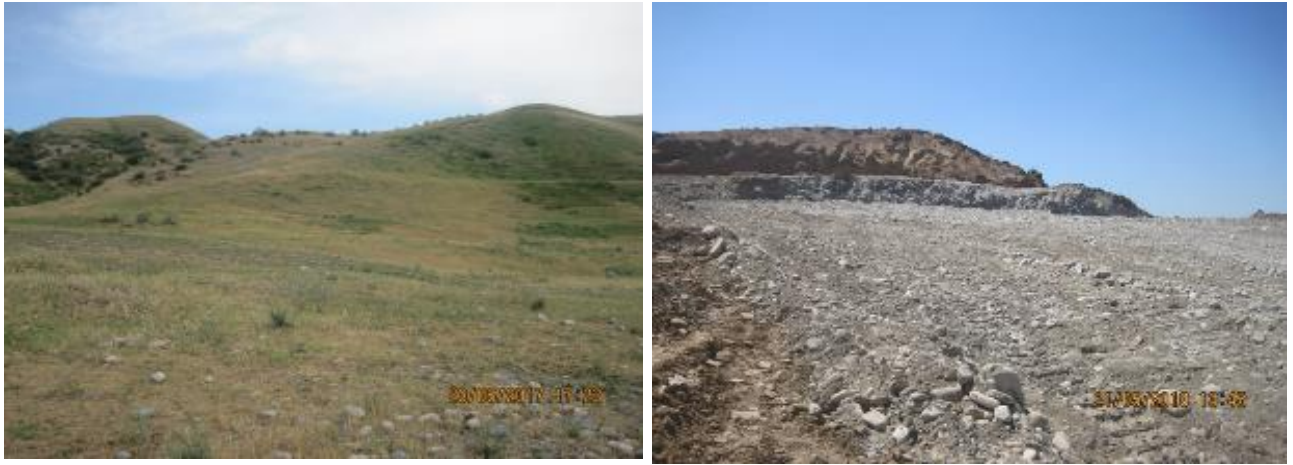
111. During the reporting period no violations in works on development of borrow-pit were revealed (Figure 333). Currently, the extraction at this borrow-pit is complete. The contractor has been reminded of and is committed to fully rehabilitating the site during 2019, as defined in the IEE SEMP Annex 14. Prior to initiating any activity the contractor, must, under, KR regulations file a rehabilitation plan with the State Agency for Environmental Protection and Forestry.

**Figure 333. Jelamysh borrow-pit before (left panel) and after mining (right panel)**

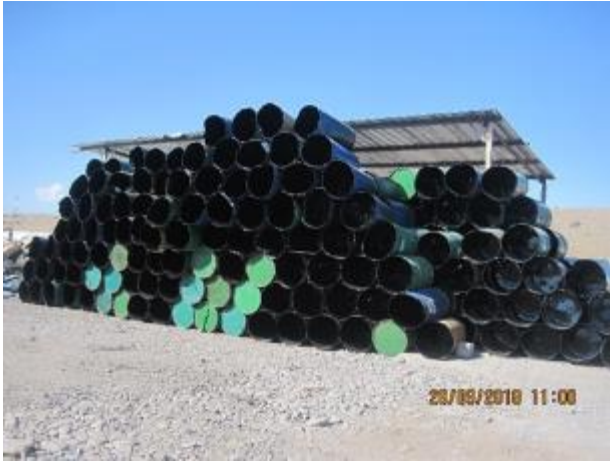
113. Bitumen issues – Since the September 2018 inspection by CSC auditors and the urgent call to stop the bitumen leakage, the contractor built an impervious concrete platform for bitumen storage. There is no more leakage of bitumen. It is now obtained in drums (about 11,500 tons between January and May 2019). Empty drums are stored in the asphalt plant (Figure 365) and are being used as safety barriers along road construction sites.

**Figure 365. Empty bitumen drum storage**

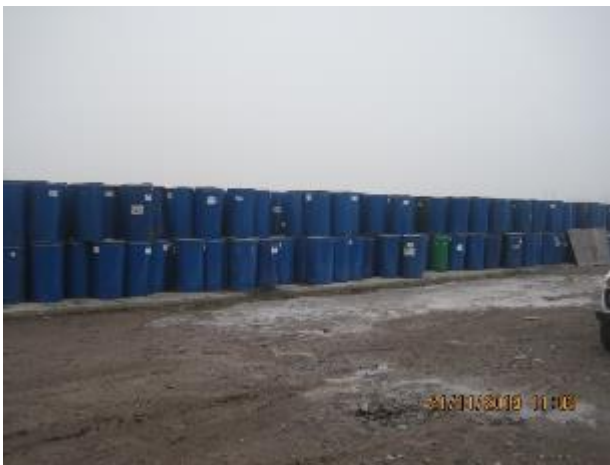
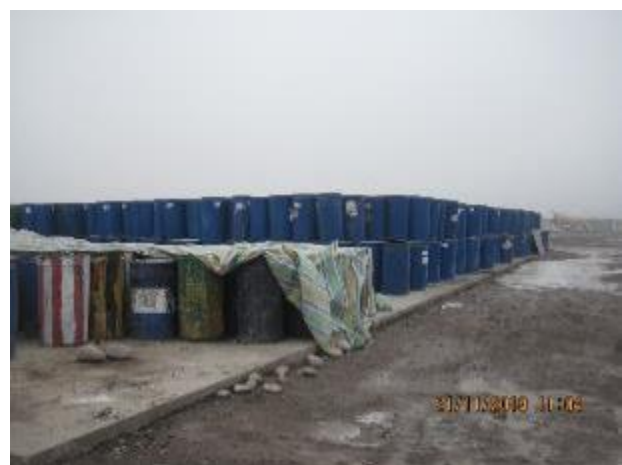
114. Starting in November 2018 bitumen was delivered to the asphalt plant in metal drums, and was stored in prepared impervious platform (Figure 376).

**Figure 376 Bitumen in metal barrels stored in the prepared platform**

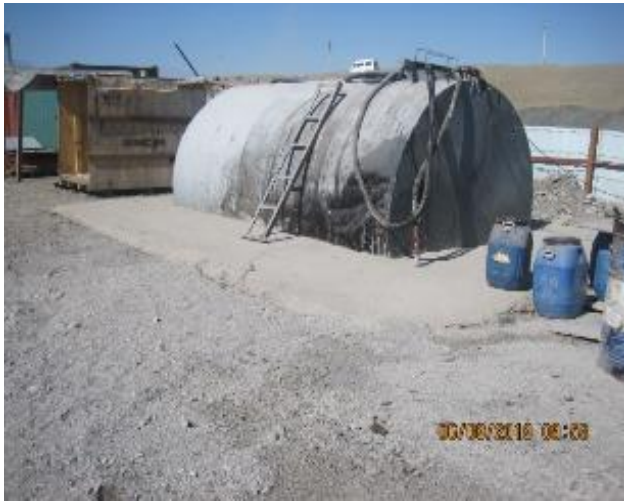
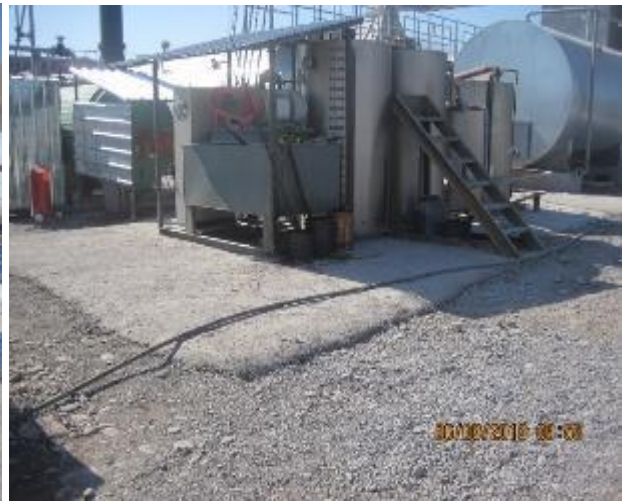
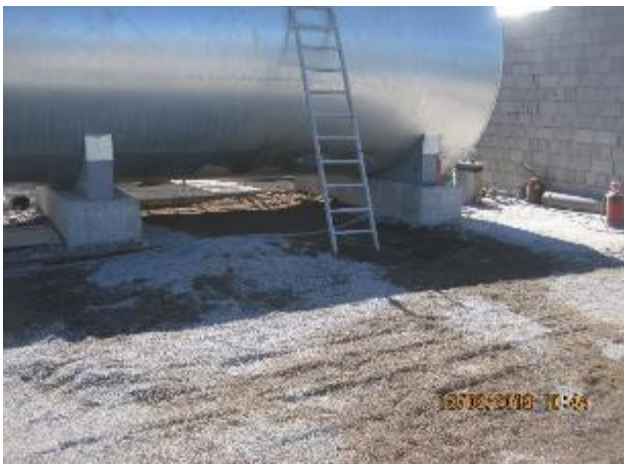
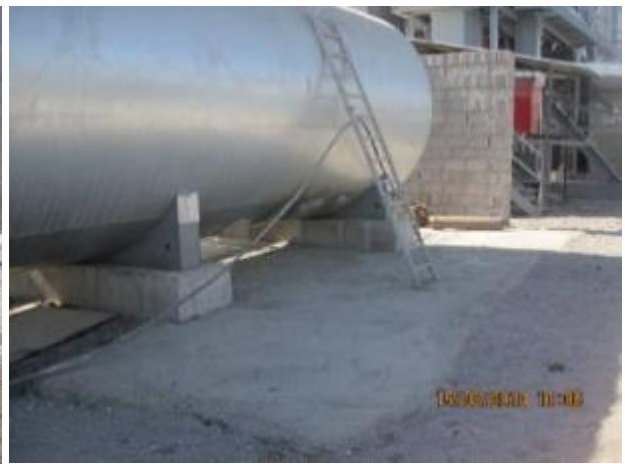
115. During the operation of the plant, all soil around the tanks with chemicals inside must be protected from leaks and spills of hazardous materials with an impermeable protective coating. To that end, the Contractor has completed this work (**Figure 387**).

**Figure 387 Chemical storage tanks with concrete platform allowing for easy clean up**

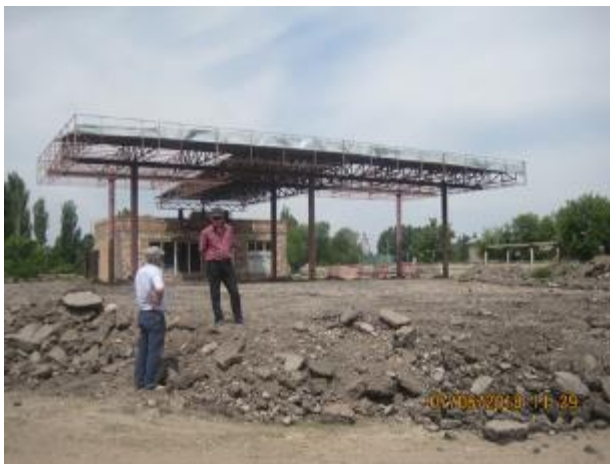
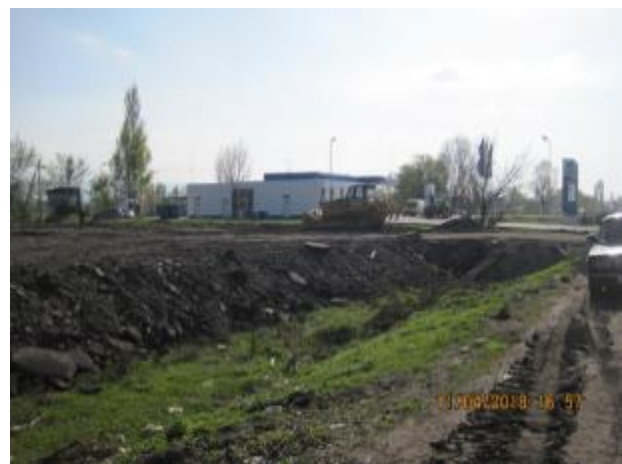
125. With the start of road works in areas 1.1 and 1.3, the contractor carried out the removal of old asphalt. The problem of crushing old asphalt remains partially solved. On the Contractor's side, the requirements of crushing old asphalt into pieces of size 20x20 are partially fulfilled. This issue is constantly discussed with the contractor. When scattering old asphalt on rural roads, the contractor rolled and smashed large pieces in place, which resulted in incomplete crushing of large pieces of old asphalt. At the request of local residents and local authorities, old asphalt is provided to fill existing pits and lay on roads that are in poor condition. These sites are usually located along the road and are used for commercial purposes (construction of shops, gas stations, etc.). In this case, the site owners level the asphalt on their own. After receiving the recommendations of the ADB, which indicated that in order to avoid harming the health of local residents, it is prohibited to transfer old asphalt to local residents for their own use. This requirement has been met and will be monitored in the current construction season.

**Figure 39. Old asphalt for backfilling of private areas at the request of the residents**

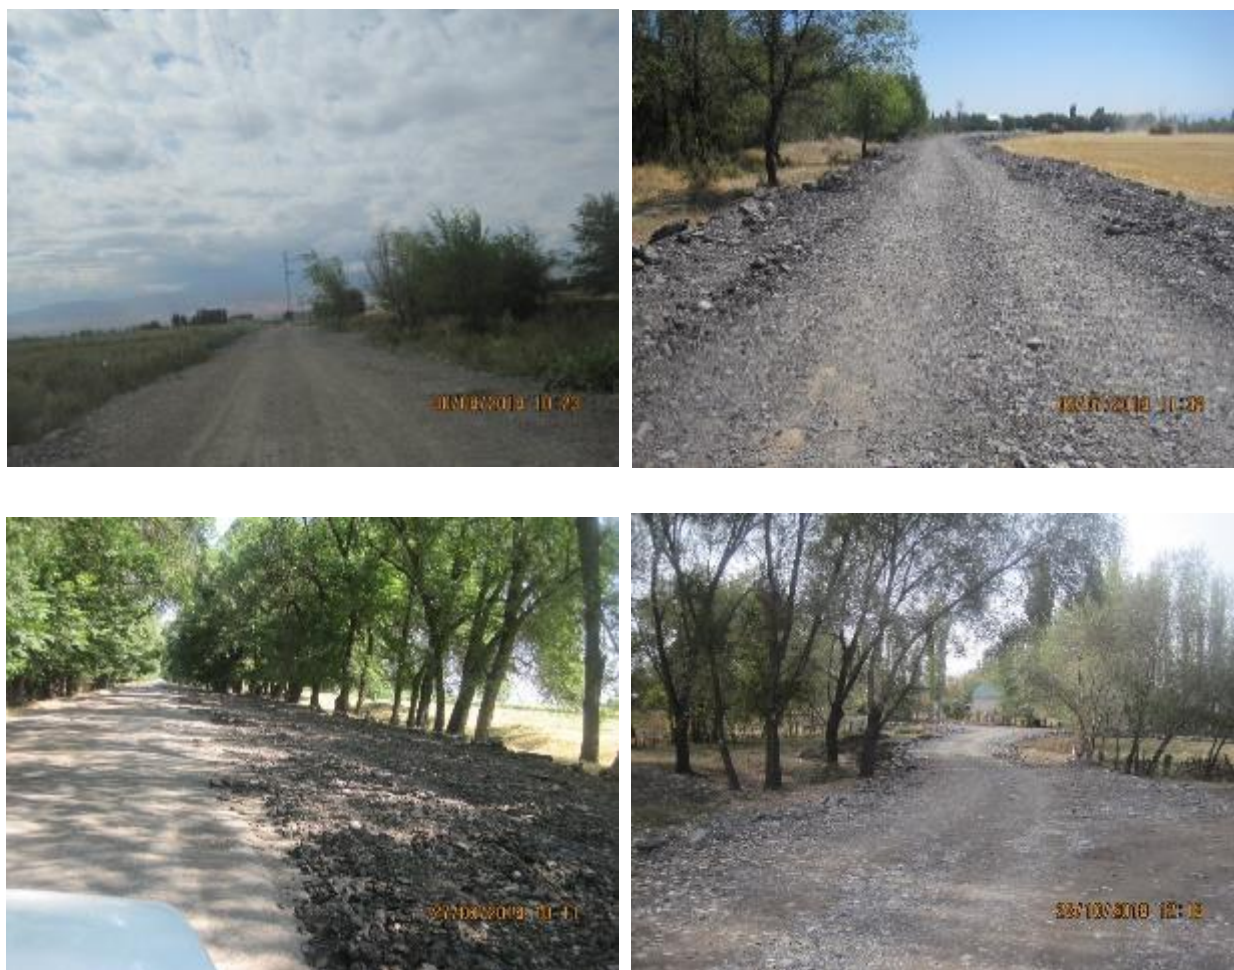
126. In 2018 after approvals were obtained from the local authorities and environmental authorities the old asphalt was taken to rural secondary roads. With every delivery a local official oversaw the placement of the crushed asphalt (Figure 400). If asphalt pieces were too large, the contractor brought in a compactor or other heavy machinery to break up large pieces.

128. At the same time, the problem of crushing old asphalt remains partially solved. Villages do not have equipment for levelling large pieces of old asphalt; therefore, the Contractor provides this service free of charge. On the contractor's side, the requirements for crushing old asphalt to small sizes (20 x 20 cm) are partially respected. After laying the old asphalt on minor roads, the contractor conducts the layout and compaction of his technique. The consultant will continue to monitor this work.

Figure 400. Old asphalt on local small roads and laneways

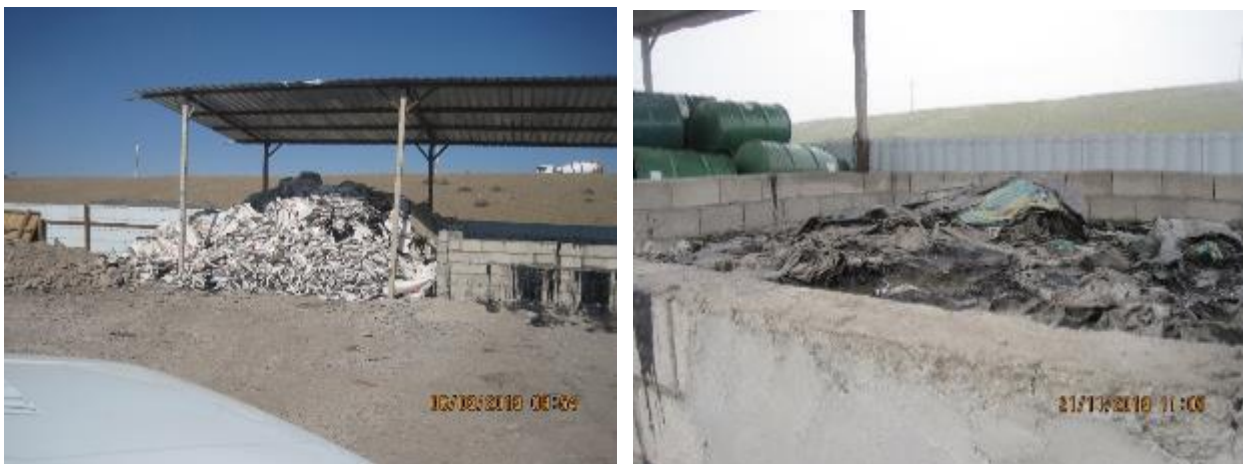
129. **Waste at the Asphalt Plant:** Waste in an asphalt plant. Waste is generated when bitumen is used in briquettes. Recently, the contractor has been using bitumen delivered in steel barrels and liquid bitumen brought in by special vehicles. The remains of plastic briquettes are currently scaled in special places to allow the use of bitumen residues during waterproofing applications.
130. The inner polyethylene bags, covered with bitumen residues, are stored in concrete bin, constructed near the plant. After separation / removal of bitumen residues, the plastic bags will be exported to a landfill authorized by SIETP.

Figure 411. plastic packaging bitumen packaged and transported in

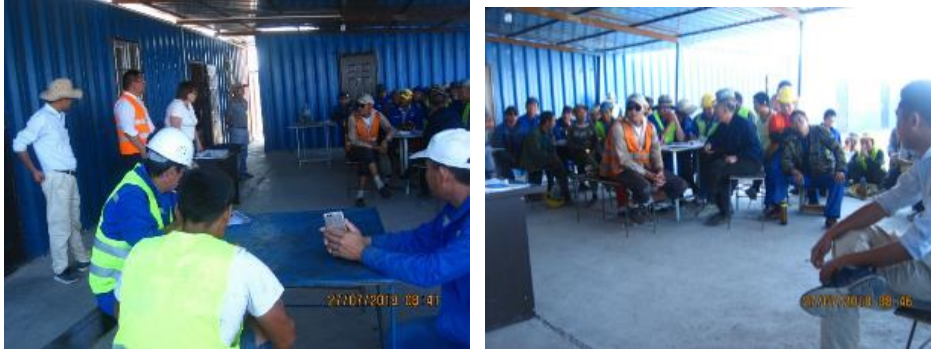
150. In early May 2018, the New Contractor's OH&S specialist gave lectures on Safety among workers at all construction sites. The CSC national environmental specialist gave four informal training sessions on EMP implementation and safety. The locations were Ak-Suu (2x), Belavodsk (1x) and Kara-Balta (1x). (**Figure. 46 Lecture lectures on Safety**)

**Figure 446. Lecture lectures on Safety**

151. Training is needed in safe large equipment operation and use of PPE.

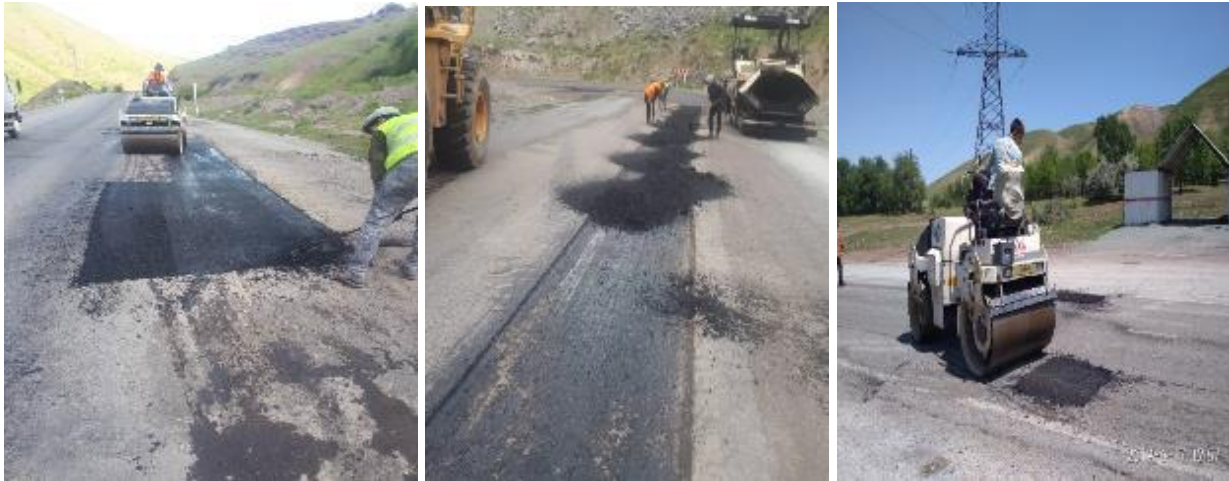
- Current repairs of pavement (patching works, crack filling, cleaning); Section 76,500-101,00 km

Figure - 5. Current repairs of the pavement

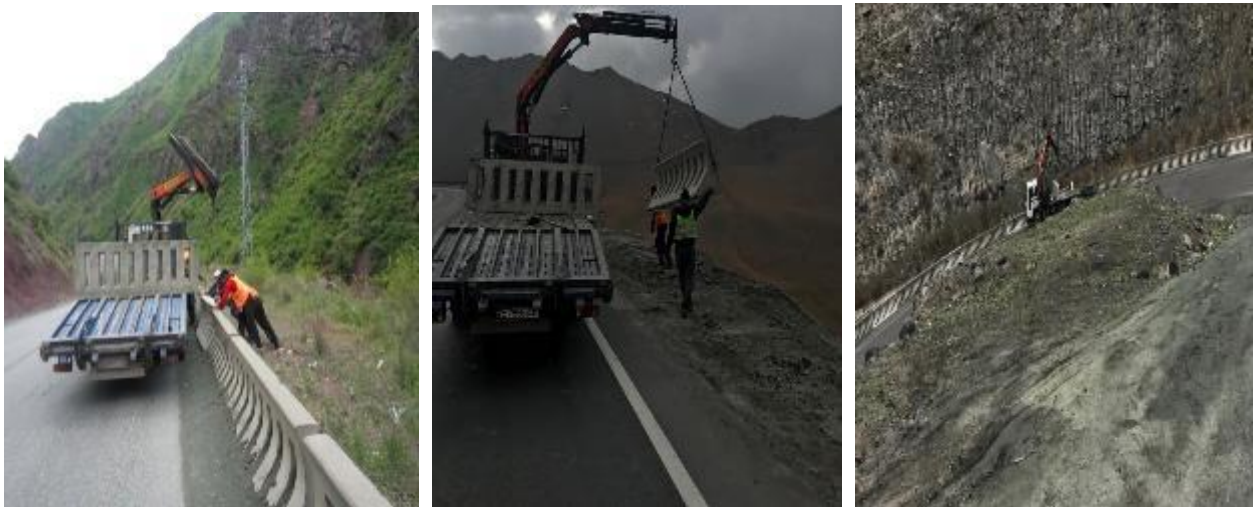
- Installing parapets Unsuitable, barrier fences as "Alarm" were replaced - 70 PCs, on the section 114-121 km

Figure 6 - Installing parapets BB-3. Unsuitables were replaced

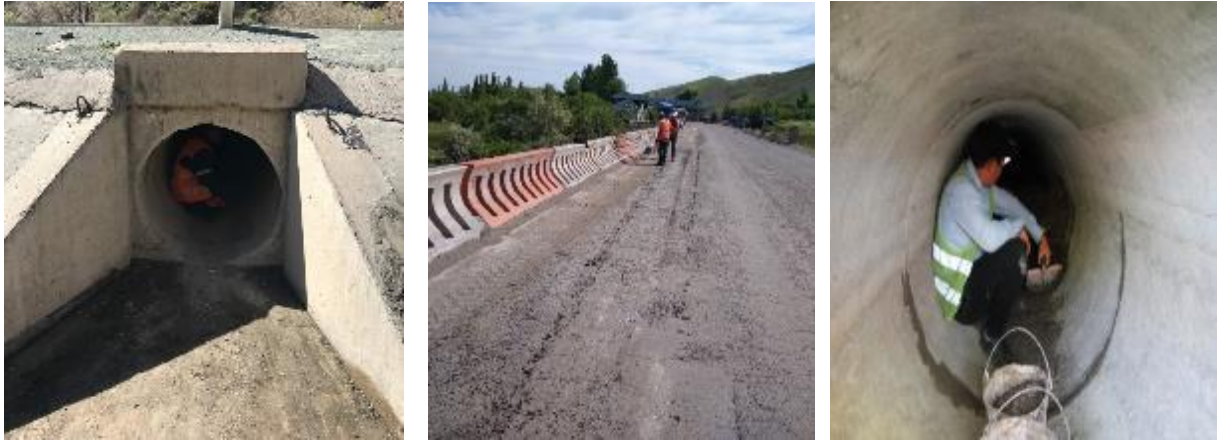
Cleaning of culvert pipes		
Section		Amount
61+00km 129+00	waste removal. Partly is completely clogged.	96PCs

Figure - 9. Cleaning culvret pipes

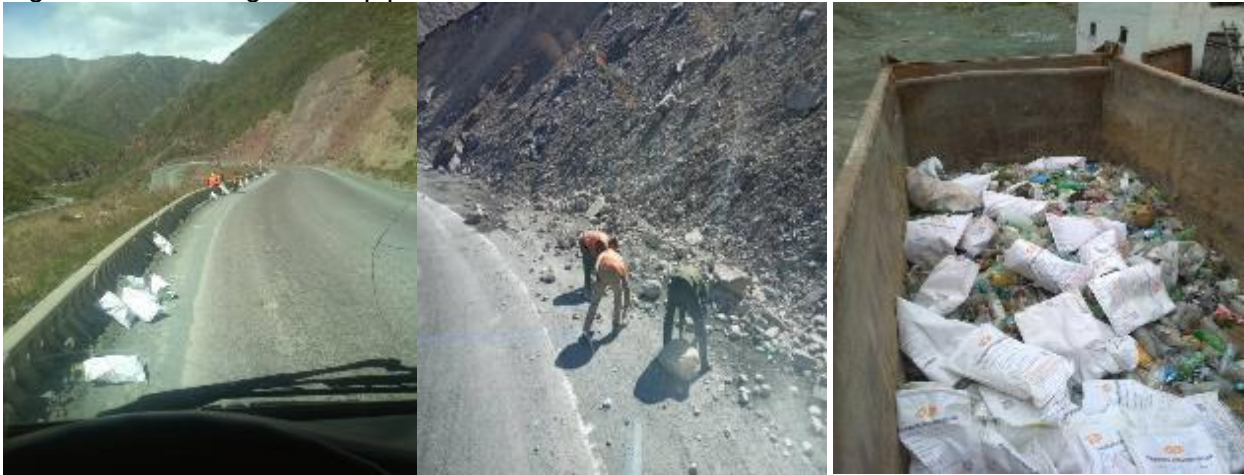
Figure-10. Collecting debris along the road

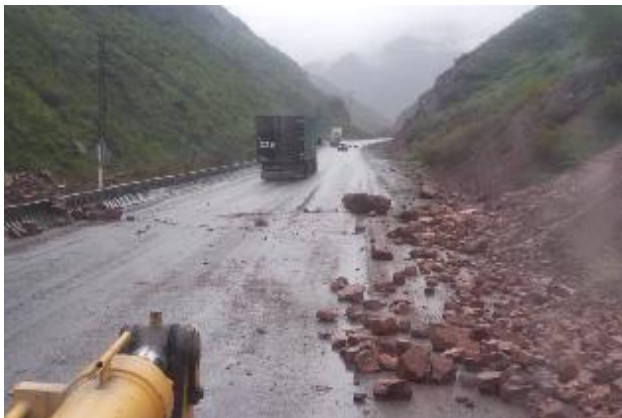
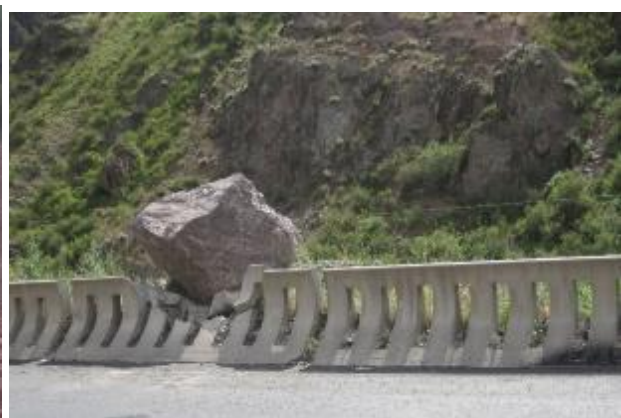
34. At sections km 86.9 - 88.7 and km 98, rockfalls occur due heavy rains. Boulders that fell on the road with parapet damage were noted. Also in this area there are large pieces of rock hanging over the road, representing the threat of spalling and falling onto the road, representing a danger to passing vehicles. A commission was created with the participation of the Ministry of Emergency Situations to survey this site in order to make a decision on eliminating this threat.

Figure 11. Danger of rockfalls
