Project Number: 45169-001
Loan Number: ADB Loan 3056-KGZ (SF)
Grant Number: 0366-KGZ (SF)

Semi-Annual Environmental Monitoring Report
January 1 – June 30, 2020

CAREC Corridor 3 Improvement Project (Bishkek – Osh road), Phase 4 (km 15.9 – km 61)

Submission date: July 2020

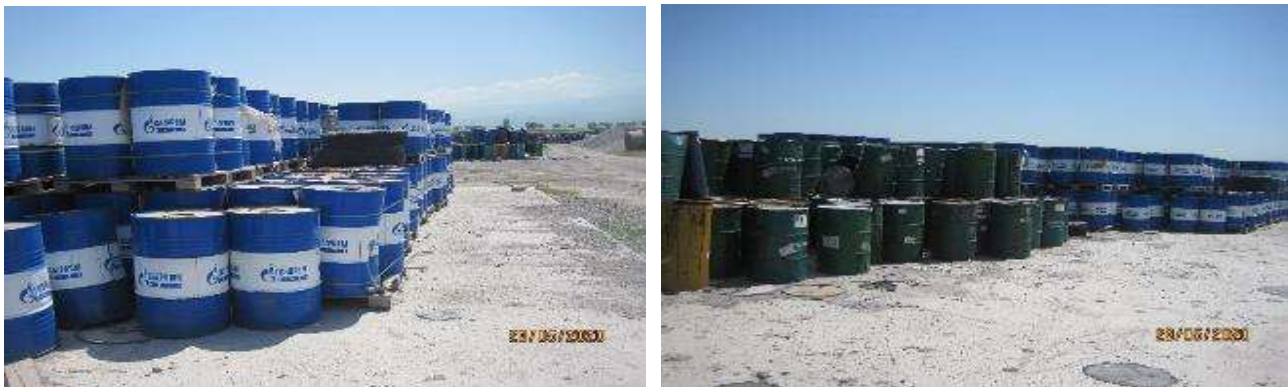
50. A large number of barrels with bitumen were delivered to the production site, which are partially placed on a specially prepared site. A large number of barrels are placed on the ground covered with waterproofing material.

Figure 20 Barrels of bitumen on a specially equipped site

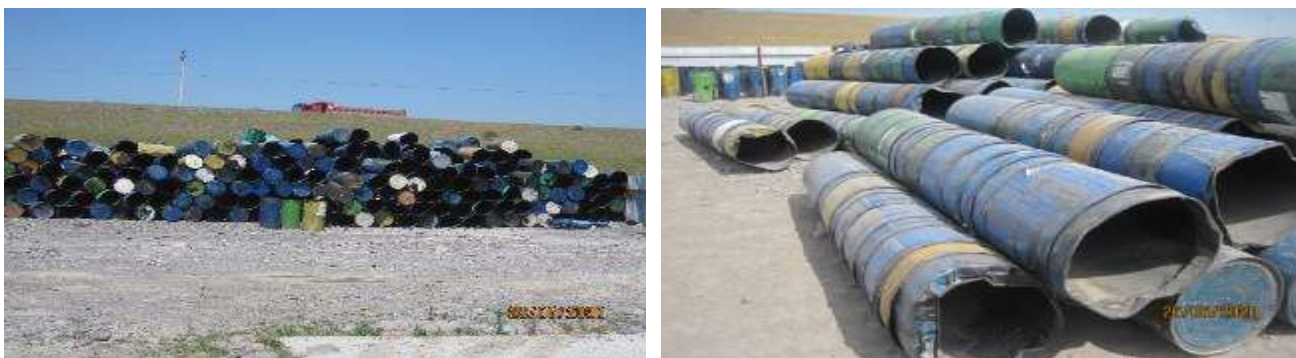
51. A large number of empty bitumen barrels and metal lids are accumulating at the production site. The Engineer instructed the Contractor to dispose of the unused empty barrels.

Figure 21 Empty barrels of bitumen under prepared for the disposal

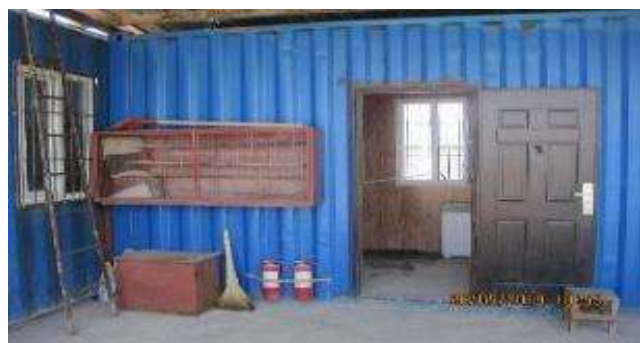
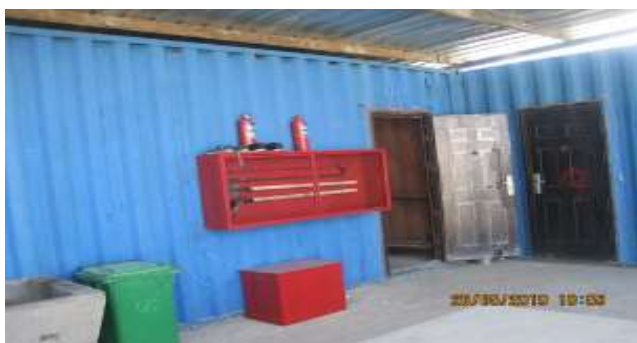
55. After a verbal warning about the need for a fire shield equipment, 2 shields were installed in the camp.

Figure 23 Fireshield equipment at the camp

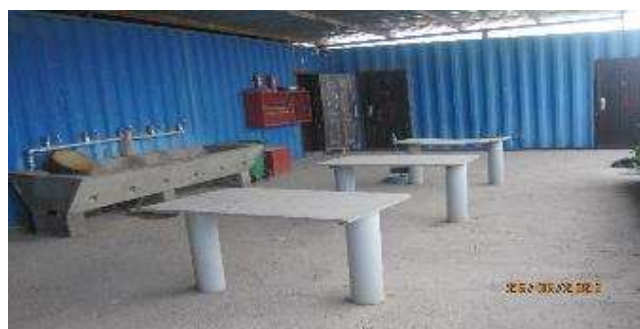
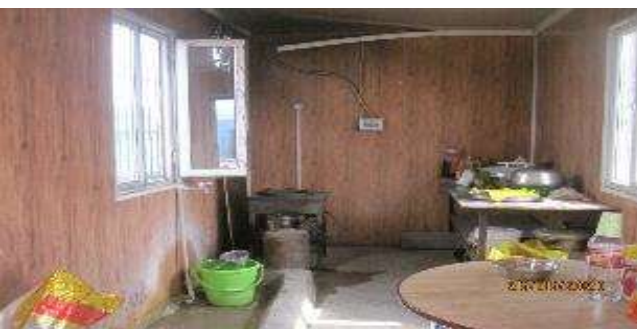
56. A warning was also given to remove gas cylinders from the kitchen and place them in metal cabinets on the street, but this warning was ignored. After repeated notifications from the Consultant, the contractor closed the kitchen, leaving only the dining room. Food delivery for workers is carried out from the base of the village of Belovodskoye or Sokuluk

Figure 24 Place for eating and gas cylinders in the kitchen

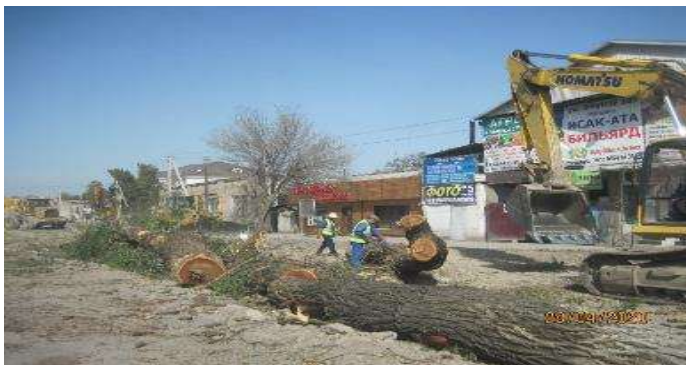
Figure 25 Tree cutting in the village of Belovodskoe

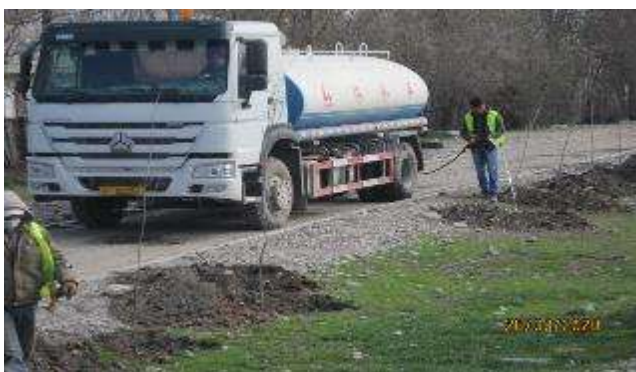
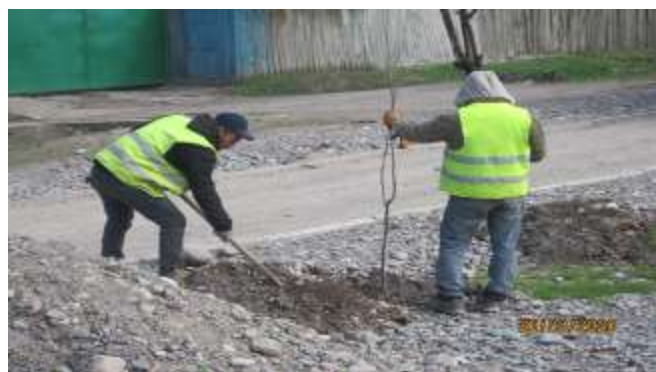
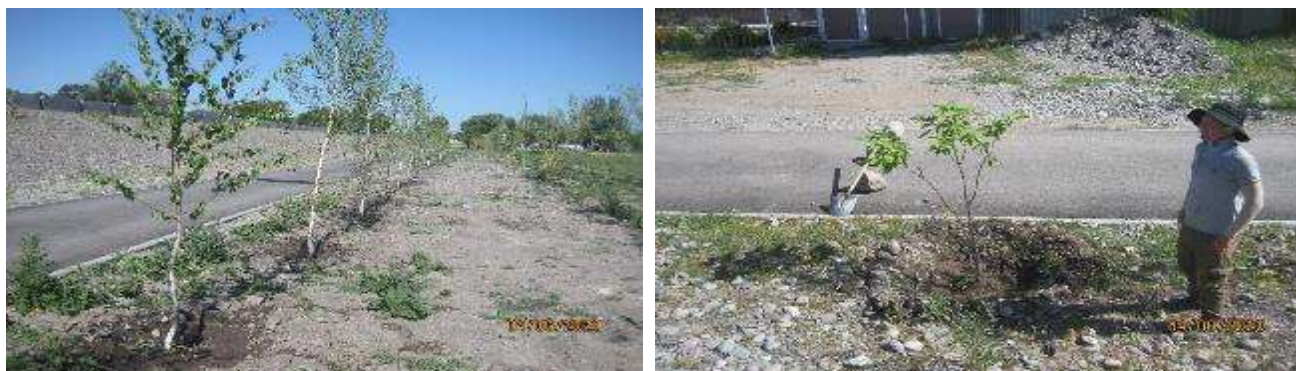
60. Seedlings planted in autumn and spring (600 pieces) are in satisfactory condition. However, with the hot weather, seedlings need systematic regular watering.

Figure 26 Planting and care of seedlings

61. A letter was sent to the contractor about the need to conduct regular watering every 3 days.

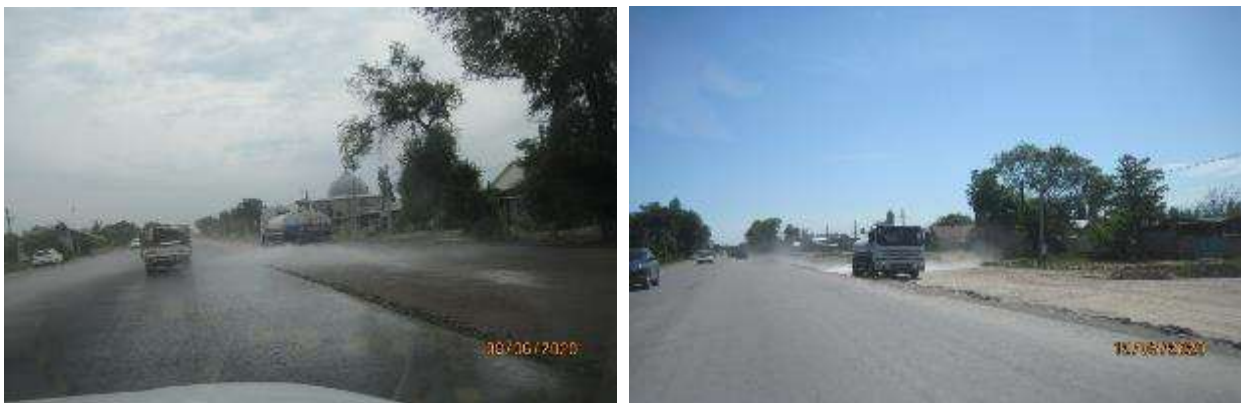
Figure 28 Water sprinkling at the road construction sites

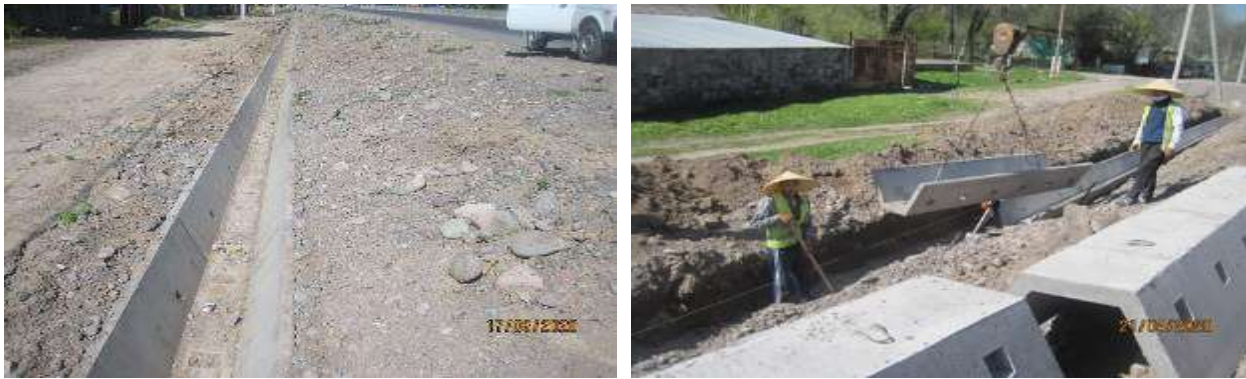
Figure 29 Construction of culvert chutes

85. Previously installed chutes are overgrown with grass and covered with construction waste. A letter was sent to the contractor to eliminate the identified violations.

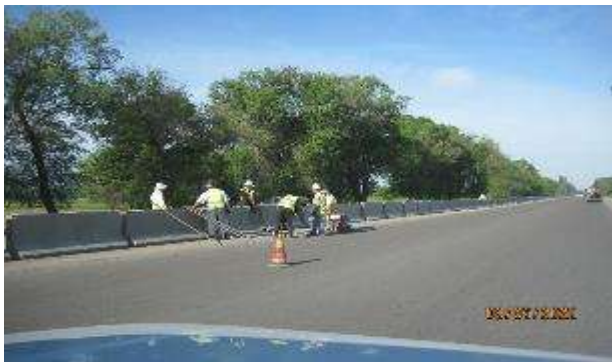
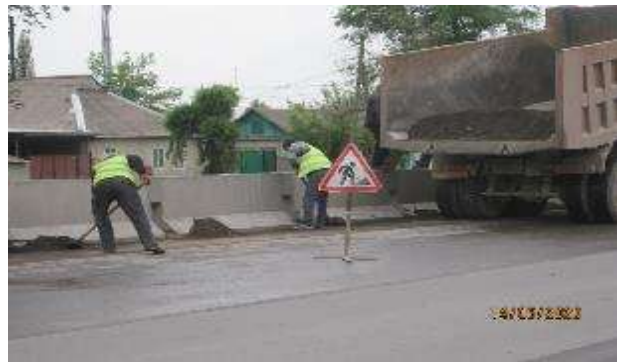
89. Then the soil accumulated near the parapets during the winter period was cleaned and removed in a timely manner.

Figure 32 Cleaning parapets from accumulated soil over the winter

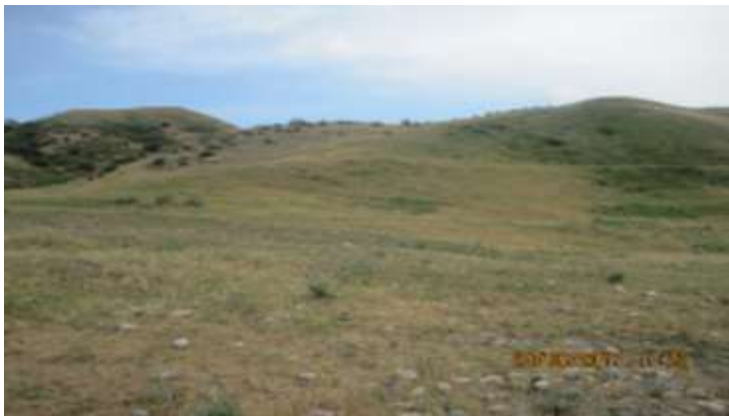
Figure 34 Jelamysh borrow-pit before development

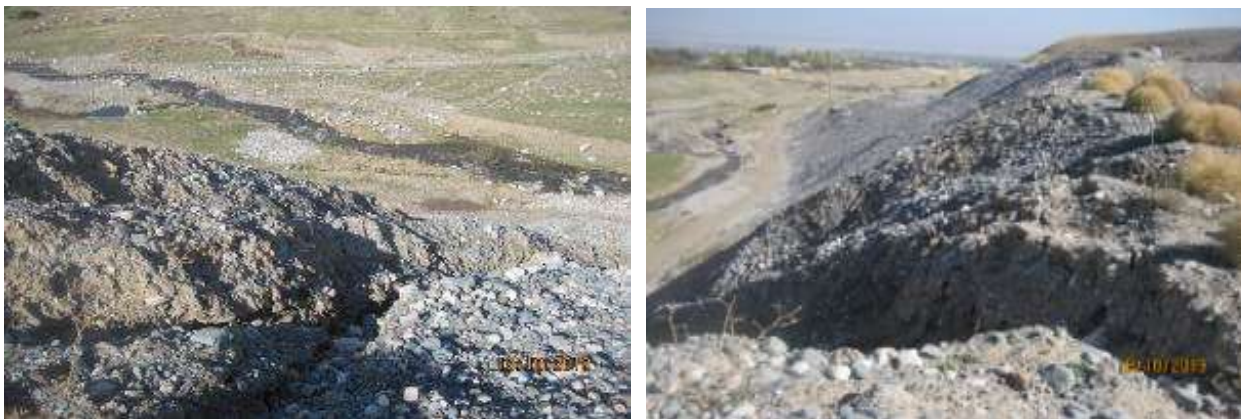
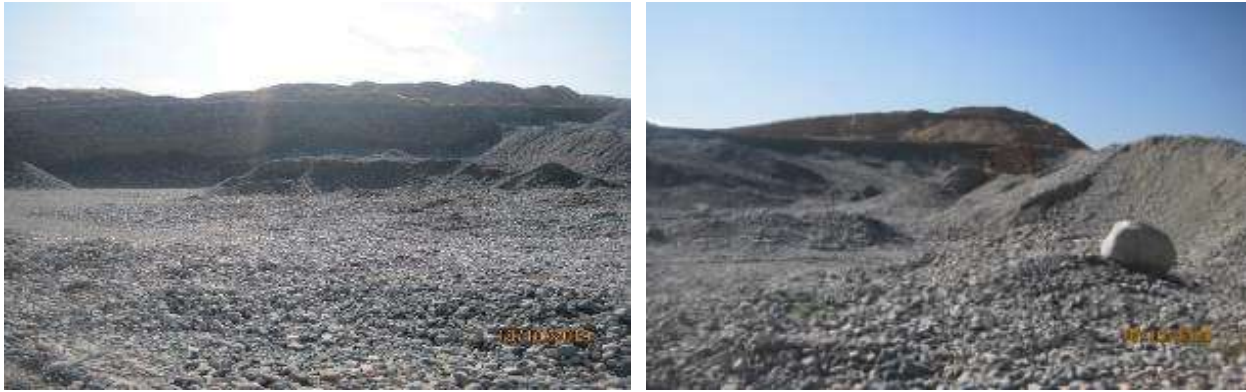
94. Currently, prior to the handover, the following work should be carried out on these borrow-pits: Jelamysh borrow-pit. At present, gullies and steep slopes on Jelamysh borrow-pit can pose a danger to the population and pets.

Figure 35 Jelamysh borrow-pit now

95. Currently, a borrow-pit reclamation plan has been drawn up and agreed. It is necessary to begin work on the borrow-pit reclamation, according to this Plan.

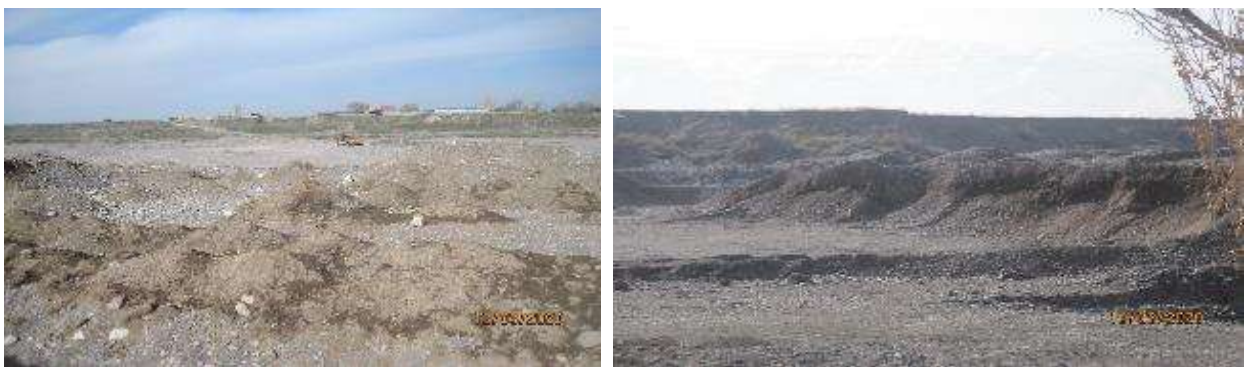
97. Kara-Balta borrow-pit. During the period of floods on the Kara-Balta river, the borrow-pit was partially reclaimed. But the main area of the borrow pit is subject to reclamation, which includes leveling all the irregularities in the area of the development.

Figure 36 Kara-Balta borrow – pit now

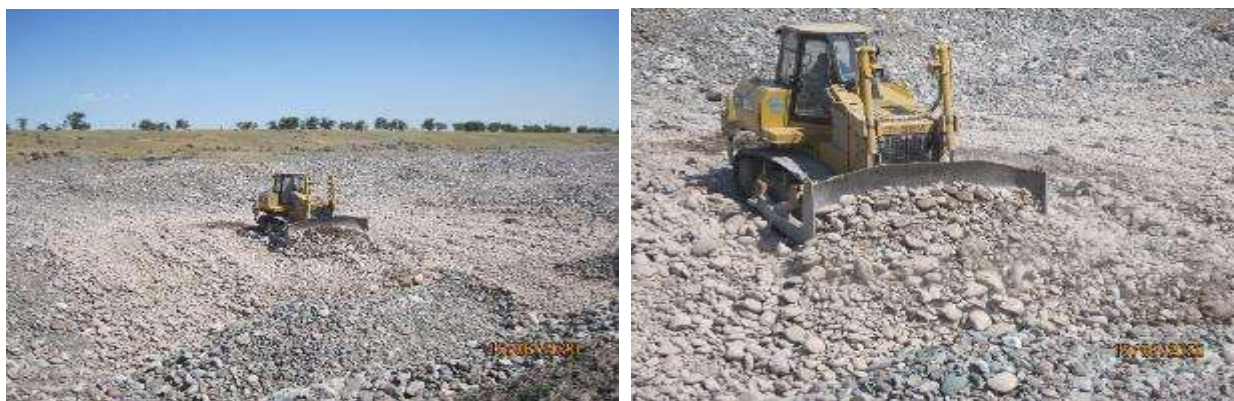
98. Ak-Suu 2. Ak-Suu 2 borrow-pit is located in the riverbed of the AK-Suu river and covers a large area. It is necessary to carry out reclamation work on the worked-out area of the borrow-pit.

99. In June, reclamation works were started at the borrow-pit, including leveling all the unevenness in the area of the workings carried out.

Figure 37 Reclamation works at the Ak-Suu 2 borrow-pit

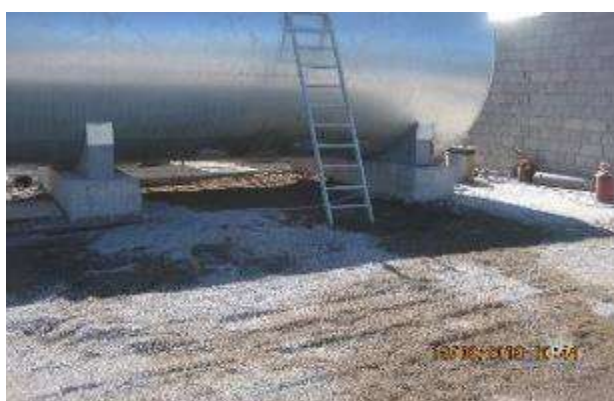
Before

102. During the plant operation, all the soil around the tanks with chemical substances should be protected from leaks and spills of hazardous materials by an impermeable protective coating.

Figure 38 Impervious protective coating around the chemical storage tanks

103. The contractor was advised to protect the soil around the tanks with chemical substances from leaks and spills of hazardous materials with an impermeable protective coating. These recommendations were taken into account and implemented by the Contractor.

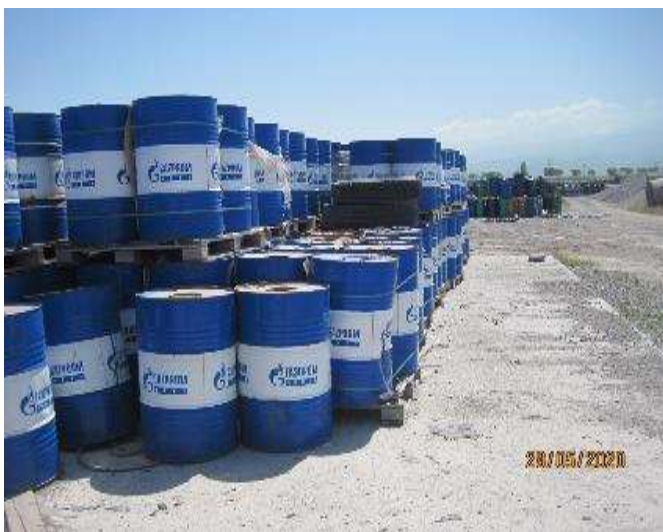
104. Barrels with bitumen are placed on a special concrete platform, part of the barrels are placed behind the platform on the ground, covered with a special anti-filtration coating - a special plastic film.

Figure 39 Barrels of bitumen on a special site

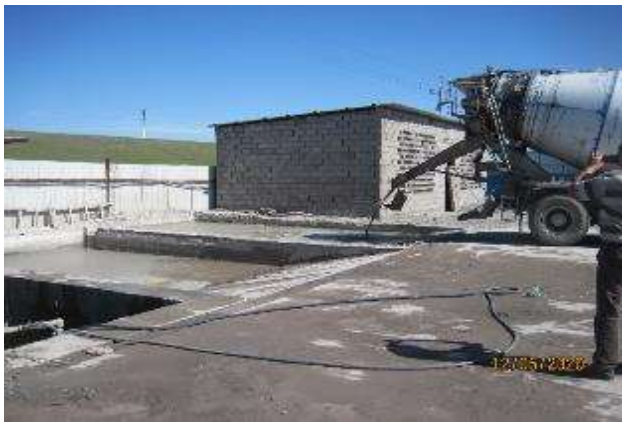
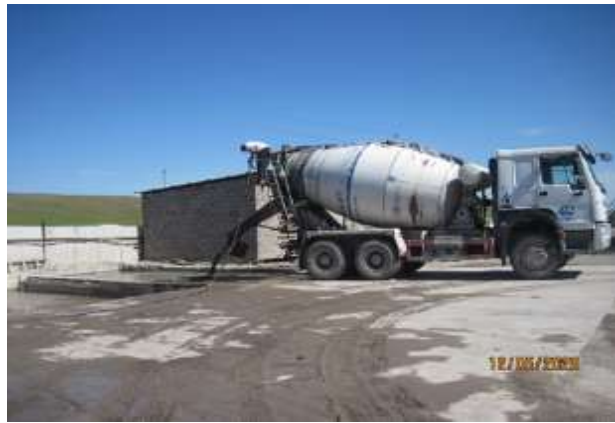
106. Washing of concrete mixers is performed on a specially designated site. Wash water is discharged into a special three-section sump. Then the wash water, after settling, is used for watering the area of the working site.

Figure 40 Washing of concrete mixers

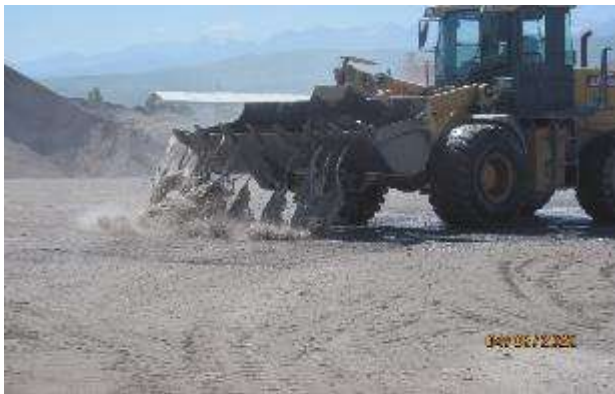
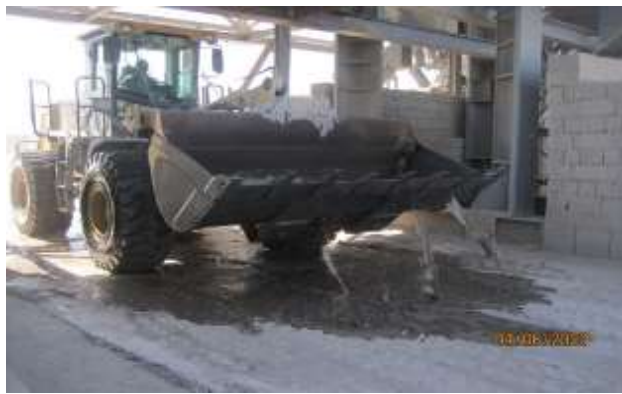
Figure 41 Water sprinkling of the area of the production site with wash waters

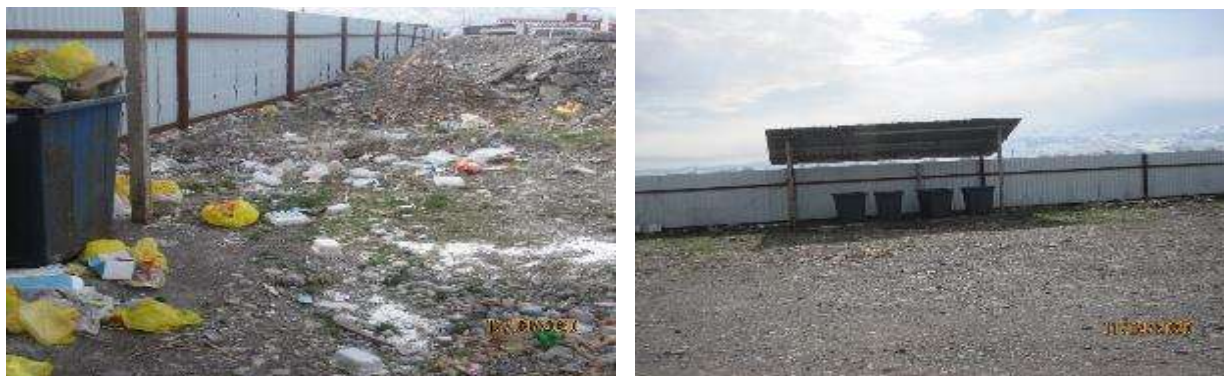
108. Previously, it was found that the territory of the production site was littered with household waste. Letter was sent to the Contractor. Currently the territory is cleared of household waste.

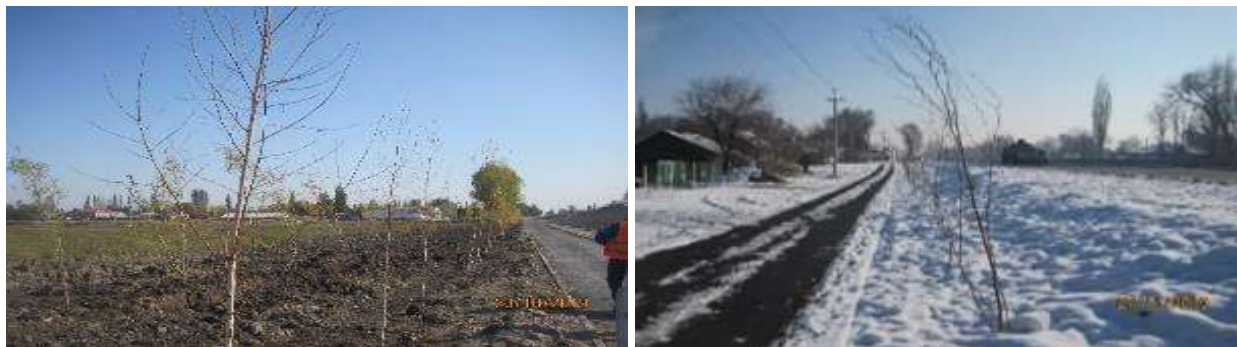
and suitable seedlings were seedlings of the Peasant Farm "Pitomnik Zherdevykh". Contractor was repeatedly informed orally and in writing about the need to start planting seedlings in the near future. The first 300 seedlings were planted at the village of Petrovka section 3 in autumn 2019.

Figure 45 Seedlings planted in autumn 2019

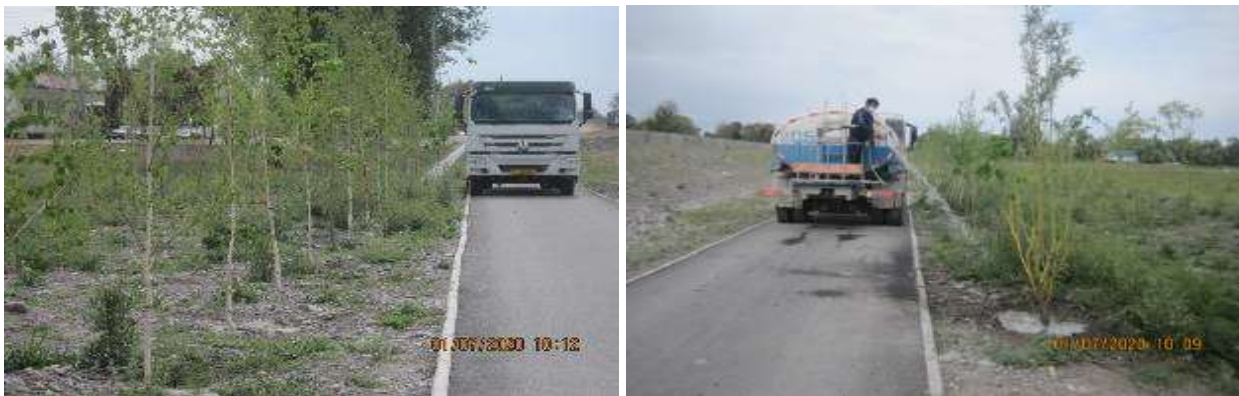
Figure 47 Seedlings after watering

113. To provide the seedlings with the right amount of moisture, watering should be done regularly every 3 days. Before the first watering, it was necessary to make holes near each seedling. A letter was sent to the contractor about the need to make regular watering every 3 days. Despite constant reminders to the Contractor, the seedlings were not watered regularly. Given the hot weather, some of the seedlings began to dry out. The consultant carried out a preliminary calculation of the survival rate of seedlings, which was 95%. Given that the planting of seedlings is not completed, the numbers on the survival rate of seedlings will change and the final percentage of survival will be summed up in 2021. The contractor was given an additional explanation that, in accordance with the terms of the current contract, all dried seedlings will be restored at the expense of the contractor

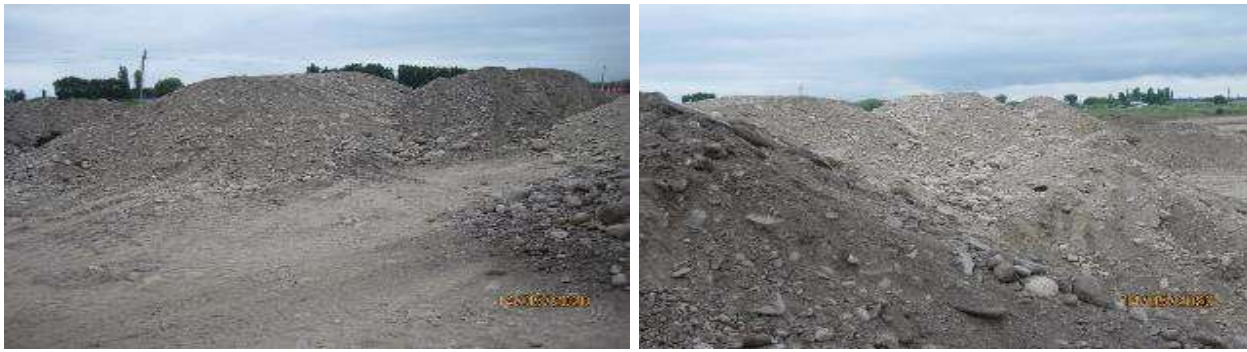
116. Given the fact that the quality of filling is not always satisfied with local residents, the administration of the villages of Alexandrovka and Sokuluk allocated site for storing unsuitable soil and removed asphalt for further use if necessary. On the part of the consultant, before storing unsuitable soil, the site was inspected for its "suitability", namely, the distance from water, the absence of a close occurrence of ground water or wetlands. According to the results of the inspection the designated area for temporary storage of unsuitable soil meets these requirements.

Figure 48 Storage of unsuitable soil for further use in Alexandrovka village

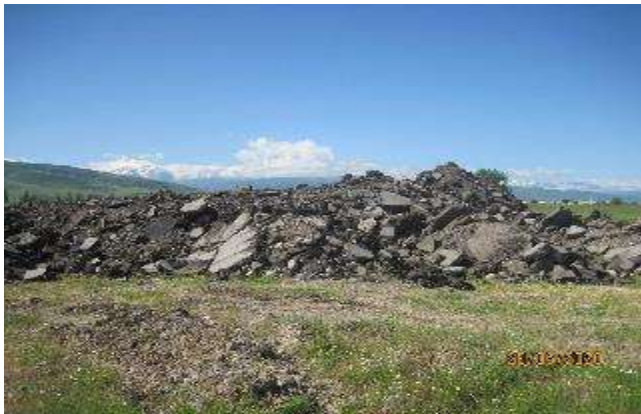
Figure 49 Storage of unsuitable soil for further use in Sokuluk village

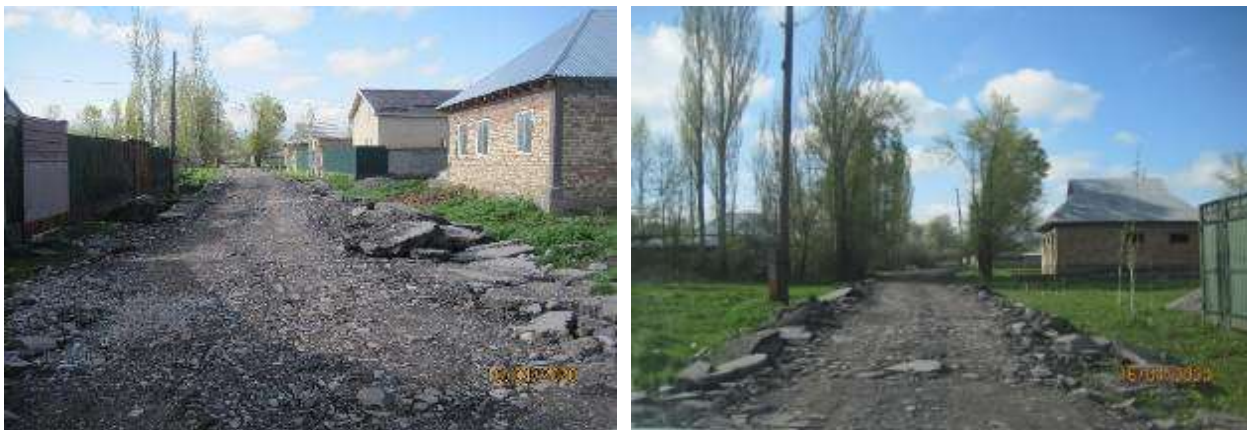
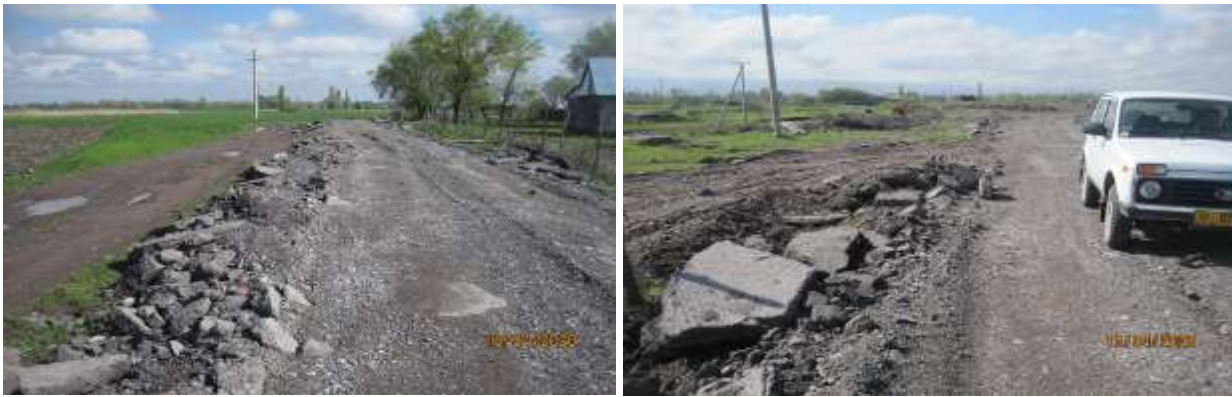
118. Old asphalt in the village of Belovodskoe was taken out to the streets specified by the local administration. Recently, removed old asphalt in village of Belovodskoye was taken out on the road in Komsomolsky Lane, Kalinina street and to the road in the field and to the road leading to the Kyrgyz feed enterprise. In many places on the roadsides, asphalt is not levelled, there are large pieces of asphalt, what is unacceptable. It is necessary to carry out additional work on crushing and levelling of the laid old asphalt.

Figure 50 Removal of old asphalt to the streets of the village of Belovodskoe at the request of residents and local administration

119. A letter was sent to the Contractor about the need to remove pieces of asphalt from the roadside, to level all placed asphalt, and level the road on Kalinina Street.

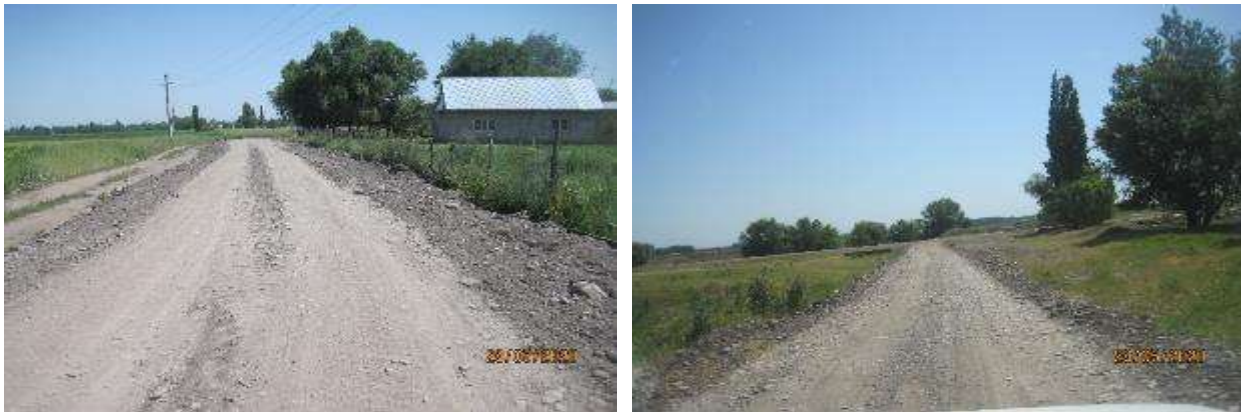
120. In May, the road on Kalinina Street was filled and levelled.

Figure 51 Kalinina street after levelling

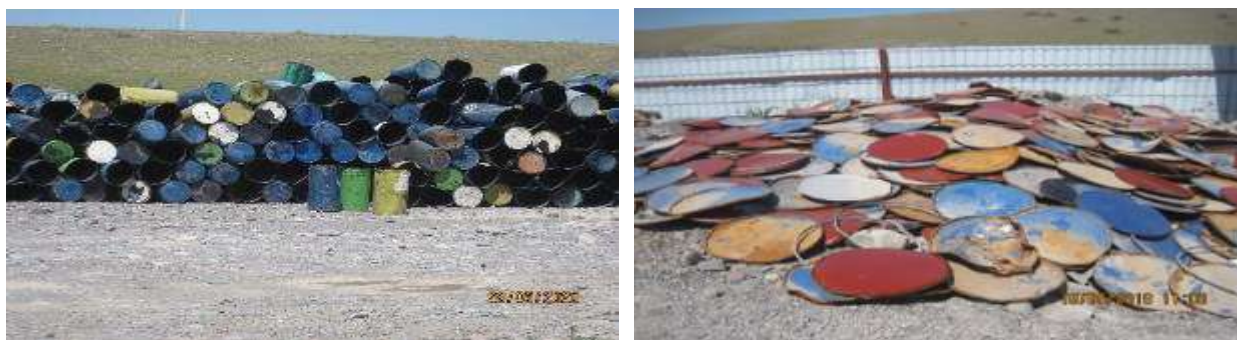
124. Production waste is also generated during the road construction. These are used engine oil, old tires, empty barrels of bitumen. According to the Contractor, the used oil is reused during the operation of certain types of equipment, the rest is handed over to a local company for further processing or recycling, the barrels will be partially sent to the plant for reuse, some of the barrels will be used for the needs of the Contractor, the remaining ones will be scrapped.

Figure 53 Storage of empty bituminous barrels and lids

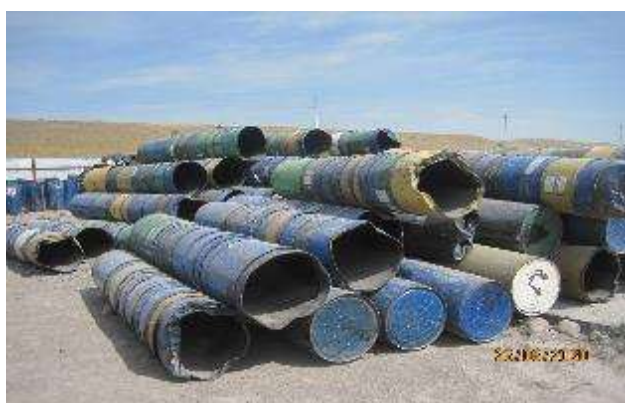
Figure 54 Barrels prepared for scrapping

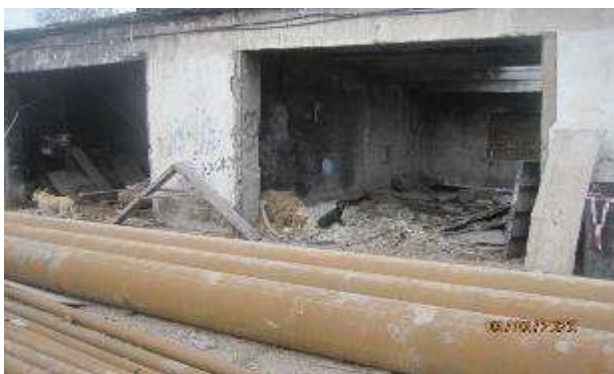
Before

125. In March, during the monitoring the state of the camps where workers lived, it was found that the camp in the village of Belovodskoye was in an unsatisfactory condition. A large amount

of production and household waste has accumulated on the territory. The house where the workers will live is also in an unsatisfactory condition. A letter was sent to the contractor demanding to bring the territory to the proper condition. The territory was partially cleaned, but it is necessary to fill the surface of the territory with crushed stone in order to eliminate dirt and puddles.

128. It was recommended to remove all waste from the camp as soon as possible. Bring the house of workers in proper condition. The fill the area of the camp with crushed stone, hold conversations with the workers living on the territory of the camp about compliance with the rules of hygienic maintenance of the territory of residence, taking into account the fact that despite the garbage cans located next to the house of residence, household garbage is thrown out on the territory.

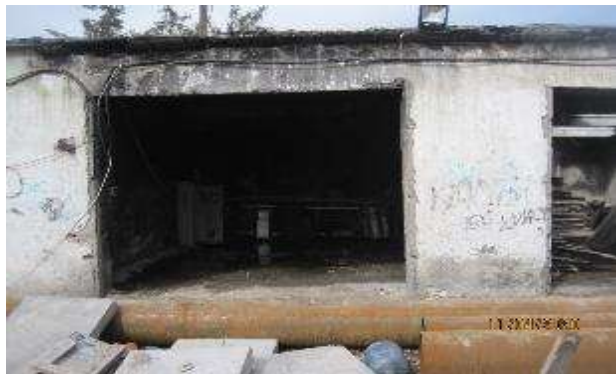
After

129. Currently, in the territory of the camp in the village Belovodskoe, used wheels were taken out, household waste was partially removed. The workshops were cleared and all unused materials were partially removed.

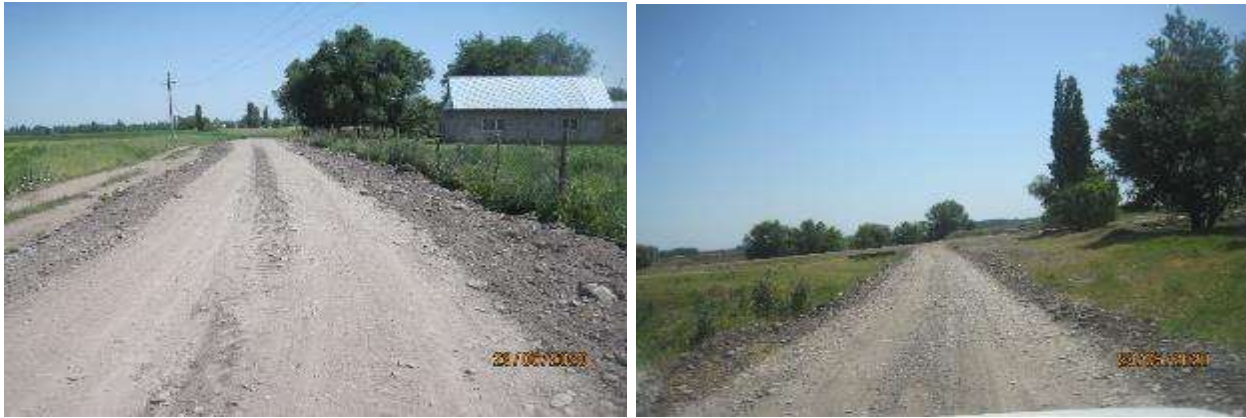
166. The Road on Kalinina street was backfilled and levelled.

Figure 63 Kalinina street after levelling

165. A letter was sent to the Contractor about the need to remove pieces of asphalt from the road shoulders, level all the filled-out asphalt, and level the road.

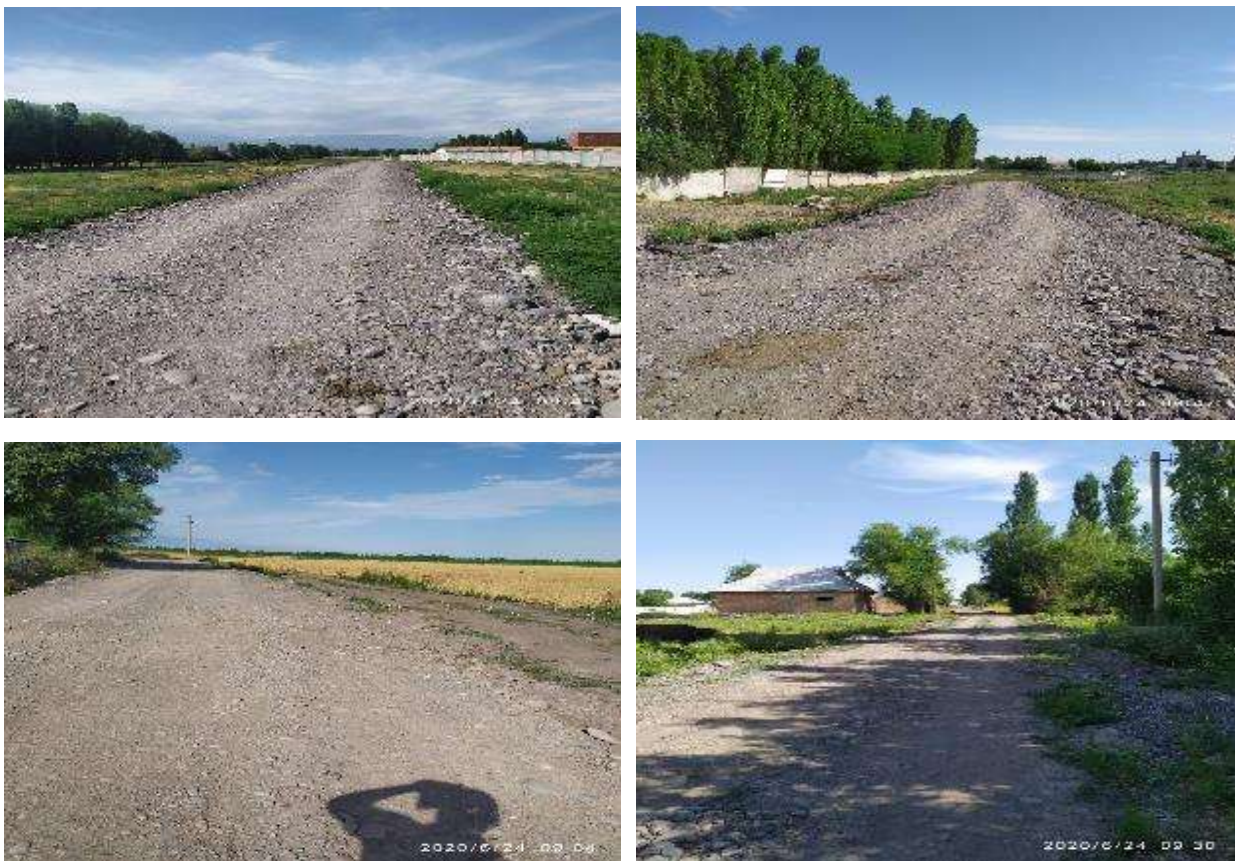
Figure 64 Removal of old asphalt to the territory of sections 5 and 6

168. The old asphalt was taken out on field road. Prior to the start of the work, approval was obtained with local authorities and environmental authorities for the use of removed asphalt on rural roads. Asphalt was not taken out to the wetlands.

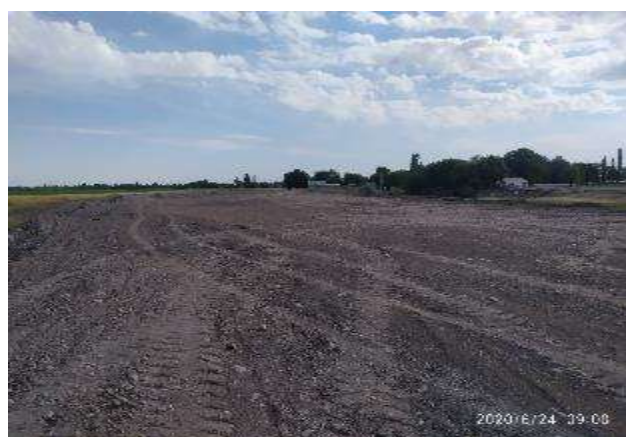
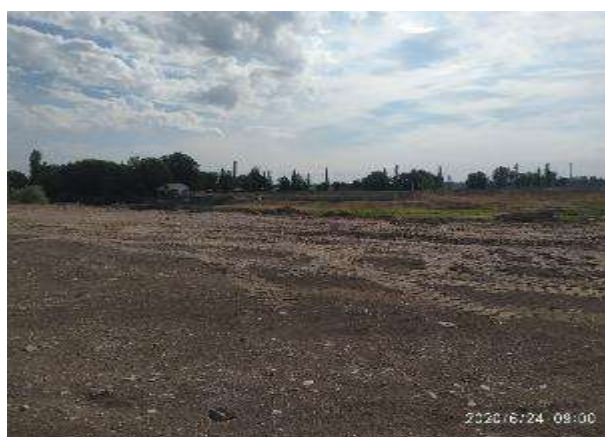
175. At the request of the local ayil okmotu, sites for the removal of unsuitable soil were also allocated on section 6 in order to improve the infrastructure of these villages. The main part of the unsuitable soil was used to fill the pits located on the territory of the village of Belovodskoe.

Figure 65 Taken out of unsuitable soil to the area of sections 5 and 6

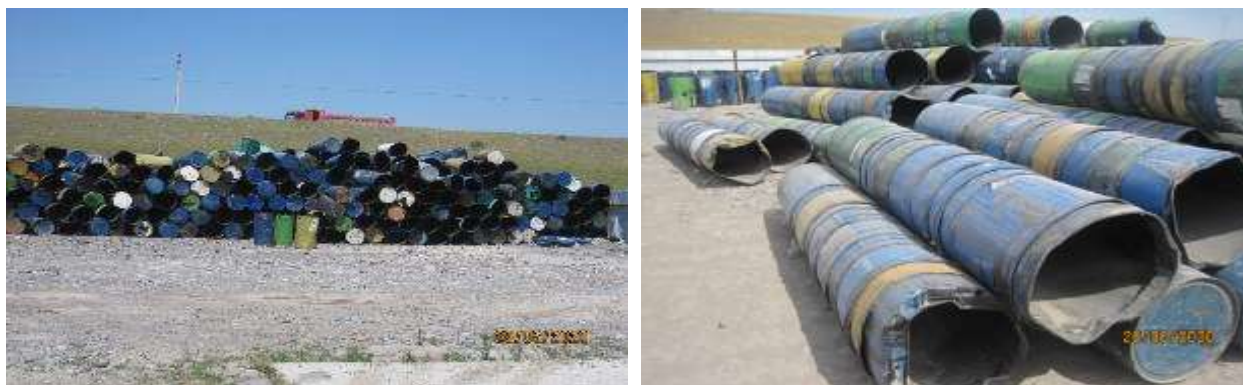
177. During the production of asphalt, waste is generated on the area of the asphalt plant. Most of these are empty barrels of used bitumen. Empty barrels are stored in the plant area. Currently, a large number of used barrels and metal lids have been accumulated, which must be disposed of. According to the Contractor, empty barrels that have not been dented during use are returned to the bitumen manufacturer's plant. The remaining barrels are partially used during roads construction work, partially sold for scrap.

178. At present, barrels are prepared for disposal.

Figure 66 Empty bitumen barrels

212. The problem of bitumen leaks at the plant virtually eliminated. The contractor purchased bitumen in metal barrels, which are placed on an impermeable base. At the same time, it was noted that the disposal of empty barrels from used bitumen is delayed. Also, the problem of recycling used tires, which have accumulated a large number at the Belovodskoe base, has not been solved.

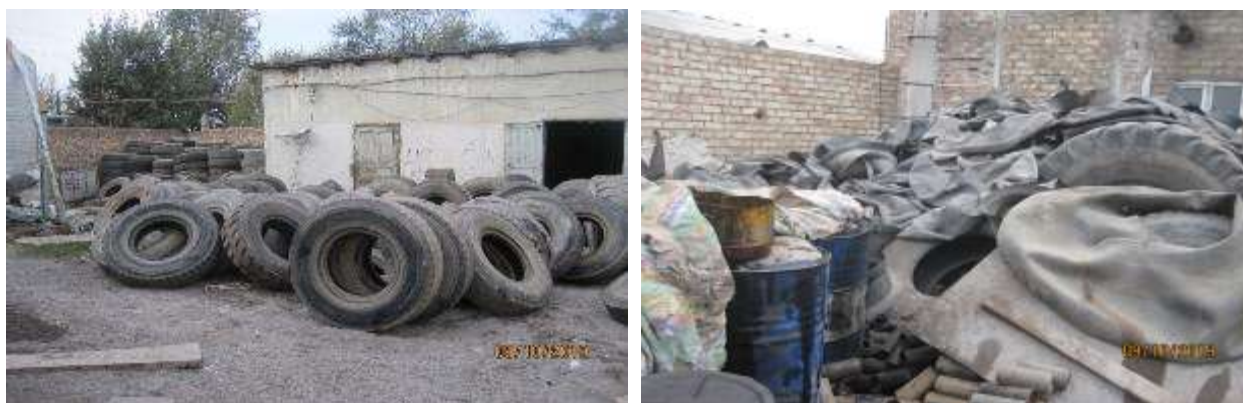
179. In Belovodskoe, a large number of old car tires are stored on the territory of the base. It is necessary to take measures for their removal and disposal. If there is no possibility of recycling Contractor should sign a contract with a specialized company.

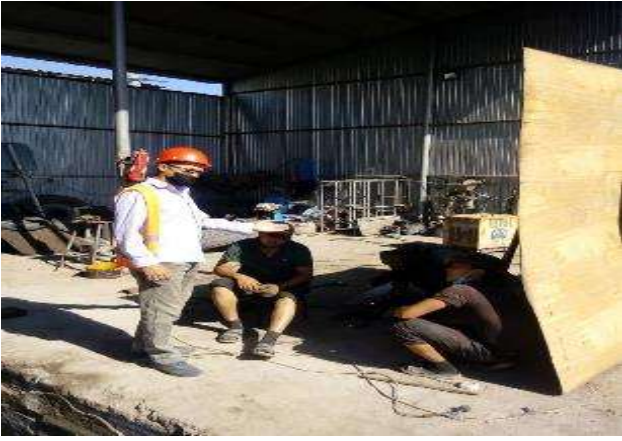
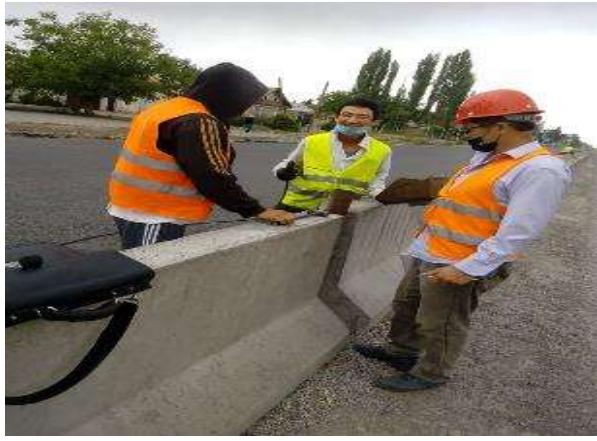
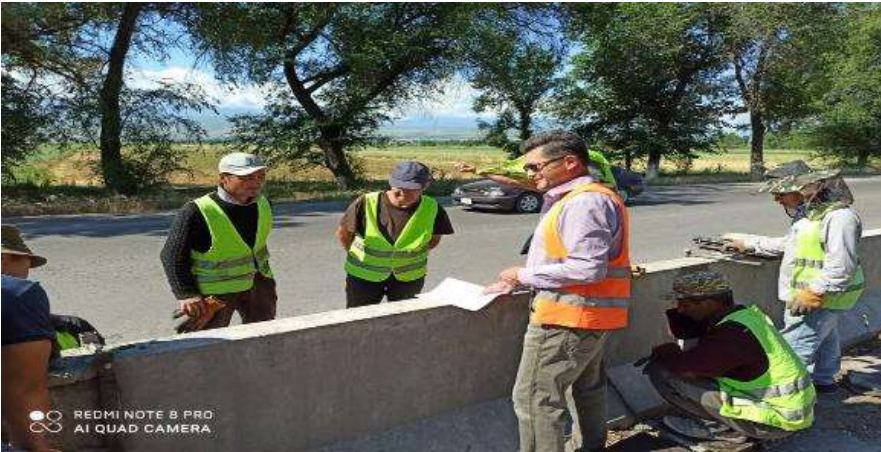
187. During the reporting period, there were several joint visits of the Eptisa's Local Environmental Specialist with the Contractor Safety Specialist. The briefing was carried out at the construction sites.

Figure 67 Site briefing

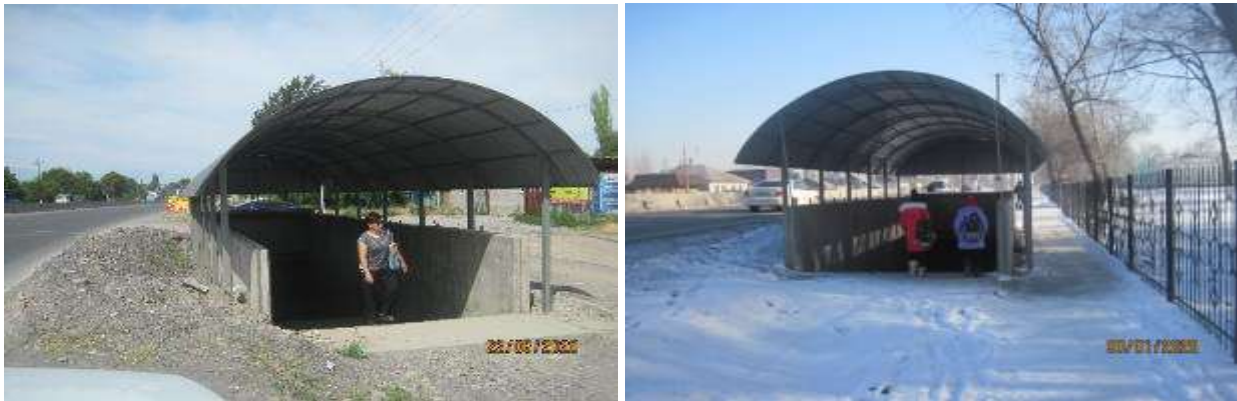
194. In order to ensure the safety of pedestrians, especially schoolchildren, the project provides for the repair of 4 existing and construction of 6 new underground passages on the road. Underground pedestrian passages are the safest option for pedestrian traffic. Currently, the

construction of five underground passages is almost completed. Adults and schoolchildren are currently crossing the road through underground passages.

Figure 69 Adults and schoolchildren use underground passages.

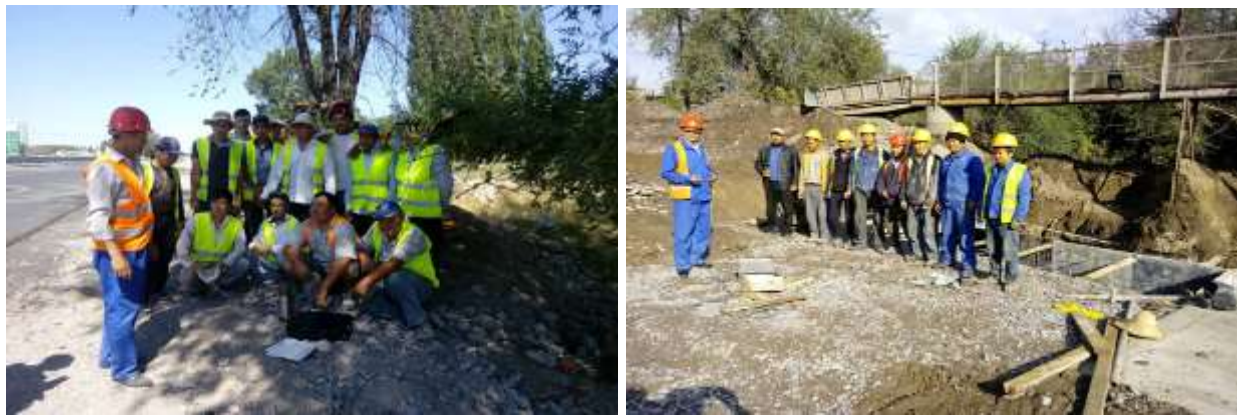
Figure 70 Conducting safety training session for Chinese and local workers
