Project Number: 45169-001
Loan Number: ADB Loan 3056-KGZ (SF)
Grant Number: 0366-KGZ (SF)

Semi-Annual Environmental Monitoring Report
January 1 – June 30, 2020

CAREC Corridor 3 Improvement Project (Bishkek – Osh road), Phase 4 (km 15.9 – km 61)

Submission date: July 2020

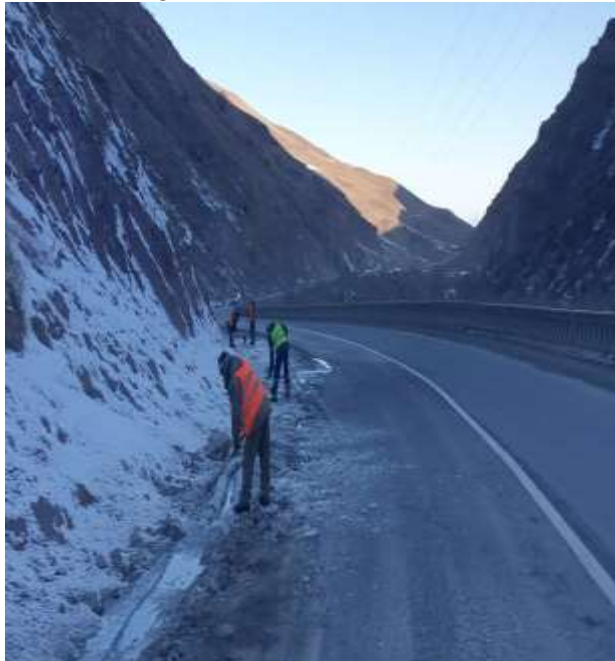
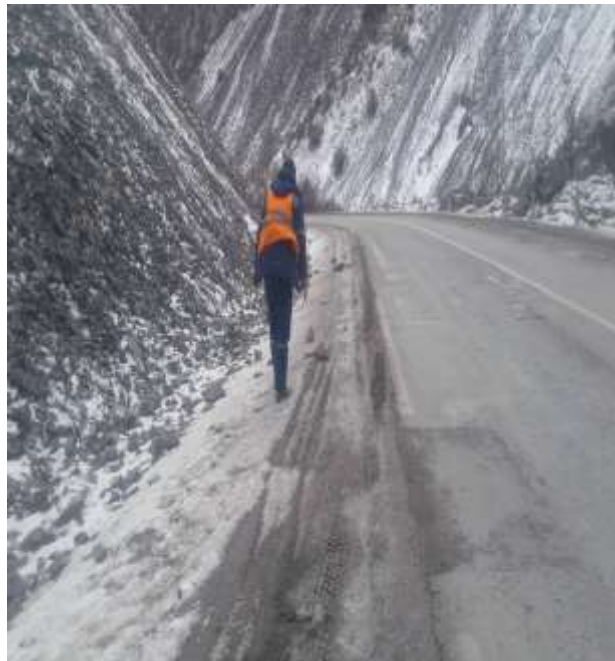
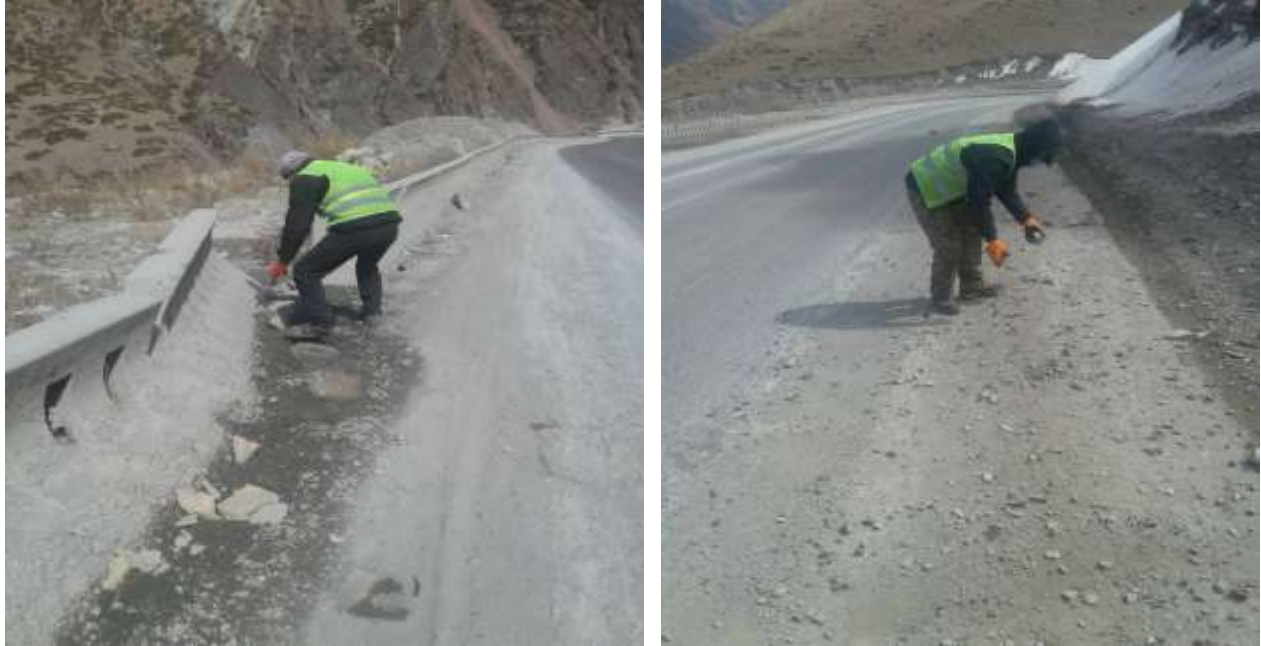
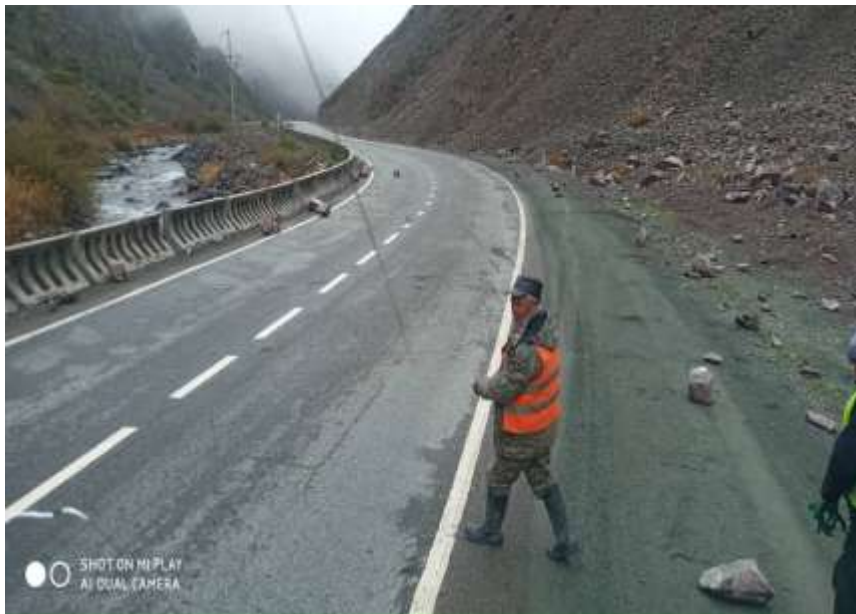
- Cleaning roads from rubbish and rockfalls. 81-129.5 km. Constantly patrolling the road, cleaning and cleaning the road from rockfalls and debris.

Figure-4. Cleaning roads from rubbish and rockfalls

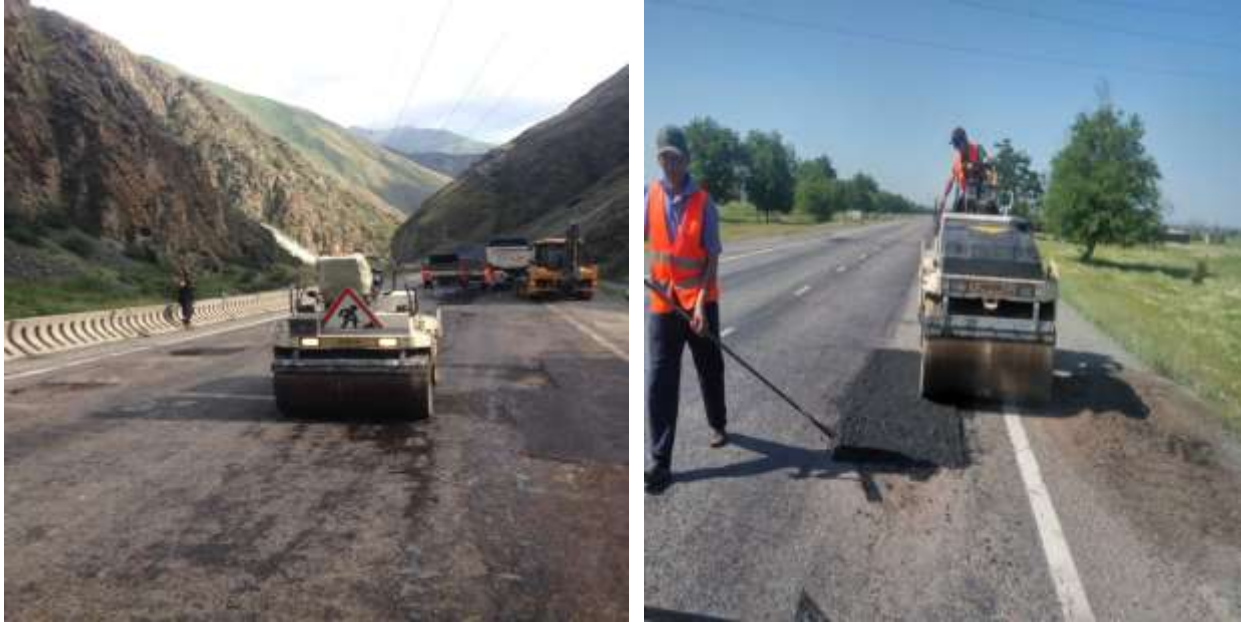
- current maintenance of pavement (patching, filling cracks, cleaning); Section 78 km-121 km

Figure-5. Current pavement repair

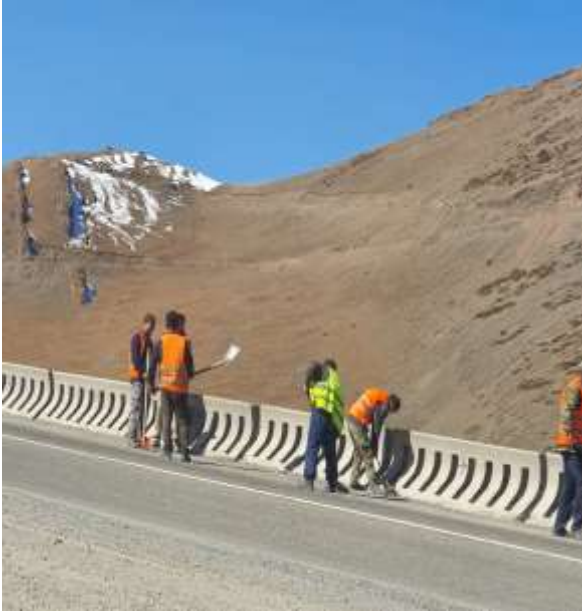
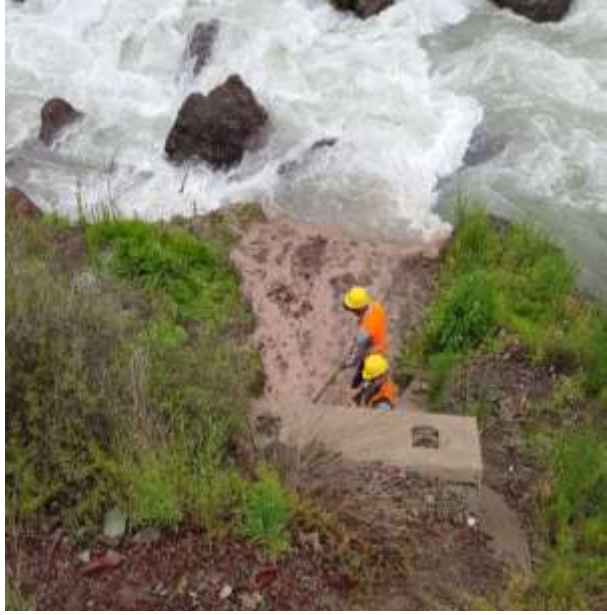
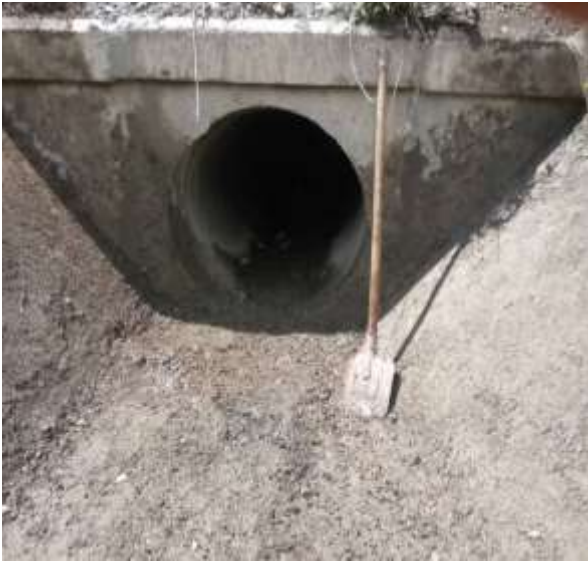
23. Cleaning and repair of drainage facilities - In total, there are 96 culverts on the site that facilitate the flow and drainage of water from one side of the road to the other, along a slope. Pipes are prefabricated concrete pipes that are cleaned by hand. All pipes are placed in earthen / soil ditches. The job consists of removing dirt and debris to ensure an unhindered flow of water. Cleaning culverts 61-129 km. Cleaning along parapets. Garbage cleaning 61-129.5 km.

Figure-6. Culvert cleaning along parapets
