Environmental Monitoring Report

7th Semi-annual Report
January 2021

KGZ: Central Asia Regional Economic Cooperation Corridor 3 (Bishkek -Osh Road) Improvement Project, Phase 4

Prepared by Joint Venture Temelsu International Engineering Services Inc., E.Gen Consultants Ltd., and Dosh Upodosh Ltd. in association with Kyrgyz TREC International, Ltd. for the Ministry of Transport and Roads of the Kyrgyz Republic and the Asian Development Bank.

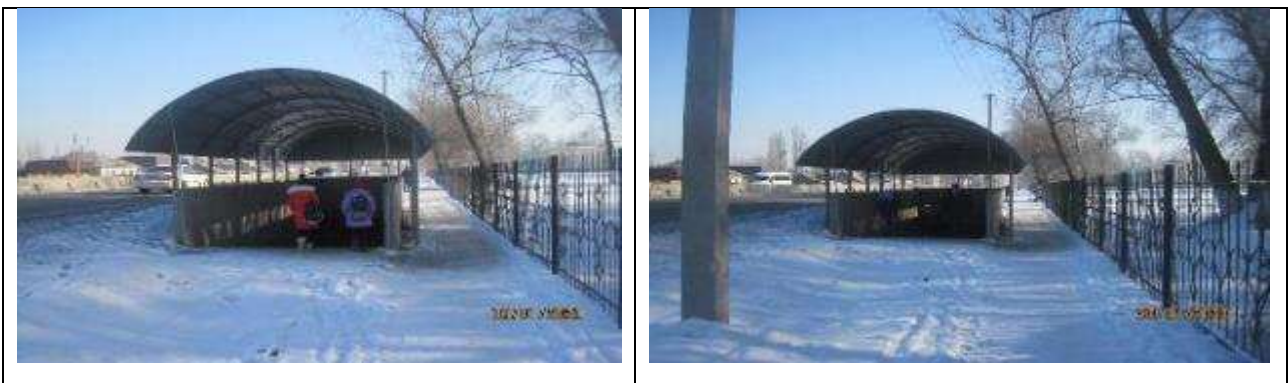
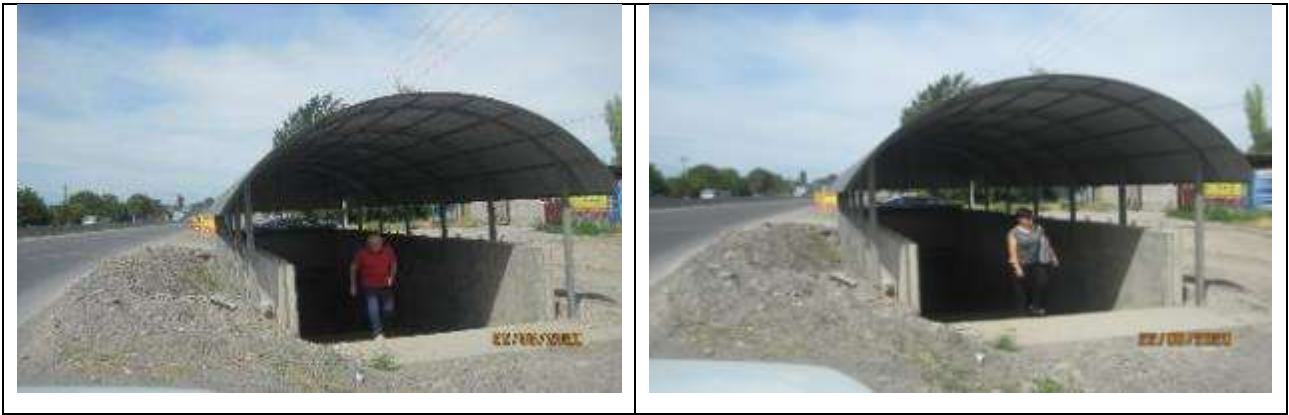
Figure 11 Construction and rehabilitation of underground passages

37. Currently, the construction of five underground passages is almost completed. Adults and children are currently crossing the road through some underground passages, and temporary lighting has been installed for this purpose. Considering that during the construction of underground pedestrian passages, a close occurrence of the underground water level was noted, the Consultant constantly monitors for detection of flooding, in order to be able to eliminate it in a timely manner.

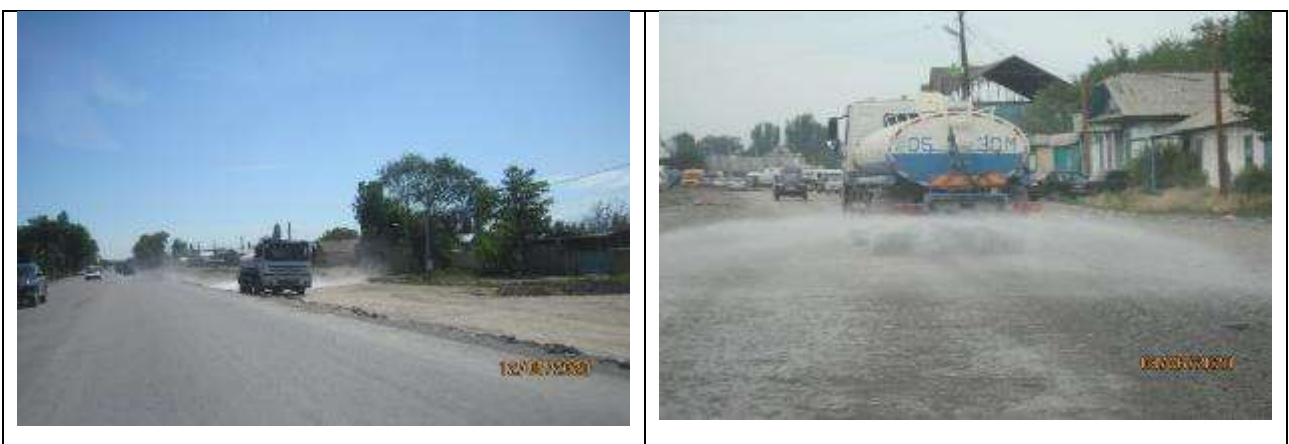
Figure 13 Water-sprinkling of the road to avoid dusting.

39. To avoid dusting, all sections where intensive construction work was carried out were water-sprinkled according to an agreed schedule. No complaints from the local residents for dust formation were registered.

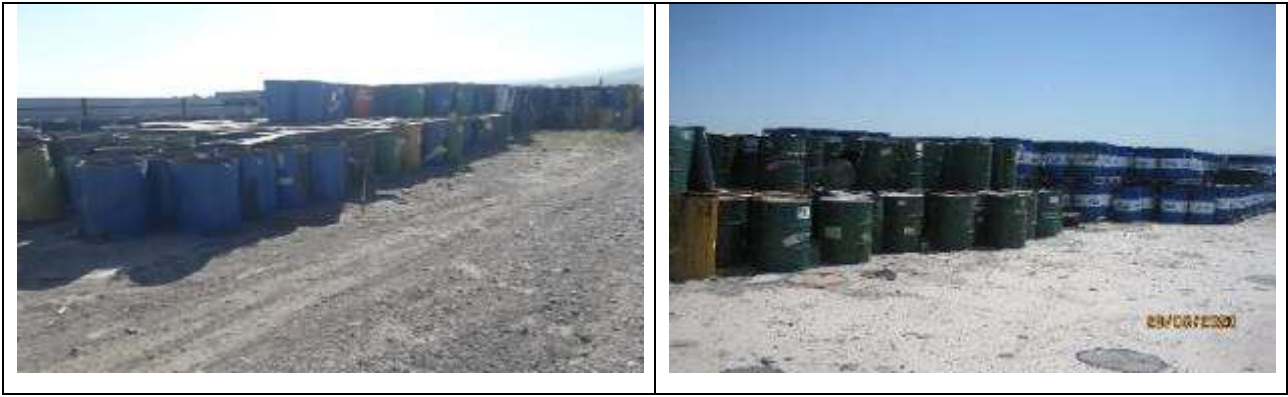
Figure 20 Barrels of bitumen on a specially prepared site

57. To prepare the asphalt mixture, a large number of barrels with bitumen were delivered to the production site, which were partially placed on a specially prepared area. A large number of barrels were placed on the ground covered with waterproofing material. No bitumen leaks were recorded during the reporting period. Soil contamination with bitumen was not observed during the reporting period.

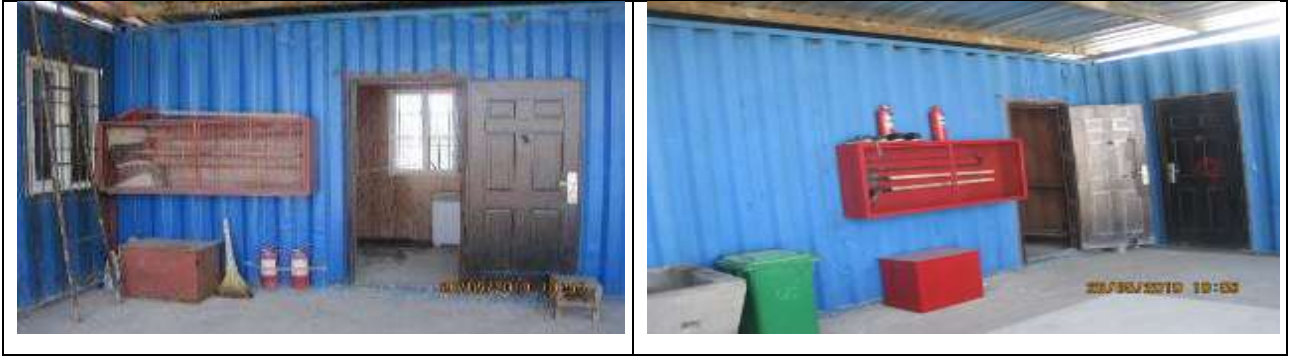
Figure 22 Fire shield equipment on the area of the camp

61. After a verbal warning concerning the need for a fire shield equipment, 2 shields were installed in the camp.

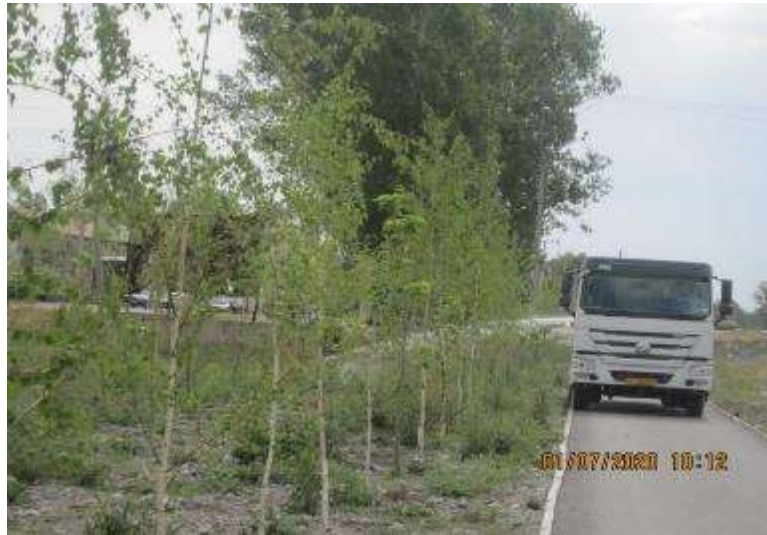
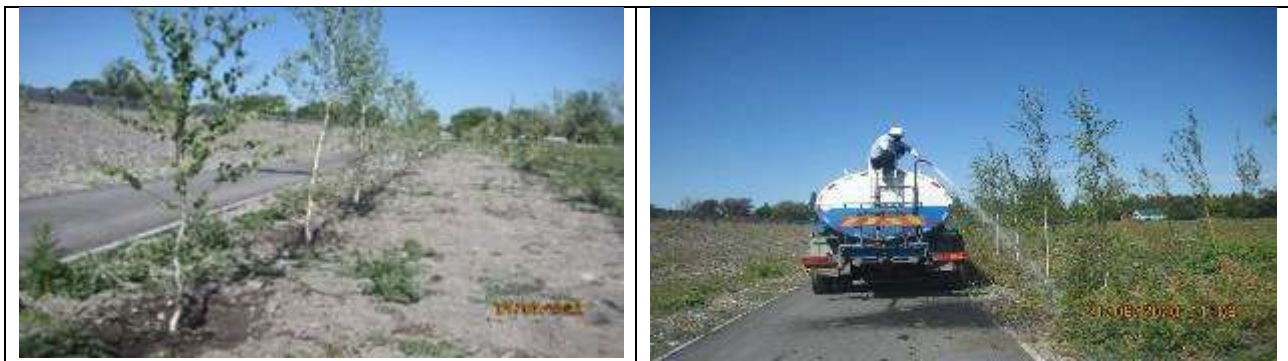
Figure 27 Watering of seedlings

68. Seedlings planted in autumn 2019 and spring 2020 (600 pieces) have taken root well and are in satisfactory condition. During the reporting period, given the hot period of the year, regular and abundant watering of the seedlings was needed. A letter was sent to the contractor about the need to perform regular watering every 3 days.

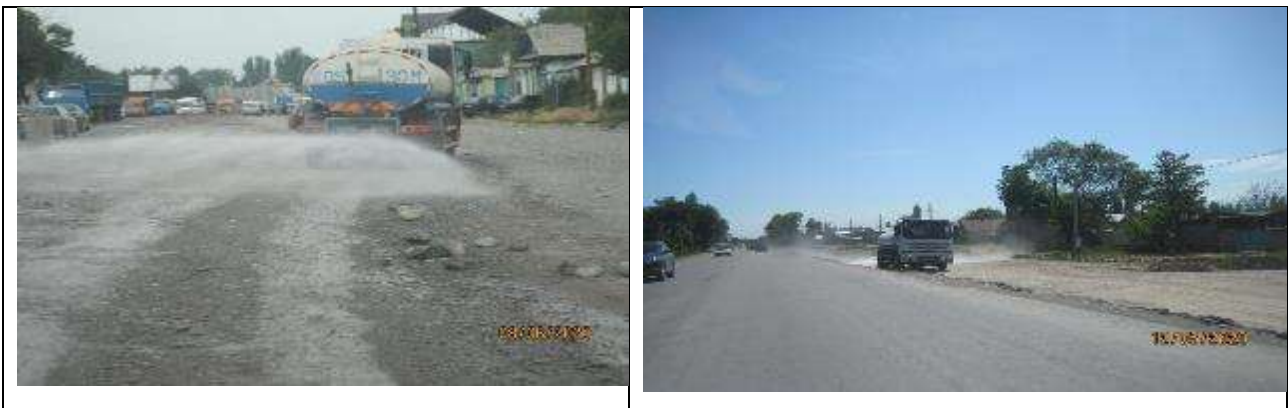
Figure 31 Water sprinkling on road construction sites

96. In previous periods dust generation has the main impact on the environment during the earthworks. In the reporting period, single cases of dust generation were noted, about which the Contractor was immediately warned. At the construction sites water-sprinkling of the road including the shoulders was carried out from 7 am to 8 pm without a lunch break. The contractor has drawn up a schedule for water sprinkling with an interval between watering 30 minutes. Considering the small scope of work on the road and the fact that several watering machines worked on the construction sites, which water the road in time, dust generation was rarely observed at the construction sites. No complaints for dust formation were received from the local residents or local government authorities during the reporting period.

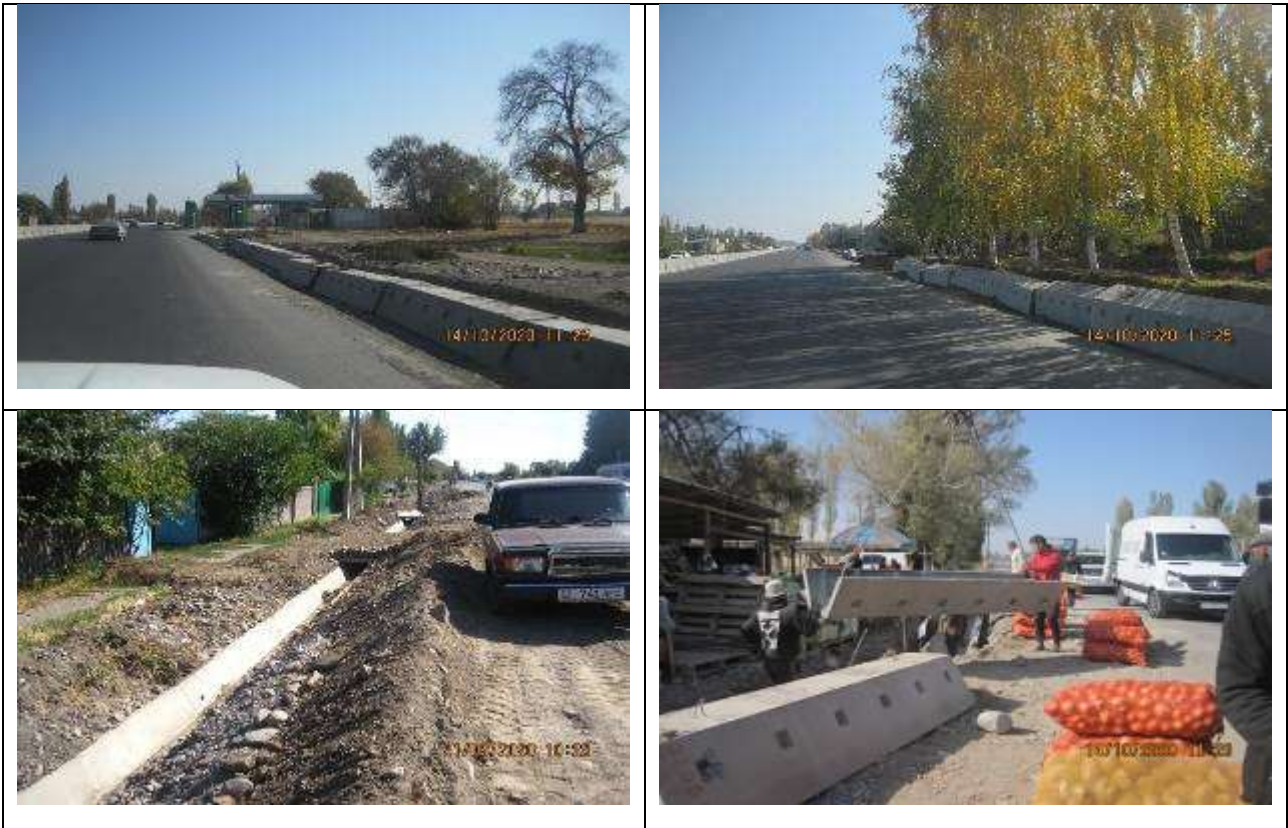
99. At previously constructed road sections installation of culvert chutes was carried out.

Figure 32 Installation of culvert chutes

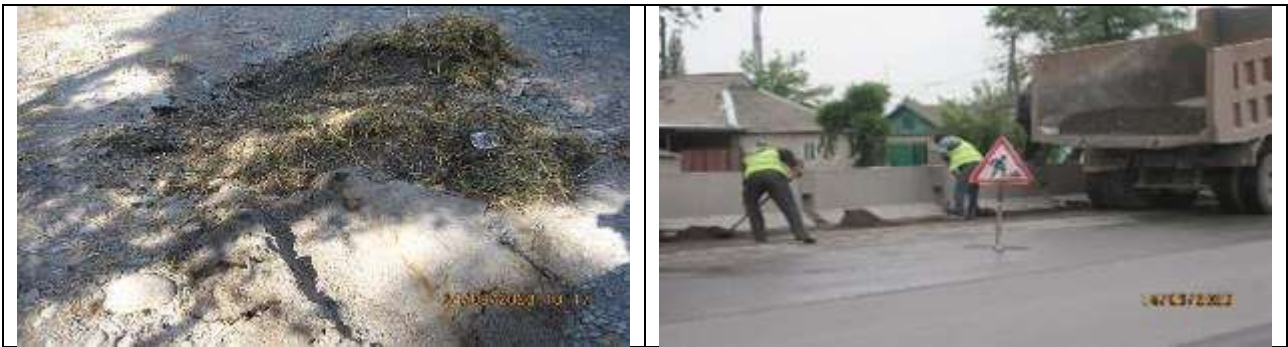
102. In course of monitoring, it was found that on the road shoulders, where work was carried out to strengthen the parapets, there were not removed soil waste, laid in the form of small piles. Under the impact of atmospheric precipitation, the waste was washed away and polluted the surrounding

area. A letter was sent to the contractor with an indication of the time frame for eliminating this violation.

Figure 35 Asphalt and plant waste on the road shoulders formed during the strengthening of the parapet

103. In due time, the soil waste was collected from the road shoulders and removed.

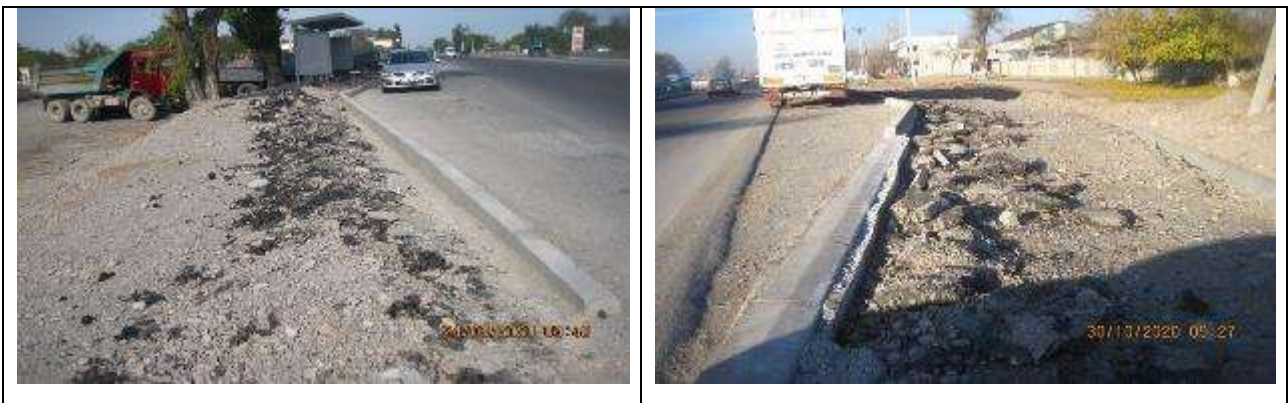
105. During the reporting period, bus stops were constructed. At the same time, a large number of asphalt scraps were formed. The contractor was repeatedly warned about the need for timely removal of waste from the road.

Figure 36 Cleaning of stops from asphalt scraps

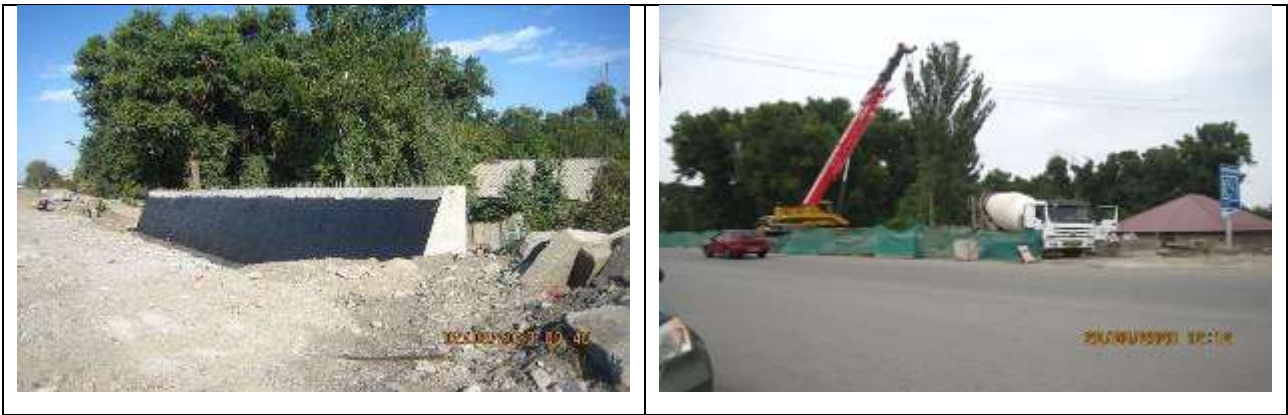
106. Retaining wall was constructed at km 26+500.

Figure 37 Construction of a retaining wall at km 26+500

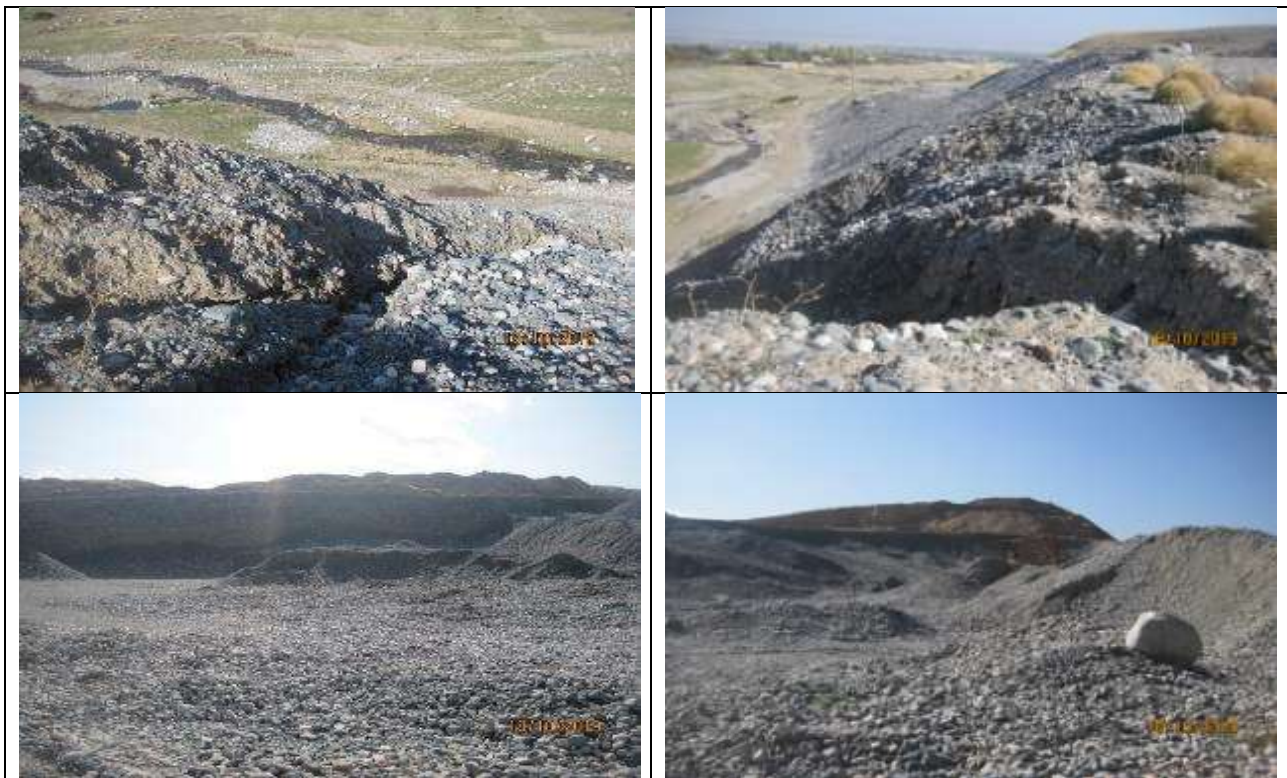
112. **Jelamysh borrow-pit.** At present, gullies and steep slopes on Jelamysh borrow-pit can pose a danger to the population and pets.

Figure 40 Jelamysh borrow pit at present time

113. Currently, a borrow-pit reclamation plan has been drawn up and agreed. It is necessary to start work on the borrow-pit reclamation, according to this Plan.

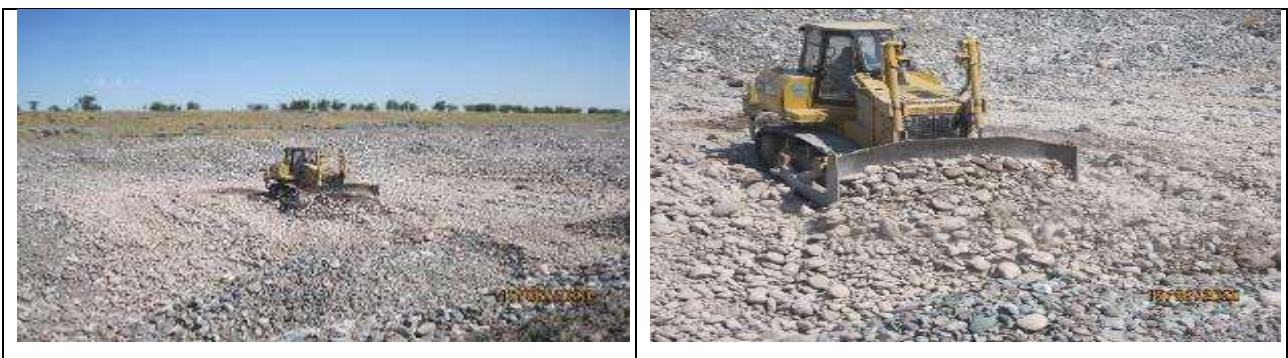
123. Borrow-pit is located in the riverbed of the AK-Suu river and covers a large area. It is necessary to carry out reclamation work on the worked-out area of the borrow-pit.

124. At the borrow-pit, reclamation work started, which includes grading all irregularities in the area of the excavations carried out, but given the lack of construction equipment, the bulldozer was sent for road construction.

Figure 42 Rehabilitation works at the Ak-Suu 2 borrow-pit

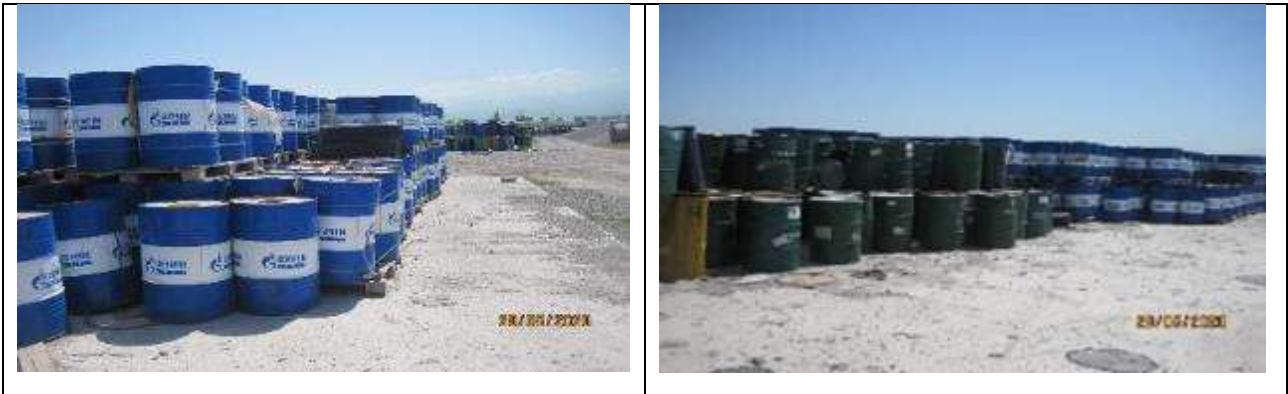
129. Barrels with bitumen are placed on a special concrete platform, part of the barrels are placed behind the platform on the ground, covered with a special anti-filtration coating - a special plastic film.

Figure 44 Barrels with bitumen on a special site

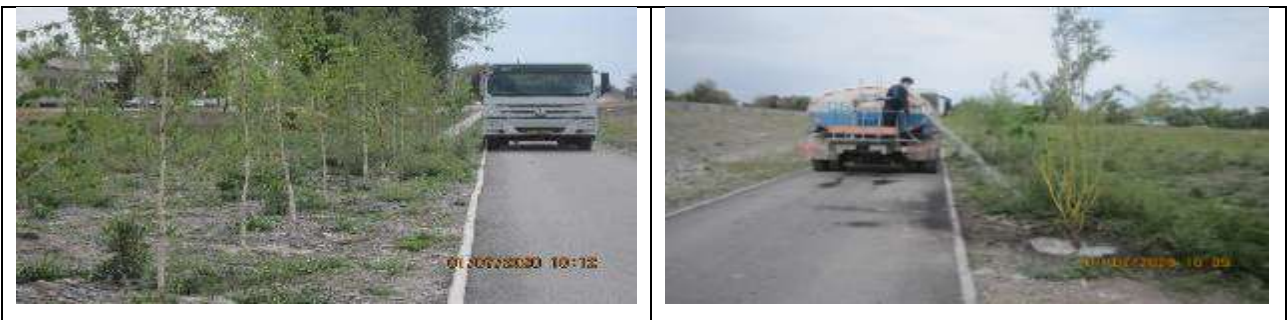
136. To provide the seedlings with the sufficient moisture, a letter was sent to the contractor about the need to make regular watering every 3 days. Despite constant reminders, the seedlings were not watered regularly. Given the hot weather, some of the seedlings began to dry out. The consultant carried out a preliminary calculation of the survival rate of seedlings, which was 95%. Given that the planting of seedlings is not completed, the numbers on the survival rate of seedlings will change and the final percentage of survival will be summed up in spring 2021. The contractor was given an additional explanation that, in accordance with the terms of the current contract, all dried seedlings will be restored at the expense of the contractor.

Figure 49 Seedlings after watering

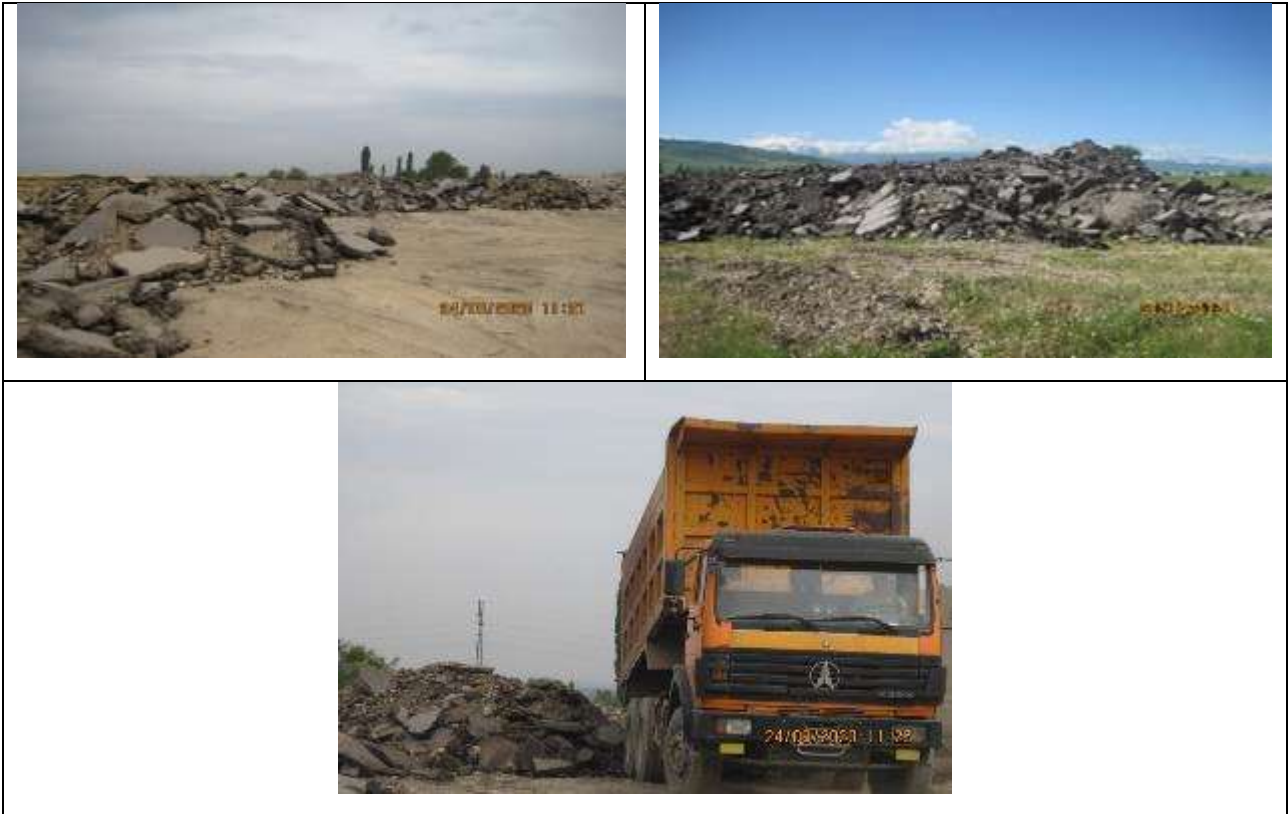
142. Given the fact that the quality of filling is not always satisfied with local residents, the administration of the villages of Alexandrovka and Sokuluk banned the transportation of old removed asphalt to fill the streets, and allocated area for storing unsuitable soil and removed asphalt to dumps for further use if necessary. On the part of the consultant, before storing unsuitable soil, the site was inspected for its "suitability", namely, the distance from water, the absence of a close occurrence of ground water or wetlands. According to the results of the inspection the allocated area for temporary storage of old asphalt and unsuitable soil met these requirements.

Figure 53 Dumping of old asphalt on a dedicated area for further use

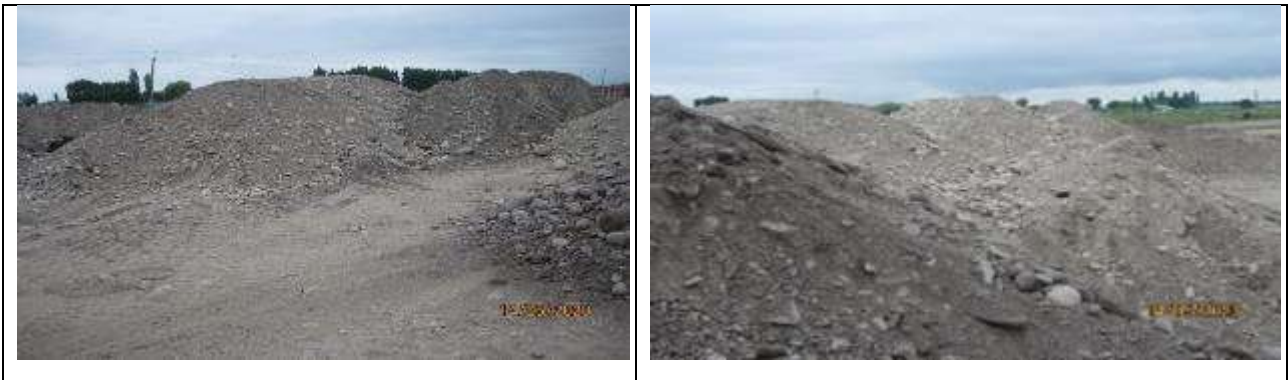
143. The soil unsuitable for the road construction is also taken to the sites allocated by the local authorities.

Figure 54 Storage of unsuitable soil for further use

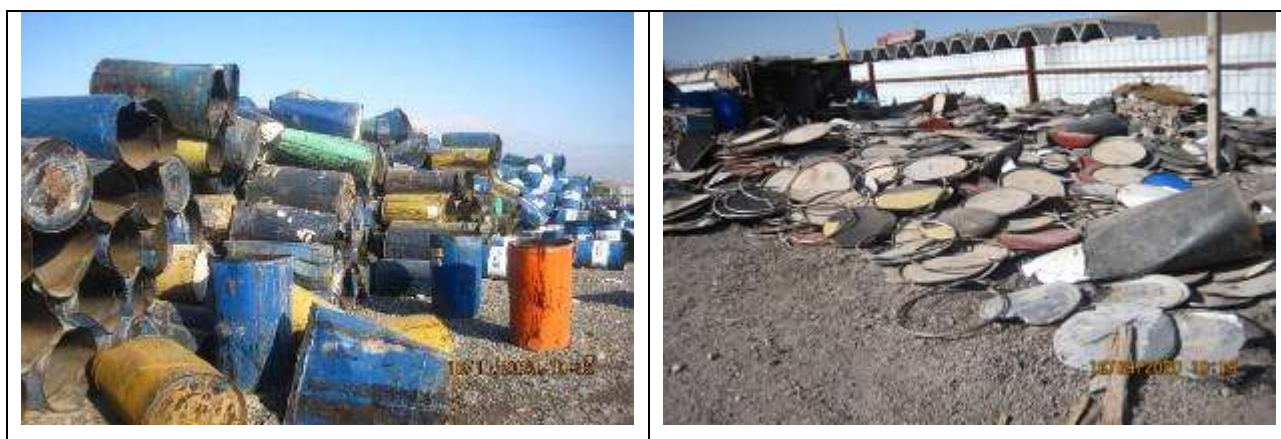
146. To prepare the asphalt mixture, a large number of barrels with bitumen were delivered to the production site, the bitumen from which was used in November. A large number of empty barrels and metal lids were accumulated, which were removed from the production site in December.

Figure 56 Storage of empty bitumen barrels and lids

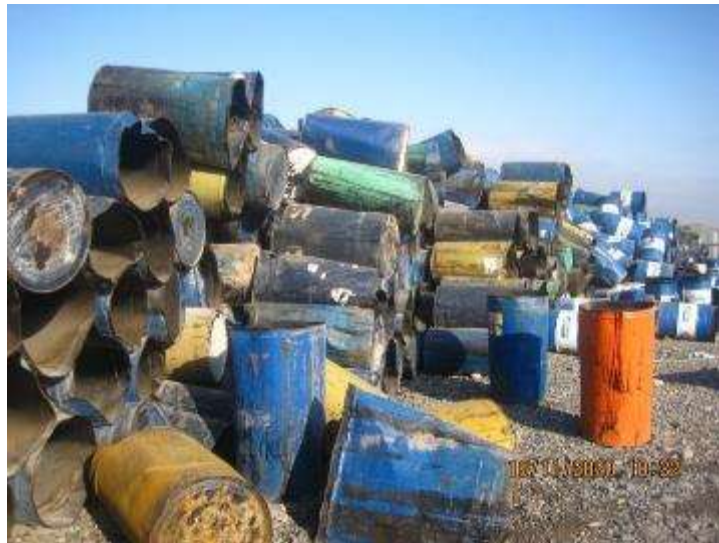
199. During the production of asphalt, waste is generated on the area of the asphalt plant. Mainly, it is are empty barrels of used bitumen. Empty barrels are stored in the plant area. Currently, a large number of used barrels and metal lids have been accumulated, which must be disposed of. According to the Contractor, empty barrels that have not been dented during the usage are partially used for roads construction work, partially for the needs of the Contractor, and main part used for metal scrap.

Figure 74 Empty bitumen barrels

200. To date, barrels are prepared for disposal.

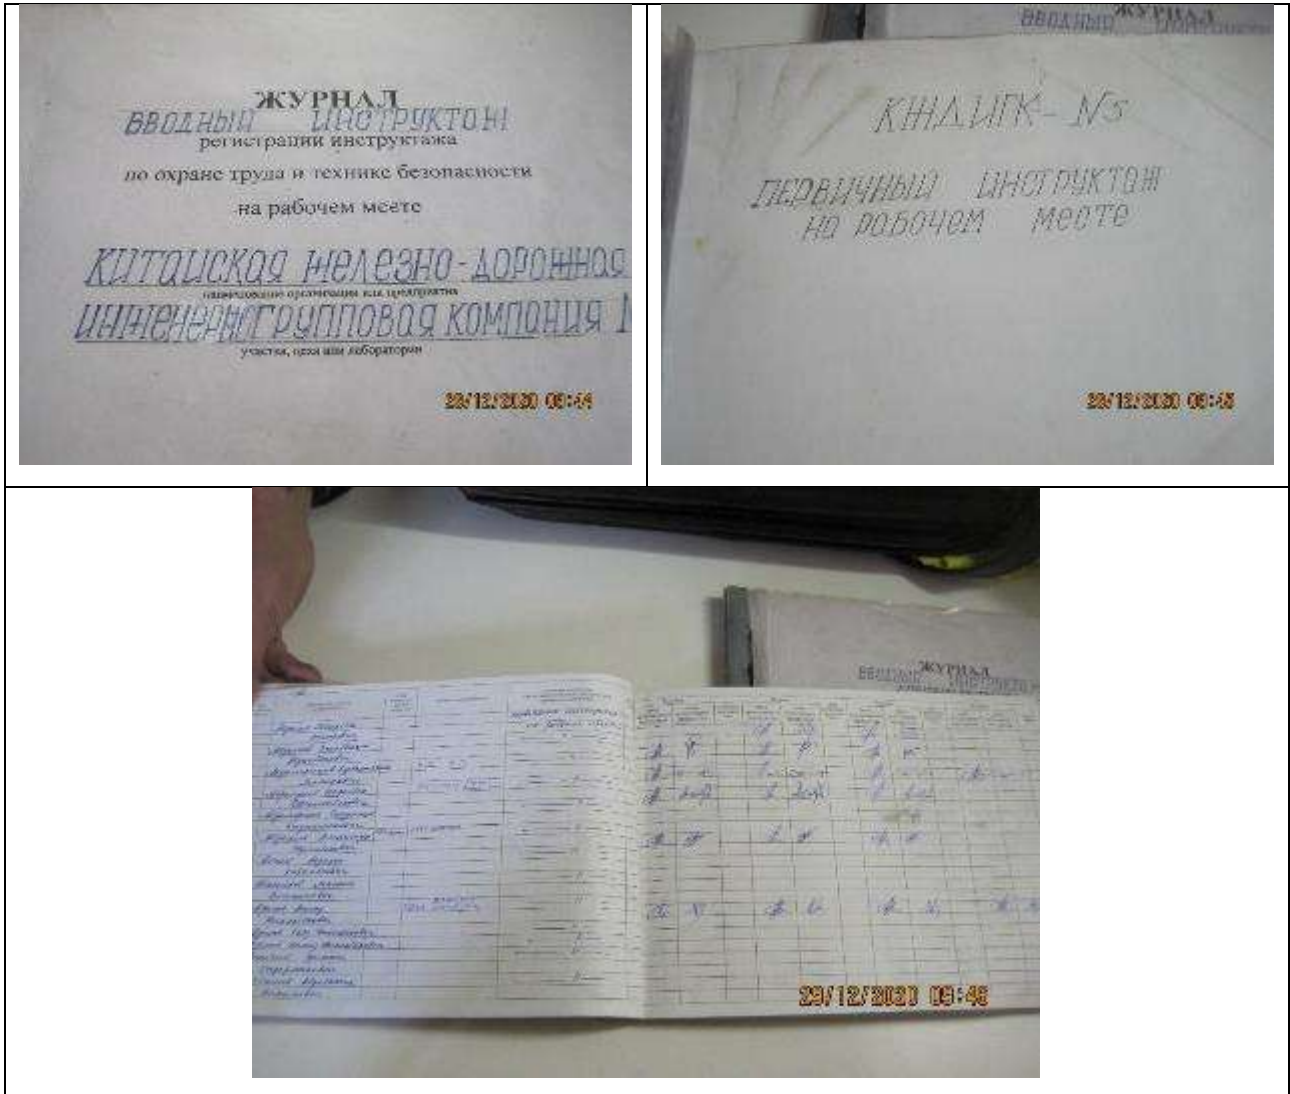
208. Induction briefings for newly recruited staff are conducted regularly. In total, 507 workers were given introductory training. Also, briefings were conducted to 365 workers at workplaces. Repeated instruction is carried out every 3 months. To eliminate injuries, seminars were held at workplaces with workers. Within six months, no accidents were recorded with the participation of our workers at the production processes.

Figure 75 Briefing logs

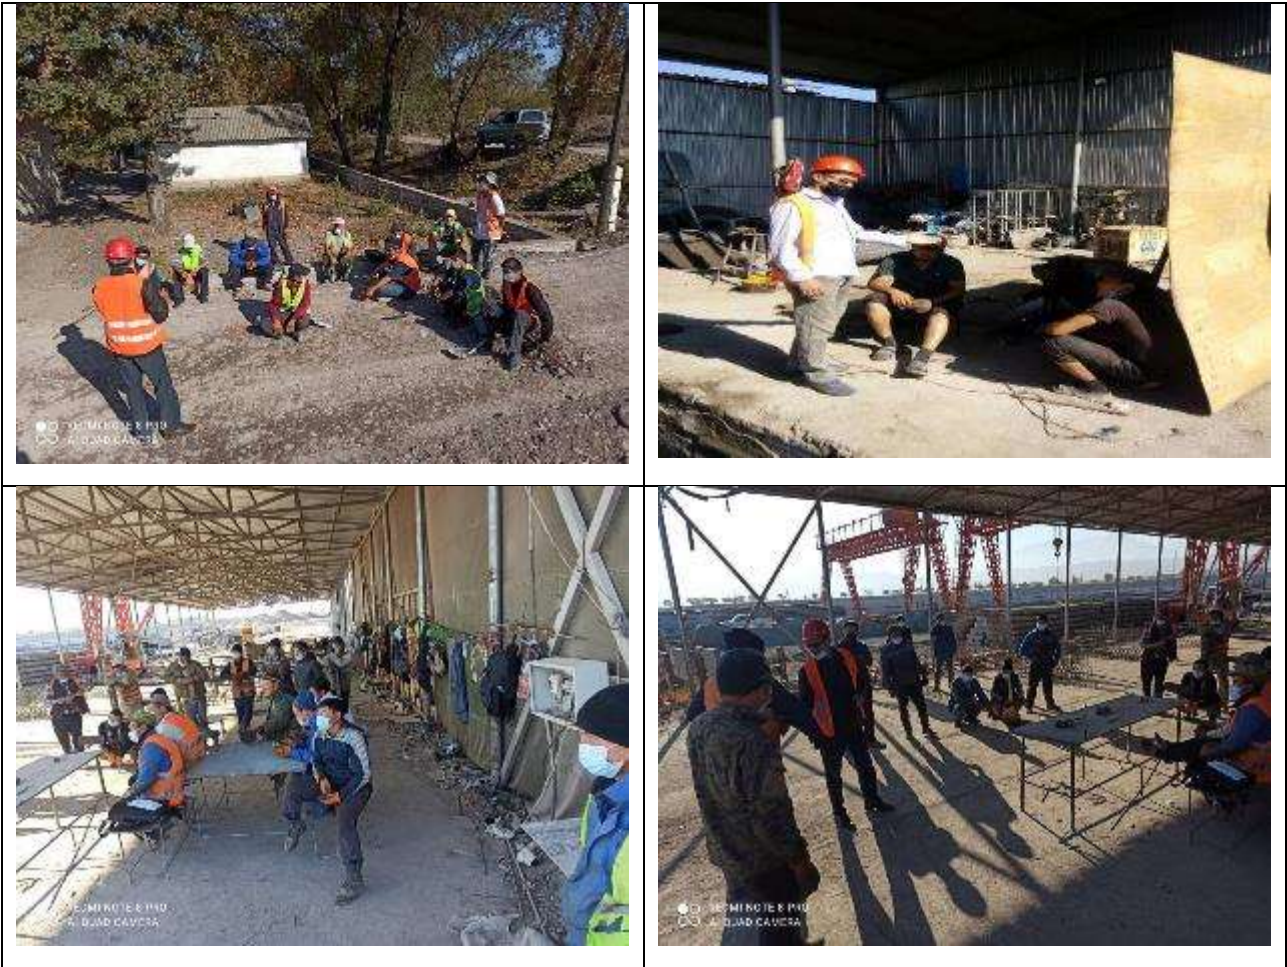
209. During the reporting period, there were several joint visits of the Consultant’s local environmental specialist with the Contractor’s Safety Specialist. The briefing was carried out at the construction sites.

Figure 76 Conducting on-the-site training

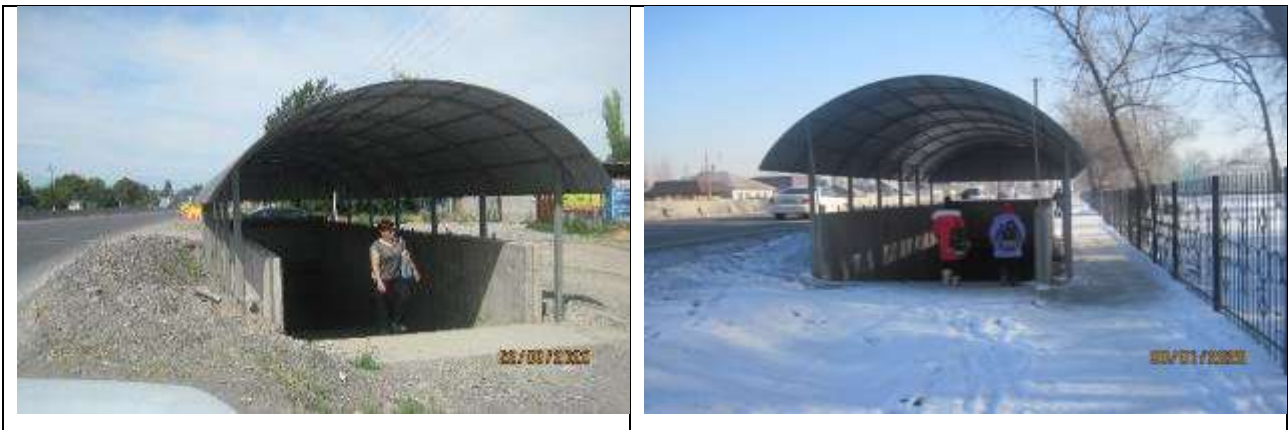
217. During the reporting period, no accidents occurred due to the fault of the contractor or construction work. The consultant constantly monitors the situation and sends a written notification to the contractor in case of noncompliance with a request for immediate elimination. In order to ensure the safety of pedestrians, especially schoolchildren, the project provides for the repair of 4 existing and construction of 6 new underground passages on the road. Underground pedestrian passages are the safest option for pedestrian traffic. Currently, the construction of five underground passages is almost completed. Adults and schoolchildren are currently crossing the road through underground passages.

Figure 78 Adults and schoolchildren use underground passages.

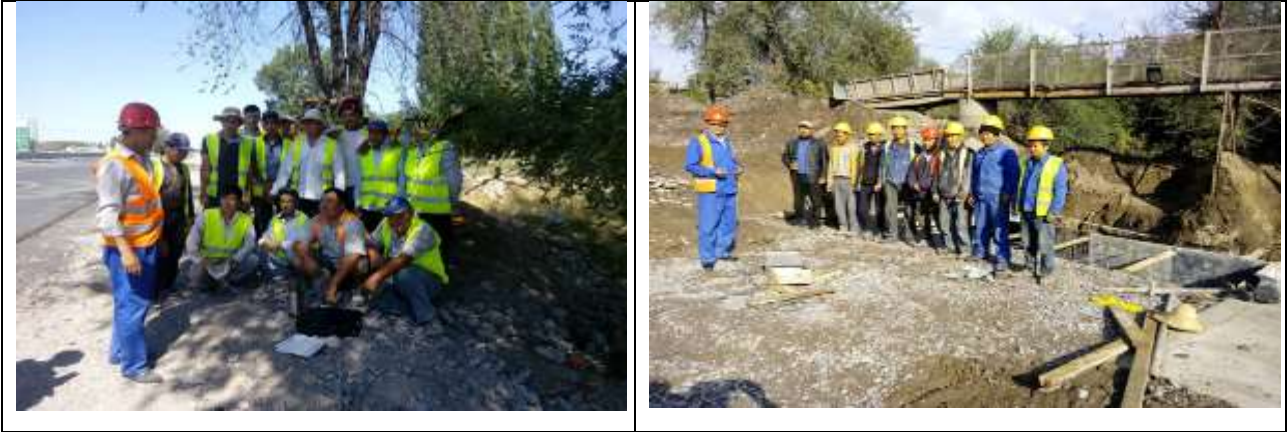
219. All construction workers were trained in basic sanitation, medical care, occupational health and safety, and the specific risks of their work.

Figure 79 Conducting safety training for Chinese and local workers

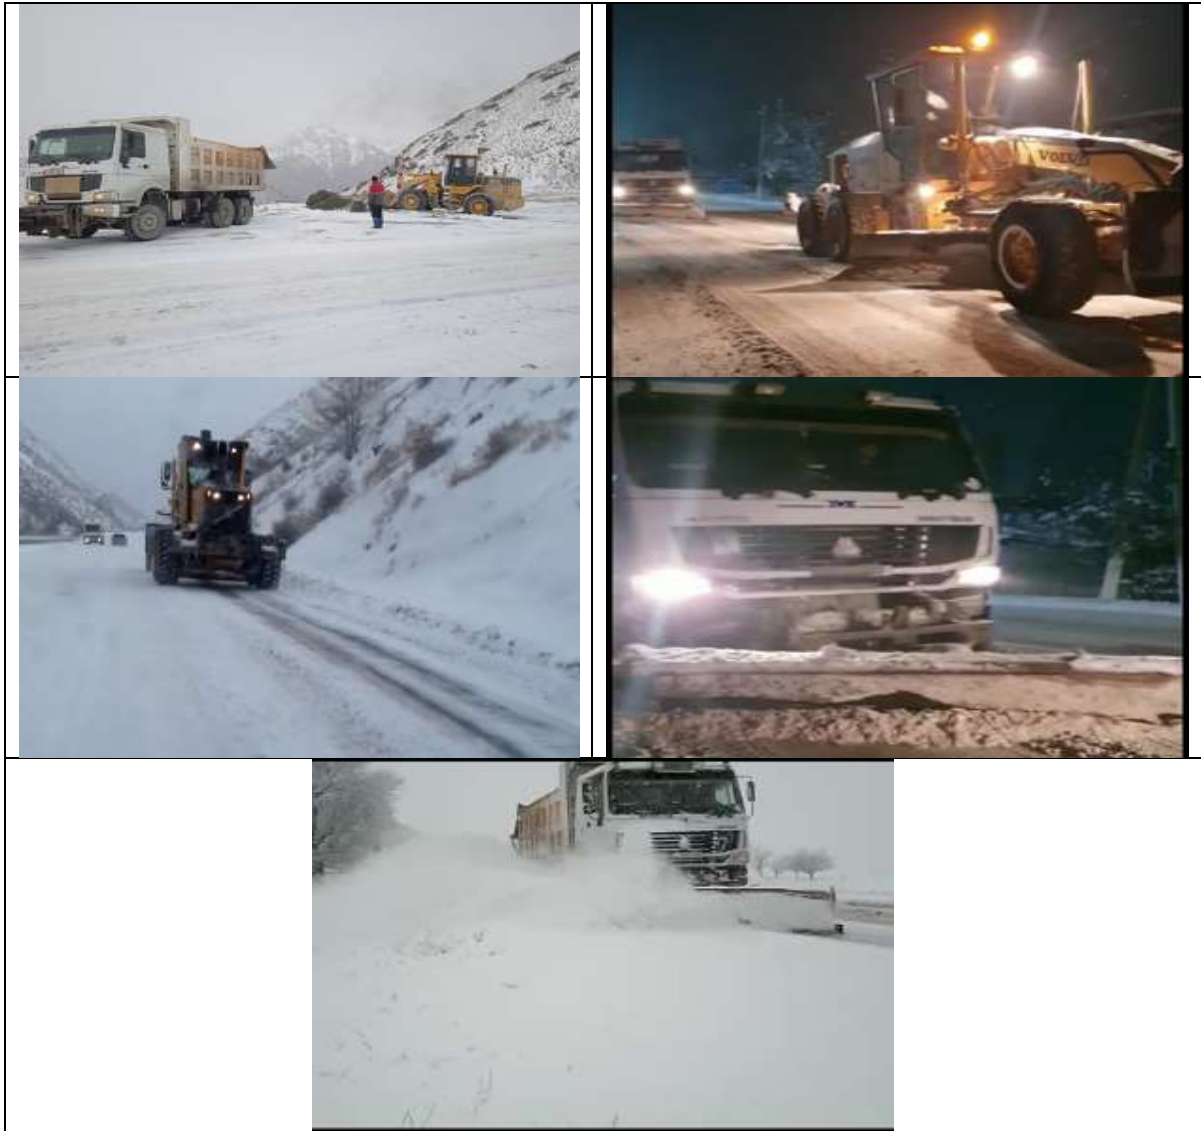
- Cleaning the roadway and roadsides (by a grader, loader). 61-129 km in the winter season. The roadside was constantly cleared of snow, and grading of the carriageway was also carried out. -121-129 km.

Figure-2. Winter road surface cleaning

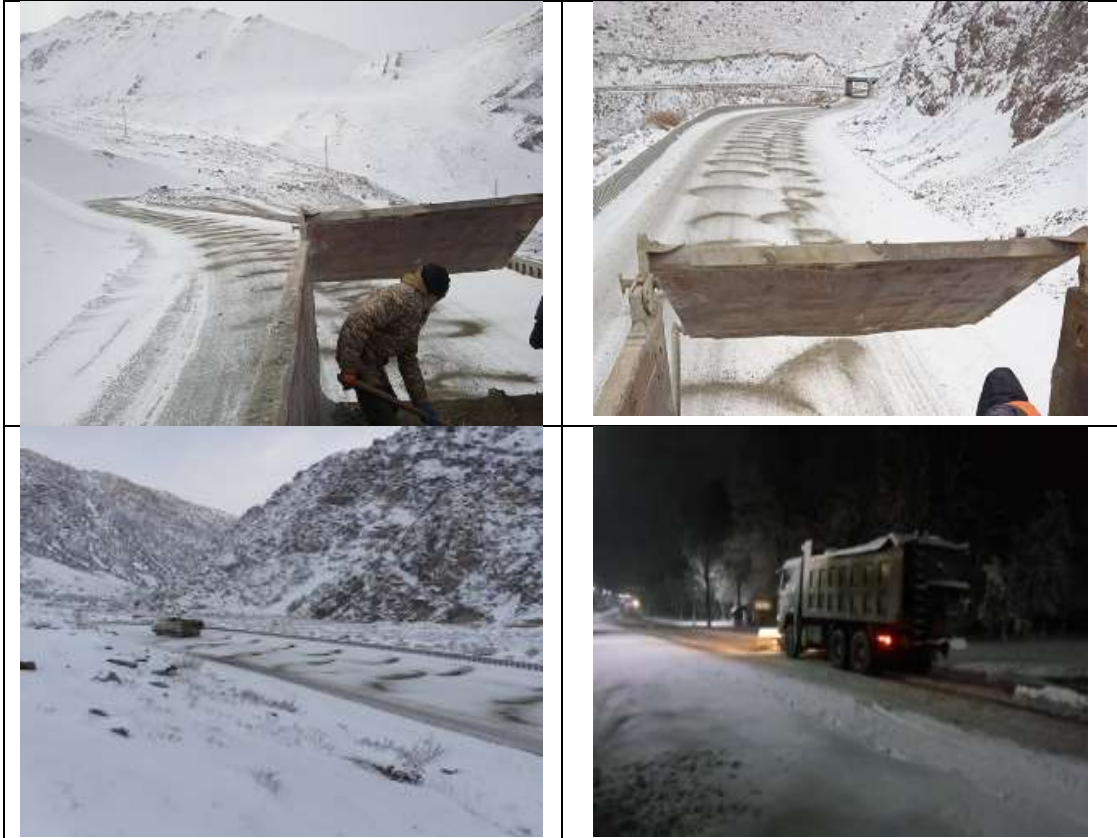
- Filling the road with sand (mechanical and manual) 61-129.5 km.

Figure-3. Sand bedding of the road

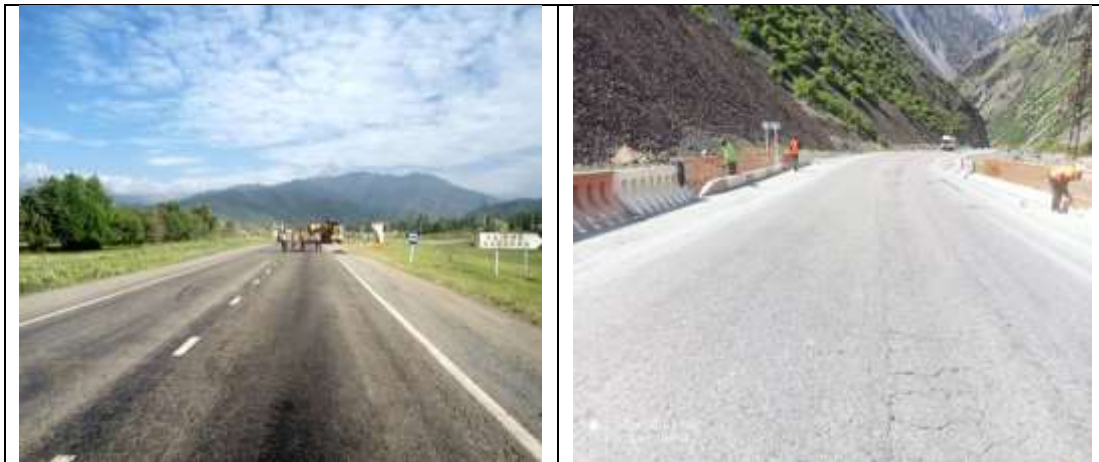
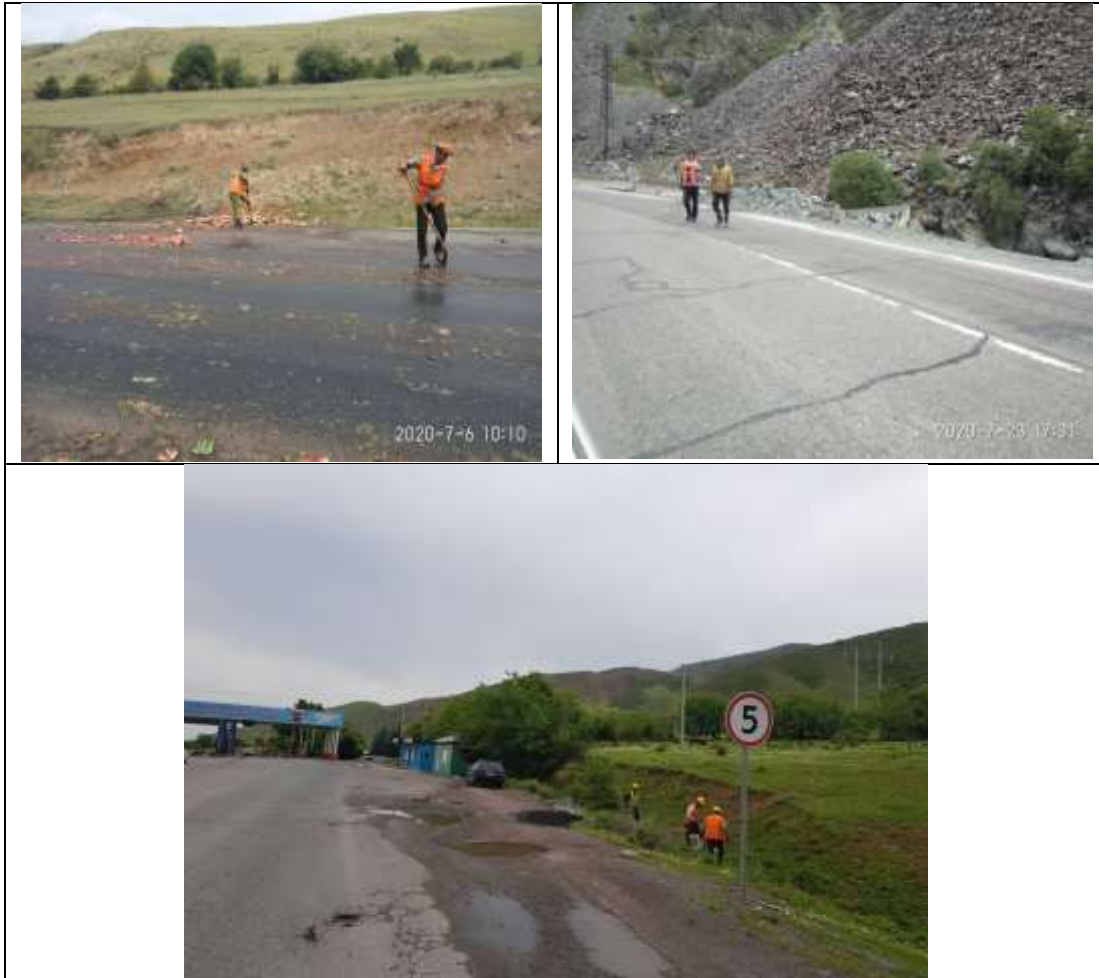
- Cleaning roads from rubbish and rockfalls. 81-129.5 km. Constantly patrolling the road, cleaning and cleaning the road from rockfalls and debris, current maintenance of pavement (patching, filling cracks, cleaning)

Figure-4. Cleaning roads from rubbish and rockfalls
