Environmental Monitoring Report

7th Semi-annual Report
January 2021

KGZ: Central Asia Regional Economic Cooperation Corridor 3 (Bishkek -Osh Road) Improvement Project, Phase 4

Prepared by Joint Venture Temelsu International Engineering Services Inc., E.Gen Consultants Ltd., and Dosh Upodosh Ltd. in association with Kyrgyz TREC International, Ltd. for the Ministry of Transport and Roads of the Kyrgyz Republic and the Asian Development Bank.

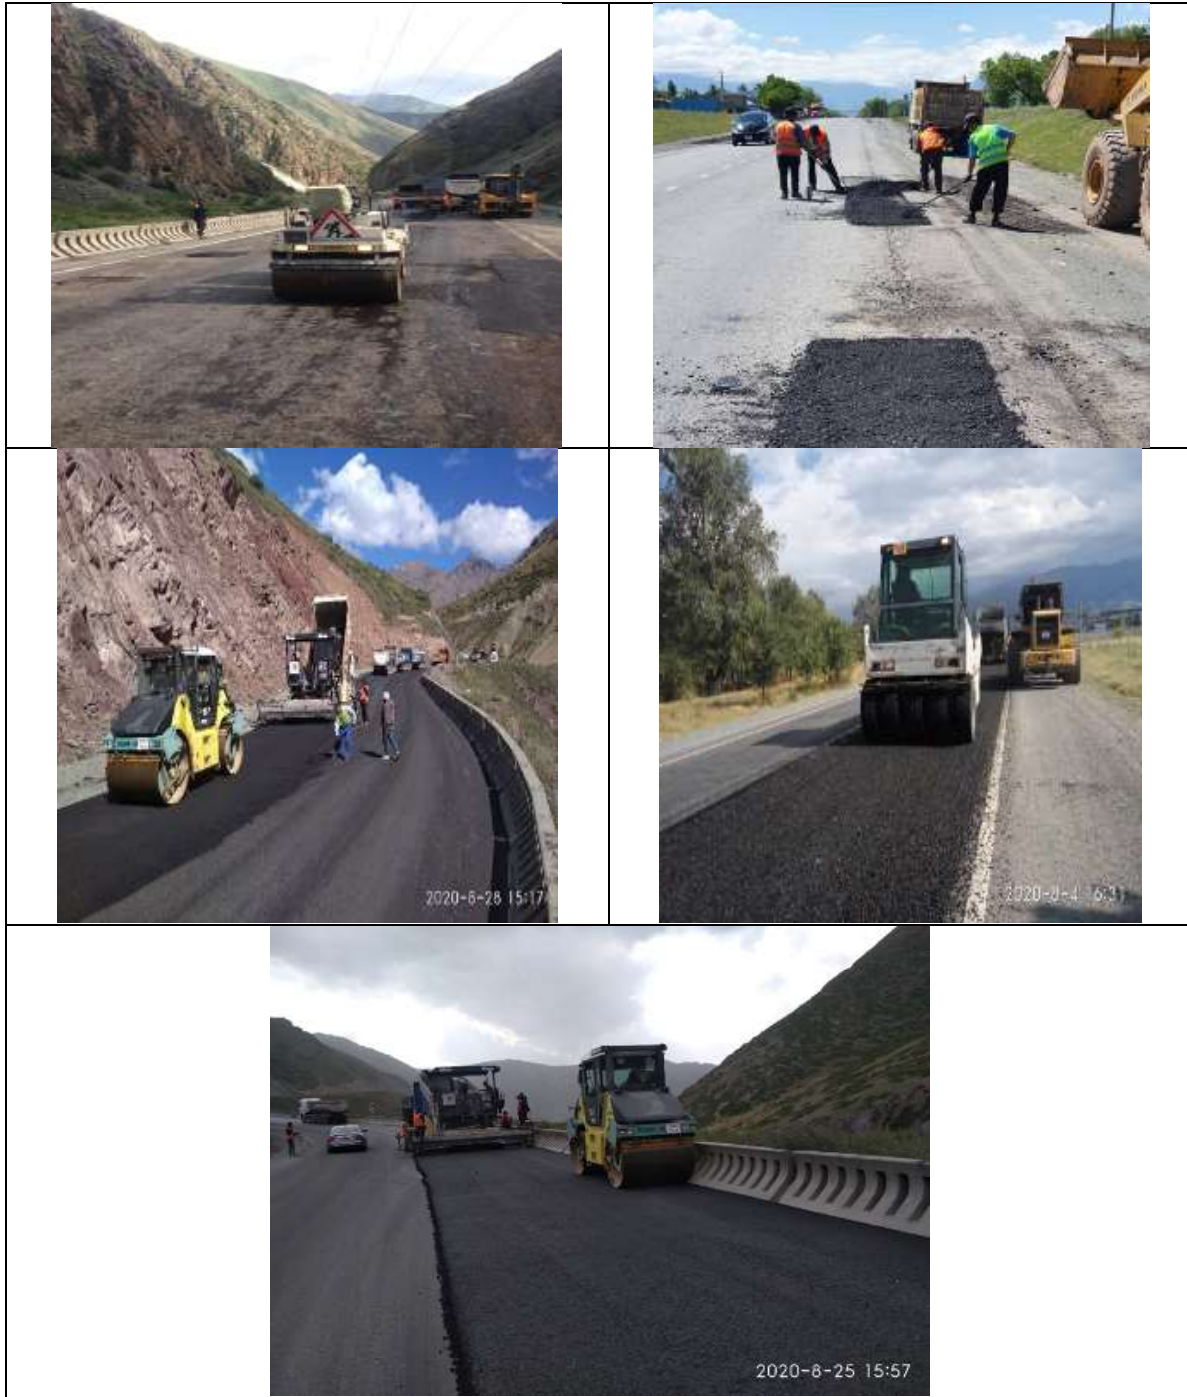
Patching		
Section	Waste material	Dump
63km-144,6km	Existing asphalt after felling.	Sosnovka village dump

Figure-5. Current pavement repair.

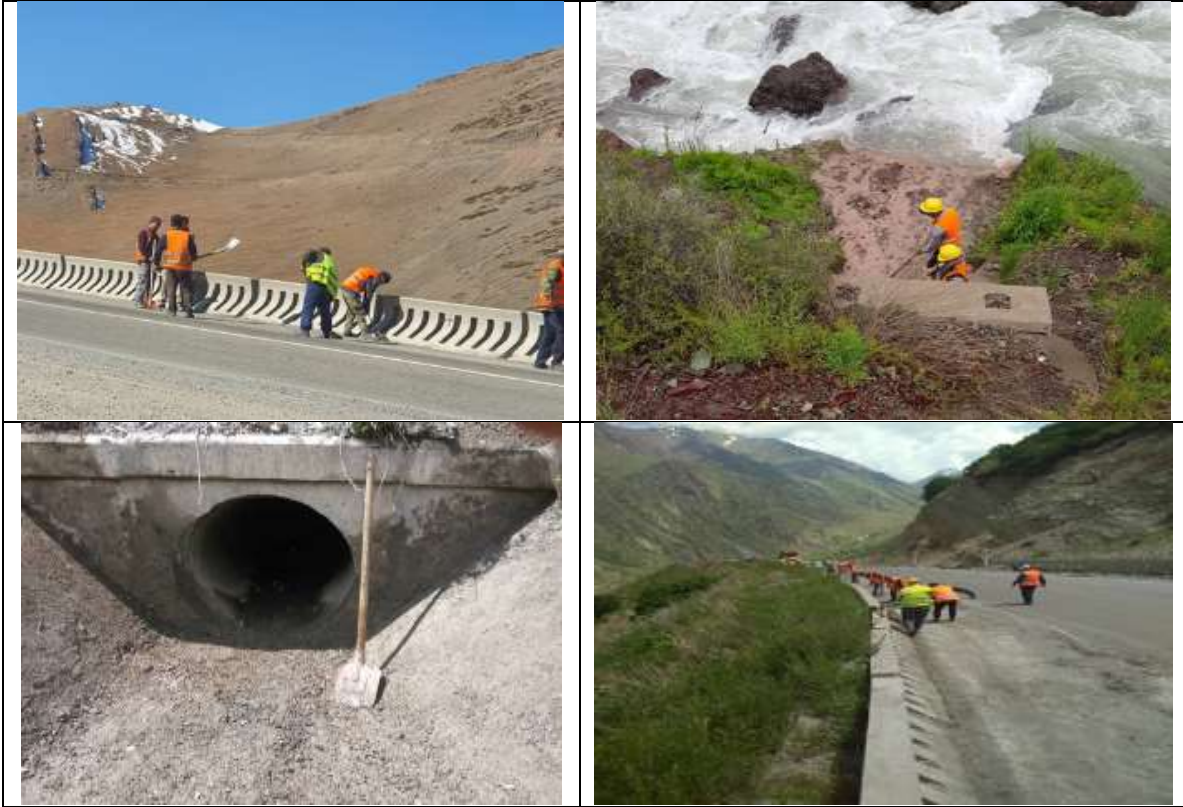
Cleaning and repair of drainage facilities - In total, there are 96 culverts on the site that facilitate the flow and drainage of water from one side of the road to the other, along a slope. Pipes are prefabricated concrete pipes that are cleaned by hand. All pipes are placed in earthen / soil ditches. The job consists of removing dirt and debris to ensure an unhindered flow of water. Cleaning culverts 61-129 km. Cleaning along parapets. Garbage cleaning 61-129.5 km.

Figure-6. Culvert cleaning along parapets

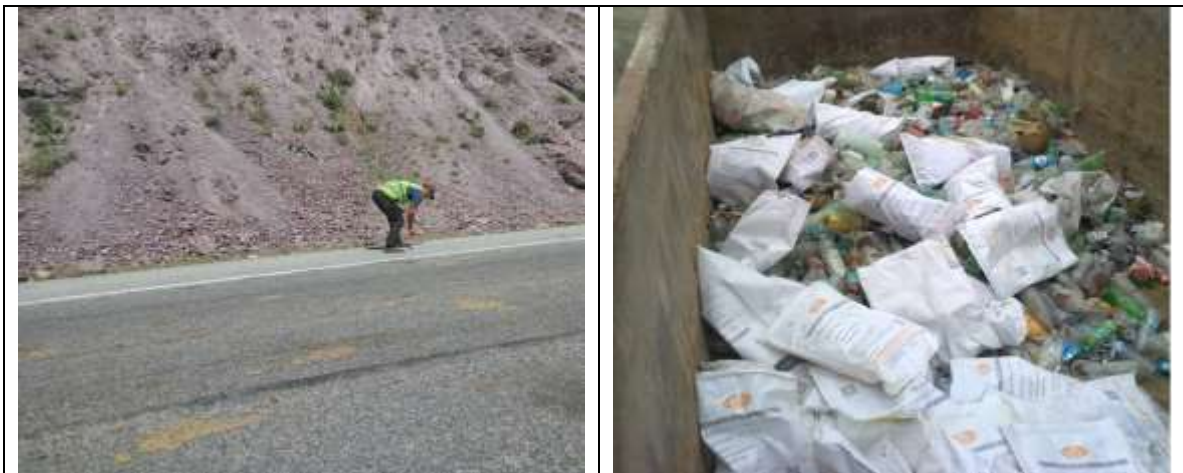
Figure-7. Garbage collection along the road
