Semi-annual Environmental Monitoring Report

Project Number: 48401-007
Reporting period: August 2020

CAREC Corridors 1 and 3 Connector Road, Section 2B Epkin-Dyikan [Bashkuugandy], Km : 89+500 – 159+200 Project

Zhumaliev T.N., National Environmental Specialist,
Gentek Consulting Ltd.
Bishkek, Kyrgyzstan

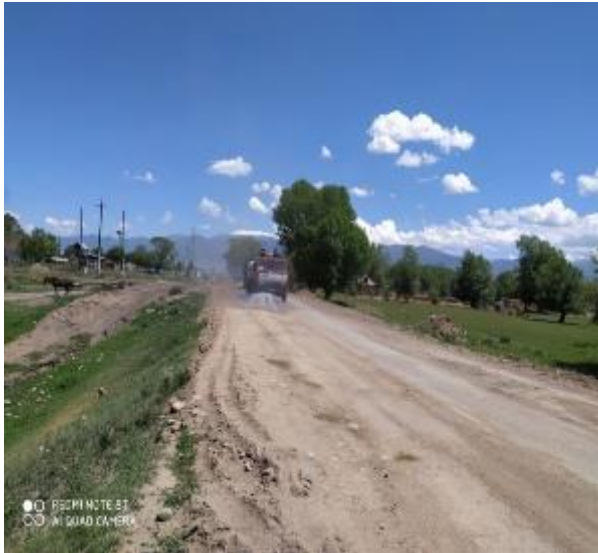
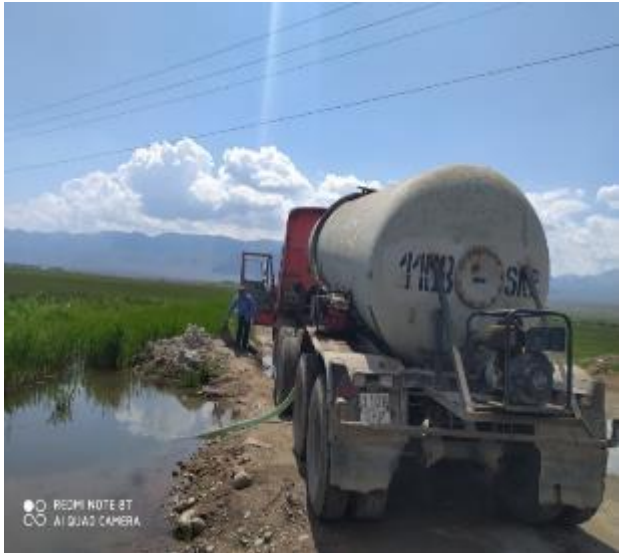
Figure 5. Irrigation on the Road

25. As hot weather had set in, regular irrigation of these areas was established, but taking into account the hot weather, dust formation is still observed on the road. 9 water sprinklers were working on the road. Water for irrigation is taken from the Jungal, Tugol-Sai and Kyzartsuu rivers. Even though, during seasonal irrigation works there were problems with local villagers regarding access to water.

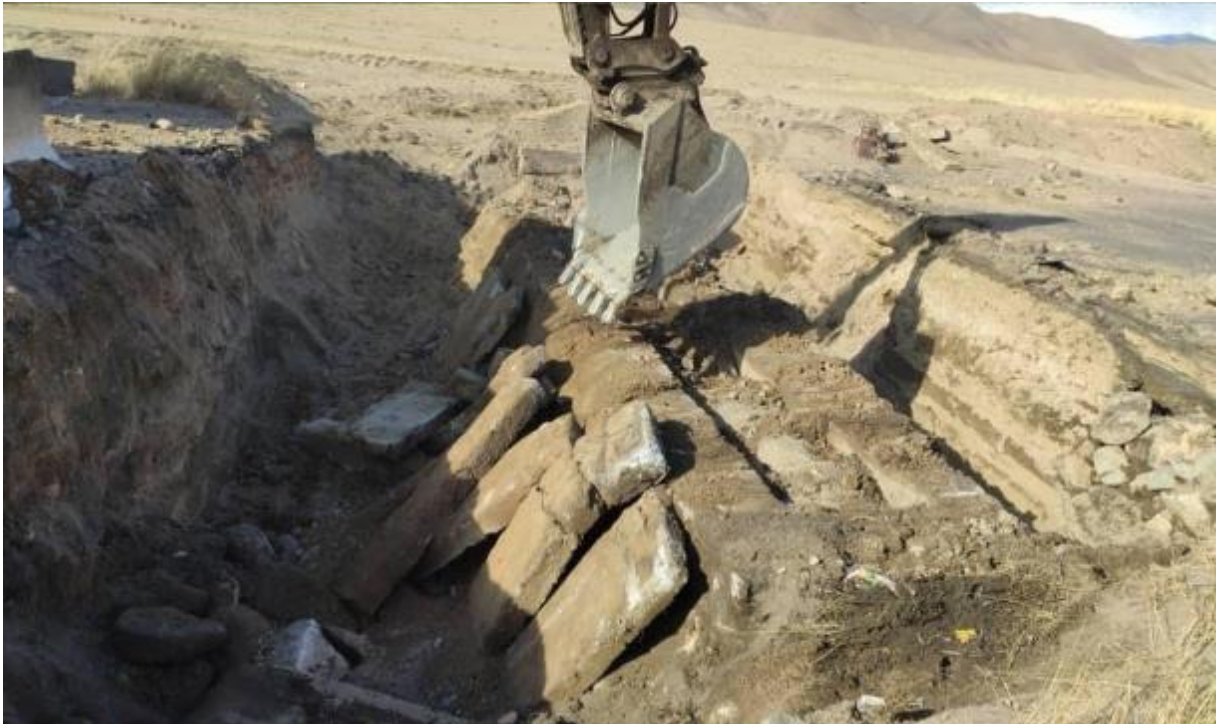
Figure 18. Existing Culverts Removal

59. Removing of old culvert is underway on the project sites.

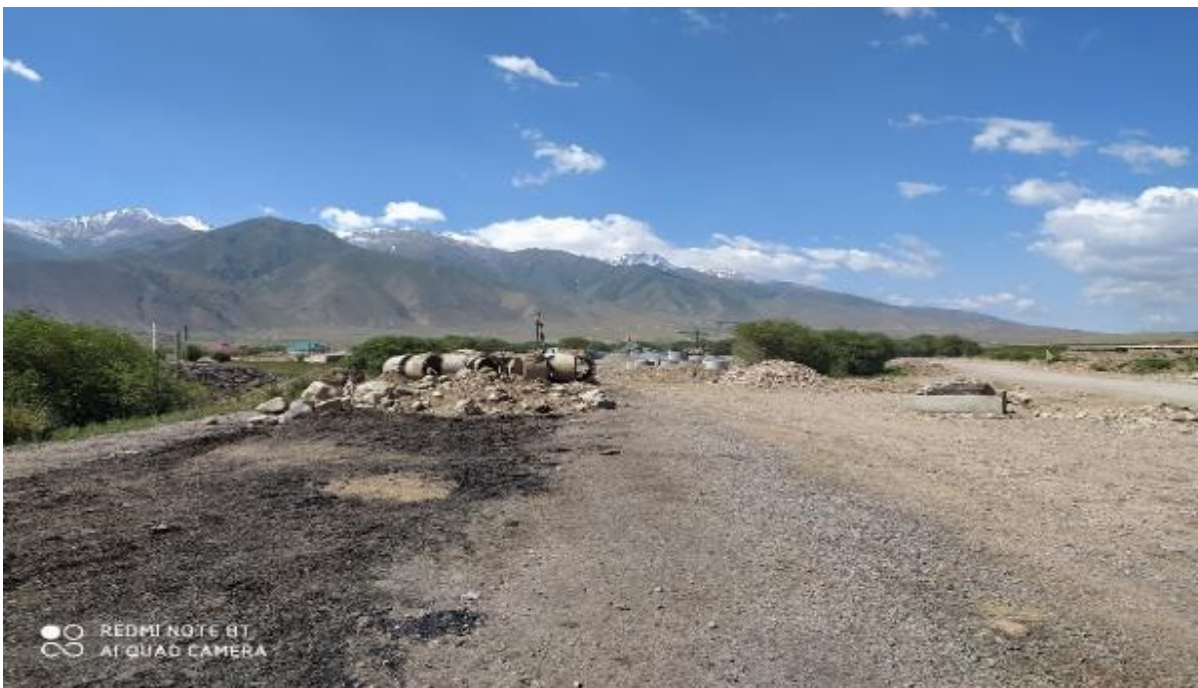
Figure 19. Stockpiling of old culverts

60. In connection with these construction works, old reinforced concrete elements are stockpiled on the shoulder, which, as soon as they are stocked in some amount, are handed over to the local Road Maintenance Company, and the broken ones are disposed of. During the reporting period, cases were identified when old culverts interfered with road safety. Disposal locations are determined by local authorities.

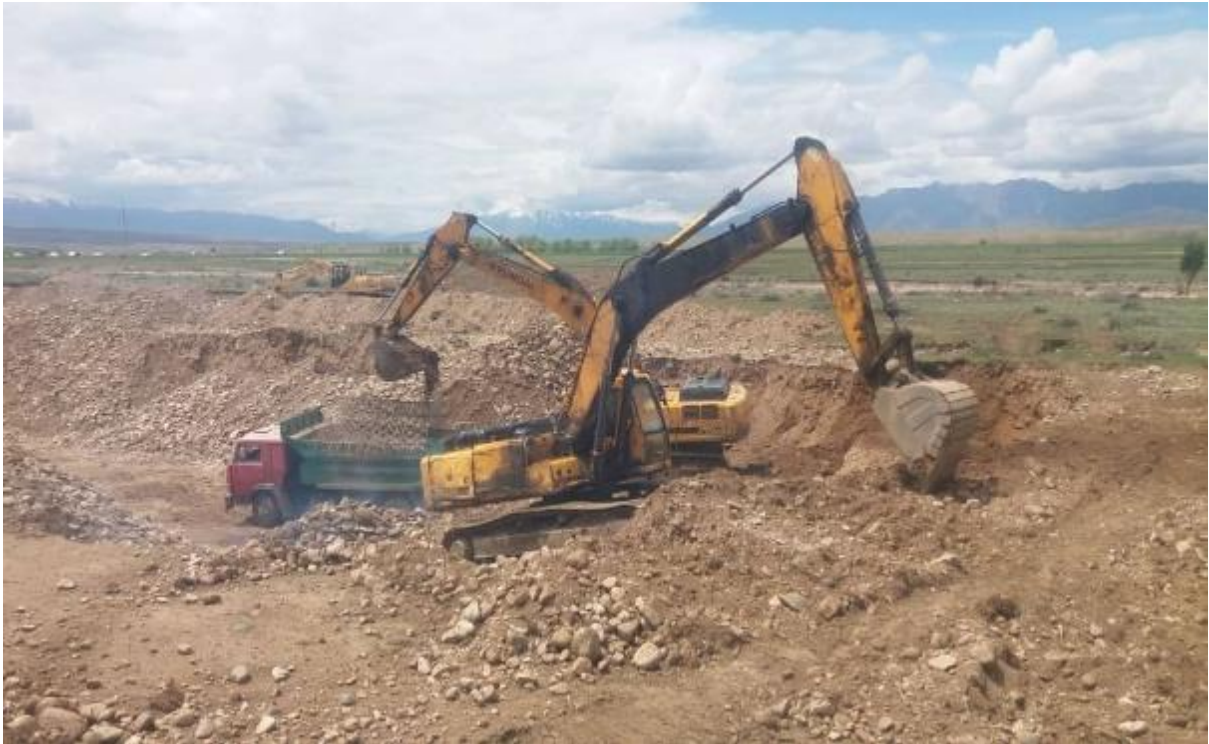
Figure 20. Quarry at km 148+630

61. The quarry at km 148 + 630 belongs to the category of self-renewing due to the quarry location in the river floodplain, exposed to mudflows.

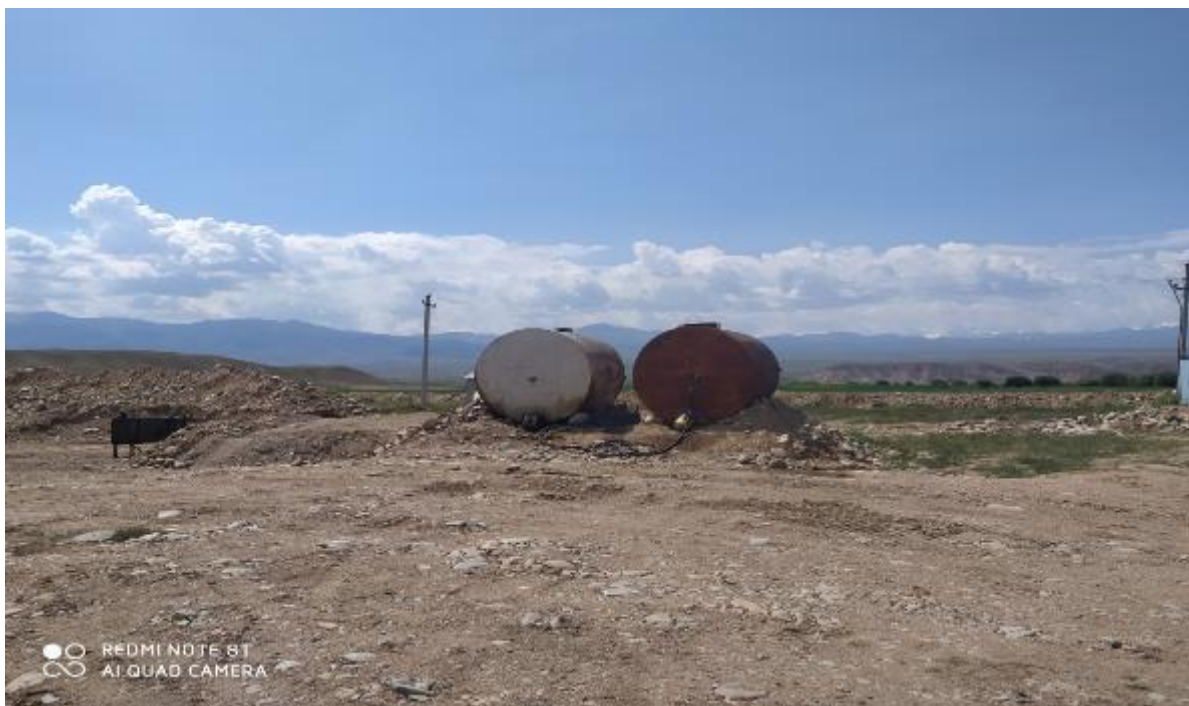
Figure 24. Tanks for fuels and lubricants

66. It was found that the Crusher was working without proper maintenance of cleanliness and order of the workplace with separate processing of construction and household waste and the absence of a fire shield in place.
67. On the production site territory, tanks for fuels and lubricants were not installed on a concrete base. Fuel and oil spill on the ground was detected during the walk-around. The fire shield was not completed. A non-compliance letter was sent to the Contractor and the problematic issues were resolved.

97. Based on the notification, the territory of the production site was cleared of construction waste. All noted violations were eliminated. Separate waste containers were installed. Fire safety measures were taken, fire shields were completed.

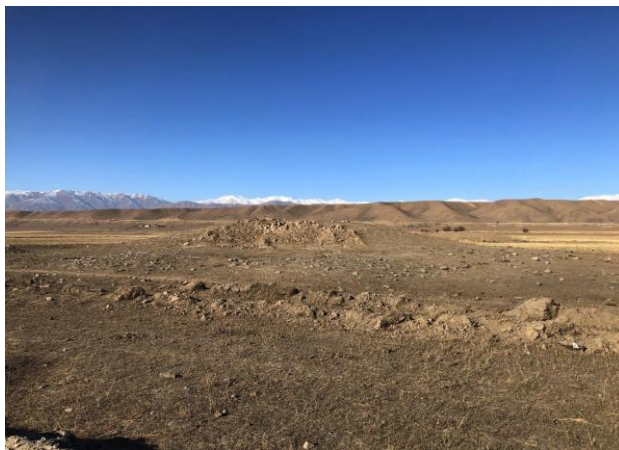
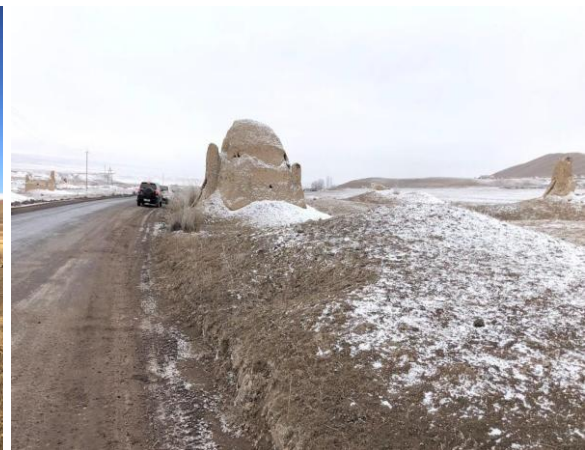
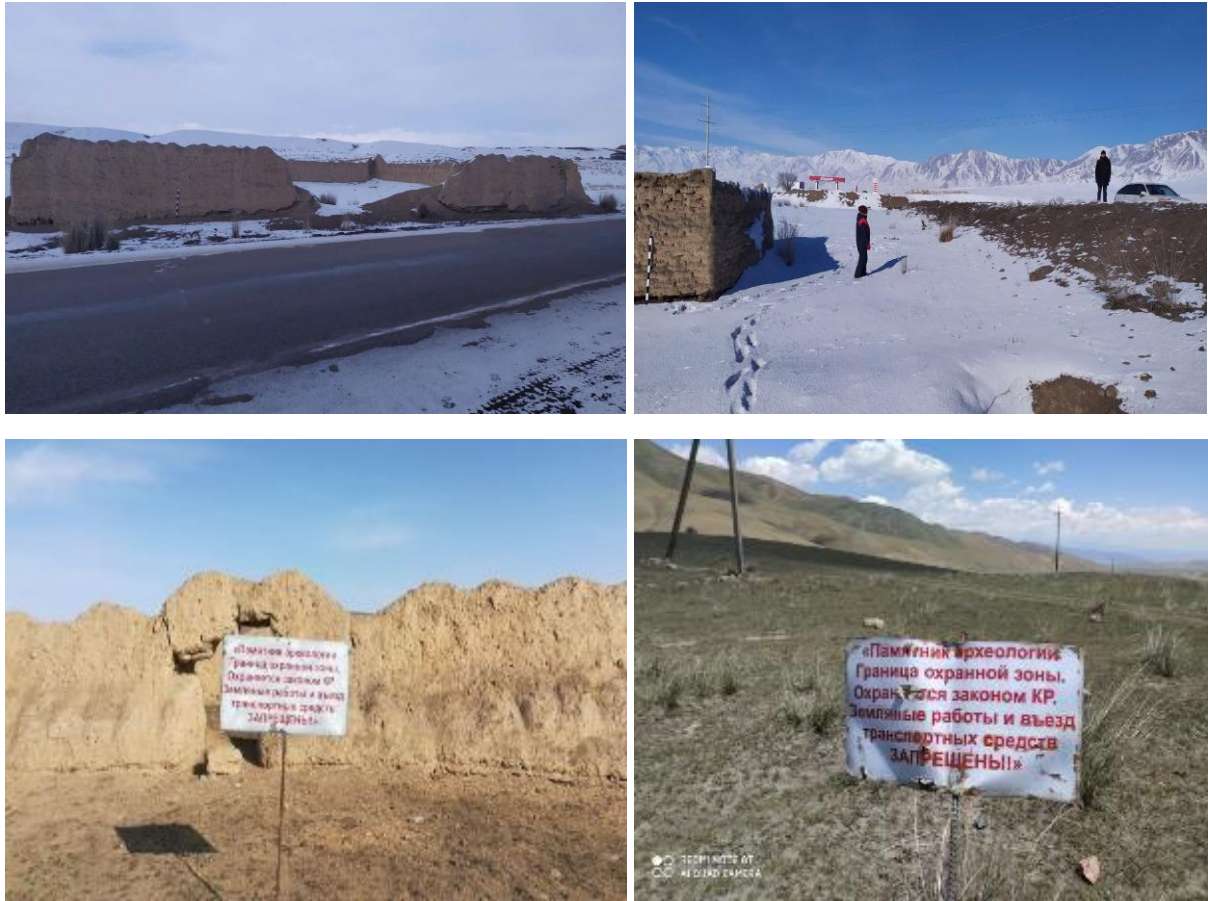
Figure 26. HCHS and protective measures

79. The contractor is taking measures to protect HCHS at the construction road section (installation of information shields and protective tapes).
80. The Contractor has not yet provided a specific report on the study of the presence of additional objects that may be encountered in the excavation work, prior to the start of construction work at the archaeological sites.

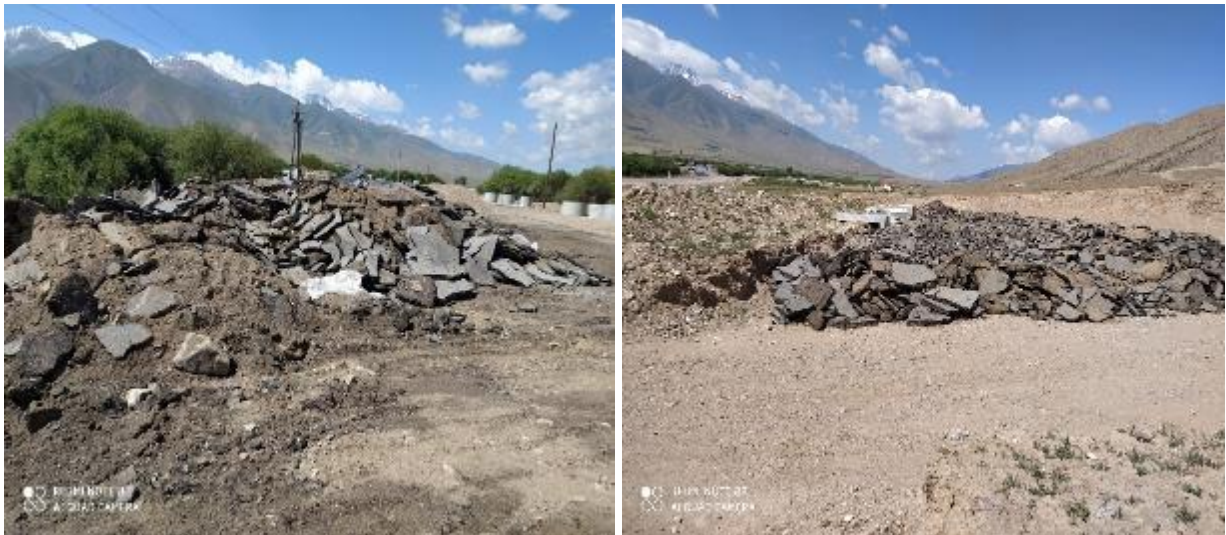
Figure 27. Old asphalt at km 91+600

88. Also, the Head of the Cholpon aiyl district asked to fill old asphalt on the internal roads of Ak-Chiy and Uzun-Bulak villages.
89. The problem of breaking up large old asphalt is a laborious job, mostly the old asphalt is taken to the backfill of rural streets proposed by the local authorities. Partially asphalt and unusable soil, at the written request of the owners, is taken out to private sites oriented /designed for commercial use.

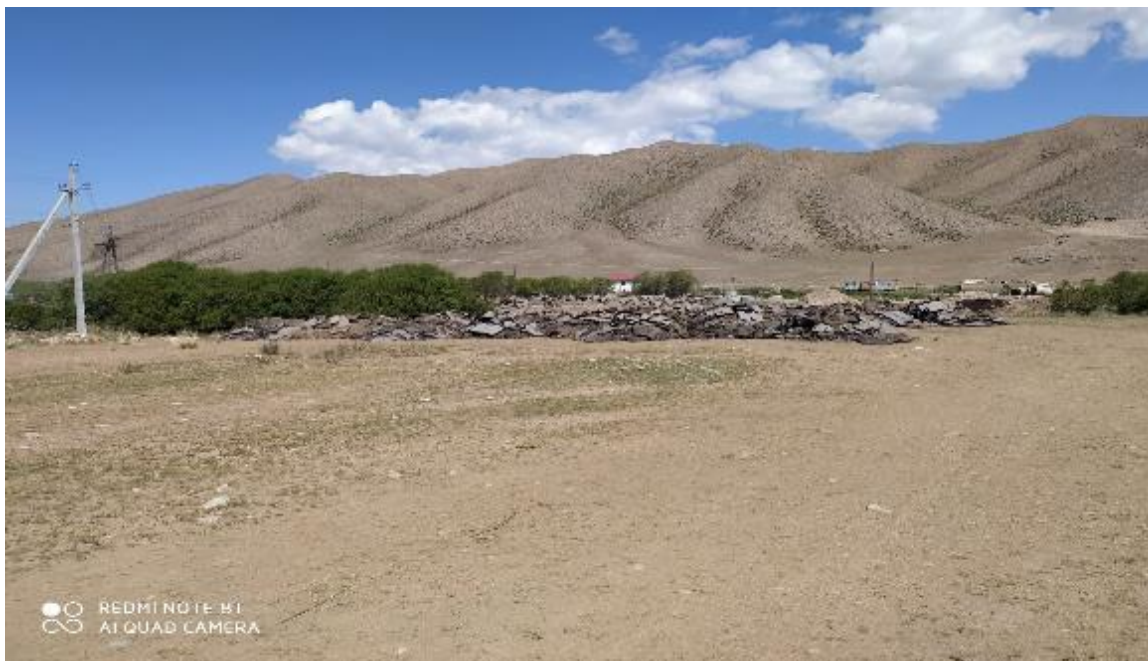
Figure 30. Old asphalt on the territory Ak-Chiy v. for backfilling roads

91. On a section km 91 + 600, the residents and representatives of the Ak-Chiy ayil okmotu addressed the Contractor with a letter to remove the old asphalt to the territory of this ayil okmotu, explaining that they need this old asphalt to backfill roads inside the village. In this regard, the stripped old asphalt in this area was removed and stored at designated sites in the territory of this village. In the future, this asphalt will be used as needed for the improvement of the internal roads of the named village.

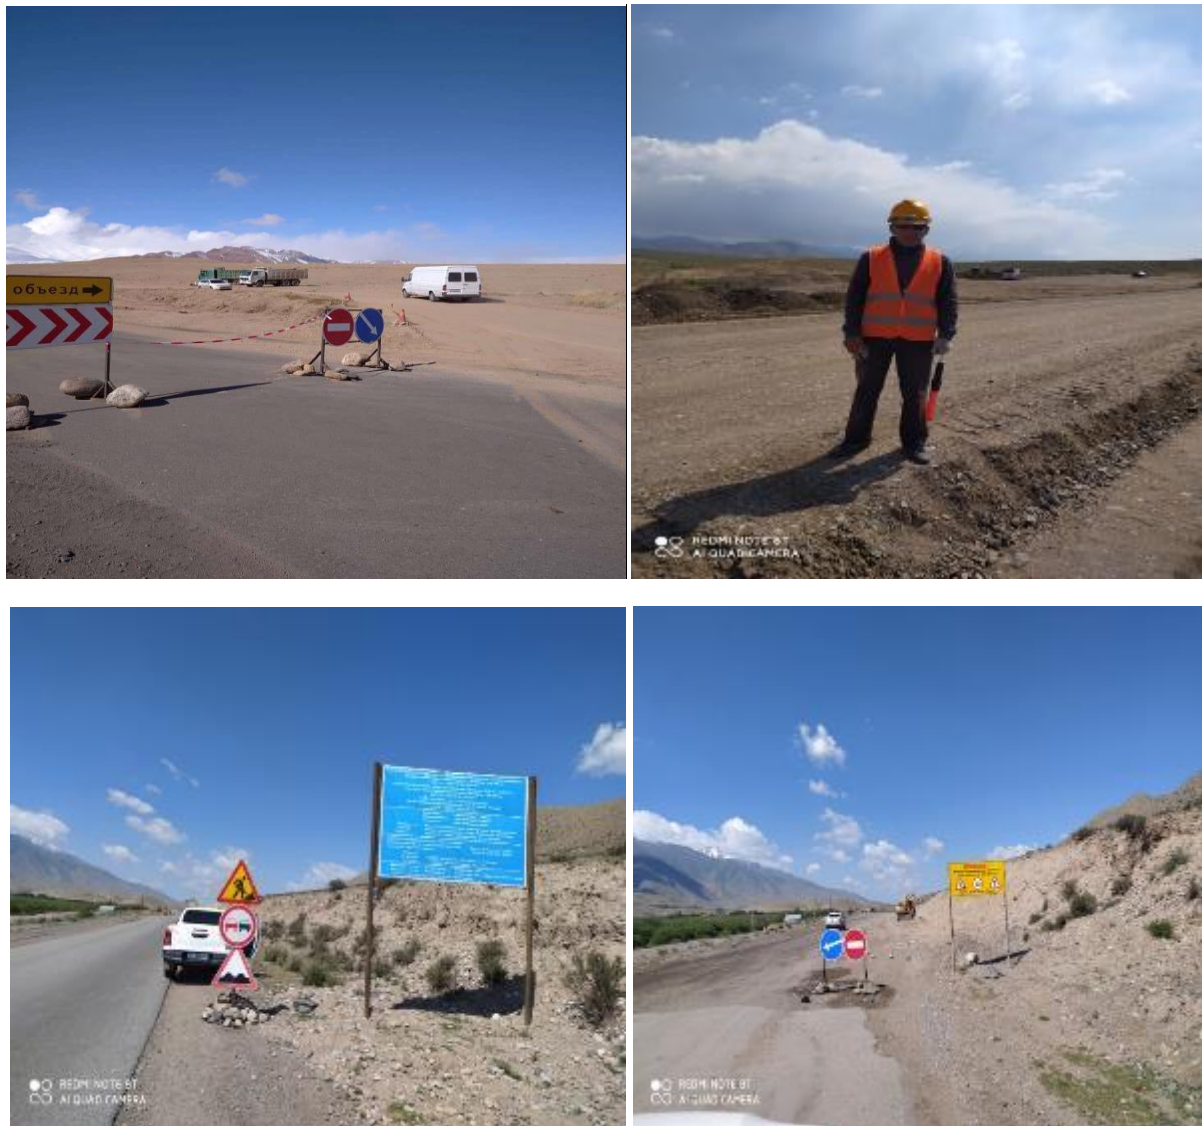
Figure 47. Implementation of Road Safety Measures

148. Road safety measures are not being properly implemented as there are not enough road signs and markings.
149. In the course of supervision of construction works, violations of safety rules made by workers were identified, such as work without personal protective equipment, lack of protective helmets, respirators, lack of special shoes and etc.
