Biannual Environmental Monitoring Report

Project Number: 42399
Grant Number: ADB Loan No. 2533-KGZ (SF) and Grant No. 0153-KGZ (SF)
Reporting Period: July-December 2013

Kyrgyz Republic
CAREC Transport Corridor -1
(Bishkek – Torugart road) Project 2
Section 1, km 365+500 – 400+600
Section 2, km 439+000 – 479+000

Prepared By the Ministry of Transport and Communications of the Kyrgyz Republic

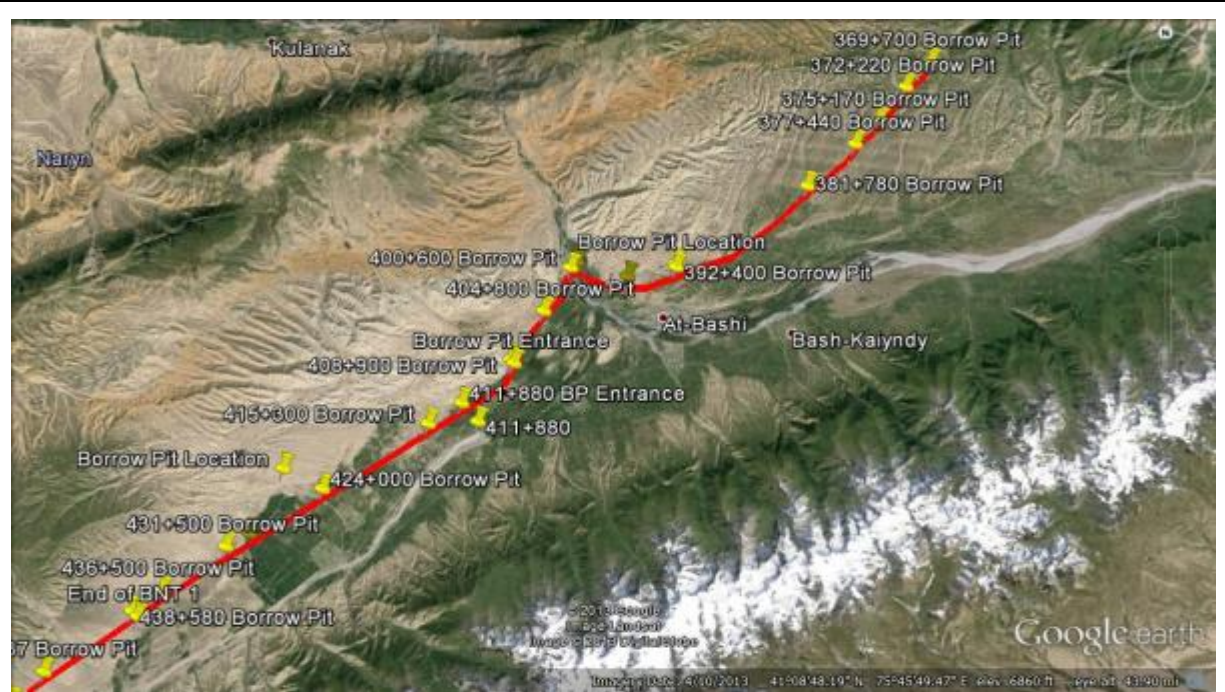
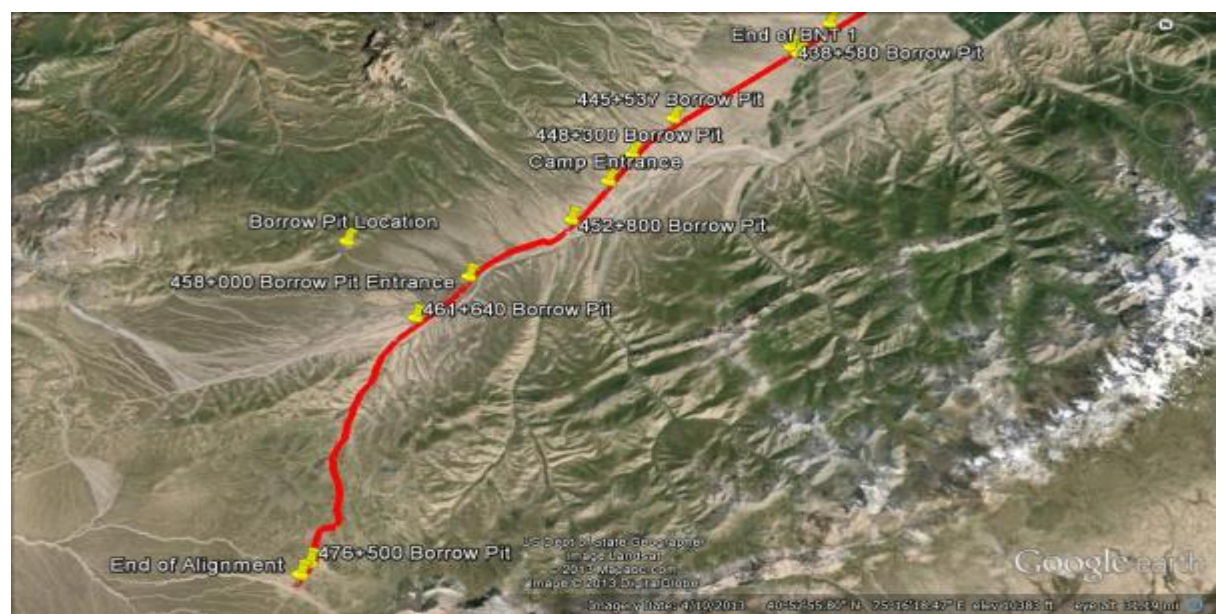
22. Under BNT 2, the Contractor has recultivated nearly all borrow, and only the one at km 396+800 remains open) by the end of October. The Commission to approve/reject the recultivated pits approved them in October. The borrow pit used for At Bashy road will not be closed until the road construction requirements are met.

Figure 3 below shows the alignment with the locations of the borrow pits.

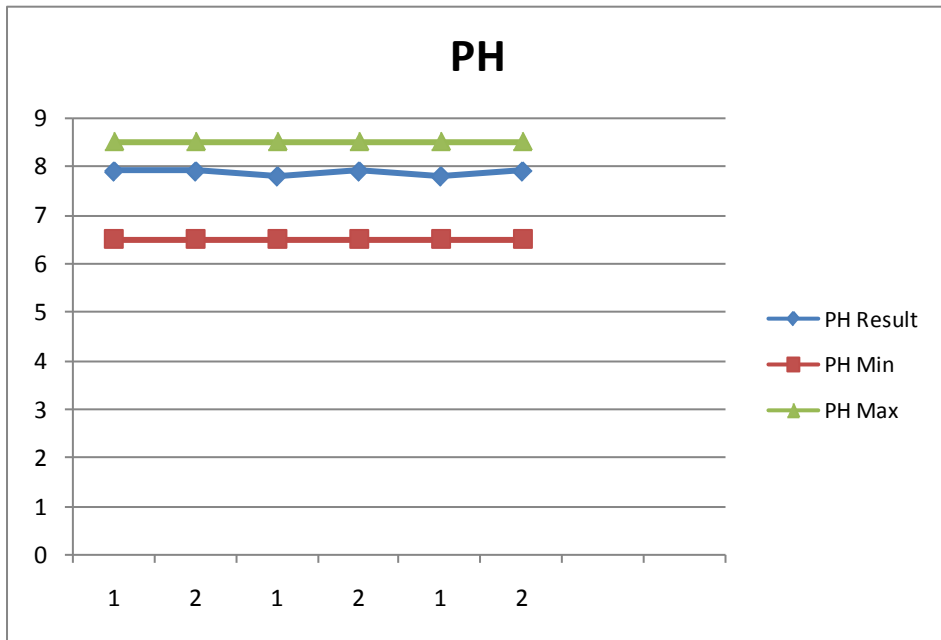
Figure 1: PH Levels

14. Test results for water quality in the Kara Koyun River were taken at the camp at km 452. The tests for PH (Figure 1), nitrates (Figure 2), sulfates (Figure 3) and oil products (Figure

PH				
Date	Points	Result	Min	Max
7/18/2013	1	7.9	6.5	8.5
	2	7.9	6.5	8.5
8/15/2013	1	7.8	6.5	8.5
	2	7.9	6.5	8.5
9/25/2013	1	7.8	6.5	8.5
	2	7.9	6.5	8.5

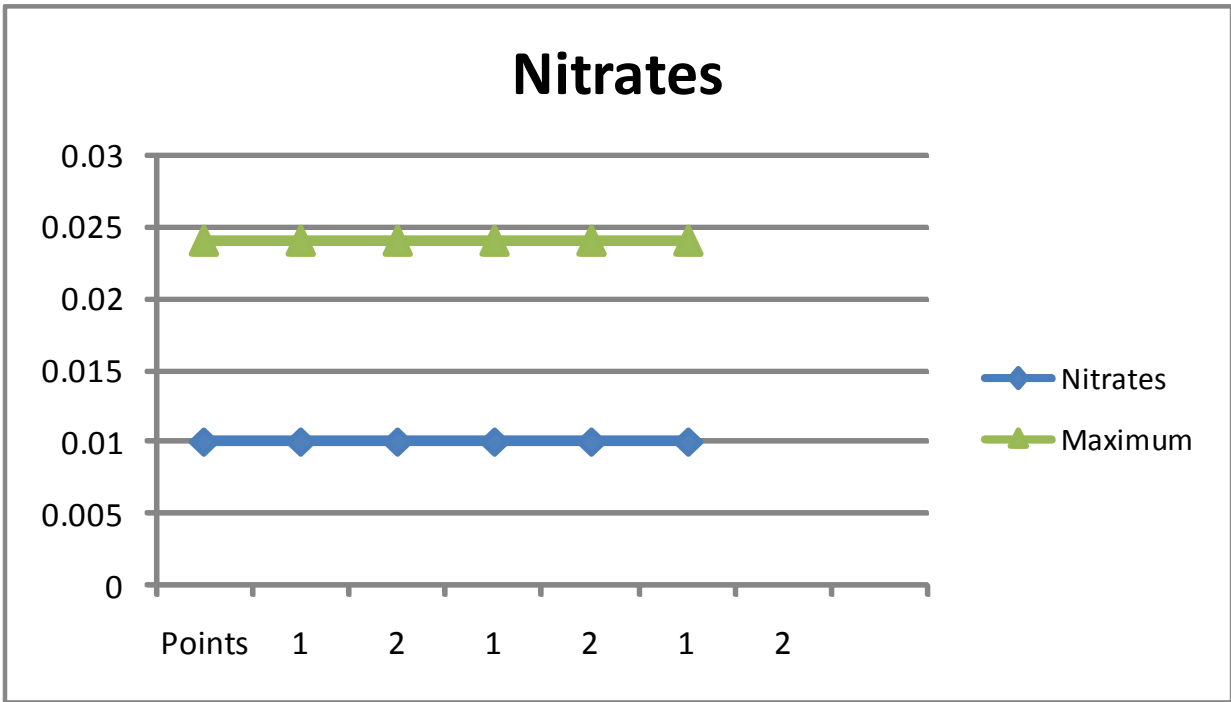
Figure 2: Nitrate Levels

Nitrates			
Date	Points	Result	Max
7/18/2013	1	0.01	0.024
	2	0.01	0.024
8/15/2013	1	0.01	0.024
	2	0.01	0.024
9/25/2013	1	0.01	0.024
	2	0.01	0.024

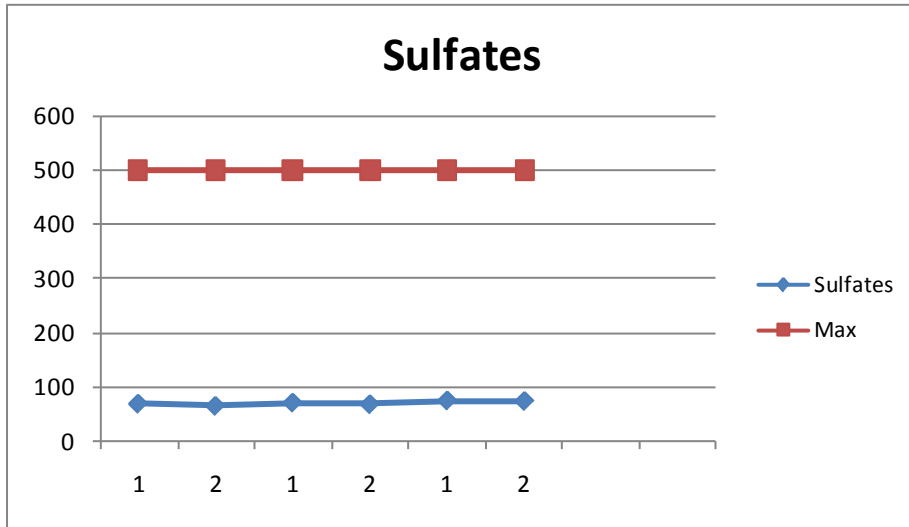
Figure 3: Sulfate Levels

Sulfates			
Date	Points	Result	Max
7/18/2013	1	69	500
	2	65	500
8/15/2013	1	71	500
	2	68	500
9/25/2013	1	75	500
	2	74	500

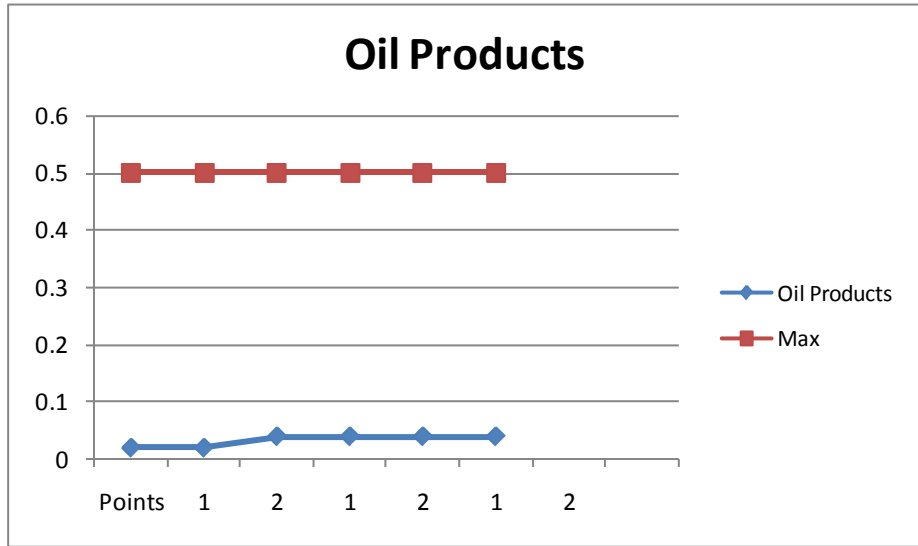
Figure 4: Levels of Oil Products

Oil Products			
Date	Points	Result	Max
7/18/2013	1	0.02	0.5
	2	0.02	0.5
8/15/2013	1	0.04	0.5
	2	0.04	0.5
9/25/2013	1	0.04	0.5
	2	0.04	0.5

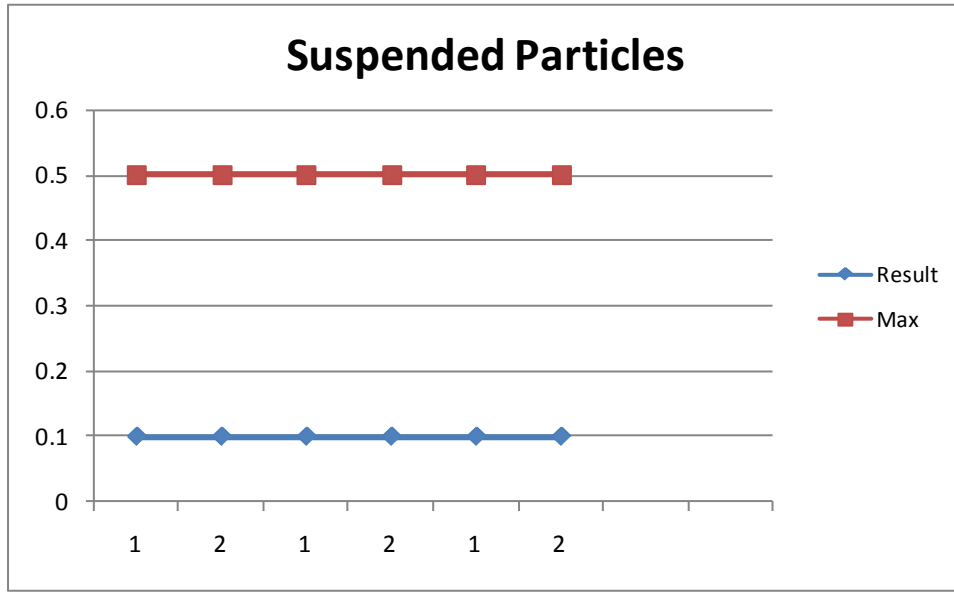
Figure 5: Levels of Suspended Particles

15. For air quality, test results for suspended particles (Figure 5), carbon monoxide (Figure 6), sulfure dioxide (Figure 7), and nitrogen dioxide (Figure 8) were all within permissible levels. Air quality at the Tash Rabat asphalt/coating plant has been closely monitored because previous test results for carbon monoxide and sulfur dioxide had exceeded permissible levels in June 2012.

Suspended Particles			
Date	Points	Result	Max
7/19/2013	1	0.1	0.5
	2	0.1	0.5
8/14/2013	1	0.1	0.5
	2	0.1	0.5
9/25/2013	1	0.1	0.5
	2	0.1	0.5

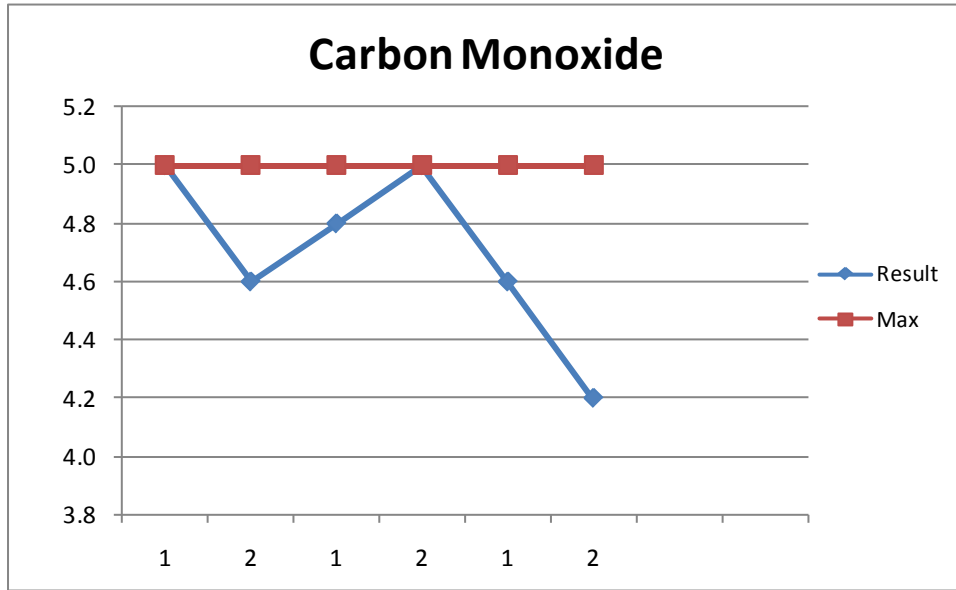
Figure 6: Levels of Carbon Monoxide

Carbon Monoxide			
Date	Points	Result	Max
7/19/2013	1	5.0	5
	2	4.6	5
8/14/2013	1	4.8	5
	2	5.0	5
9/25/2013	1	4.6	5
	2	4.2	5

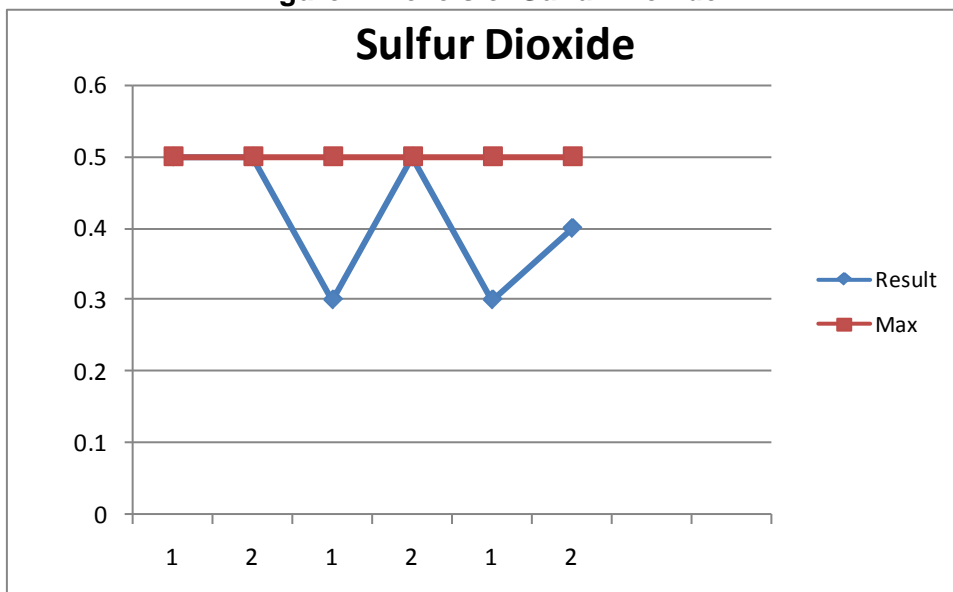
Figure 7: Levels of Sulfur Dioxide

Sulphur Dioxide			
Date	Points	Result	Max
7/19/2013	1	0.5	0.5
	2	0.5	0.5
8/14/2013	1	0.3	0.5
	2	0.5	0.5
9/25/2013	1	0.3	0.5
	2	0.4	0.5

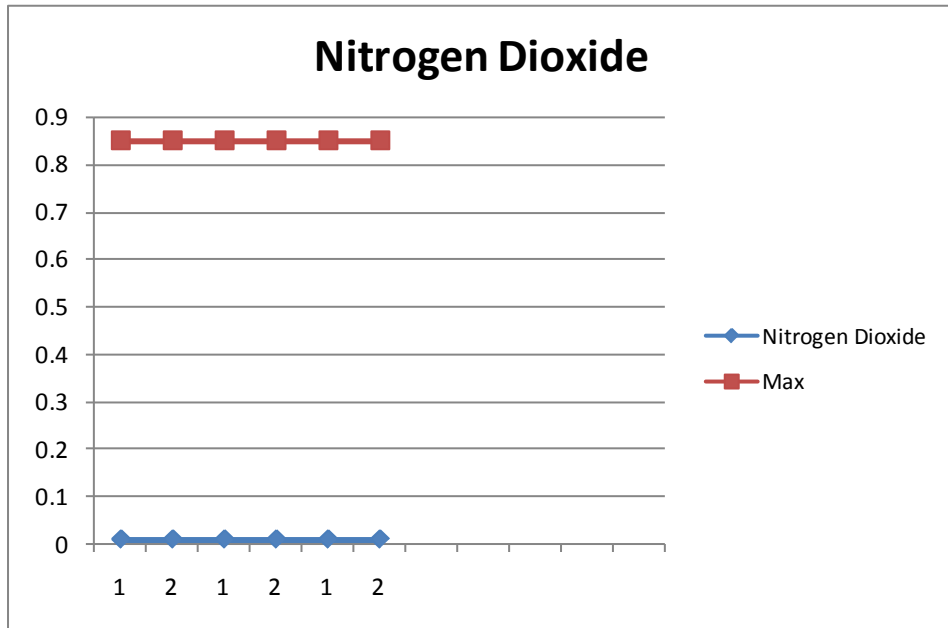
Figure 8: Levels of Nitrogen Dioxide

Nitrogen Dioxide			
Date	Points	Result	Max
7/19/2013	1	0.01	0.85
	2	0.01	0.85
8/14/2013	1	0.01	0.85
	2	0.01	0.85
9/25/2013	1	0.01	0.85
	2	0.01	0.85
