Environmental Monitoring Report

Project Number: 42399-02
Grant Number: ADB Loan No. 2755-KGZ (SF)
Reporting Period: June to December 2013

Kyrgyz Republic
CAREC Transport Corridor -1
(Bishkek – Torugart road) Project 3
SECTION KM479 to 539

Prepared By the Ministry of Transport and
Communications of the Kyrgyz Republic

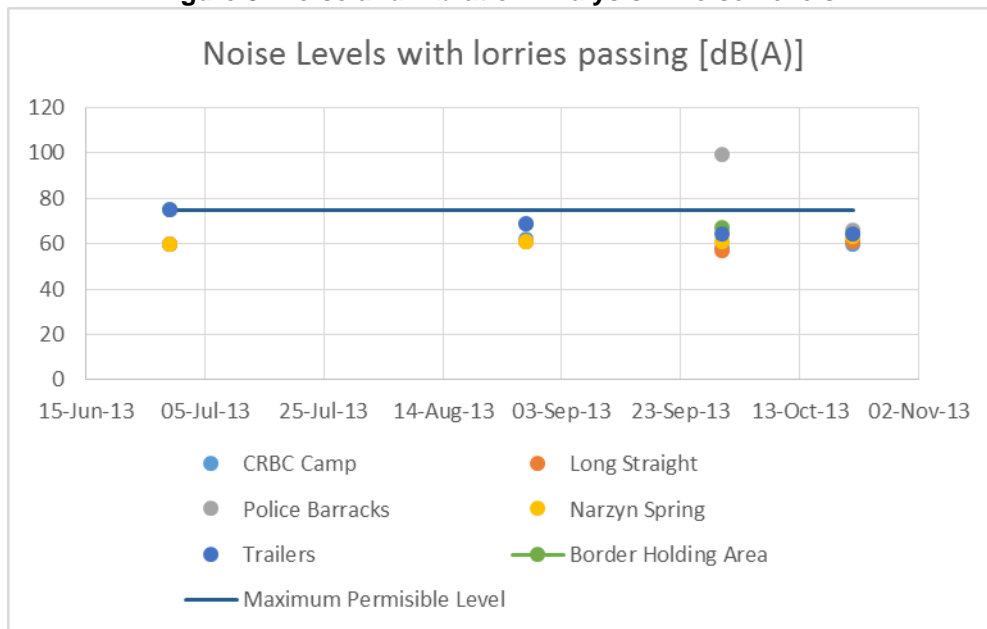
Figure 8: Noise and Vibration Analysis – Noise Levels

108dB with levels generally higher in the Border Holding Area as expected, where Heavy Duty Diesel Vehicles (HDDV) are maneuvering and loading engines. Given the relatively low intensity of operations on the road, it is suggested that monitoring equipment may have been inappropriately set up and operated on the initial monitoring operation in July 2013 and the results treated with caution. This situation has not been repeated, subsequent results are all compliant and no further investigation is proposed. It is noted that vibration measurements are generally higher, though compliant, in the border control holding area at Km 531.

30. The current monitoring situation reflects a before project condition and no noise or vibration mitigation actions are required at this time. However, it is proposed that future monitoring includes a photo record of the position of the noise / vibration monitor.

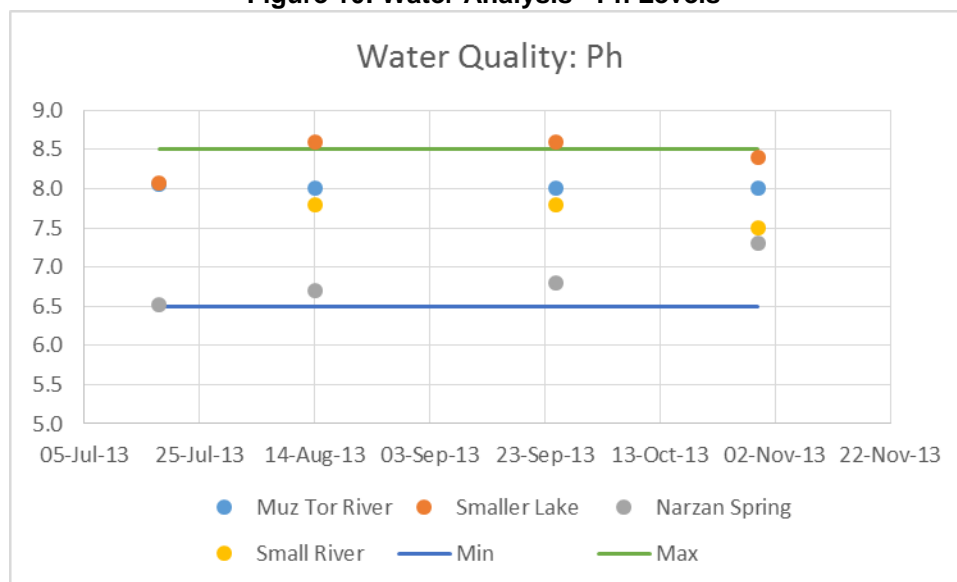
Figure 10: Water Analysis - Ph Levels

32. The results for Ph (Table 5 and Figure 10 on page 28), nitrates (Table 6 on page 28), sulfates (Table 7 and Figure 11 on page 29) and oil products (Table 8 on page 29) are all within permissible levels. Though the current works are unlikely to be having any impact on water quality it is noted that Ph values at the Lesser Lake were marginally high in August and September. It is also noted that results of nitrate and oil product testing were compliant and below detection limits. The current results indicate that project activities including the asphalt and crushing plants and camp have had limited or no impact on water quality.

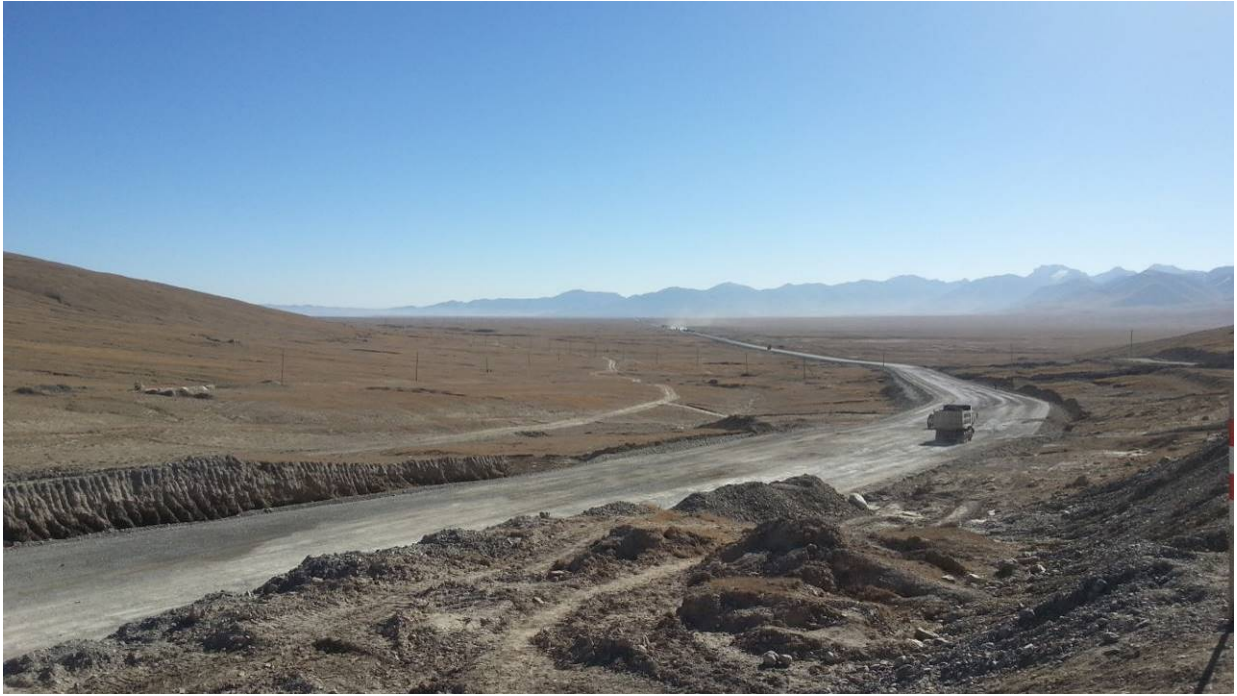
Figure 13: Looking from Camp at Km500 into the KJSR (October 2013)

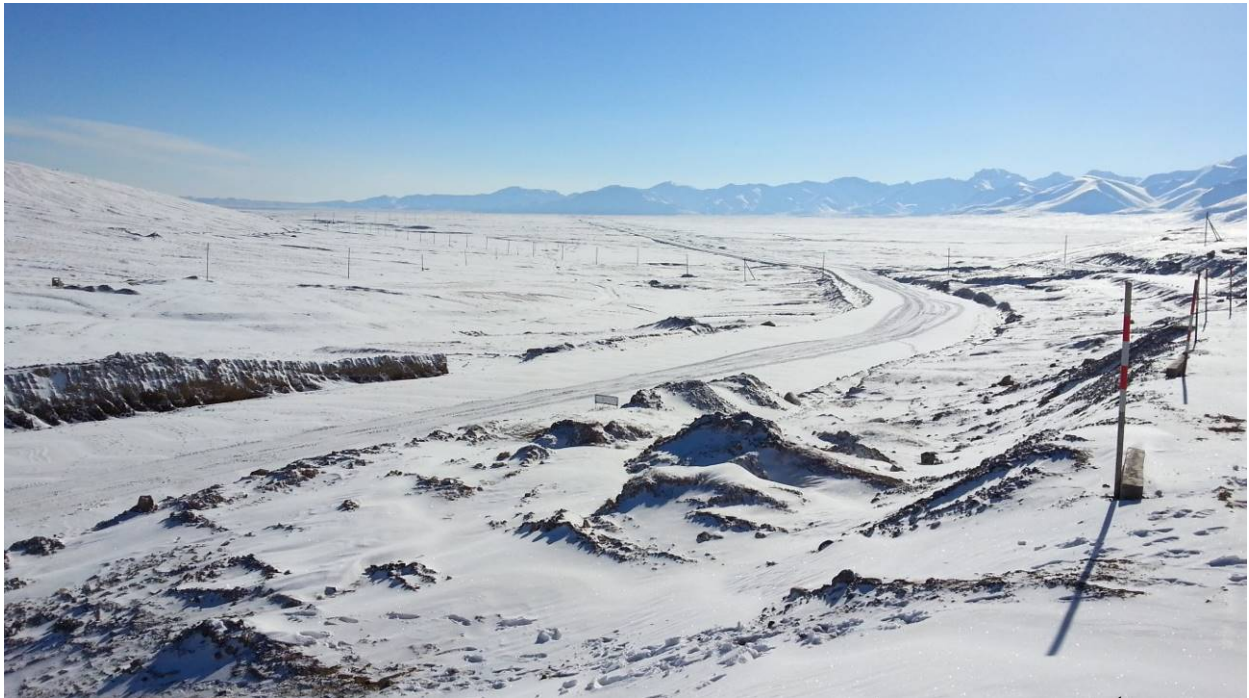
Figure 14: Looking from Camp at Km500 into the KJSR after first snow (October 31st 2013)

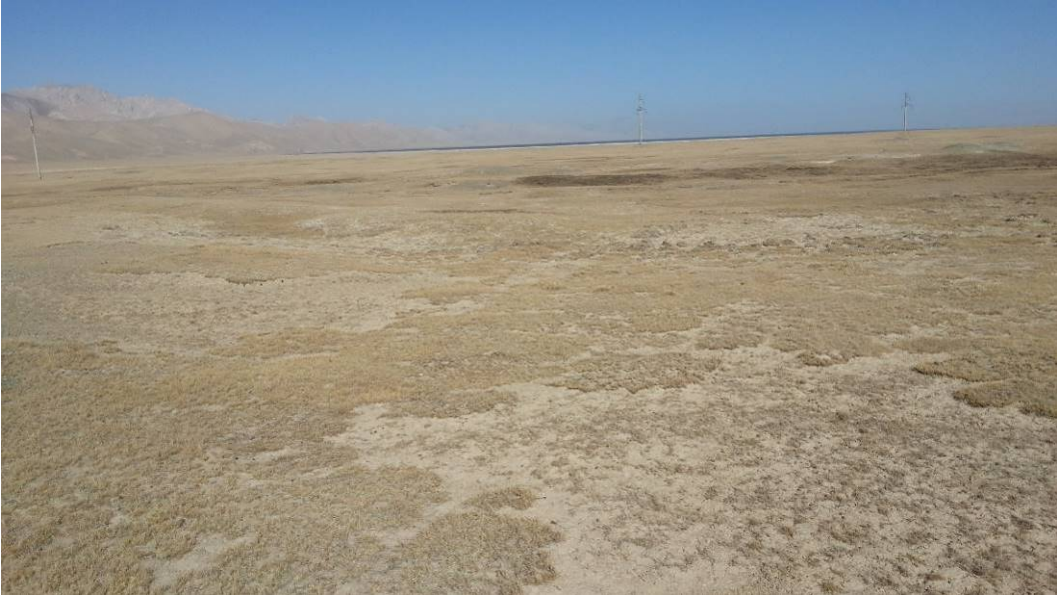
Borrow Pit # / Location	Date	Status	Photo – Current Status
<p>#9</p> <hr/> <p>Within KJSR</p> <hr/> <p>507+600 RHS</p> <hr/> <p>Volume 225,000m³</p> <hr/> <p>450 x 250 m</p> <hr/> <p>200m from road</p>	<p>Oct 2013</p>	<p>Not started <input checked="" type="checkbox"/></p> <p>In progress <input type="checkbox"/></p> <p>Extraction complete <input type="checkbox"/></p> <p>Restoration phase <input type="checkbox"/></p>

<p data-bbox="1016 857 1562 889">Figure 33: Borrow Pit #9 – Before any work</p>
<p>#10</p> <hr/> <p>Within KJSR</p> <hr/> <p>514+600 RHS</p> <hr/> <p>Volume 250,000m³</p> <hr/> <p>500 x 250 m</p> <hr/> <p>150m from road</p>	<p>Oct 2013</p>	<p>Not started <input checked="" type="checkbox"/></p> <p>In progress <input type="checkbox"/></p> <p>Extraction complete <input type="checkbox"/></p> <p>Restoration phase <input type="checkbox"/></p>

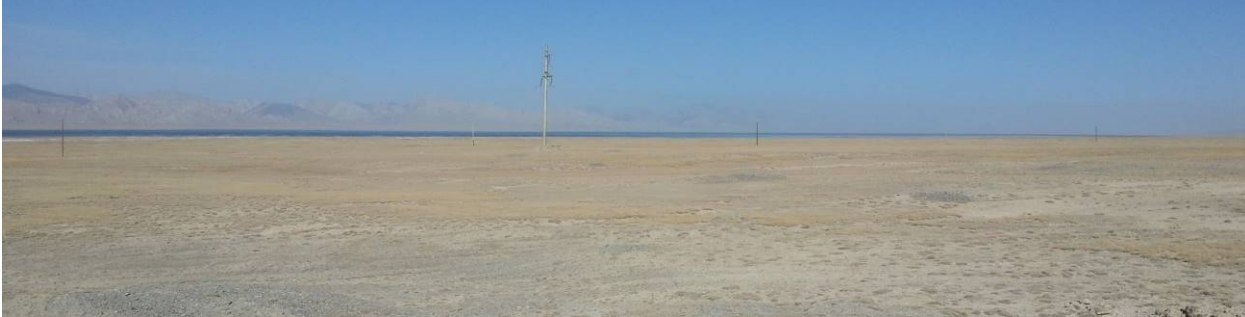
<p data-bbox="1010 1208 1570 1240">Figure 34: Borrow Pit #10 – Before any work</p>

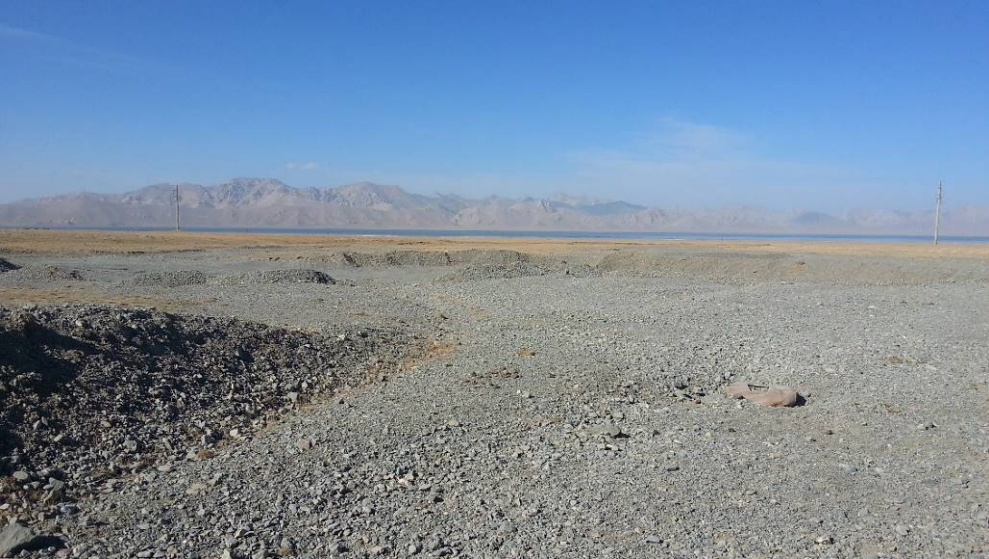
Borrow Pit # / Location	Date	Status	Photo – Current Status
<p>#11</p> <p>Within KJSR</p> <hr/> <p>518+000 RHS</p> <hr/> <p>Volume 325,000m³</p> <hr/> <p>650 x 250 m</p> <hr/> <p>100m from road</p>	<p>Oct 2013</p>	<p>Not started <input checked="" type="checkbox"/></p> <p>In progress <input type="checkbox"/></p> <p>Extraction complete <input type="checkbox"/></p> <p>Restoration phase <input type="checkbox"/></p>

<p data-bbox="1014 824 1564 849">Figure 35: Borrow Pit 11 – Before any Work</p>
<p>#12</p> <p>Within KJSR</p> <hr/> <p>528+200 RHS</p> <hr/> <p>Volume 325,000m³</p> <hr/> <p>650 x 250 m</p> <hr/> <p>160m from road</p>	<p>Oct 2013</p>	<p>Not started <input checked="" type="checkbox"/></p> <p>In progress <input type="checkbox"/></p> <p>Extraction complete <input type="checkbox"/></p> <p>Restoration phase <input type="checkbox"/></p>

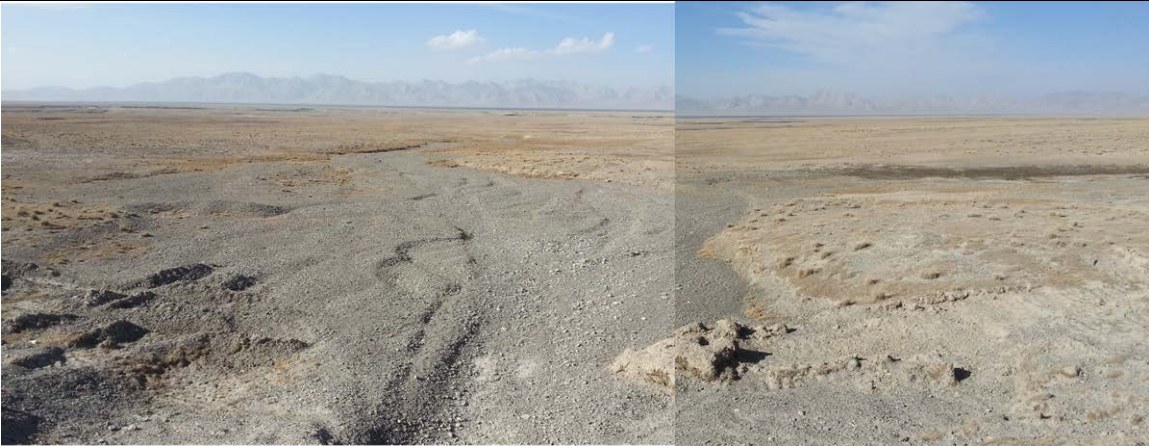
<p data-bbox="718 1300 1283 1341">Figure 36: Borrow Pit #12 – Before any Work</p>
